FILED
August 30, 2023
Data Center
Missouri Public
Service Commission

Exhibit No. 10

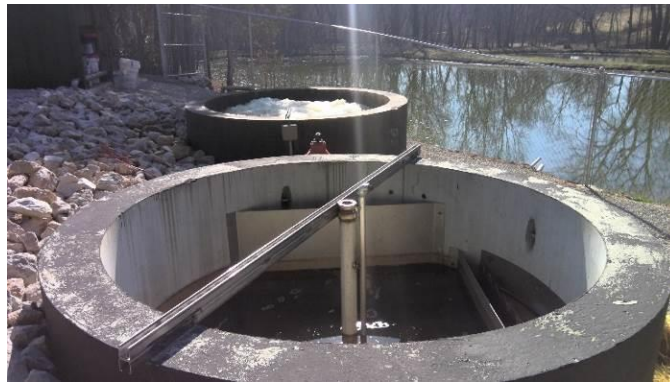
Lake Virginia Lagoon MBBR and clarifier project

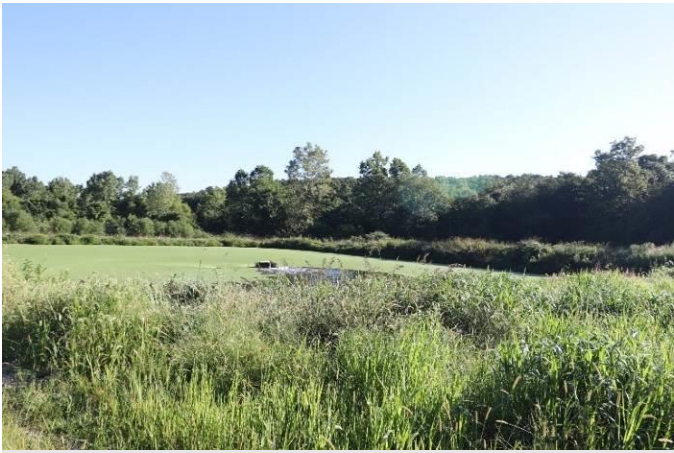
11 *Vegetation growth around 3-cell lagoon*

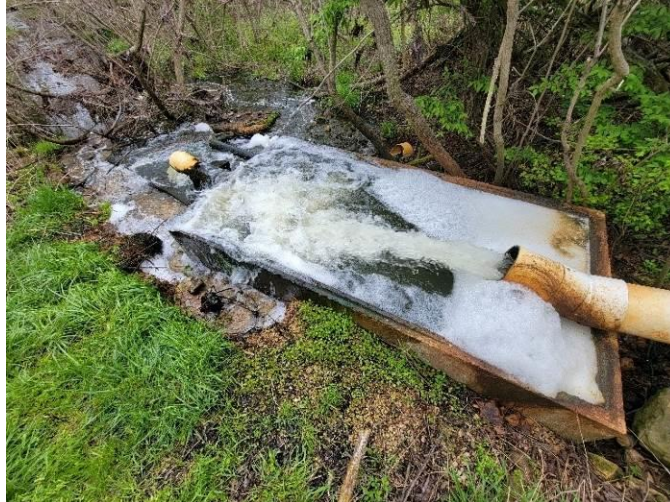
Disinfection system overwhelmed with high flows due to I&I issues. Note overflows over the sides of the contact chamber walls

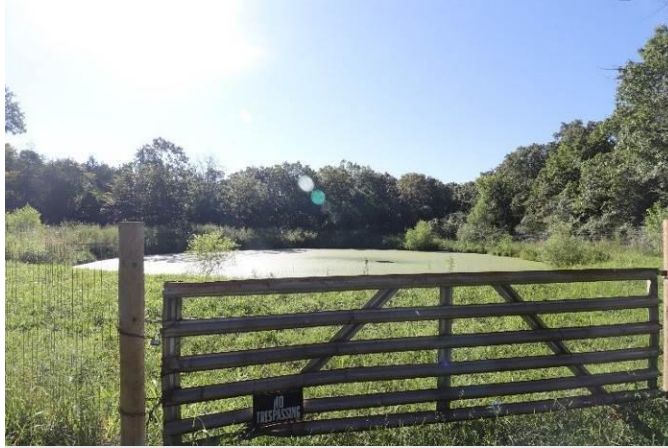
Overgrowth around lagoon, varmint damage on berms visible

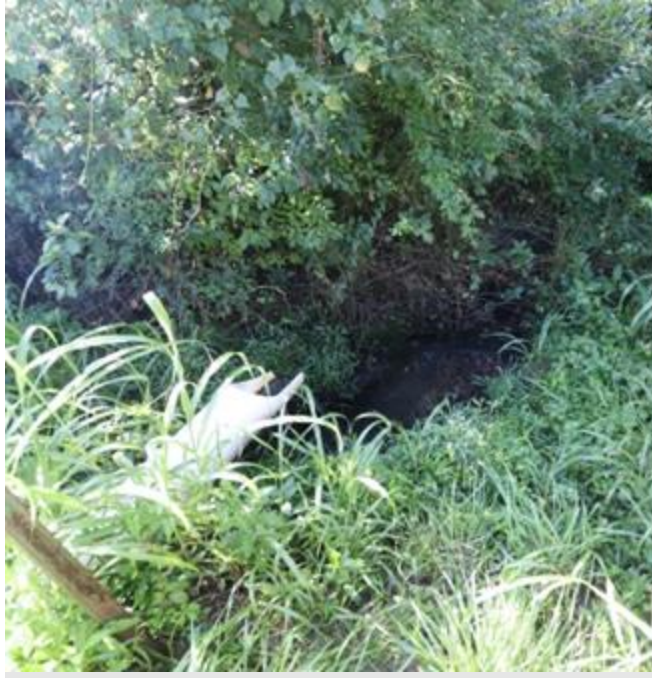
Discharge from single cell lagoon with no disinfection equipment

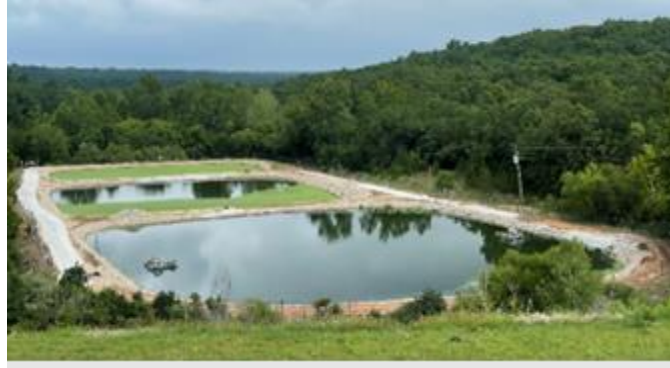
Cleared and rock-lined berms and paths around lagoon

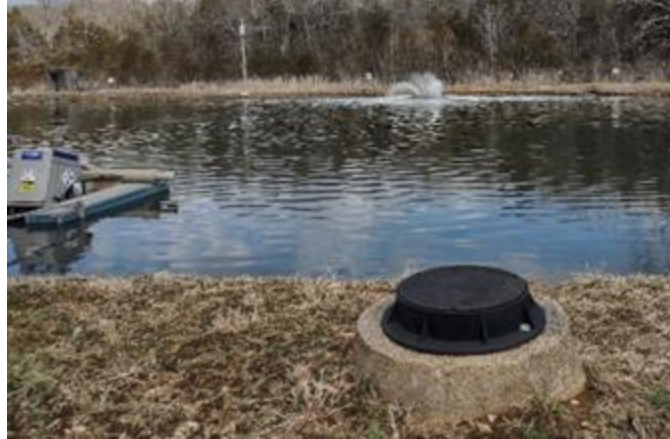
New Airmaster aerators installed in first cell of the lagoon system

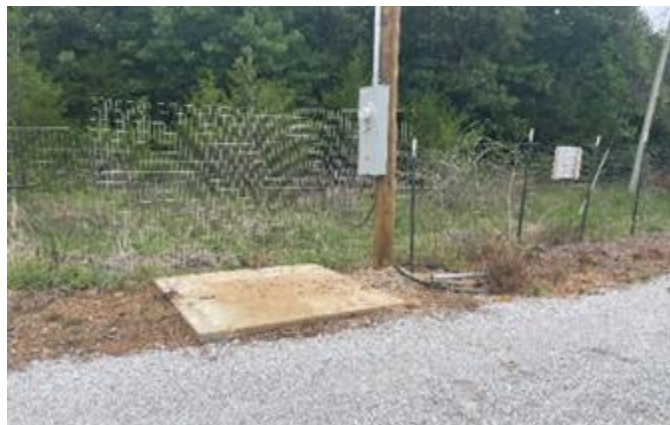
Site of old control shack and new power service to site

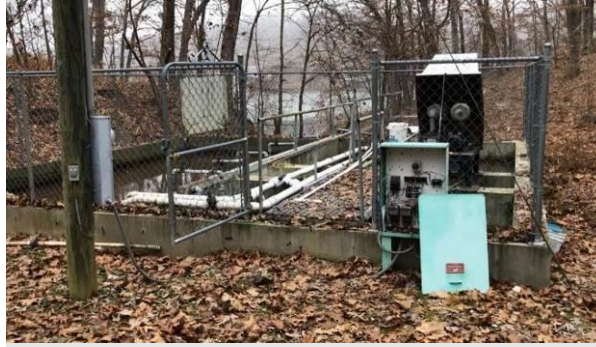
Overview of facility at acquisition

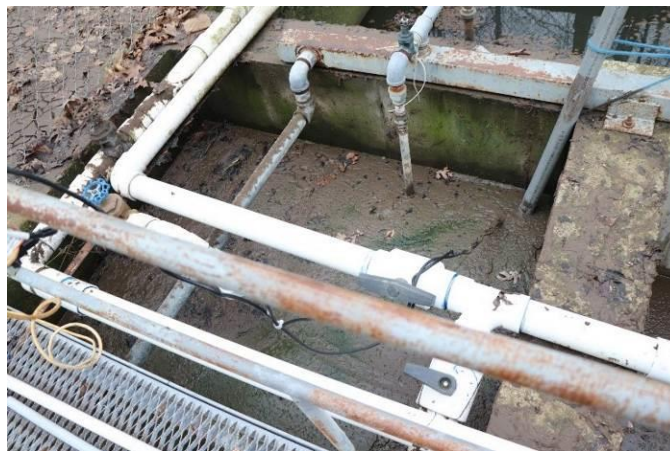
Overfilled sludge digester

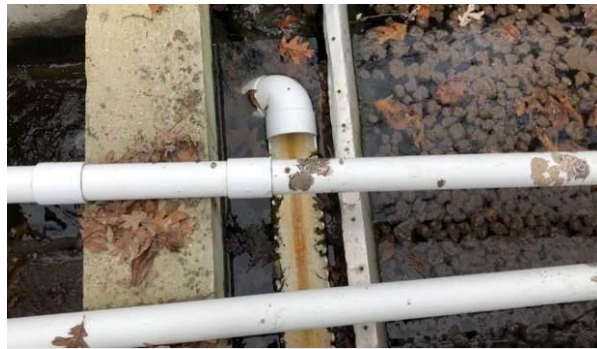
9
10 *Sludge floating in clarifier basin, cobbled together PVC piping*

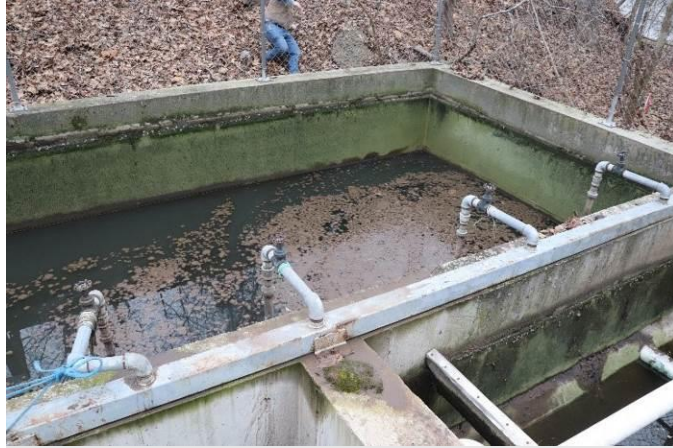
4 *Poor condition of steel aeration piping (note blue ropes holding pipes in place at left) also note aeration*
5 *system was not running and floating sludge in aeration basin*
6
7

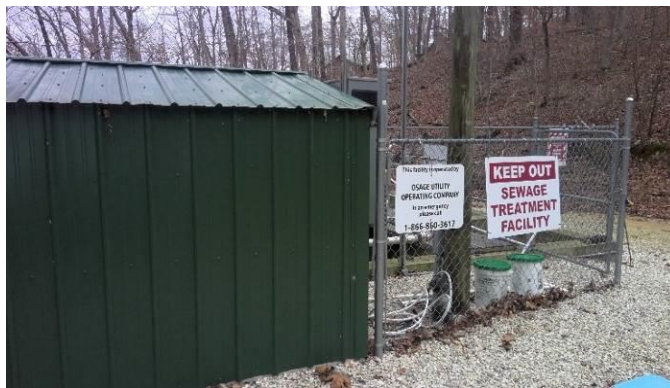
New blower housing and fence area

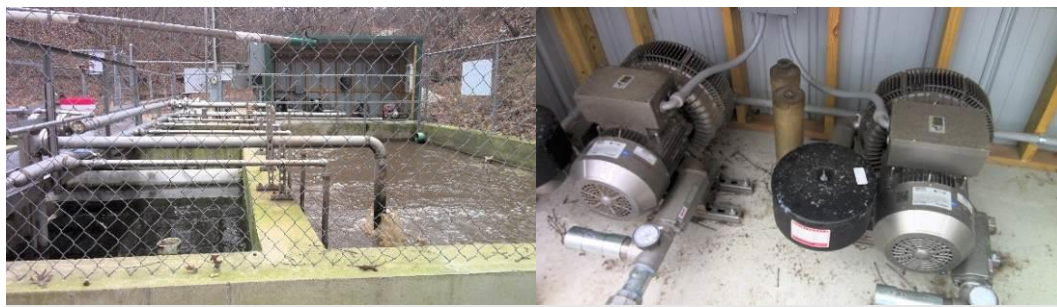
New aeration piping, blowers, and valving

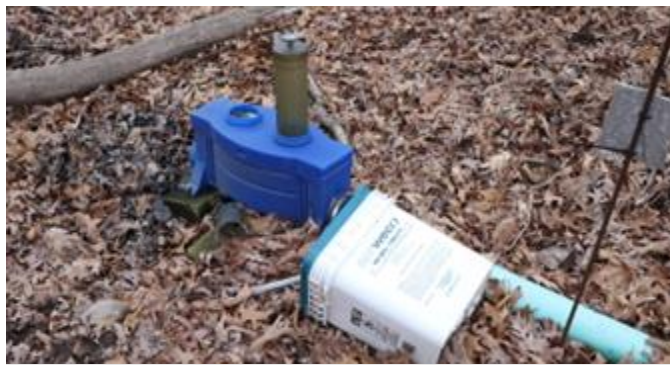
New dechlorination tablet feeder

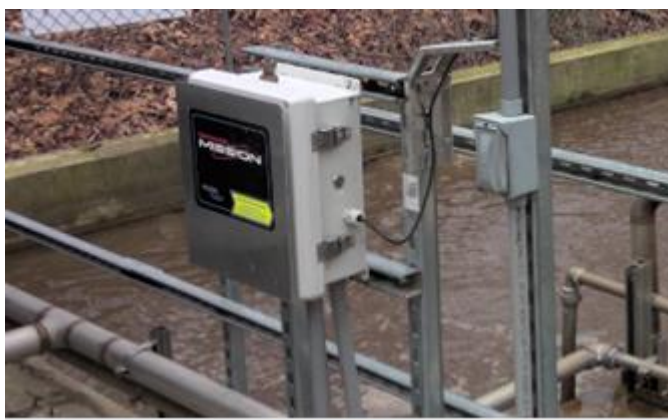
Newly installed remote monitoring system

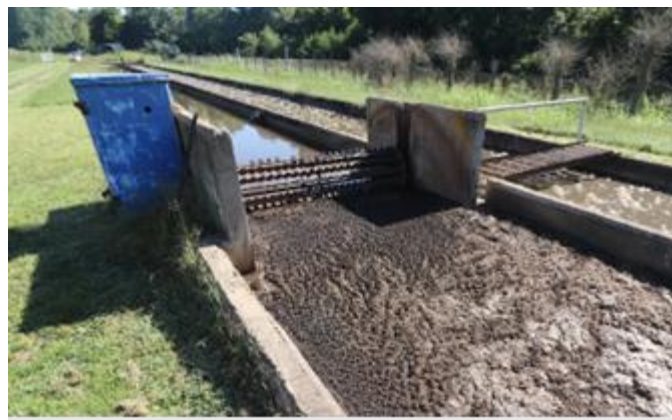
15
16 *Failed brush aerator at Oxidation Ditch*

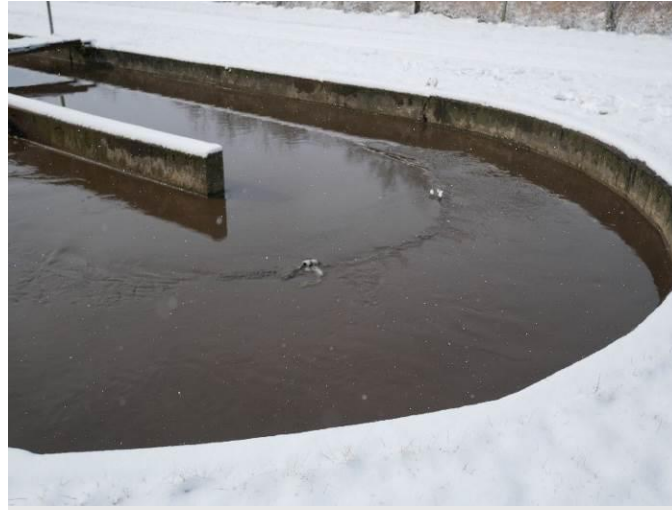
4
5 *Sludge accumulation breaking the surface of water in the Oxidation Ditch*

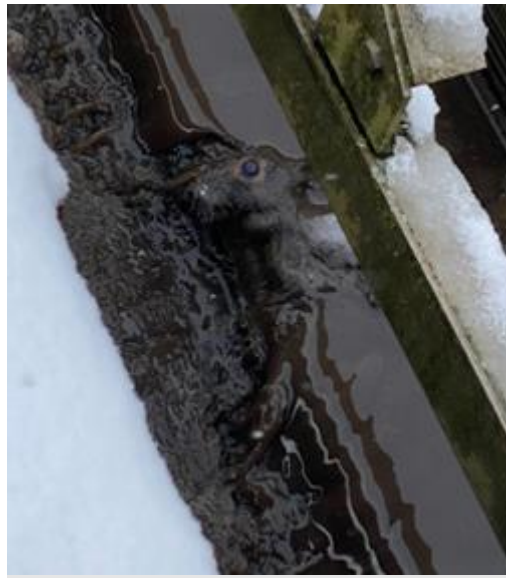
Dead rabbit in sluice box

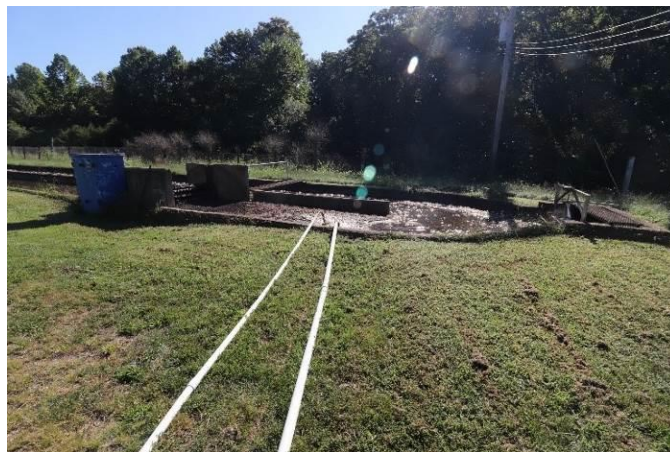
Above ground RAS lines at Oxidation Ditch

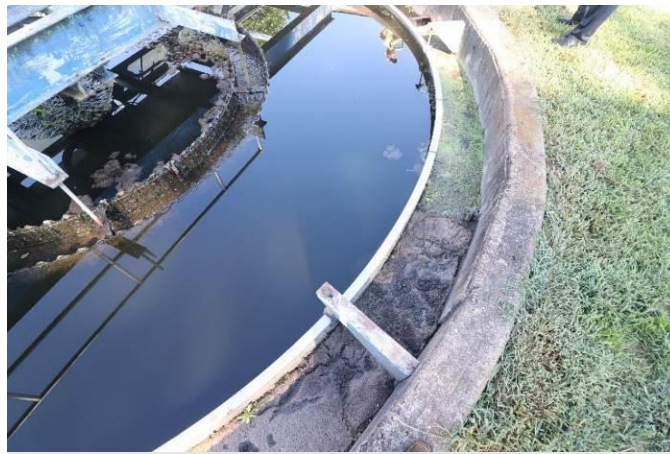
7
8 *Significant accumulation of sludge in skimmer trough due to failed mechanical components of clarifier*
9

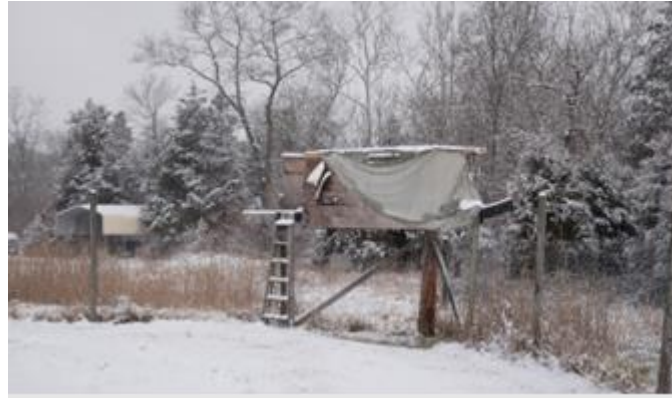
4
5 *Hunting blind on utility property*

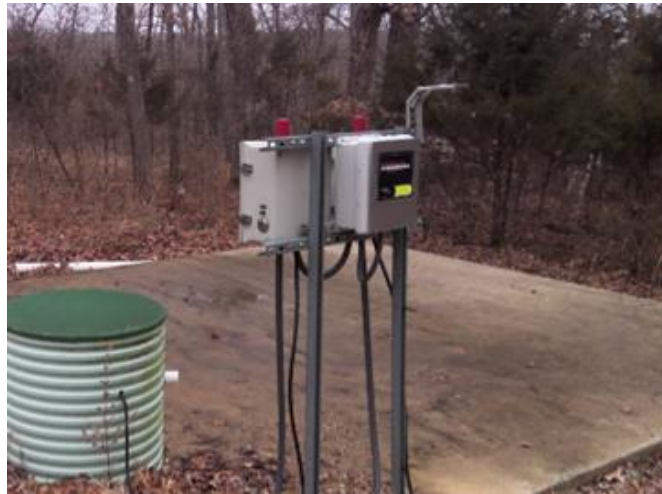
6
7 *Remote monitoring unit at treatment facility*

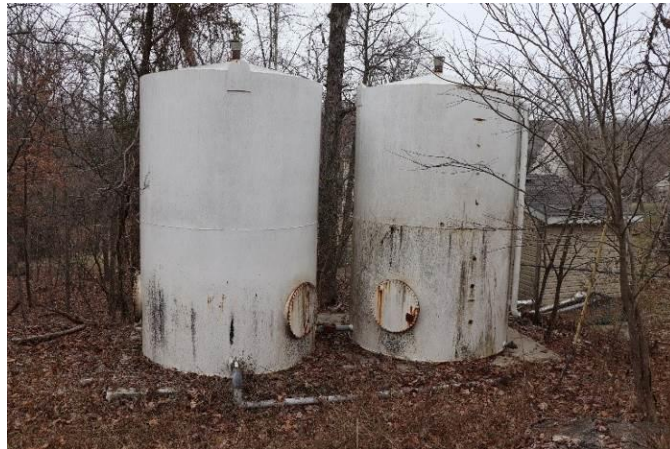
12 *Condition of ground storage tanks at acquisition*

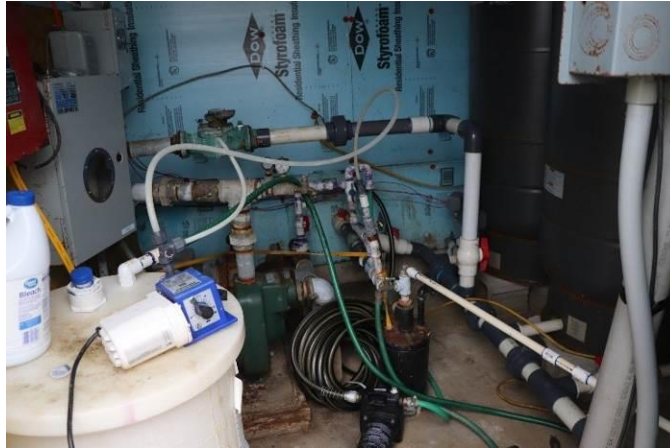
4 *Well house interior, note coils of garden hose, rusted well head plate, exposed wiring, bleach bottle*

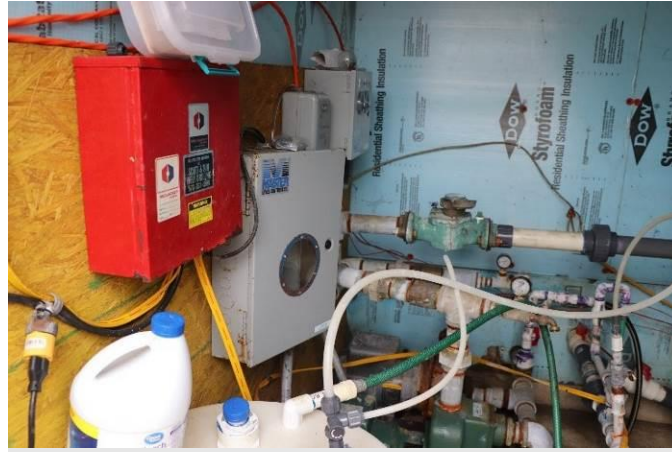
Power and control system condition at acquisition

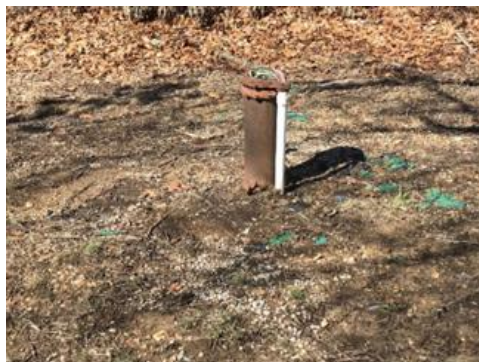
Rust and improper electrical wiring at Well #1 well head

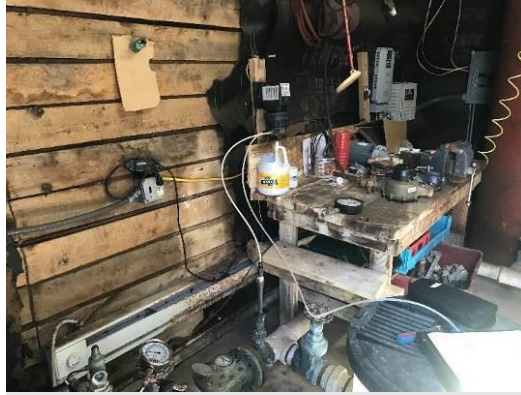
Housekeeping and electrical issues in Well #1 well house

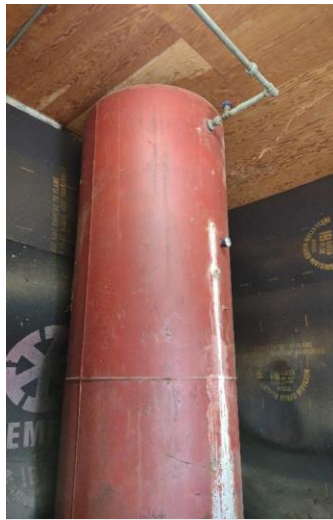
Leaking hydropneumatic tank in Well #1 well house

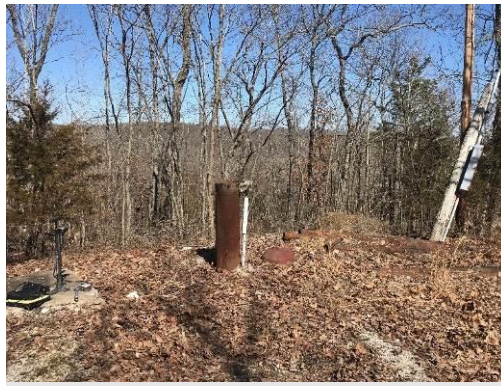
Well #2 – note rusting and lack of fencing

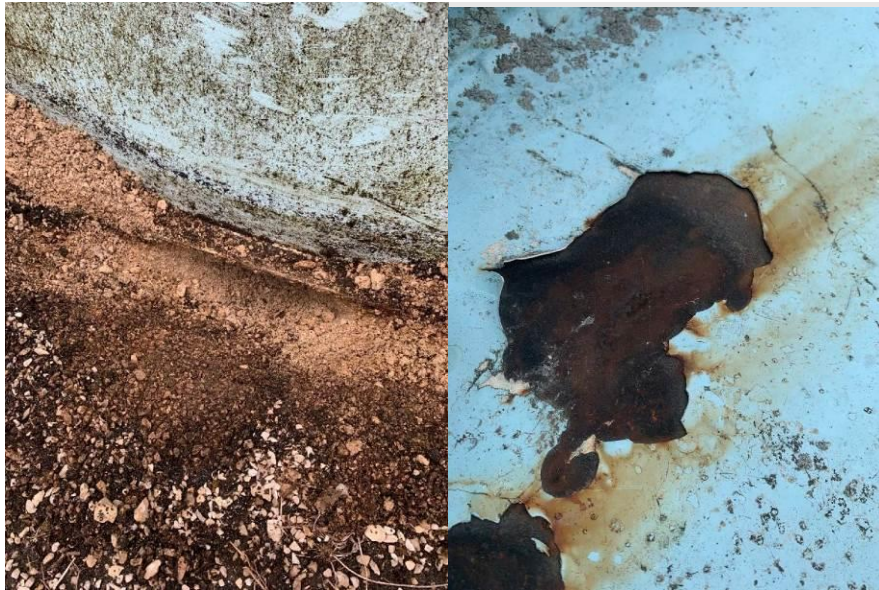
3
4 *Erosion around standpipe gravel footing / corrosion to standpipe coating*
5
6

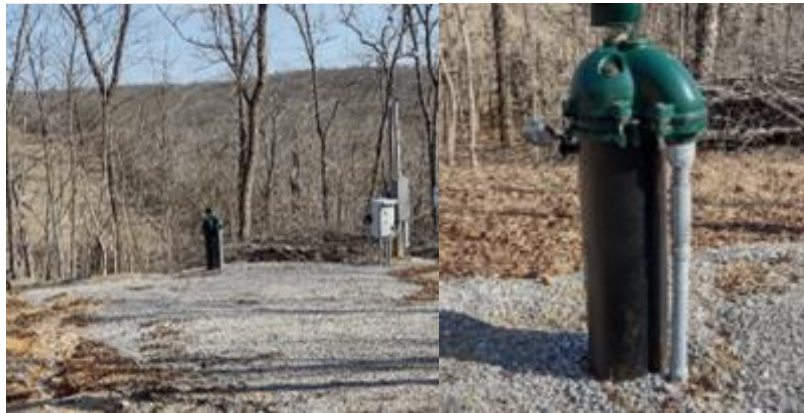
12
13 *Rehabilitated Well 2*

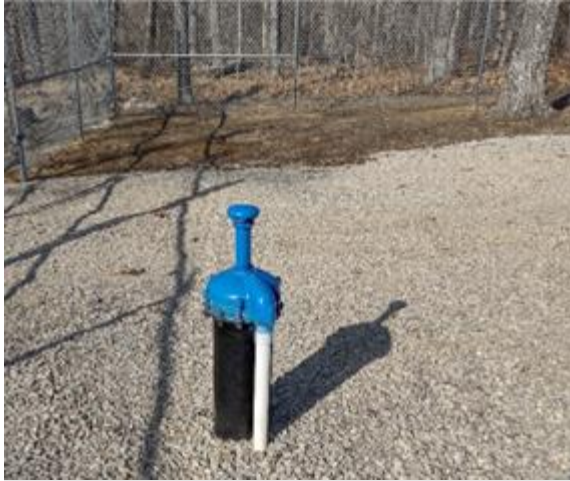
New gravel, well head equipment, and coating at Well #1

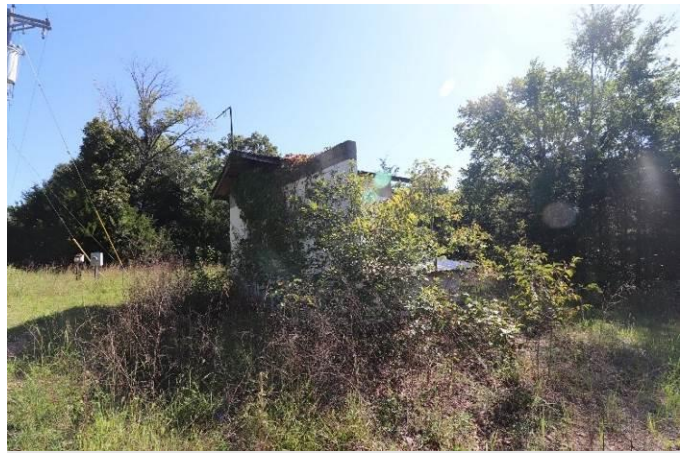
Vegetation overgrowing the Well #2 well house.

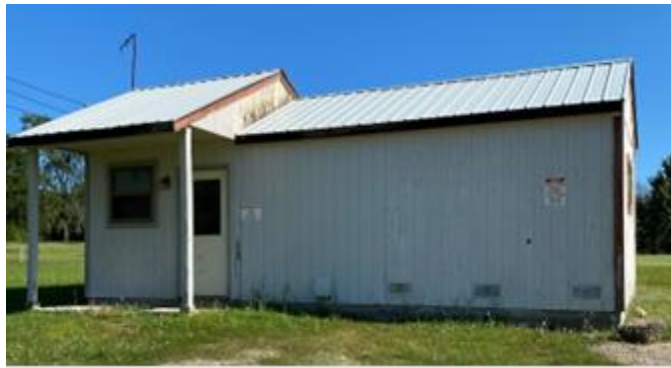
12 would be turned on to maintain adequate water production to the system. The reliance on
13 Well #2 is disconcerting given the ongoing issues with radionuclides at Well #2.

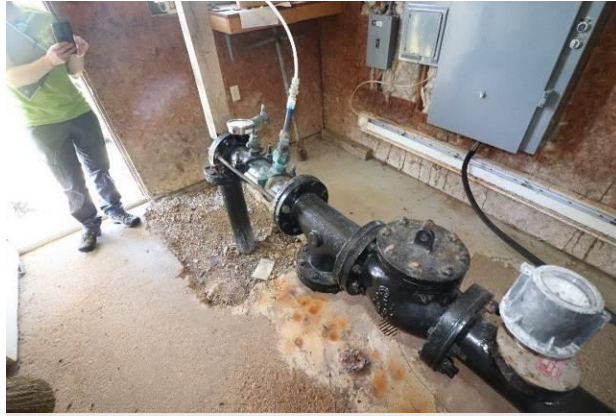
Well # 3 well house interior with damaged floor

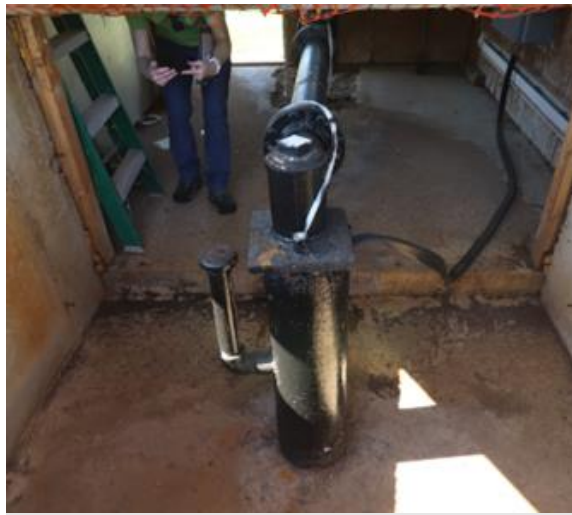
Rust on Well #3 well head.

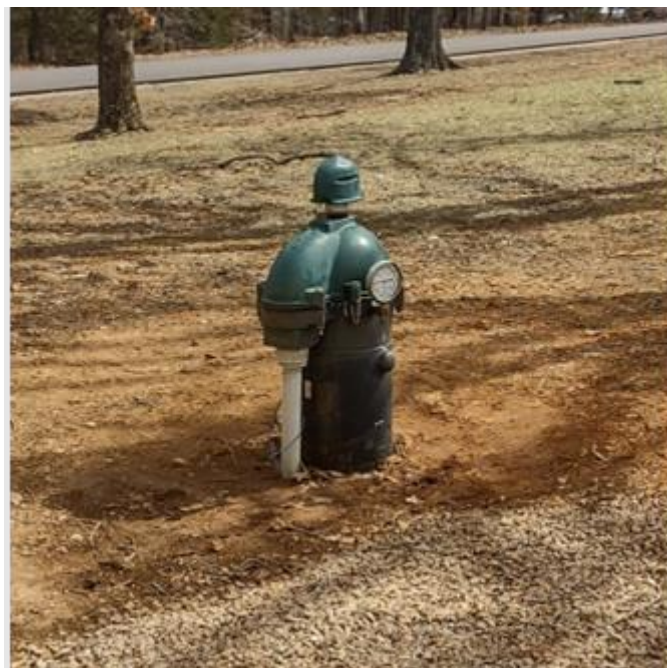
1 same issues with radionuclides as Wells #1 and 2, and had a more modern well house.
2 The separate rooms in the well house allowed for separation of controls/valving from
3 disinfection equipment and avoided the problem of deterioration of well equipment
4 resulting from the presence of the chlorination chemicals. As mentioned, well #4 was
5 generally in good condition though it did exhibit some rusting to the piping located in the
6 room where disinfection equipment was located. In such a situation, piping should be
7 constructed from PVC to avoid rusting.

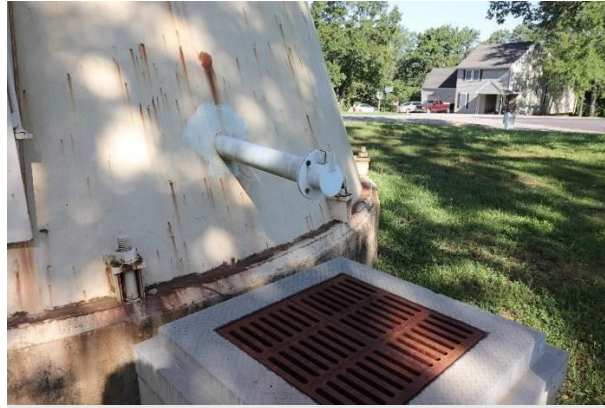
Base of tank near well #4

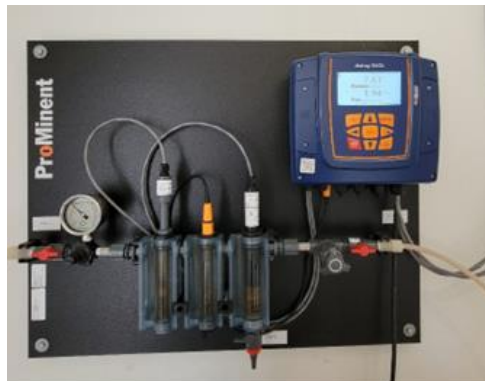
Chlorine Analyzer system (well #4)

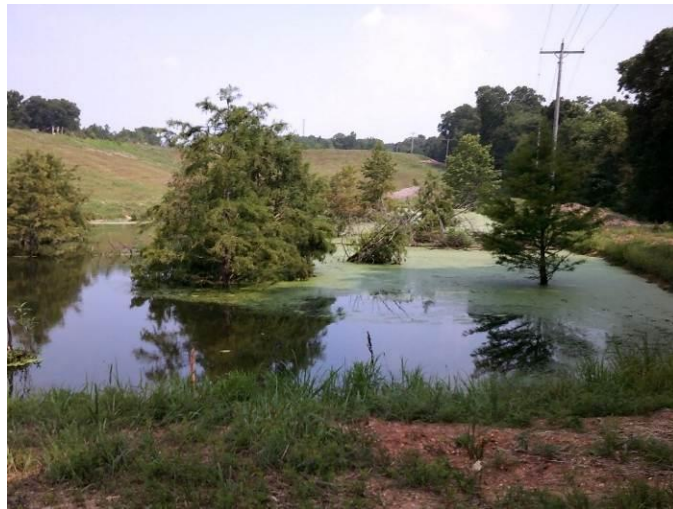
Trees growing and rotting in Port Perry lagoon cells

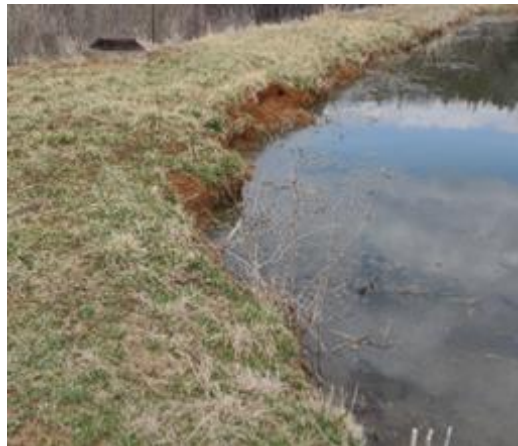
9
10 *Varmint damage at Terre du Lac three-cell lagoon*
11

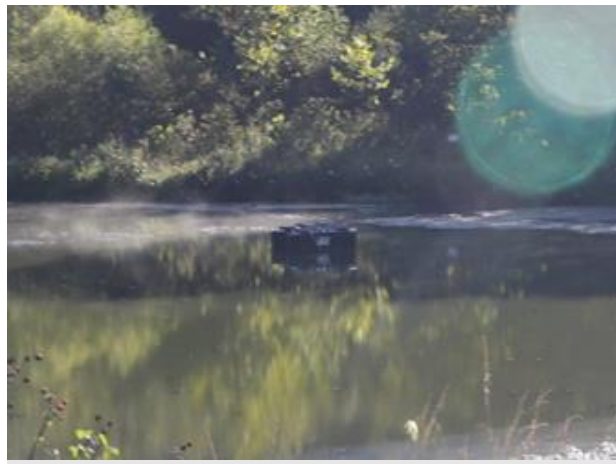
8
9 *Failed aerator at Terre du Lac three-cell lagoon*
10

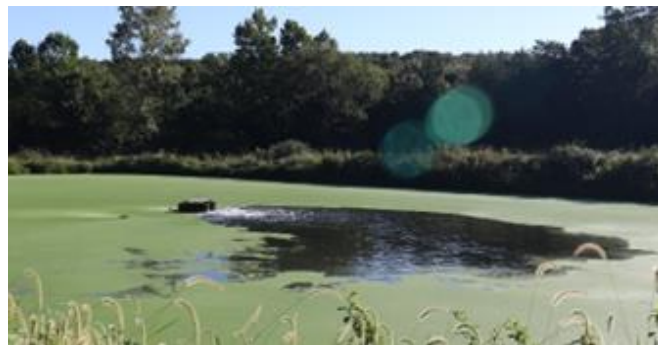
11
12 *Underperforming surface aerator at Terre du Lac three-cell lagoon*
13
14

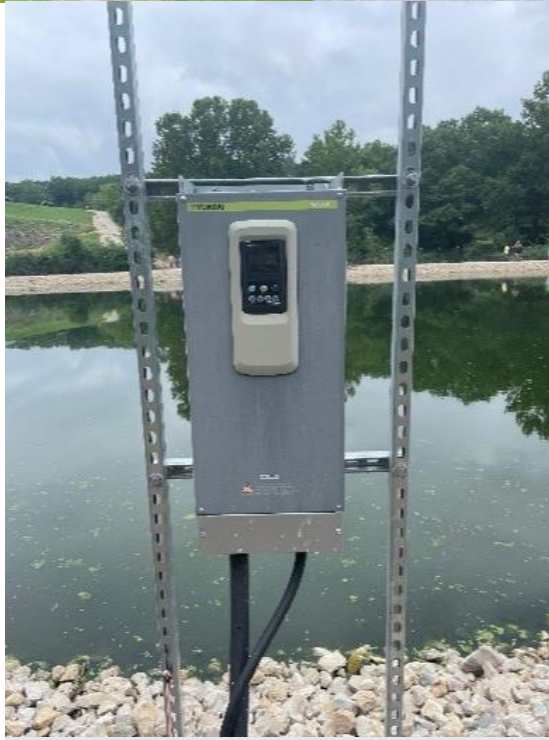
Before and after control/power system replacement at Terre du Lac three-cell lagoon

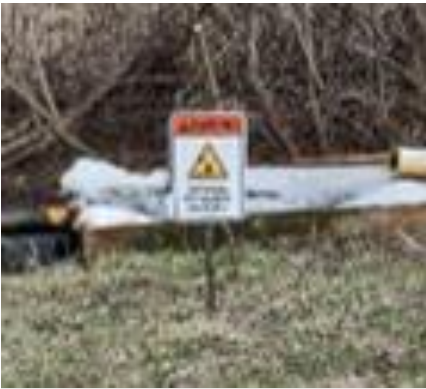
Overwhelmed disinfection system at Terre du Lac three-cell lagoon

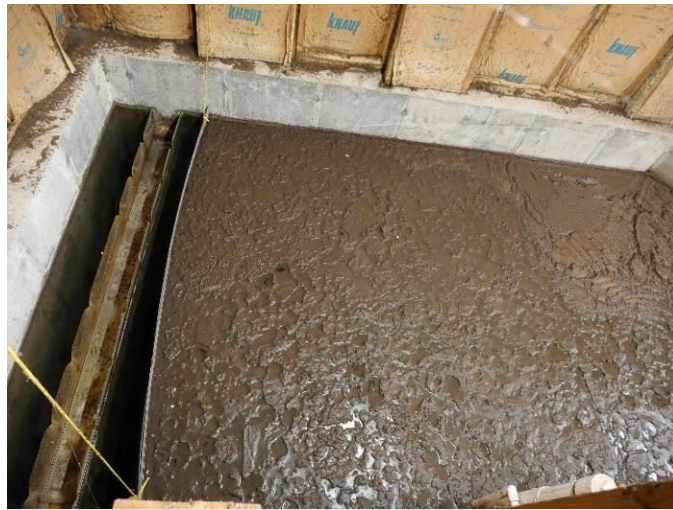
6
7 *Clarifier at Cedar Green filling with pin floc sludge, indicating failed skimmers*

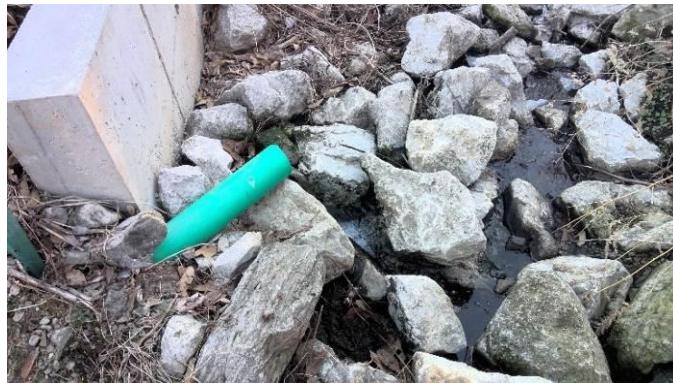
9
10 *Sludge accumulation in receiving waters at Clemstone due to infrequent hauling of sludge from facility*

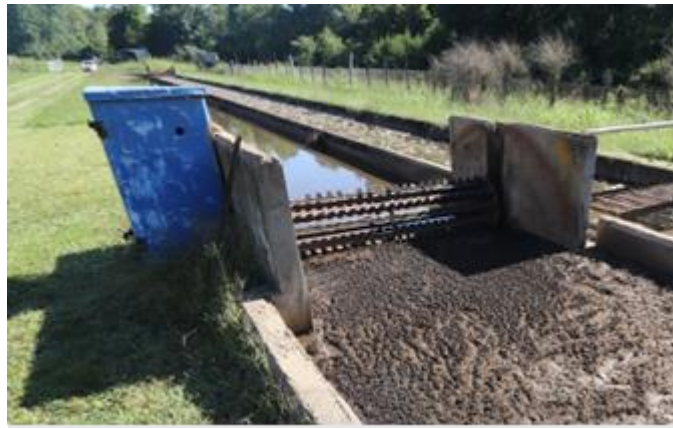
Failed brush aerator at Terre du Lac Oxidation Ditch

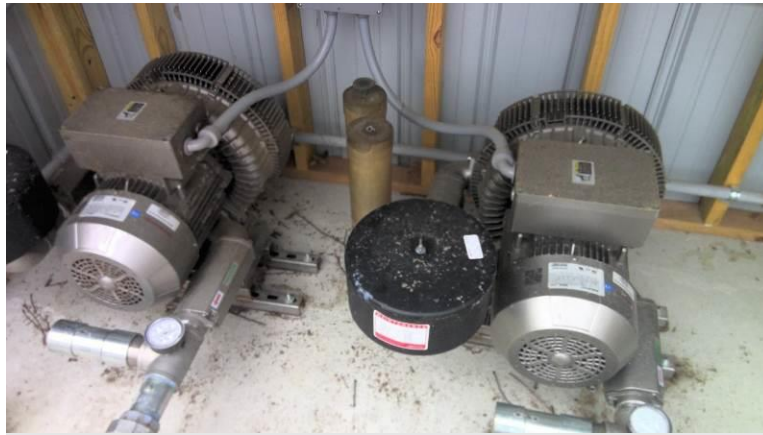
New blowers at the Chelsea Rose facility which had no functional blowers at acquisition

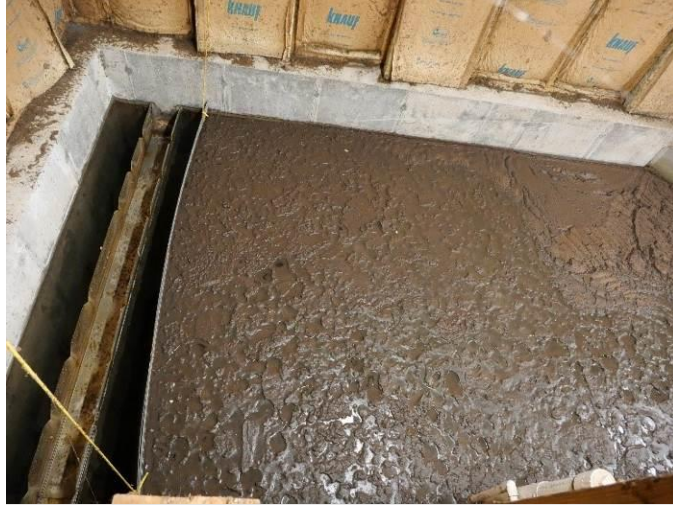
The following photographs show some of the clarifier problems that Confluence Rivers has found at activated sludge systems it has acquired:

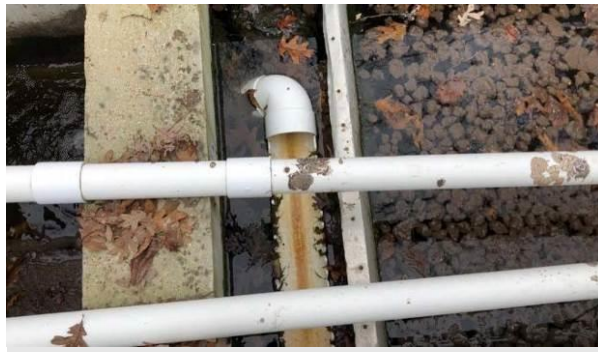
Pin-floc sludge overwhelming clarifier at Cedar Green system due to failed skimmer.

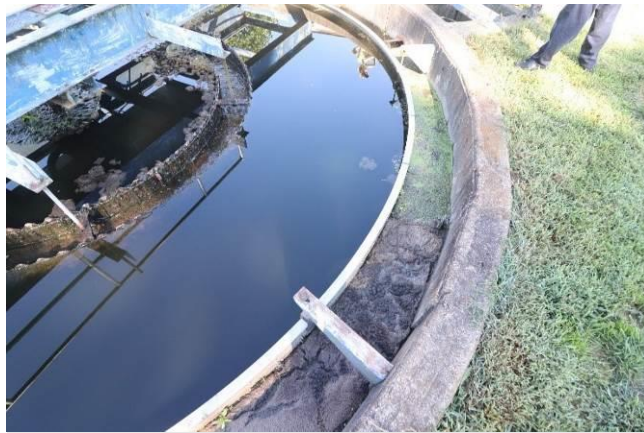
Poor condition of clarifier at Chelsea Rose

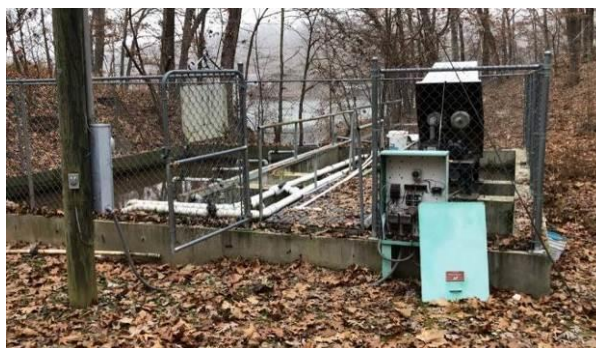
Failed control and power systems at Chelsea Rose facility

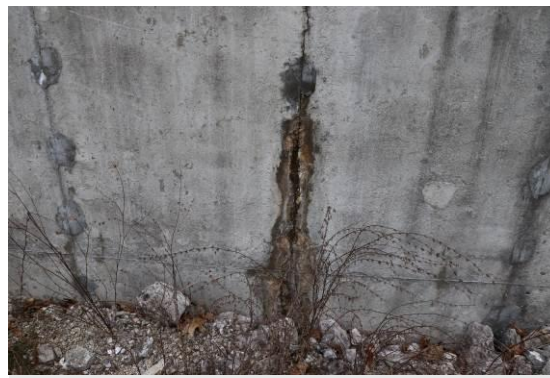
8
9 *Crack in concrete tank at Chelsea Rose facility with signs of leaking*

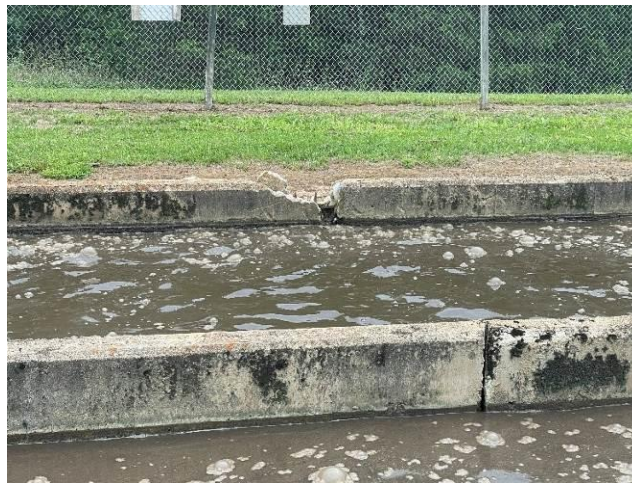
10
11 *Damage to oxidation ditch track tanks at Terre du Lac*

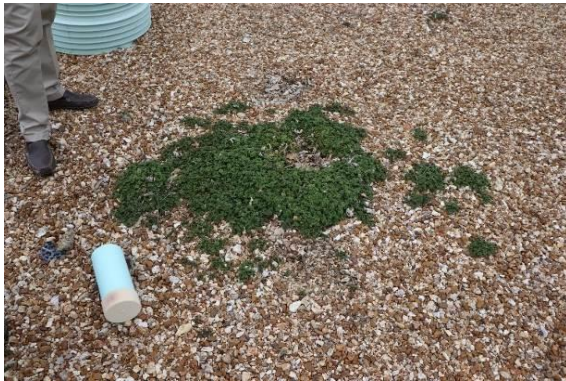
12
13 *Vegetation growing on surface of Cedar Glen filter beds.*

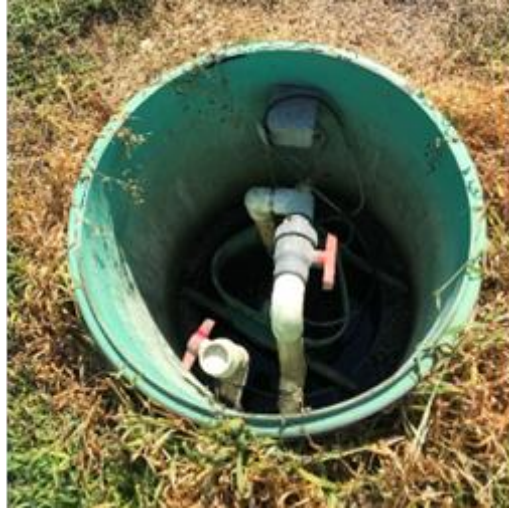
1 restored along with the distribution piping, an even distribution of the wastewater was
2 ensured across the sand bed restoring the full treatment capacity to the filter basins.

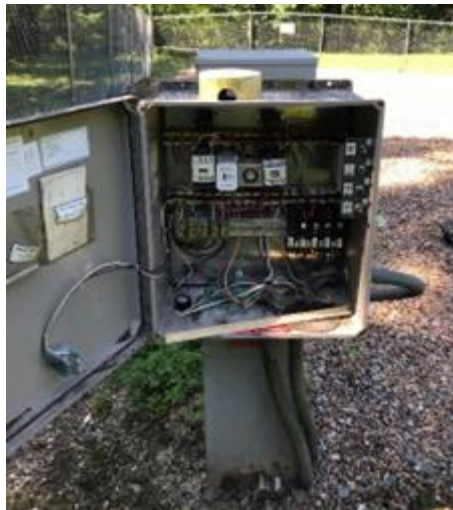
Failed distribution pump at Berkshire Glenn

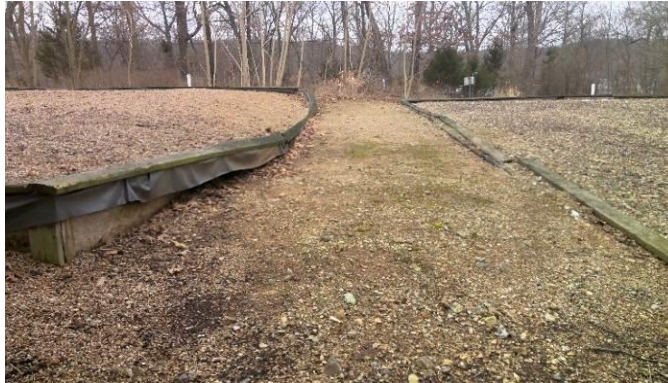
4
5 *Failing wood structure at Cimarron Bay*

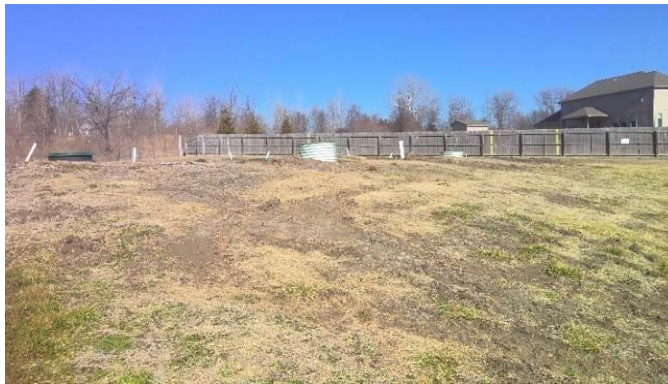
6
7 *Evidence of leaks in earthen face of sand filter at Berkshire Glenn*

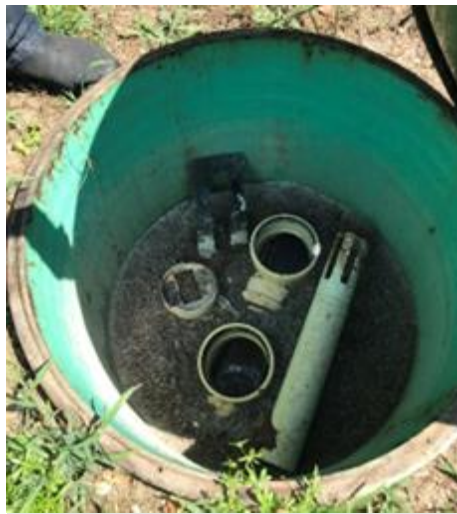
8
9 *Damaged tablet chlorinator at Fox Run*

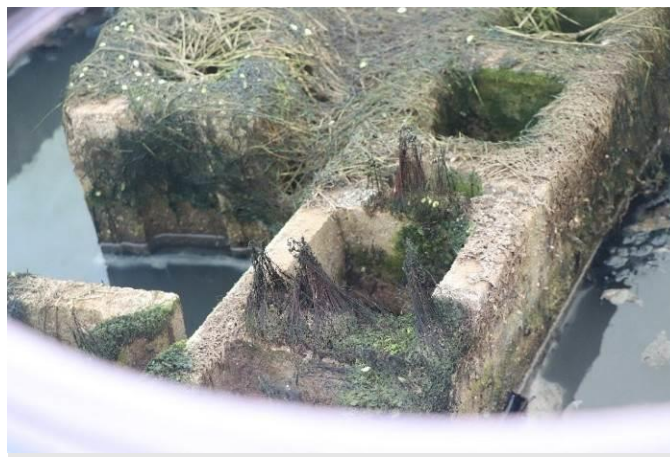
10
11 *Sludge filled contact chamber with significant vegetation growth at Eagle Woods*

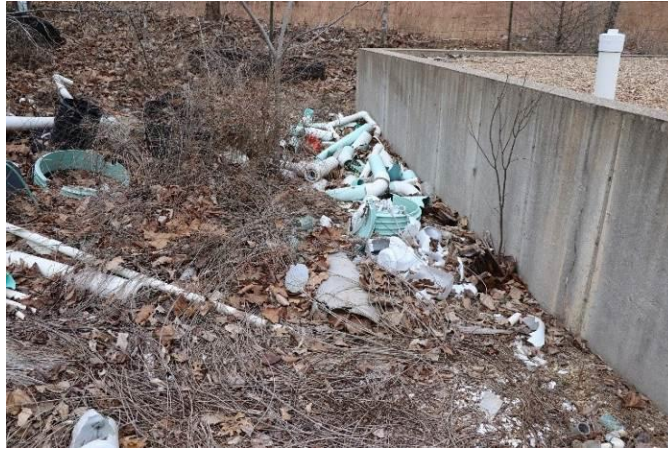
Piles of trash and debris on the Eagle Woods site

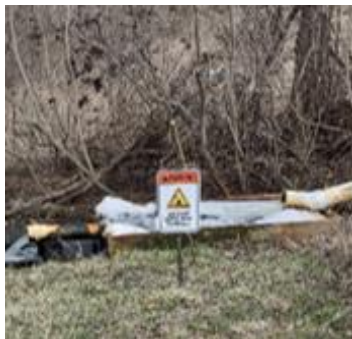
Extremely high I&I flows in discharge rate at Terre du Lac three-cell lagoon

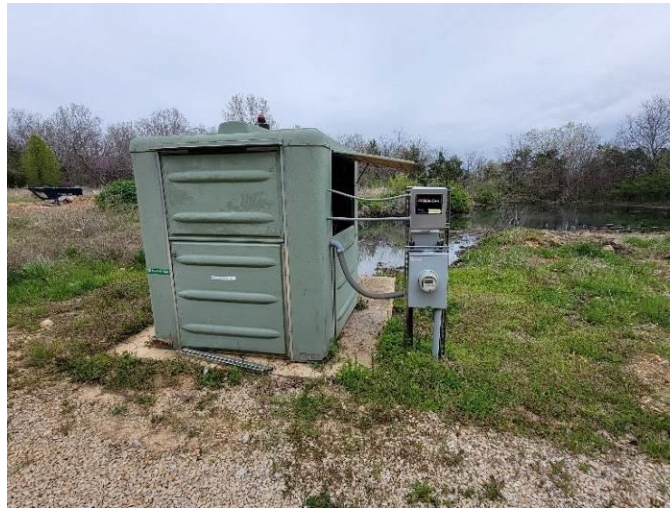
Example of Terre du Lac lift station with unapproved surge basin

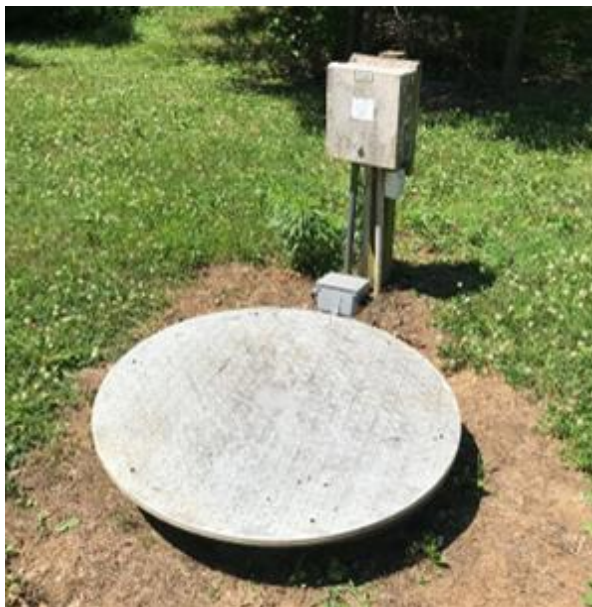
Lift station at Park Estates, missing redundant pump

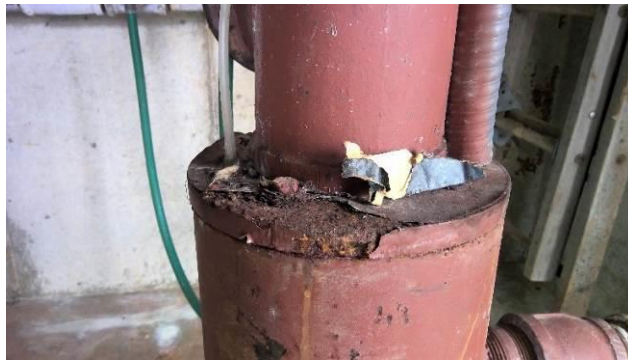
Rusting on well head at Cedar Green Well house.

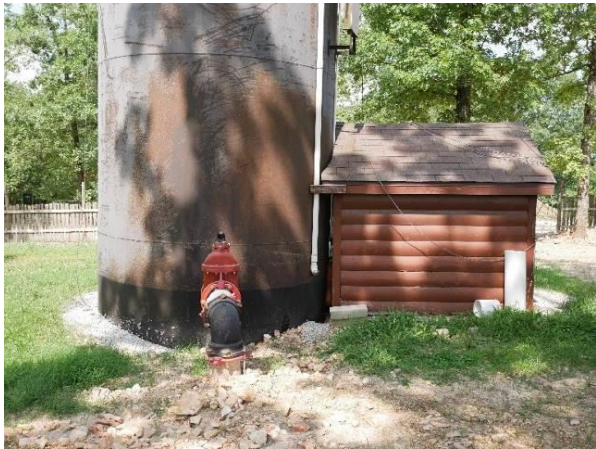
11
12 *Significant rust at base of Branson Cedars standpipe tank*

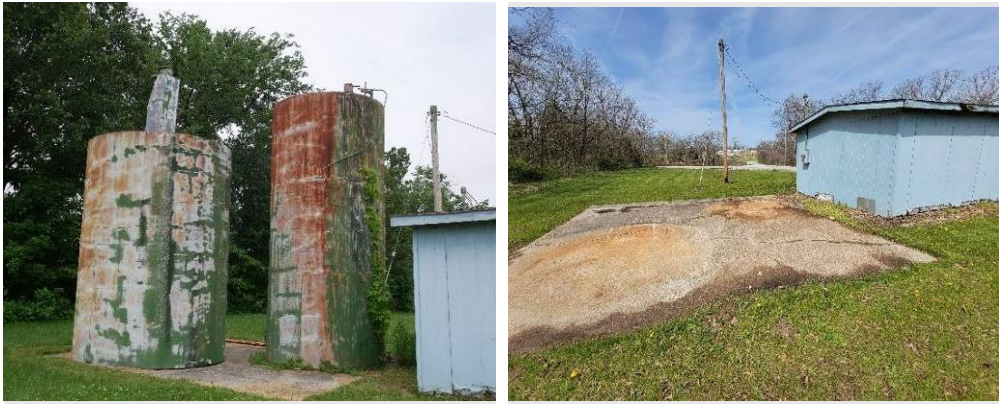
13
14 *Deteriorating abandoned storage tanks at Fawn Lake (removed by Confluence Rivers)*

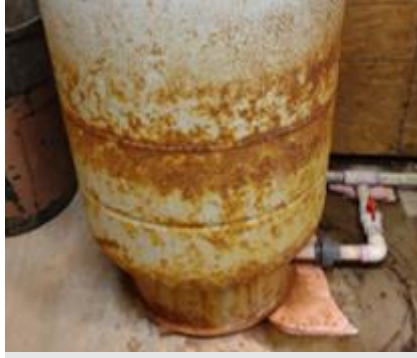
Rusting bladder tank at Missing Well system

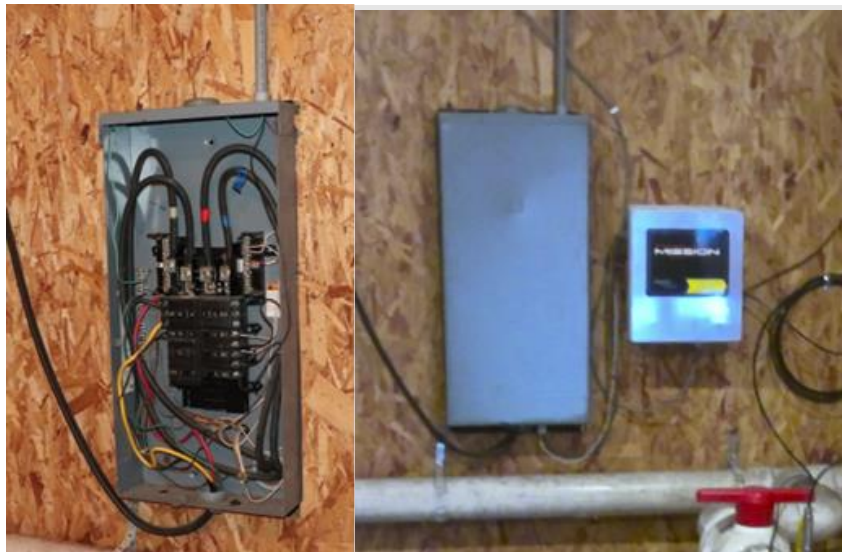
12
13 *Damaged power panel, exposed wiring at Cedar Glen. Panel repaired and remote monitoring installed.*
14
