# TAUM SAUK UPPER DAM BREACH (FERC P-2277)

## Technical Reasons for the Breach (12/14/05)

Technical Reasons for the Breach  
of December 14, 2005

FERC Independent Panel of Consultants (IPOC)

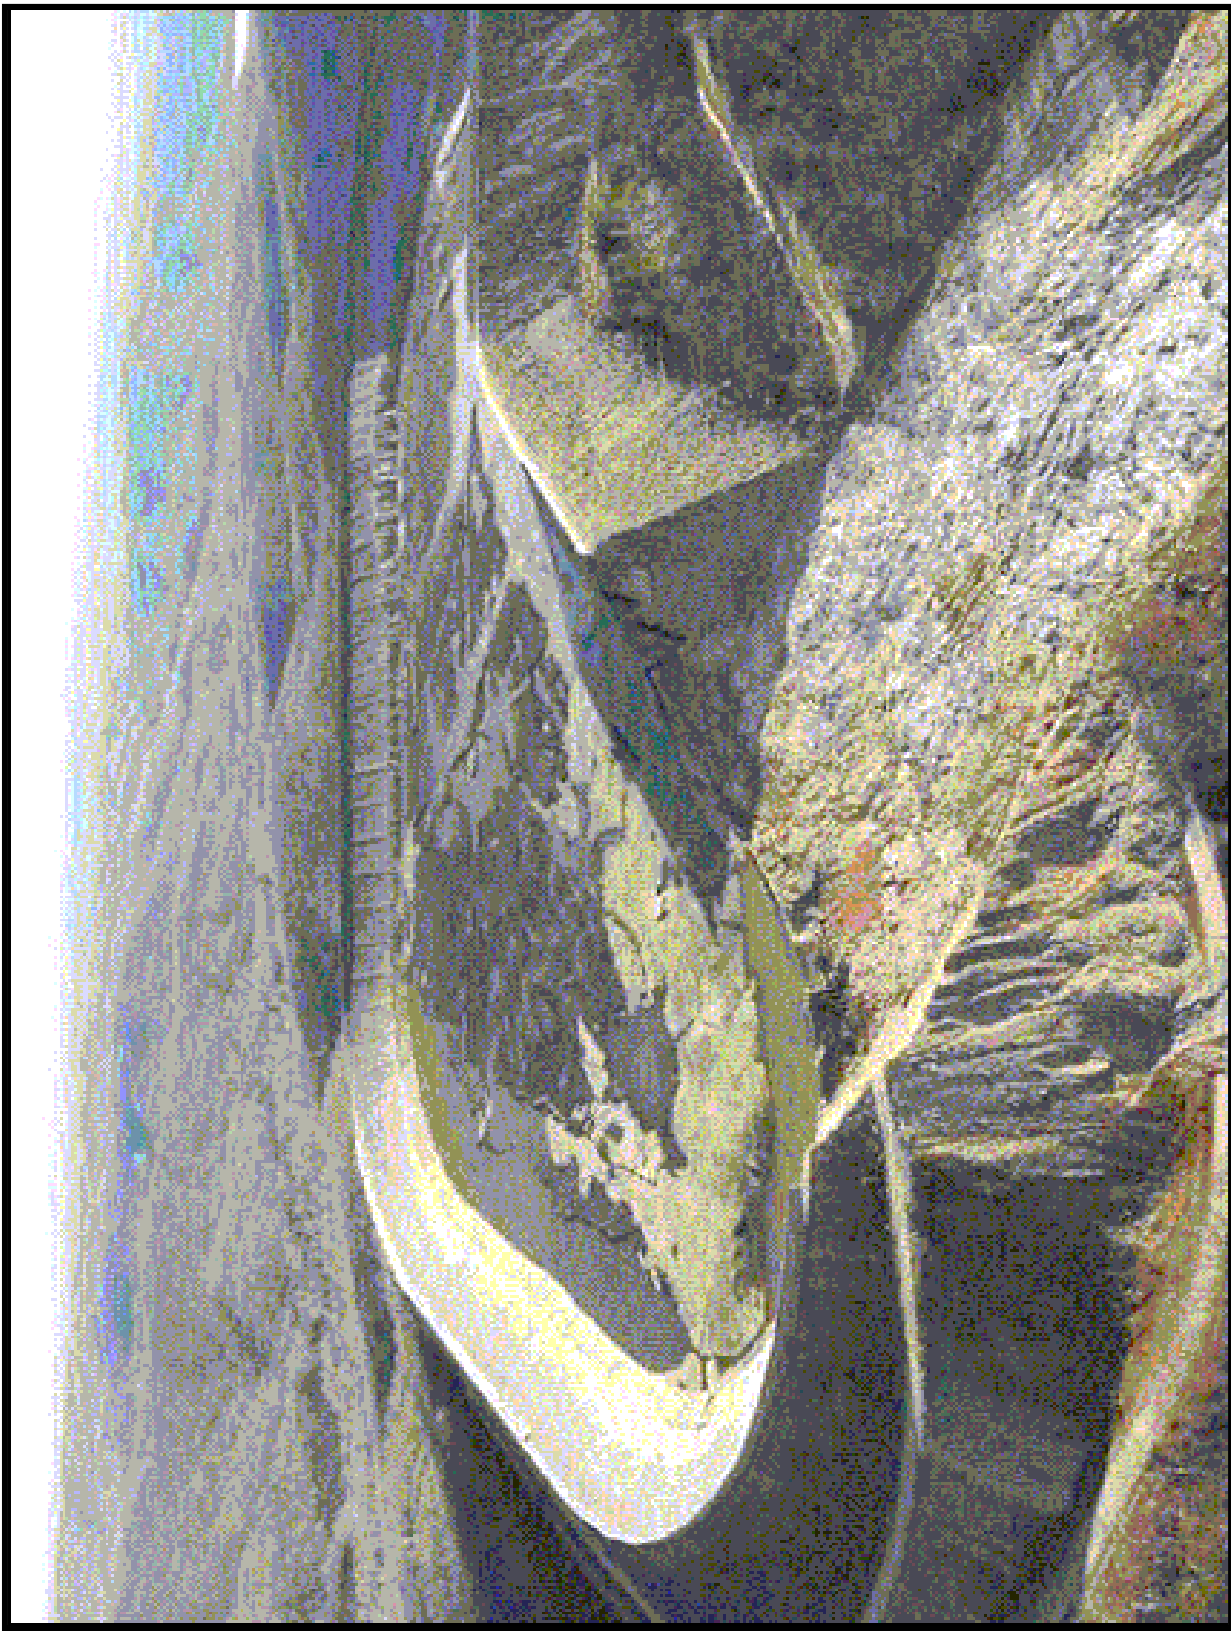
**Figure 1-2**

Taum Sauk Upper Reservoir Breached

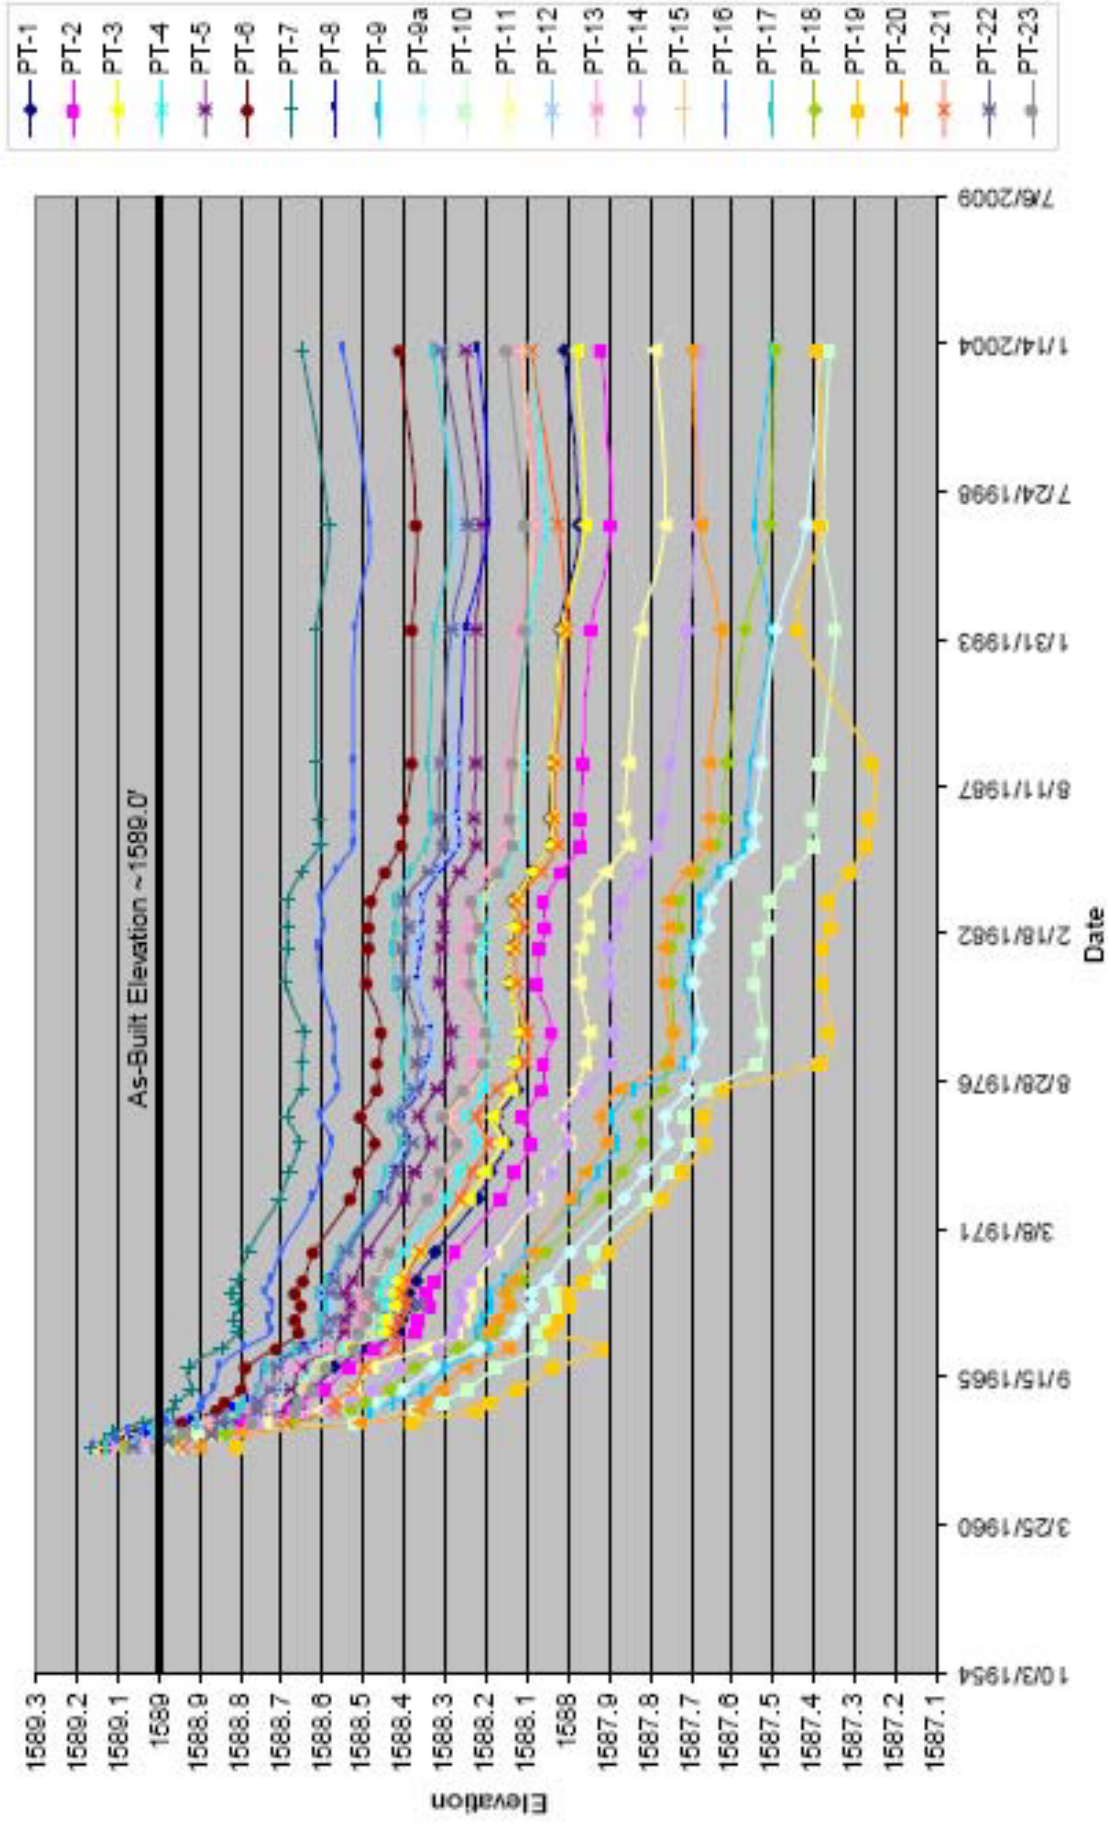
Total Settlement History  
Upper Reservoir Pin Elevations  
**Figure 3-3**

Thus, the Upper Reservoir Embankment has had a long history of settlement and high underseepage. Its performance as an effective water barrier was difficult to gage, since it has, in-fact, performed over the past 42 years. Although there were many periods of concern and needed repair to keep the water within the reservoir, the embankment and parapet wall did function as the containment for the Upper Reservoir. The rockfill embankment, as discussed in Section 3.1, was a steep dumped rockfill and the storage of water on the high parapet wall was unprecedented. There was most likely no margin for additional loading or overtopping, as was the case with the breach on December 14<sup>th</sup>. The holes which developed on the upstream side of Panels 90-95 in the 1963-1964 time frame suggested that the plinth was not extended to rock in that area, as should have been done, for a normal CFRD constructed in the middle 1960's. As discussed in Section 6, Figures 6-5, 6-6, and 6-7 indicate that the actual plinth was not extended down to rock. Early project correspondence by J.B. Cooke, M.W. Fler, Raymond Weldy and an unknown Union Electric employee are given in Appendix C, which refer to early behavior of the Upper Reservoir and the possible resistance to erosion in the event of overpour over the parapet wall.

If it is noted that the original survey pins 18 and 19 (Figure 3-4) correspond to Panels 90 and 95 within the breach area and it is shown on Figure 3-3 that the 2004 elevation of Pin 18 and Pin 19 are 1587.5 and 1587.4, respectively. Then

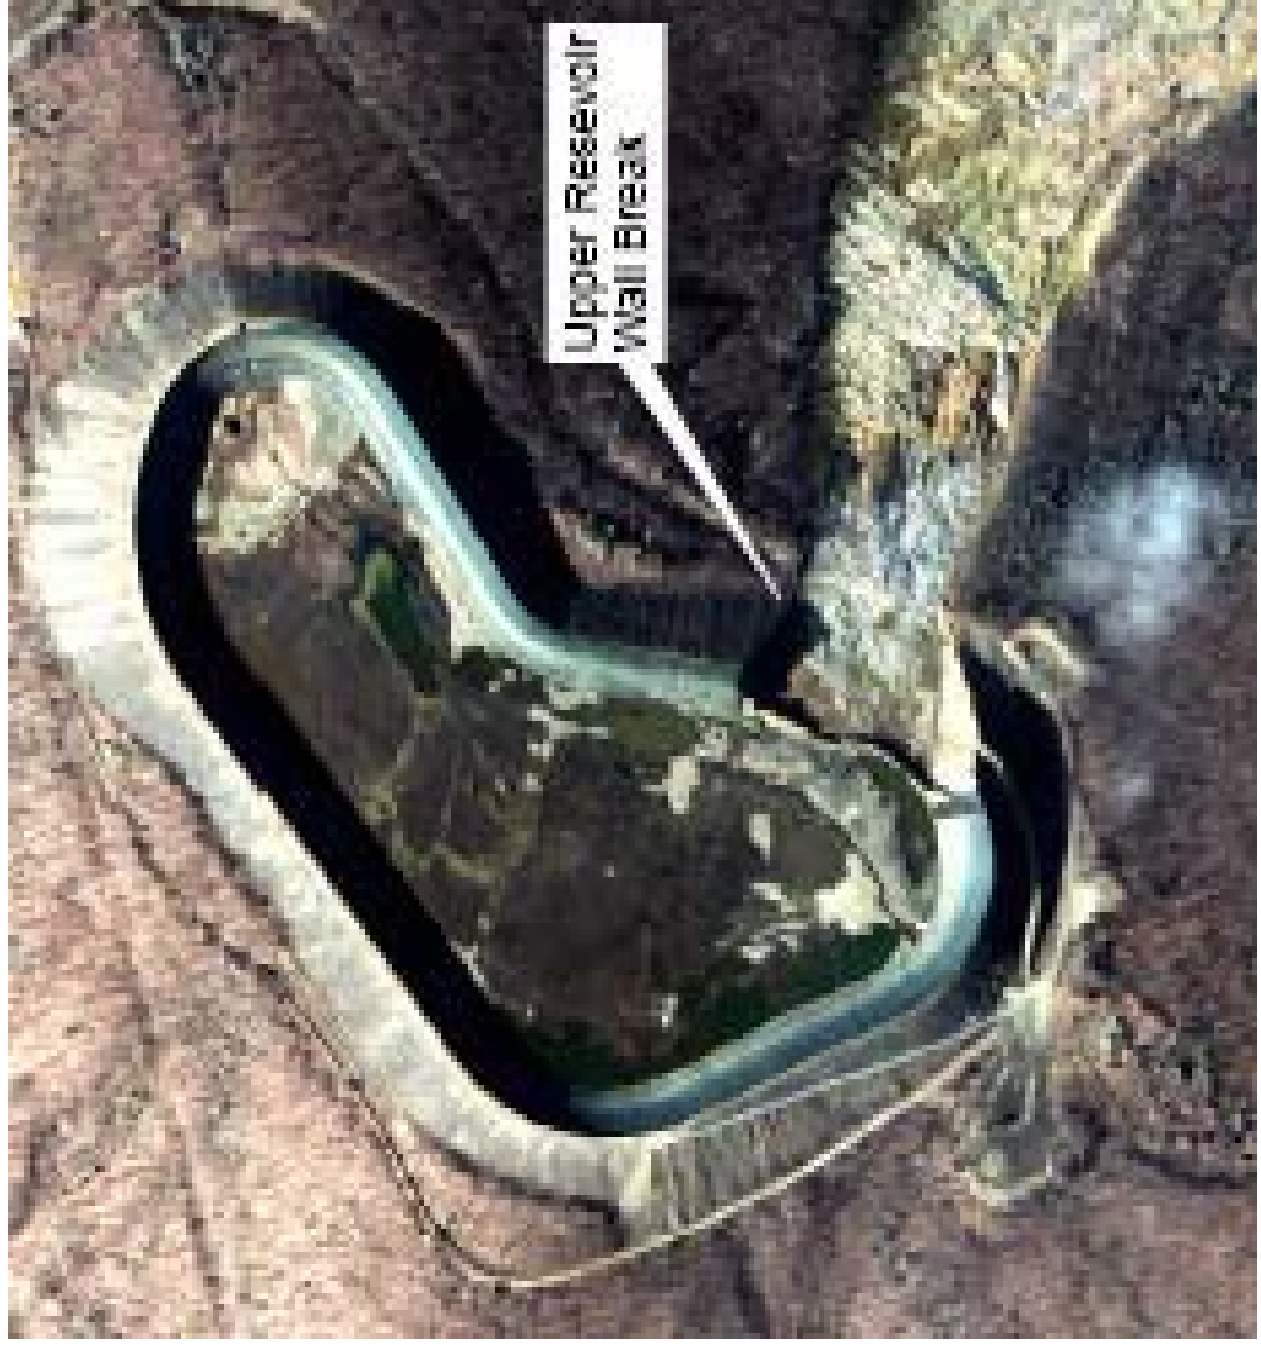
**Figure 6-1**

On December 14, 2005, an uncontrolled release of water from the upper reservoir occurred at the Taum Sauk Pumped Storage Project resulting in the damage shown in Figures 6-1 and 6-2. The time history of the reservoir transducers and the penstock transducer just before, during, and after the breach is shown in Figure 6-3. It is shown on Figure 6-3 that the full breach developed within about 25 minutes from the initial dropping of the reservoir level.

Taum Sauk  
Upper Reservoir  
Breach 12/14/05

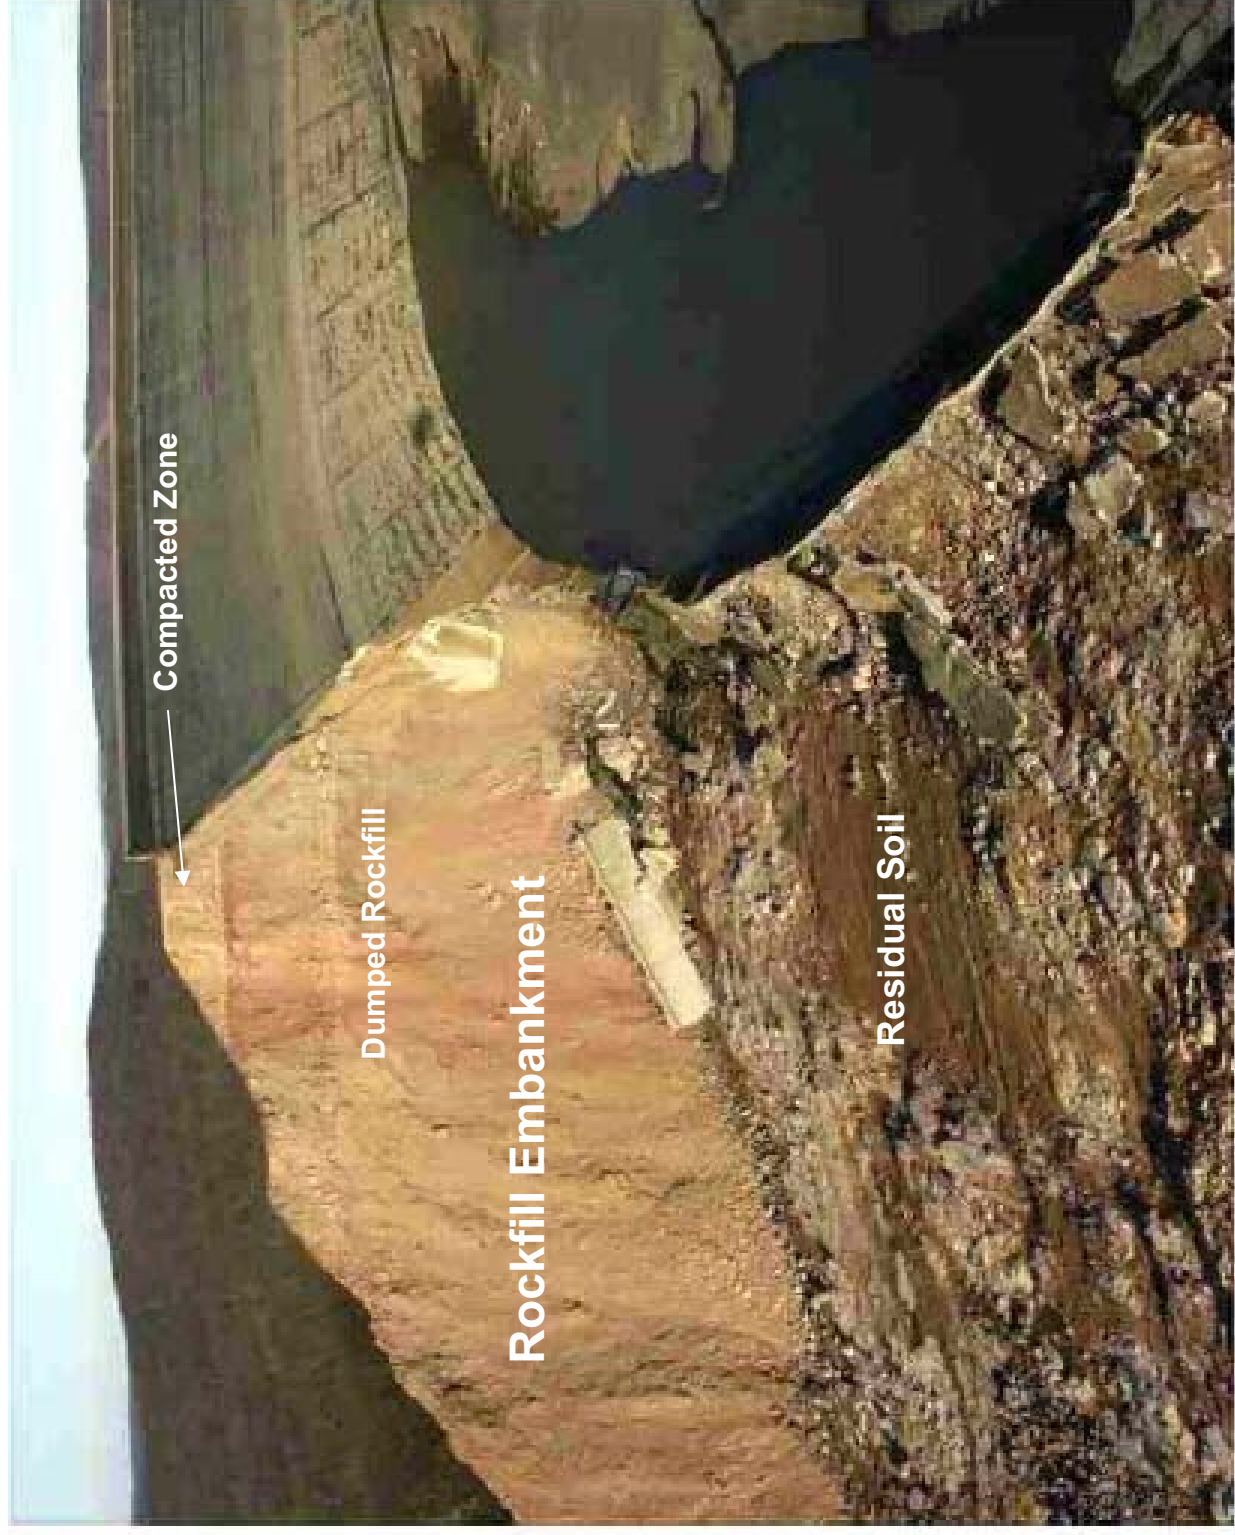
**Figure 6-4**

During IPOC inspections at the site, a good cross-section of the embankment could be observed on the north side of the breach as shown in Figure 6-4. In Figure 6-4 the dumped rockfill can be observed below the upper 20 ft of compacted rockfill. The rockfill exposed in this section is dirtier than a normal rockfill and as such would be more erodible and would be less free draining than a normal rockfill. In fact Dr. Frank Nickell (one of the original consultants during design) mentioned in one of his reports that the rockfill with the most fines could be used in the upper 20 ft of compacted rockfill for the roadway on the outside of the parapet wall.

A residual soil zone of weathered rhyolite could also be observed in the breach area; and one location is shown in Figure 6-4. The residual soil was observed to

be clayey and it was judged to have an effective shear strength almost dictated by the clay portion of the soil. Exposed rhyolite bedrock is also observed in Figure 6-4 as well as the remnants of the lower face slab and plinth.

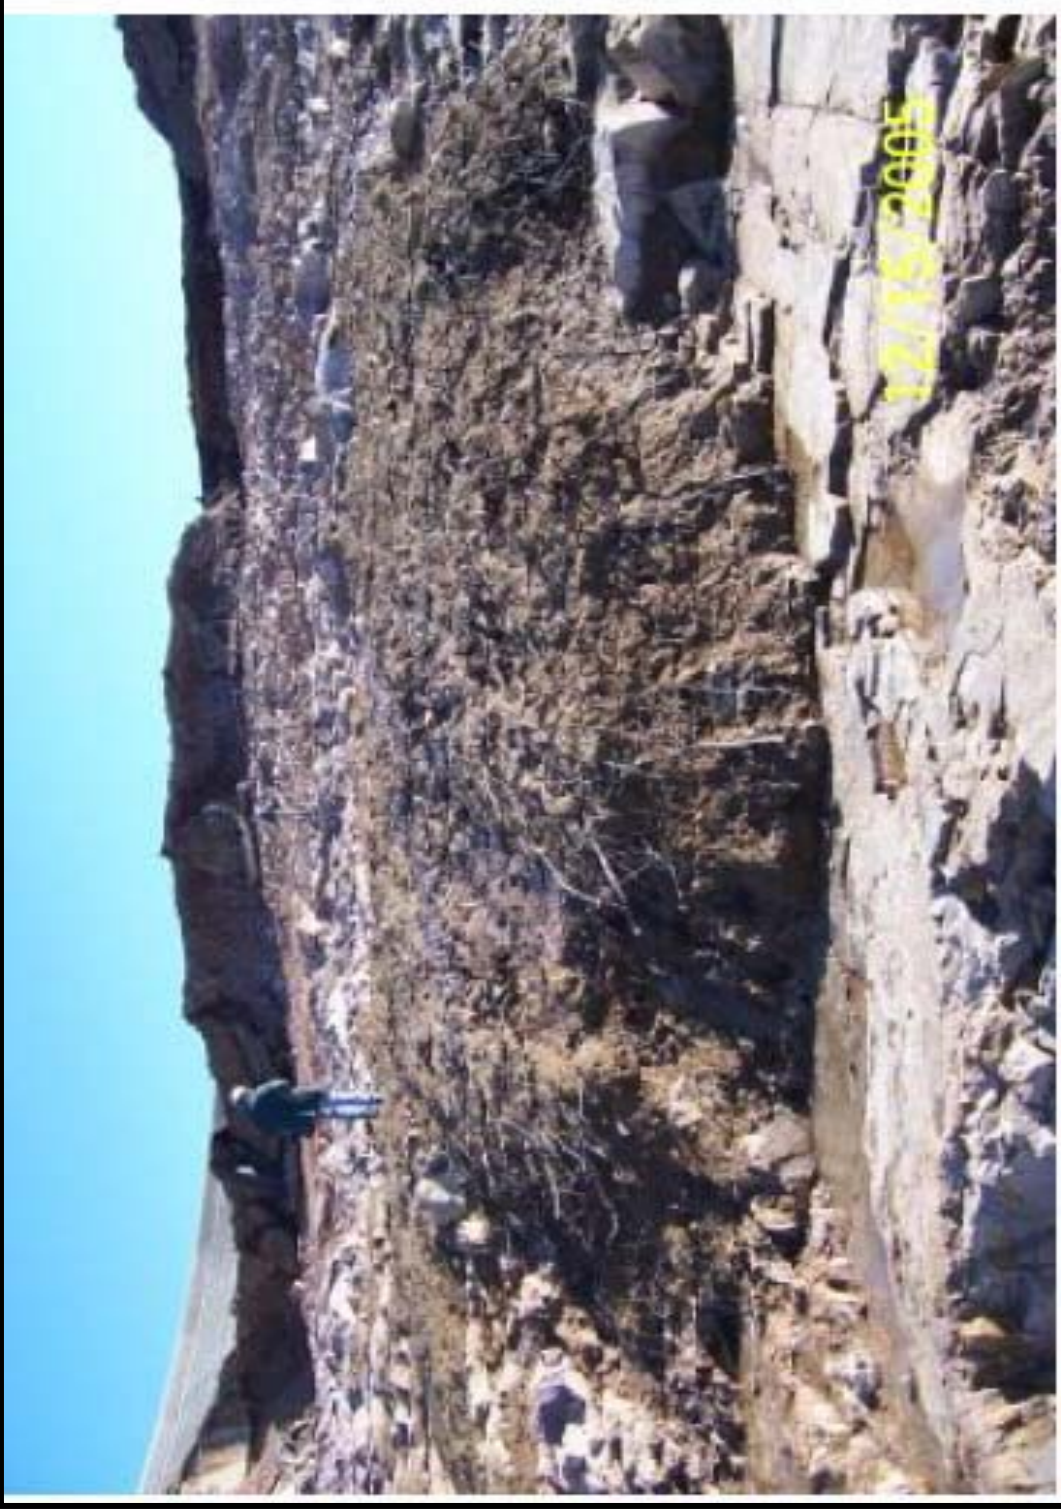
**Figure 6-5**

A closer view of the exposed rhyolite bedrock and residual soil is shown in Figure 6-5. This photo is taken looking east and the rather flat looking joint surface in the rhyolite dips toward the camera in a westerly direction. This discontinuity was observed in the field to dip nearly west at a dip of about  $10^{\circ}$ . This discontinuity is described as Fracture Set 8 (FS-8) in the Rizzo Report and is reported to have a dip of  $8^{\circ}$  and a dip azimuth of  $270^{\circ}$ . As a result of the observation of the residual soil, the IPOC requested that samples of the residual soil be taken for direct shear testing.

Eroded foundation, note rock jointing and overlying clay materials

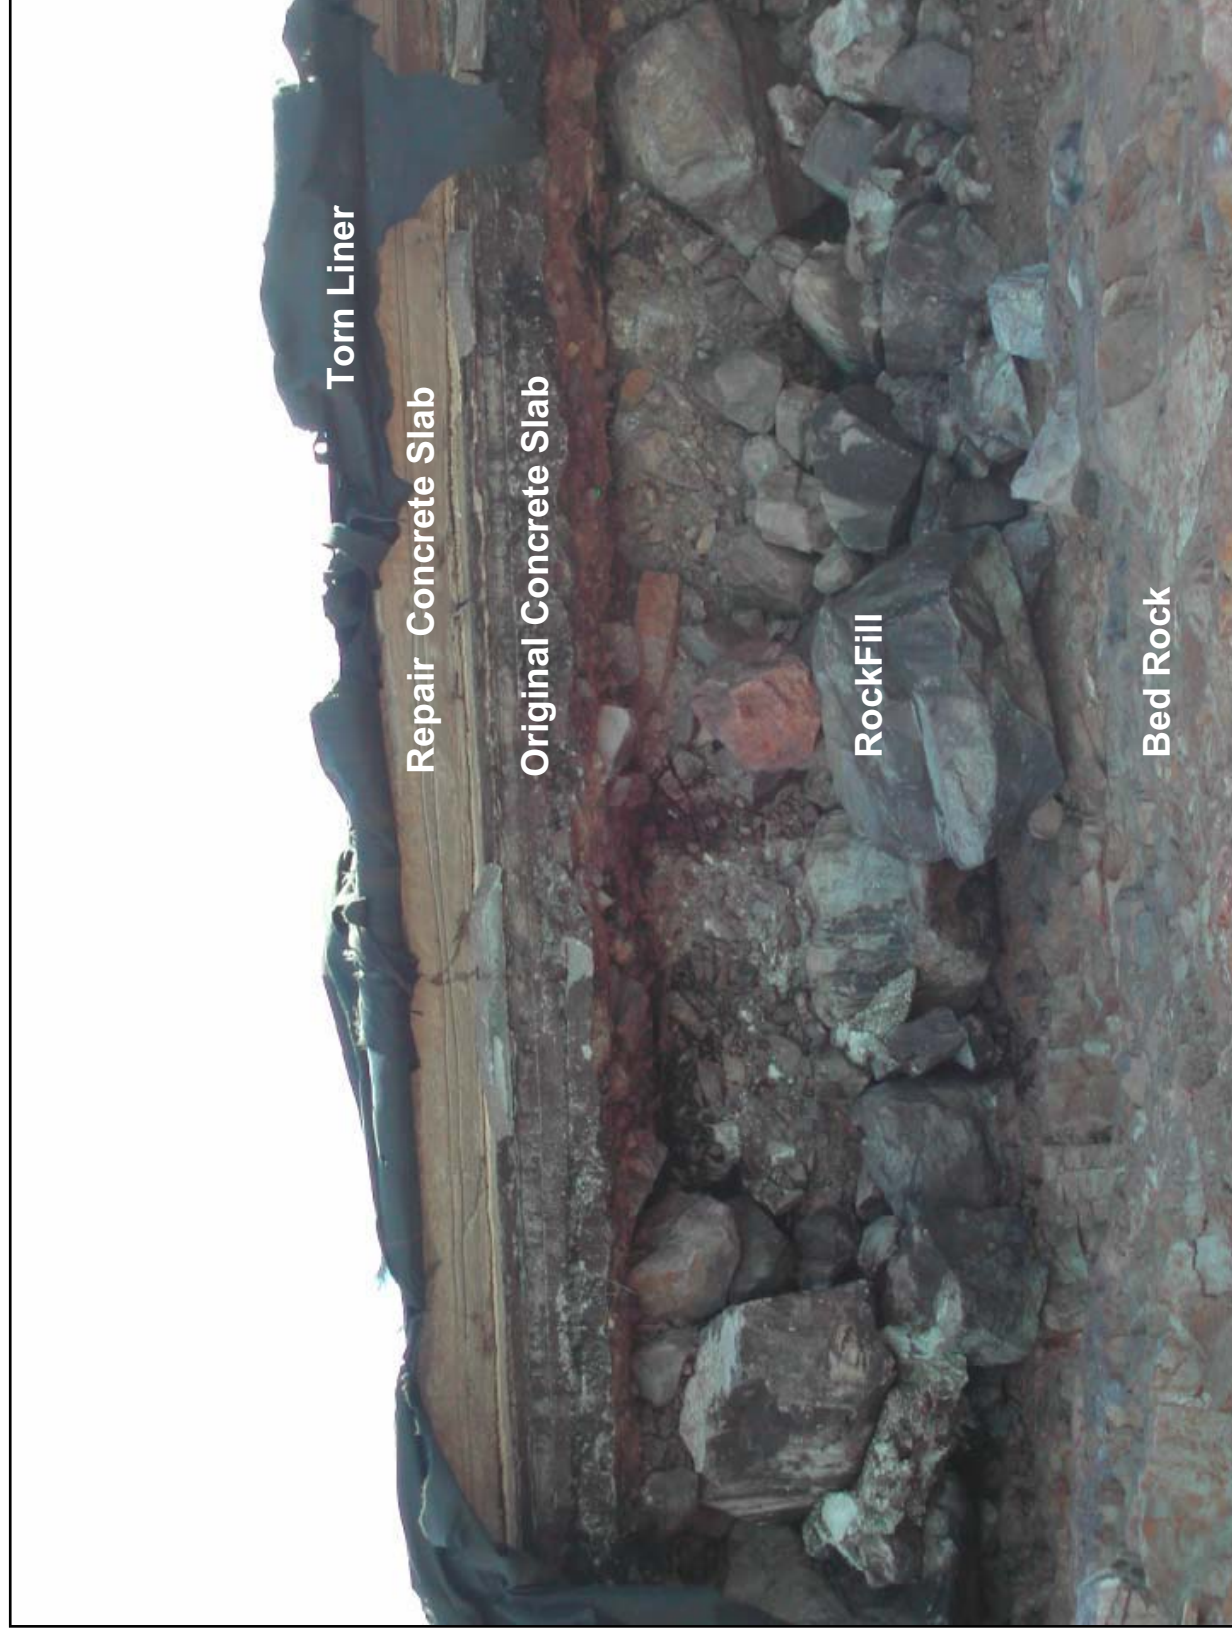
Figures 6-6, 6-7, and 6-8 show three views of the area under the base of the bottom of the face slab and plinth. The most glaring issue revealed by Figure 6-6 for example is that it appears that the plinth was not taken down to the rhyolite bedrock shown at the bottom of the photo. This is not considered good practice today and it was not good practice in 1963. Figures 6-7 and 6-8 show similar construction along the plinth area. This observation makes it consistent to rationalize the blow outs and holes that had to be repaired upstream of Panels 90-95 in 1963 and 1964. It definitely appears from these inspections that the plinth was not extended to bedrock for this dam, at least in the breach area.

Rockfill between top of rock and base of plinth

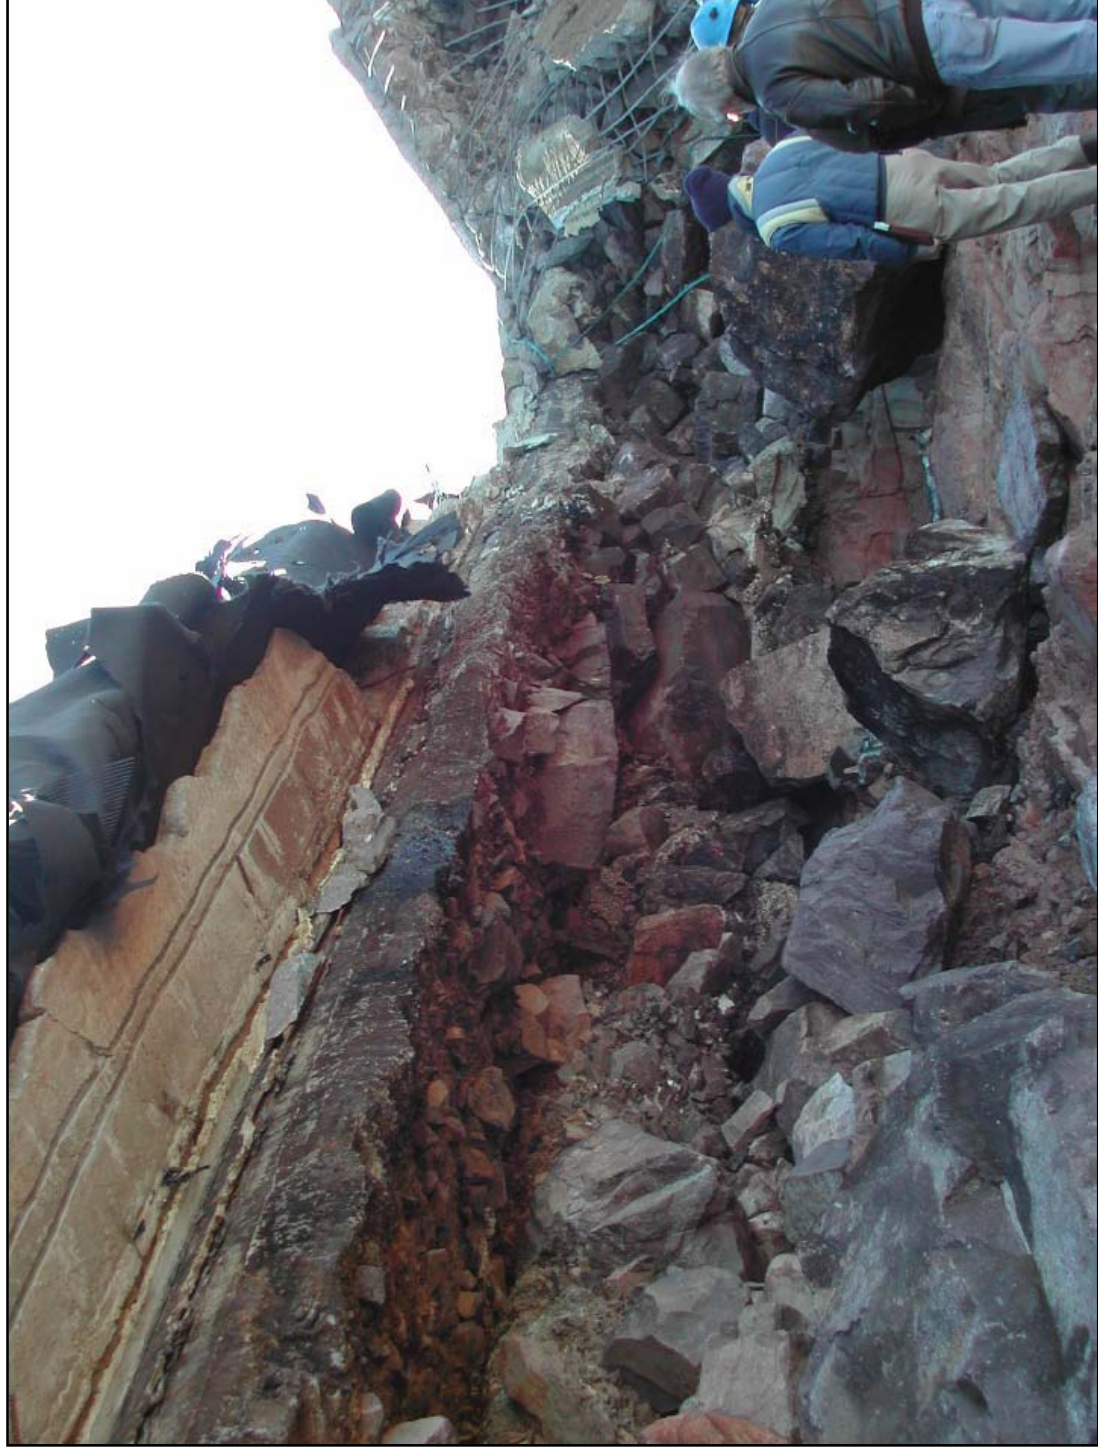
**Figure 6-7**

Rockfill between top of rock and base of plinth,  
note reddish grout in rockfill beneath the plinth

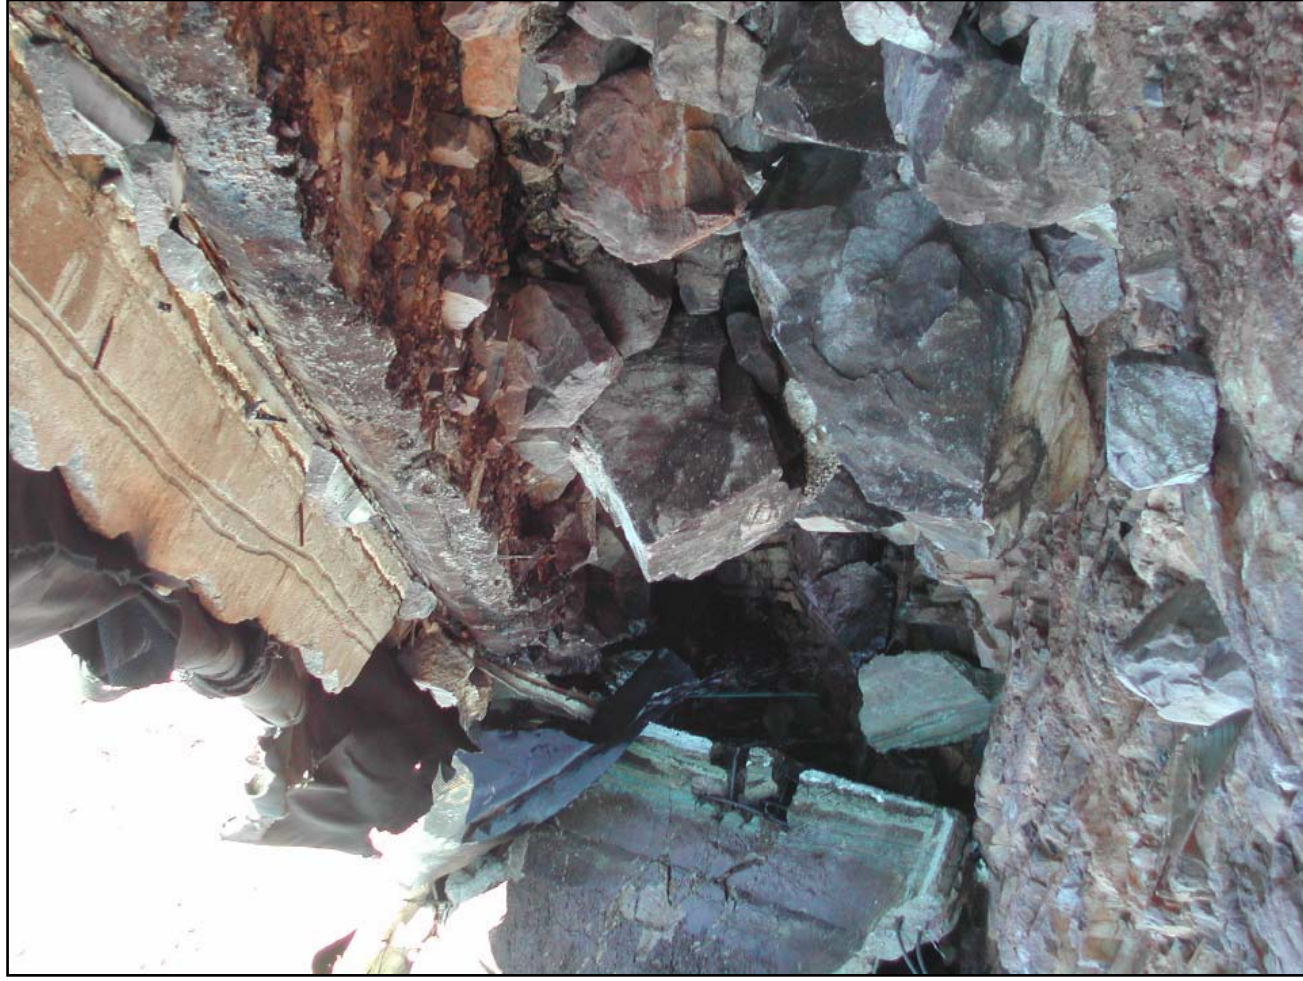
**Figure 6-8**

Rockfill between top  
of rock and base of plinth

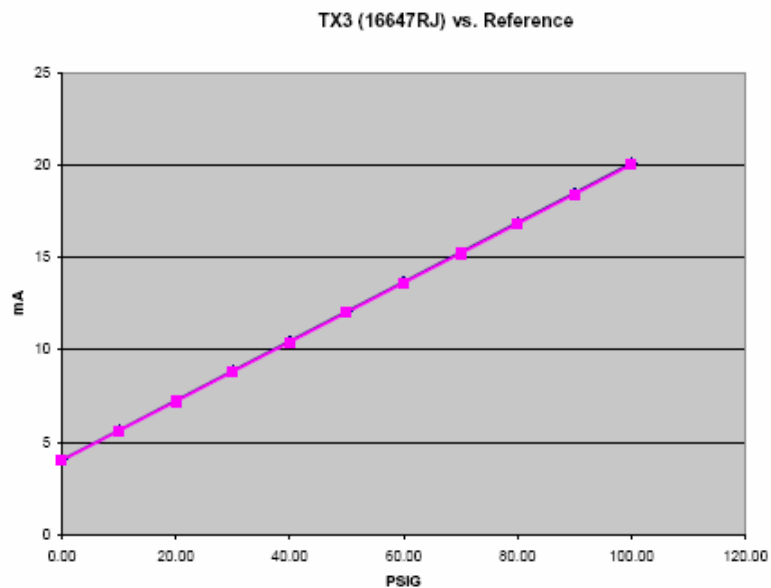
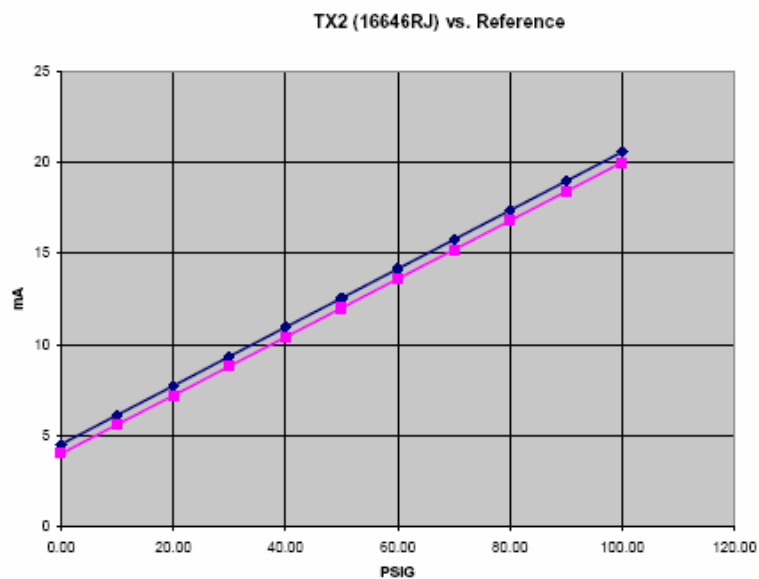
Figure 7-1 shows plots of ma output versus PSIG for TX2 and TX3 compared to a reference (ideal) transducer. Both TX2 and TX3 have linear response to pressure but TX2's ma output represents about a 7.86 feet higher indication than the reference curve while TX3's ma output represents about 0.85 feet higher indication than the reference curve. Figure 6 on page 20 of 76 in Appendix A of the Rizzo report shows that the as found PLC logic includes a subtraction of 9.38 feet from the TX2 pressure indication and a subtraction of 2.4 feet from the TX3 pressure indication. The basis for these adjustment values is not stated in Appendix A of the Rizzo report.

**Pressure Transducers TX2 and TX3  
Compared to Reference Transducer  
(TX2 reads average of 7.86 feet high  
and TX3 reads average of 0.85 feet high)**

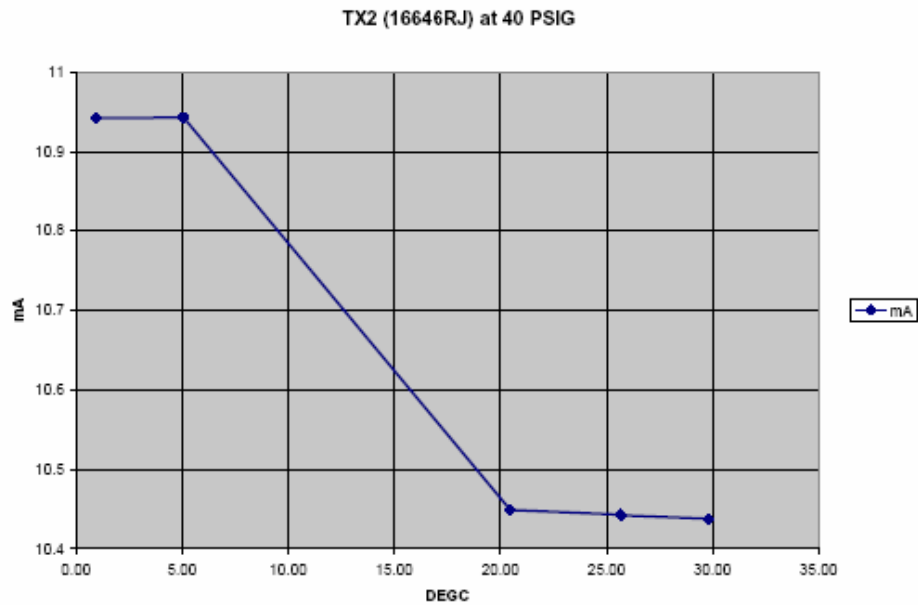
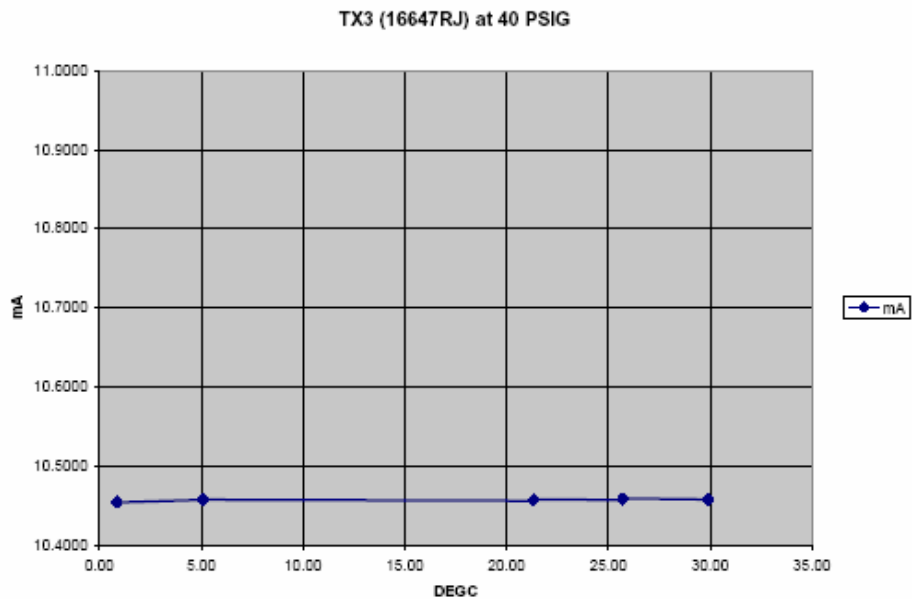
Figure 7-2

**Pressure Transducer Temperature Sensitivity  
(TX2 Output Shift Represents +7.11 Ft. of Water Level  
at 5 degrees compared to 20 degrees)**

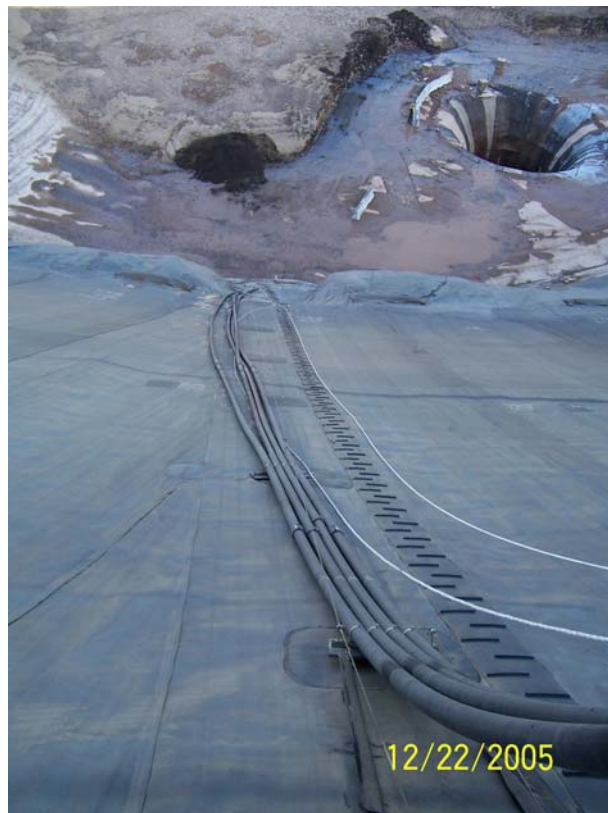
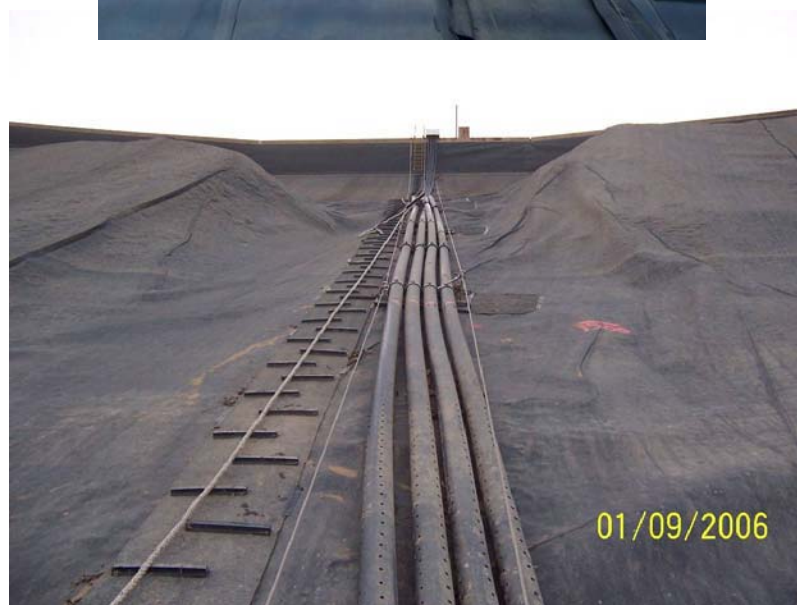
Figure 7-5

It should be noted that the as found displaced position of the transducer pipes does not necessarily represent the maximum position achieved prior to the breach event. In the days following the event, the transducer pipes gradually straightened out and moved back to near their original position. As such, the actual vertical movement of the pressure transducers was likely somewhat higher than the calculated 3 feet value.

Note, straightening of protective pipes  
between dates of above photos.

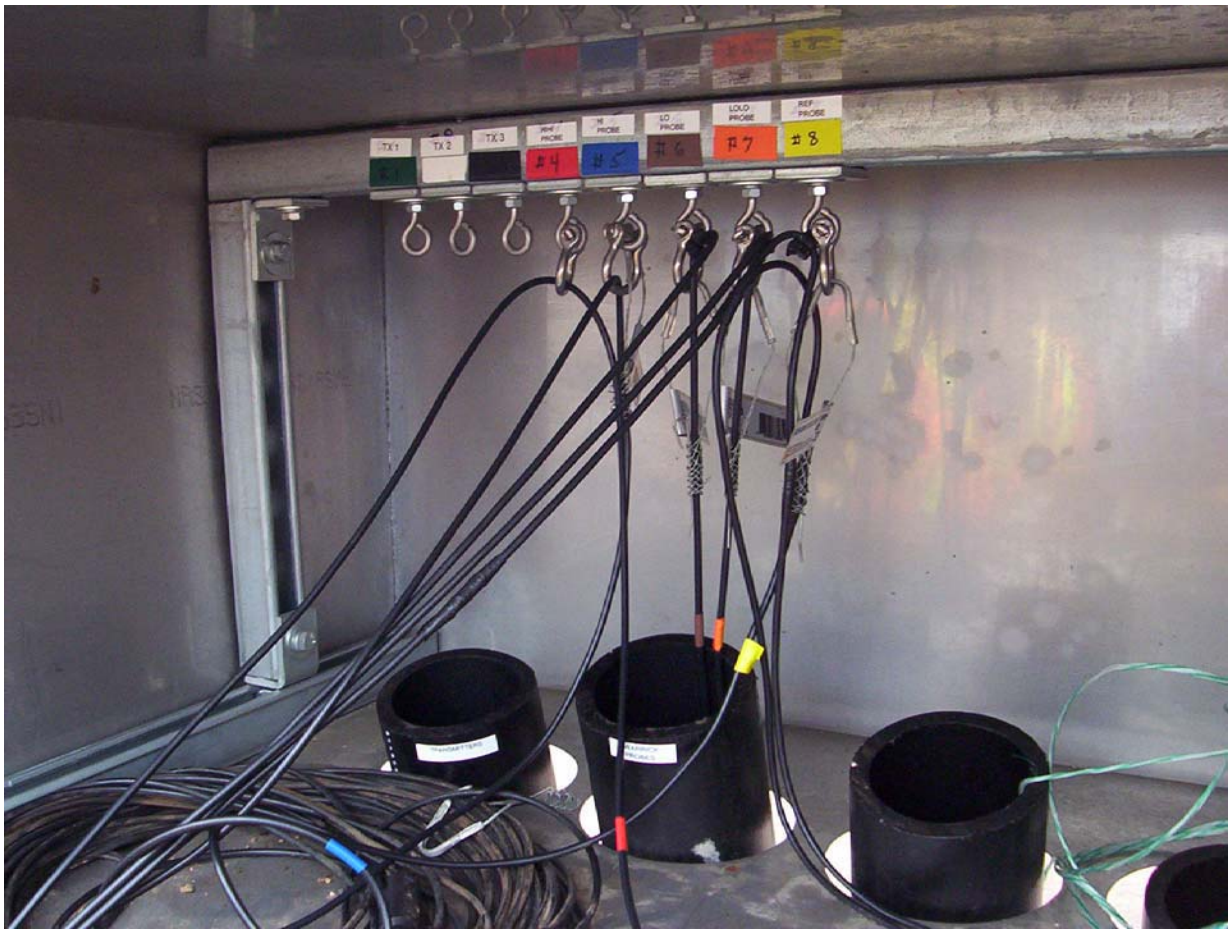
**Figure 7-6**

**Upper ends of protective pipes  
with instrument cables in enclosure on parapet.  
Pressure transducers use left pipe  
and conductivity probes use the second pipe from left.**

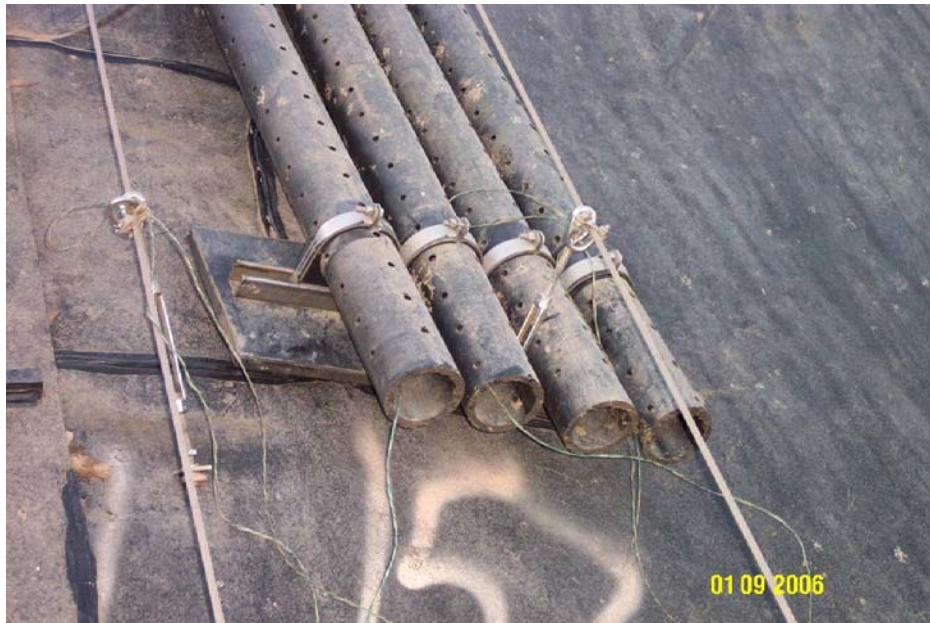
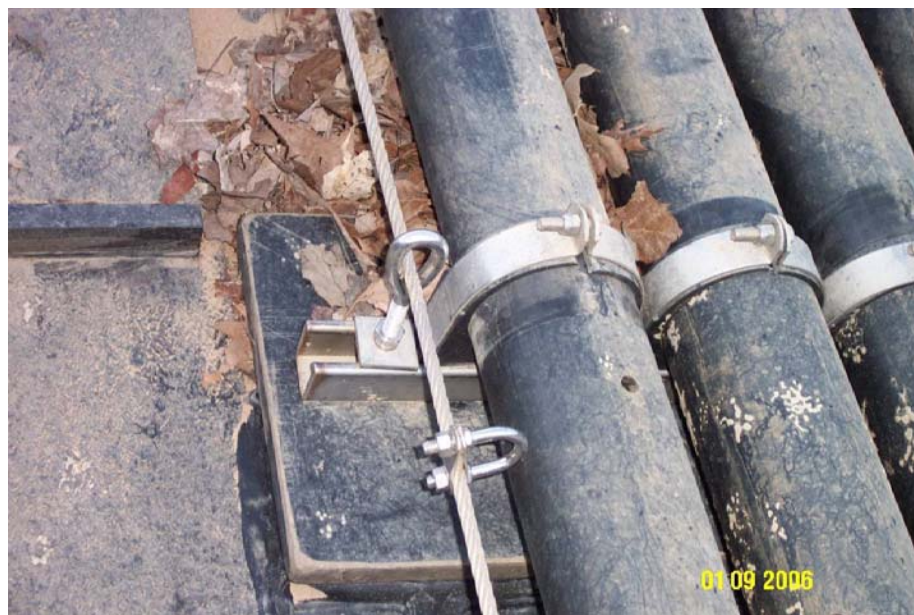
Figure 7-7

To avoid penetrations of the liner material and the creation of possible leakage paths, the protective pipes were supported on plastic plates that were connected by eye bolts to two stainless steel guide cables. The cables were secured only at the bottom and top of the reservoir. Figures 7-7 and 7-8 show these support systems as found after the breach event.

Protective pipe base plates are not anchored to reservoir.  
Left guy cable has come loose from base plate in top photo.

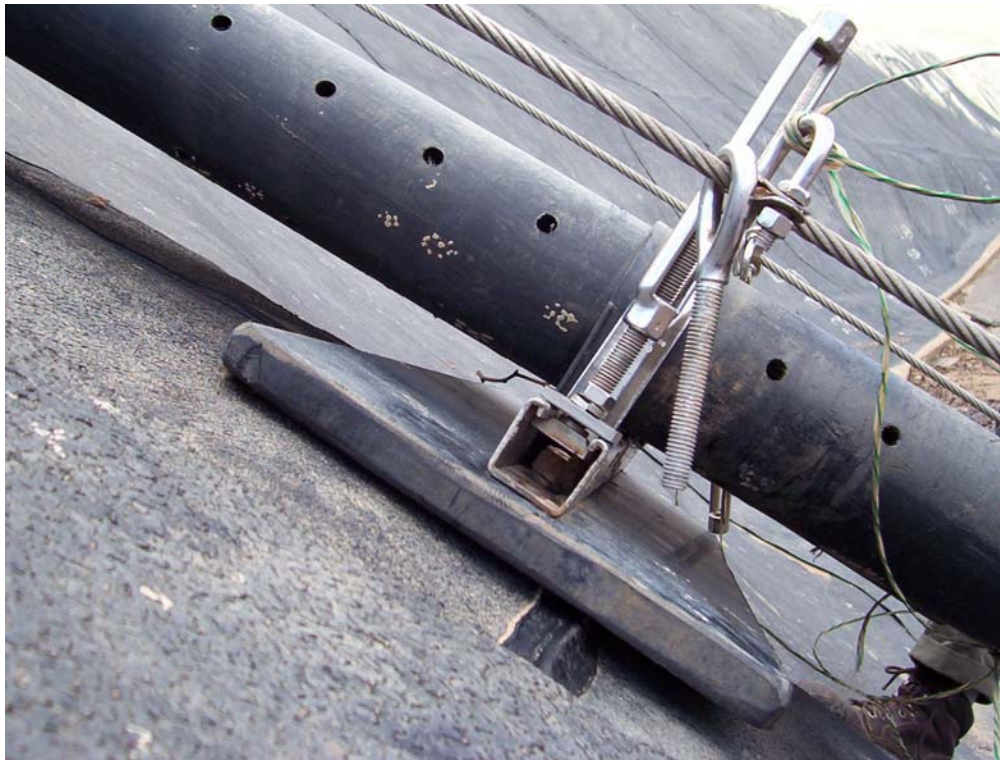
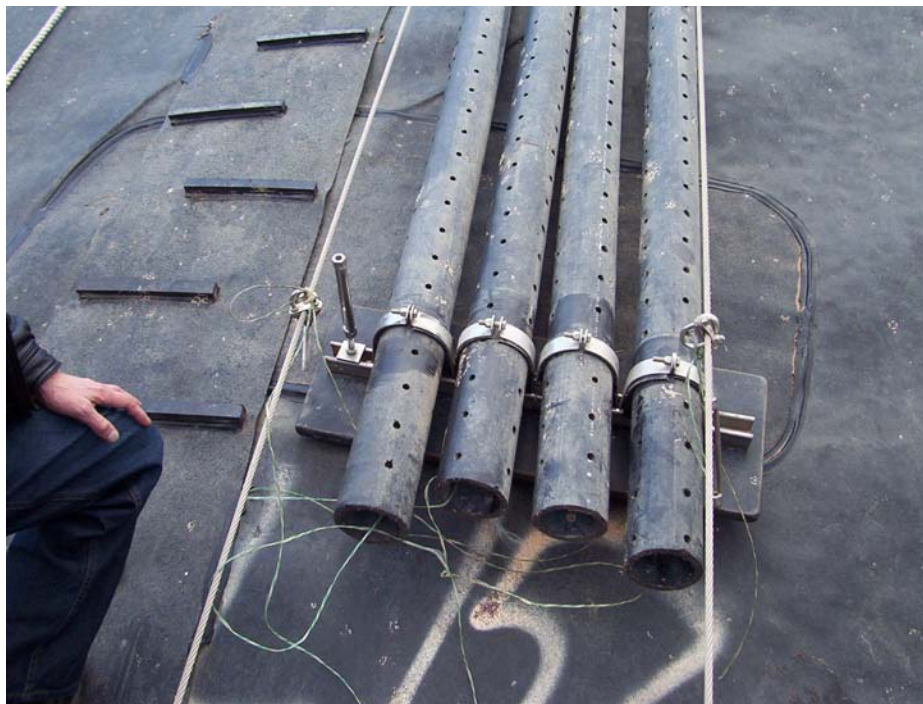
Figure 7-8

Protective pipe support system as found. Note eye bolt unthreaded from turnbuckle. Also note lock washer in place at connection to U channel but lack of lock washer at turnbuckle.
