# TAUM SAUK UPPER DAM BREACH (FERC P-2277)

## Technical Reasons for the Breach (12/14/05)

Technical Reasons for the Breach  
of December 14, 2005

FERC Independent Panel of Consultants (IPOC)

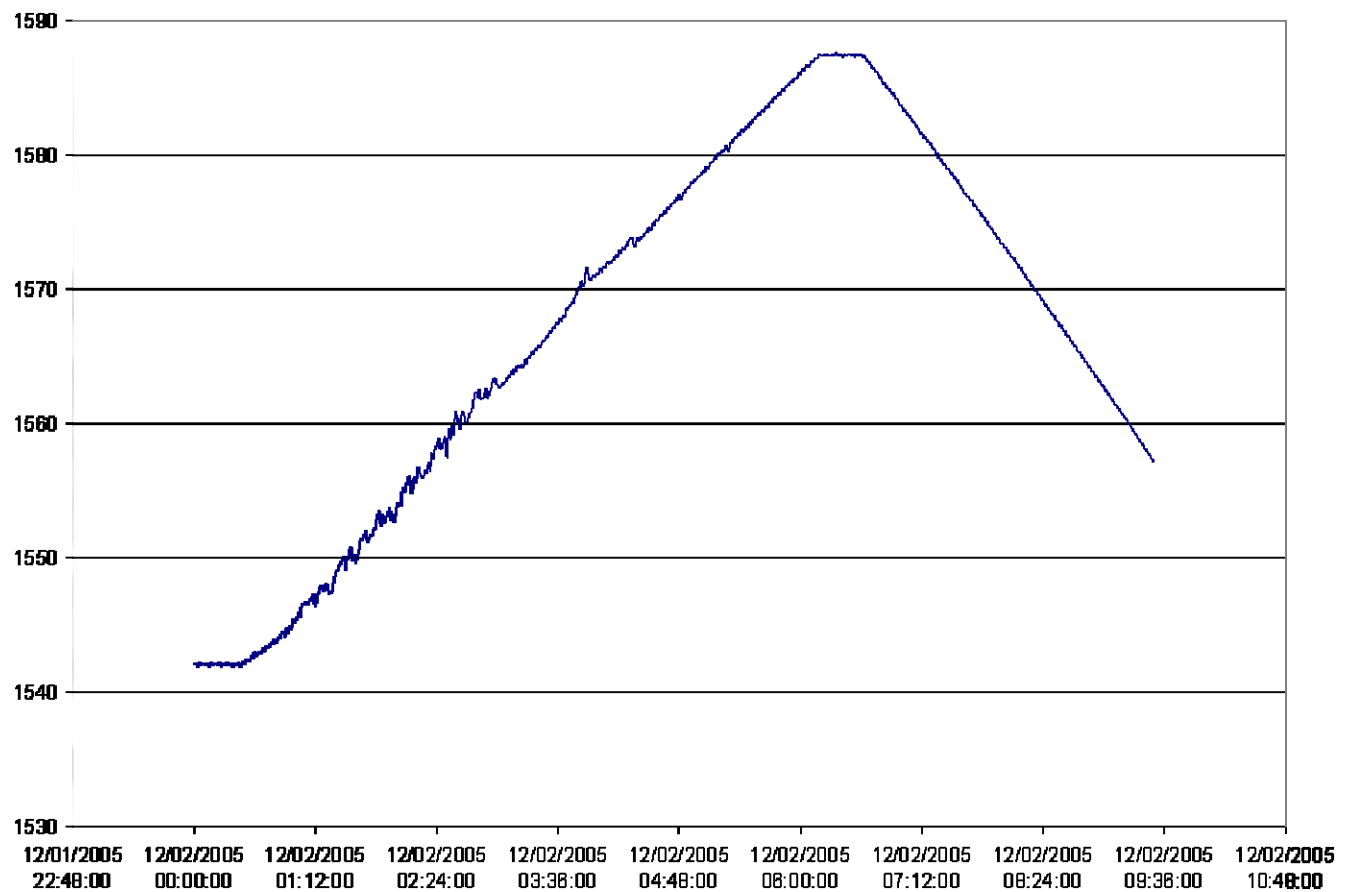
Figure 7-14 shows a continuation of water level readings from December 2, 2005. Once the level rose above about Elev. 1563, the large fluctuations decrease significantly and are very small when the water level was falling during generation later in the day. This pattern of water level fluctuations is found on most days after December 2, 2005. This evidence suggests that the pump discharge pattern created substantial forces acting on the protective pipes and/or the support cables when the water level is lower and that these forces diminish as the flow discharge pattern shifts upward at higher water levels. The evidence also suggests that the generation mode flow pattern into the intake is more stable and produces much less disturbance to the protective pipes. This is consistent with the much higher exit losses associated with discharge into an open reservoir compared to entrance losses for the same geometry.

**Dec. 2<sup>nd</sup>. Note erratic behavior on rising and lower level compared to falling level.**

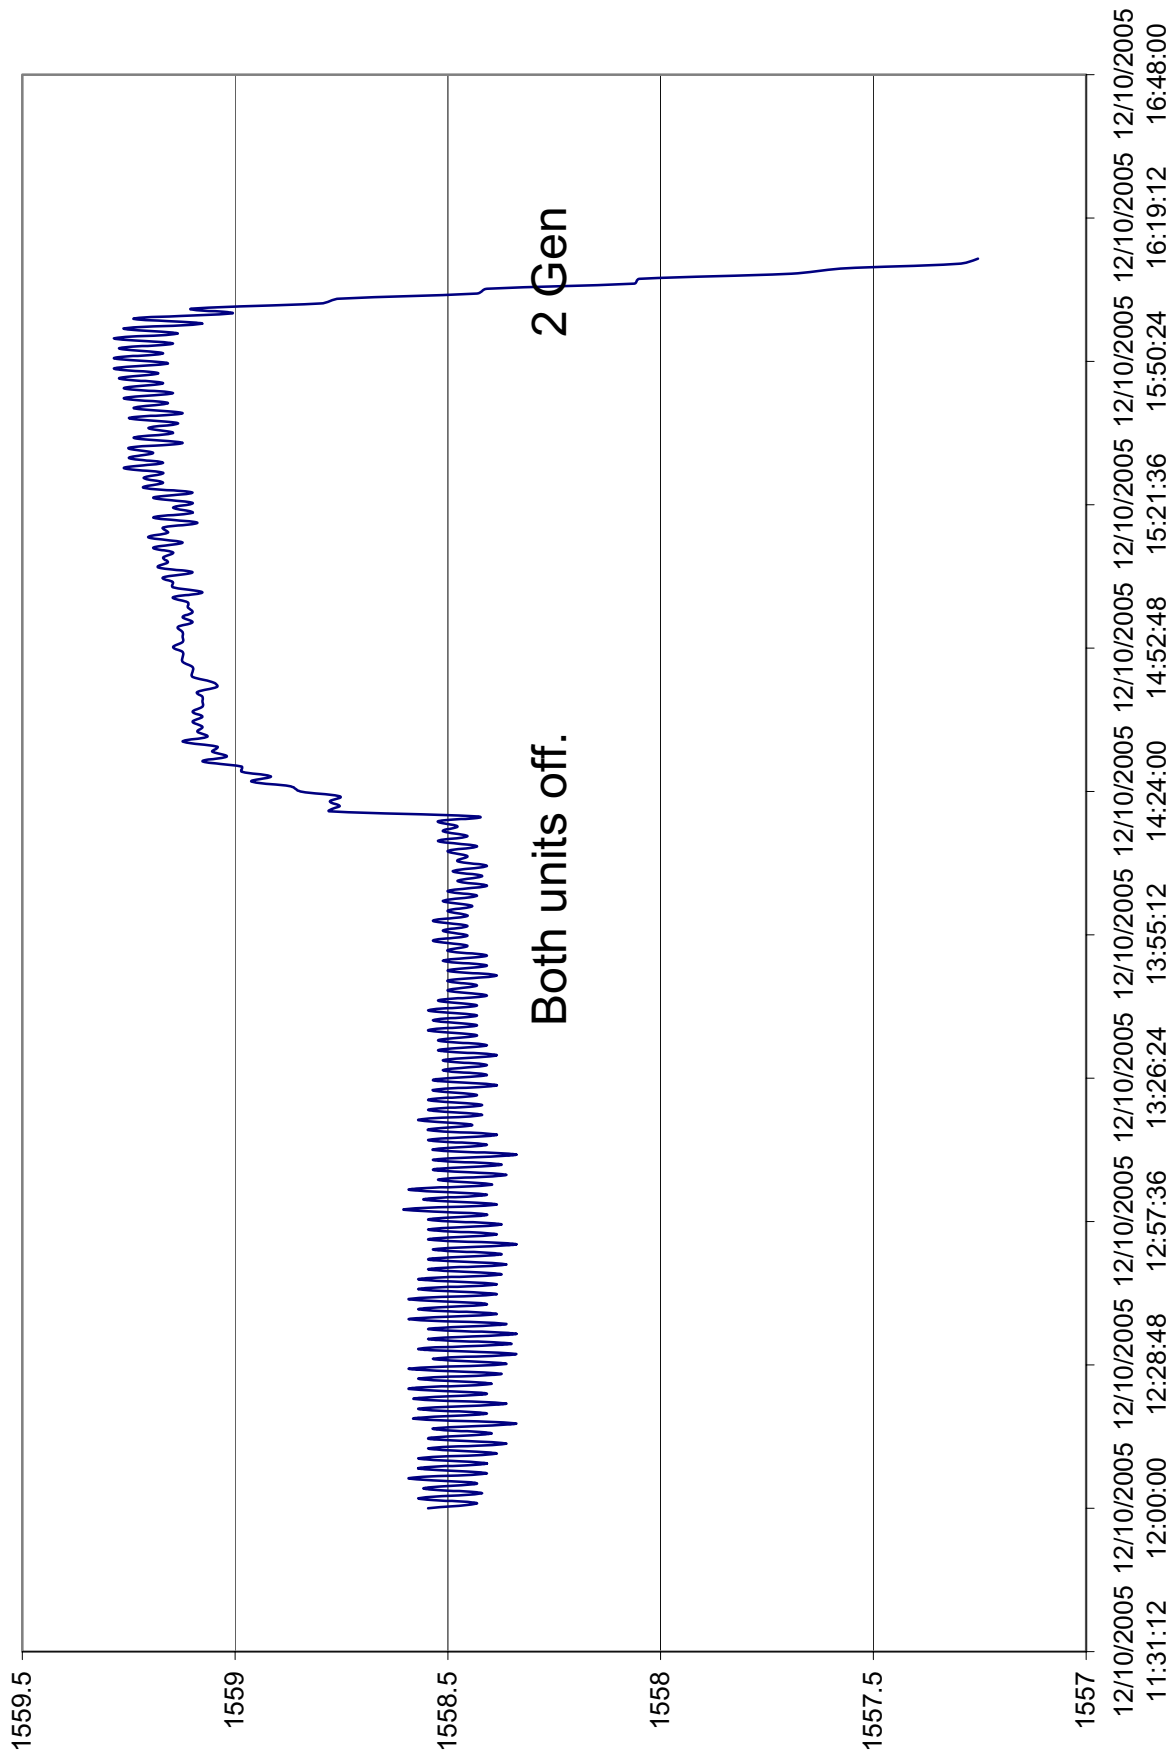
Figure 7-23 shows an interesting pattern of water level readings for December 10, 2005 with both units off followed by both units generating. We don't know if these level fluctuations are due to transducer movement or other causes. The left portion of the plot seems to be damping out until the disturbance around 14:24. The subsequent fluctuations appear to be building in amplitude until the two generators began operation.

**Erratic level indications on Dec. 10<sup>th</sup>.**

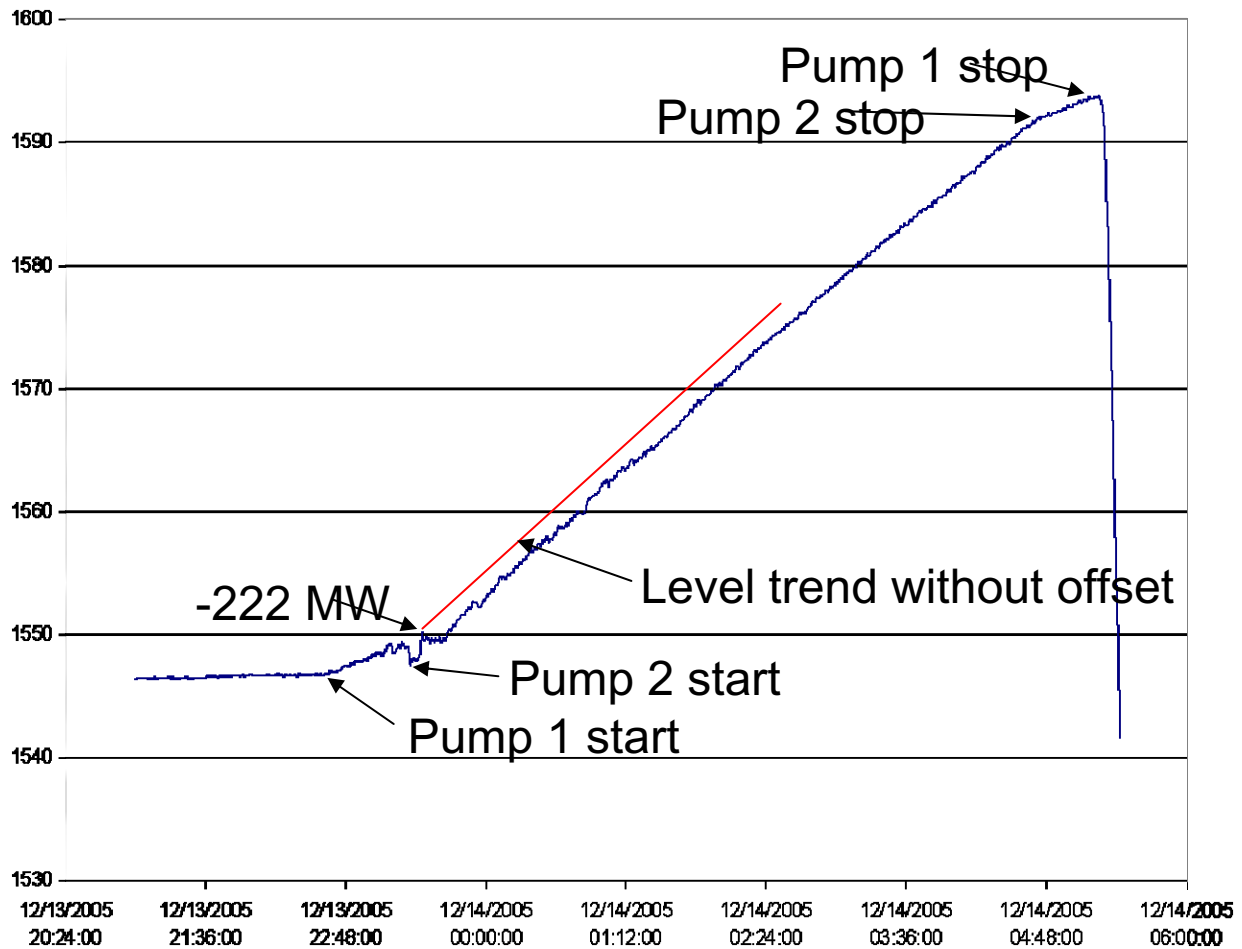
Figure 7-24 shows the water level readings from the start of both pumps on December 13, 2005 through the reservoir failure on December 14, 2005. The – 222 MW arrow shows the indicated water level when pump 2 completed its start sequence. The water level indication remained level for about 12 minutes rather than immediately beginning the more rapid rate of rise that it should have. At that level of Elev. 1550, two pumps were producing a level rise of about 10 feet per hour or about 2 feet in those 12 minutes. While there were smaller subsequent level indication fluctuations, they did not restore the level readings back to the trend line shown.

The most logical explanation is that during those twelve minutes the transducers were moving up at about the same rate as the water level, hence showing no level change during the interval. The line labeled “Level trend without offset” shows where the water level indications should have been without the offset. It should be noted that the level indication at the beginning of the plot is not necessarily accurate given the many indications of prior transducer movement and erratic readings. It is also possible that generating mode flows past the transducers may have tended to bring the protective pipes back to near their original positions resulting in some periodic level error corrections.

**Level indications after pump 2 start shows an offset.  
-222 MW = Completion of pump 2 start sequence.**

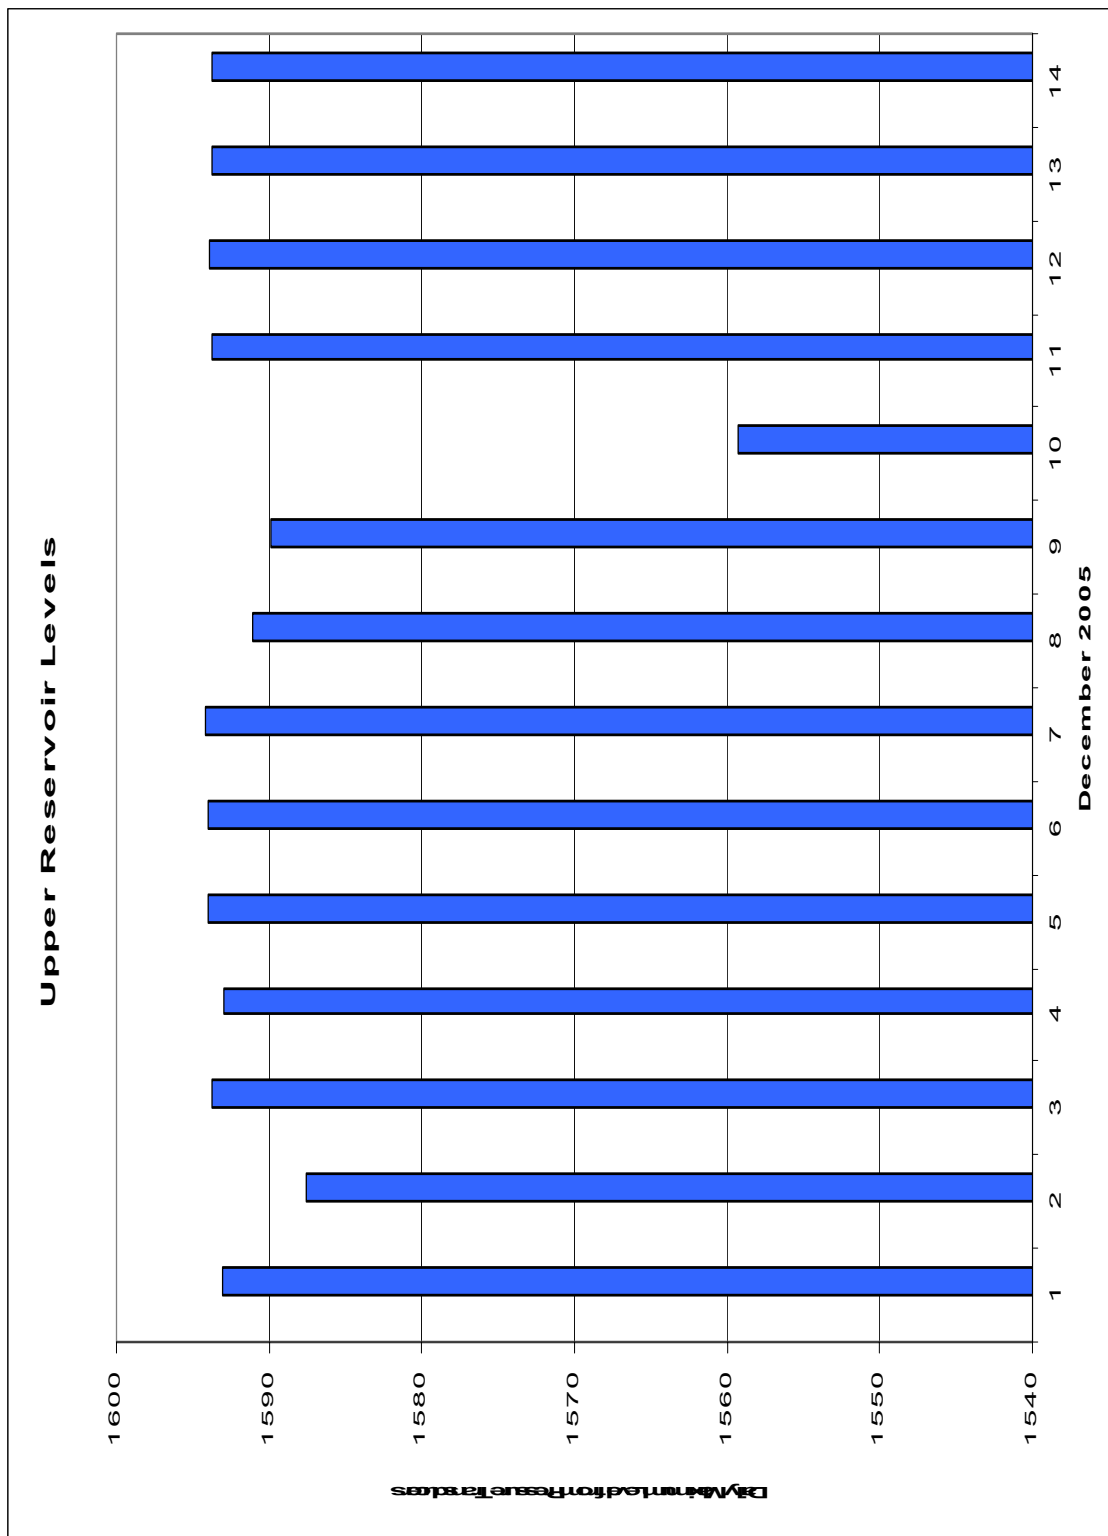
Figure 7-27 is a plot of maximum daily water level indications for December 2005. The plot shows that level indications as high as that shown for December 14, 2005 were achieved on many earlier days. Since reservoir failure did not occur on those dates, it suggests that the level reading offset described above for December 13, 2005 is primarily responsible for the failure to shut down the last pump. As noted above, that offset resulted in the actual water level being at least two feet higher than the pressure transducers indicated.

Daily maximum indicated levels.

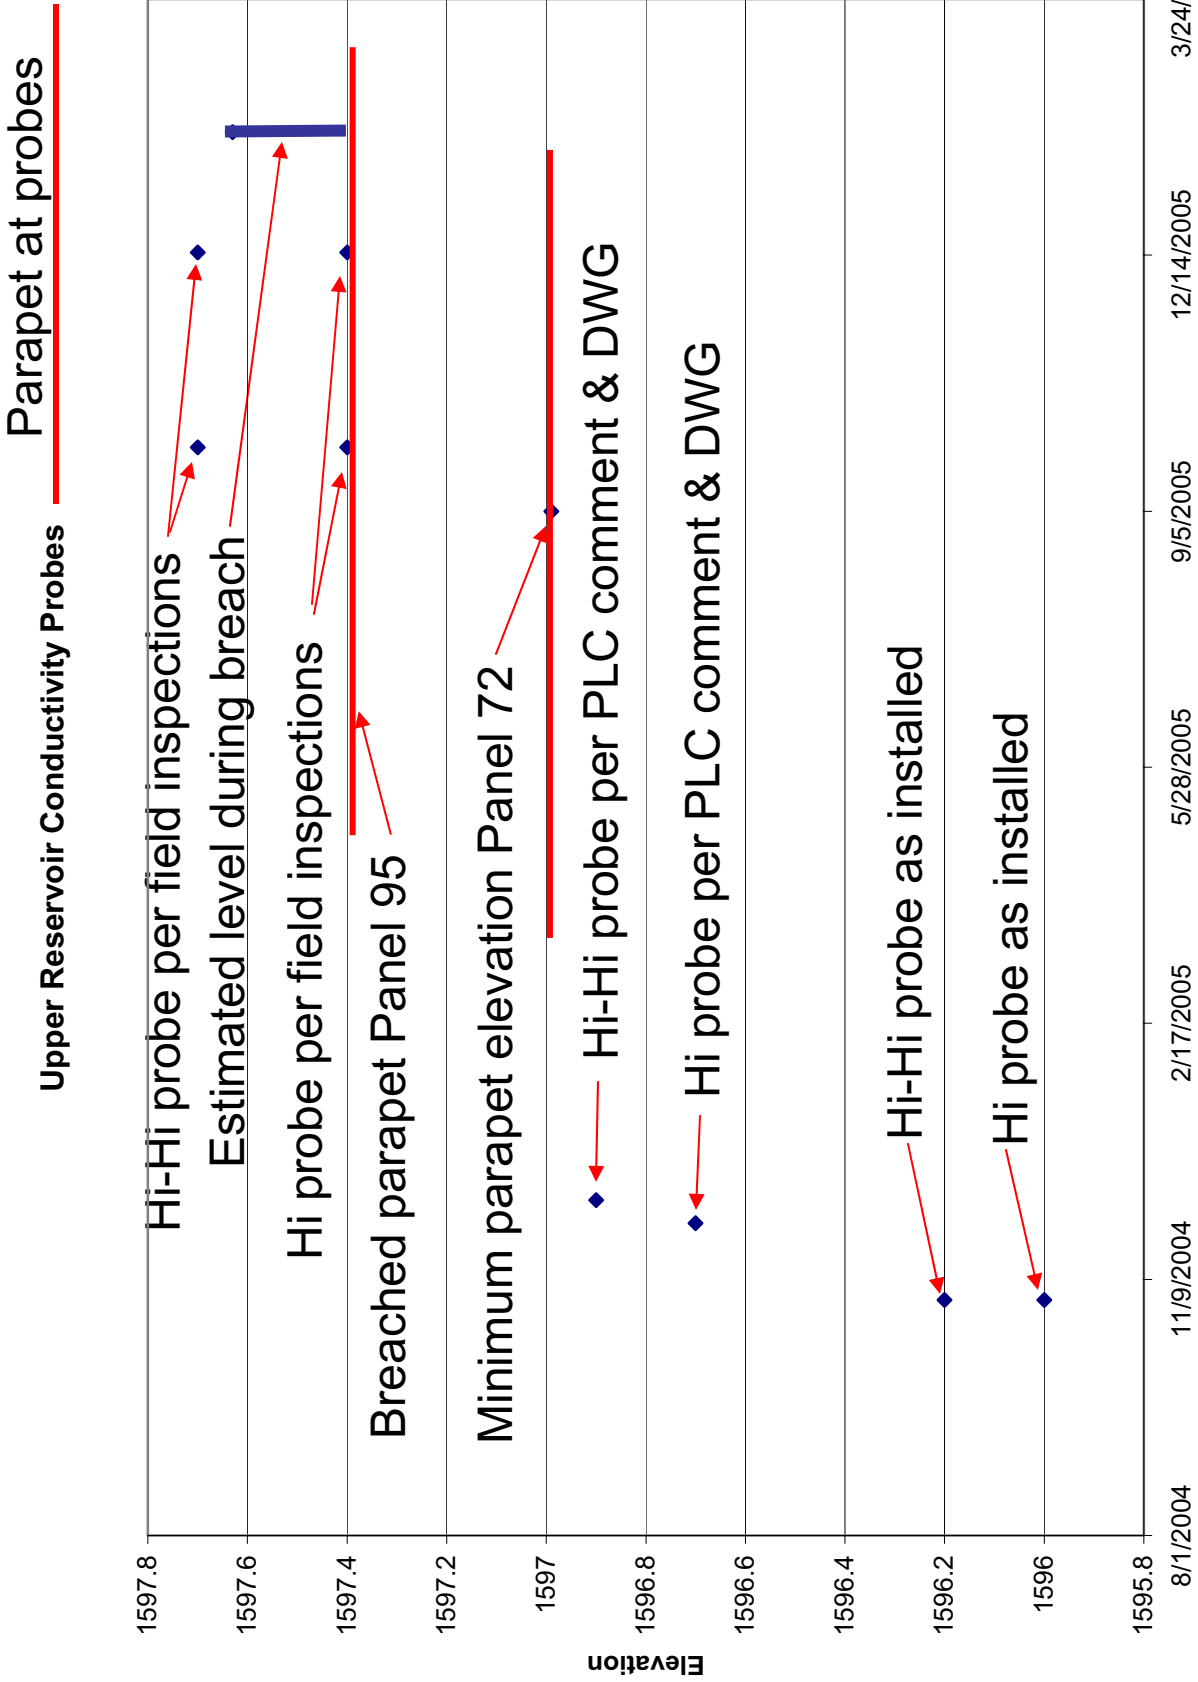
After the breach, the Hi and Hi-Hi conductivity probes were found to be 4" and 7" below the top of the wall as described in the above e-mail of October 7, 2005. As shown on Figure 7-28, this places the Hi-Hi probe above the top of Panel 95 (1597.39), in the breached area and above the top of Panel 72 (1596.99), the minimum elevation of any panel in the reservoir. We received no documents or interview responses indicating why or when the conductivity probes were raised to these elevations.

Figure 7-28 is a summary of the results including the as found elevations of the Hi and Hi-Hi conductivity probes. The estimated level during breach is shown as a range of levels dependent on method of calculation noted above. The maximum water level based on the as found displaced shape of the transducer pipes is excluded for the reason given above.

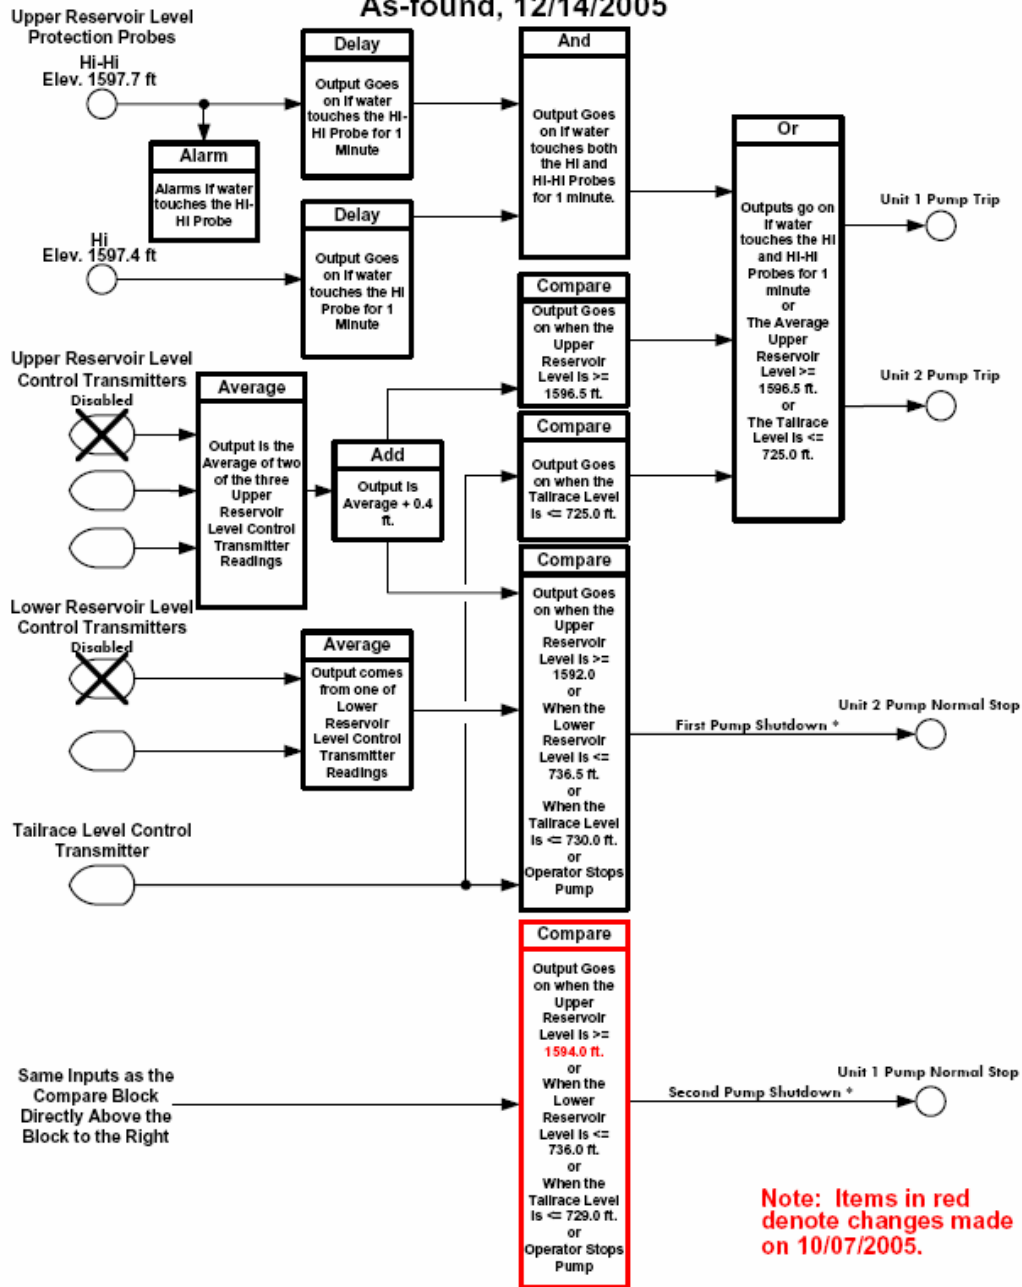
Figure 7-31

Note: Due to programming error made on Sept. 16, 2005, Unit 2 pump shutdown due to level protection probe response was disabled.
