Missouri Public Service Commission

Gas Incident Report

**Missouri Gas Energy
Case No. GS-2003-0468**

3441 Chestnut Avenue
Kansas City, Missouri
March 9, 2003

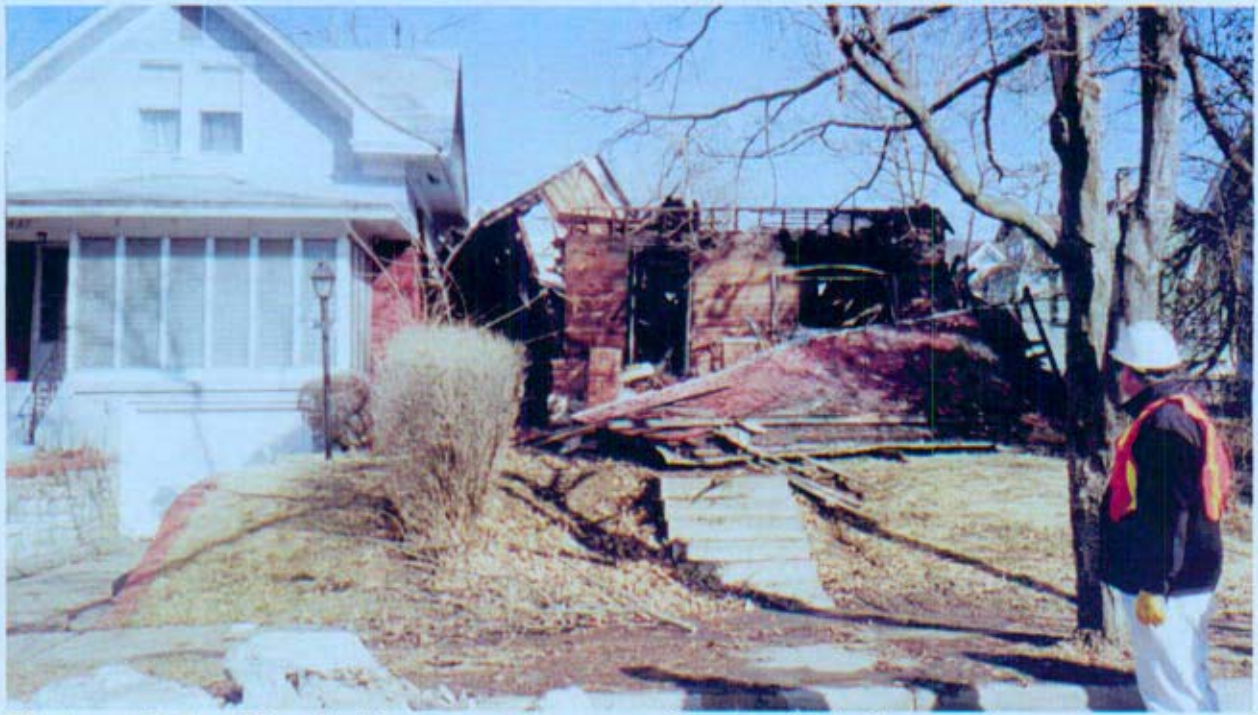
As a result of the natural gas explosion and subsequent fire, the 3441 Chestnut dwelling was left uninhabitable and as a complete loss of structural and personal property. To the north and adjacent to 3441 Chestnut is the residence of 3437 Chestnut, which consequentially suffered minor damage from the extraction of debris and the collapse of the 3441 Chestnut residence (Appendix B-1, Photograph 1). MGE reported estimated property damage of \$50,000.

Photograph 1. – View looking east at damages suffered by 3441 Chestnut Avenue as a result of the explosion and subsequent fire.

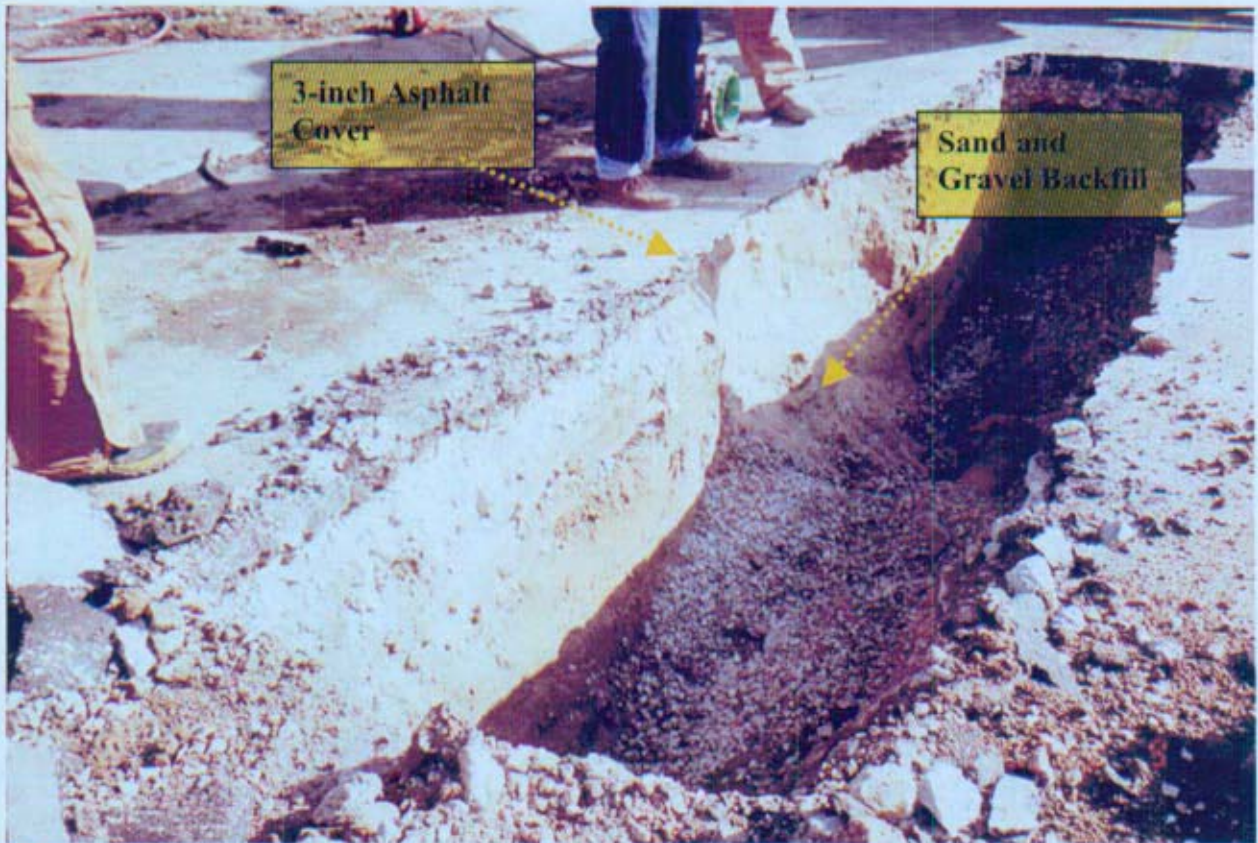
As excavation continued to expose the origination of the leaking natural gas, examination was made of soil conditions over the 6-inch diameter cast iron main. A 4-foot by 16-foot excavation in the street, near the base of the driveway to 3441 Chestnut, revealed backfill material consisting primarily of sand and gravel (Appendix B-1, Photograph 2). The street over the leak location consisted of various layers of asphalt and/or concrete, with only an approximate 3 to 4-inch layer of asphalt east of the excavation and approximately 11 to 12-inch thick layering of asphalt/concrete (Appendix B-1 and B-2, Photographs 2 and 3, respectively) west of the excavation.

Photograph 2. – Viewing looking southeast at excavation of the 6-inch diameter cast iron main and surrounding backfill material. Note most backfill material consisted of sand and gravel.

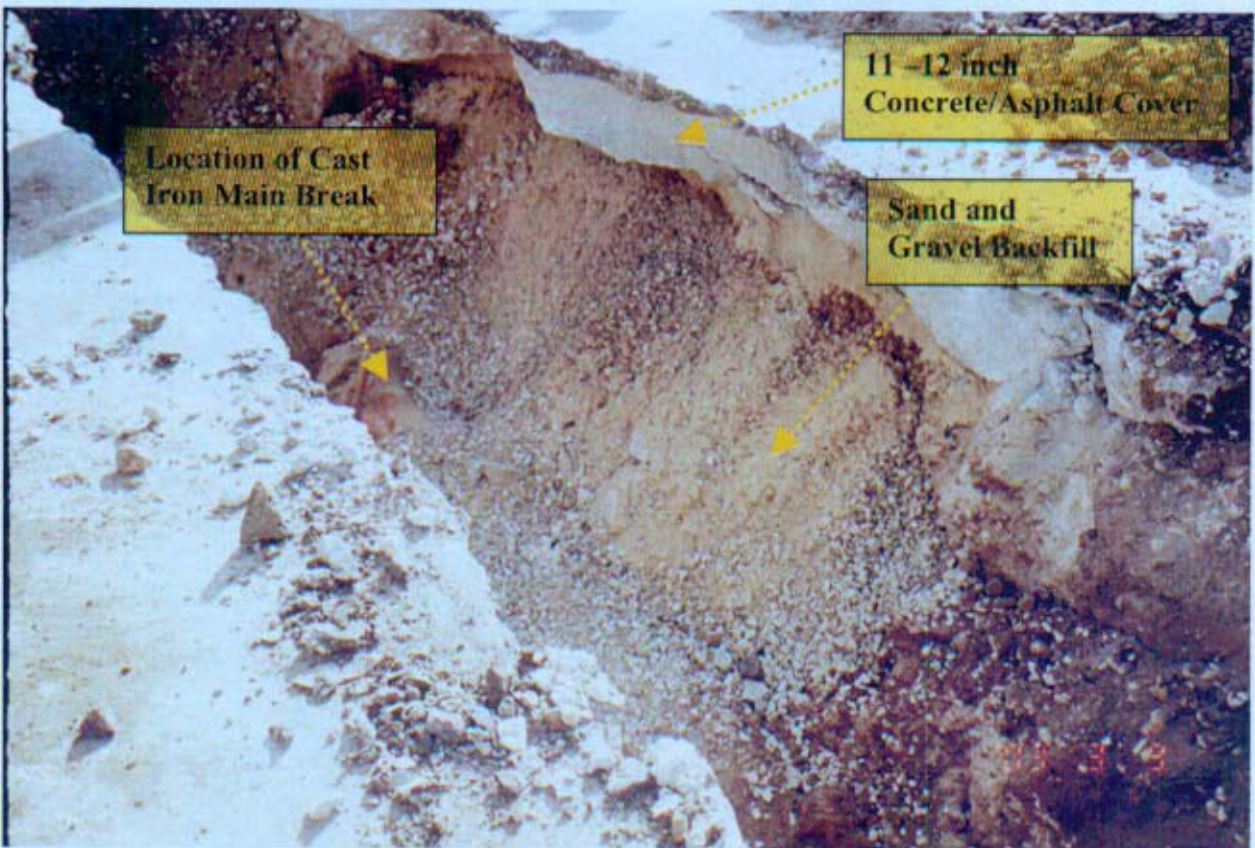
Photograph 3 – Looking southwest at the backfill material.

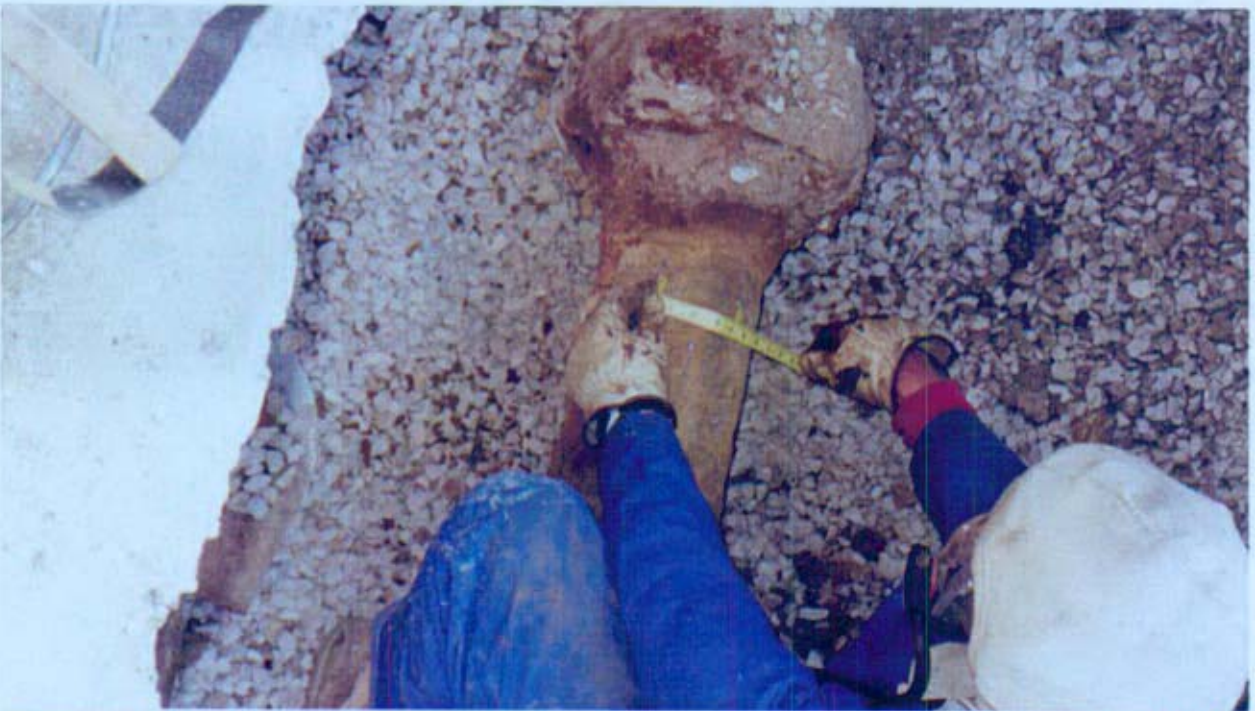
Shortly before 4:00 p.m., a circumferential crack was discovered on the 6-inch diameter cast iron main (Appendix B-2, Photograph 4). The fracture extended from the 1 o'clock position to the 11 o'clock position, with greatest separation of the cast iron main (1/8-inch) occurring at the 6 o'clock position, or the bottom of the pipe. MGE construction personnel were able to install a full encirclement clamp to stop the leaking natural gas. The Company expressed that this was a temporary repair as plans were being made to have the section of cast iron main, which included the crack, replaced.

4. The cause of the cast iron main fracture was the application of external forces in combination with insufficient pipe support from backfill material, which resulted in induced stresses beyond the yield point at the fracture location. Records indicate that sewer excavation activities occurred in the area of the fracture and backfill material consisting of sand and gravel provide evidence of prior excavation activities. MGE reports that it was not aware of the sewer excavation and did not receive a locate request notification.

Photograph 4 – View of circumferential crack in 6-inch cast iron main. The crack extended from the 1 o'clock position to the 11 o'clock position. The worker's left thumb marks the 11 o'clock position.

The 6-inch diameter cast iron main in the 3400 block of Chestnut Avenue was replaced with 4-inch diameter PE piping on April 24, 2003.
