RE: Case No. GS-2000-673

Gas Incident Report

At approximately 3:15 p.m., Central Standard Time (CST), on Saturday, March 25, 2000, natural gas was ignited and an ensuing fire occurred at 416 Boyce Avenue (416 Boyce) in Farmington, Missouri. Fire damage was primarily localized to the kitchen area, but smoke damage was present throughout much of the ground floor of the two-story residence. Total damage was estimated at \$20,000. Five individuals were inside the residence when the natural gas was ignited. One individual, who was working in a crawlspace beneath the kitchen floor, suffered burns to his face and right arm. He refused initial medical attention, but sought medical treatment on March 29 in Columbia, Missouri, where he was treated for 2nd degree burns and released. There were no fatalities resulting from the incident.

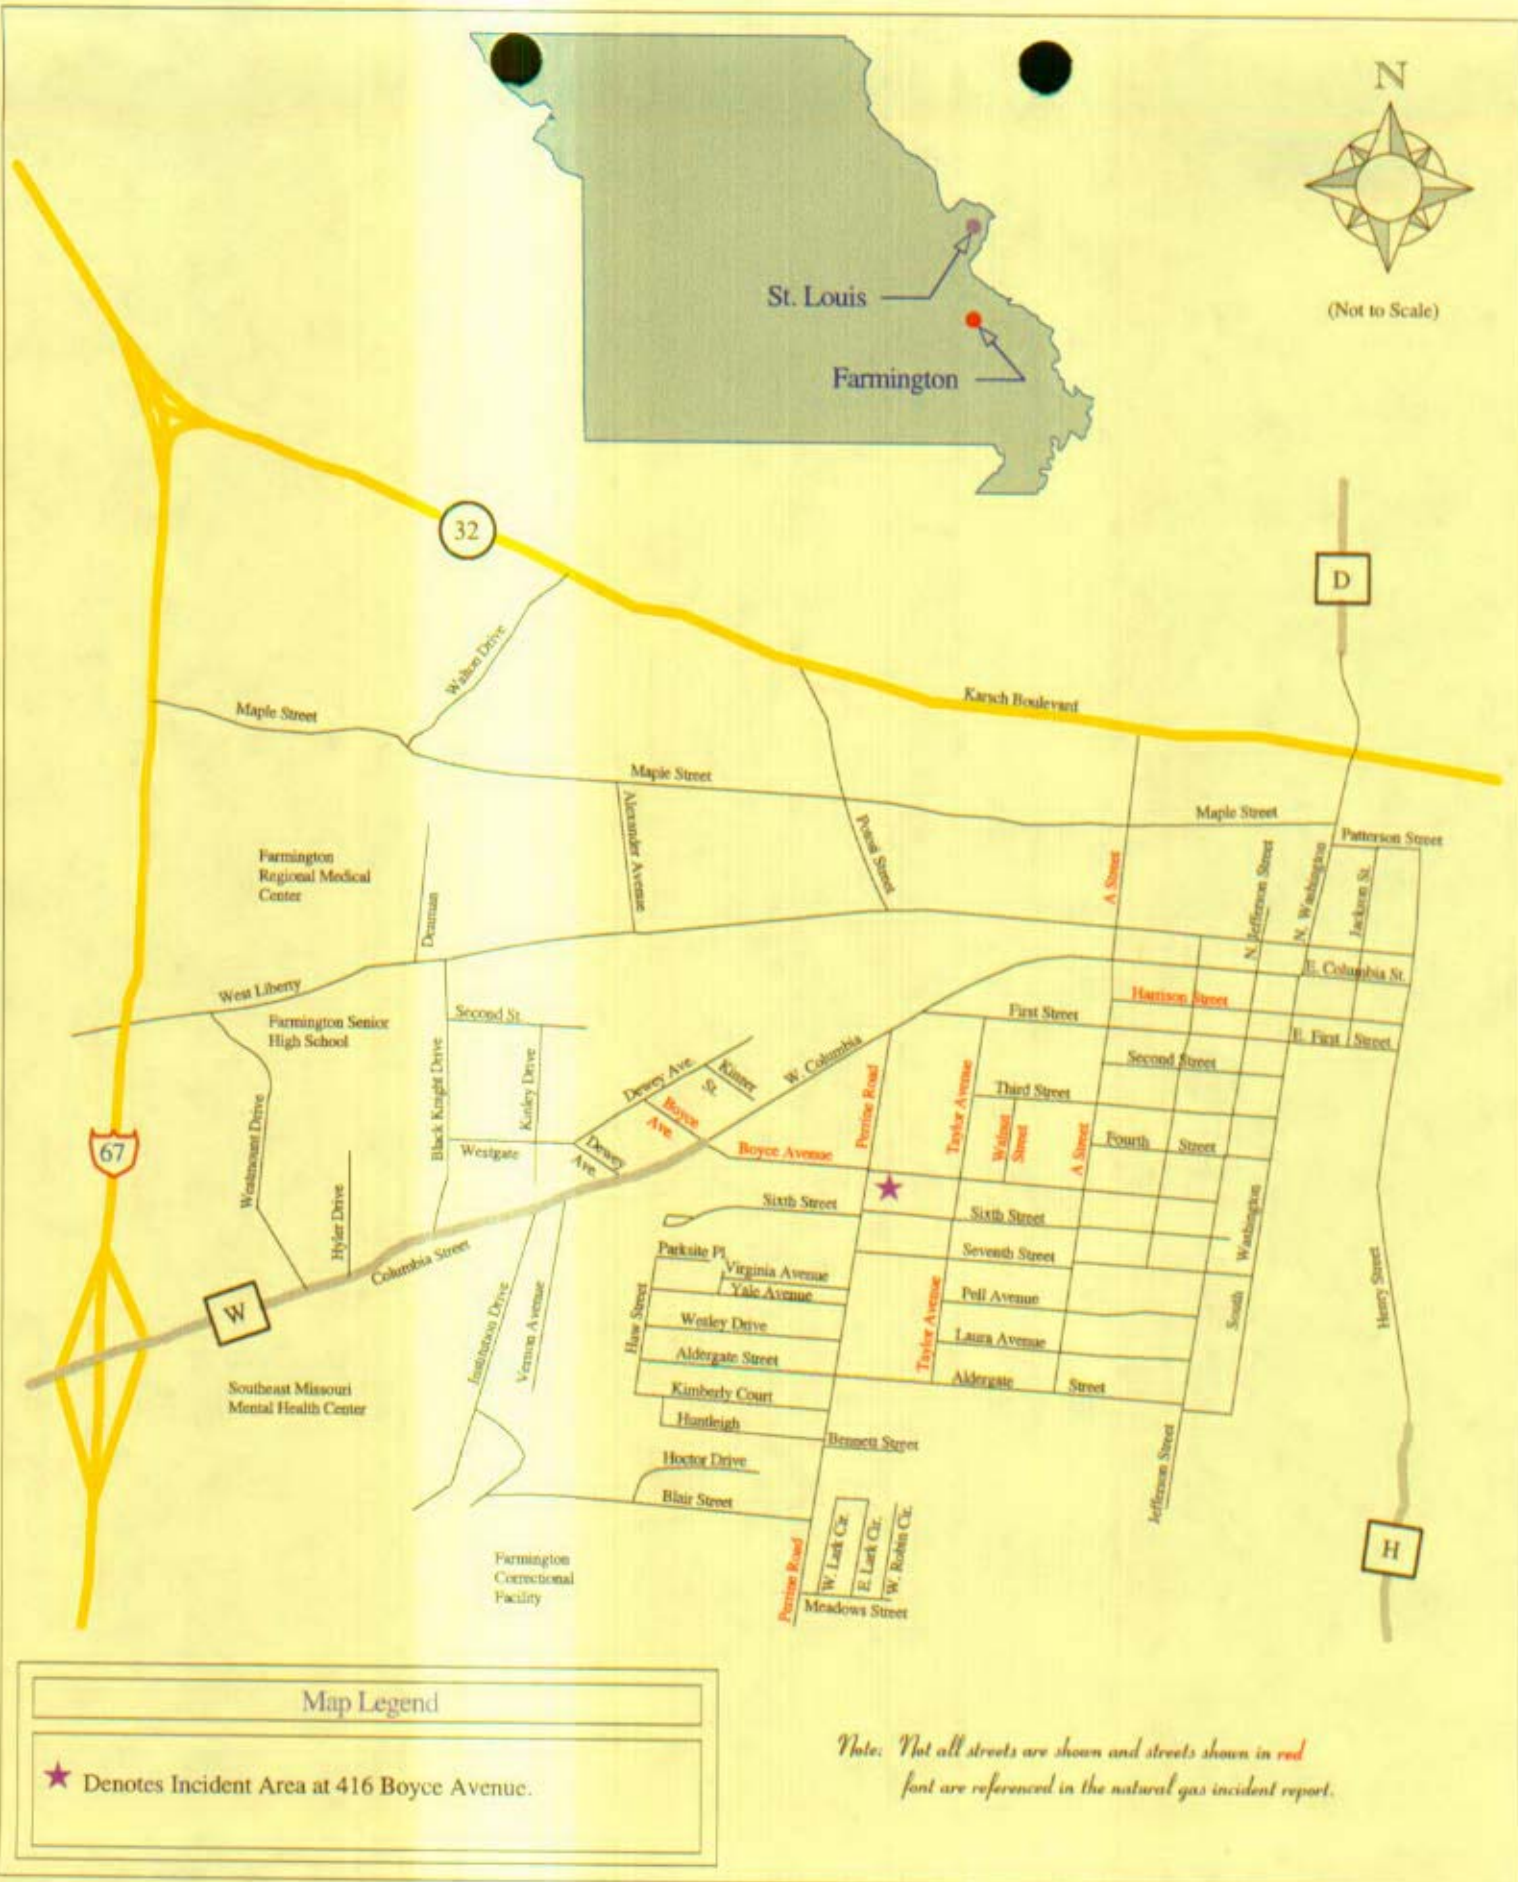
Figure 1
Overall View of 416 Boyce Avenue Incident Location
Appendix A-1

At 6:20 p.m. on March 25, approximately 2½ hours after initial arrival, the Company continued to expand its leak investigation to now include both sides of Boyce Avenue, from Perrine Road to 'A' Street (See Appendix A-1, Figure 1). Roof vents of 414 and 416 Boyce were checked, with no indications of natural gas. The highest gas-in-air readings (70% - 90%) were obtained through the asphalt over the 4-inch main in front of 416 and 414 Boyce. Subsurface gas-in-air readings resulting from bar-hole surveys taken west of Perrine Road and east of 414 Boyce indicated no presence of migrating natural gas. However, inside the sewer manhole, located in front of 401 Boyce, (approximately one block away from the incident site) a 7% gas reading was obtained. In addition, approximately two blocks away from 416 Boyce, inside a sewer manhole at the Boyce Avenue/'A' Street intersection, 1.2% gas was detected. At this time, 416 Boyce was being ventilated and utilities were shut off. A 20% gas reading (previously 26%) was still being obtained within the sewer pipe below the kitchen floor while the sewer manholes were being vented.

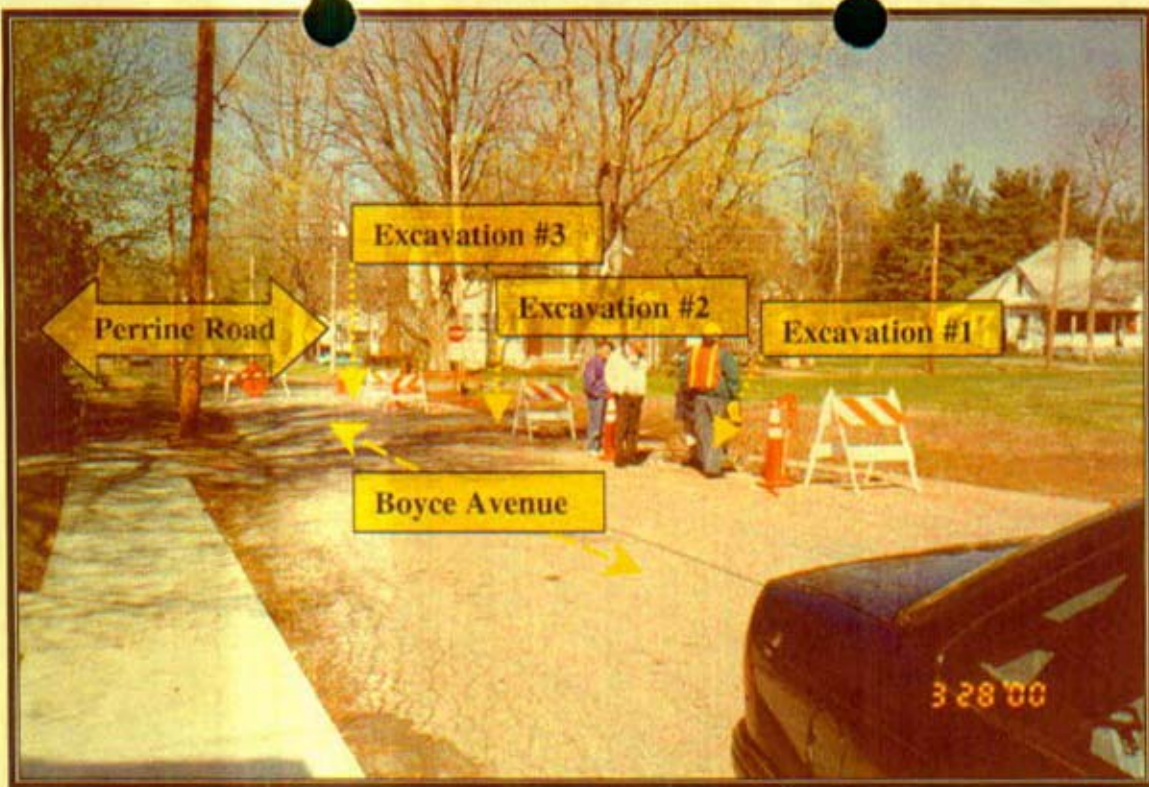
Photograph 1 Looking northwest at excavations made by Laclede personnel.

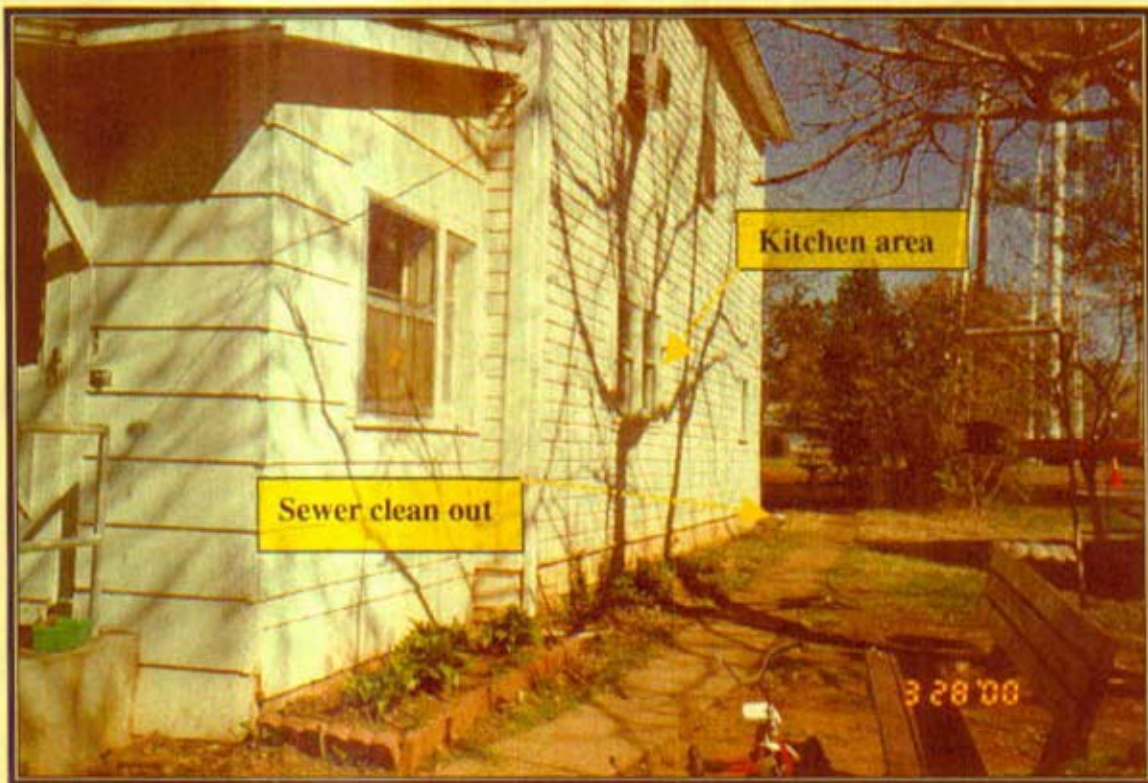
Photograph 2 View of the southeast corner of 416 Boyce Avenue. Note the sewer cleanout location in the background.

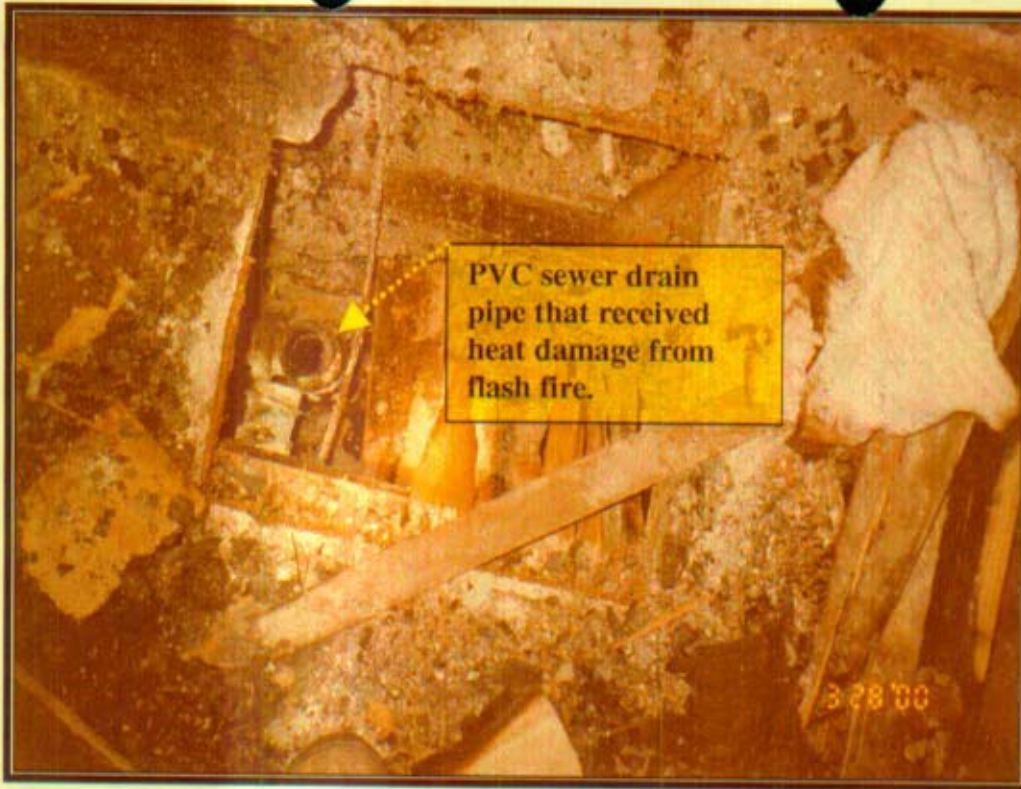
Once inside the kitchen of 416 Boyce, the Superintendent of Service observed the damage and was informed that prior to his arrival, a policeman had extinguished a fire emanating from a sewer pipe located in the crawlspace beneath the kitchen floor. He also became aware that two family members standing in the kitchen smelled natural gas shortly after another family member separated the sewer drainpipe. Further information gathered indicated that a family member turned on the gas range thinking that a recently replaced range knob had become disoriented and that the valve was in the 'on' position, but the burner was not lit. He also observed that the sewer pipe was visible from the kitchen because the fire department had removed the natural gas range and cut a hole, approximately 18-inches square, in the floor (See Appendix B-2, Photograph 3). The initial responding serviceman and the Superintendent of Service obtained a sustained reading of 26% gas taken from within the sewer pipe beneath the floor.

Photograph 3
Looking down through a square opening made in the kitchen floor of 416 Boyce Avenue. Gas-in-air readings of 26% were taken after the incident from the sewer drain piping.

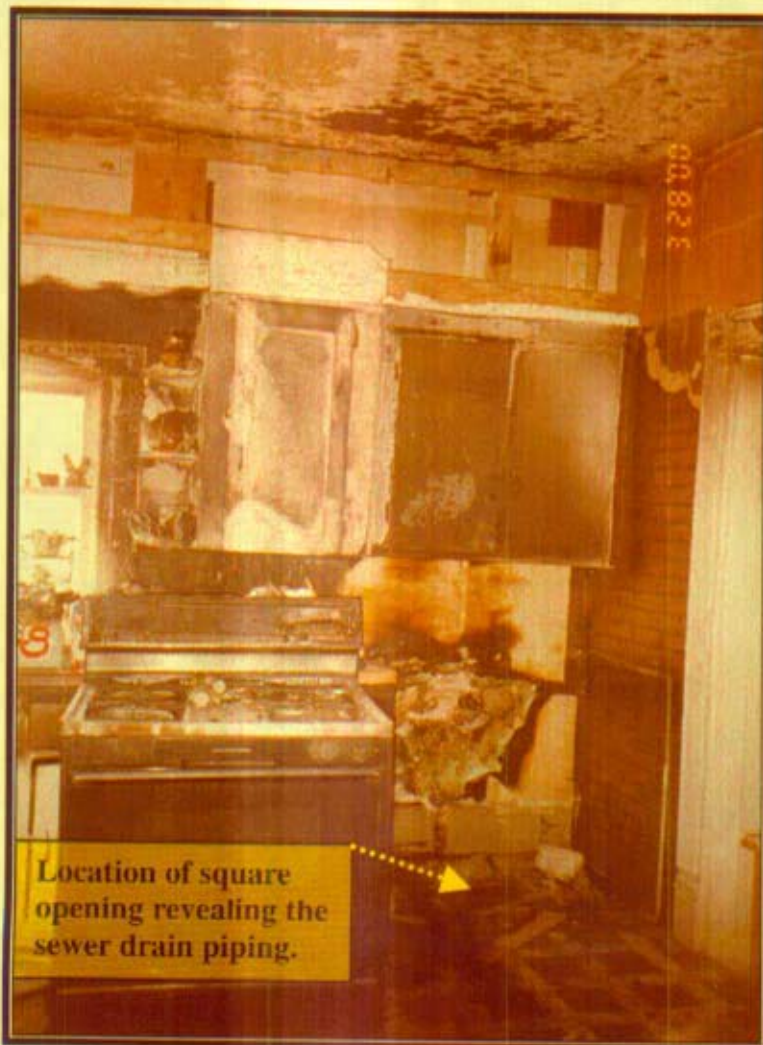
The family member who had separated the sewer piping beneath the kitchen allowed access to 416 Boyce, and guided Staff and a Laclede claims representative from St. Louis through the structure, while describing his actions on March 25. The ground floors of 416 Boyce primarily consisted of a kitchen, bedroom, living room, and utility room, which was located at the back of the structure. Visible fire damage was primarily confined to the kitchen, along the east exterior wall. Kitchen cabinets and appliances, lining the length of this wall, exhibited varying degrees of light to moderate fire/heat damage (See Appendix B-2, Photograph 4).

Photograph 4 View of the kitchen area for 416 Boyce Avenue. Observe the heat damage to the ceiling, cabinets, and wall areas.

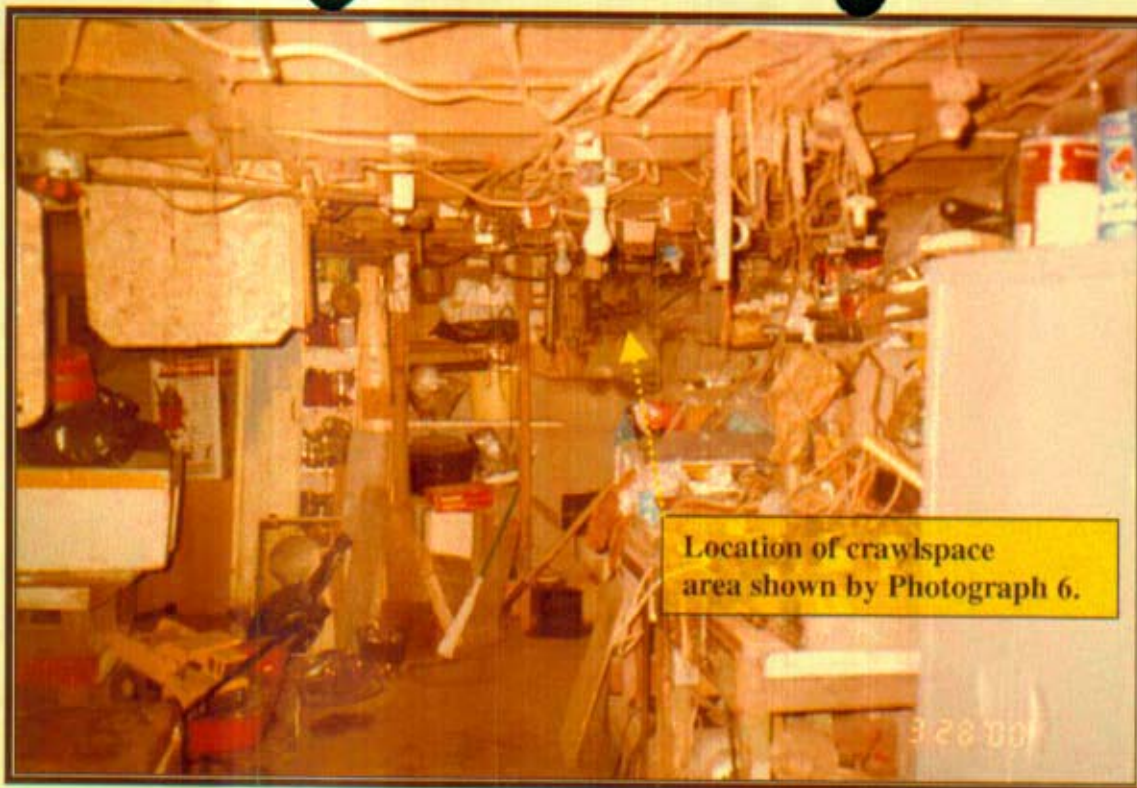
Photograph 5 View of the half-basement of 416 Boyce Avenue, looking east.

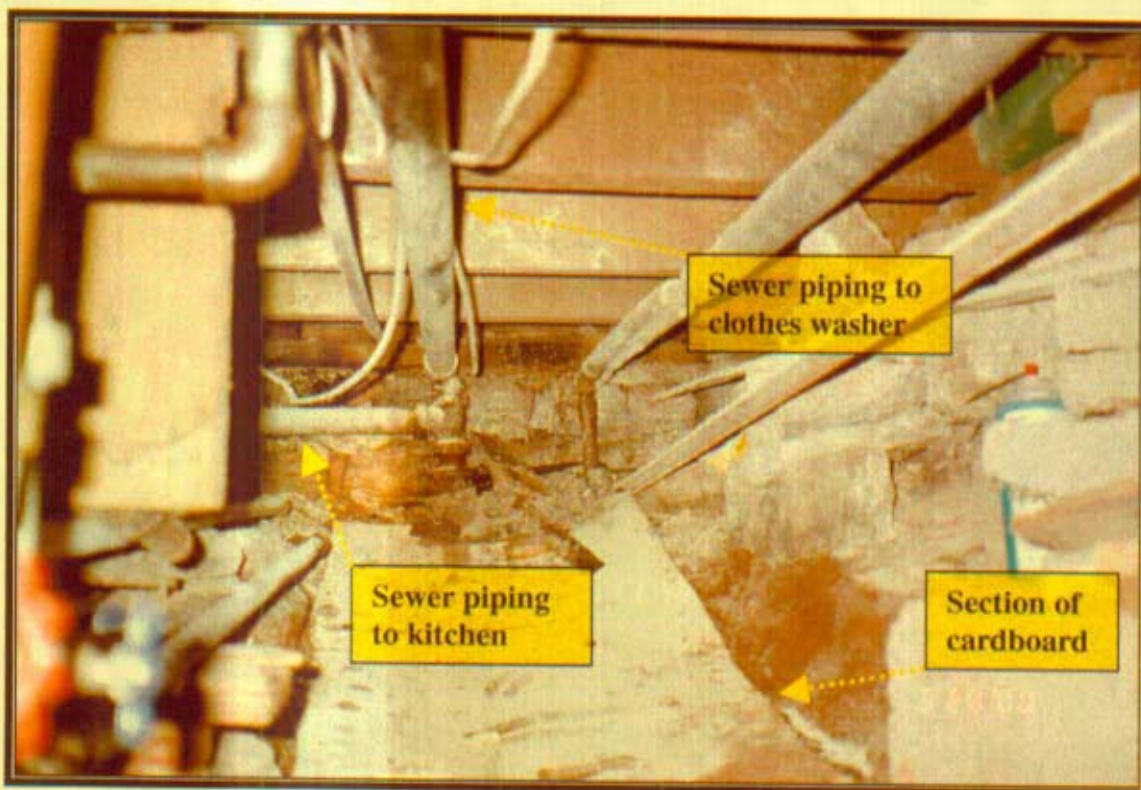
Photograph 6 View looking east in the crawlspace for 416 Boyce Avenue. Observe the sewer drain piping to the kitchen and clothes washer. A relative of the residents of 416 Boyce Avenue was positioned on the cardboard at the time of the natural gas ignition.

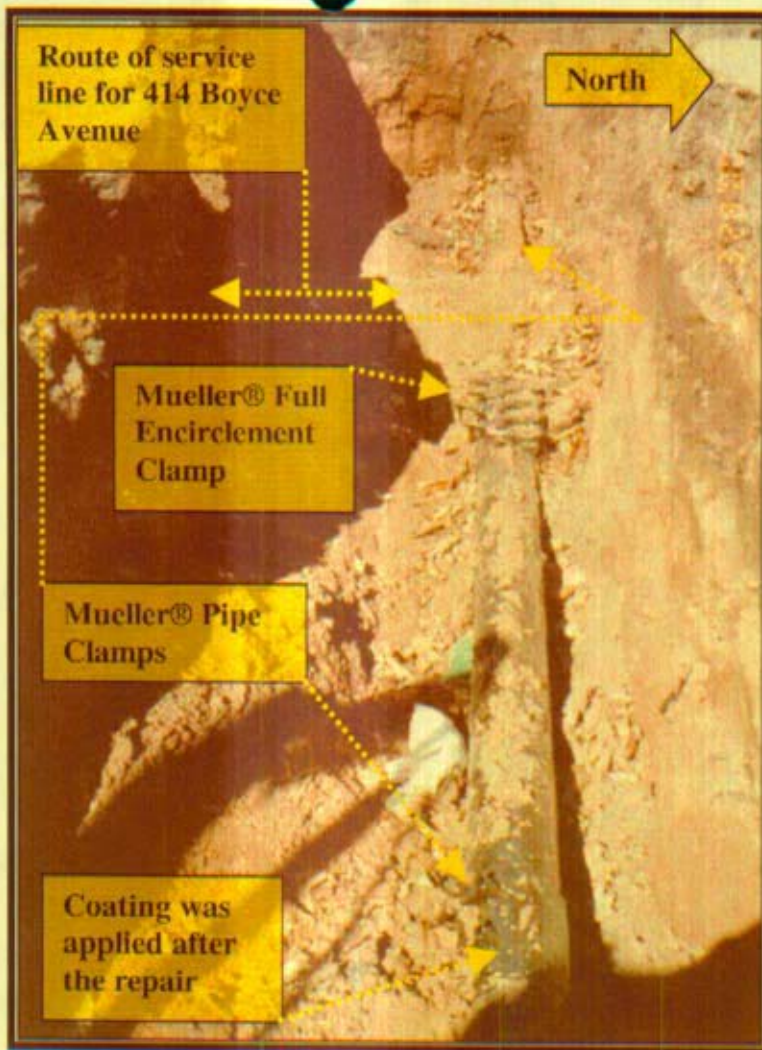
Laclede continued leak investigations, and a fourth and final corrosion leak was exposed. Excavation #1 was expanded eastward, beyond the first corrosion leak repair, to expose the fourth corrosion leak, the third on the 4-inch main (See Appendix B-4, Photograph 8). Again, Laclede installed a Mueller® clamp to repair the fourth corrosion leak. All repairs were completed by 7:00 p.m. Monday, March 27.

Three excavations, as previously mentioned, exposed the 4-inch main and service lines to 414 and 416 Boyce. Excavation #1, approximately 16 feet by 4 feet, contained three completed corrosion repairs to the 4-inch main, near the 414 Boyce service tap (Appendix A-2, Figure 2 and Appendix B-4, Photograph 7). Three Mueller® repair clamps were used to complete the repairs in Excavation #1. The condition of the pipe coating, adjacent to the repair clamps, was inspected, understanding the possibility that excavation efforts may have scratched or gouged any exposed original pipe coating. In their assessment of the 4-inch main condition immediately after it was exposed, Company personnel who also inspected the adjacent pipe coating were requested for their opinions, and each described the coating as in good condition when exposed. At this time, all re-coating efforts and final inspections of the 4-inch main prior to backfilling had not been completed (See Appendix B-4, Photograph 8). The floor and walls of the Excavation #1 were also examined for condition of soil. Visible and sparsely dispersed rocks, ranging approximately 3 inches to 5 inches in size, bulged from the floor and walls of the excavation.

Photograph 7 Looking west inside of Excavation #1 at the three repaired corrosion leaks on the 4-inch natural gas main. The service line for 414 Boyce Avenue was not exposed. The excavation over the 414 Boyce Avenue service line and full encirclement clamp was made on March 25, 2000. The excavation was elongated, both east and west directions, on March 27, 2000.

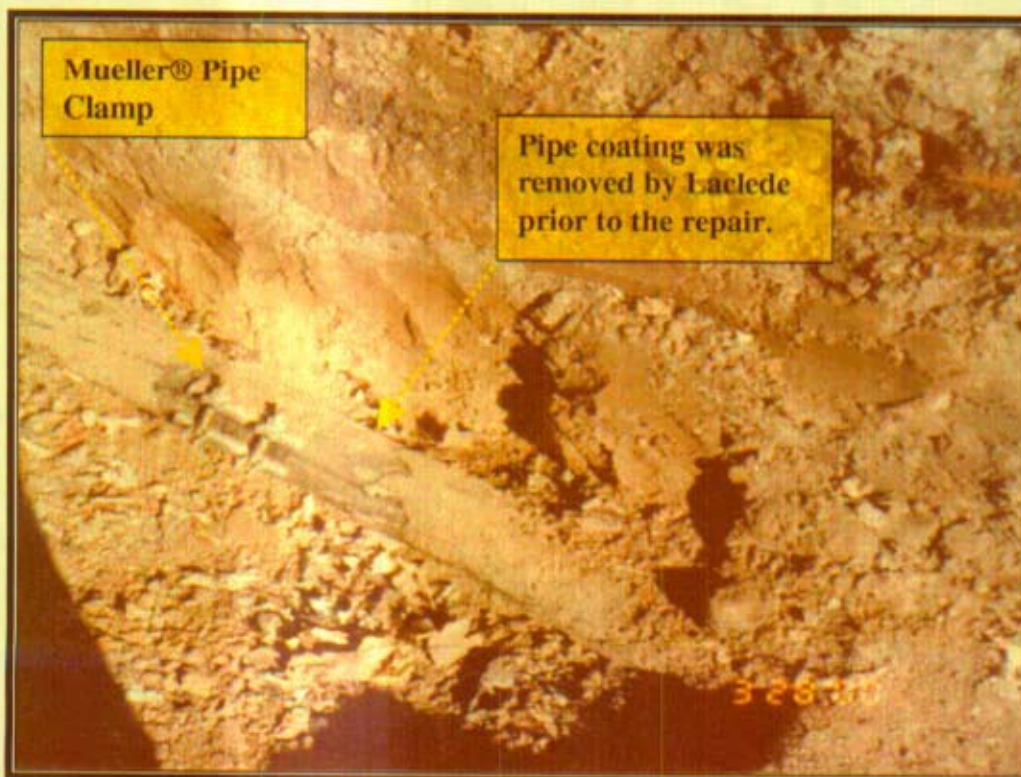
Laclede C&M personnel returned Monday morning (March 27) around 8:15 a.m. to conduct follow-up leak investigations, to ensure no other leaks existed, before backfilling the excavation over the 4-inch main and ¾-inch service to 414 Boyce. Sustained natural gas readings of 20% were obtained when Company personnel leak surveyed within the excavation over the exposed 4-inch main, leak investigations, therefore, continued. Within 1 hour and 15 minutes from their arrival that morning, Laclede had excavated and placed a Mueller® clamp over a second corrosion leak found on the bottom of the 4-inch main, approximately 3 - 4 feet west of the 414 Boyce service (See Appendix B-4, Photograph 8). This corrosion hole was the largest of the three (a third corrosion leak is described below) found on the 4-inch main, it was approximately the size of a dime.

Photograph 8 View of the repair clamp as shown in the upper right-hand corner of Photograph 7. This section of main had a dime-sized corrosion hole in the bottom-half of the pipe.

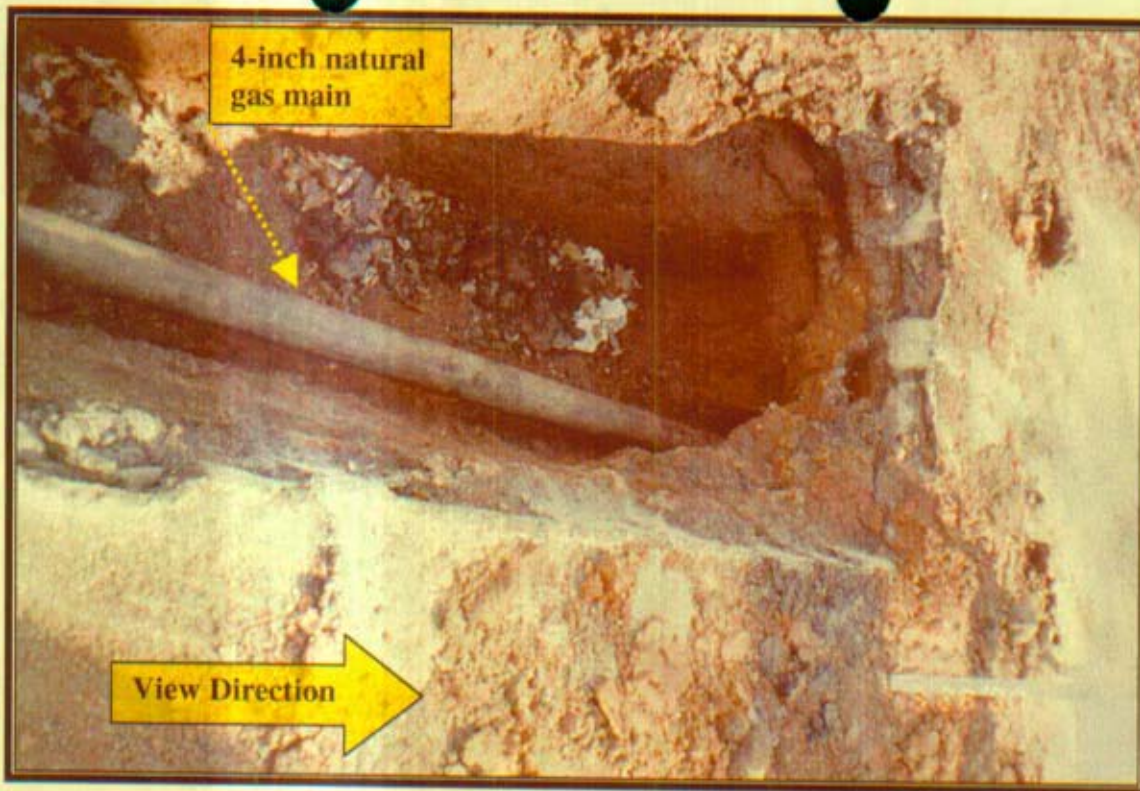
While expanding Excavation #1 on Monday, Laclede began breaking the asphalt in Boyce Avenue, 14 feet west of Excavation #1 to expose the 4-inch main. This excavation, Excavation #2 (See Appendix A-2, Figure 2 and Appendix B-2, Photograph 9) was made to ensure no other leaks existed and to determine the extent of any active corrosion.¹² The 4-inch main's original coating was removed, revealing the pipe wall for examination of additional corrosion. Laclede personnel, who took part in

Approximately 14 feet separated Excavation #1 from Excavation #2, which was approximately 12 feet by 4½ feet in size. In Excavation #2, the 4-inch main's original external coating could not be examined because Laclede had removed much of it during their investigation and repairs (See Appendix B-5, Photograph 9). This, however, did facilitate ready inspection of the condition of the exterior pipe wall. The soil consistency of the excavation wall and floor were also observed and noted as resembling that of Excavation #1, described above.

Photograph 9 Looking east inside of Excavation #2. The pipe coating was removed to determine the extent of any further active corrosion. No corrosion leaks were observed in this excavation.

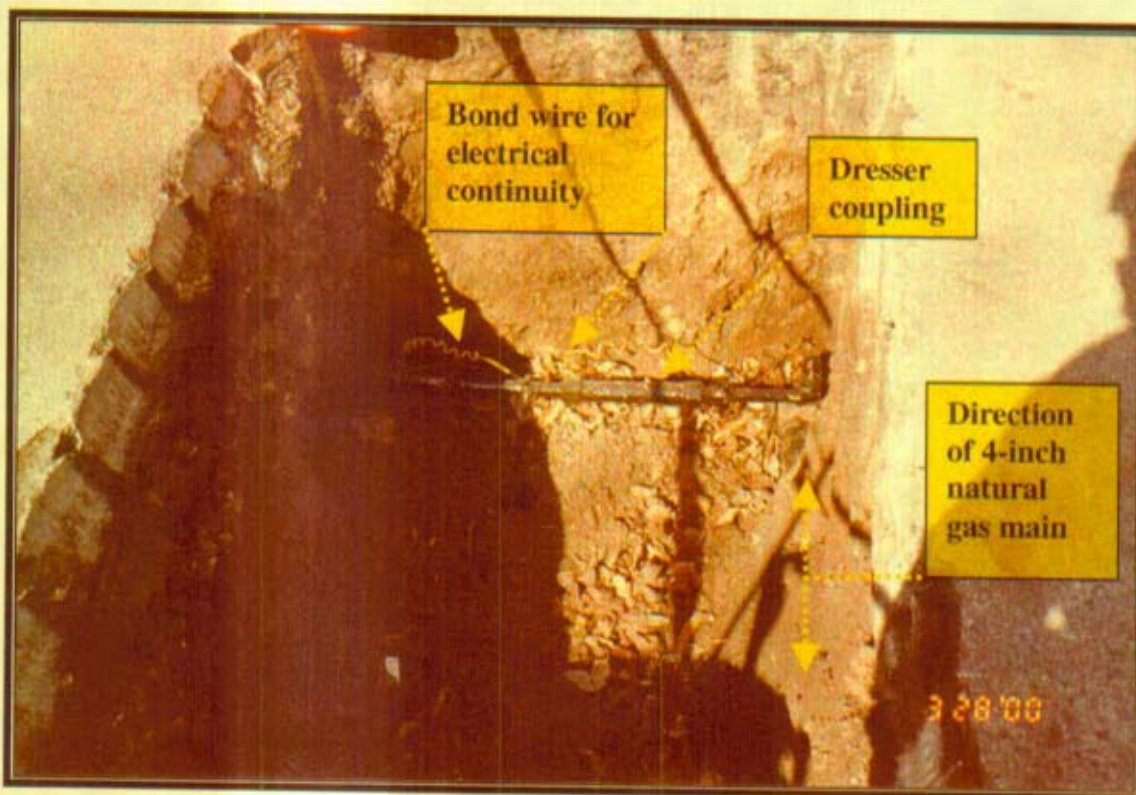
Excavation #3 exposed the ¾-inch service to 416 Boyce; general observations were made of the repair as well as the soil consistency within the excavation (See Appendix B-5, Photograph 10). Laclede personnel stated that they did not believe the leak on the ¾-inch service to 416 Boyce contributed to the incident. Laclede explained their belief that the relatively small nature of the leak (a fizzer) would have been insufficient in magnitude to migrate over 65 feet to the 416 Boyce sewer lateral. In addition, the service line did not cross the dead end sewer main.

Photograph 10 Looking west inside of Excavation #3. Observe the repaired $\frac{3}{4}$ -inch diameter, coated steel natural gas service line that serves 416 Boyce Avenue. The small corrosion leak found at this location was not believed to have contributed to the incident.
