**BEFORE THE PUBLIC SERVICE COMMISSION
OF THE STATE OF MISSOURI**

In the Matter of Laclede Gas Company)
Concerning a Natural Gas Incident at)
Premio Lane in Fenton, Missouri)

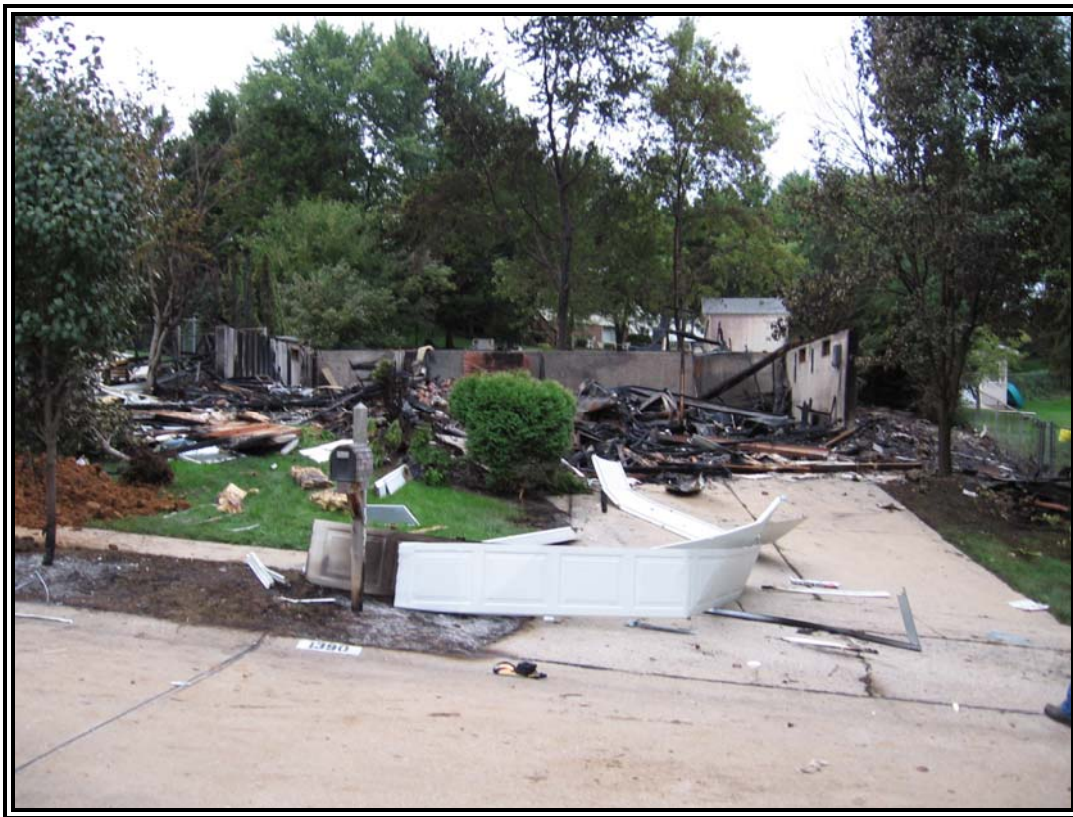
Photograph 1 View looking southwest at the scattered debris from 1390 Premio Drive. Note the burned grass along the curb in front of the house and along the driveway.

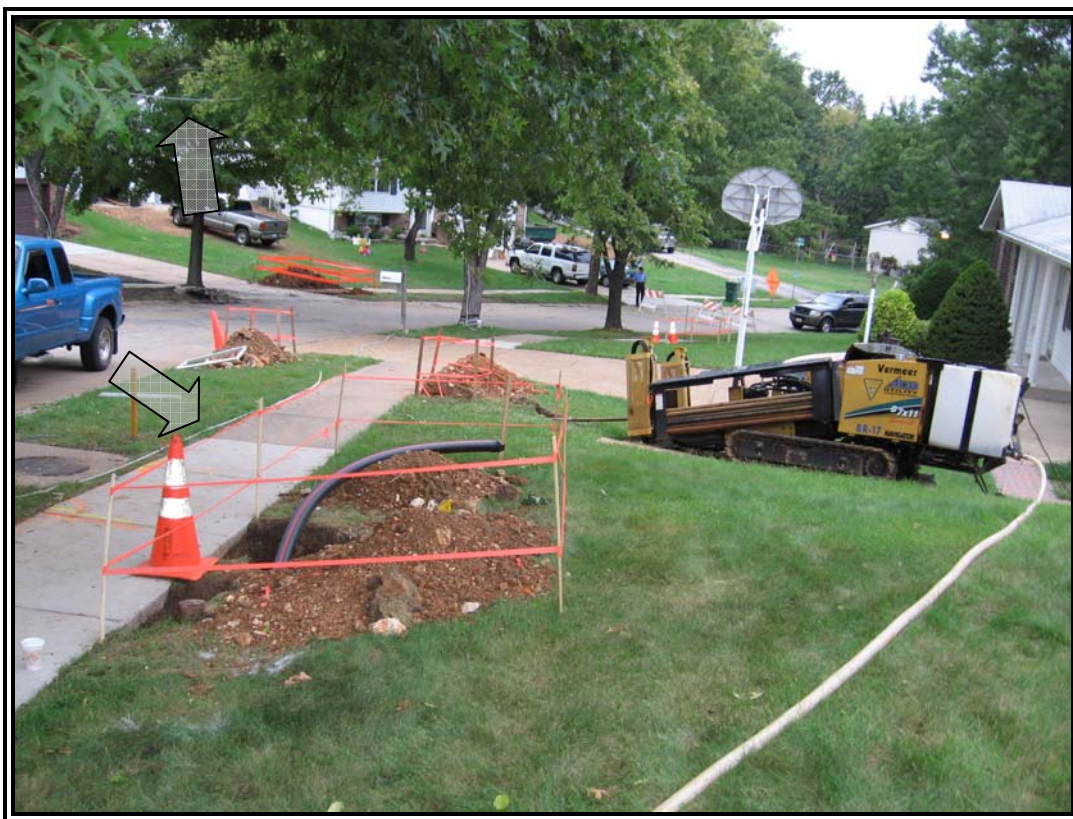
Photograph 2 View looking west at boring equipment used by ADB Utility Contractors. Note the temporary electric cable running along the sidewalk and across the street in the trees.

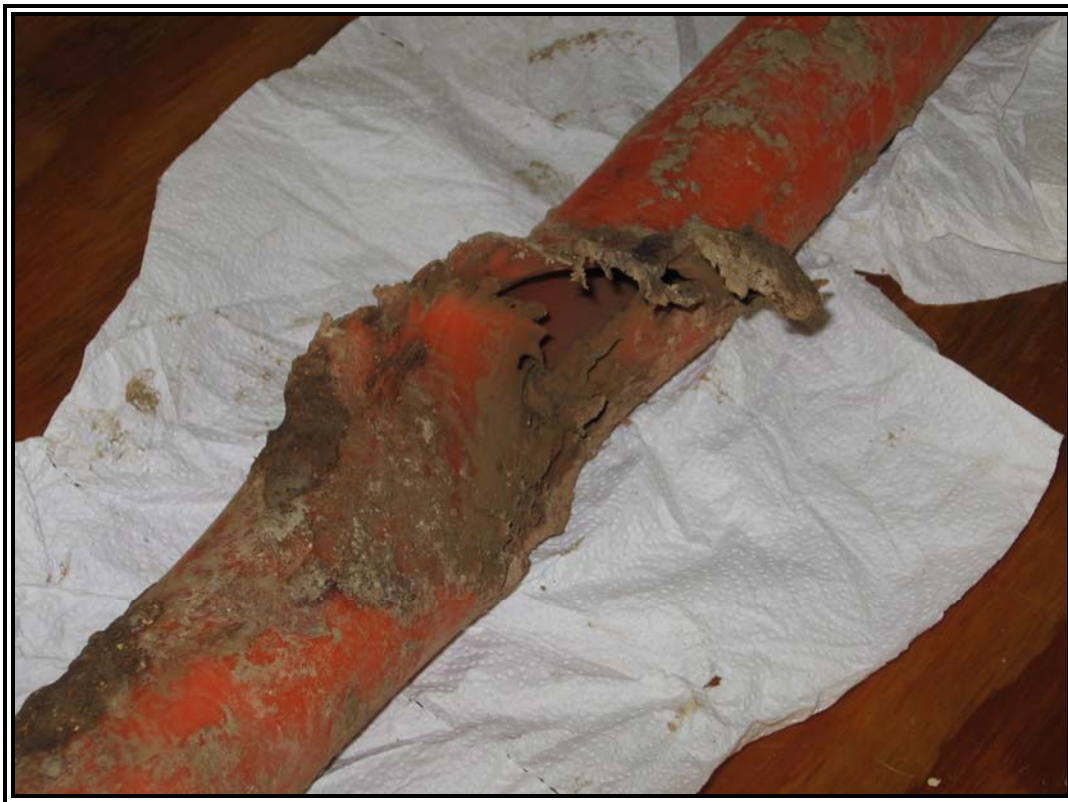
Photograph 5 Close-up view of damage to underside of 2-inch diameter polyethylene main.

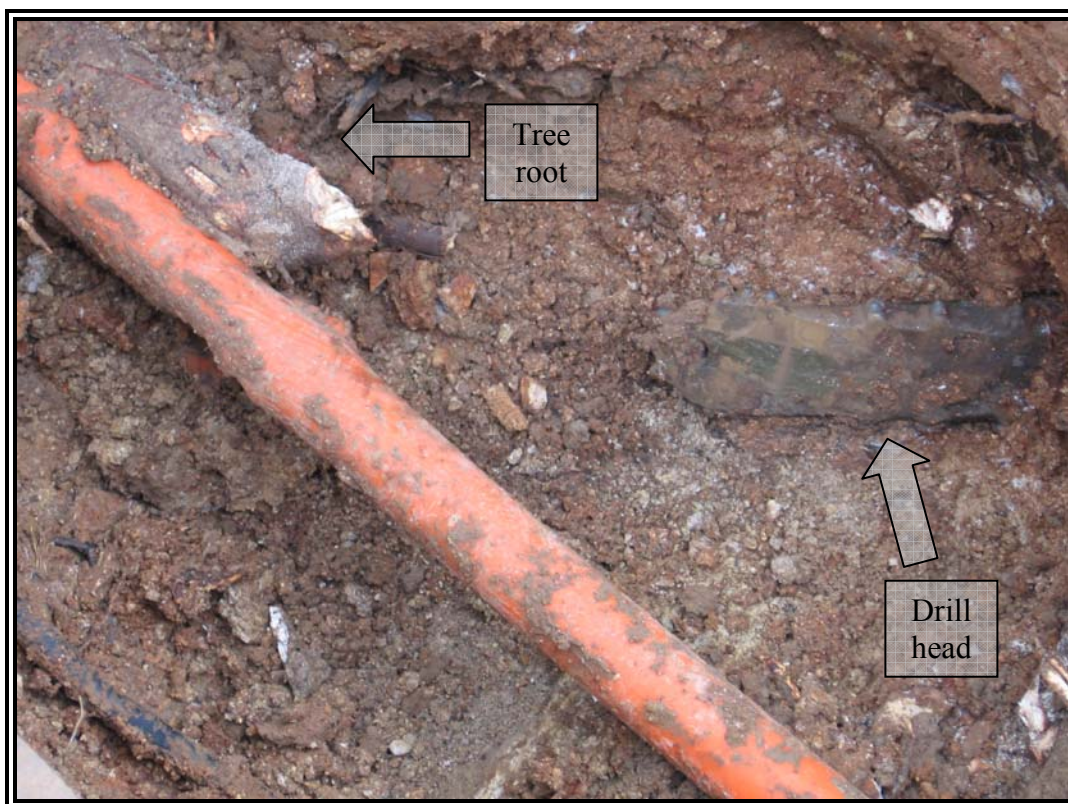
Photograph 6 Close-up view of exposed damaged natural gas main and drill head. Note the tree root growing alongside the gas main.

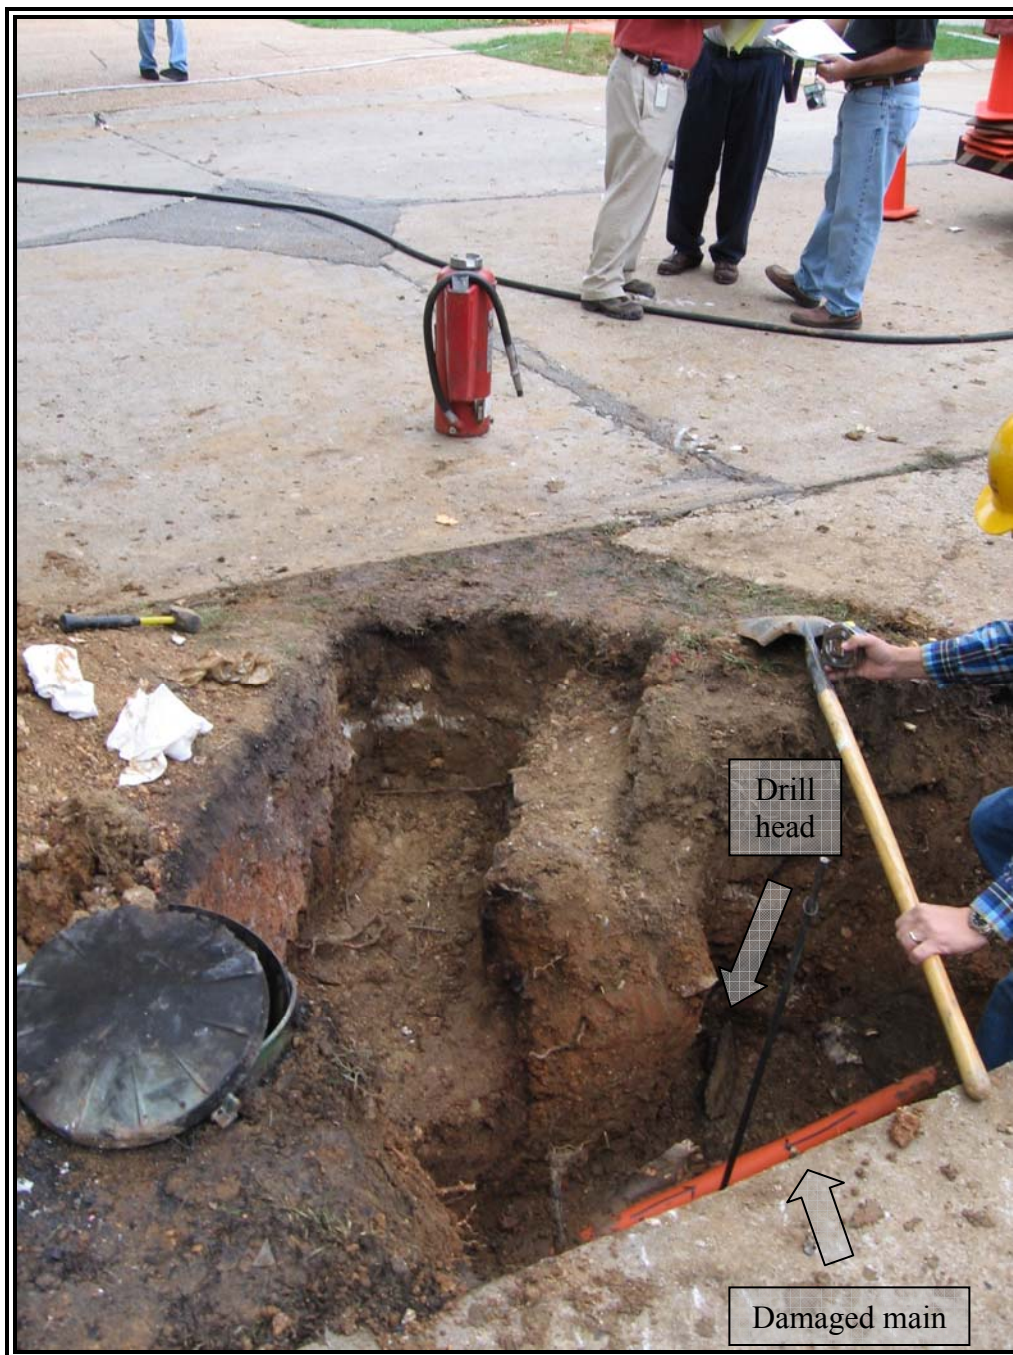
Photograph 7 Overhead view of exposed damaged natural gas main and the drill head that hit the line. Note the electric pedestal and the shallower target hole to the left that was excavated by ADB Utility Contractors.
