Gas Incident Report

**City Utilities of Springfield
Case No. GS-2004-0040**

Frisco Building
Ozark Empire Fairgrounds
Springfield, Missouri
June 18, 2003

Gas Safety/Engineering Section ... Energy Department ... Utility Operations Division
December 2003... Jefferson City, Missouri

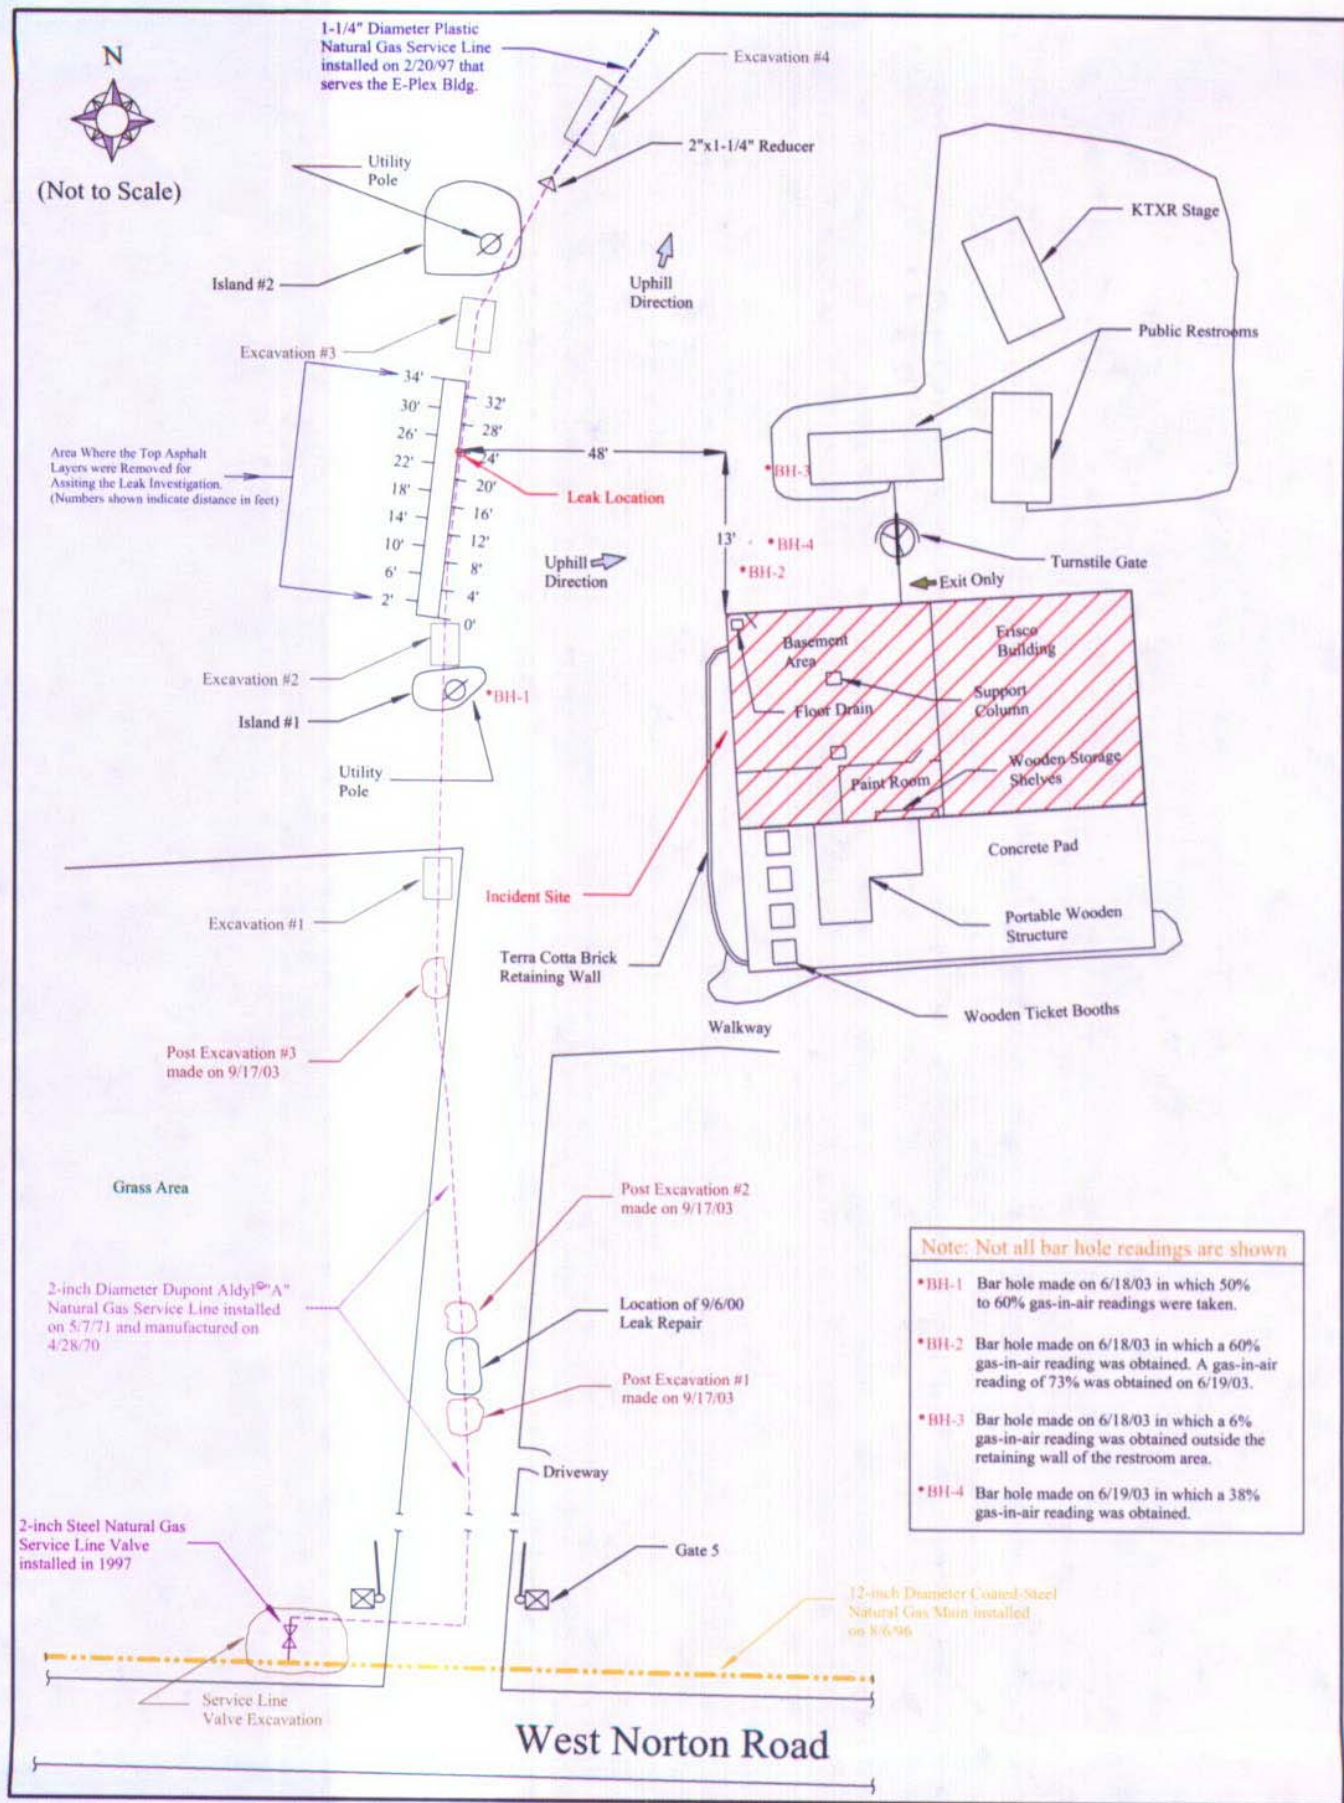
Figure 3
Detail View of 1001 W. Norton Road-Frisco Building Incident Location
Appendix A-3

The Class 2 leak, repaired on September 6, 2000, on the 2-inch diameter plastic natural gas service line, was on piping installed on May 7, 1971 (See Appendix A-3, Figure 3, “Location of 9/6/00 Leak Repair”). The leak was 234 feet north of the centerline of West Norton Road, just north of the entrance to Gate 5. City Utilities repaired the leak by replacing a 2-foot portion of the leaking plastic service line. City Utilities recorded the primary cause of this leak as an “aged/worn component.” According to City Utilities personnel, the “aged/worn component” leak cause description is typically used whenever several types of failures occur. A crack failure that has occurred due to rock impingement is one of these types.

Upon initial arrival at the incident site, City Utilities’ leak surveyors and leak investigators consulted a map of the location of the natural gas lines in the incident area. At approximately 12:35 p.m., leak surveyors and leak investigators began to leak survey in the immediate area of the incident site to check for any indications of migrating natural gas. FI units were used to sample the atmosphere above the ground near the Frisco Building and over existing natural gas mains and service lines. During this initial leak survey, two indications of gas were detected near the retaining wall flowerbed just west of the restroom building (BH-3), and in the flowerbed around a utility pole and tree (Island #1, BH-1) located approximately 40 feet west of the west foundation wall of the Frisco Building (See Appendix A-3, Figure 3).

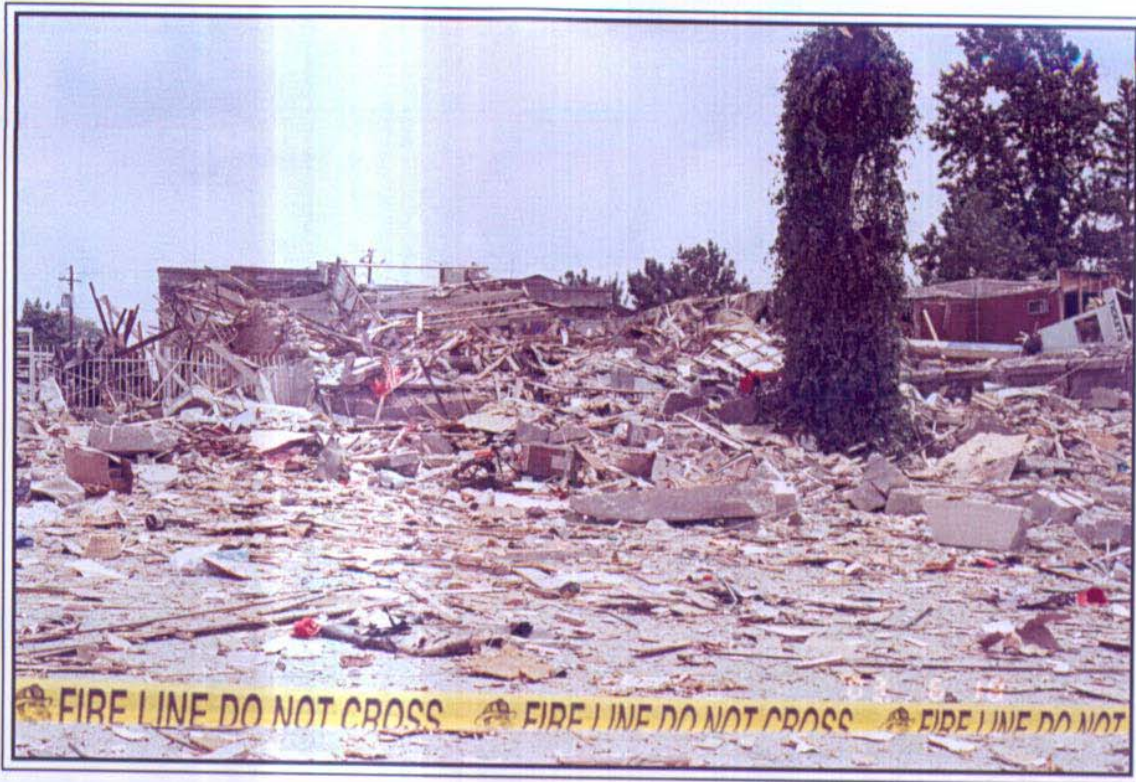
Photograph 1 View looking approximately east towards the northwest corner of the destroyed Frisco Building within the Ozark Empire Fairgrounds. Excluding the basement walls, only a portion of the north and east walls on the main level remain. This photograph was taken a short time after the incident. (Photograph was provided by City Utilities of Springfield)

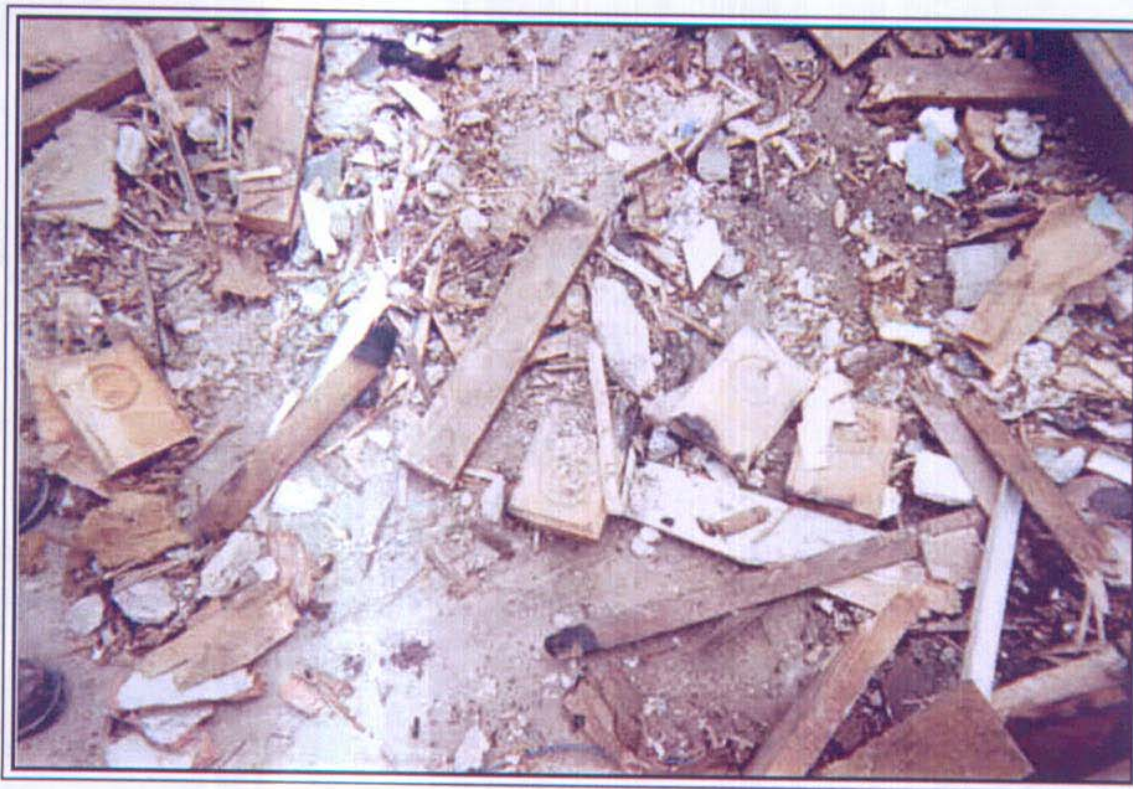
Photograph 2 Looking at a portion of the remaining contents of the basement area of the Frisco Building. Observe various pieces of wood that were believed to have been part of a lattice structure suspended from the ceiling in the basement area, that received minor burn damage. This was the only evidence of burning that was observed within the Frisco Building.

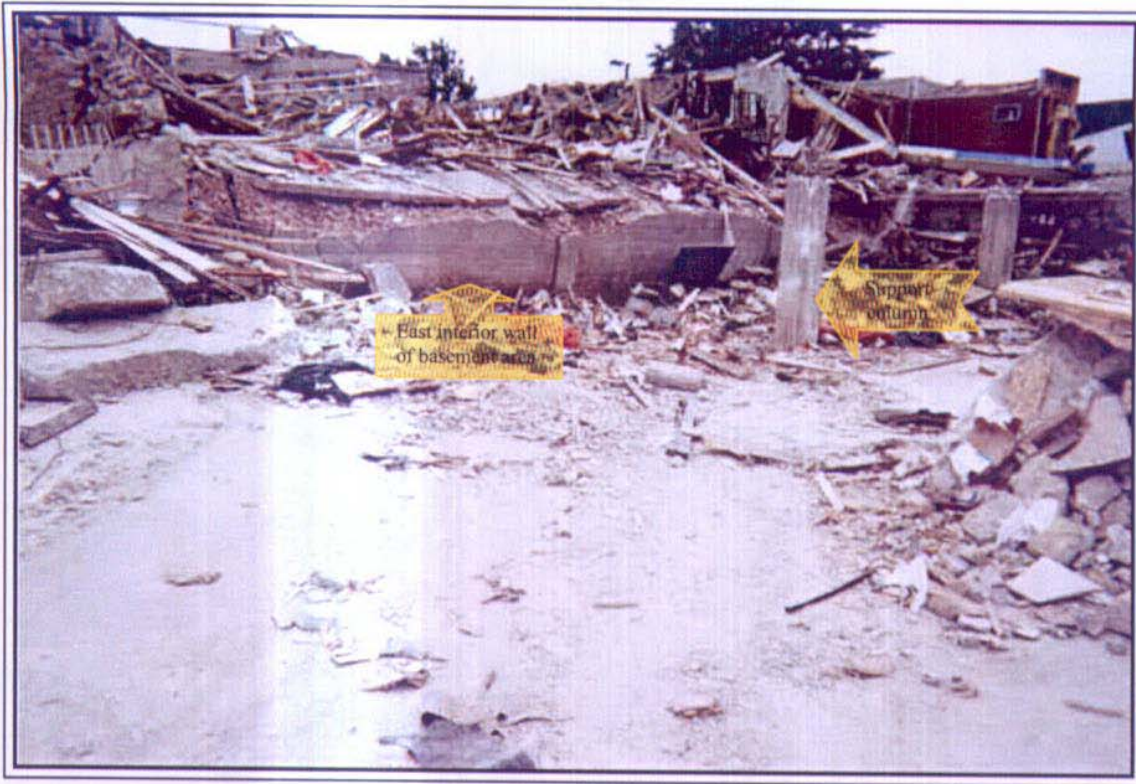
Photograph 3 View looking approximately east at the east interior wall of the basement area within the Frisco Building. The east interior wall was severely damaged and was leaning to the inside of the structure. The majority of the north basement wall was also destroyed. Several sections of the east basement wall were dislodged from the structure. Note the two support columns that remained. This photograph was taken after most of the debris had been removed from the basement area.

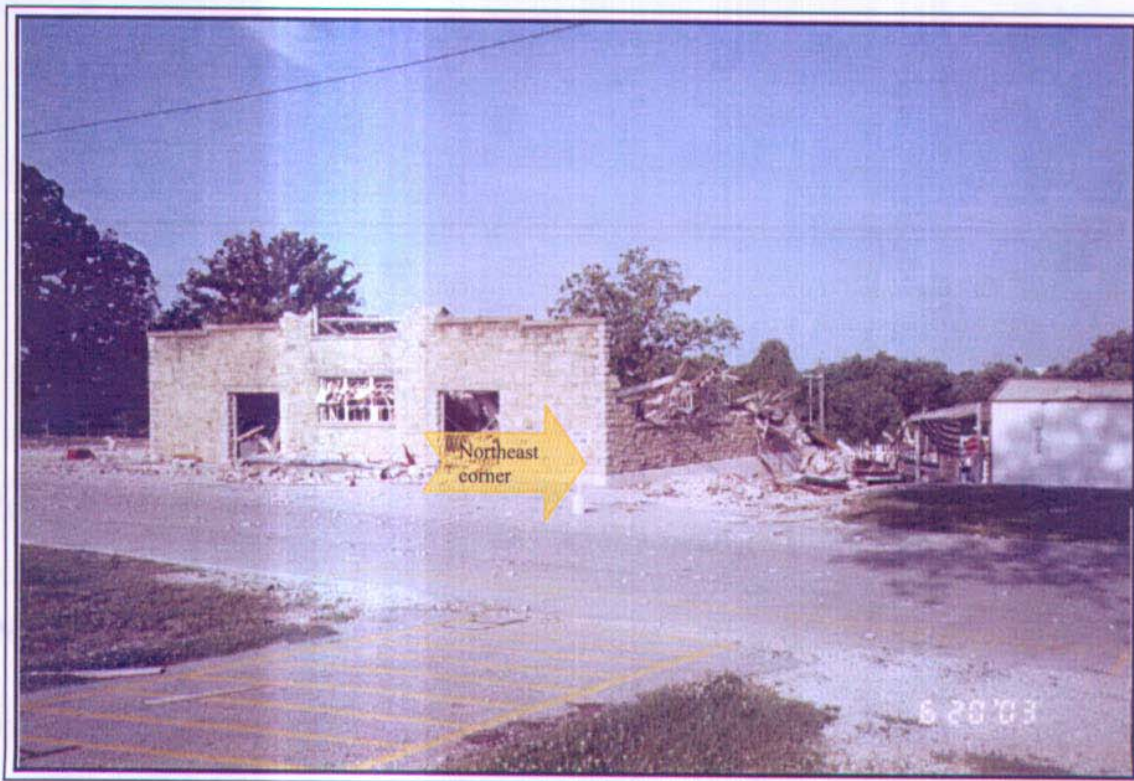
Photograph 4 View looking towards the northeast corner of the Frisco Building. Excluding the upper portion of the roof structure, most of the vertical section of the east wall remained intact. Excluding glass breakage, most of the debris field was displaced in a west to northwest direction as far away as 400 feet.

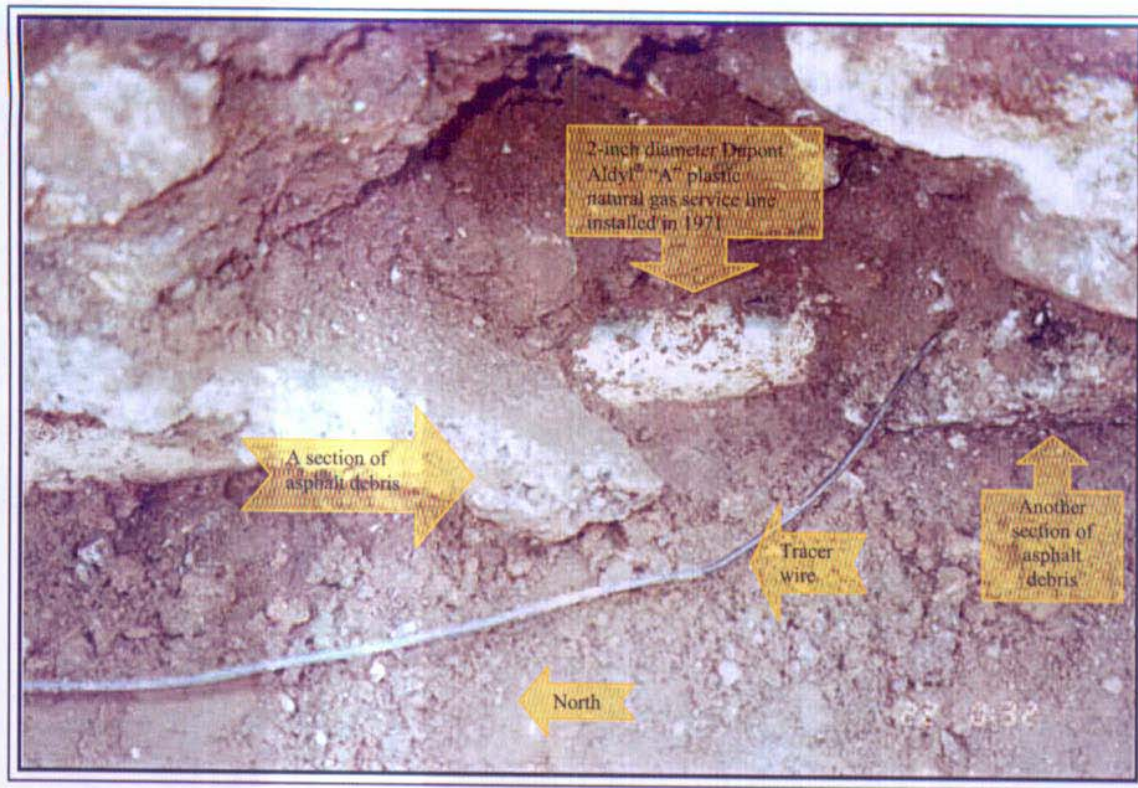
Photograph 5 A view of an excavation that was made along the west side of the 2-inch diameter plastic natural gas service line. Observe the various layers of asphalt and rock that were surrounding the pipe wall in this area. The black wire in the foreground is a tracer wire that is typically used to assist with locating underground facilities that are non-metallic. No proper bedding material was observed in this area to protect the wall of the plastic pipe.

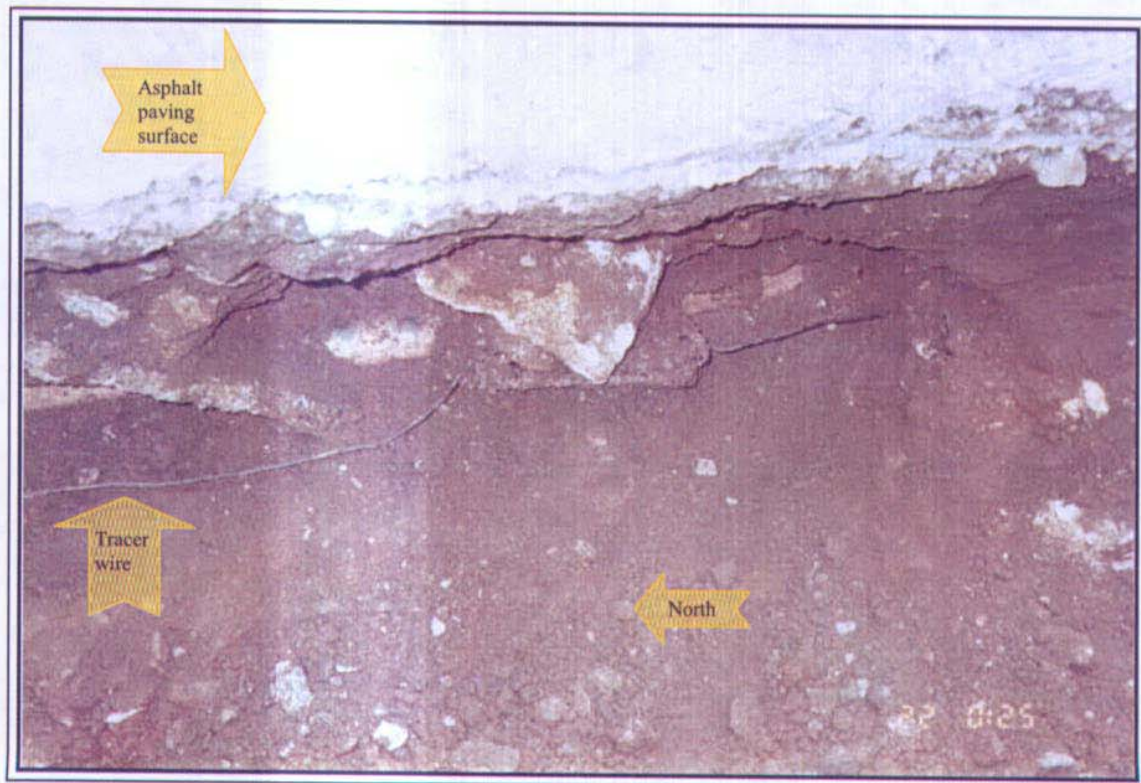
Photograph 6 Another view looking down into the same excavation that was made along the west side of the plastic pipe. The depth of the pipe installation in this area was approximately 30 inches.

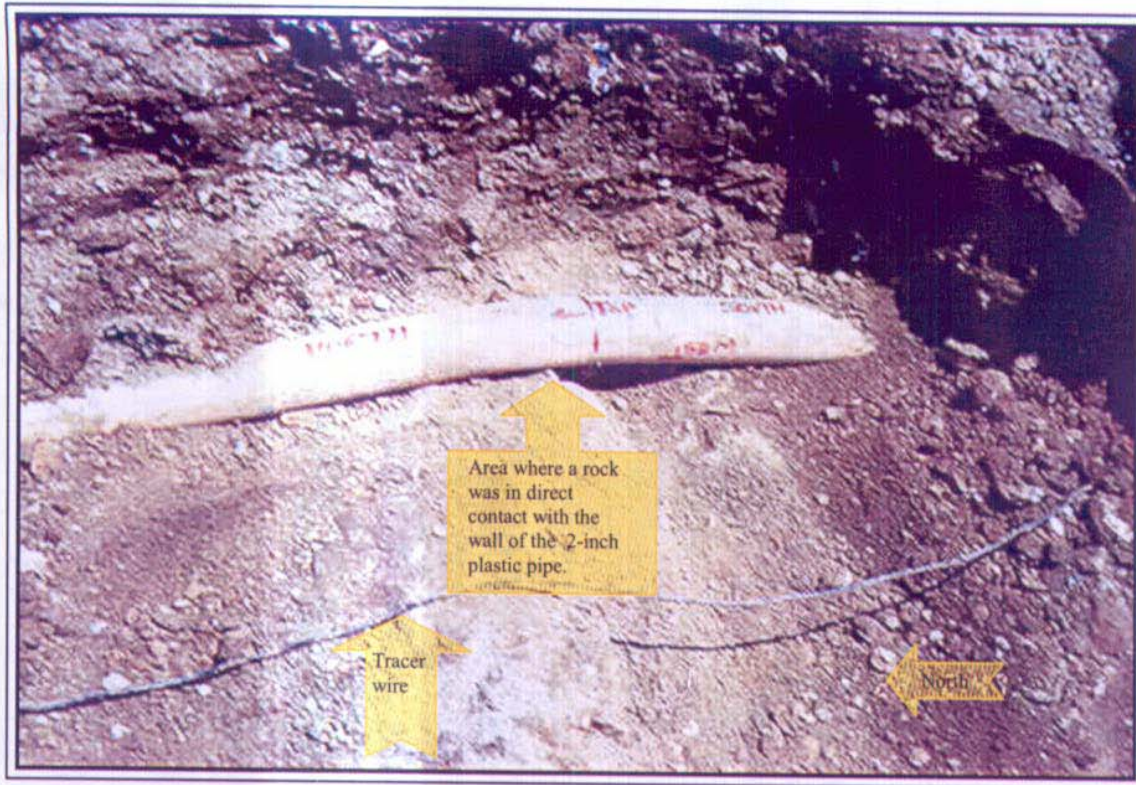
Photograph 7 Looking towards the east wall of the excavation that was made to uncover the leaking section of 2-inch plastic piping. Observe how the pipe has an upside down u-shaped appearance and also notice the portion of rock that is in direct contact with the plastic pipe. The plastic pipe also had an egg-shaped or oblong appearance over the circumference of the pipe both north and south of the rock location until the sun had heated the pipe back to its original circular shape.

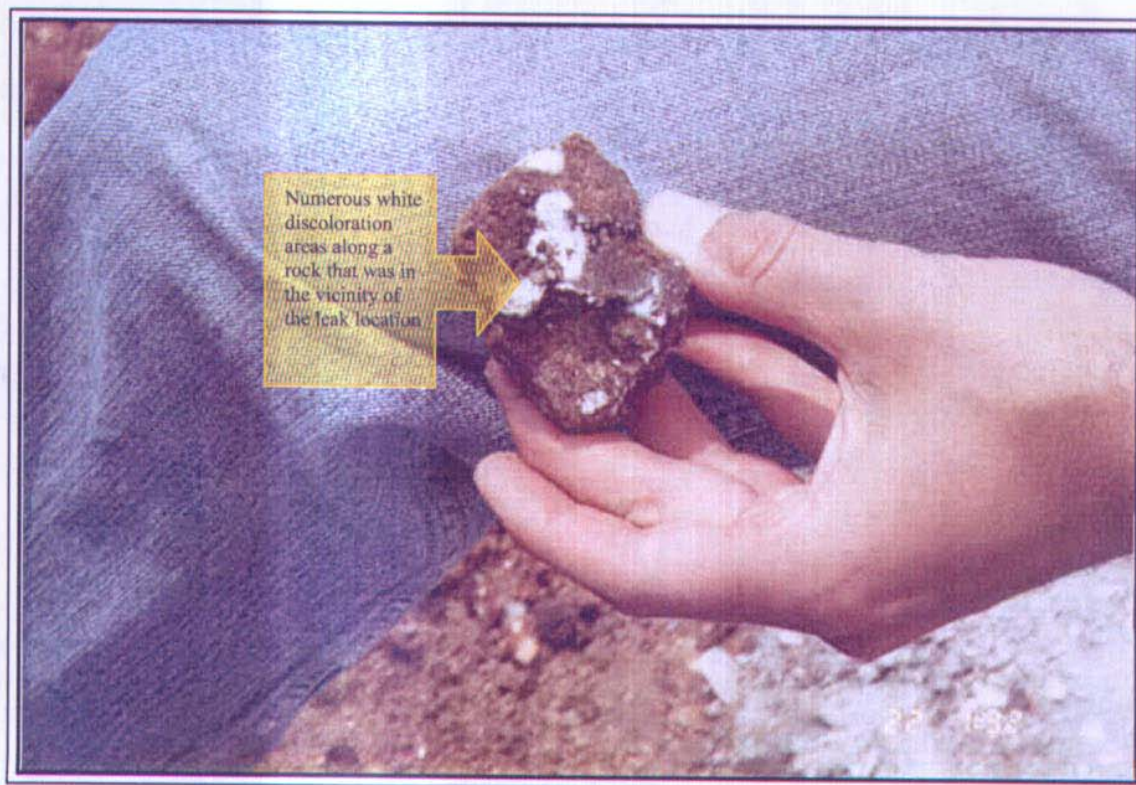
Photograph 8 View of a rock that was removed in close proximity to the leaking section of 2-inch diameter plastic natural gas service line. Note the white residue on the rock.

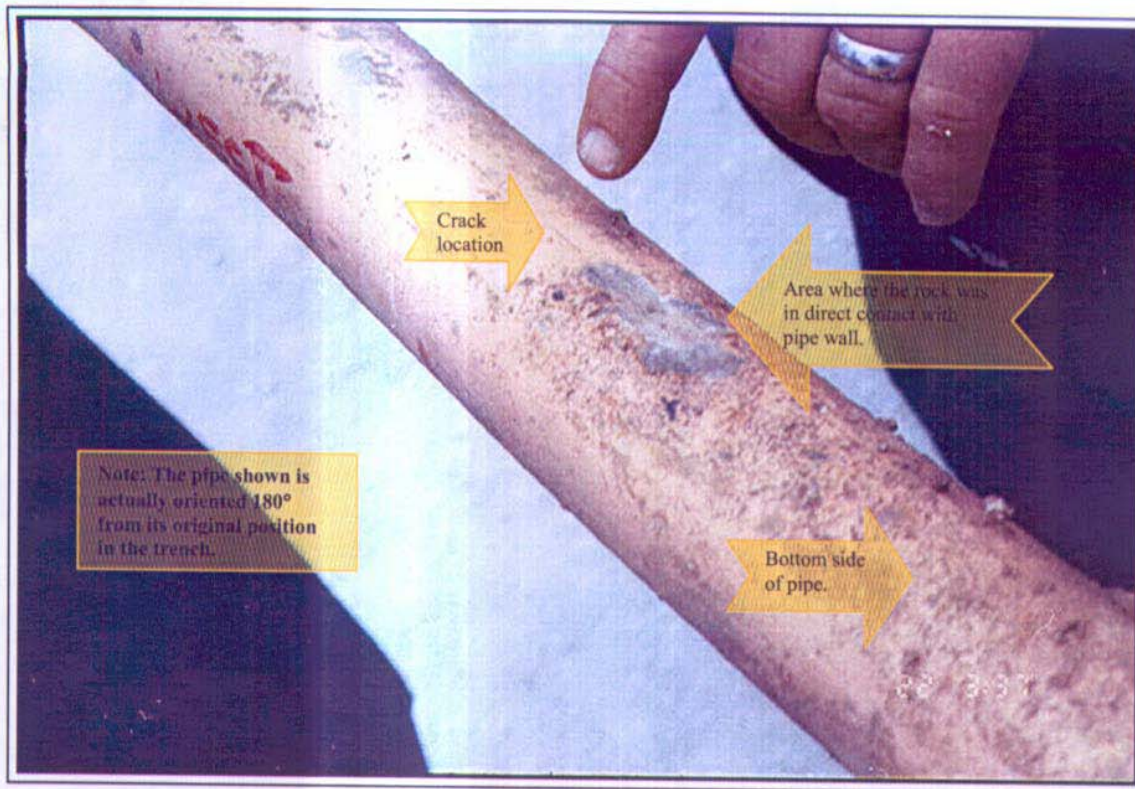
The damage resulted from the effects of improper backfill surrounding the pipe that allowed rocks to come in direct contact with the pipe wall. Over time the rock contact with the pipe induced high-localized stress on the pipe wall causing it to crack. It was not determined how or when the improper backfill (rock) came in contact with the service line, or who placed the backfill at the location.

Photograph 9 View of the removed section of 2-inch Dupont Aldyl® "A" plastic service line piping that contained the leak location. Observe the crack that was along the longitudinal axis of the plastic pipe. The crack was located on the bottom of the pipe where a rock that was in direct contact with the pipe wall. This leak was found approximately 13 feet north and 48 feet west of the NW corner of the Frisco Building.

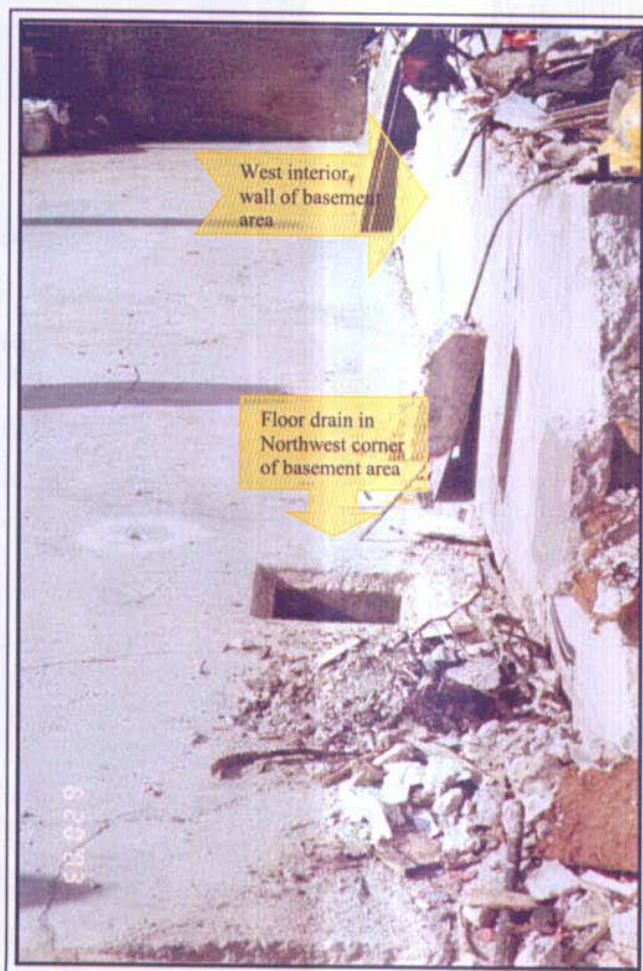
Photograph 10 View looking at the floor drain in the northwest corner of the basement area after debris removal. This particular view is looking south along the west wall. A sustained reading of 50% gas-in-air was obtained in the floor drain on June 19, 2003 after the incident. Samples of air drawn from this floor drain tested positive for natural gas.

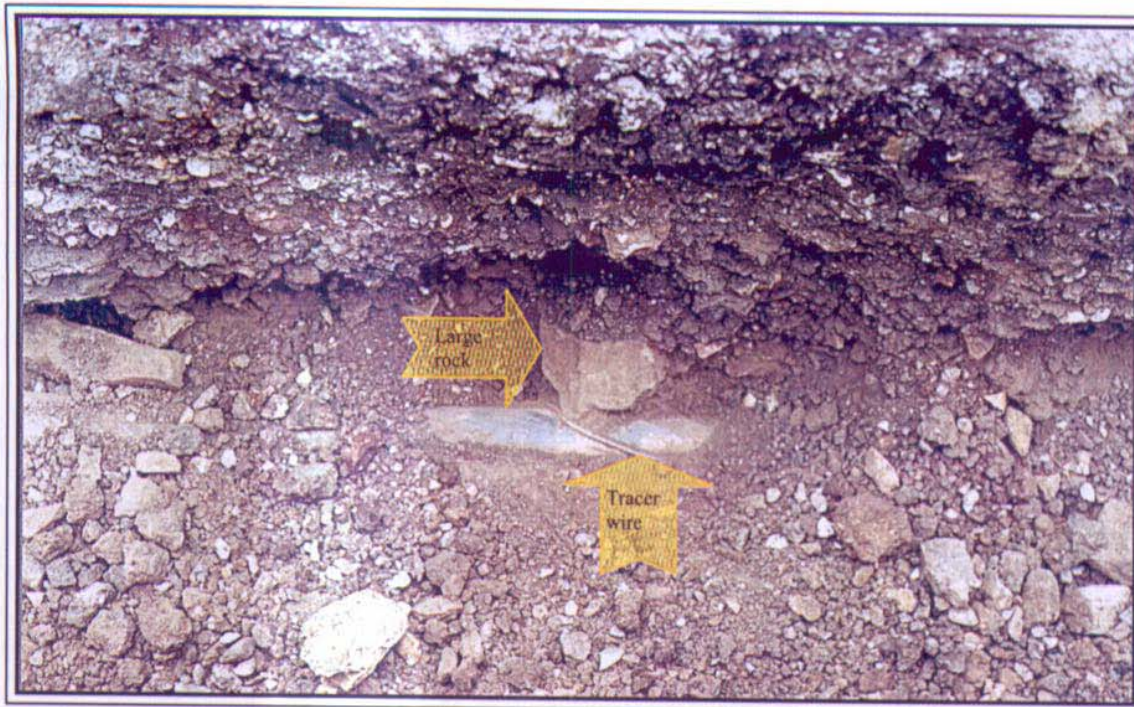
Photograph 11 Looking at the exposed section of 2-inch Dupont Aldyl® "A" natural gas service line piping that served the motel at 3050 North Kentwood. Observe the large rock that is directly contacting the top portion of the plastic pipe wall. The backfill material used was native soil that contained rocks and no bedding material (e.g.-AG limestone, sand, or mine screenings) was placed around the pipe for protection from rock impingement.

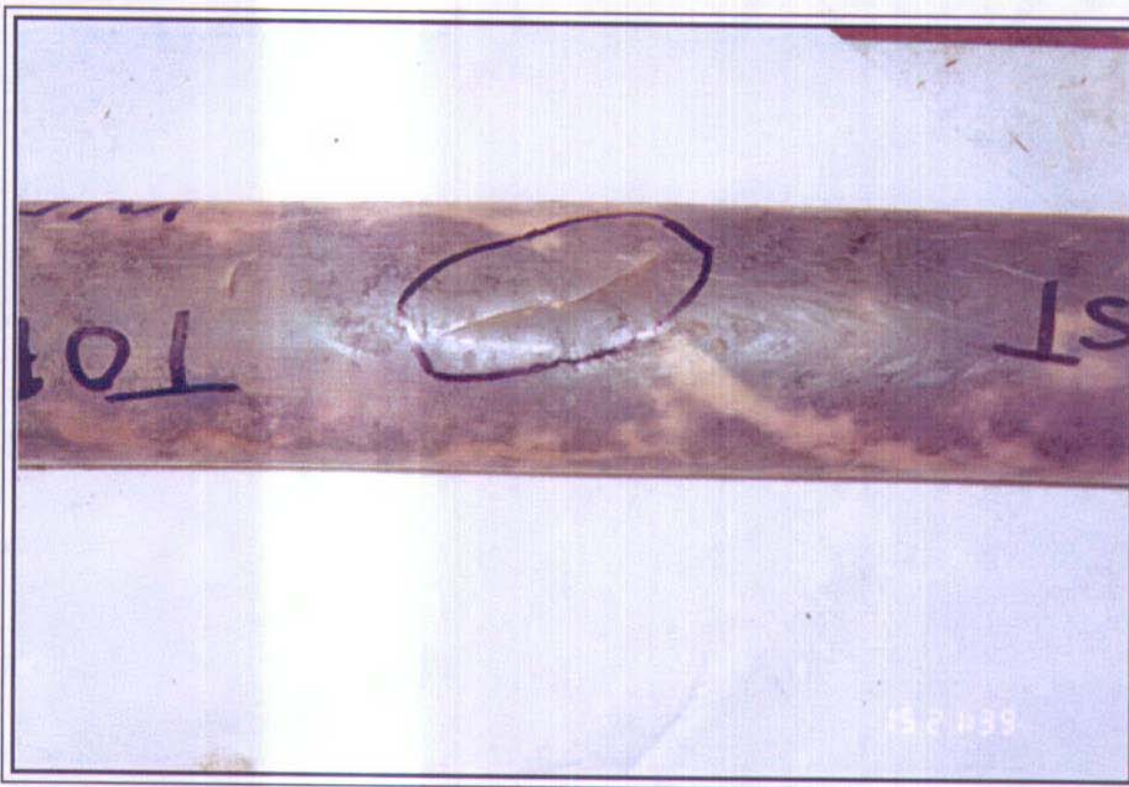
Photograph 12 Close-up view of the section of 2-inch diameter plastic piping that was removed from 3050 North Kentwood. The plastic piping contains a crack location where a large rock (as seen in Photograph 11) was in direct contact with the top portion of the plastic pipe wall. The orientation of the plastic pipe in this photograph is similar to the position observed within the trench in Photograph 11.
