# Missouri Public Service Commission

## Gas Incident Report

**City Utilities of Springfield  
Case No. GS-2003-0129**

1904 E. Burntwood Street  
Springfield, Missouri  
September 25, 2002

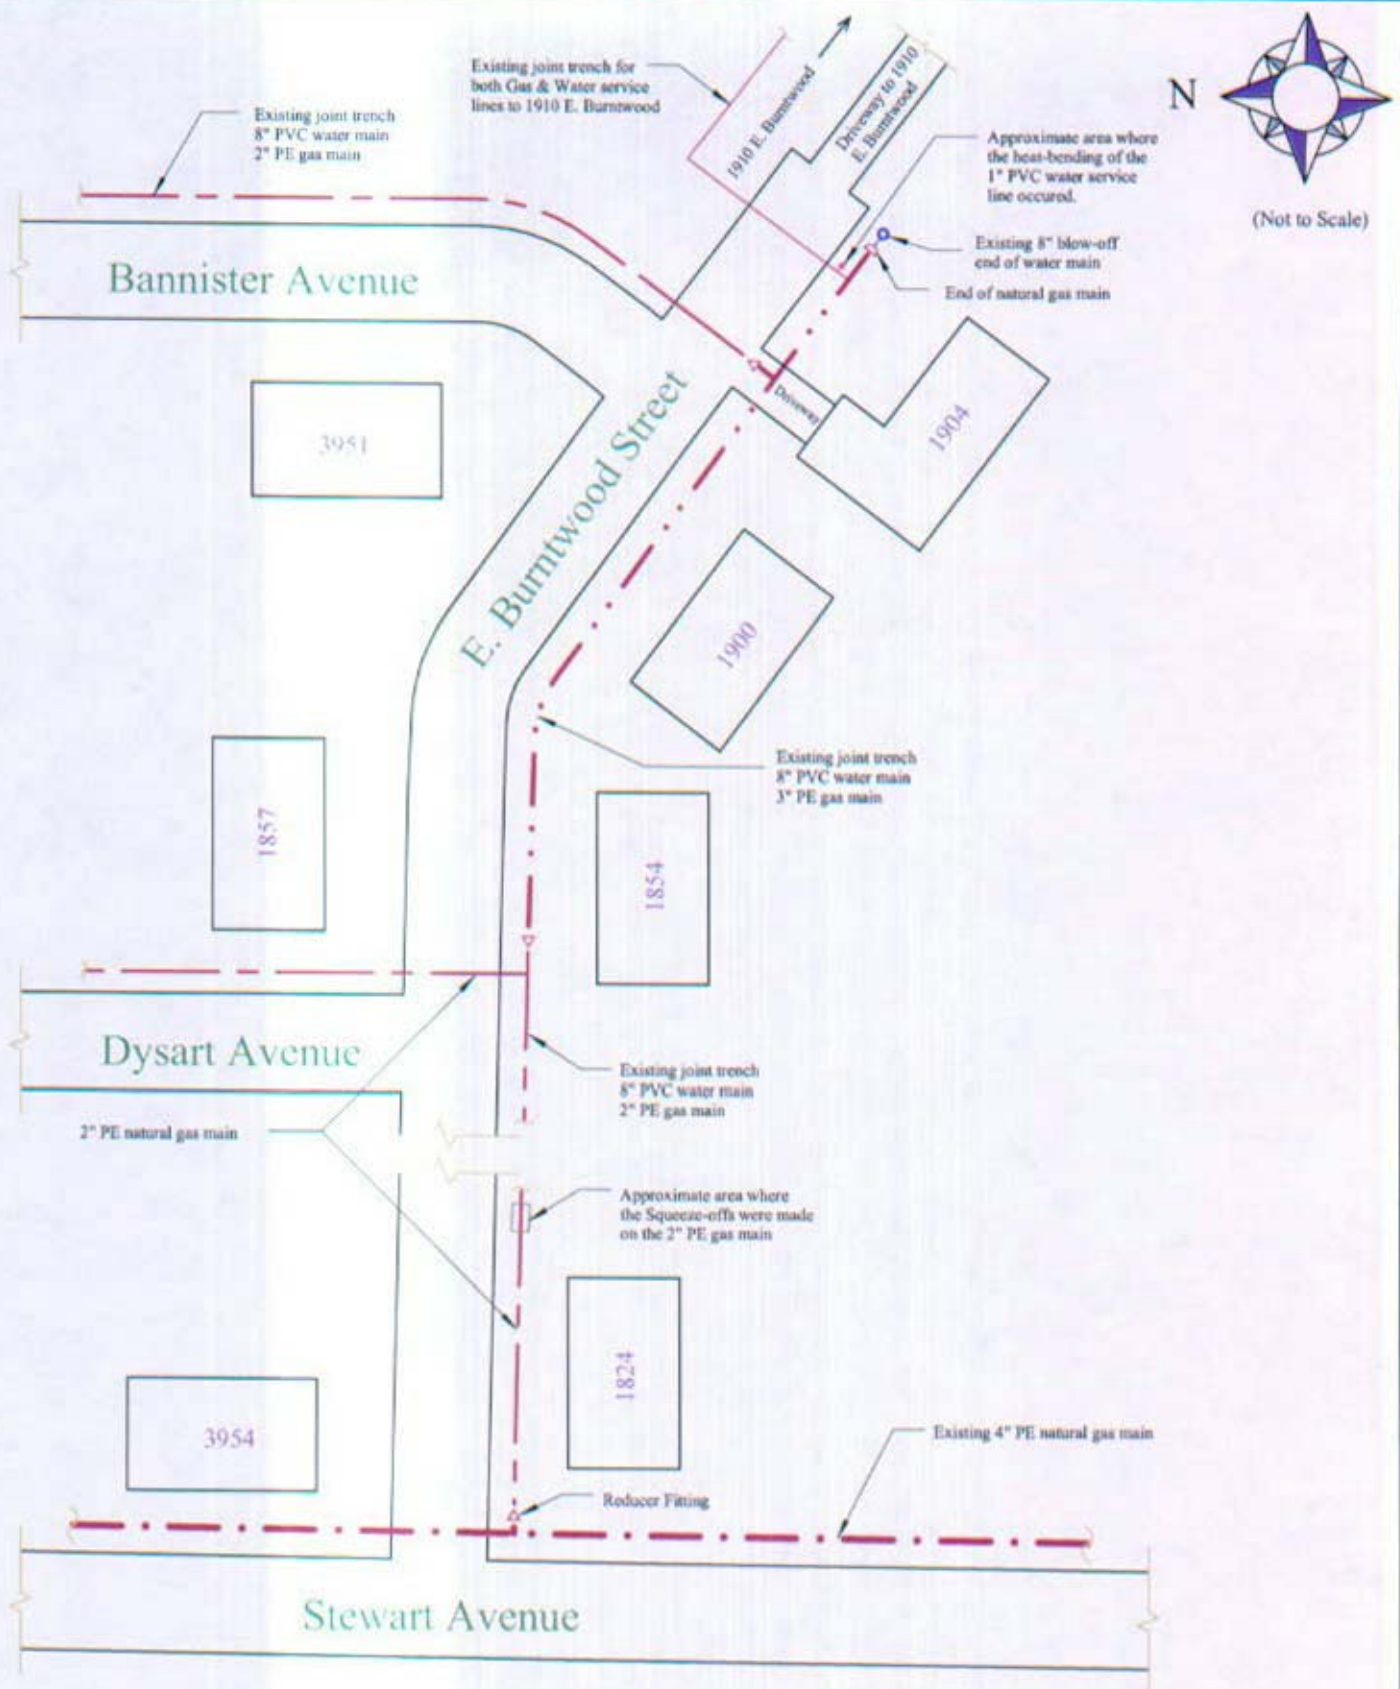
Figure 2  
Plan View of 1904 E. Burntwood Street-Incident Location  
Appendix A-2

by a 3-inch diameter, high pressure<sup>3</sup>, PE main. The natural gas main in front of 1904 E. Burntwood Street is located parallel to and 5 feet south of the south curb line of E. Burntwood Street (See Appendix A-2, Figure 2), and was installed by City Utilities in 1979 at a depth of approximately 40 inches, in a joint trench with an 8-inch diameter, PVC water main. There was approximately one foot of separation between the natural gas and water mains, with the natural gas main situated one foot above and one foot north of the water main. At the time of the fire, the 3-inch diameter, PE natural gas main in front of 1904 E. Burntwood Street was operating at a pressure of approximately 56 psig as indicated by the nearest telemeter<sup>4</sup> located at Kearney and Packer Roads. The maximum allowable operating pressure<sup>5</sup> (MAOP) for this PE main segment was 60 psig.

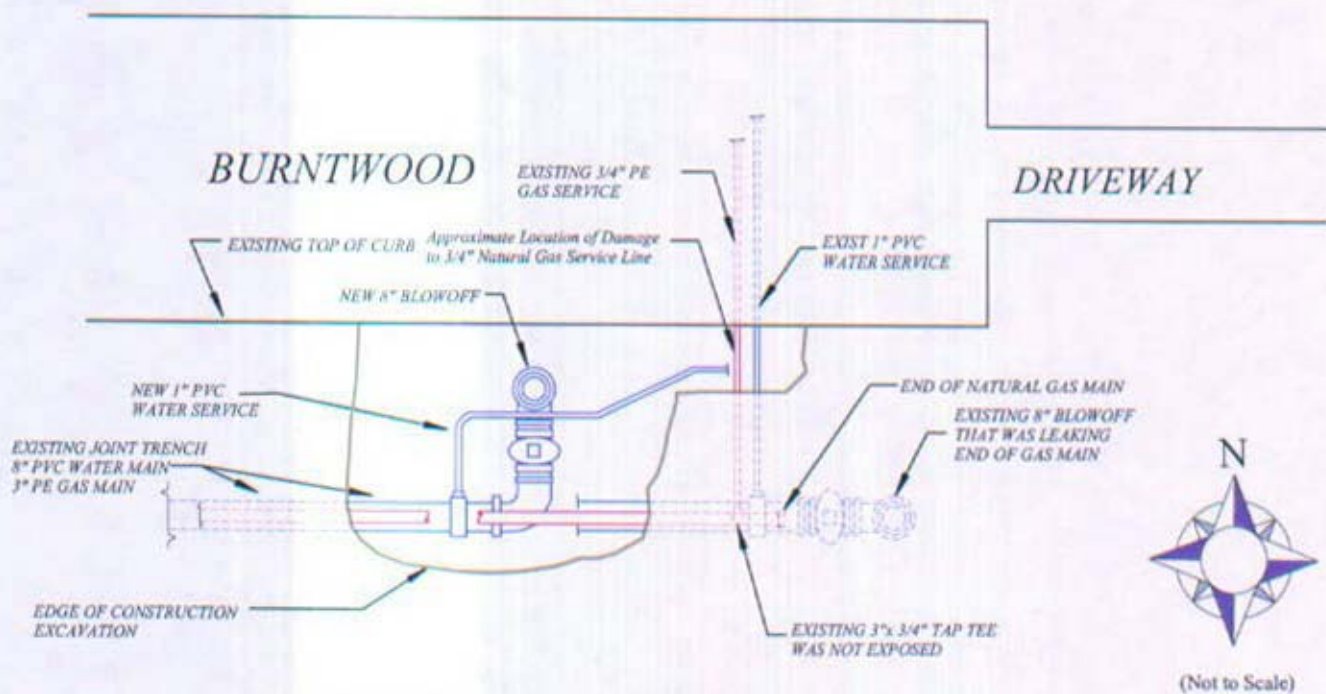
Figure 3-B (Top View of Excavation in Front of 1904 E. Burntwood Street)

The excavation itself was located immediately south of the south curb of E. Burntwood Street (See Appendix A-3, Figure 3-B). The excavation was approximately 20 feet long and 6 feet wide and was approximately 4½ feet in depth. The excavation contained the following: exposed sections of 3-inch diameter, polyethylene (PE) natural gas main and 8-inch diameter, polyvinyl chloride (PVC) water main, exposed sections of ¾-inch diameter, PE natural gas service line and 1-inch diameter PVC water service line, and segments of burn damaged plastic natural gas and water main and service line piping.

The natural gas service line serving 1910 E. Burntwood Street consisted of a ¾-inch diameter, PE pipe that was installed by City Utilities in July of 1992. The 1-inch diameter, PVC water service line that served 1910 E. Burntwood Street was installed with the natural gas service line in a single “mole” hole<sup>6</sup> approximately 34 inches below the top of the curb of and extending north under E. Burntwood Street (See Appendix A-3, Figure 3-B).

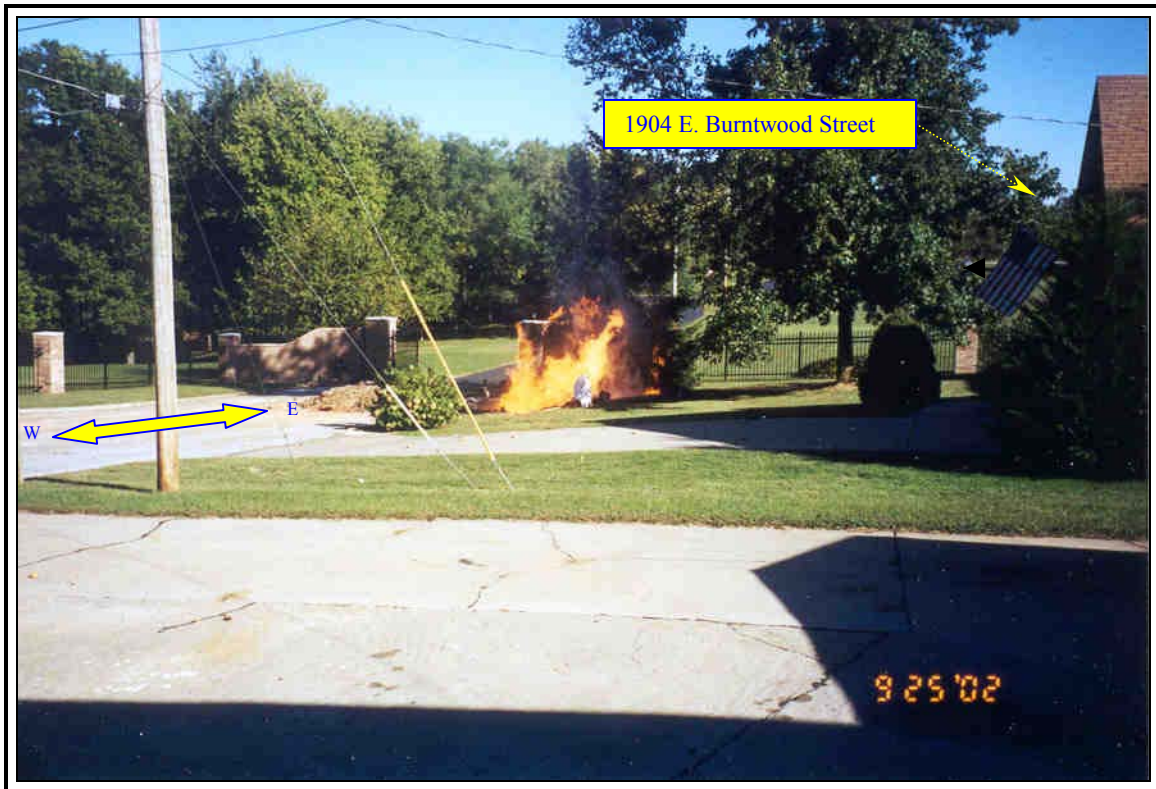
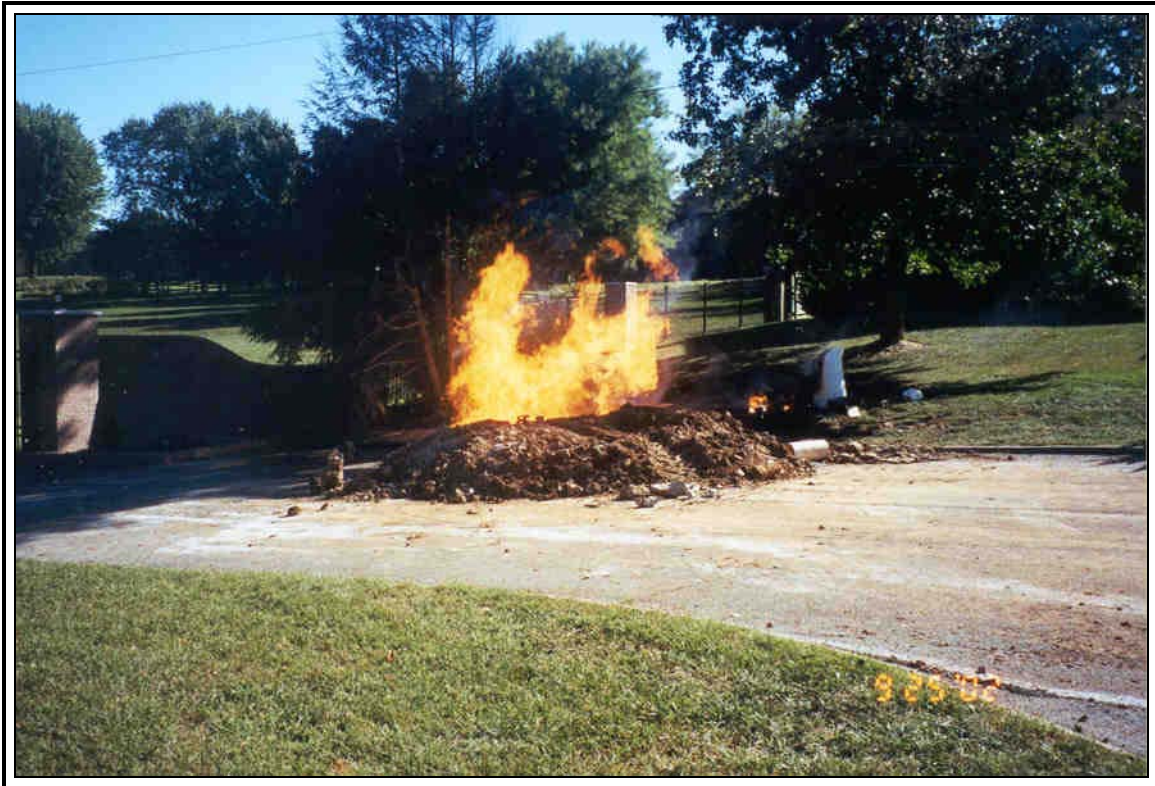
Upon arrival at the incident site, City Utilities Gas Department Personnel reported that a fire was burning in the front yard of 1904 E. Burntwood Street by the edge of the street (See Appendix B-

**Photograph 1:** View looking east as the natural gas fire was in progress in front of 1904 E. Burntwood Street. (Courtesy photograph provided by City Utilities of Springfield)

**Photograph 2:** Close-up view of the natural gas fire looking southeast. (Courtesy photograph provided by City Utilities of Springfield)

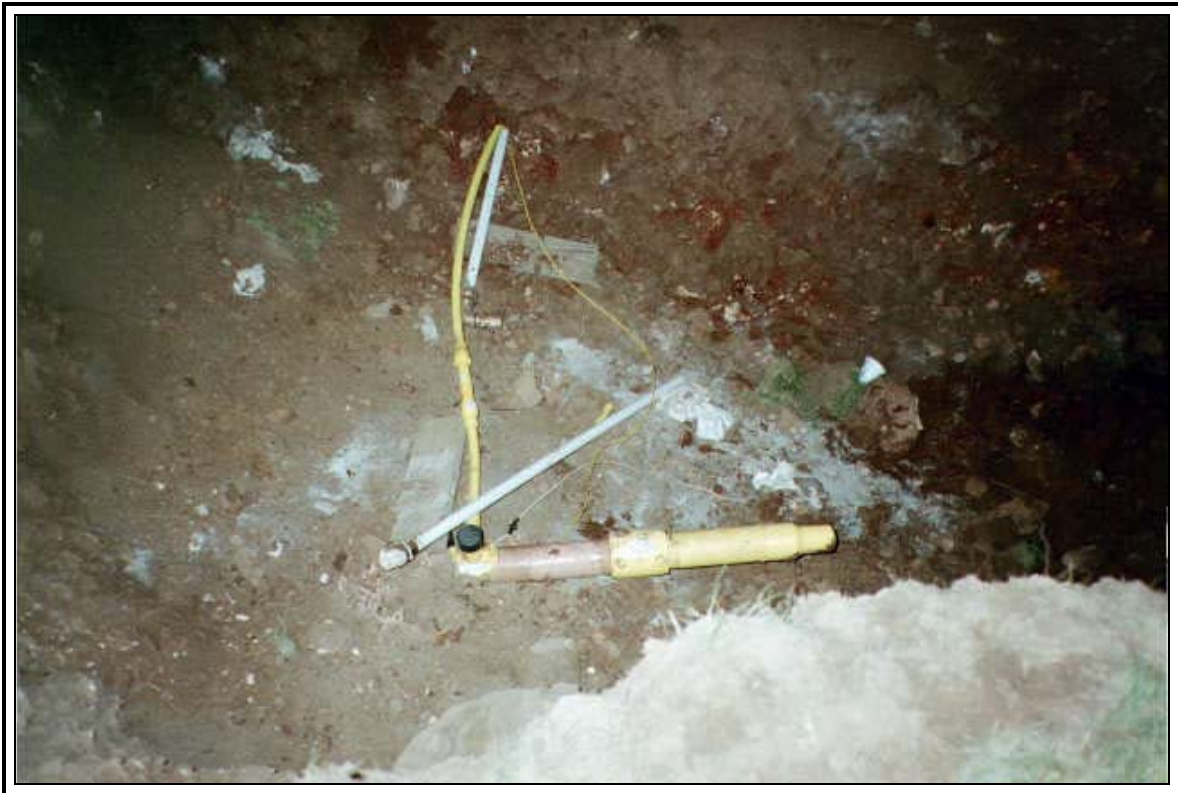
**Photograph 4:** View of the new natural gas PE piping that was installed on the evening of 9/25/02 to restore natural gas service to 1910 E. Burntwood Street.

As mentioned in the **Synopsis and Property Damage** sections of this report, natural gas piping and fittings in the excavation in front of 1904 E. Burntwood Street were either destroyed or severely damaged as a result of the fire. Repair of these destroyed and damaged natural gas facilities was initiated at approximately 5:00 p.m. on September 25, 2002. The repairs to the natural gas facilities were completed at approximately 6:45 p.m. the same day. Upon completion of the repairs to the natural gas facilities and restoration of the flow of natural gas to the affected area, at approximately 7:15 p.m., City Utilities Gas Department personnel proceeded to conduct another leak survey of the area, obtain additional odorant intensity tests, and relight all of the affected customers.

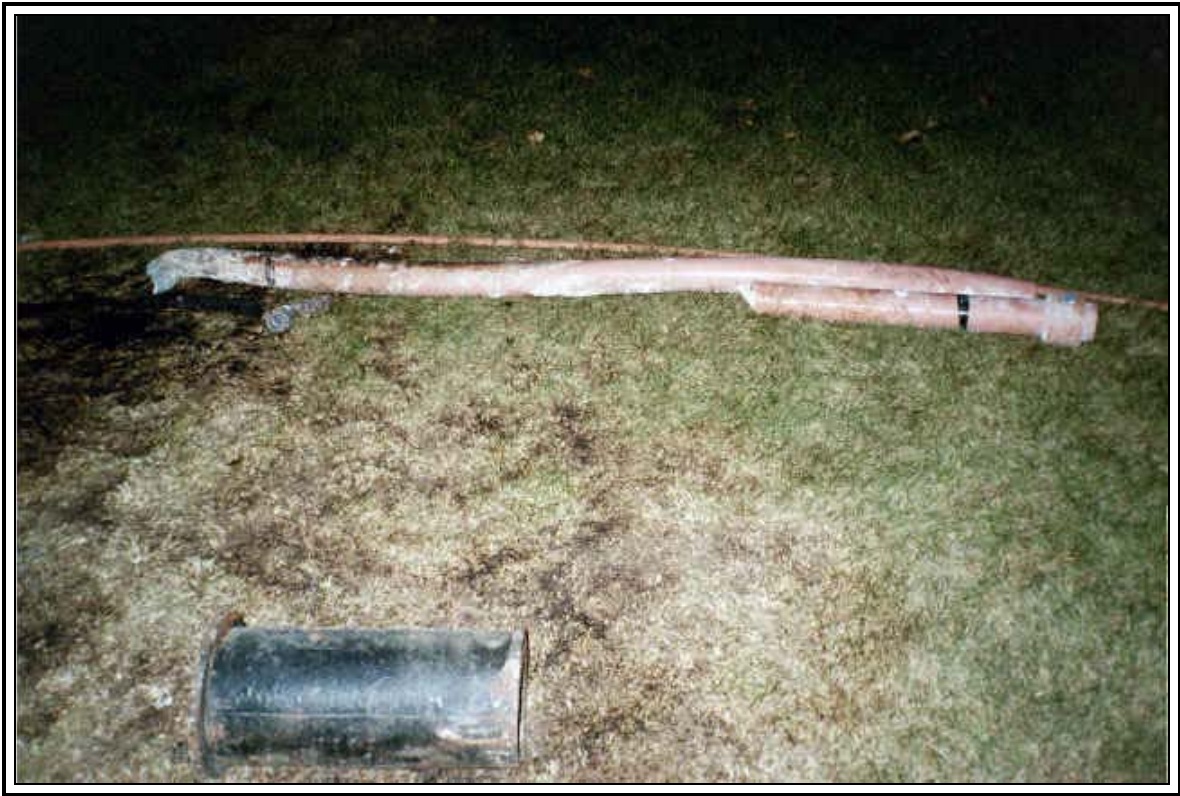
Several segments of 3-inch diameter and ¾-inch diameter, PE natural gas piping were laying on the ground just south of the excavation (See Appendix B-3, Photograph 5). Some of this piping was burned, melted, and scorched and some of the piping was undamaged. The piping had been removed from the excavation by City Utilities Gas Department personnel and was later transported to the City Utilities Calhoun office for safe keeping and testing. The Staff also observed other tools and equipment, which had been utilized by the Water Department crew and Gas Department crew, on the ground beside the excavation. Among these tools and equipment

**Photograph 5:** View of the burned segments (in the background) of 3-inch diameter PE natural gas piping that were removed from the excavation on the evening of 9/25/02.

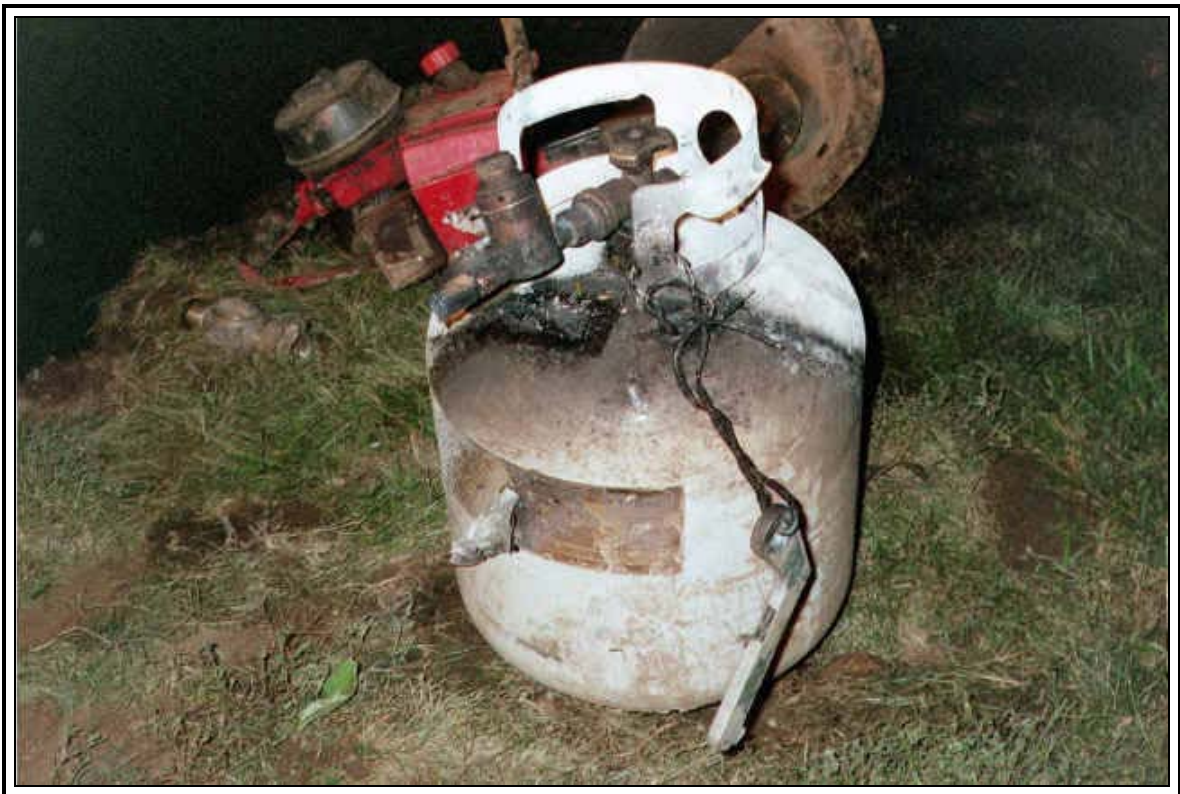
was a 20-pound propane tank that was burned and scorched on one side (See Appendix B-3, Photograph 6). This propane tank had been used by the Water Department crew to provide the fuel for the heating torch to heat-bend the PVC water line.

**Photograph 6:** View of the 20-pound propane tank that was being used by the City Utilities Water Department crew.

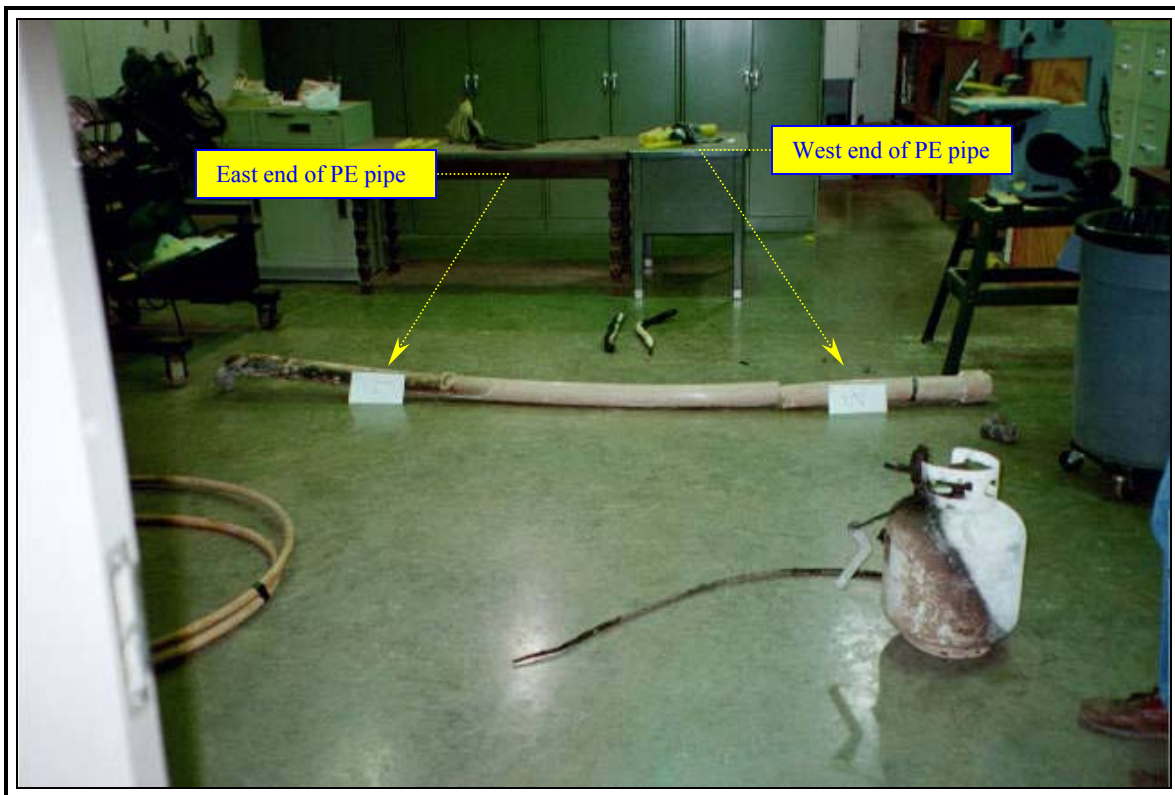
**Photograph 7:** View of the 3-inch diameter PE natural gas main and propane tank that were removed from the excavation. The plastic piping was oriented in the approximate position that the natural gas facilities would have been positioned prior to the incident.

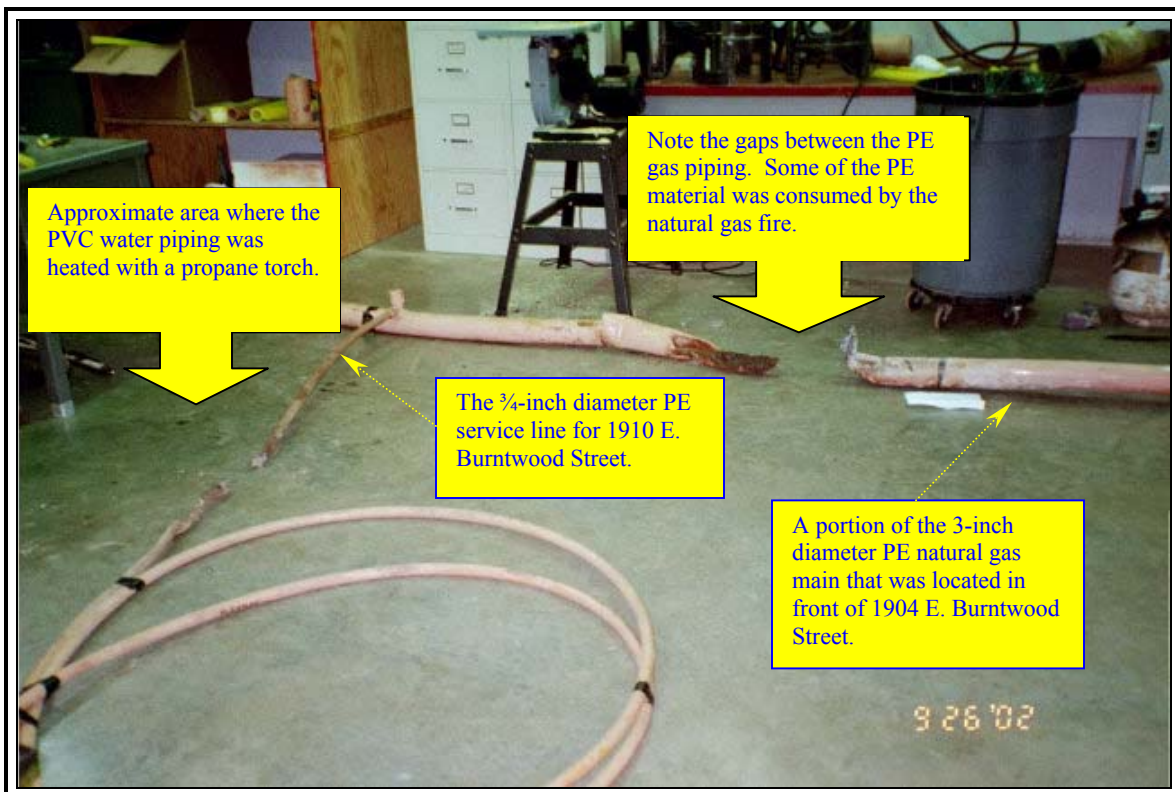
**Photograph 8:** Approximate layout of the burned 3-inch diameter PE natural gas main and 3/4-inch diameter natural gas service line that was removed on 9/26/02.

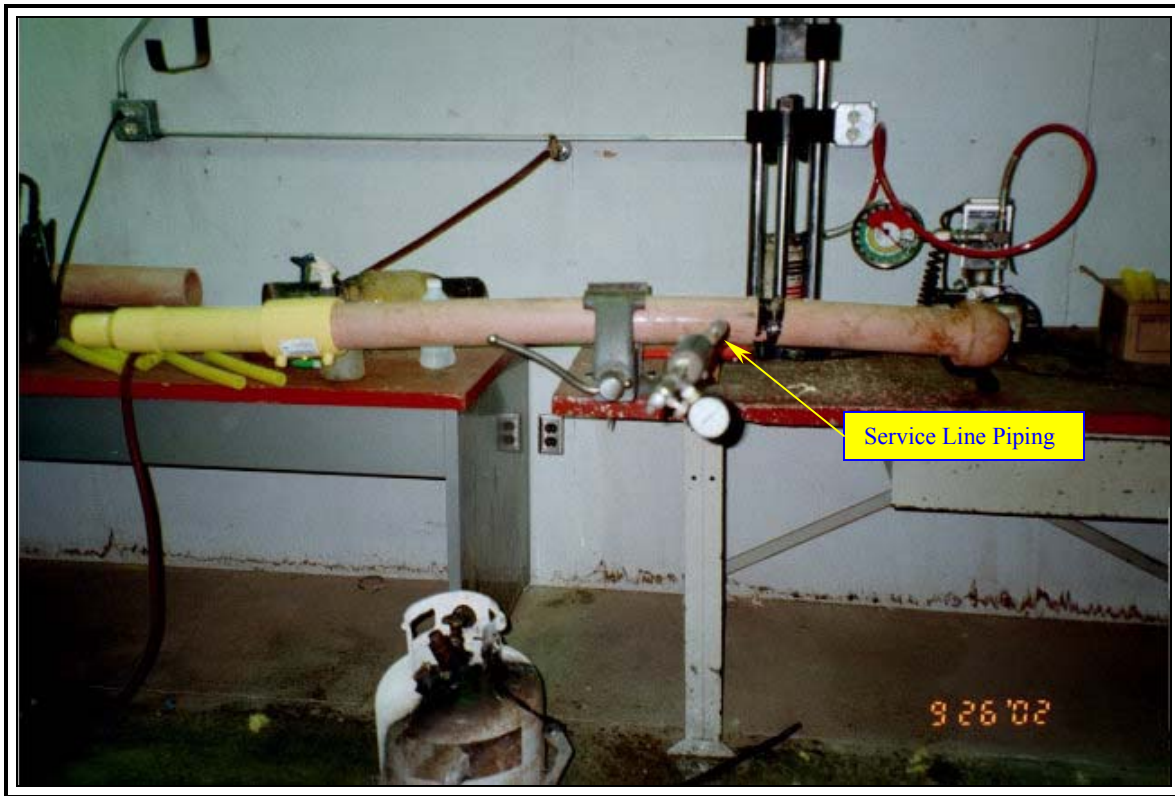
**Photograph 9:** Pressure test of the intact portion of 3-inch diameter PE natural gas main and tapping tee with service line piping (small segment) that served 1910 E. Burntwood Street. This natural gas piping was removed from the excavation in front of 1904 E. Burntwood Street on 9/26/02. A new section of yellow PE piping was added (upper left side of photograph) to facilitate the pressure test.
