**BEFORE THE PUBLIC SERVICE COMMISSION
OF THE STATE OF MISSOURI**

In the Matter of Laclede Gas Company)	
Concerning a Natural Gas Incident at)	
7527 Michigan Avenue, St. Louis,)	Case No. GS-2009-0270
Missouri.)

STAFF'S FINAL STATUS REPORT

Gas Incident Report

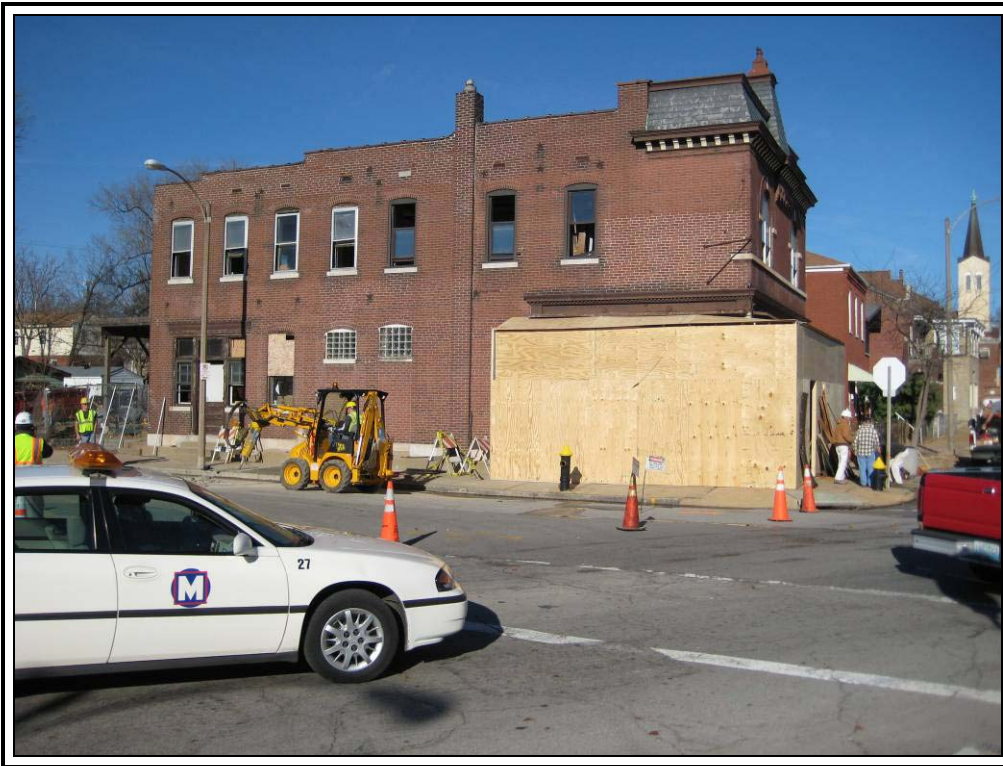
Photograph 1 View looking approximately north toward the south wall of 7527 Michigan Avenue. The structure was undergoing renovation for a public bar and the front side was boarded up.

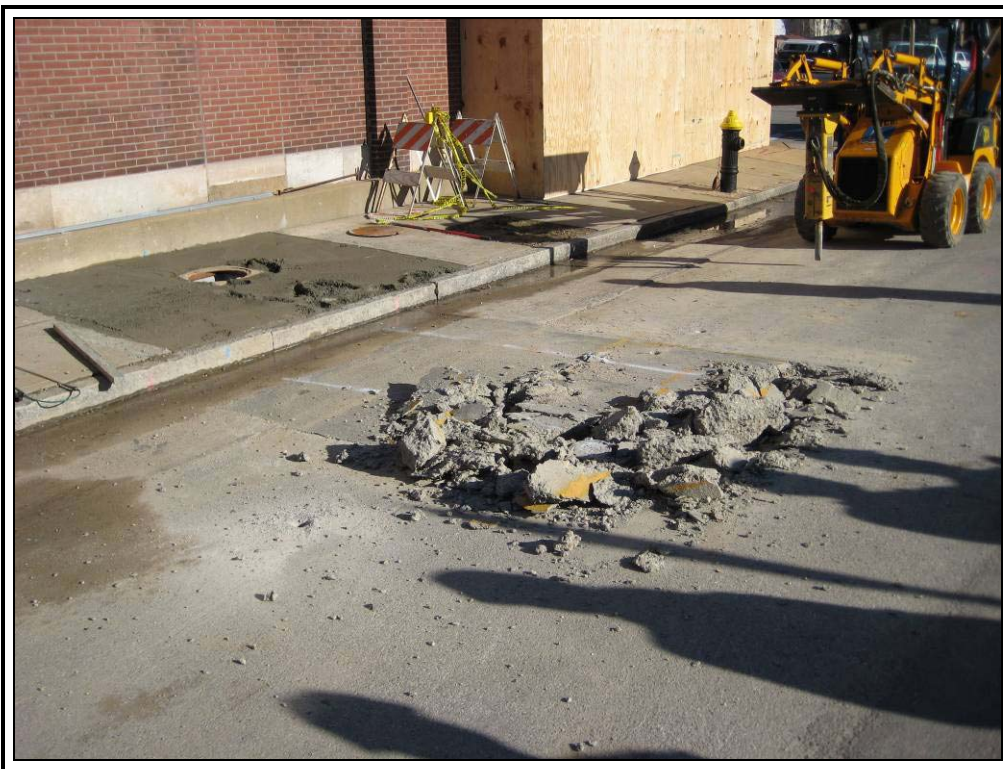
Photograph 2 View looking approximately to the east at the south wall of 7527 Michigan Avenue. The pavement in the street along Steins Street was broken in this location to access the Company's 4-inch natural gas CI main. Observe the freshly poured concrete sidewalk in the foreground along the south wall of 7527 Michigan Avenue.

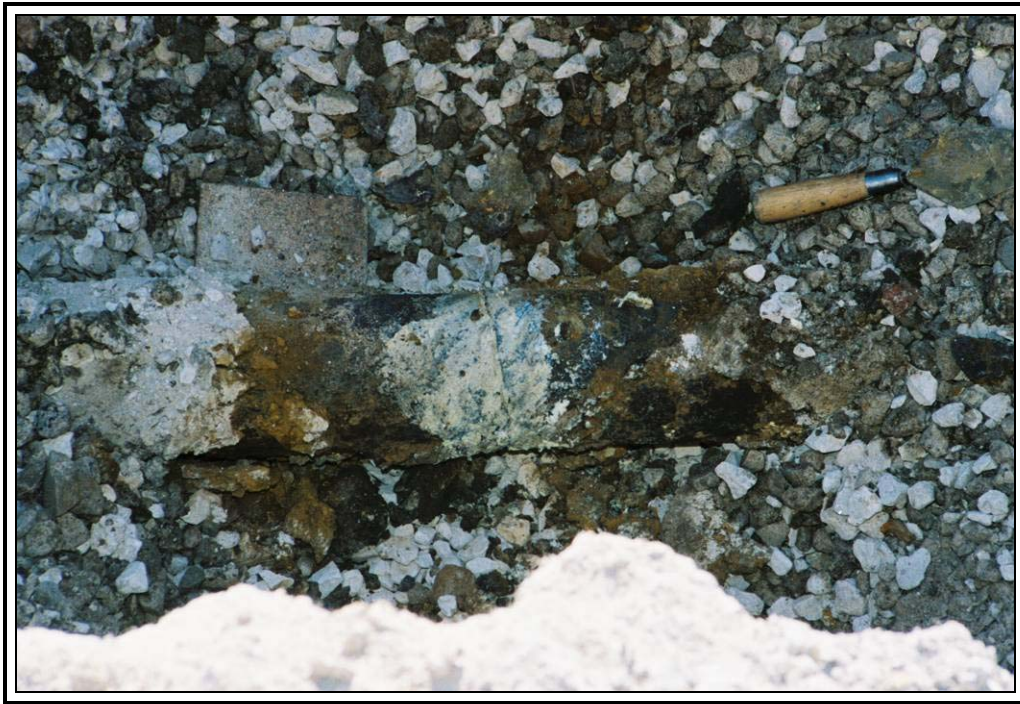
Since the 4-inch CI main was not supported in the excavation prior to the gravel backfill and the poured concrete street patch, the additional weight of the concrete plus any additional weight from vehicular traffic would have resulted in downward loading forces that were distributed along the previously undermined 7-foot section of CI piping. Over a period of time, this external loading would have induced stresses that exceeded the yield point of the 4-inch CI piping until a stress-induced circumferential fracture occurred. This fracture likely

3. The probable cause of the incident was a combination of sequential actions. One of those actions included the removal of soil support beneath an approximate seven-foot span of 4-inch CI natural gas main. The Plumbing Contractor undermined this section of 4-inch CI main and no temporary or permanent shoring or support was provided from November 19, 2008 until the excavation was backfilled with 1-inch clean rock gravel (hereafter referred to as gravel) on December 18, 2008. The other action involved the pouring of cement to a depth of approximately 10 inches directly above the 4-inch CI main to complete a concrete street patch. The weight from this concrete street patch would have induced downward loading stresses that were distributed along the seven-foot section of 4-inch diameter CI main. The combination of these actions along with any settlement of the loose gravel backfill eventually caused the 4-inch CI natural gas main along Steins Street (south of 7527 Michigan Avenue) to fail by circumferential fracture.

Photograph 3 View looking inside of the excavation along Steins Street after the concrete patch for the street was removed on December 30, 2008. Observe the fracture area around the circumference of the 4-inch natural gas CI main.

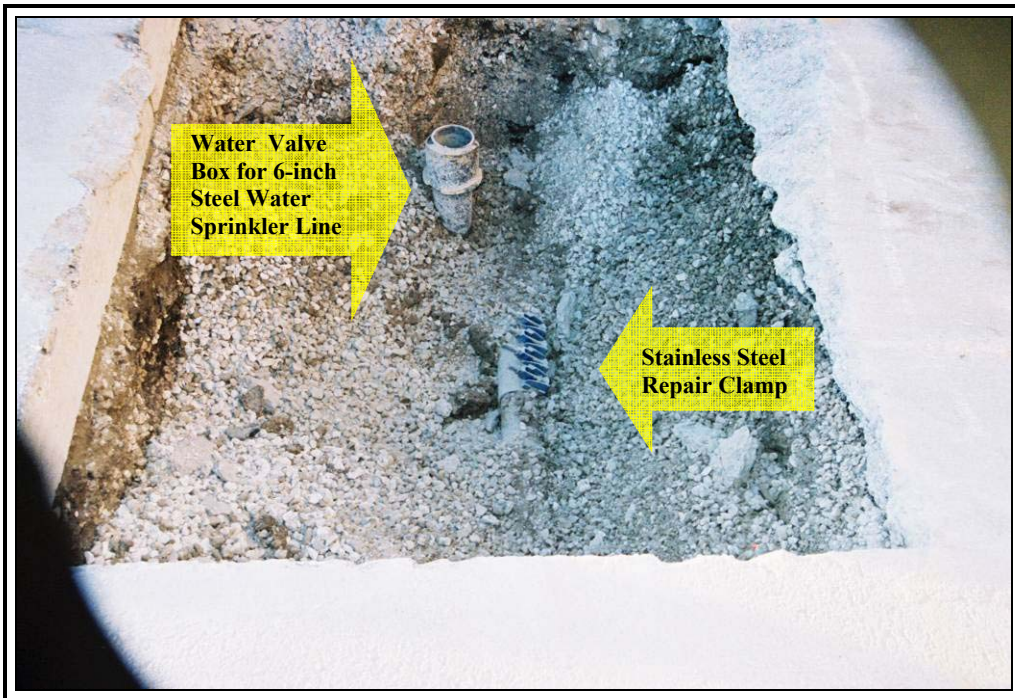
Photograph 4 View looking approximately to the west at the excavation in Steins Street. A stainless steel repair clamp was placed around the circumference of the 4-inch natural gas CI main to seal the leaking fracture area. The standpipe to the left of the natural gas CI main served as a valve box for a 6-inch steel water sprinkler line. A 75% gas-in-air reading was obtained at this water valve box location by the first responding S.A.I.D. Leak Technician on December 30, 2008.

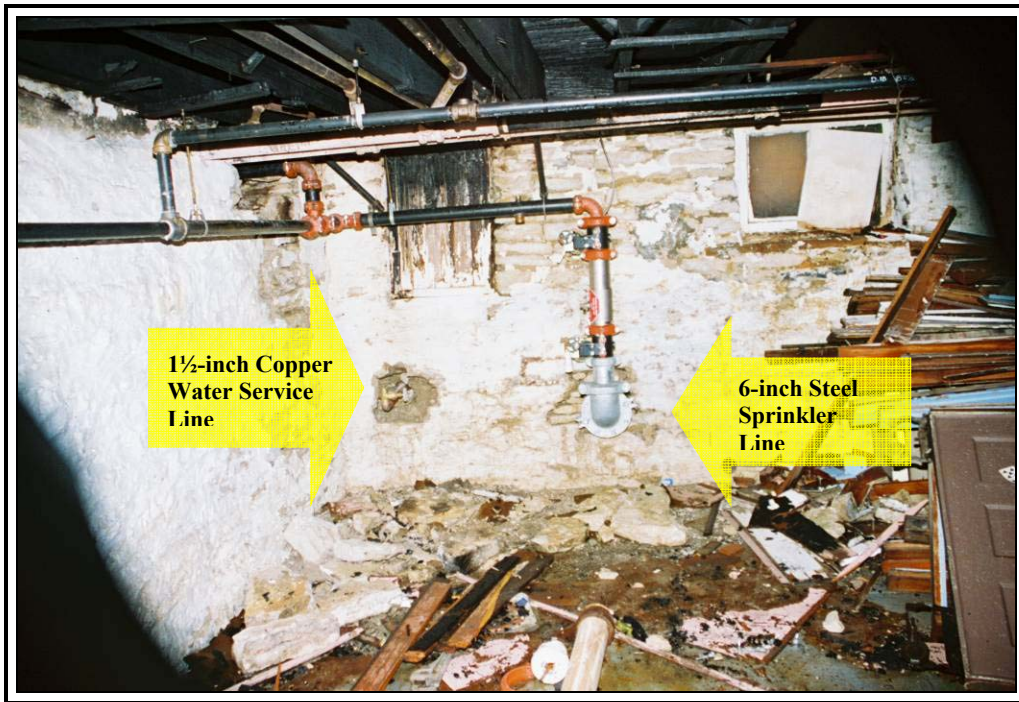
Photograph 5 View looking towards the south interior basement wall of 7527 Michigan Avenue where the 1½-inch copper water service line (to the left) and 6-inch steel sprinkler line entered. Note the burn damage to the wooden floor joists and the first floor flooring above.

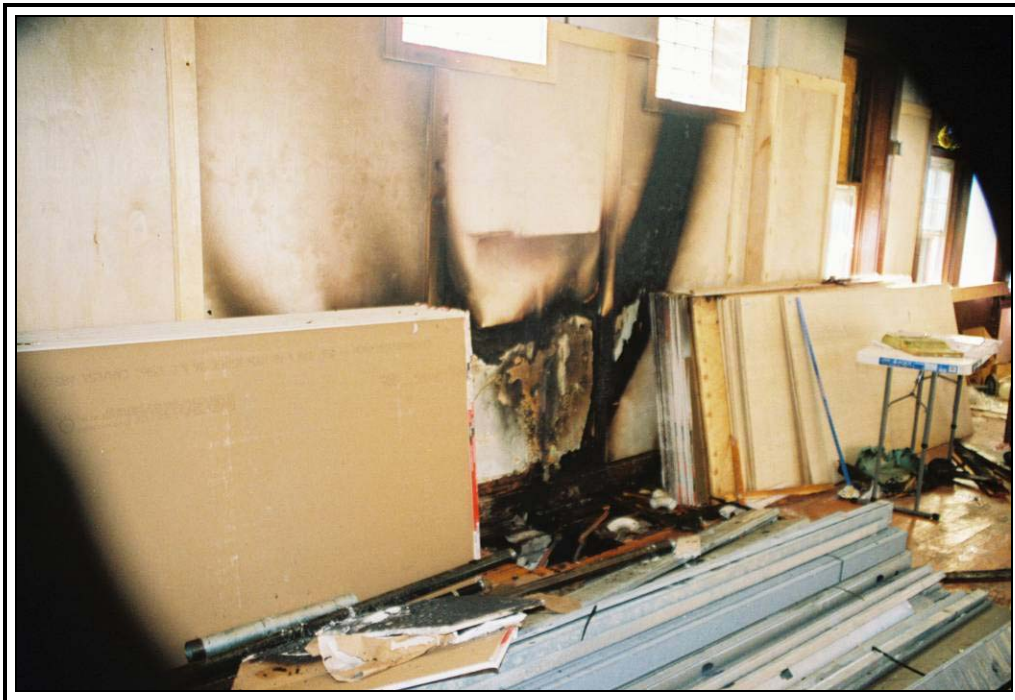
A two-story commercial brick building at 7527 Michigan Avenue was undergoing a renovation project at the time of the incident. A portion of the wooden floor joists and flooring for the 1st floor of the building, as viewed from the basement area, received extensive fire and smoke damage in the vicinity of the southern basement wall. Some of the drywall covering the southern wall of the 1st floor also received fire, smoke, and water damage. The property damage to this two-story structure was originally estimated to be approximately \$100,000 by Laclede. After receiving property damage information from the insurance company for the building owner on July 1, 2009, this estimate was reduced to \$33,056.45. The cost to repair the damaged 4-inch CI main was calculated by Laclede to be \$4,561.34.

Photograph 6 View looking approximately to the southwest at the south wall of the first floor room inside of 7527 Michigan Avenue. A portion of the floor (located between the two stacks of sheet rock that were placed against the wall) was removed during fire suppression activities and a portion appeared to have been consumed by the fire. Observe the v-pattern burn that appears along the wall and above the opening in the floor.
