# FERC TAUM SAUK INVESTIGATION TEAM

April 28, 2006

Report of Findings on the Overtopping and Embankment  
Breach of the Upper Dam - Taum Sauk Pumped Storage  
Project, FERC No. 2277

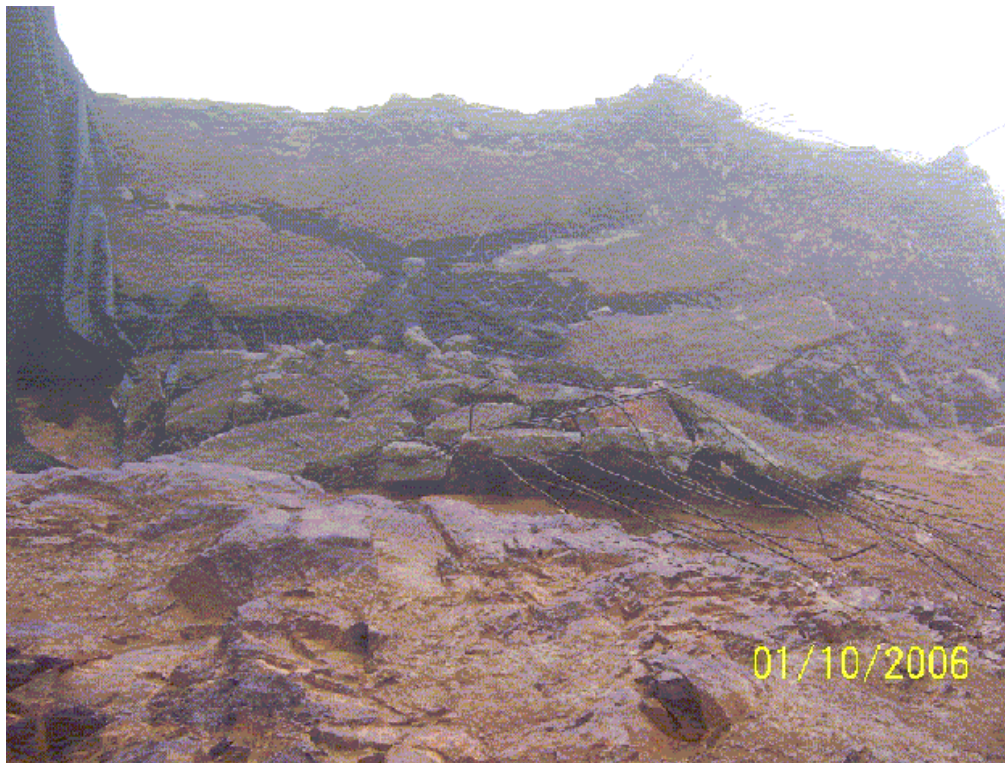
**Figure 2.4 - View of bedrock immediately below failed embankment section.  
Note weathered clay in lower portions of the exposure.**

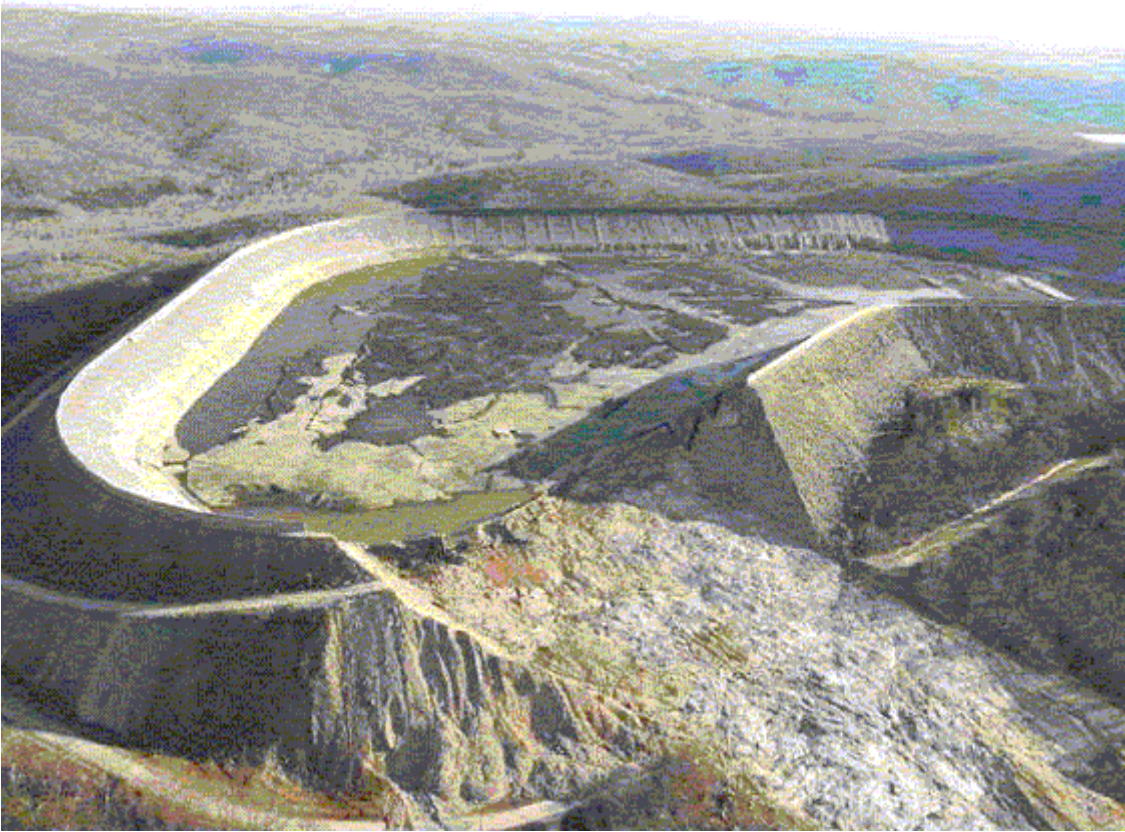
**Figure 2.5 - View of bedrock within, and immediately below failed embankment section. Note distribution of weathered rock (red-brown color) and topsoil (green-brown color). The “fish-pond” area contains water and is immediately upstream of the breach.**

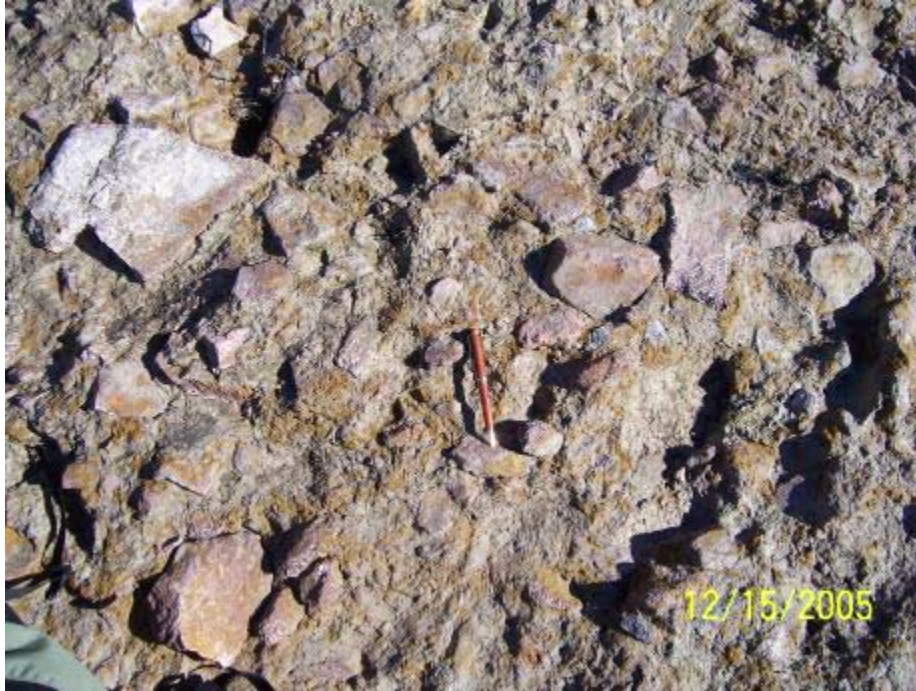
An area of the foundation in the breach section contained clay with low-moderate plasticity and weathered rock in the area just beneath the breach. The clay and weathered rock zone could have provided a failure surface for embankment sliding. The clay appears to be a residual weathering product of the bedrock (Figure 2.6), and in areas, relict bedrock structure can be observed in partially and completely decomposed clay remnants. No records were made available that indicate the extent of clay that was left in the breach area. However it could be conjectured that the settlement of the parapet wall in this area may have been accentuated due to consolidation of this clay deposit if it was of substantial thickness. The clay appeared saturated and contained groove marks from debris (Figures 2.7-2.9). This area was over-excavated in the footprint of the reservoir due to the clay foundation conditions, forming the “fish-pond” area of the

**Figure 2.6 - Foundation area composed of weathered rhyolite with some clay, located in breach area.**

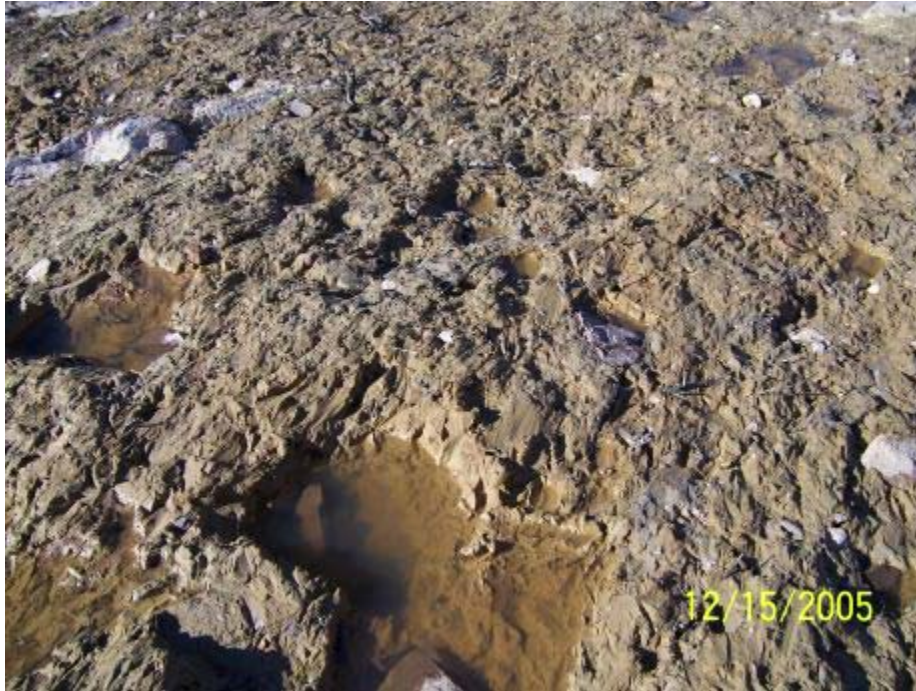
**Figure 2.7 - Grooves cut into an area of clay-seam foundation by the floodwaters. This area is located immediately downstream and in the center of the breach.**

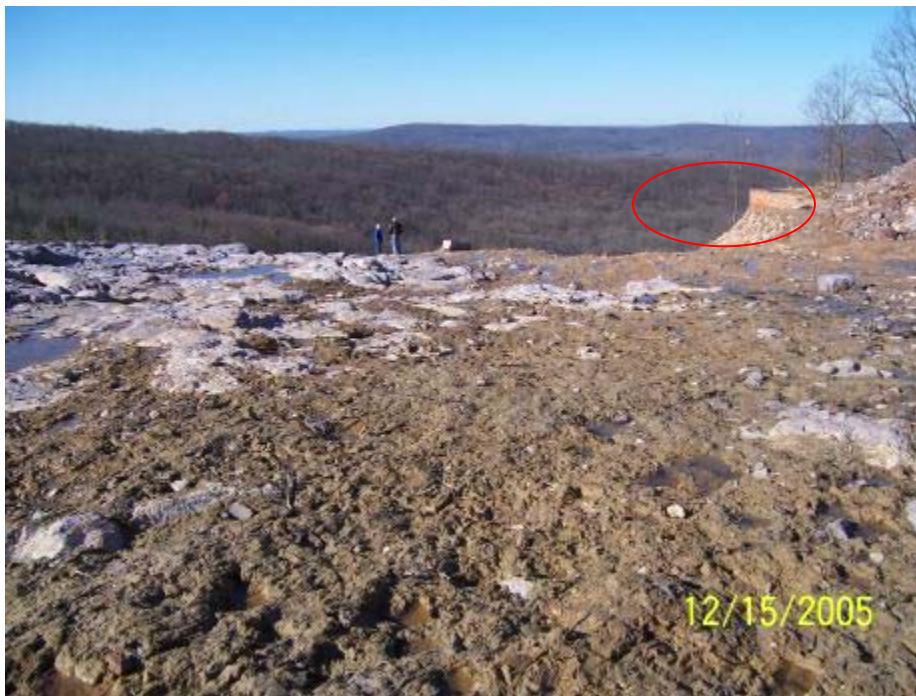
**Figure 2.8 - Overview of area shown in previous photograph. Note washed out access road (circled).**

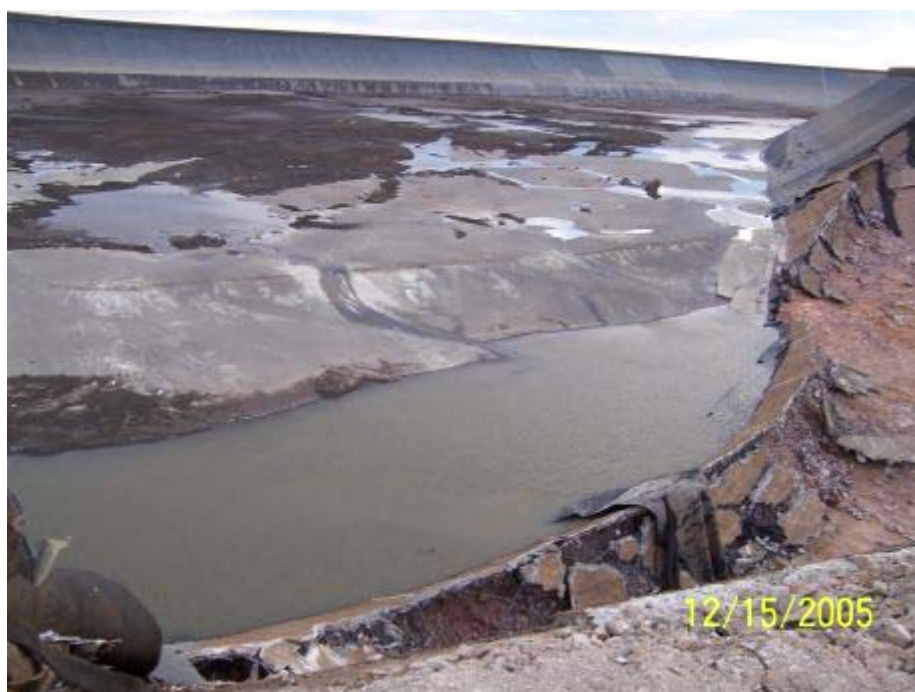
**Figure 2.10 - Breached area. Note “fish pond” area immediately upstream of the breach. This area was over-excavated during original construction due to poor foundation conditions.**

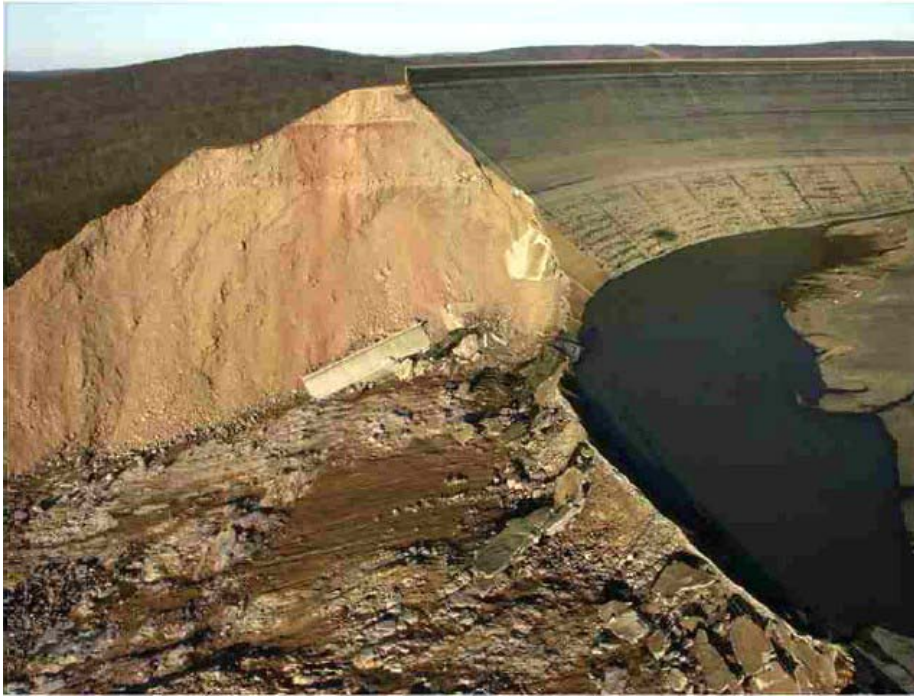
**Figure 2.11 - Weathered rock and discontinuous clay seam foundation just downstream of fish-pond area.**

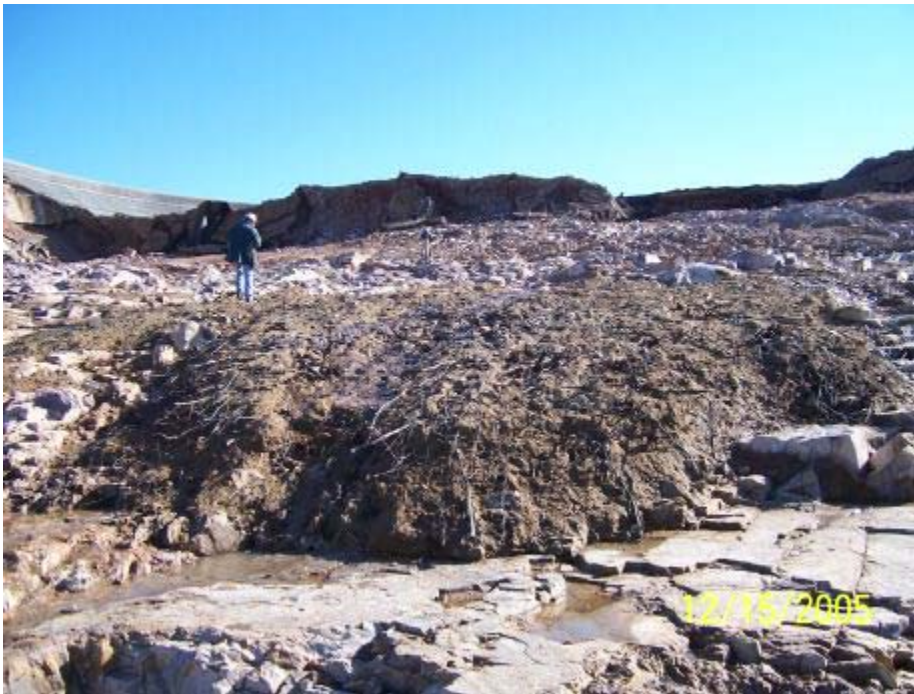
**Figure 2.12 - Root-laden remnant native soil in breach area, resting on fresh rhyolite.**

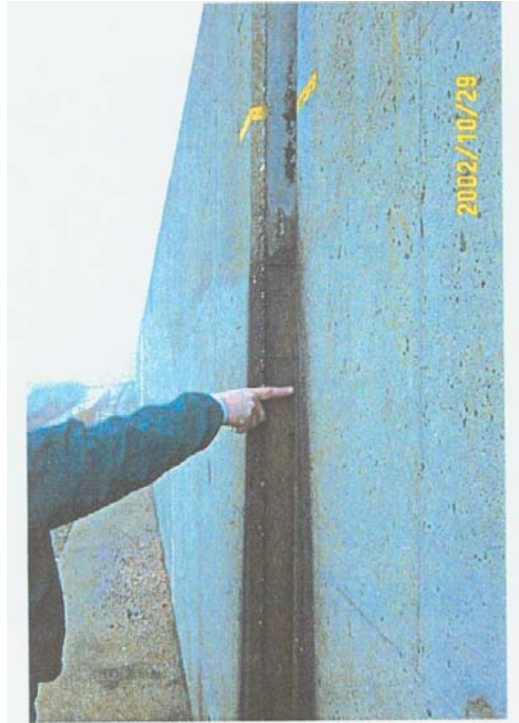
"The maximum horizontal movement observed was at joints 89/90 and 106/107, with about 4-5 inches of translation and rotational movement. Photograph 3 (*of the report – see below Figure 3.4*) shows panel 90 having moved downstream relative to panel 89. The copper waterstop was visible in the joint. This magnitude of movement is likely sufficient to tear the waterstop, but probably does not affect the wall stability."

**Figure 3.4- Movement at Upper Dam Parapet Wall at Joint 89/90 from 2003 Eighth Part 12D Report**

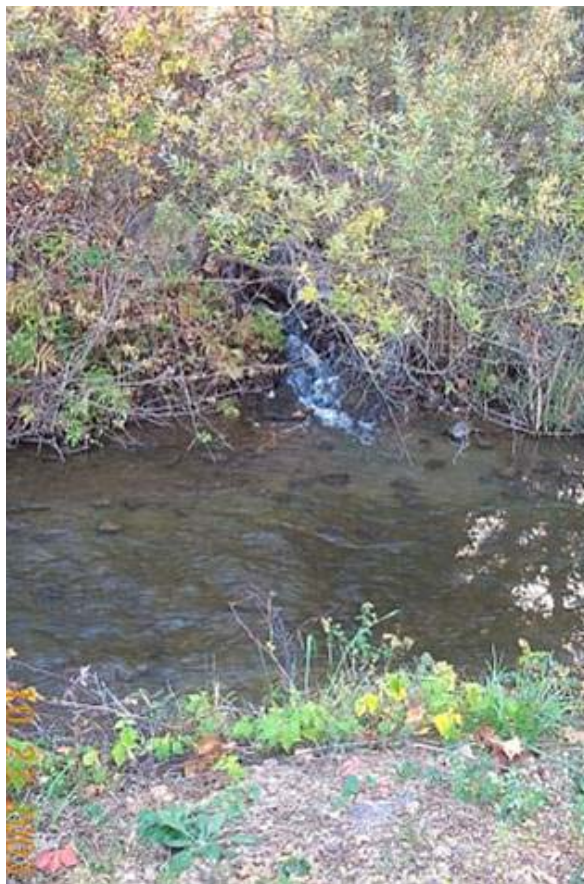
**Figure 3.7 - Concentrated Seep Before liner installation  
(2003 FERC Operation Inspection Report)**

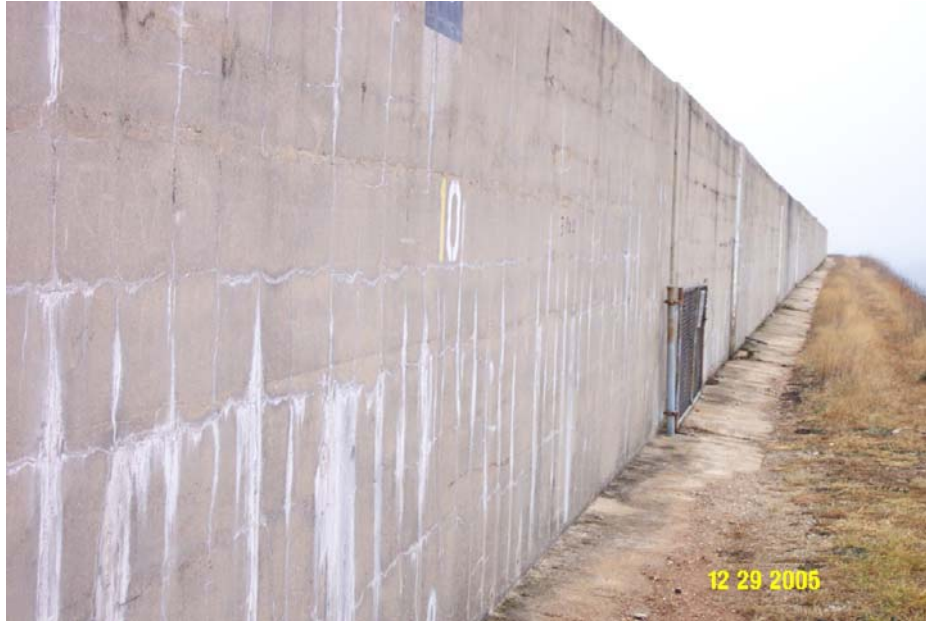
**Figure 4.2 - Panel 10**  
**Note grass is lain over near footing**  
**Damage from overtopping was judged as Minimal**  
**Estimate 0.1 ft. of overtopping**

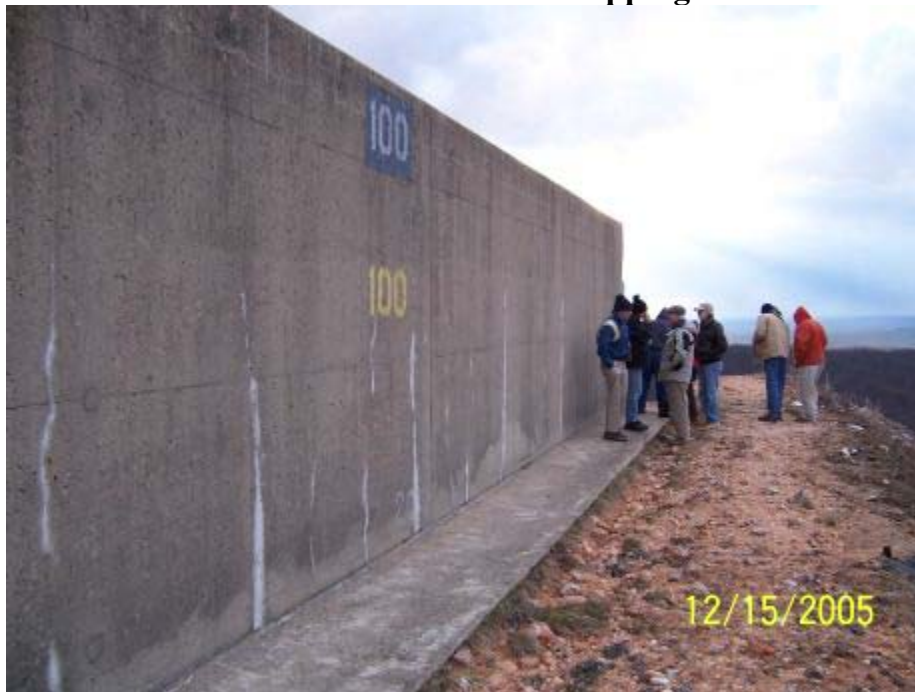
**Figure 4.3 - Panel 100**  
**Adjacent to the right side of the Breach**  
**Note erosion at toe of parapet wall footing**  
**Damage which was judged as moderate to significant**

The elevations of Panels 100 and 101 were measured between elevations 1597.67 and 1597.82 ft (Figure 4.3). The damage at Panel 100 and 101, which was judged as moderate to severe, does not appear to agree with the estimates of the peak reservoir estimates occurring on December 14, 2005. However, wind-induced waves could have overtopped these walls by several inches on December 14, 2005. Damage may have been the result of the December 14, 2005 event and/or the September 25, 2005 wave overtopping event.

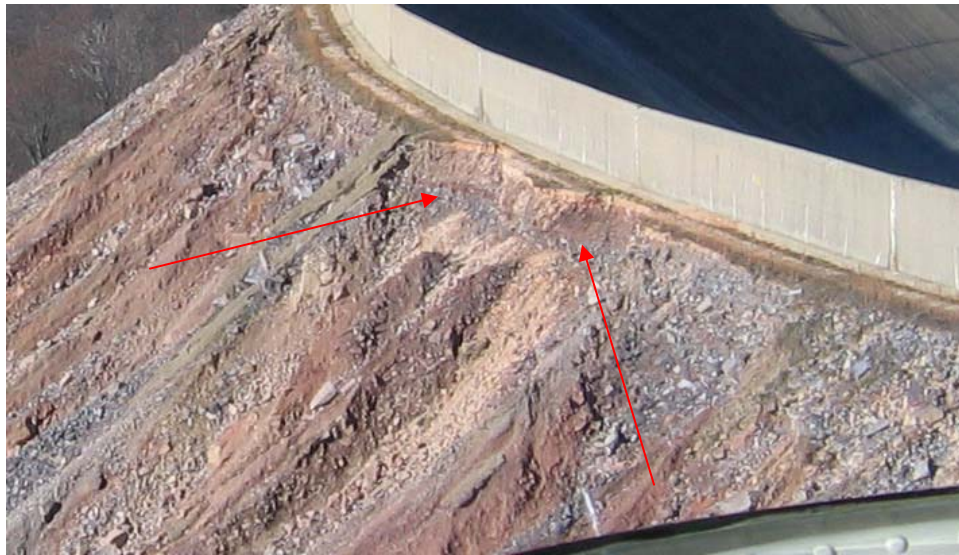
**Figure 4.4 - Erosion Panel 48/49**

**Note scarps that may be the results of a localized slope failure  
Damage judged as significant  
Estimate 0.5 ft of overtopping**

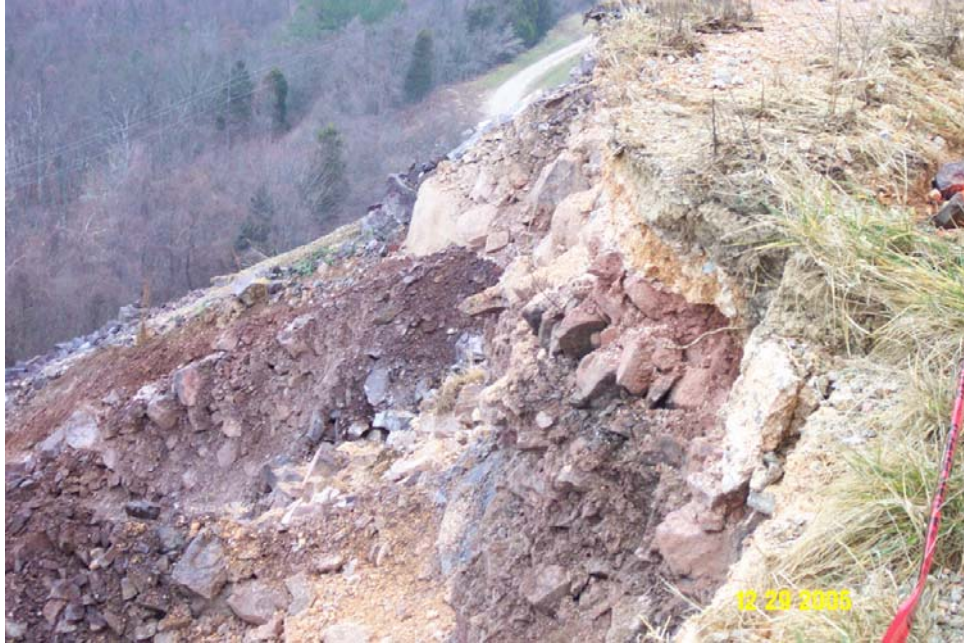
**Figure 4.5 - Panels 48 and 49**  
**Scarp near toe of parapet wall footing**

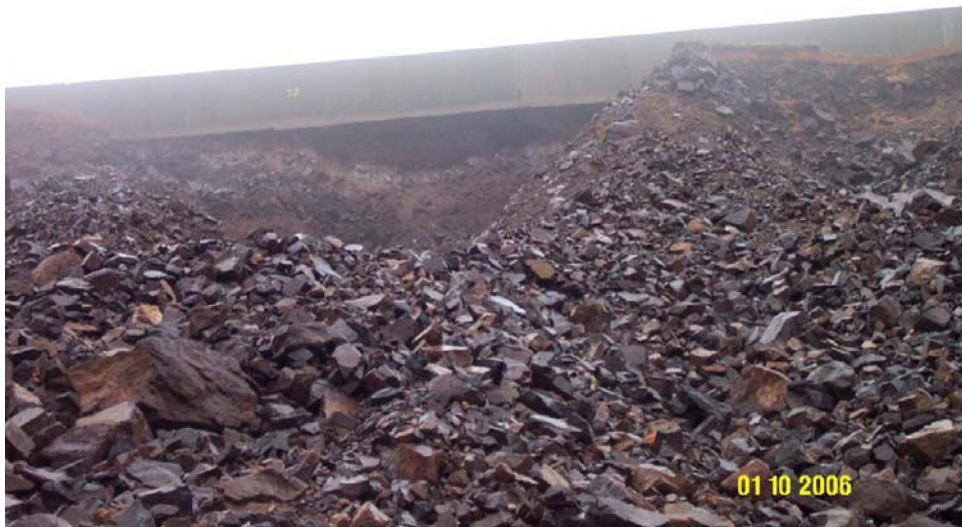
**Figure 4.7 - Panel 72**  
**Note erosion deep beneath the parapet wall**  
**Damage judged as significant**  
**Estimate 0.7 ft of overtopping**

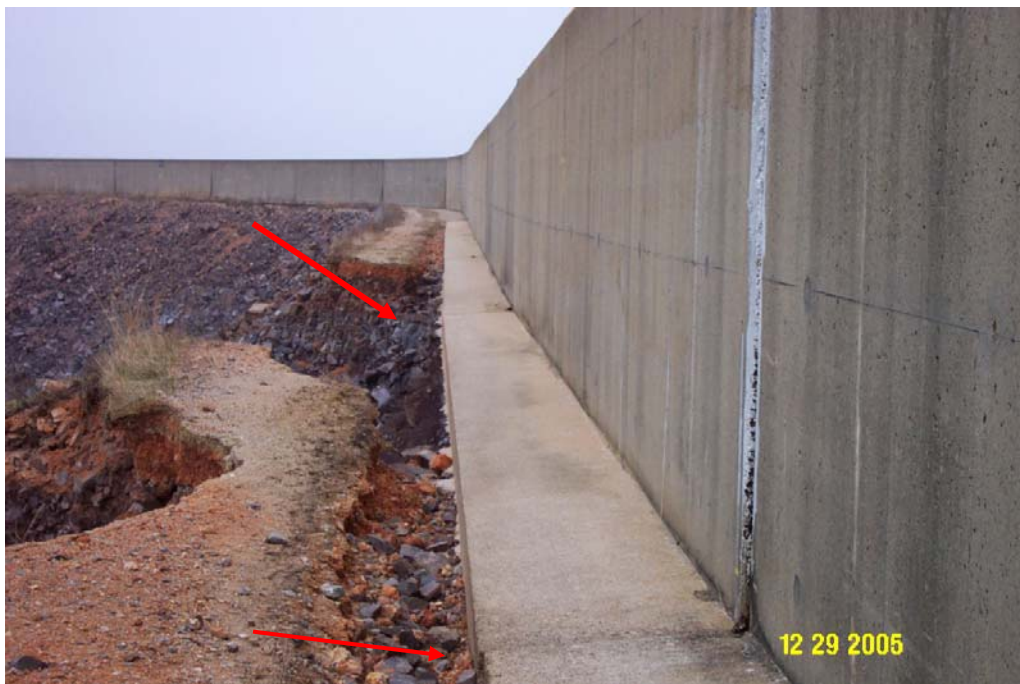
**Figure 4.8 - Erosion at Panel 71 footing**  
**Note the horizontal displacement between Panel 70 and 71(foreground) and**  
**bowing at the joint between Panels 71 and 72. Erosion at the footing is**  
**similar to that described during the September 25, 2005 wave overtopping.**

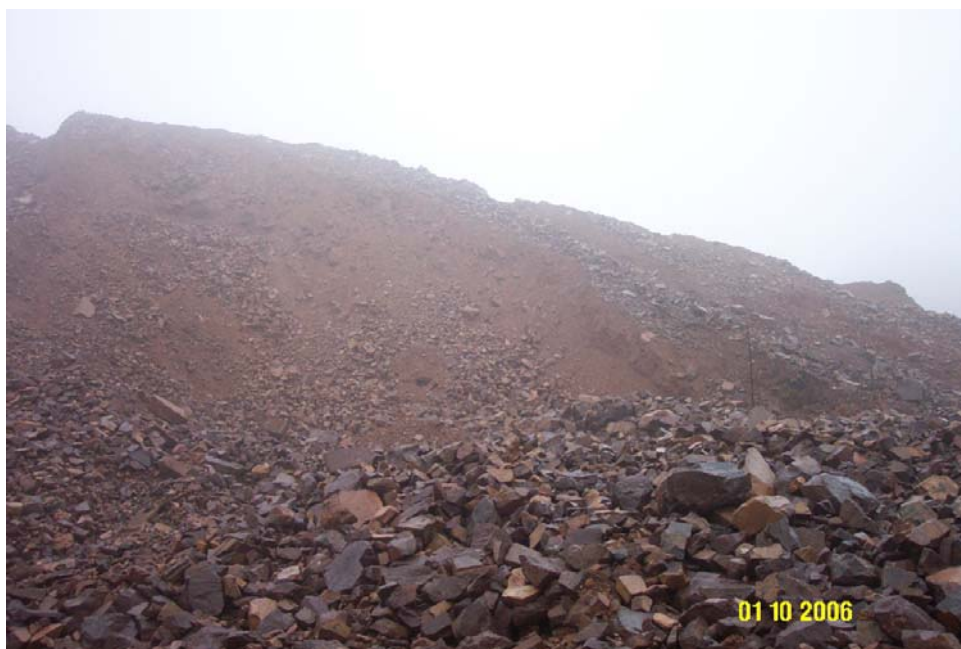
**Figure 4.9 - Possible slope failure between Panel 100 and the full breach section**

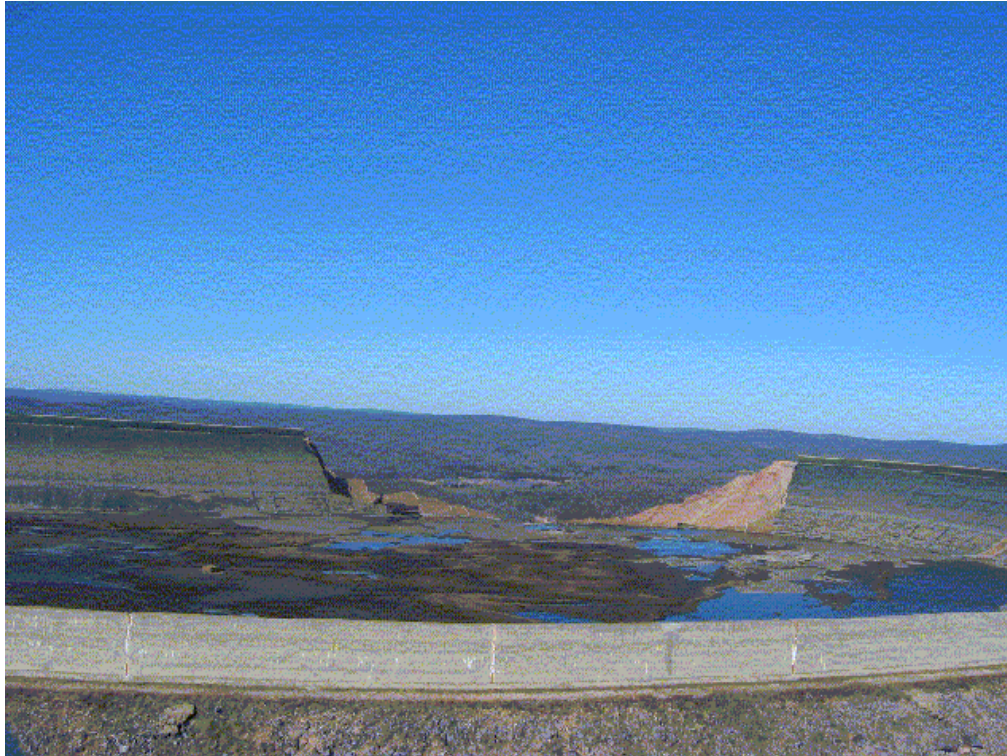
**Figure 4.10 – Breach Panels 88 - 99 removed during the event  
Estimate 0.2 -0.3 ft. of overtopping. (Missouri DNR Photo)**

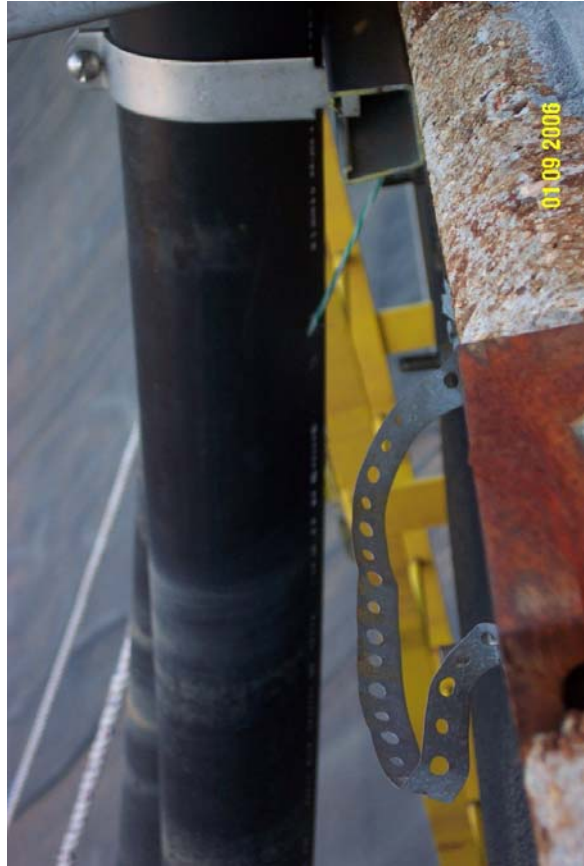
Evidence of the monitoring system not operating as designed was found at the gage house with water marks noted on the HDPE pipes. The elevation of the watermarks indicates the peak reservoir level may have been routinely above elevation 1596 ft. Figures 5.6 and 5.7 are a photograph and schematic of the high water marks, respectively.

**Figure 5.6 - High Water marks on HDPE Tubes**

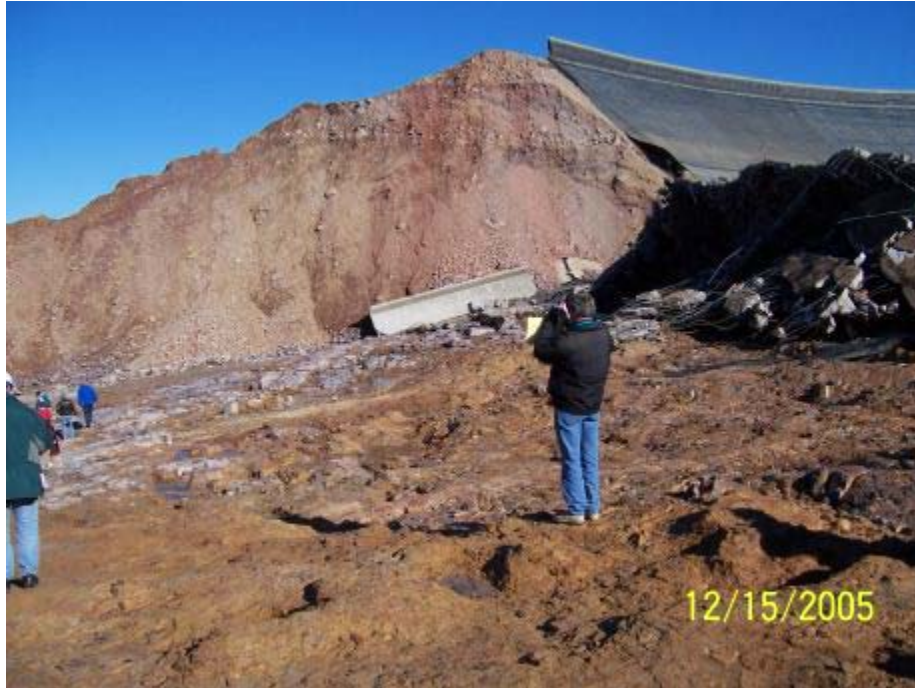
There is no evidence to support a conclusion that the weathered rock or clay layer extended beneath the entire footprint of the breach area. However, it was assumed in the stability analysis that there was a layer of weak material resting on top of bedrock throughout the area that was stripped by the discharge through the breach. Both the clay layer and weathered bedrock were treated as having the same shear strength. This assumed continuous layer of weak material results in more conservative (lower) factors of safety than would have existed if the rock fill had been placed directly on top of bedrock. This should give a lower-bound estimate for stability of the rock fill in the breach area. The foundation was divided into two components; 1) sound rock and, 2) weathered rock/topsoil.

**Figure 9.2 - Area of weathered rhyolite, which is in-line with the “fish pond” depression in the reservoir (background).**

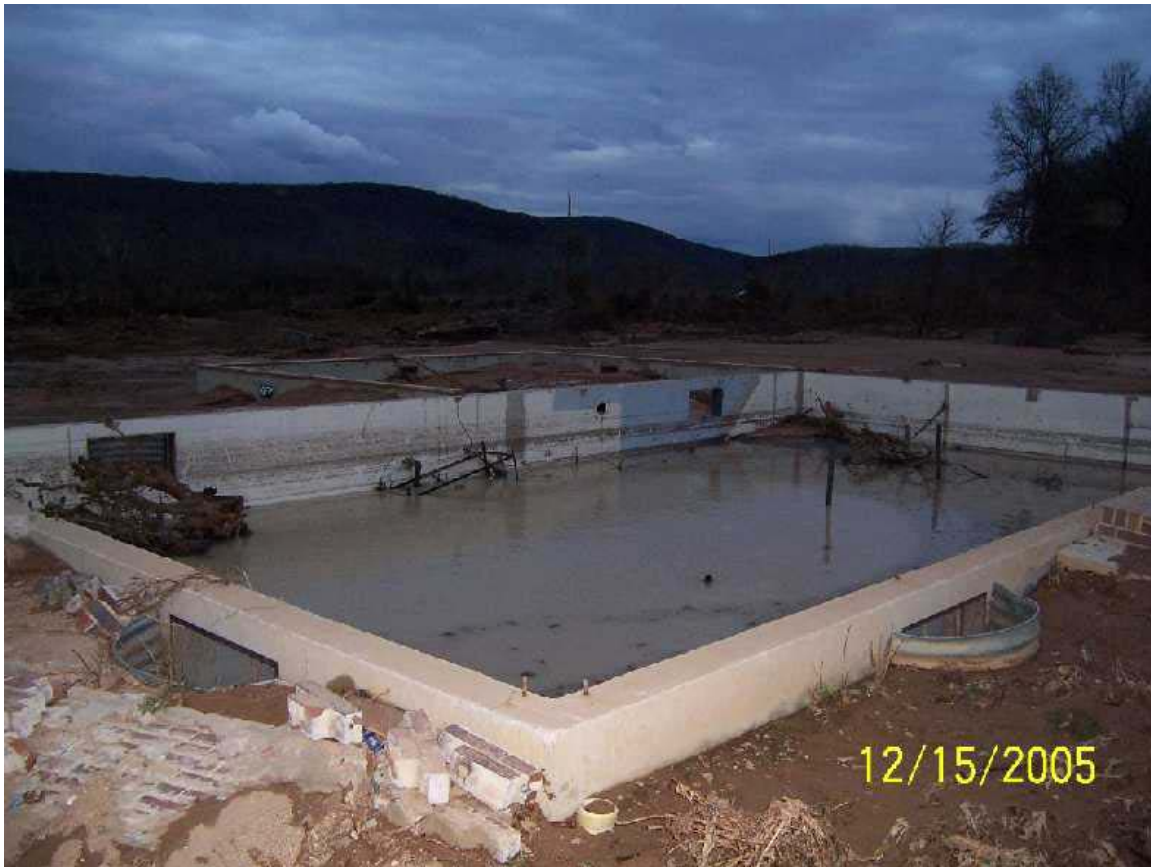
**Figure 11.1 - State park superintendent's former home. (Source: Staff)**

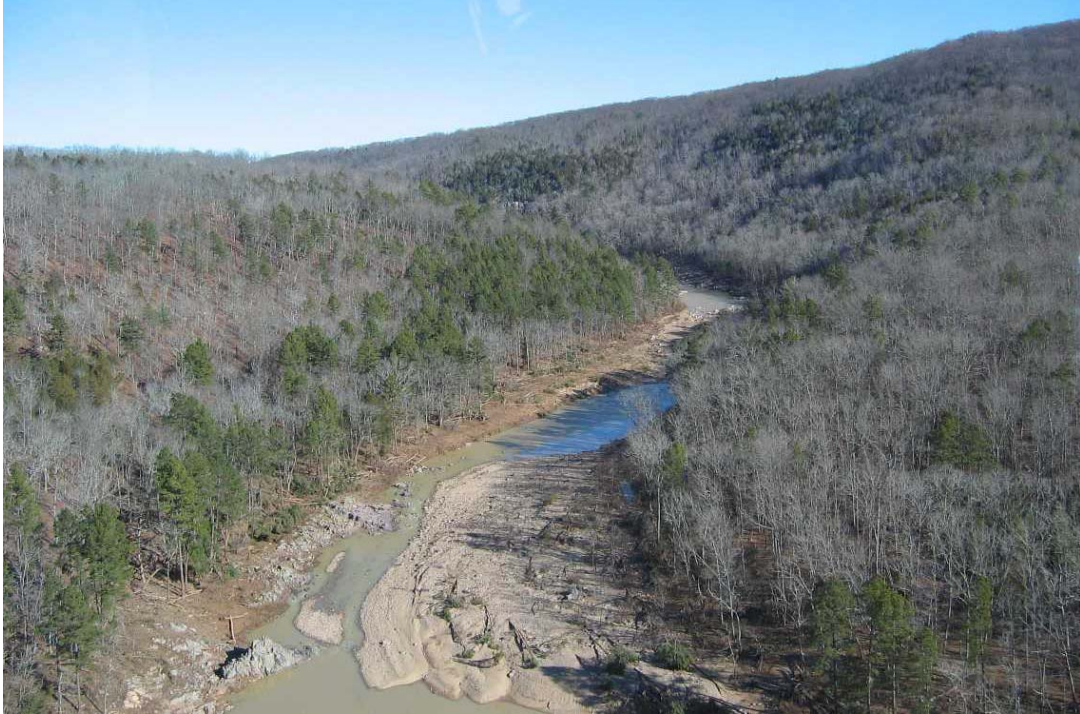
**Figure 11.14 - Deforested riparian vegetation below Shut-Ins area of state park. (Source: MDC)**
