STAFF'S INCIDENT REPORT

Electric Incident Report

Kansas City Power & Light Company
Case No. ES-2010-0009

Iatan Unit 1 Turbine High Pressure Rotor Bow
Iatan Plant
Weston, Missouri
Incident date: February 4, 2008

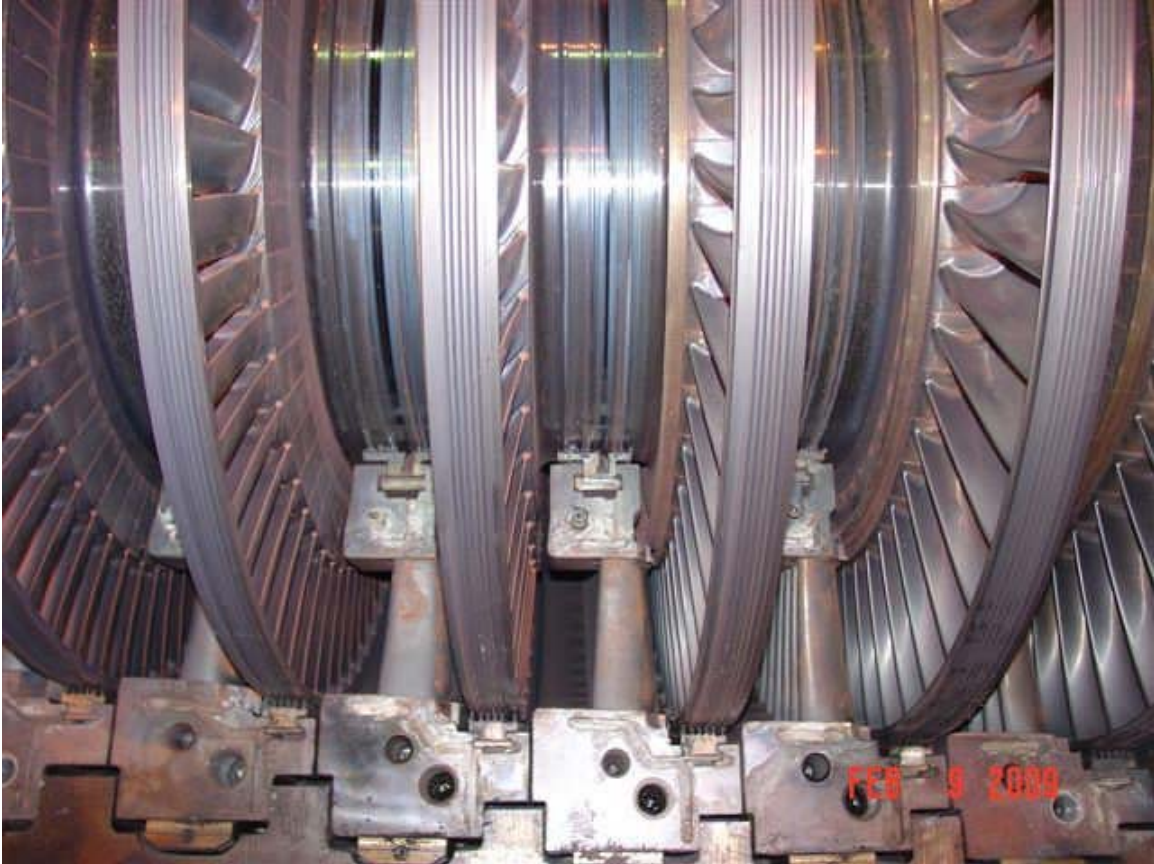
HP Interstage Diaphragm Packing Damage

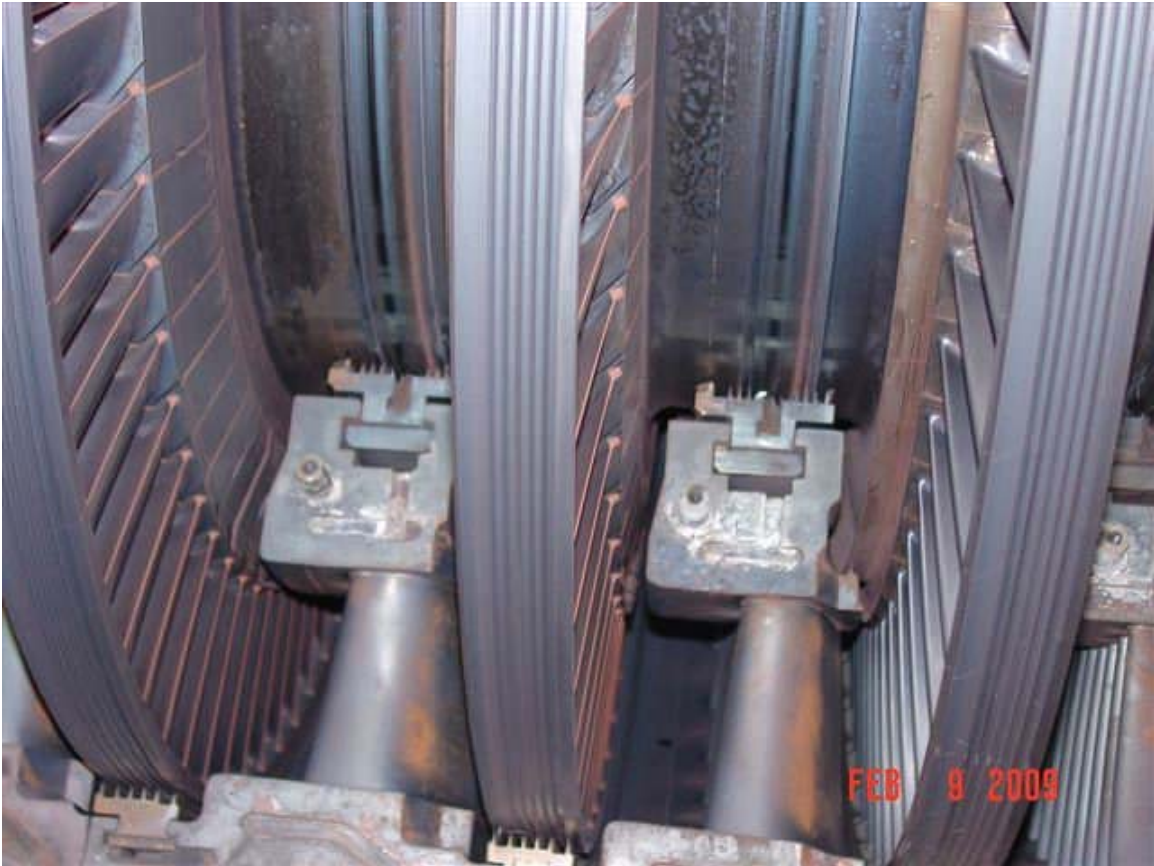
HP Interstage Diaphragm Packing Damage

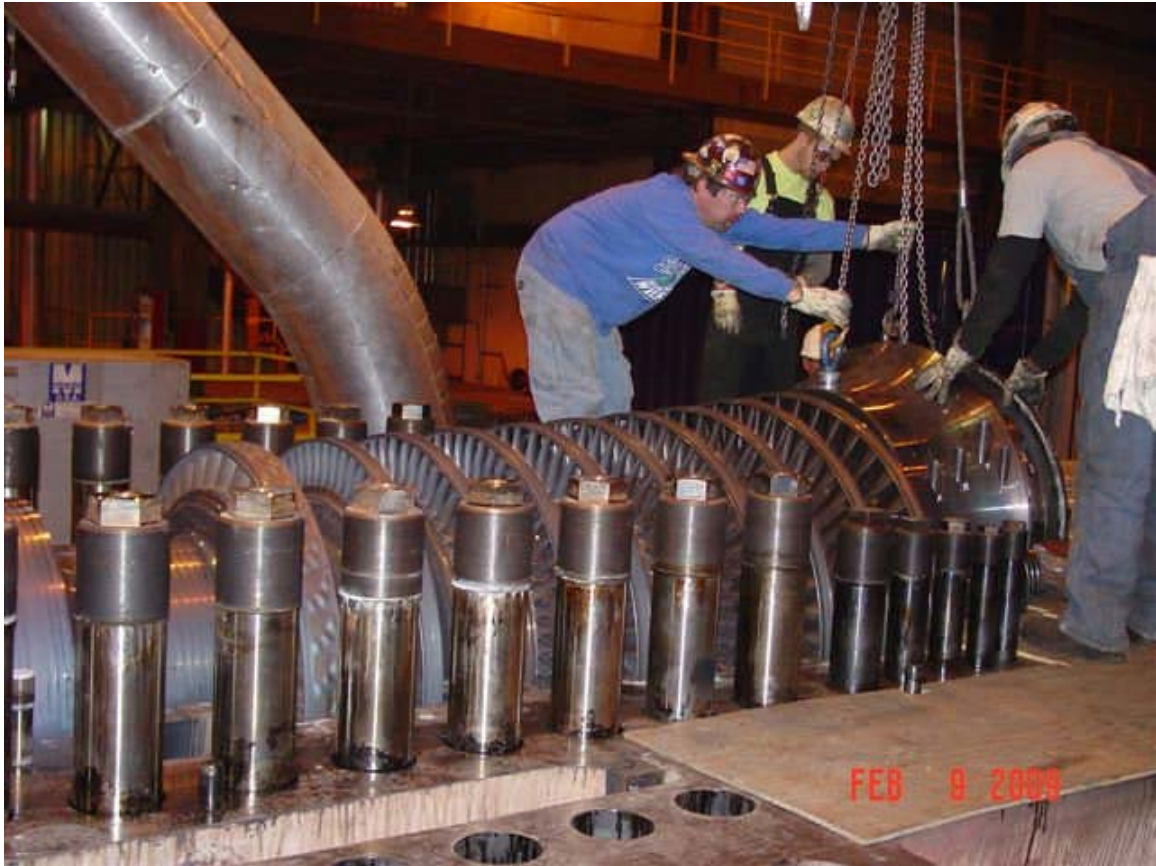
Removing UH N1 Packing Casing

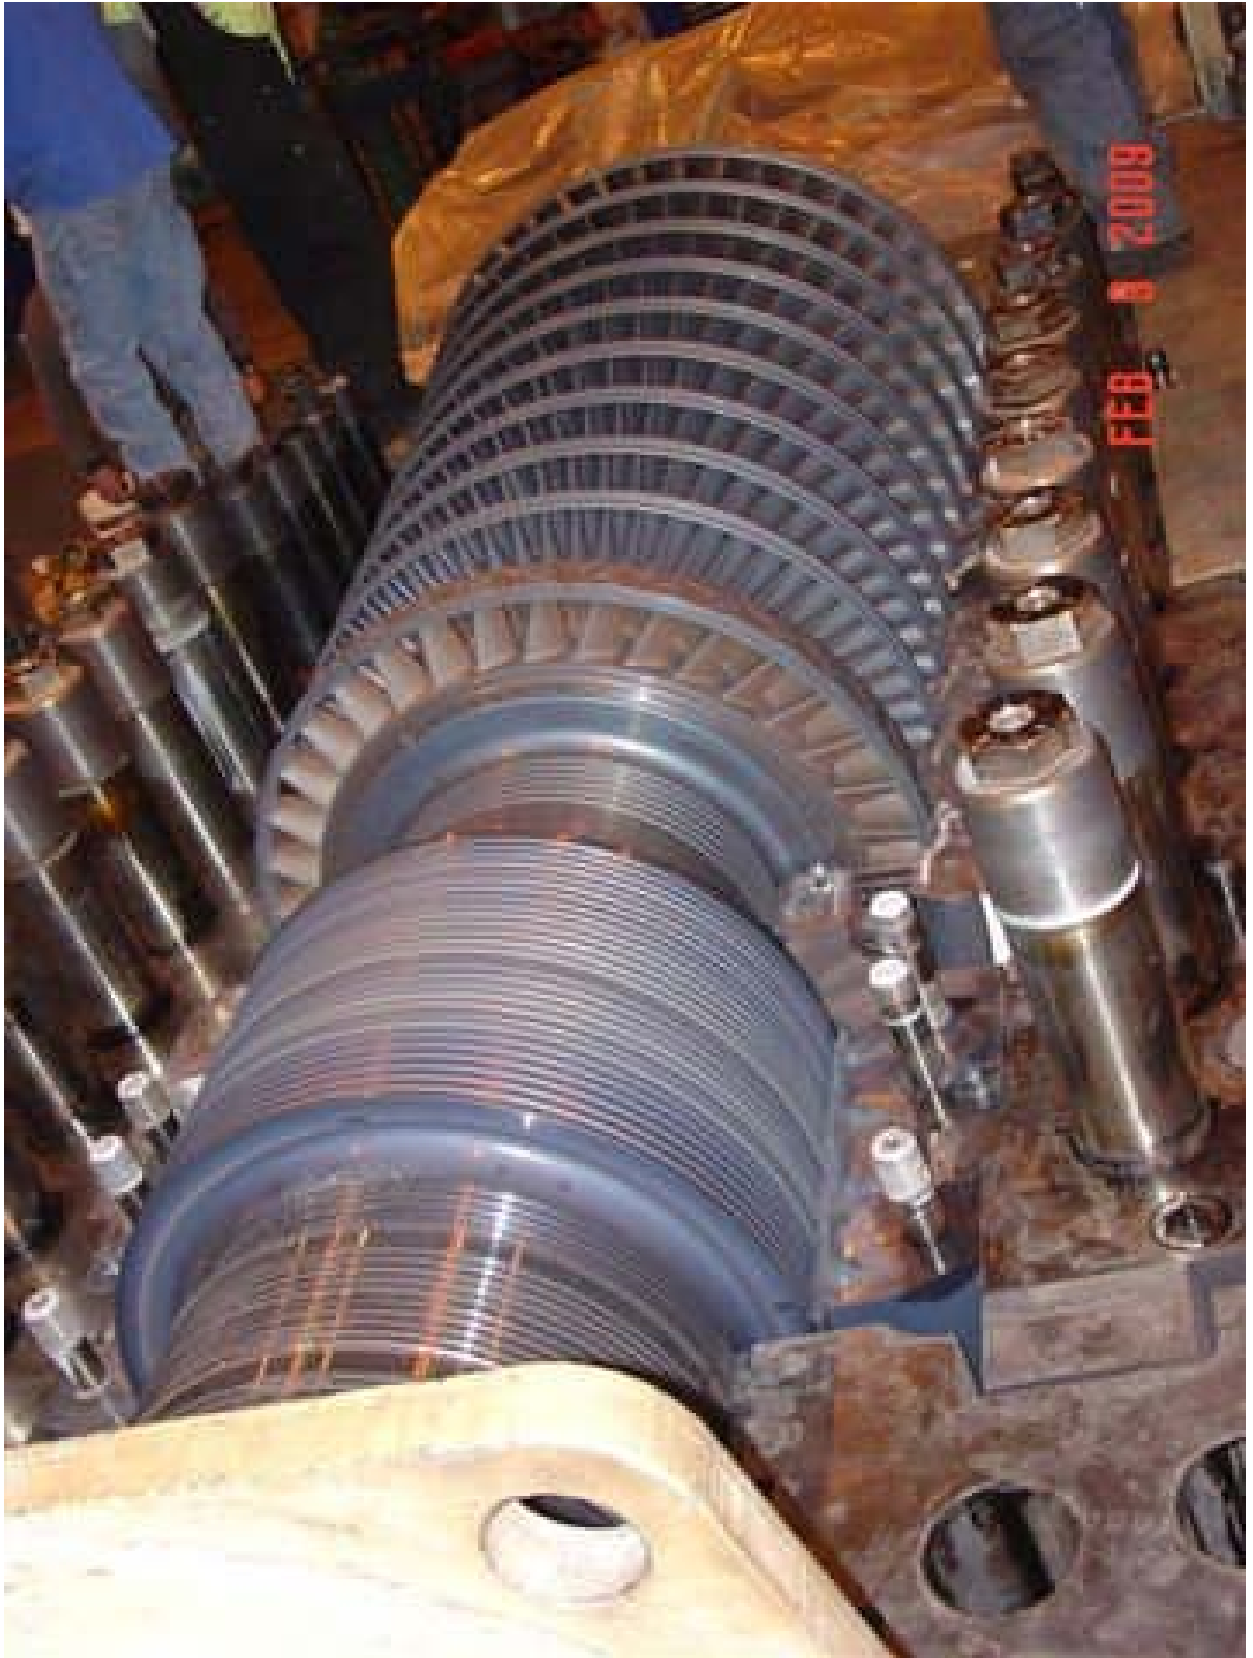
HP Rotor with UH Diaphragms Removed

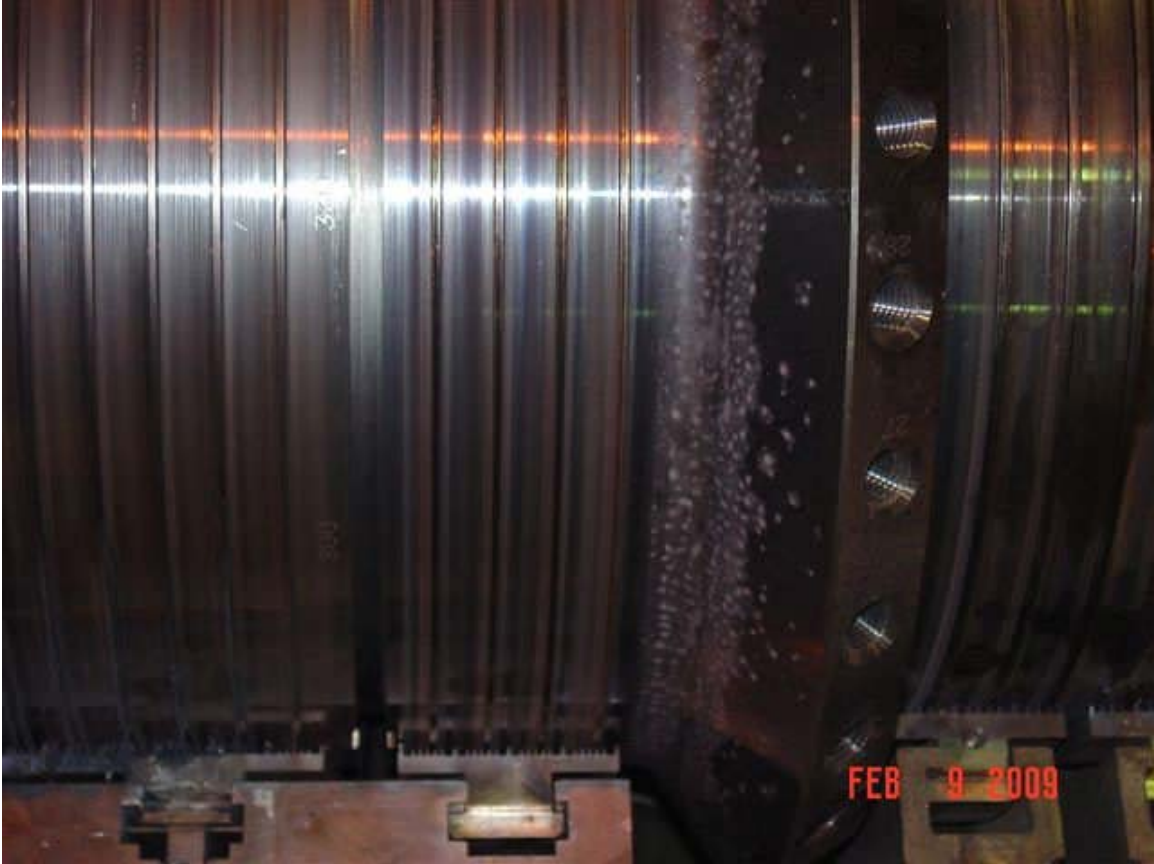
HP N1 Packing Casing Wear
