**SIEMENS' REPORT**  
**MARCH 24, 2006**  
**AmerenUE**

## AmerenUE Taum Sauk Incident Instrumentation and Controls Root Cause Investigation Report

March 24, 2006

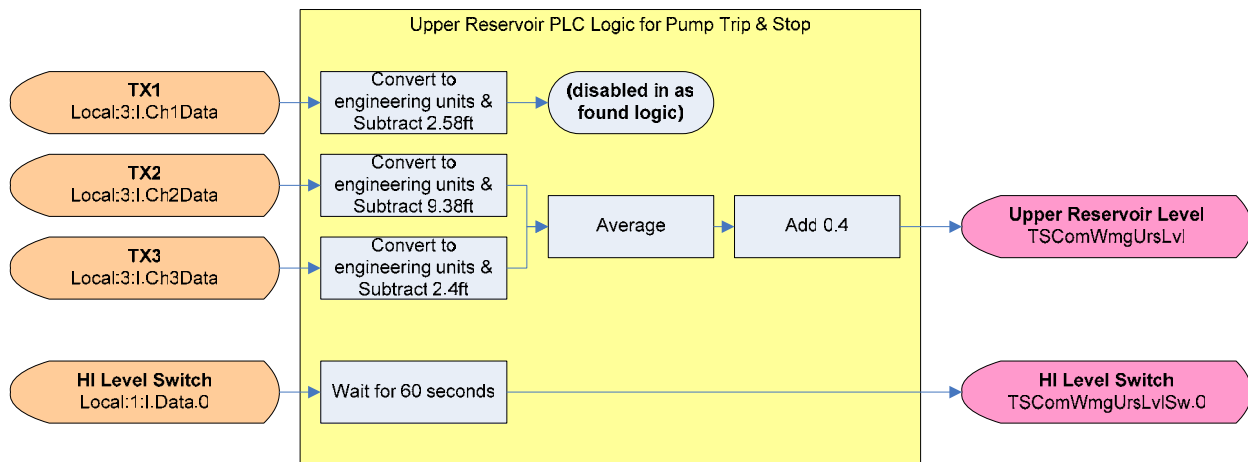
Figure 6: Upper Reservoir PLC Logic Diagram

The upper reservoir PLC is to read the three level transmitter signals through channel 1, 2 and 3 of the analog input card in slot 3. In the as found logic, the level transmitter signals are converted from 0.10000 integer range into actual engineering units. After this conversion, constants are subtracted. These constants were determined during the initial installation of the system in November 2004. The as found logic forms the average value of the two transmitters TX2 and TX3 and adds a constant of 0.4 to the average value. Transmitter TX1 is not used. The PLC also reads the HI level switch through channel 0 of the digital input card in slot 1. If the value becomes a 1 (e.g. the contact is closed), the PLC is to wait for 60 seconds before it makes this value available to other PLCs.

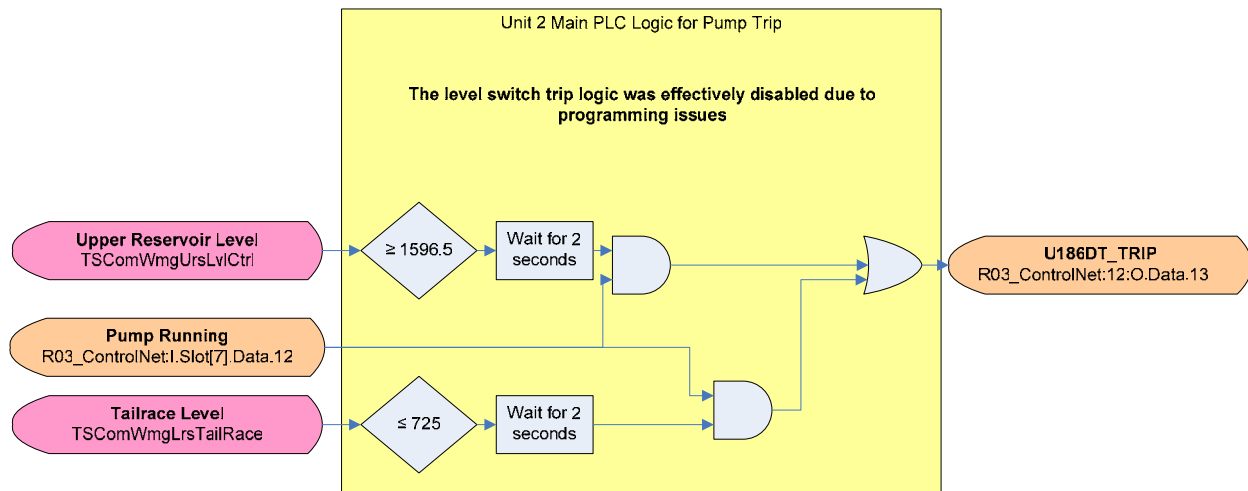
Figure 11: Unit 2 Main PLC Logic for Pump Trip

The trip logic implemented in the unit 2 PLC considers only the tailrace level and the upper reservoir level. The signals for the HI and HI-HI probes are not transmitted into the PLC. The logic for receiving the probe signal addresses the level transmitters; this appears to be in error. A review of the unit 2 main PLC program indicated a possible spelling error which led to this situation.

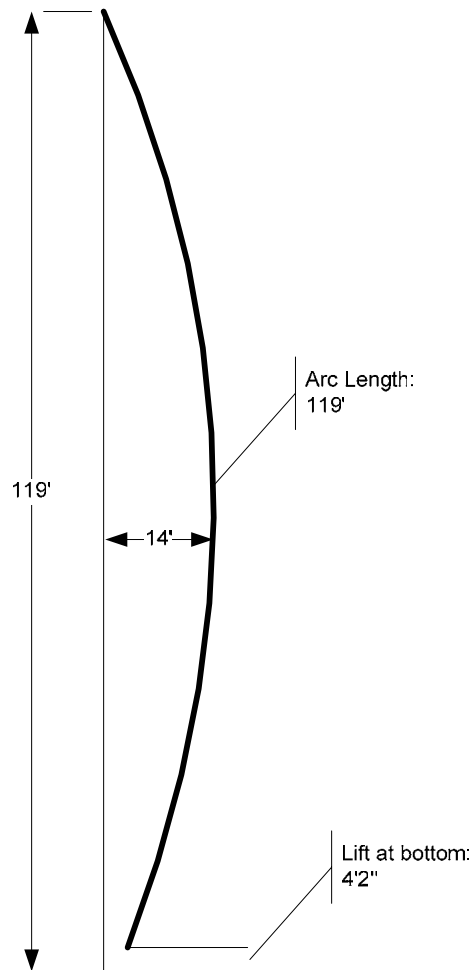
**Figure 14: Instrument Pipe Bow Sketch**

transmitter above its original elevation of 1500 feet and made it read a lower than actual level. Pipes in the photo marked as 16-Dec-05 were substantially straighter than those in the photos marked 15-Dec-05 and as observed by Siemens on 12-Jan-06, the pipes appeared to be further straightened. As reported to Siemens by Ameren engineers, these pipes straightened on their own. Ameren provided Siemens what they represented to be a rough calculation based on the 15-Dec-05 pipe position showing a rise in transmitter elevation of at least 2.54 feet at the time of the event (see sketch below). This rise would result in an analog reading of at least 2.54 feet low. Based on the straightening observations and the fact that the pipes were buoyant it is reasonable to assume that the pipes were even more curved at the time of the event causing an even larger corresponding error. Ameren engineers performed further analysis which considered the number of failed clamp/unistrut assemblies. Based on this analysis, the maximum lift could have been significantly higher. However based on the historical data analysis, a lift of more than 4 feet seems to be unlikely (see chapter 5.2.3).

The analog transmitter calibration was checked during the initial filling of the upper reservoir and an adjustment factors were put into the PLC code to compensate for the error in elevation placement or signal output of the transmitters. Another adjustment factor of 0.4 ft was added to the PLC's level calculation to recalibrate the transmitters on 9/27/05. This 0.4 feet may take into account some of this bend since just 1 week later on 10/03/05 the breakage of supports and bowing of the pipes was reported by Ameren to have been noticed.

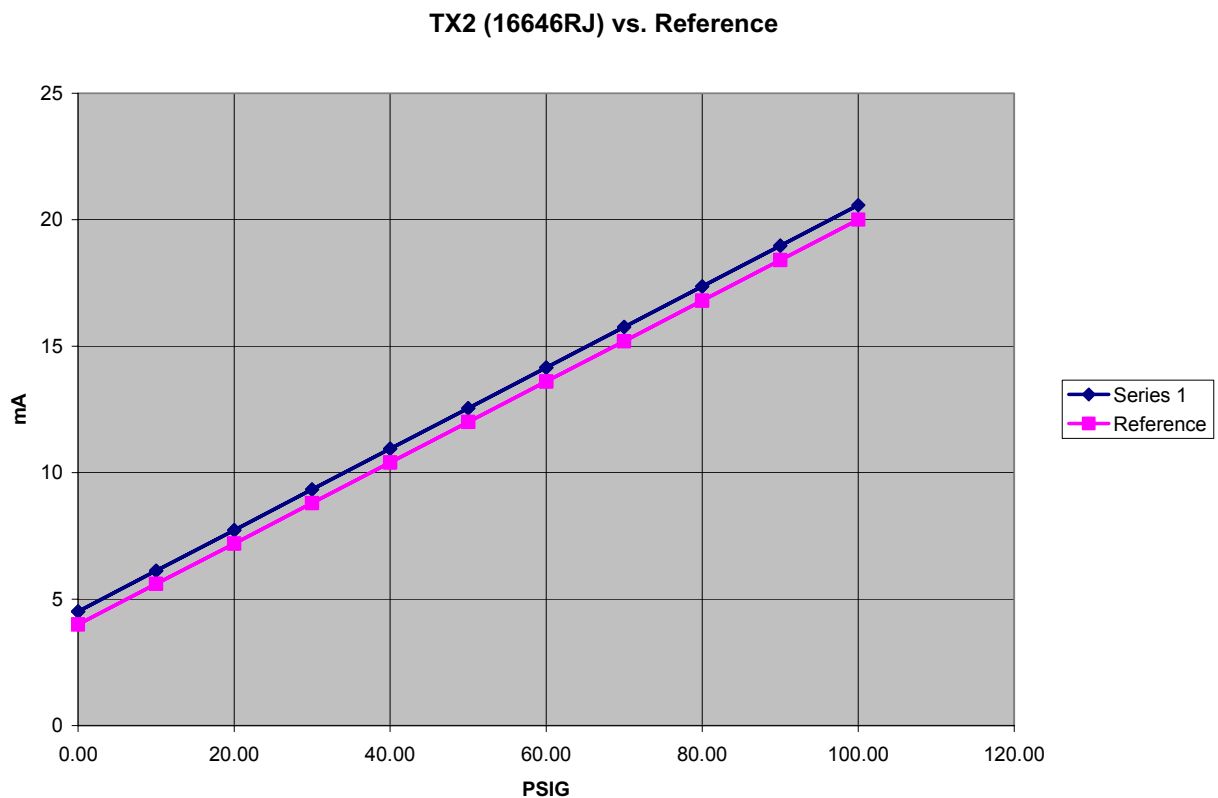
**Figure 17: TX2 (16646RJ) vs. Reference**

TX2 relates to the reference transmitter with a correlation coefficient of 0.99999994. This means that it is very linear. The average difference between TX2 and the reference transmitter is 0.545338 mA which equates to approx. 7.86 feet of water level at 5 degree Celsius.

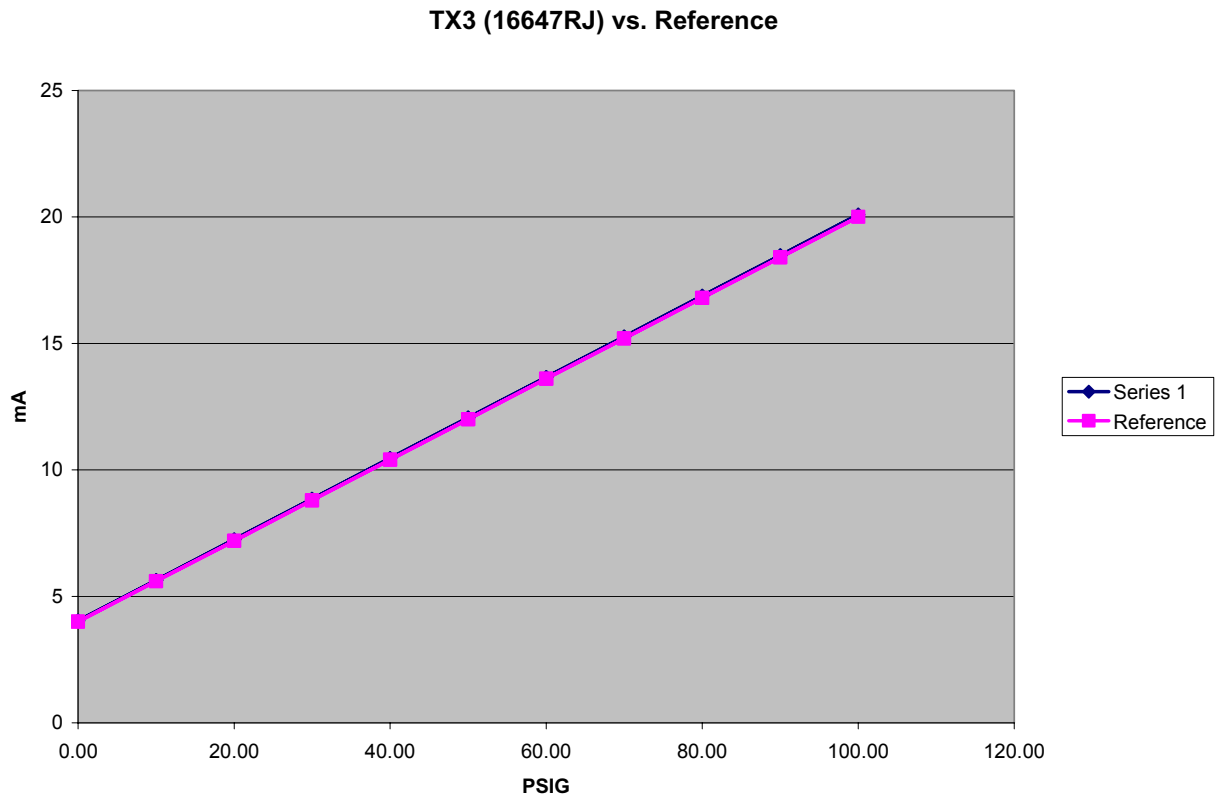
**Figure 18: TX3 (16647RJ) vs. Reference**

TX3 relates to the reference transmitter with a correlation coefficient of 0.99999996. This means that it is very linear as well. The average difference between TX3 and the reference transmitter is 0.059567 mA which equates to approx. 0.85 feet of water level at 5 degree Celsius.

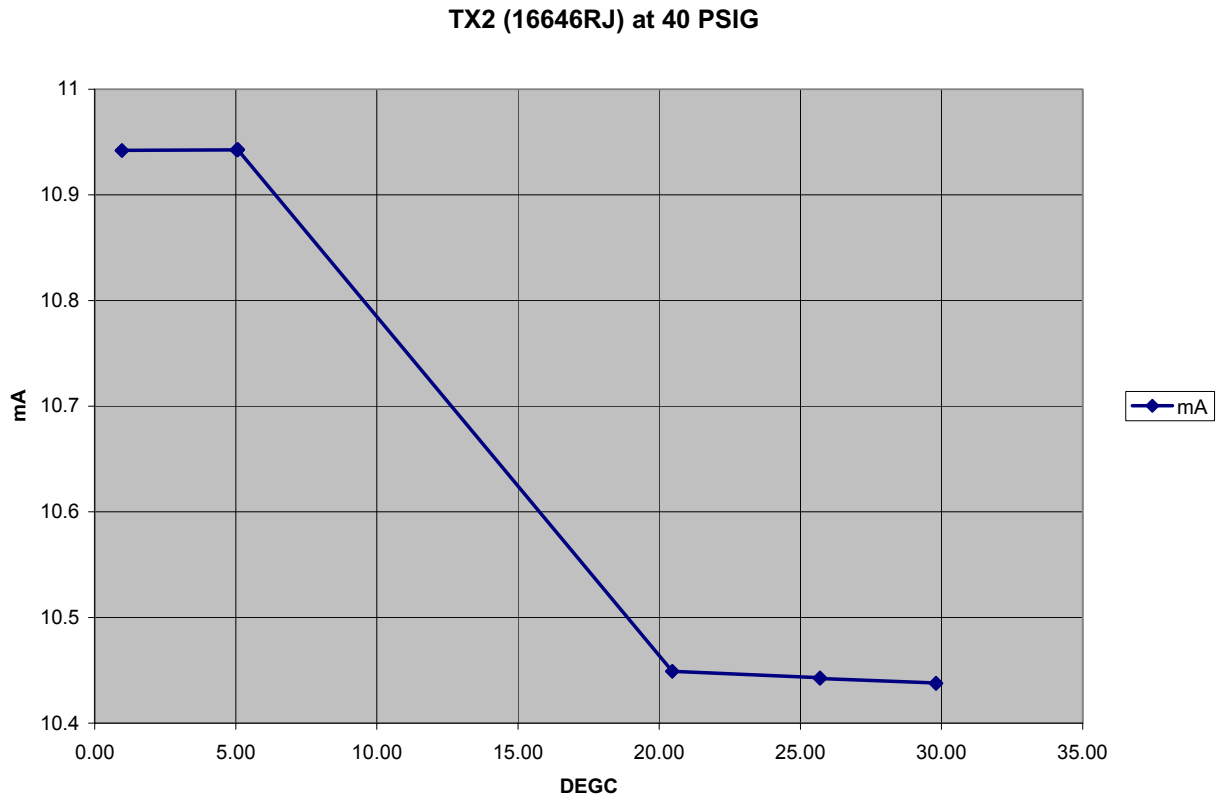
**Figure 19: Temperature Sensitivity of TX2**

One can see that there is a 0.5 mA step change between 5 degrees Celsius and 20 degrees Celsius. This 0.5 mA change equates to approx. 7.11 feet of water level (at 5 degrees Celsius).

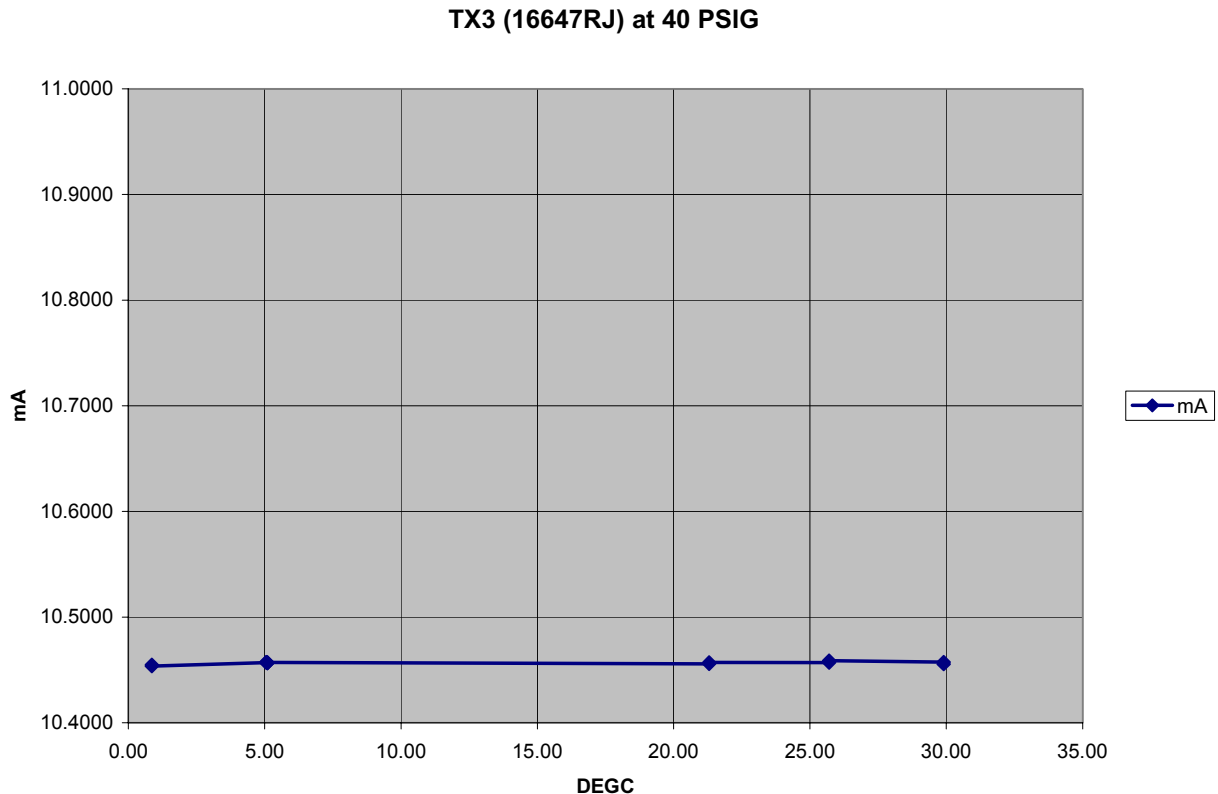
**Figure 20: Temperature Sensitivity of TX3**

TX3 is less sensitive to temperature changes.

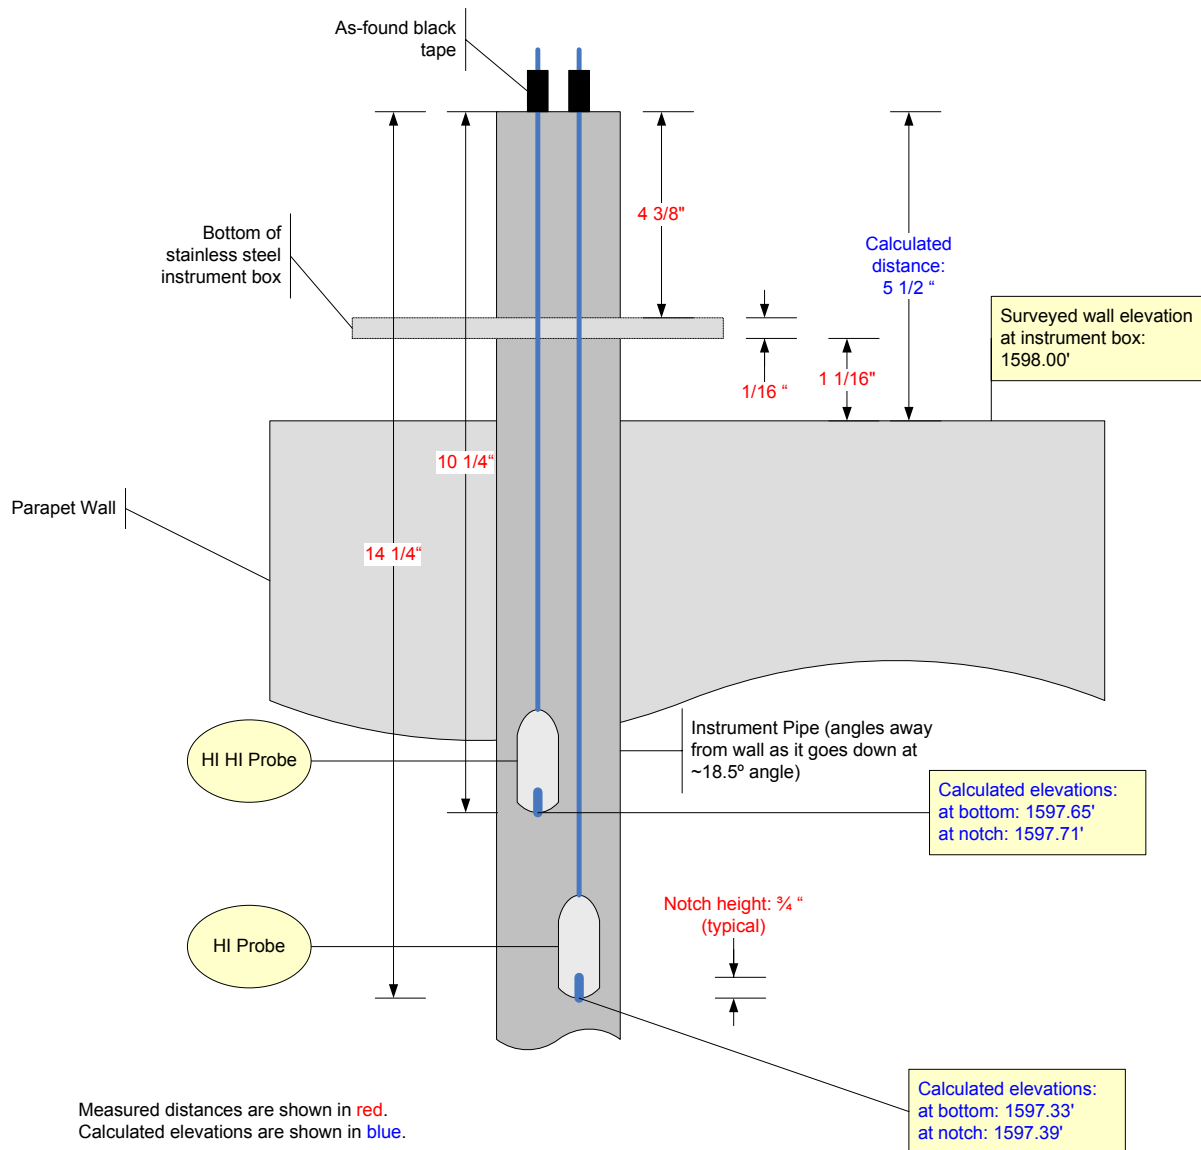
**Figure 21: Level Probe Elevation Calculation**

The elevation reported of the top of the parapet wall at the instrument box is 1598.0 feet, however the elevation of the lowest part of the wall was only 1597.0 feet (according to drawings provided by Ameren), 0.3 and 0.7 feet below where the Hi and Hi-Hi sensors were located respectively. If this is the case, water would have passed over the lower portions of the parapet wall before these probes would have sensed water. No reference markings showing wall elevation and low point wall elevation were found near the location where the sensors would be adjusted.

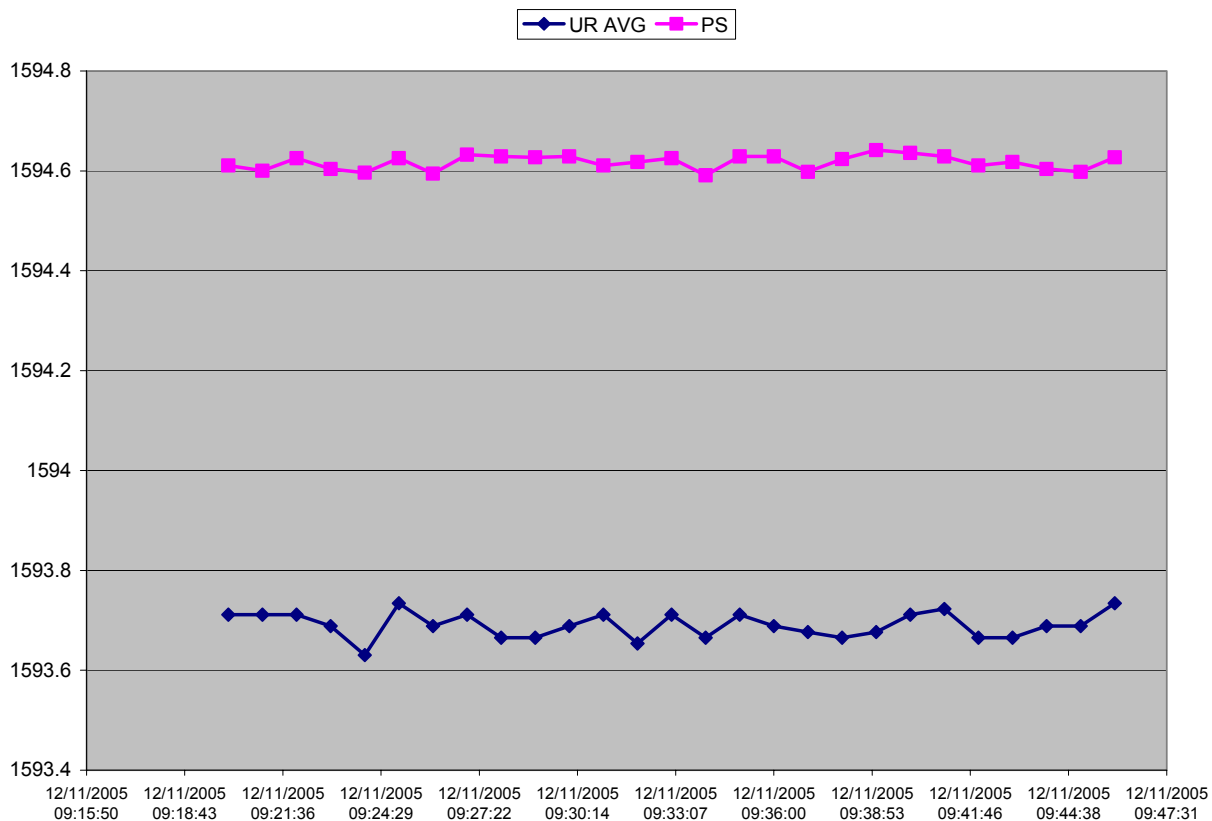
**Figure 26: UR Average Transmitter Readings vs. PS Transmitter Readings**

This chart indicates again that the levels measured by the UR average transmitters and the levels measured by the PS transmitters correlate and that the PS level transmitter shows less signal noise. Siemens concludes that the installation of the penstock transmitter filters out most wave action affects on level measurement.

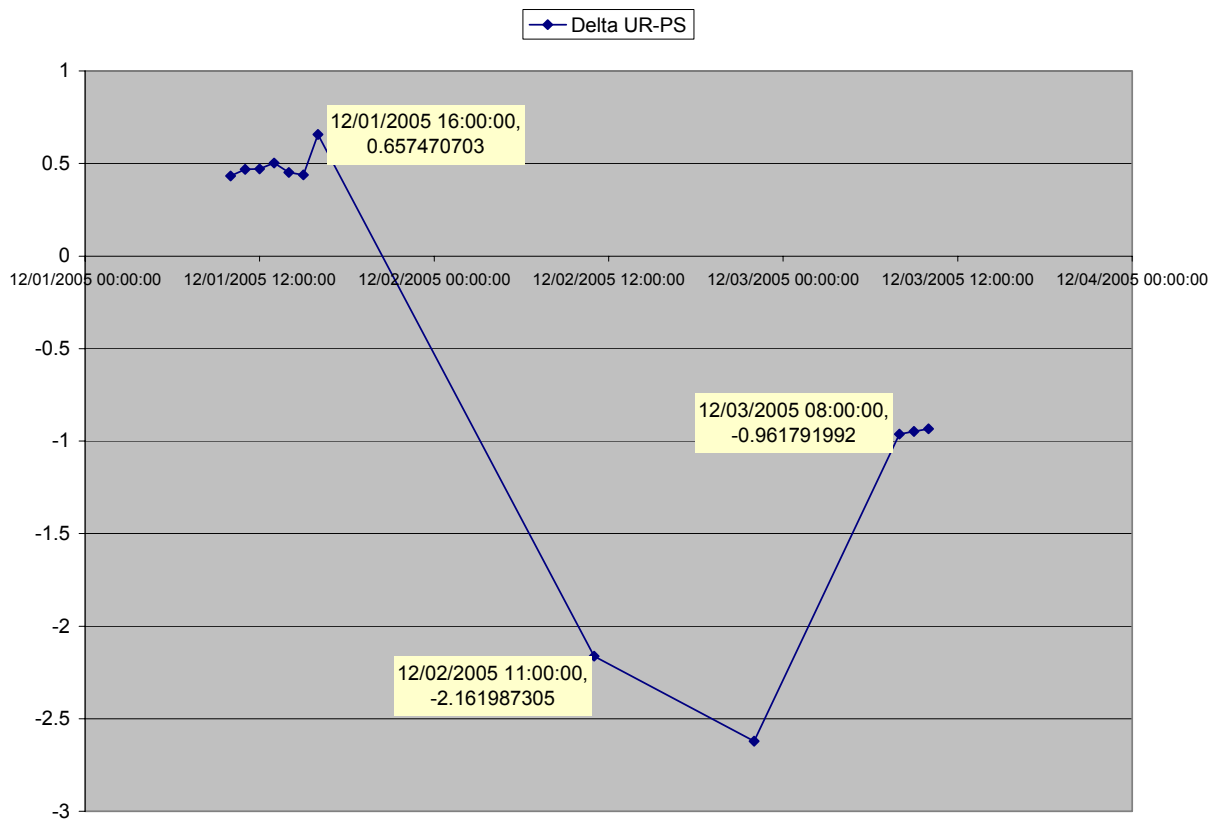
**Figure 29: Difference between UR Transmitter Average and PS Transmitter between 1-Dec-05 and 3-Dec-05**

Note the change in between 1-Dec-05 16:00, 2-Dec-05 11:00 and 3-Dec-05 08:00. This sudden change can not be explained by a change of environmental conditions. One assumption could be that the location of the UR level transmitters may have shifted during that time period.
