APPENDIX B

“PICKEL REPORT”

May 15, 1964

TAUM SAUK PROJECT
UPPER RESERVOIR
CORRECTIVE WORK - MARCH 14 TO APRIL 17, 1964

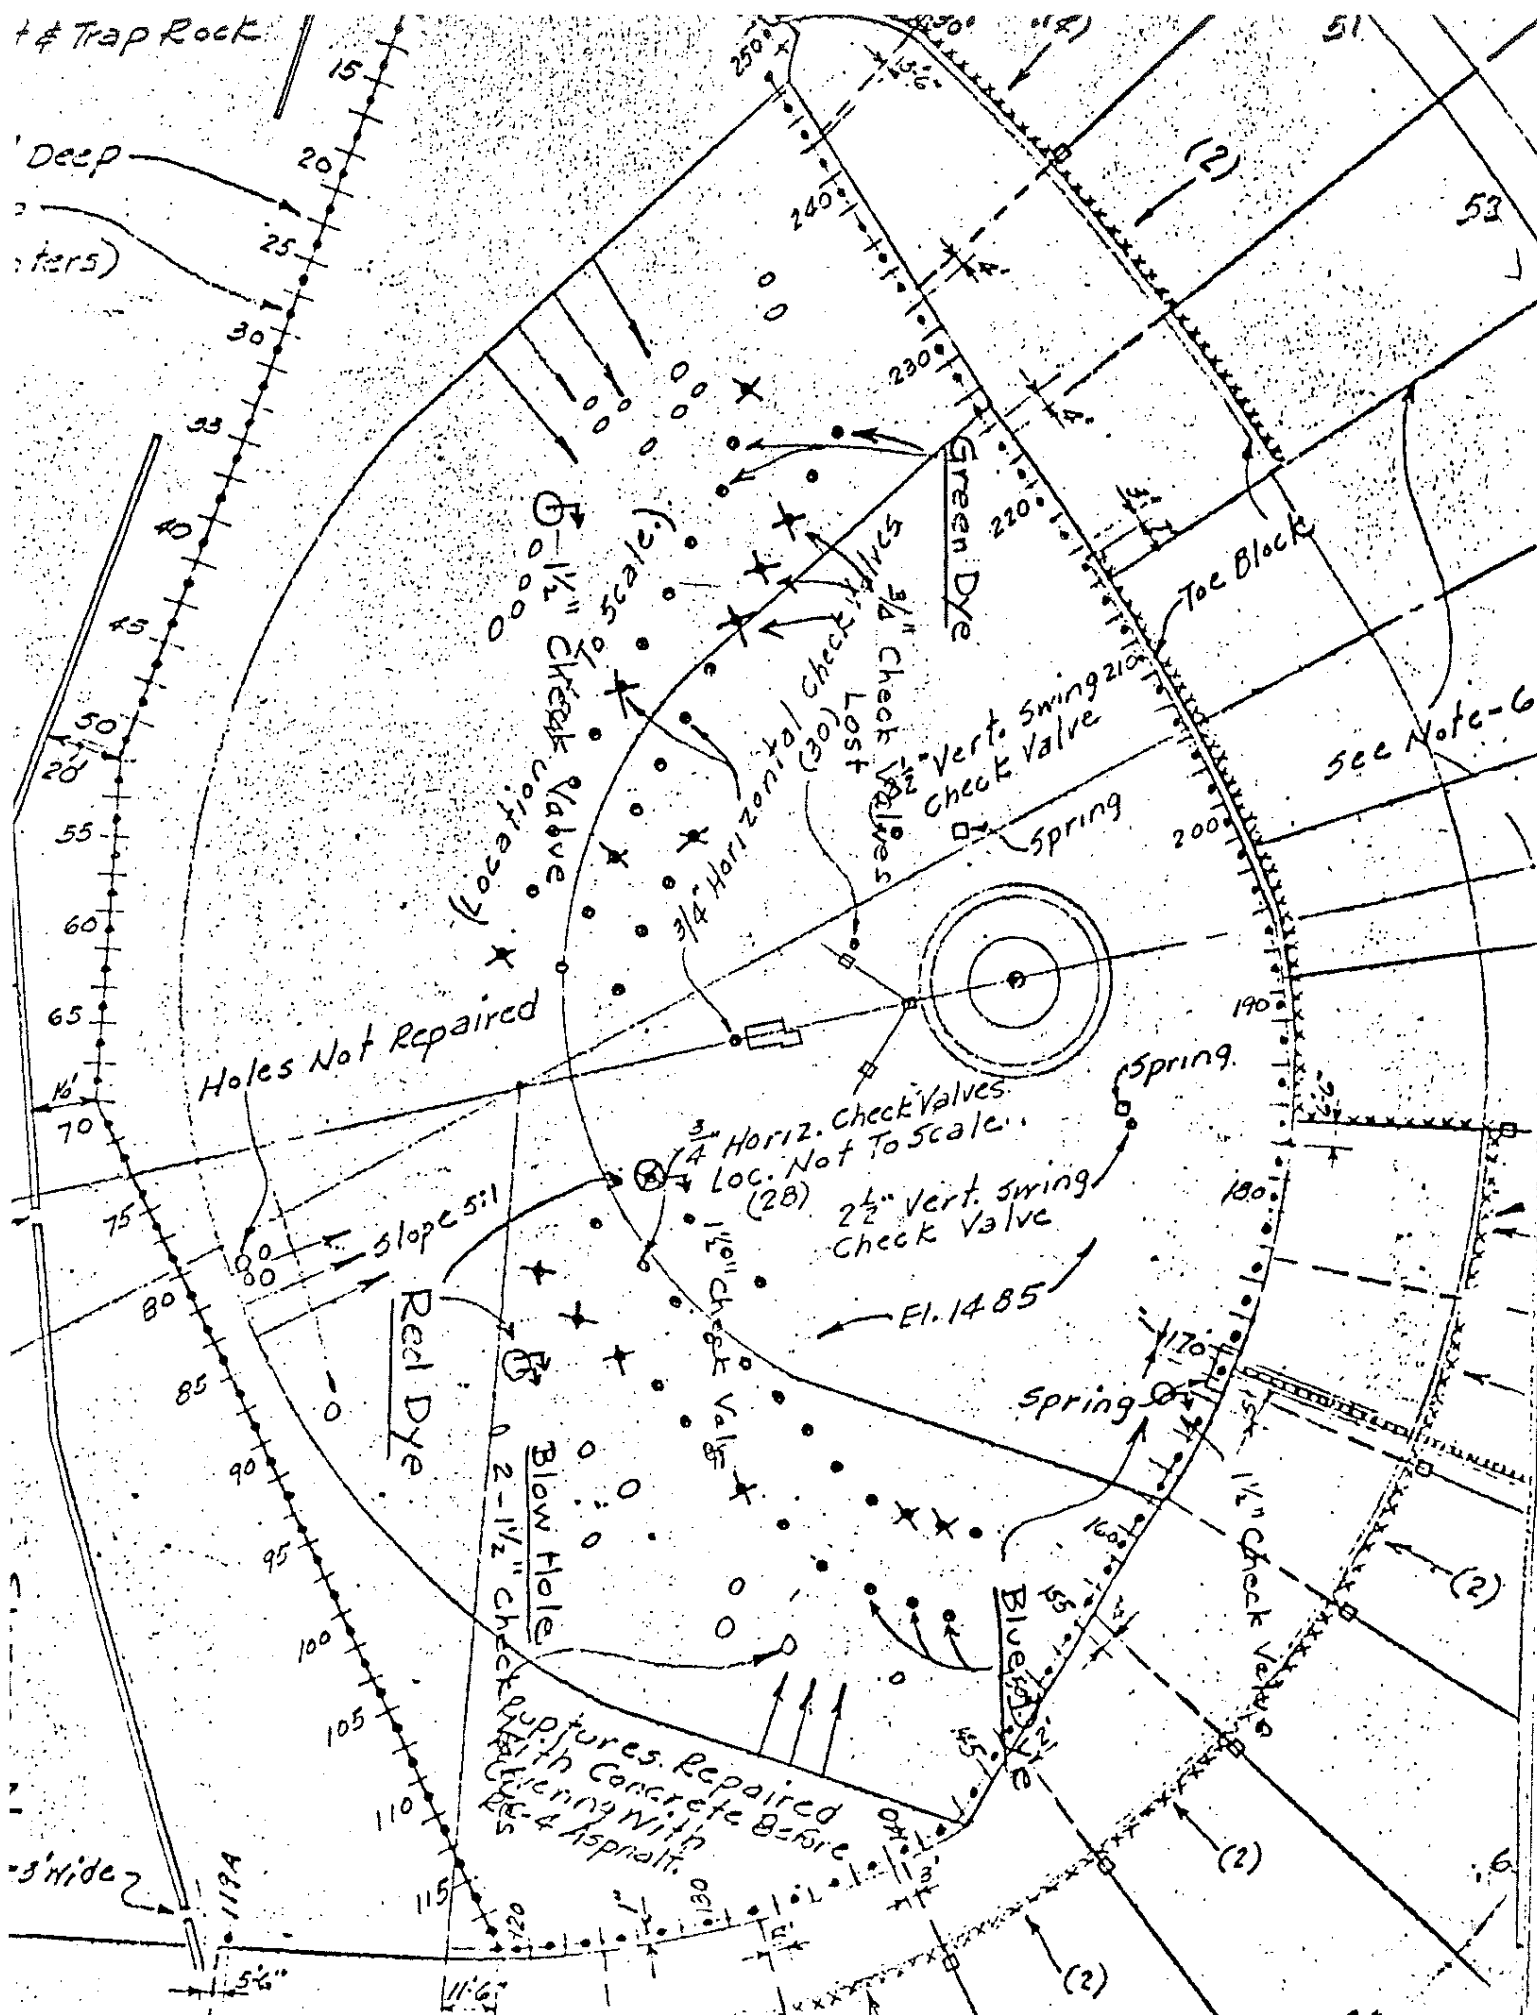
The blow-out at a previously repaired rupture was cleaned out and patched with concrete. Two 1-1/2" pipes with check valves were installed prior to placing the concrete.

A similar concrete patch in the floor near Panel 49 showed evidence of leakage and having raised up. This was completely removed and replaced with new concrete and a 1-1/2" check valve vent.

Construction equipment working in the area broke off or damaged 15 of the 3/4" check valves installed in November. The nipples were removed and the holes filled with grout.

Two holes showed running water all during this outage. In order to grout these holes it was necessary to install relief pipes, which were then closed with 1-1/2" check valves.

Green, red, and blue dye was inserted in several vent pipes for the purpose of tracing and identifying future leakage. Location of dye and other features described above is shown by Sketch No. 1.

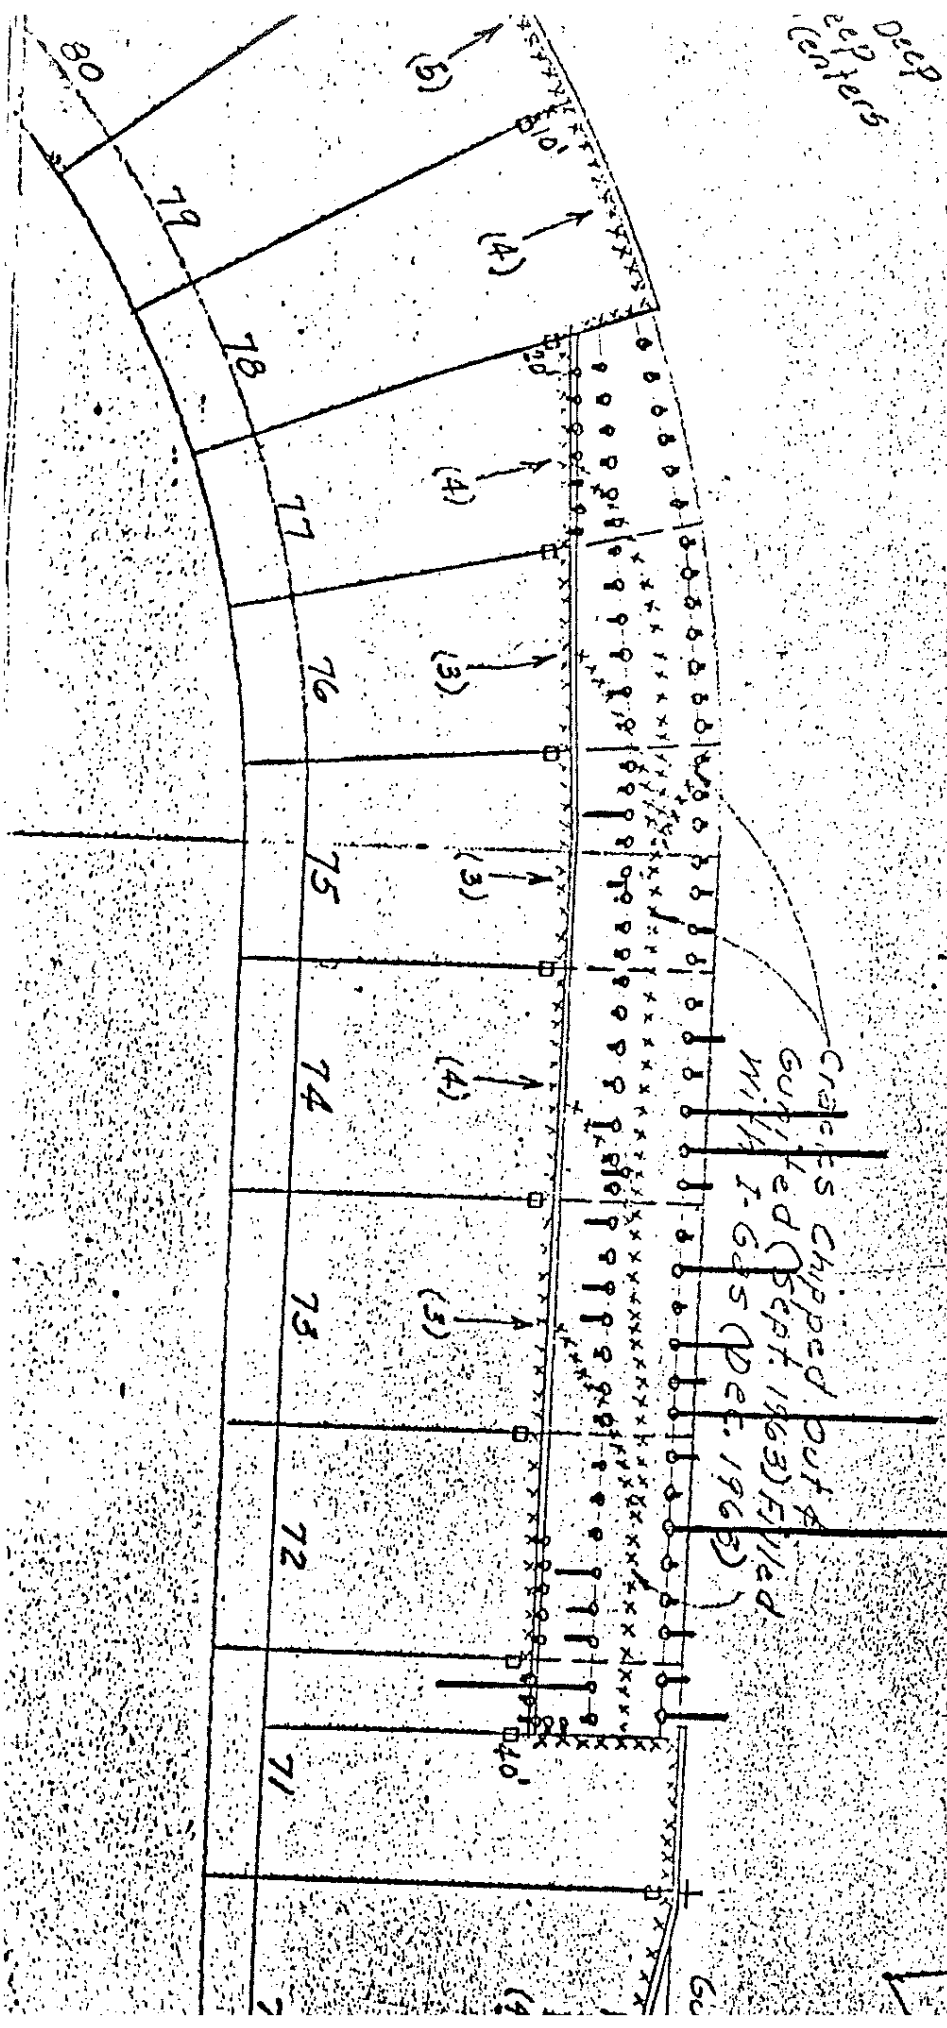
Panels 72 to 77 As the major horizontal crack in the face apron in this area was being cleaned out and old patching material removed, some voids and hollow spots were visible below the gunall face. It was then decided to consolidate the rock by pressure grouting, with a line of grout holes below the crack and another line above it.

Two and one-half inch drill holes ten feet deep were drilled on ten foot centers. All holes were diagonal or sloping. The bottom row of holes encountered some discontinuity as compared to solid hard rock at various depths to about eight feet, after which the rock was hard. The upper row was generally more sound. A number of vertical holes were drilled at the top of the berm, but since these had to be hand drilled, and the rock was hard, this row was not completed.

A total of 100 holes were drilled in this area and required 1,108 cubic feet of cement grout to fill. Grout requirement varied from a minimum of one to a maximum of 155 cubic feet per hole. In most cases the holes held a pressure of 50 to 60 psi after filling, although in one case the gunall face was cracked with a pressure of 30 psi.

Location of holes and distribution of grout is shown by Sketch No. 2.

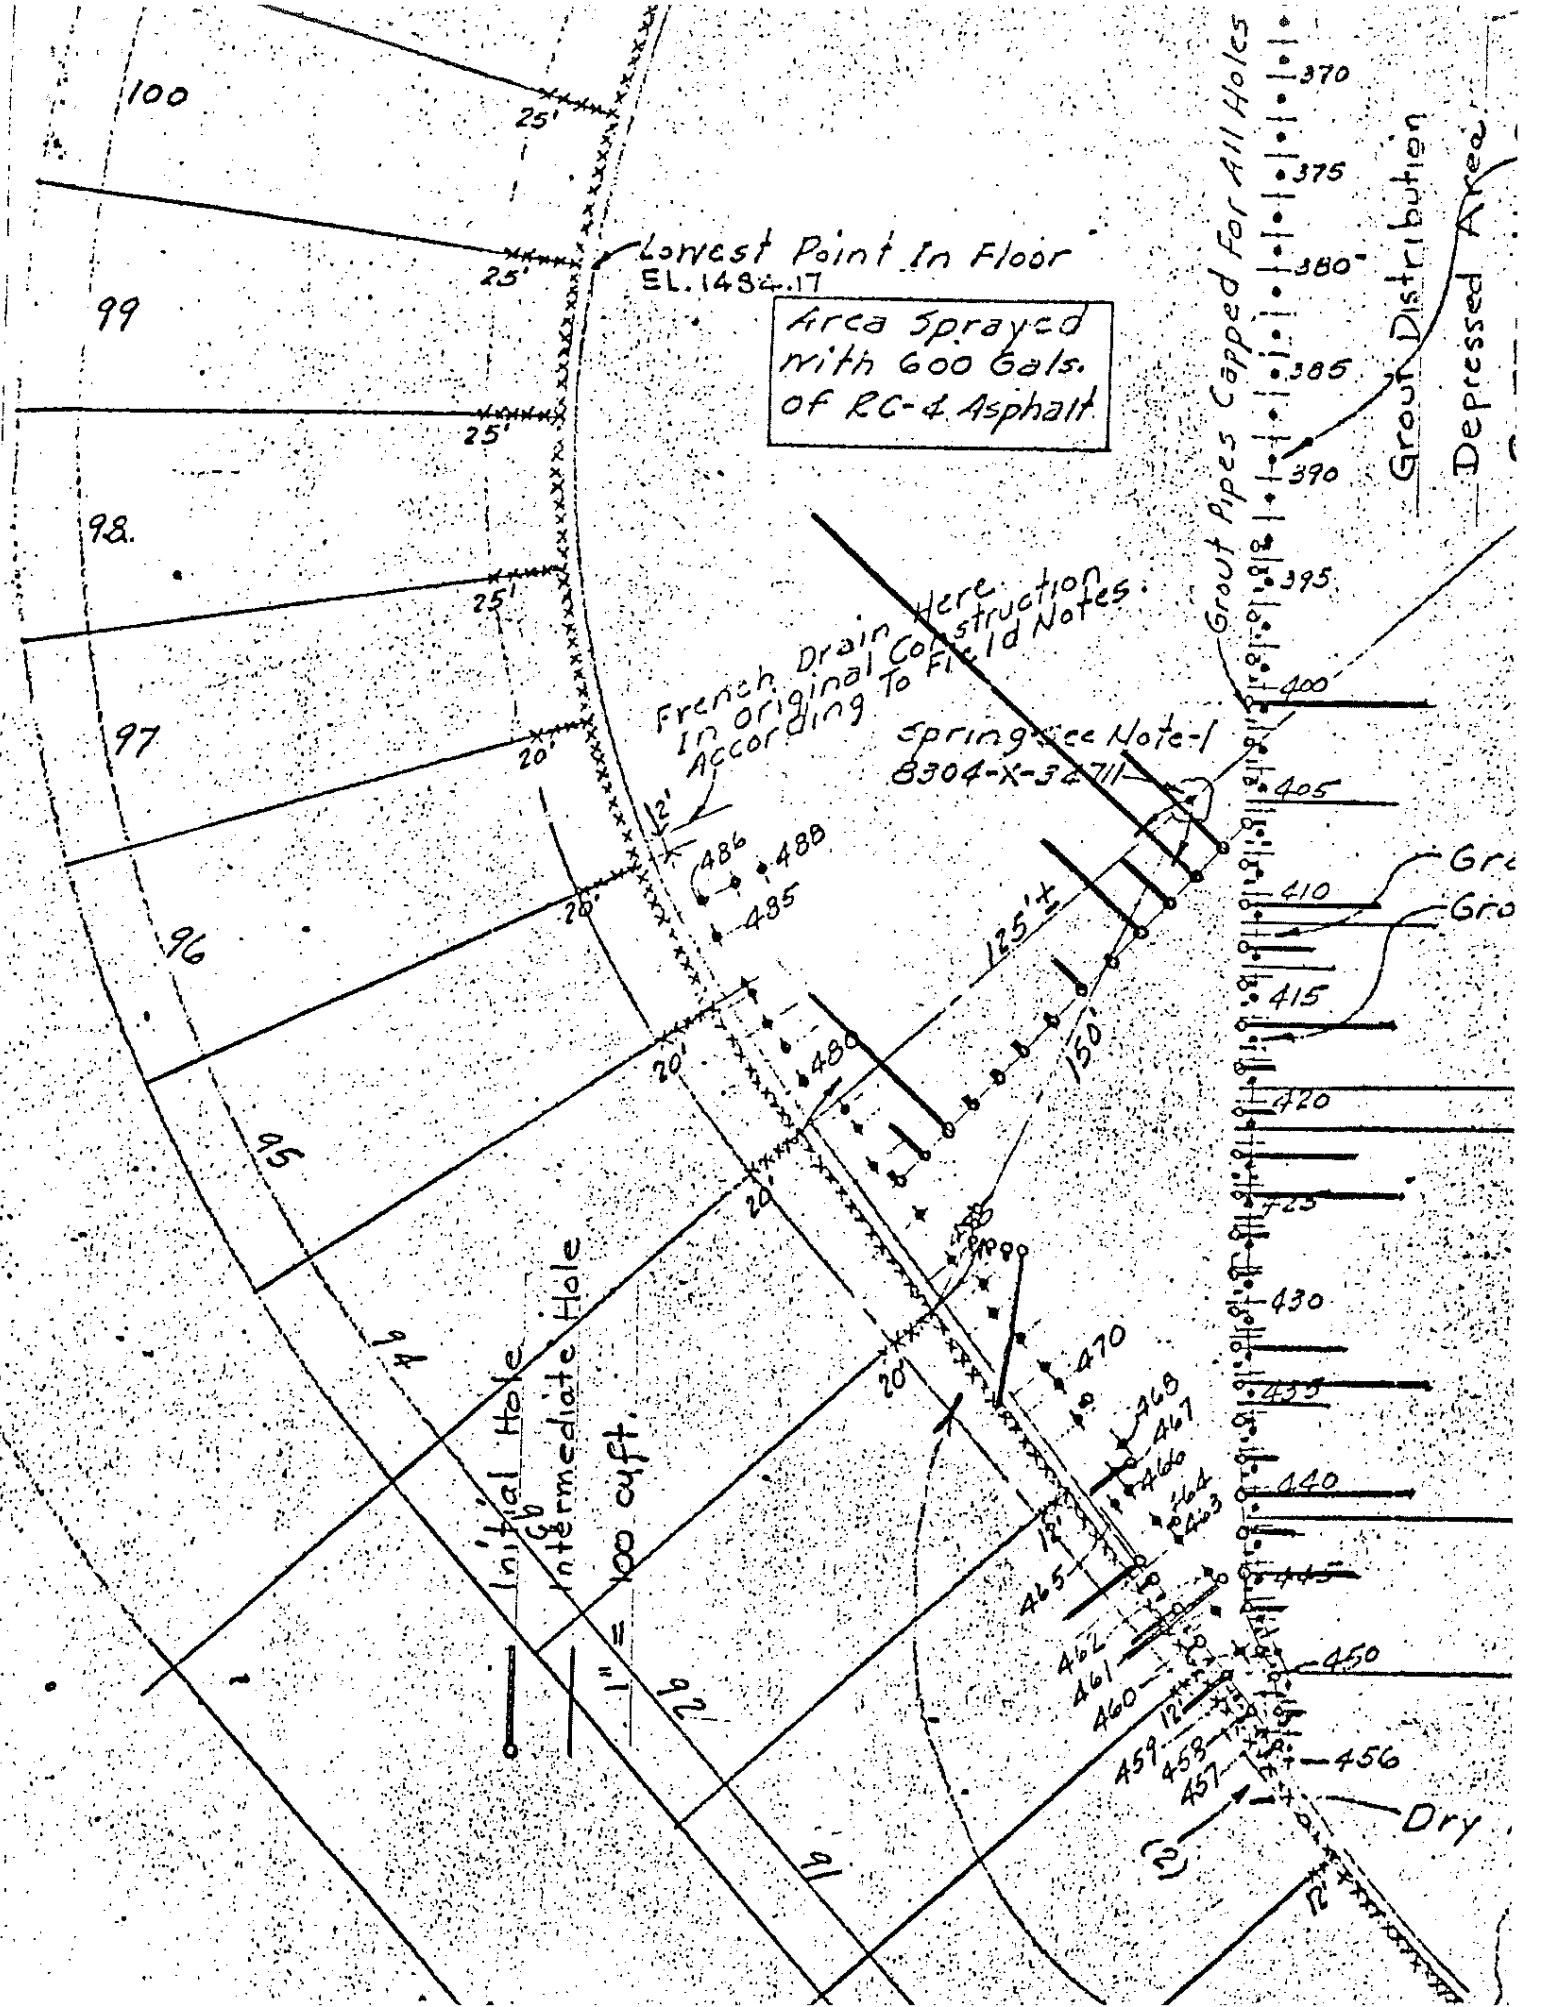
Depressed Area Additional grout holes were drilled in the depressed area in front of Panels 90 to 95. These were on a line parallel to and about four feet from the original grout curtain placed in November, and were spotted between the original holes. Additional holes along the toe block and across the depression were also drilled, as shown on Sketch No. 3.

Holes were drilled 10 and 20 feet deep. Generally the drill encountered several feet of clay and soft or broken rock, with hard rock consistently below seven feet.

A total of 97 holes were drilled, and required 2,739 cubic feet of grout. In some cases the grout pressure held at 40 to 60 psi, but as a general rule grouting had to be stopped when the asphalt floor started to raise. In several cases grout appeared in adjacent holes. Maximum take for one hole was 278 cubic feet.

See attached Sketch No. 3 for grout distribution.

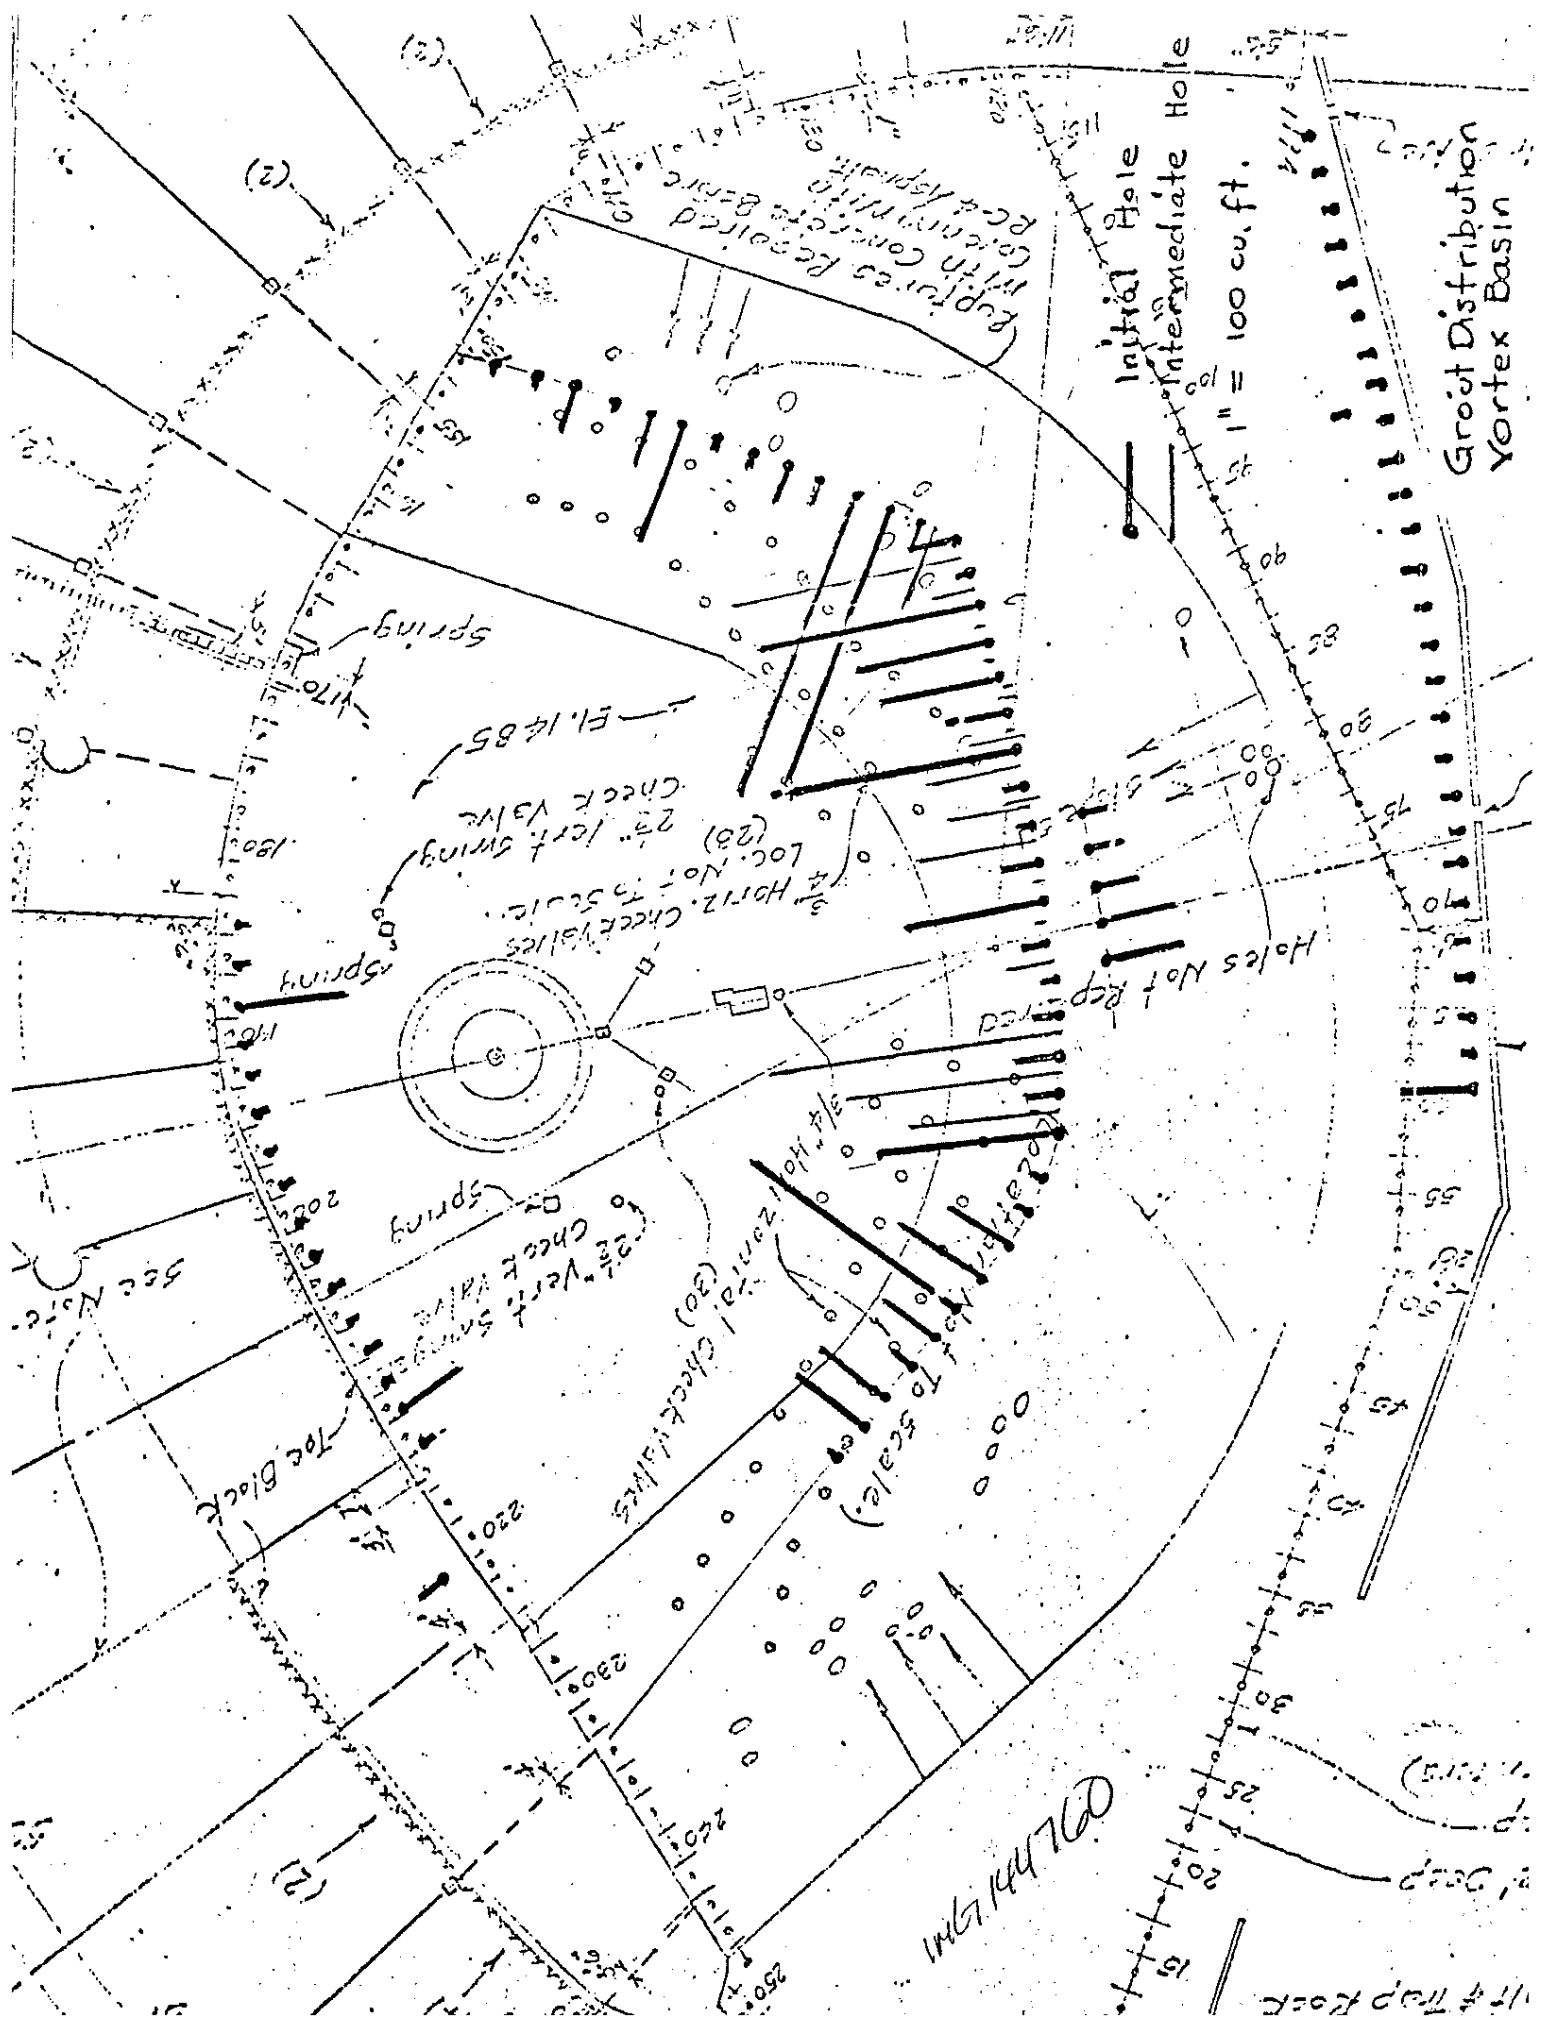
Vortex Basin In this area, grout holes were drilled in three separate locations.

Along the rain dike a row of ten foot holes on ten foot centers was drilled, and also several random holes where air had been sucked in during emptying of the reservoir. Rock in this area is shattered for several feet, with some voids, then generally hard. After the initial holes had been grouted, six additional holes were drilled near one which had taken 37 cubic feet. These were drilled diagonally to a depth of 30 feet. When grouted, the average requirement was five cubic feet. The total requirement was 185 cubic feet for 29 holes.

At the toe in front of Panels 53 to 56, sixteen holes 20 feet deep were drilled between old grout holes. As in the previous grouting program, considerable trouble with water was encountered. The total requirement for these holes was 169 cubic feet.

Along the slope between the shaft and the rain dike, a series of ten foot holes on 10 foot centers was drilled. After grouting, intermediate holes 20 feet and 30 feet deep were drilled. The drilling process was very difficult because of broken rock up to six feet below the surface. Below six feet the rock was generally sound and hard, but many cavities were encountered. Three of the ten foot holes were redrilled to a depth of 20 feet after initial grouting. Although one of these holes had taken 123 cubic feet initially, none took more than four cubic feet when redrilled. A total of 77 holes required 2,828 cubic feet of grout.

Location of grout holes and distribution of grout in the vortex area is shown by Sketch No. 4.
