GOUHOU DAM PAPER

BREACHING OF THE GOUHOU CONCRETE FACE SAND AND GRAVEL DAM

ZUYU CHEN

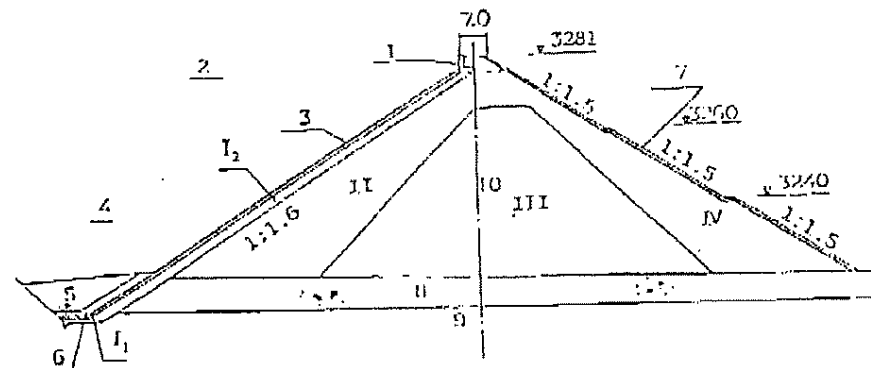
Fig. 1 Cross section of the dam

1. Crest wall; 2. Normal water level; 3. Face slab; 4. Dead water level; 5. Random fill; 6. Clay.
7. Dry packed rock; 8. Alluvium; 9. Bed rock; 10. Dam axis

The dam was divided into four zones as shown in Fig. 1. Main features of the four parts are indicated in Table 1 from which one may find that no serious restrictions to the gradings of different zones were given. Since large pebbles were rare, the dam was essentially a uniform sand and gravel one (Hong, 1990).

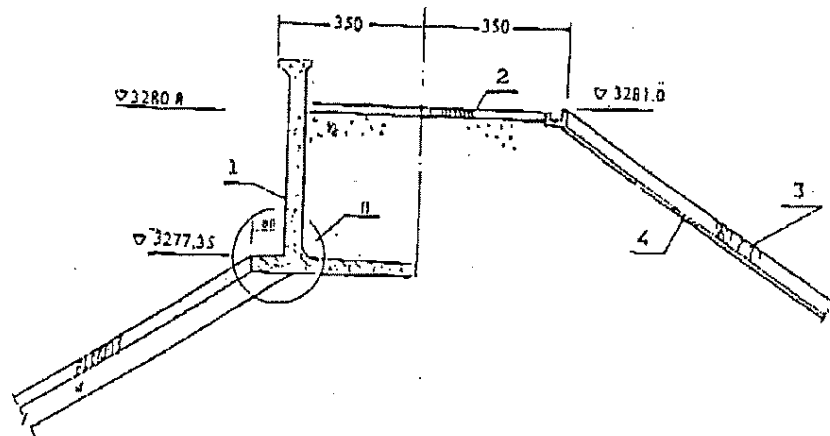
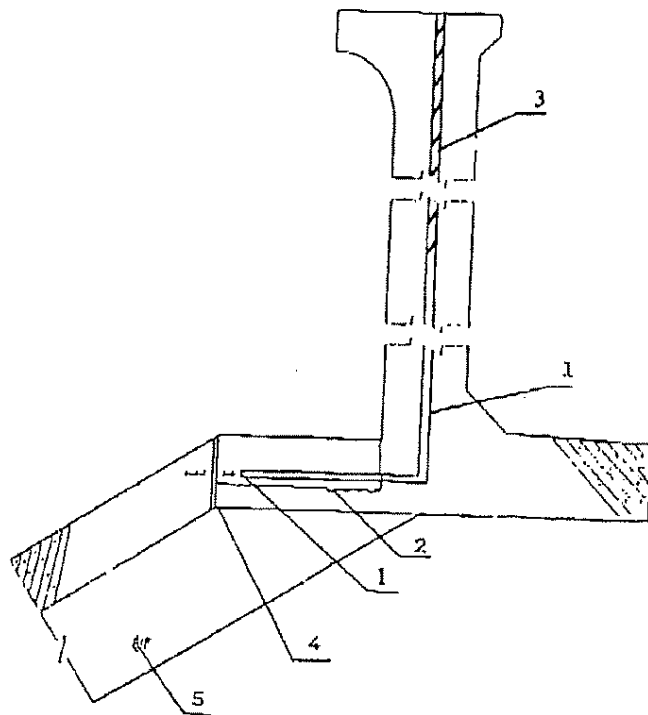
Fig. 2 The crest wall

1. Reinforced concrete; 2. Pavement; 3. Masonry; 4. Transition.

1. Rubber water stop; 2. Top of the intact concrete; 3. Timber soaked by oil; 4. Timber Fill; 5. Transition.

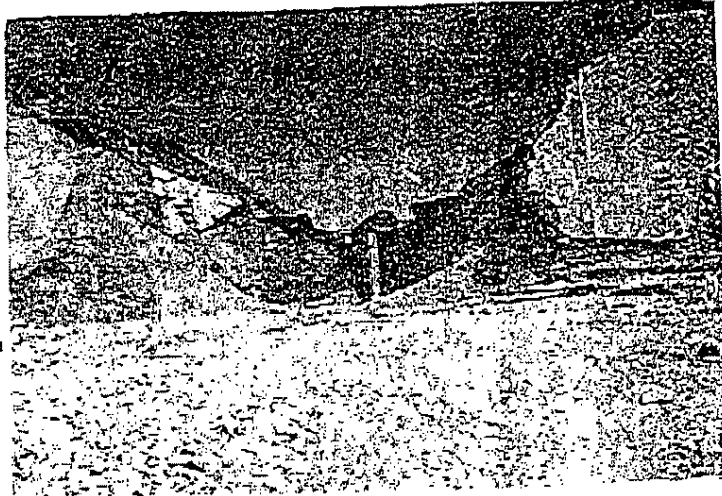
图 3. 失事后的大坝全景
Fig. 3. The breached dam

The breaching of the dam created a triangle weir on the concrete face slab, which is 137 meter wide at the dam crest. The elevation of the lower point was 3250m. Part of the slot went along the horizontal joint of the face slab. The flood cut through the dam body and created a 61m wide chute with almost vertical side walls. Total amount of water released was estimated to be 2.61 million m³. The remaining part of the dam body lower than 3250m kept retaining water which overtopped the crest and created a water fall as shown in Fig. 3.

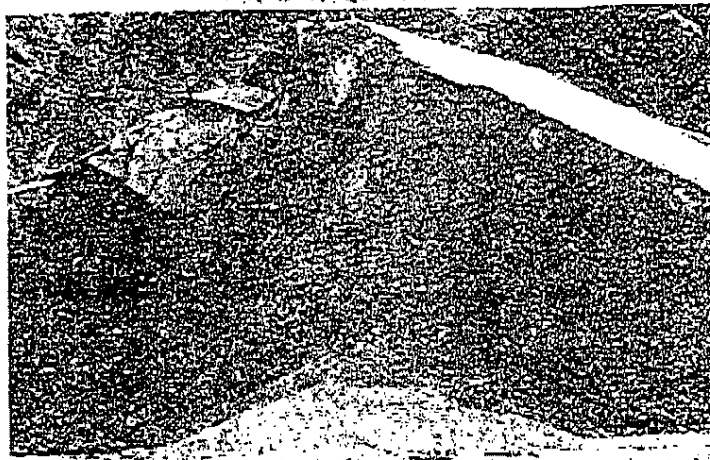
图 4. 大坝缺口左侧
面上滴水形成的冲沟
Fig. 4 The gullies cut
by the flowing water

- A number of concentrated flow which appeared on the side walls, creating more than ten gullies on both sides. The water flow lasted for at least two days (Fig. 4).
- Two concentrated flows identified on the downstream slope masonry of the remaining right part of the dam at elevation 2765m.
- Three typical piping holes seen on the left vertical wall, at the elevation 3226m.

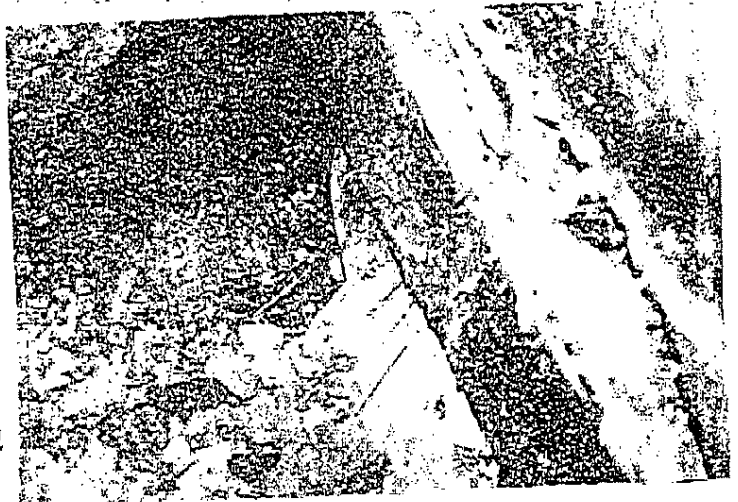
图 5. 防浪墙底板碎裂情况
Fig. 5 The horizontal
slab of the crest wall

It was surprising to find that all the remaining horizontal slabs of the crest wall were highly fractured. The investigators were told that not long after the placement of the concrete, cracks developed on the slabs. They were then corrected by pasting cement mortar which again cracked. As a result of the concrete crumbling on top of the horizontal slabs, the existing intact slabs were invariably lower than the rubber water stop (Fig. 2). There is no doubt that water would come into the dam through the unsealed gaps between the face slab and crest wall as soon as it exceeds the horizontal slab. The investigators did find a number of holes and dug out some weed powder, indicating the path of seeping water (Fig. 5). As discussed above, the water level had been close or higher than the horizontal slab for about 24 hours before the failure.

(4) This dam has an important feature that the normal water level is above the horizontal slab of the crest wall. The reason of the cracking of the crest wall slab is still a question of much needed study. However, correcting the cracking by cement mortar is by all means wrong. As an important part of the dam structure, the crest wall is subjected to very complicated working conditions including settling of the foundation, rotating due to earth pressure, etc. Details of the crest wall must be carefully studied to assure safe performance of the wall.

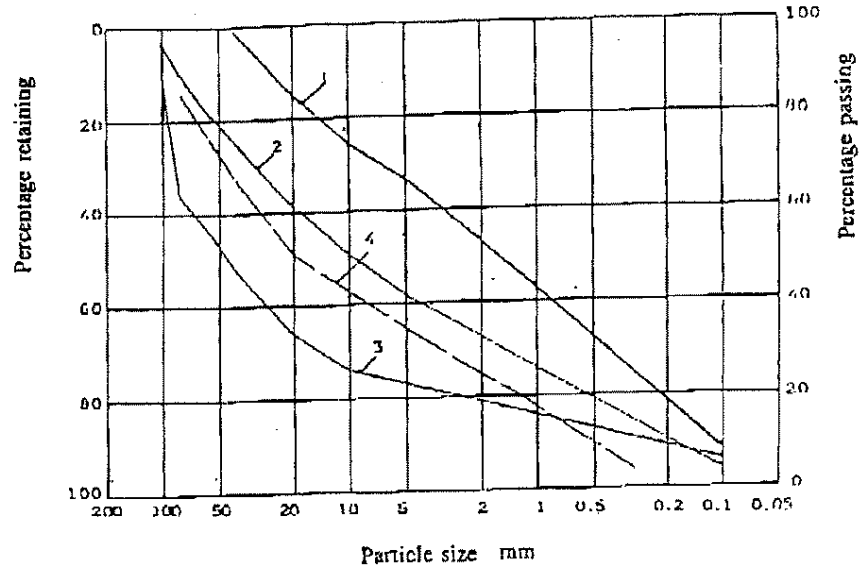
Fig. 6 Gradations of the fills

The lack of adequate drainage of the dam has aroused common concern about the grading of the fill material. All available field gradation test results have been collected. They include the 55 gradings obtained from the borrow pit and the dam body. The tests were carried out by the contractor for quality inspection purpose. The smallest, average and greatest contents of fines (particles less than 5mm) are 23.5%, 41.7%, 66.8%; and those of silt (particles less than 0.1mm) are 0.3%, 4.3%, 8.3% respectively. Fig. 6 gives three curves that represent the finest, coarsest and average gradations of the samples.

1,2,3: Selected gradings of 55 samples. 1, finest; 2, average; 3, coarsest. 4, Average of 8 samples taken from exploratory pit of borrow area.

(3) The permeability of the fill material is a problem of common concern. The design of the dam was based on the test data taken from the borrow pit, which gave a value of 1.48×10^{-4} cm/s. The available 56 gradings of the fill material exhibit big variance as can be seen in Fig. 6. The average of the 55 samples taken from the dam was finer than that of the 8 samples taken from the borrow pit during design stage. Some risk analysis might be desirable in assessing the reliability of the field test data if the number of tests is not large enough and the locations of the samples are not reasonably representative.

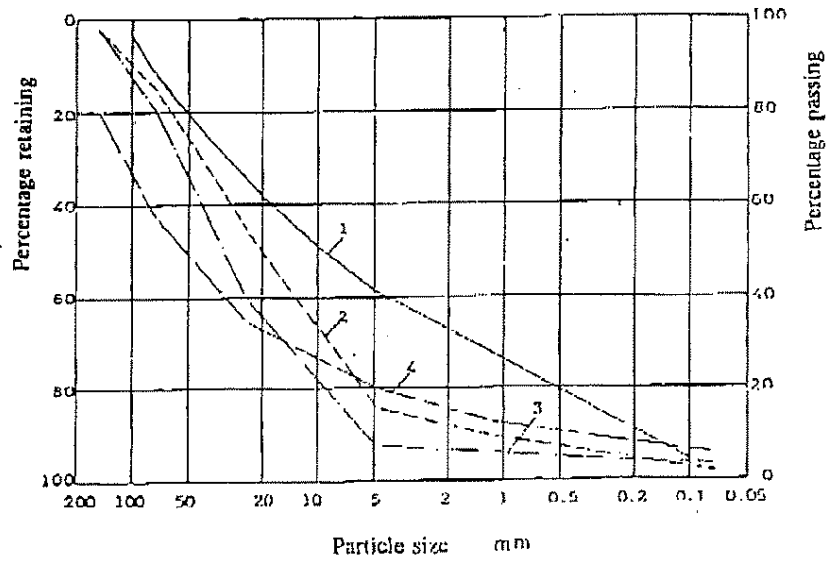
Fig. 7. Comparisons of gradings.

(2) The Qiapoqia River is a small creek with a natural runoff not more than $0.8 \text{ m}^3/\text{s}$ at the time of failure and it was found that the reservoir water level kept rising instead of lowering before failure. This means the maximum seepage into the dam body would not exceed $0.8 \text{ m}^3/\text{s}$, an order of magnitude several CFRDs have also experienced without failure. Compared with the gradings of the then existing three CFGDs in the world (Fell, R. et. al., 1992, Fig. 7), the Gouhou fill material was

1. Gouhou (based on 55 gradings; 2. Crotty; 3. Salvagina; 4. Golillas

relatively fine. However, unlike the three dams, special free drainage zone was absent. The designers have given similar discussions (Chu, 1992).
