## 2.0 SUMMARY DESCRIPTION OF THE TAUM SAUK PLANT

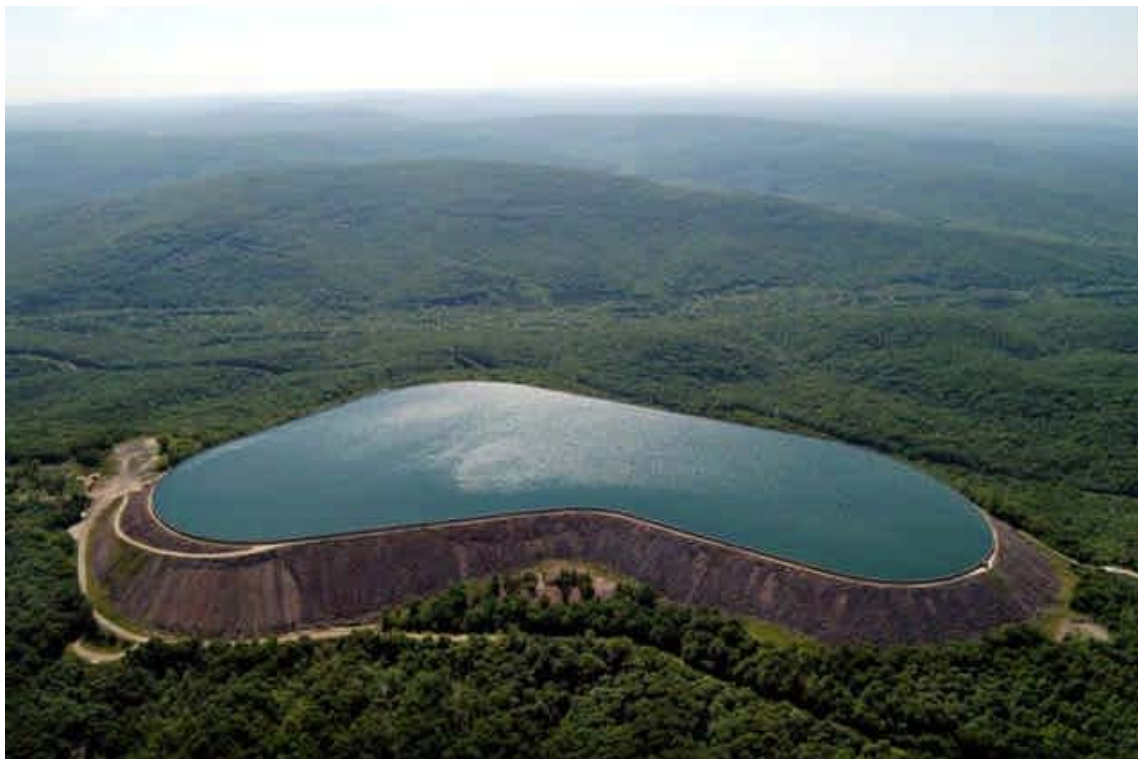
**FIGURE 2-2**

The Upper Reservoir Dike is 6,562-feet long and forms a kidney-shaped reservoir as illustrated on **Figure 2-2**. The Dike is a concrete-faced dumped rockfill dam (CFRD) with a maximum height in the range of 84 feet above the reservoir floor. The floor is generally at El. 1505 and the 12-foot wide crest of the Dike is at El. 1589. A 10-foot- high, 1-foot-thick reinforced concrete Parapet Wall on the crest of the Dike fill extends the maximum pool level to El. 1599. However, as the Dike has settled over time, the true top of the Parapet Wall is as much as two feet lower than the design level at El. 1599.

**VIEW OF UPPER RESERVOIR**

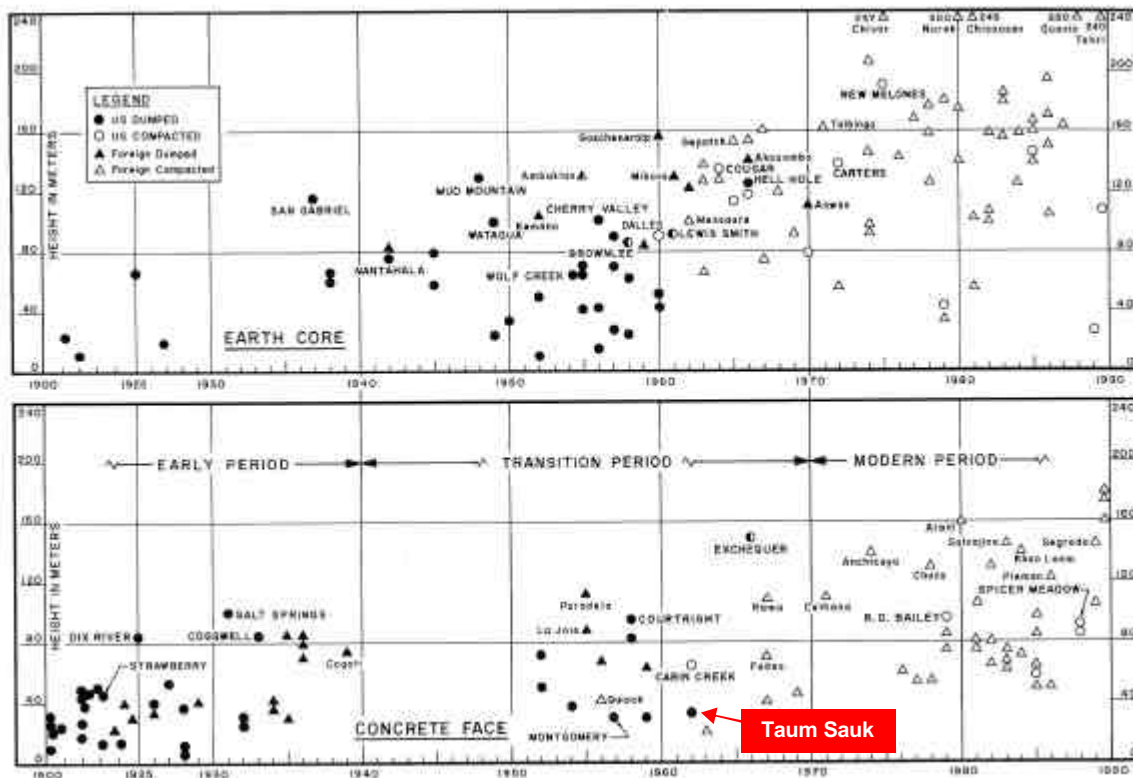
FIGURE 2-6

## TRENDS IN TYPE AND HEIGHT OF ROCKFILL DAMS

Poor behavior of dumped rockfill versus compacted rockfill was known at the time. It would appear, in hindsight, that the design was flawed and not consistent with the evolving state of the practice in the early 1960s. It is noted that the URRD was the last dumped rockfill dike built in the United States and possibly in the world (refer to *Figure 2-6* shown above).

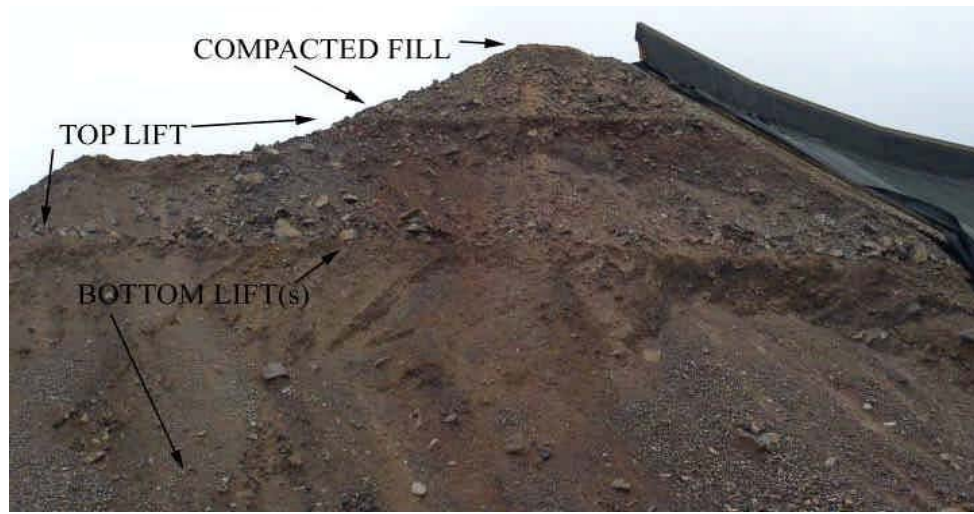
**FIGURE 2-7**

The fines content issue stands out on the slopes of the Breach Area as illustrated below on **Figure 2-7**, which is a photo of the north side of the Breach Area. This is supposed to be a rockfill, but it is apparent that fines were left in place and comprise a significant percentage of the overall embankment. We submit that this was not the original designer's intent and that the shear strength and drainage properties of this finer material acts negatively on the performance of this type of dam and dike construction.

**VIEW OF NORTH SIDE OF BREACH AREA**

| REFERENCE | SPECIFICATION OR LANGUAGE | POST EVENT OBSERVATION |
|---|---|---|
| Spec. EC-311<br>IV-b-7, Sec. D<br>Rev. Mar. 1, 1961. | “All rock within this area shall be thoroughly sluiced to prevent the accumulation of fines in the upper portions of the face fills.” | Specification not satisfied.<br>See <i>Figure 2-7</i> . |
| Spec. EC-311<br>IV-b-7, Sec. D<br>Rev. Mar. 1, 1961. | “The criterion for determination of adequate sluicing by visual inspection shall be that the entire height of the progressing face and side slopes shall have the appearance of clean rock, and that no areas of concentrated fines, dirt or mud are in evidence.” | Specification not satisfied.<br>See <i>Figure 2-7 and Figure 4-3</i> (presented later). |

| <b>REFERENCE</b> | <b>SPECIFICATION OR LANGUAGE</b> | <b>POST EVENT OBSERVATION</b> |
|---|---|---|
| Spec. EC-311<br>IV-b-8, Sec. E<br>Rev. Mar. 1, 1961. | “The jetting shall accomplish, principally, the following:<br>a) Wash surface zones of fines away.<br>b) Excavate pockets of spalls and distribute the spalls into voids between larger rocks in contact.” | Specification not satisfied. See <i>Figure 2-7 and Figure 4-3</i> (presented later). |
