3.0 SUMMARY DESCRIPTION OF THE SITE GEOLOGY

3.3 GEOLOGIC MAPPING OF THE BREACH AREA

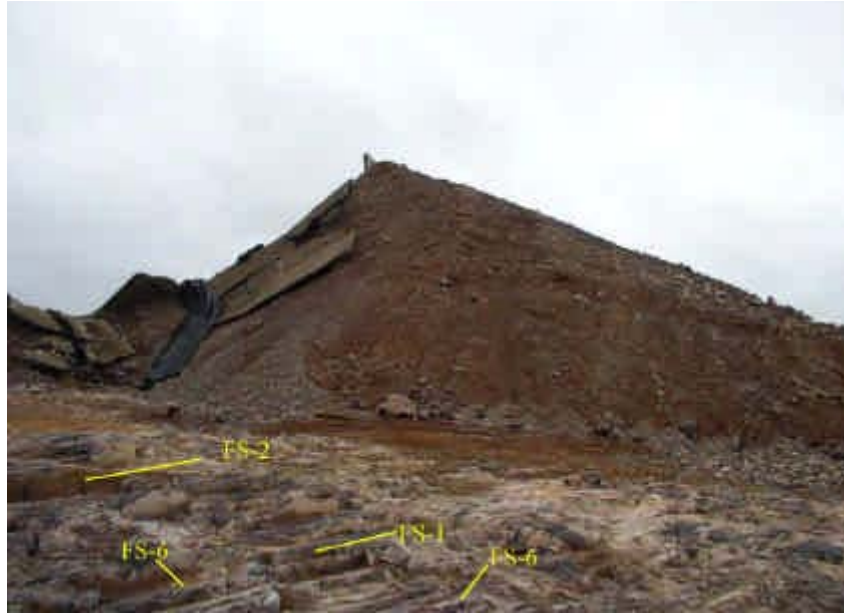
FIGURE 3-4
FRACTURE SETS FS-1, FS-2, AND FS-6

Figures 3-4 through **3-7** show some of the prevalent fracture sets in the breach area foundation.

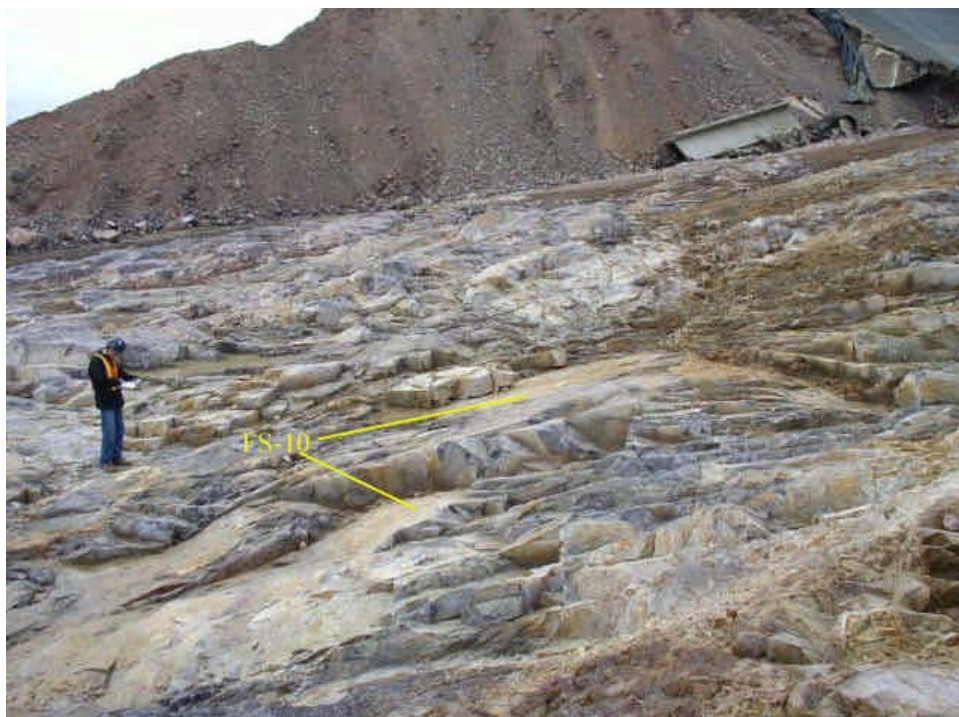
FIGURE 3-6

FRACTURE SET FS-10

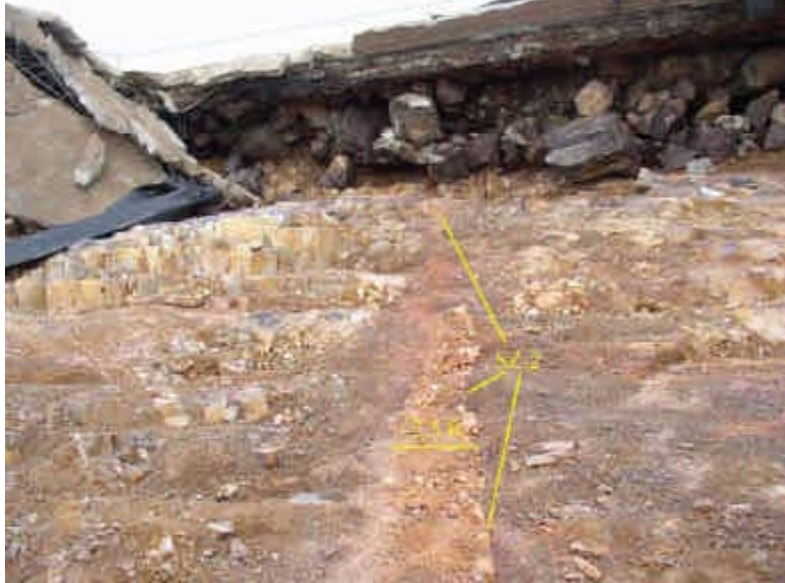
FIGURE 3-7
SHEAR ZONE SZ-2

In addition to fractures, shear zones and faults exist with the breach area. Five roughly east-west striking, steeply dipping shear zones are noted and presented on *Plate 3-1*. These shear zones are linear, very continuous, and cut all other features. Rock within these shear zones is very broken. *Figure 3-7* shows shear zone SZ-2 from *Plate 3-1*. A sense of offset on this feature could not be determined.

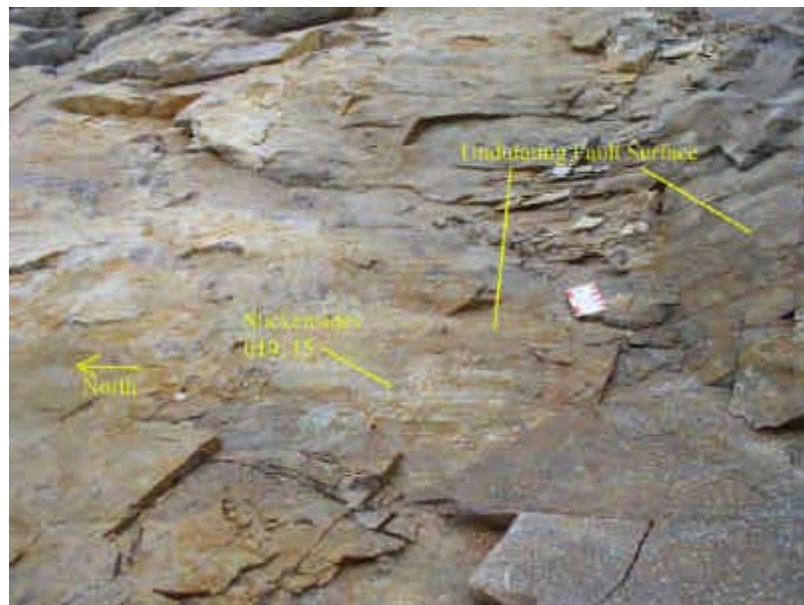
FIGURE 3-8
LOW ANGLE FAULT WITH SLICKENSIDES

Two fault zones with slickensides were mapped in the breach zone area. These faults strike N80-85E, exhibit shallow dip (20-30 degrees) to the NNW, and have slickensides that rake north to N10E and dip 15-20 degrees (*see Figure 3-8*).

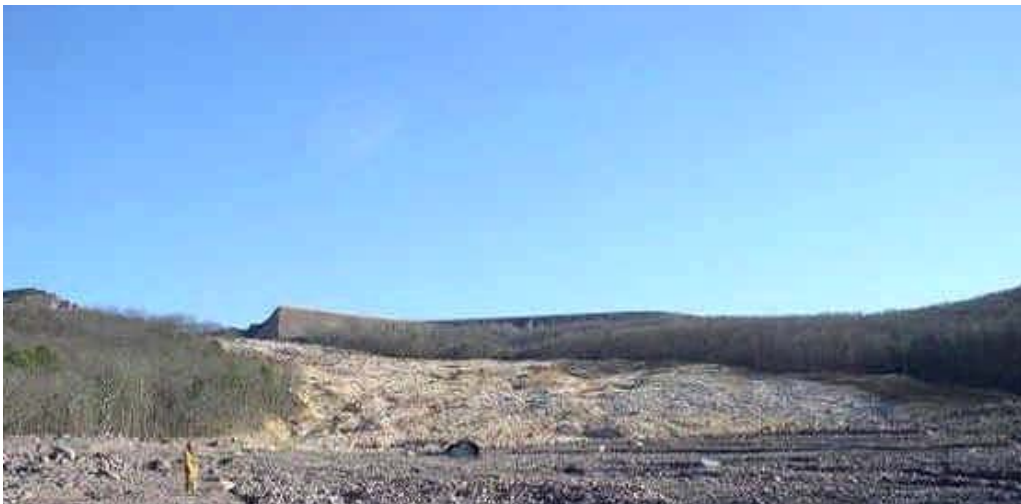
FIGURE 3-11

The zone of depletion of the debris (the zone where the displaced material was below the original ground surface) is the area from the downstream toe of the Rockfill Dike to the break in slope. This area is characterized as having a few remnant patches of residual soil, no vegetation and no material derived from the Rockfill Dike (or facing concrete). Only a small concrete block is observed close to the top. *Figure 3-11* shows this area as it is seen from the slope break to the initiation area.

ZONE OF DEPLETION FROM THE INITIATION AREA TO THE SLOPE BREAK

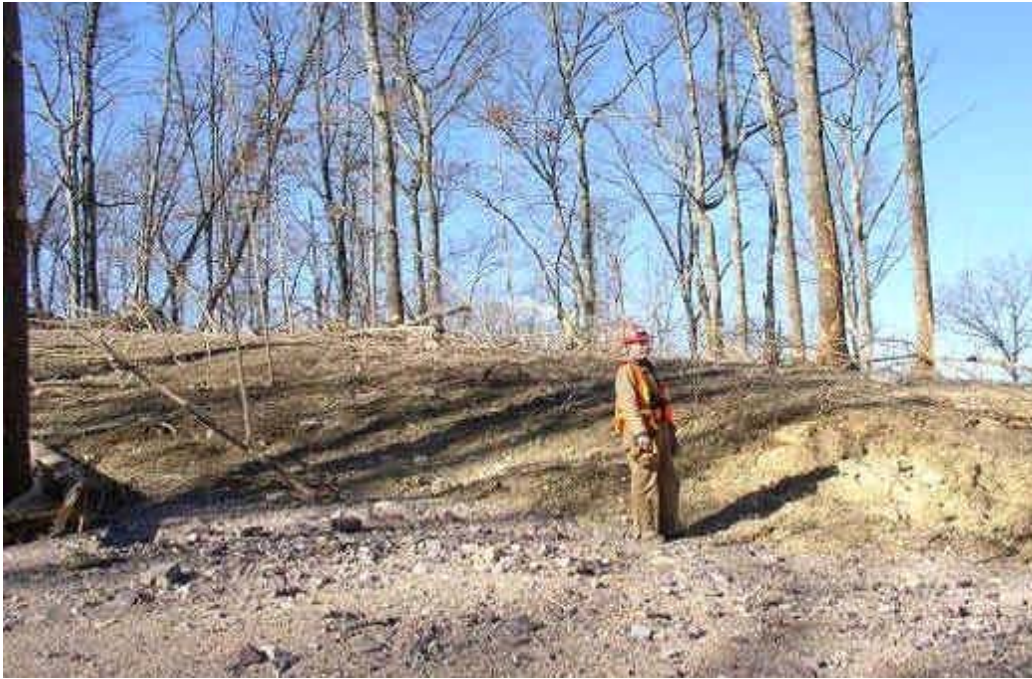
FIGURE 3-12

Once the availability of the source of material ended, i.e., when the Dike was fully breached, there was some local remobilization based on the fact that plugs of debris and banks were cut as much as 6 inches and boulders were remobilized from their original position. The height of the mix flow is shown to be at least 10 feet high, from overbank flows, based on marks left by rocks on trees left standing on the hillsides, where almost all minor vegetation was partially removed (*Figure 3-12*).

**FACIES S1/S3 DEPOSITS OVER SLOPE IN SW OF SECTION 1,
WITH MARKS ON TREES CAUSED BY ROCK PARTICLES**

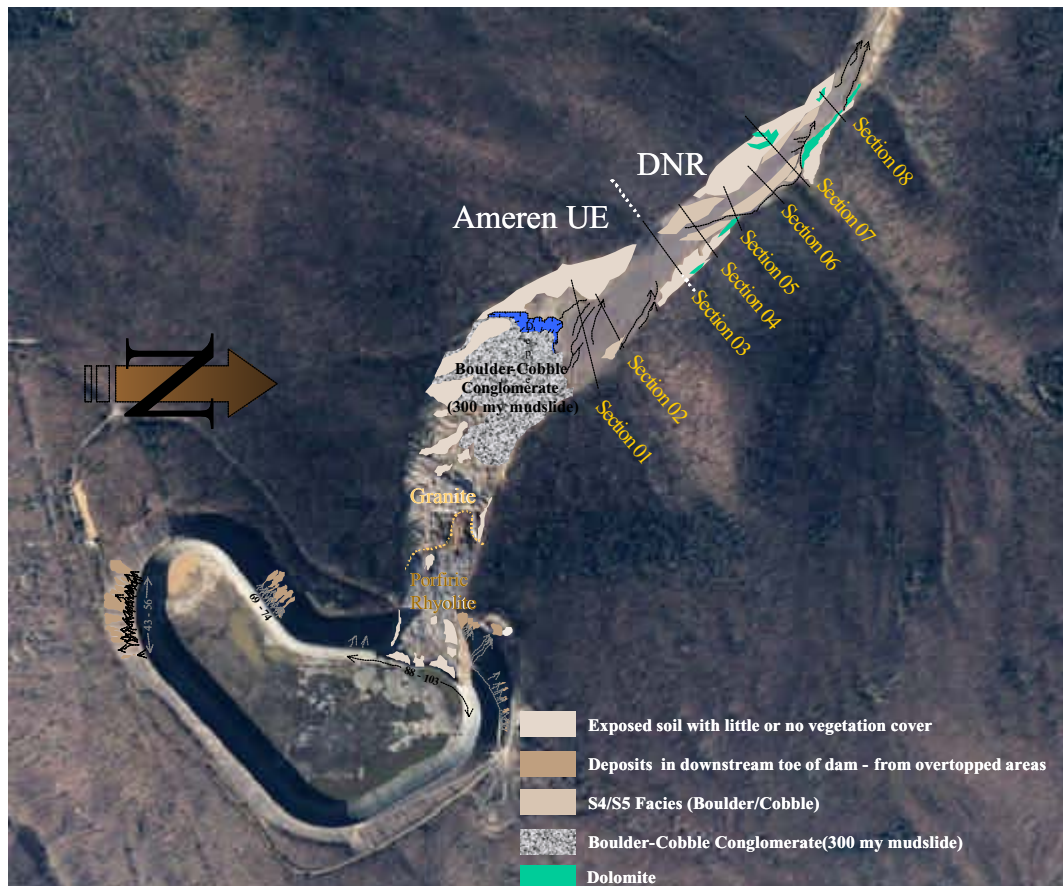
FIGURE 3-14

**GENERALIZED DISTRIBUTION OF DEPOSITS DERIVED FROM BREACH AREA
AND SUBSEQUENT DEBRIS TORRENT**

Referring back to *Figure 3-14*, the deposits shown in Breach Area are those distinctive facies S4/S5, with larger particle sizes as shown on *Figure 3-18*. The facies at the other sections indicated on *Figure 3-14* are shown on *Figures 3-18 and 3-19*.

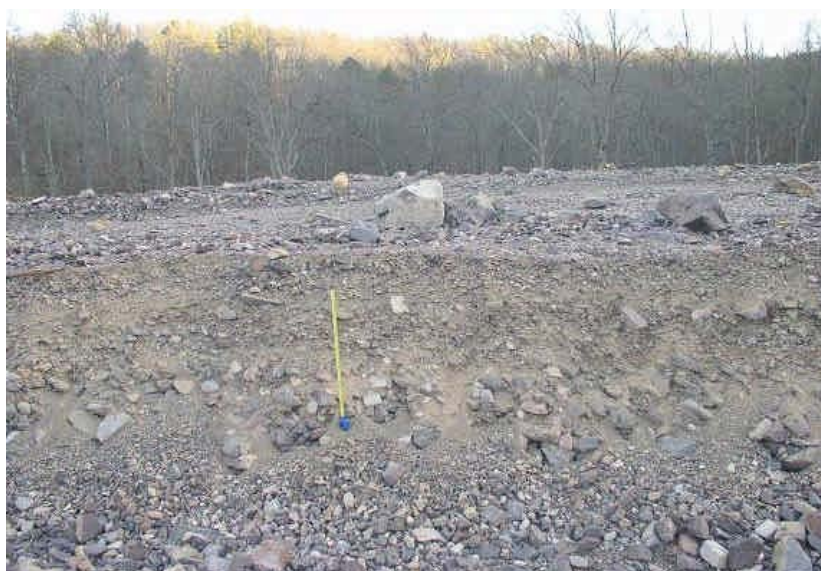
FIGURE 3-16

STRUCTURED DEPOSITS IN A DEBRIS PLUG CUT

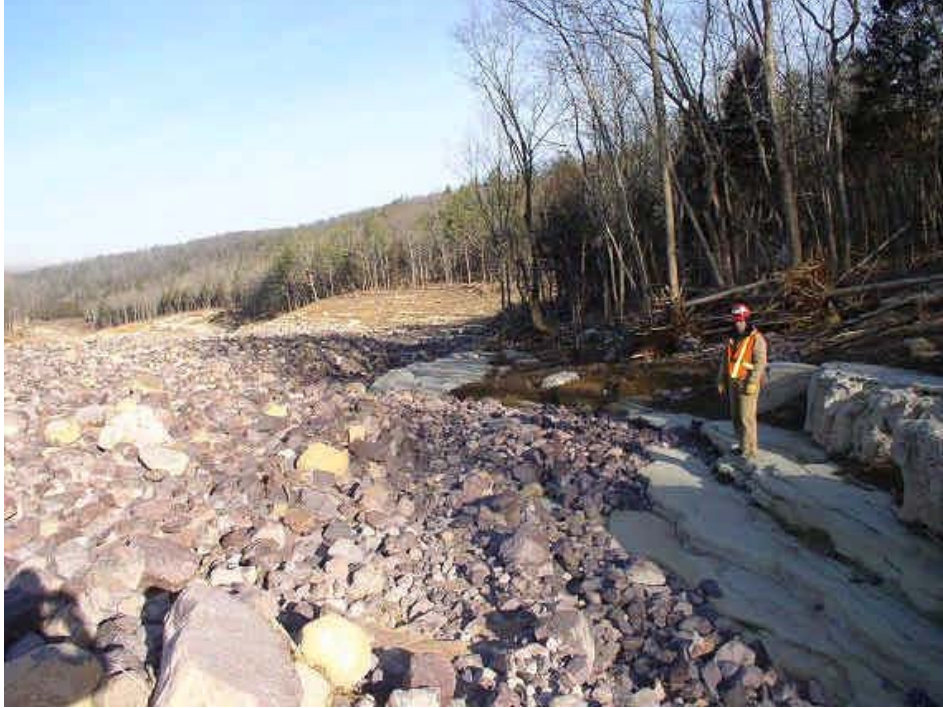
FIGURE 3-17

WELL-SORTED FACIES S4/S5 SHEET DEPOSIT, SECTION 6

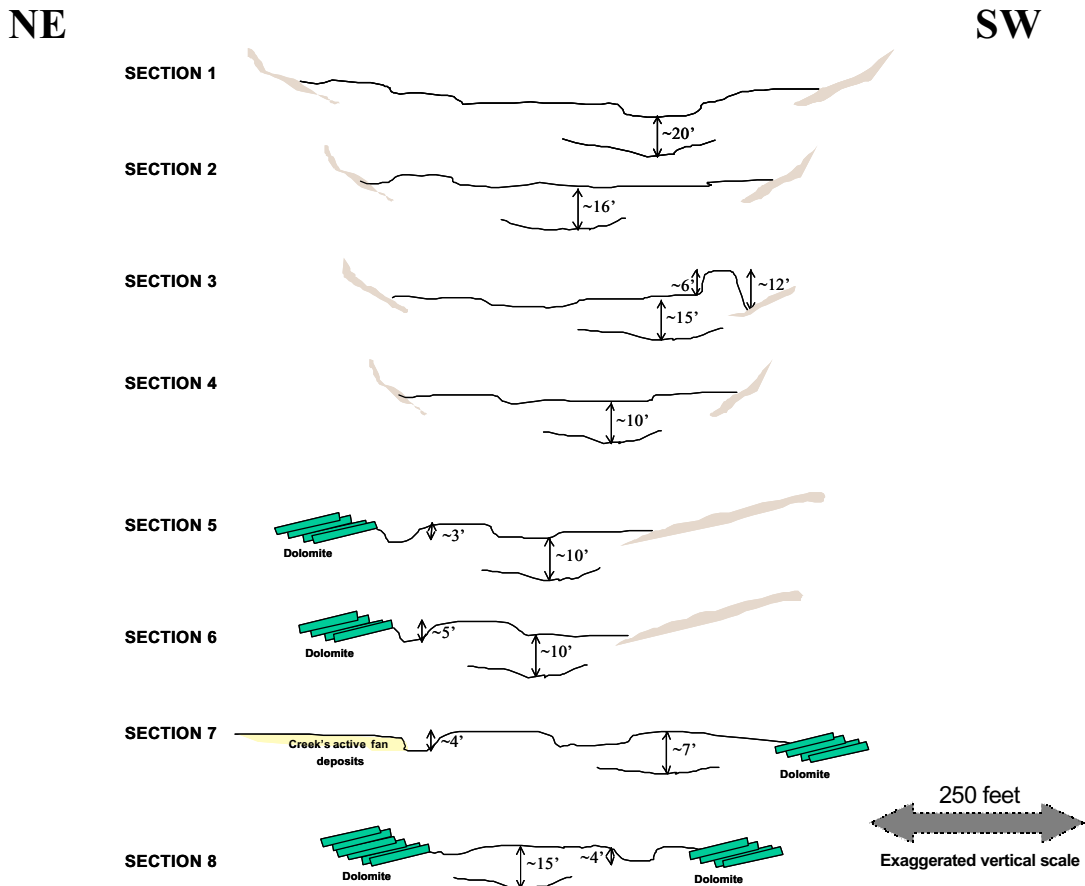
FIGURE 3-20
CROSS SECTIONS OF BREACHED CHANNEL

The Sections located on **Figure 3-18** are shown below on **Figure 3-20** and the fraction of the various facies at each section is indicated on **Figure 3-21**.
