4.0 DESCRIPTION OF THE DECEMBER 14, 2005 INCIDENT

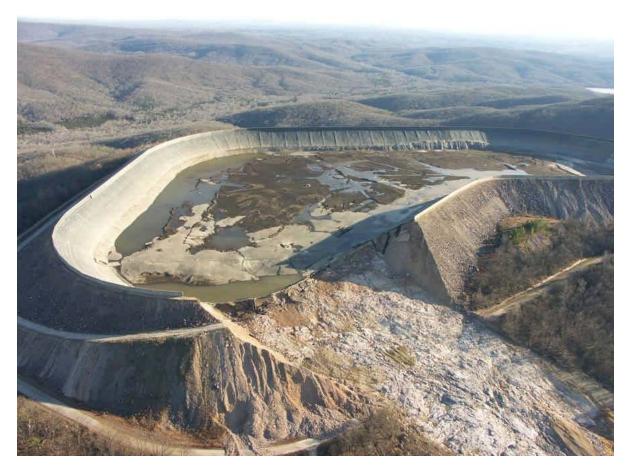
FIGURE 4-1
OVERALL VIEW OF THE BREACHED DIKE

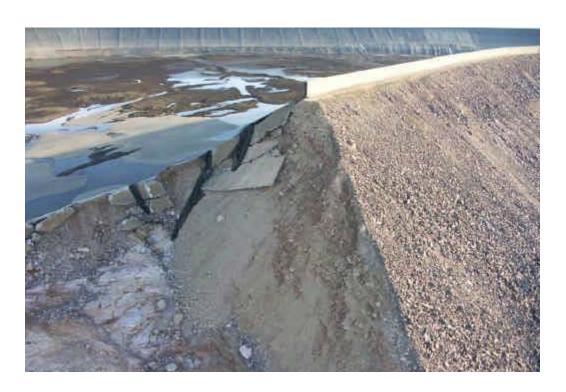
FIGURE 4-2
CLOSE UP VIEW OF WEST SIDE OF BREACH AREA

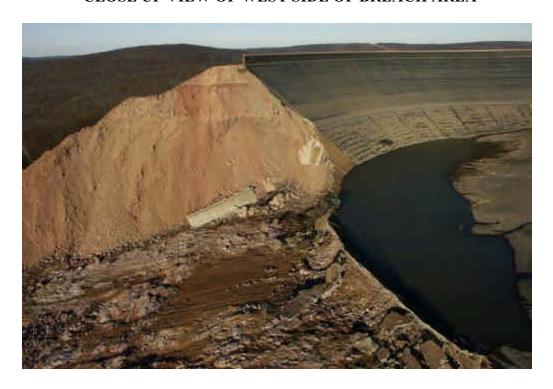
FIGURE 4-3
CLOSE UP VIEW OF EAST SIDE OF BREACH AREA

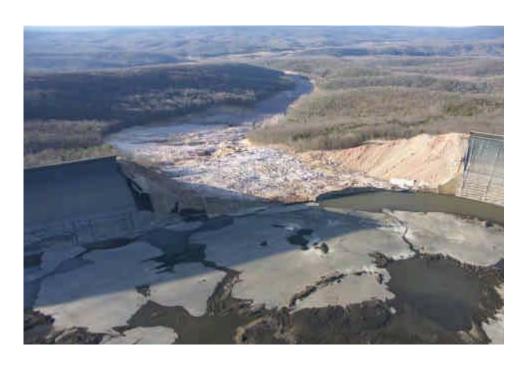
FIGURE 4-4
VIEW FROM INSIDE UPPER RESERVOIR TOWARDS FLOW CHANNEL

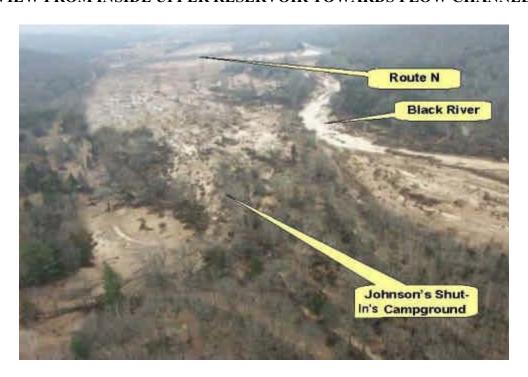
FIGURE 4-5
VIEW LOOKING NORTH AT FLOW CHANNEL

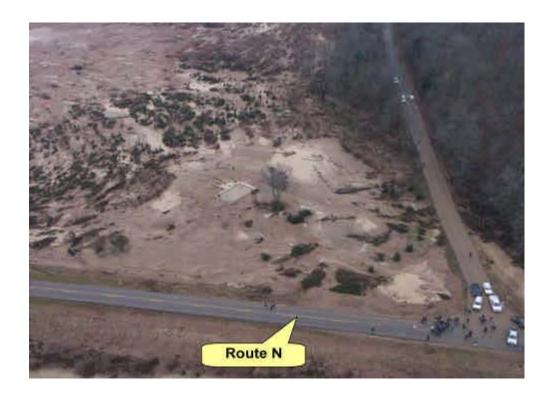
FIGURE 4-6

VIEW OF FLOW CHANNEL AND ROUTE N
