## 8.0 ANALYSIS OF UPPER RESERVOIR BARRIERS

### 8.1 OVERTOPPING ANALYSIS

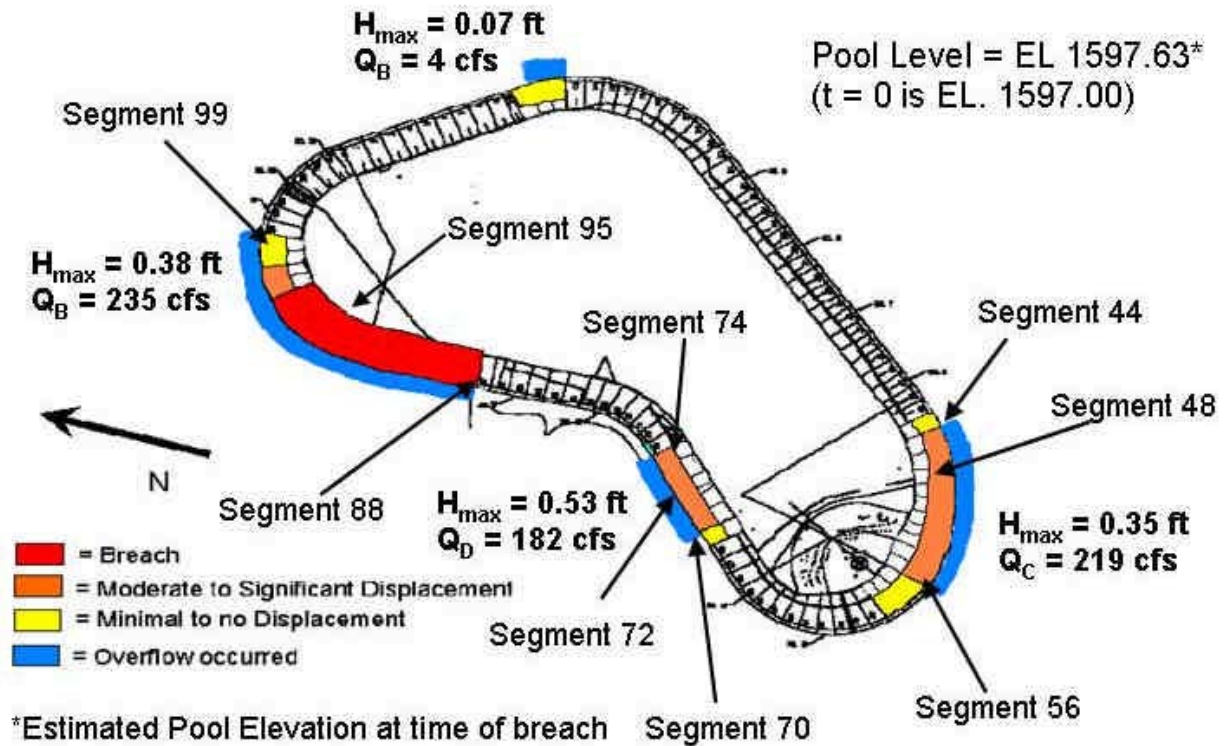
FIGURE 8-1  
OVERTOPPING ZONES

The results of the overtopping analysis shown on **Figures 8-1 and Figure 8-2** indicate that the total flow near Parapet Wall Segment 95, where the Breach occurred, is estimated to be 235 cfs at  $t = \sim 10$  minutes, 20 seconds. The total flow over Wall Segment 95 (60 feet long) having an average top Elevation of 1597.25 is 38.1 cfs, or 0.64 cfs/ft. The overtopping flow rapidly infiltrated into the Rockfill Dike, resulting in a rapid rise in the phreatic surface and the pore pressure on the critical Dike/foundation interface.

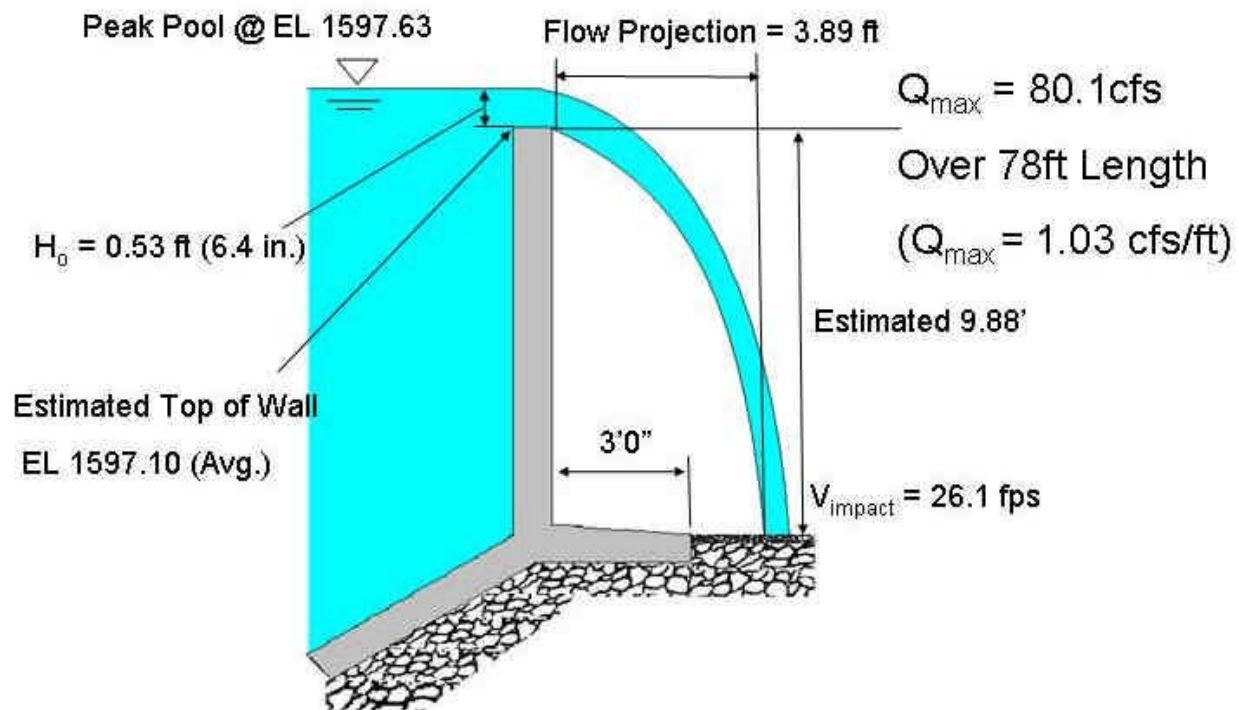
**FIGURE 8-3**

The total flow over Wall Segment 72 (78 feet long) having an average top Elevation of 1597.10 is 80.1 cfs, or 1.03 cfs/ft. This is slightly greater than at the Breach Area but over a more concentrated zone. In the southwest corner as shown on **Figure 8-4** for Parapet Wall Segment 48, the flow is estimated to be 33.1 cfs over a length of 60 feet or about 0.55 cfs per foot. These

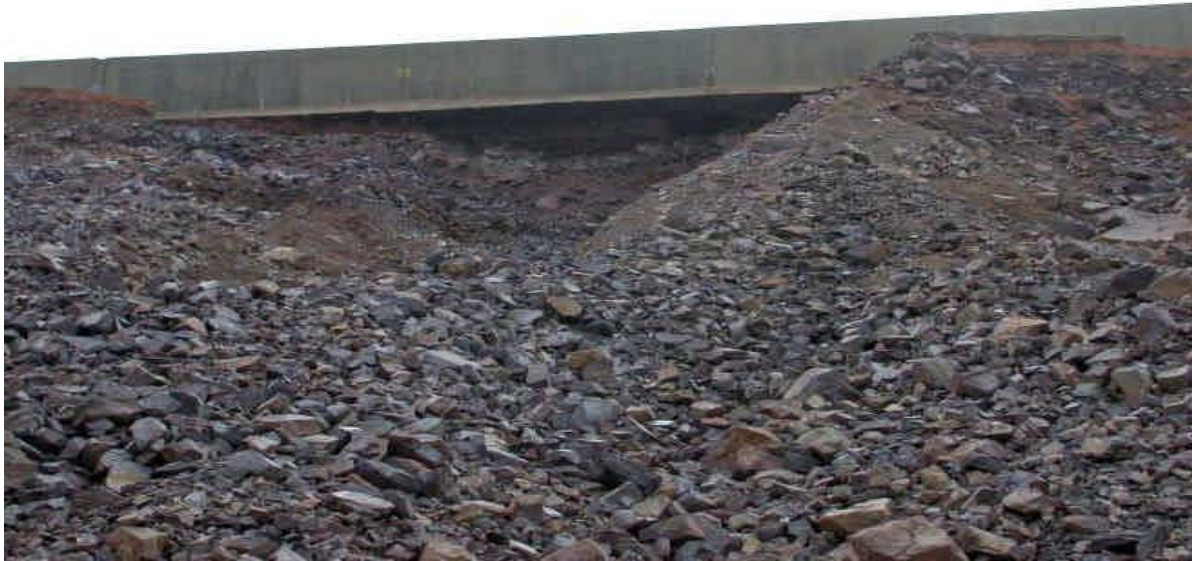
**FIGURE 8-5**

flows caused Parapet Wall Segment Nos. 72 and 48 to be undermined as illustrated below on *Figure 8-5* and *Figure 8-6* respectively.

**PARAPET WALL SEGMENT 72 UNDERMINING**

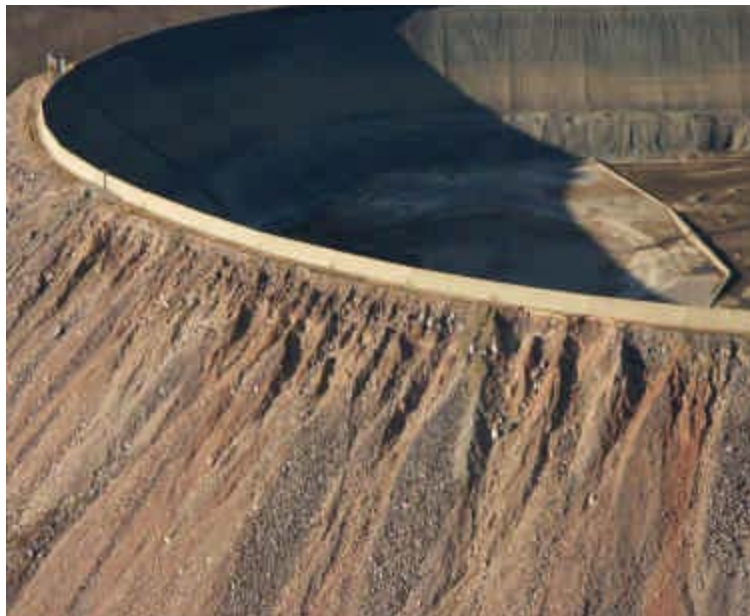
**FIGURE 8-6**

**PARAPET WALL SEGMENTS 44 TO 56 UNDERMINING**

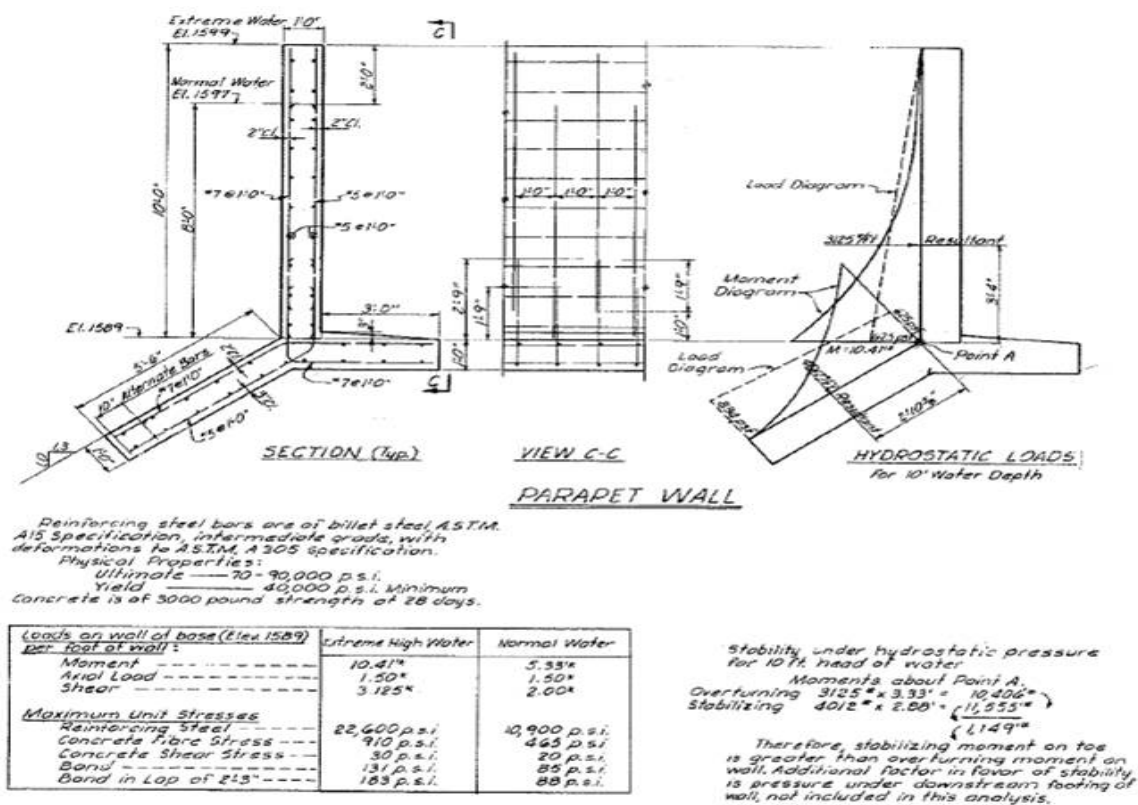
FIGURE 8-7

We have a few comments on this analysis. Firstly, the designer summed moments about Point A at the downstream bottom corner of the vertical stem of some of the acting forces - not all. Theoretically, one can sum moments about any point so long as all forces and moments are considered. Practitioners normally sum moments about the downstream toe, i.e., about the lower right hand corner of the base and all of the forces and moments would be considered.

Secondly, the originating analyst ignored the weight of the concrete and the soil pressure, and thirdly, the analyst ignored any uplift pressure that might develop under the foundation when the water level is in the range of El. 1598.

Our conclusion on this matter is that the original analysis would not be acceptable in a modern regulatory environment.

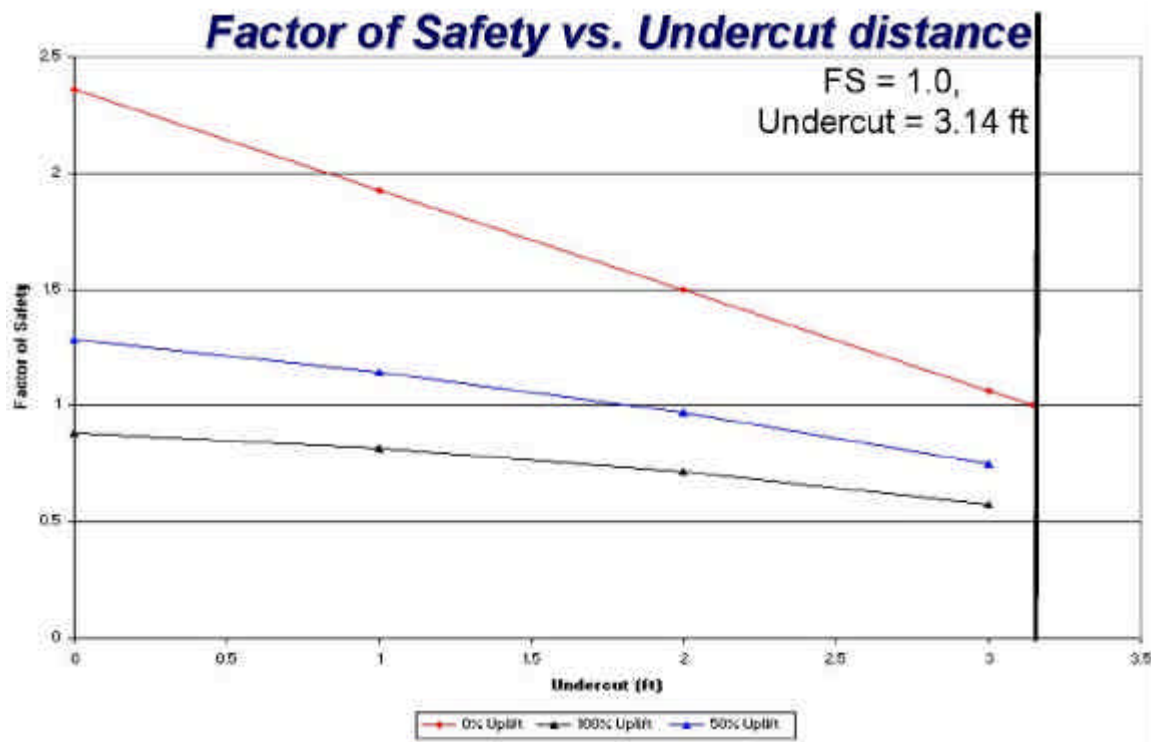
**FIGURE 8-13**

The forces considered for this analysis are illustrated below on **Figure 8-12** with the results shown on **Figure 8-13**. The results indicate that the Wall becomes unstable when undercutting penetrates about three feet under the wall. This analysis is two dimensional, and therefore for the Wall segment to actually fail, the entire 60 feet long Wall Segment would have to be undermined to this degree. We observe that Wall Segment 72 shown on **Figure 8-5** was probably “saved” by three dimensional action and the Wall Segments 44 to 56 shown on **Figure 8-6** were not undermined enough to result in an unstable situation.

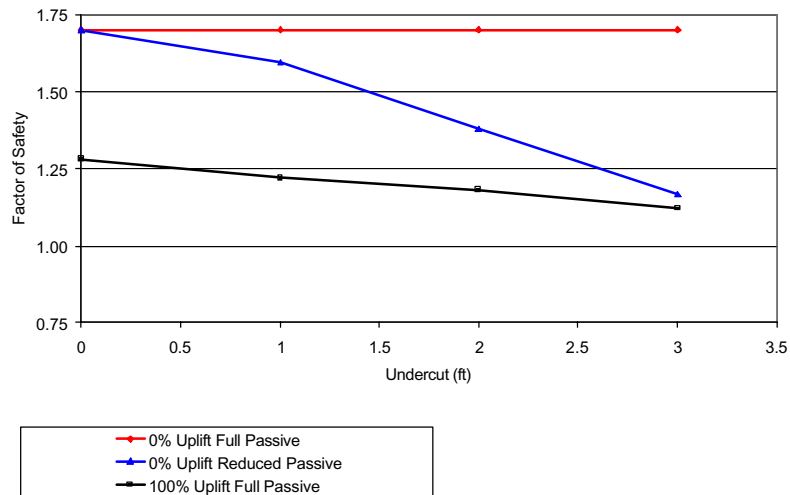
**FIGURE 8-14**

The forces considered for this analysis are illustrated are the same as shown on *Figure 8-10* for the overturning analysis and the results shown below on *Figure 8-14*. The results indicate that the Wall will probably fail first due to overturning (before sliding) when undermining occurs, primarily because of the upstream sloping base.

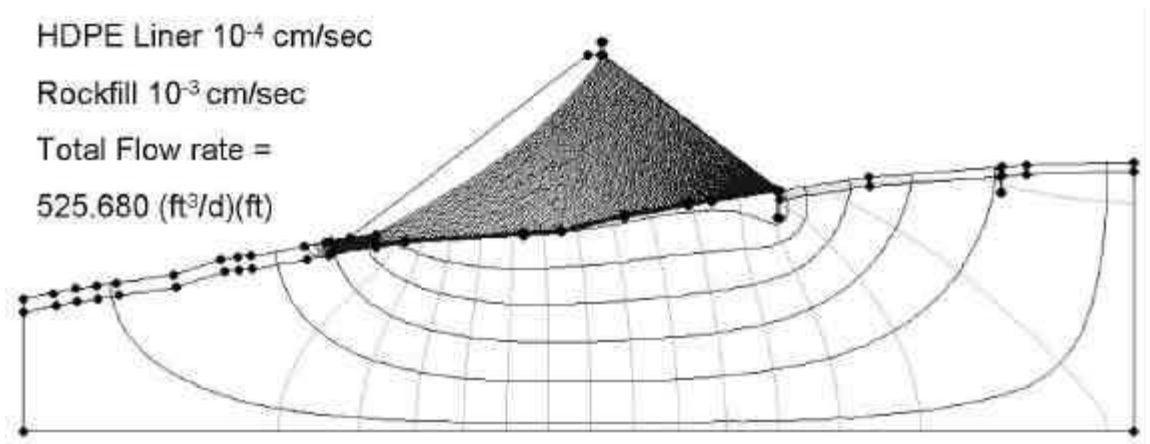
**FIGURE 8-16**

A secondary observation with this model is that there are certain zones in the Dike, such as at the upstream toe, where the gradient may have been relatively high. This would suggest the possibility of fines transport within the Dike itself, i.e., movement of fines from the toe area toward the center of the Dike. Except for the small zone at the extreme downstream toe, the gradients were too low to move the fines through the Dike entirely. This observation is consistent with reports by AmerenUE that major quantities of fines were not observed in the Pump-Back Pond at the southeast corner of the Upper Reservoir, the sink for the toe drainage ditch. RIZZO personnel observed only minor quantities of fines buildup in portions of the drainage ditch, e.g., in the reach below Parapet Wall Segment 72.

Additionally, the gradients shown in **Figure 8-16** and field observations suggest that clogging of the filters under the downstream slope of the Dam did not occur.

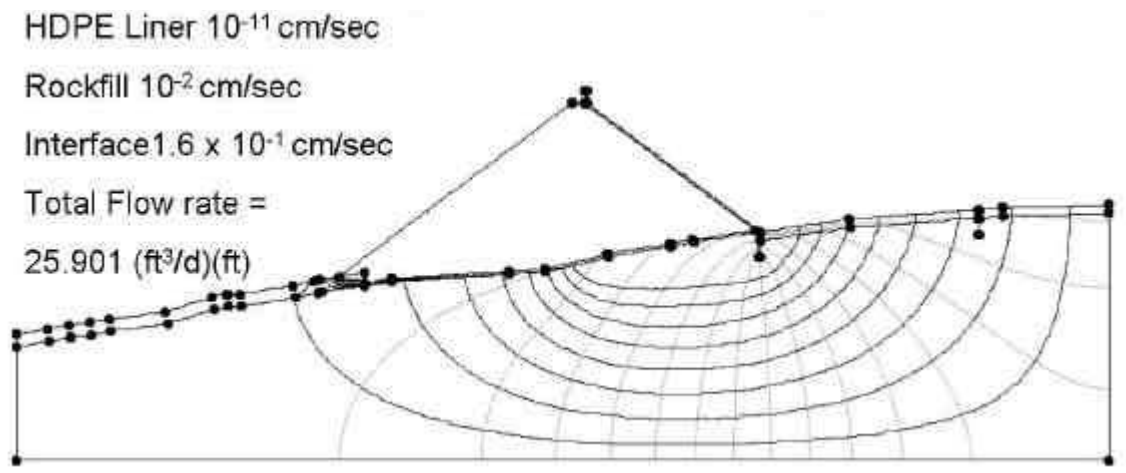
**FIGURE 8-18**

After calibrating the model shown on **Figure 8-15** and adding the HDPE Liner on the upstream face of the Dike, we performed a series of seepage analysis runs on the “Best Estimate” Model developed on **Figure 8-15** and modified to include the HDPE/LDPE Liner as shown in **Figure 8-17**. The resulting flow net shown on **Figure 8-18** indicates that the Liner significantly changed

the flow regime, dropping the phreatic surface to the level of the interface. This change increases the factor of safety for wedge failures along the interface significantly.

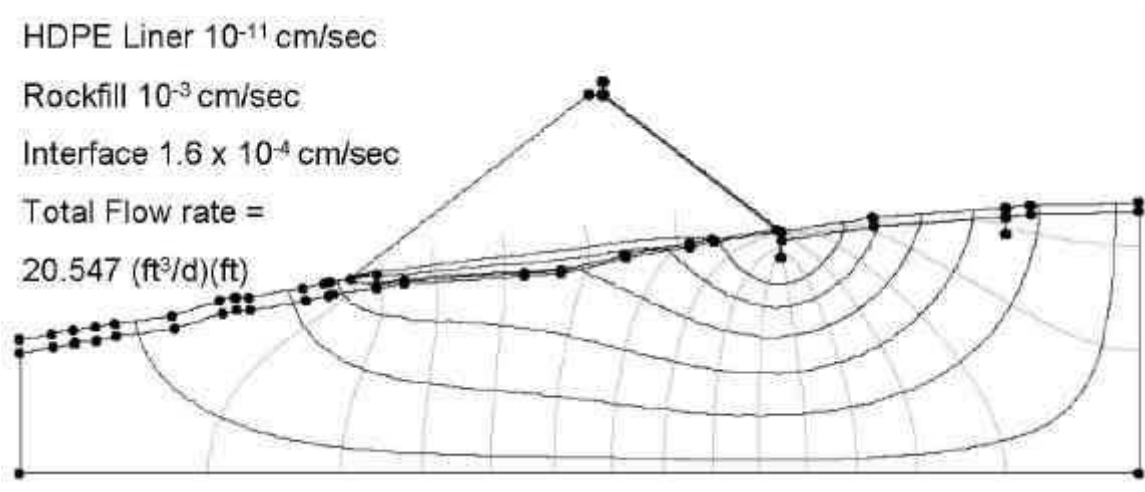
The results of these parametric runs presented in **Table 8-1** indicate that the permeability of the soil at the Dike/foundation interface and the Filters has a significant effect on the pore flow net and the pore pressure on the interface. To illustrate this point, we show below on **Figure 8-19** the flow net for Case 6 where the permeability of these two zones is postulated to be in the range of  $1 \times 10^{-4}$  cm/sec. The results also indicate that with the HDPE Liner in place, the permeability of the rock fill comprising the Dike is less important for the range of parameters that we considered.

**FIGURE 8-19**  
**FLOW NET FOR PARAMETRIC CASE 5**  
**( $K_{\text{INTERFACE}} < K_{\text{ROCKFILL}}$ )**

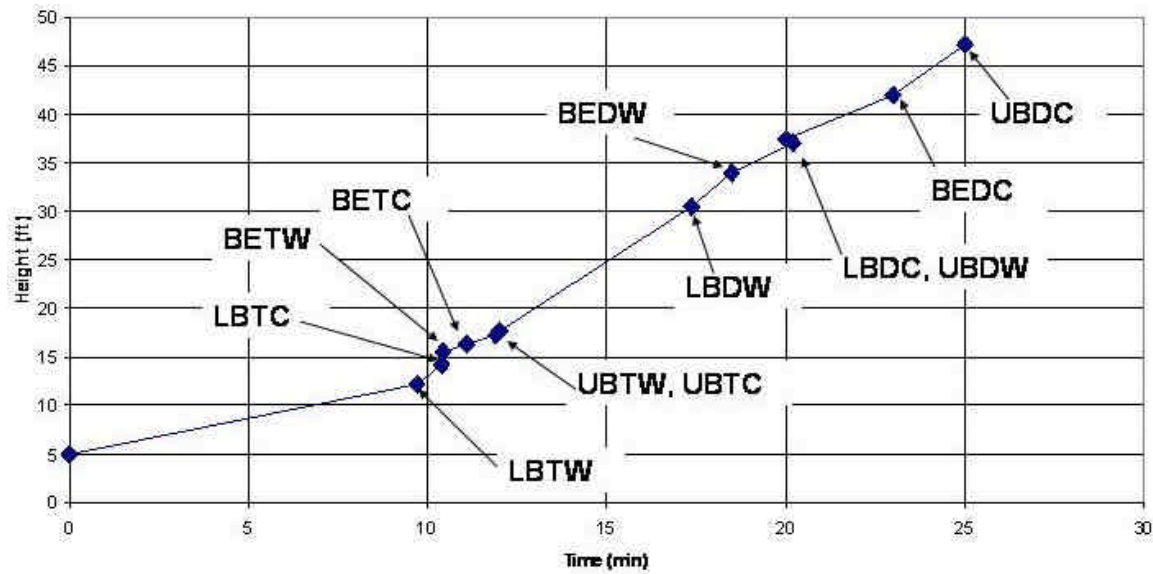
**FIGURE 8-20**

The first line of Table 8-5 indicates that RIZZO estimates that it would take about 18 minutes for the phreatic surface to increase to 34 feet above the bedrock. With the phreatic surface at this level, an intermediate to deep wedge type failure would have a factor of safety of one. Based on the analyses presented, it is RIZZO's opinion that the failure began at the toe (with either a wedge or circular failure). **Table 8-5** indicates that the toe failure condition reached a factor of safety of one when the phreatic surface was in the range of 12 feet to 17 feet above the bedrock. This occurred in the range of 10 to 13 minutes after the Upper Reservoir level reached El. 1597. The results also indicate that while failure began at the toe, probably exacerbated by run off down the slope, it rapidly progressed up slope within minutes.

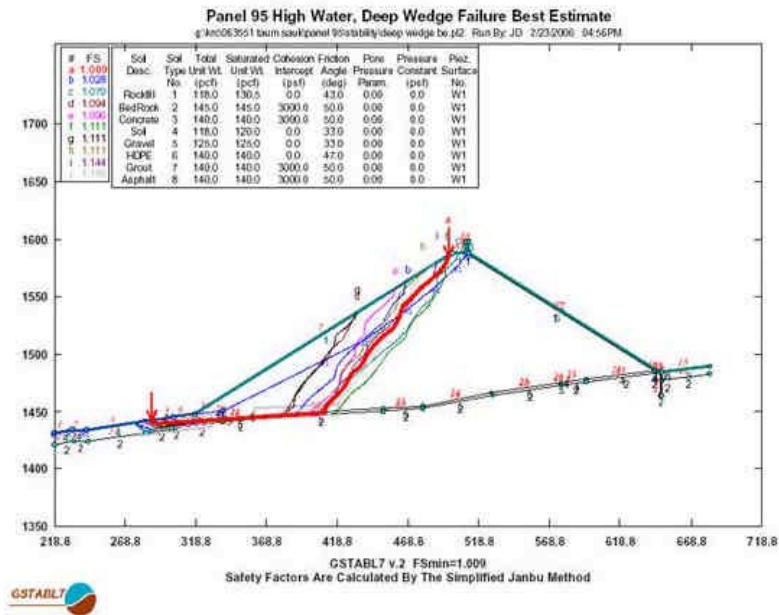
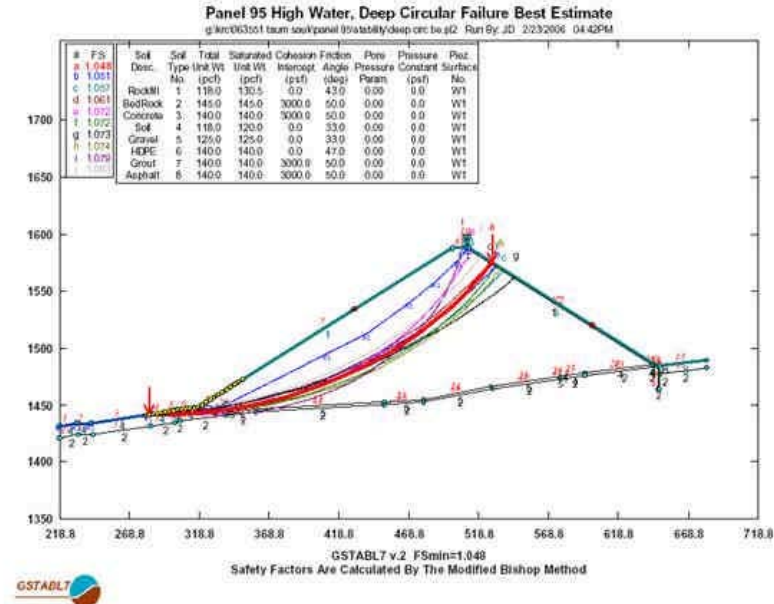
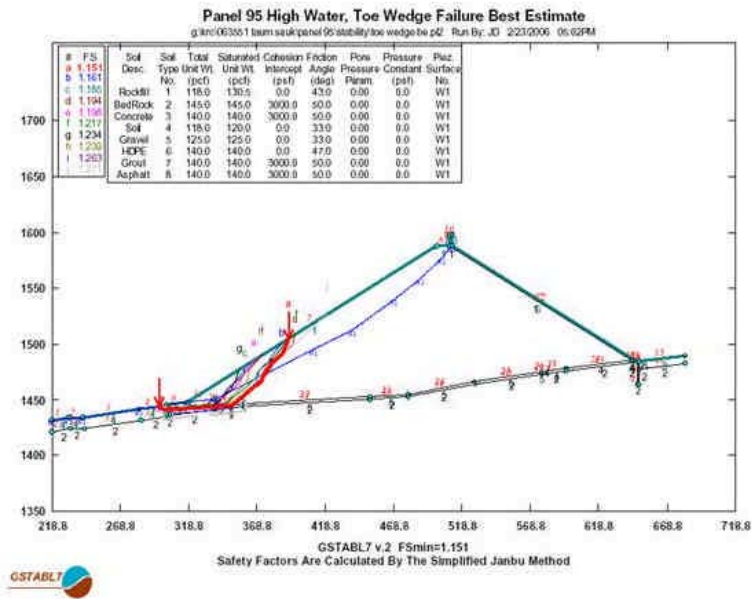
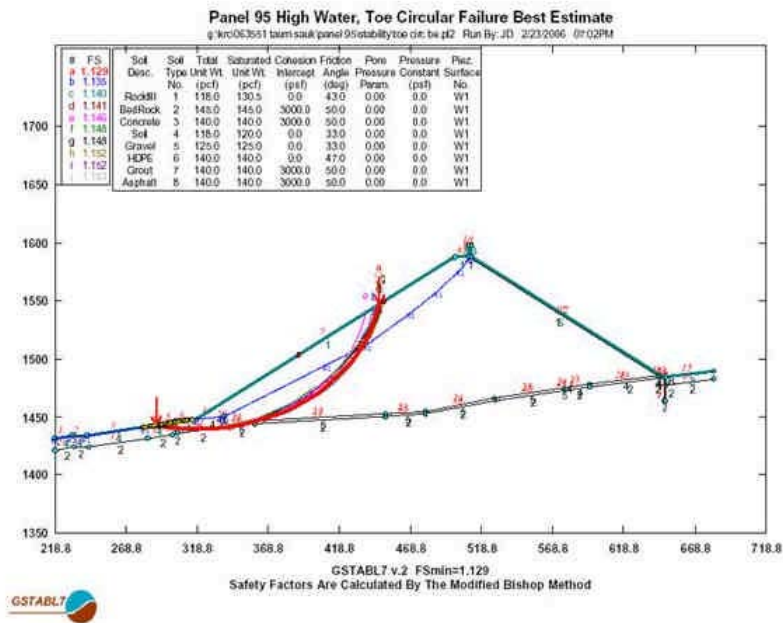
It is noted that significant pore pressure probably existed at the Dike/foundation interface before the HDPE liner was installed. The results presented in *Table 8-3* indicate that the Rockfill Dike

prior to installation of the geosynthetic liner in the Breach Area was marginally stable where the material properties were in the range of selected Lower Bounds.

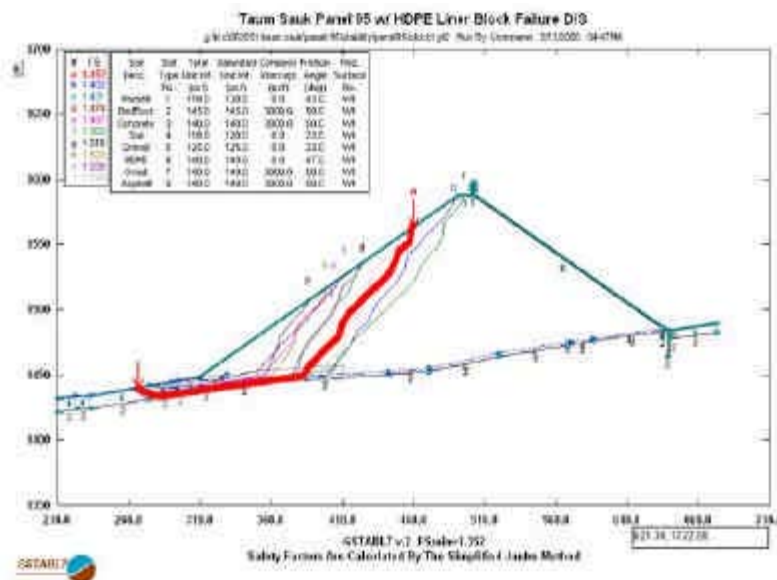
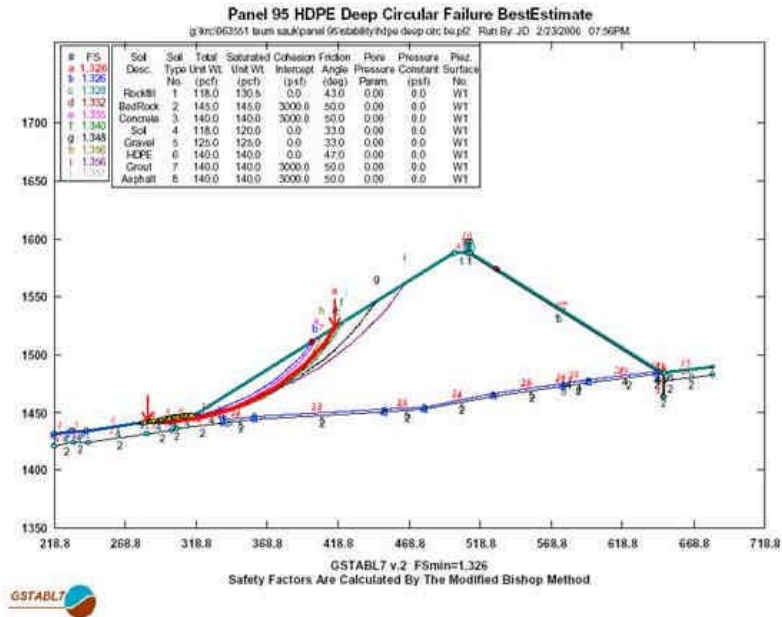
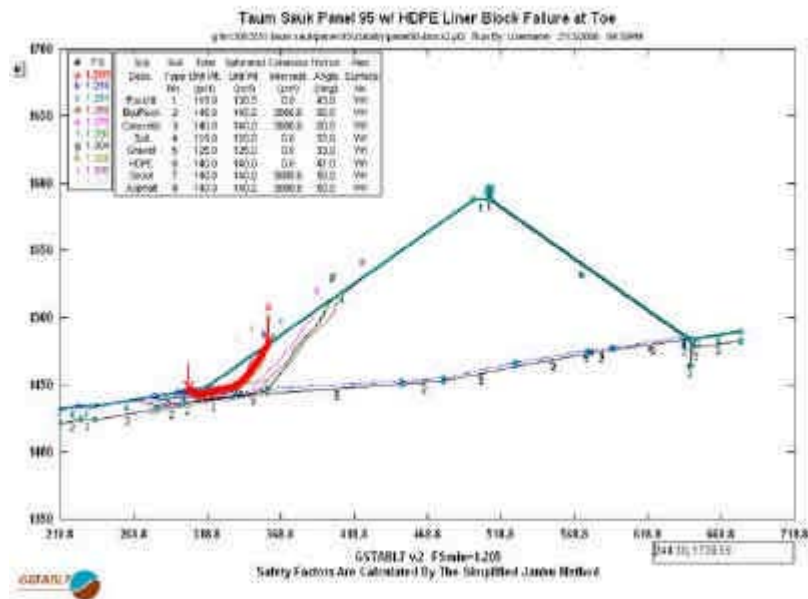
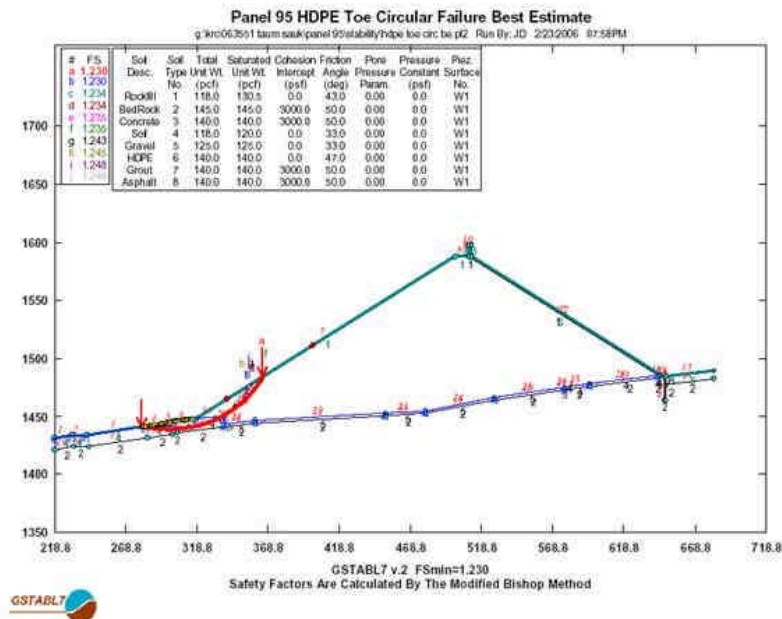
The results presented in **Table 8-4** indicate that the Rockfill Dike after installation of the geosynthetic liner in the Breach Area resulted in a slightly higher factor of safety. However, the results indicated that the section would still not meet FERC criteria for stability under static conditions for maximum storage pool (i.e., FS=1.5) (FERC, 1991). Although dynamic analyses have not been run, past experience suggests a high probability of failure under significant earthquake loading. The addition of a pseudo-static earthquake coefficient would result in a lower factor of safety approaching one. A pseudo static factor less than about 1.3 results in some amount of permanent deformation which increases exponentially with successively lower factors of safety.

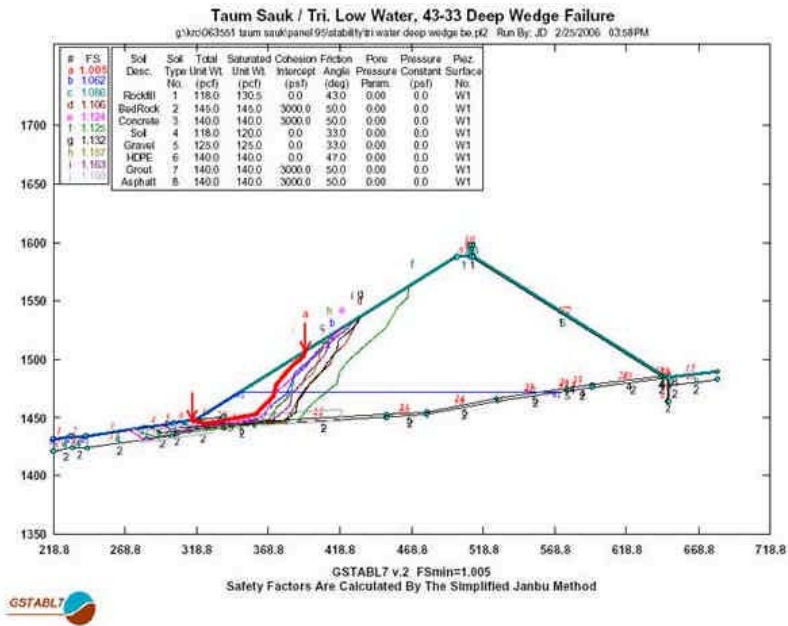
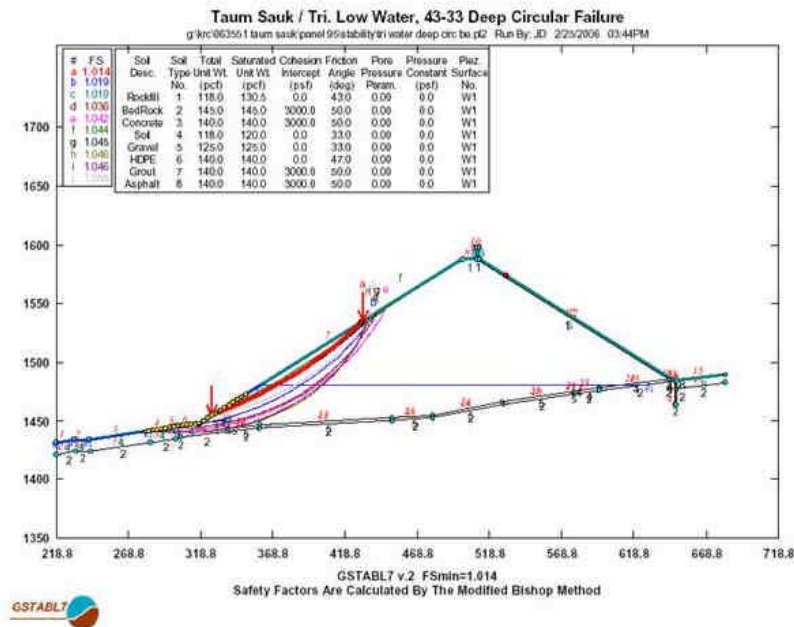
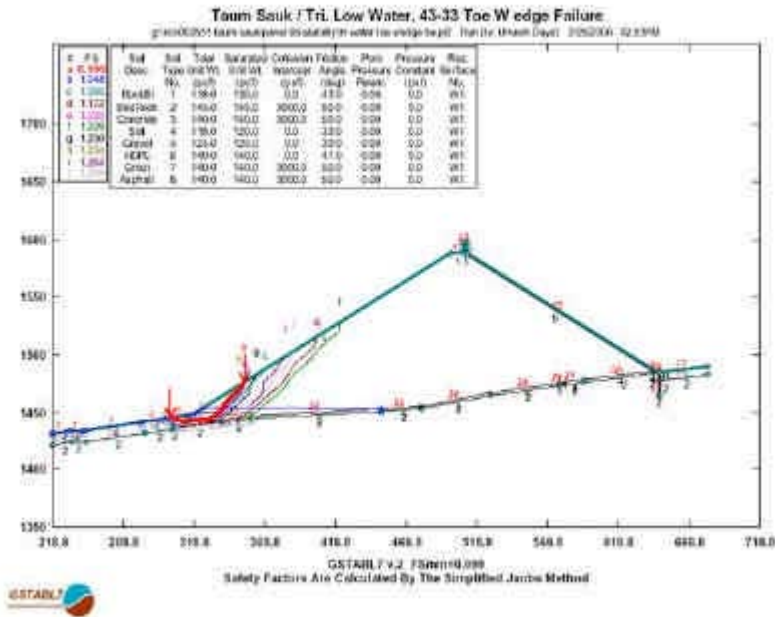
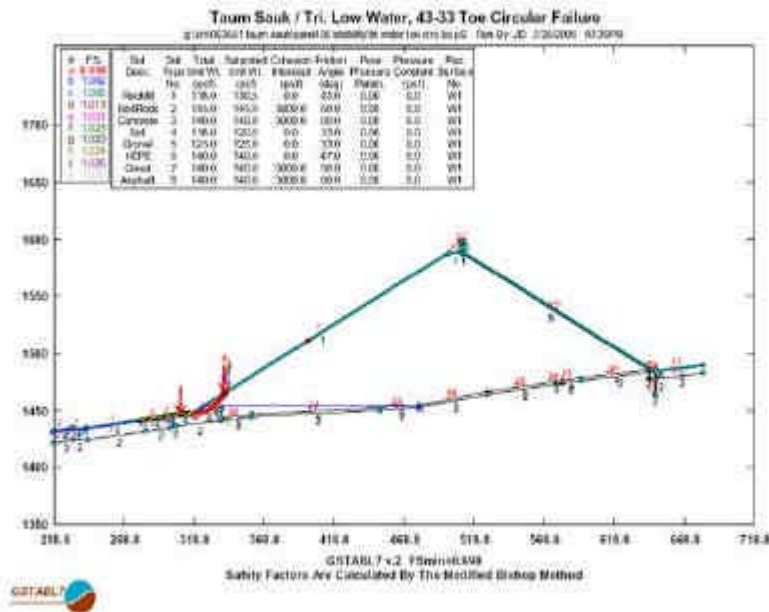
The increase in phreatic surface within the Dike on the day of the Event is directly attributed to the overtopping flow. RIZZO is unable to measure or calculate with precision the level and shape of the phreatic surface just prior to the overtopping. The analyses summarized in **Table 8-5** assumed that the initial (pre-overtopping) phreatic surface was about five feet above bedrock. In terms of the Barriers presented in **Section 5.0**, this assumed initial phreatic surface might have been elevated by an ineffective Grout Curtain, Asphalt Pavement, or the Foundation Filters. Performance of the Foundation Filters was discussed and dismissed in **Section 8.3.1** as non-causal. If, on the other hand, the Grout Curtains and/or Asphaltic Pavement were ineffective and causing leakage through or seepage under, either could have impacted the level or the shape of the pore pressure distribution at the Dike/foundation interface. An increase in pore pressure would have diminished the (pre-overtopping) factor of safety against stability failure of the Rockfill Dike and possibly result in a faster time to failure as compared to the times presented in **Table 8-5**. However, it is RIZZO's opinion that neither the Grout Curtains nor the Asphalt Pavement played a substantial role in the Event and that, at best, an ineffective Grout Curtain or an ineffective Asphalt Pavement may have been a secondary contributing cause.

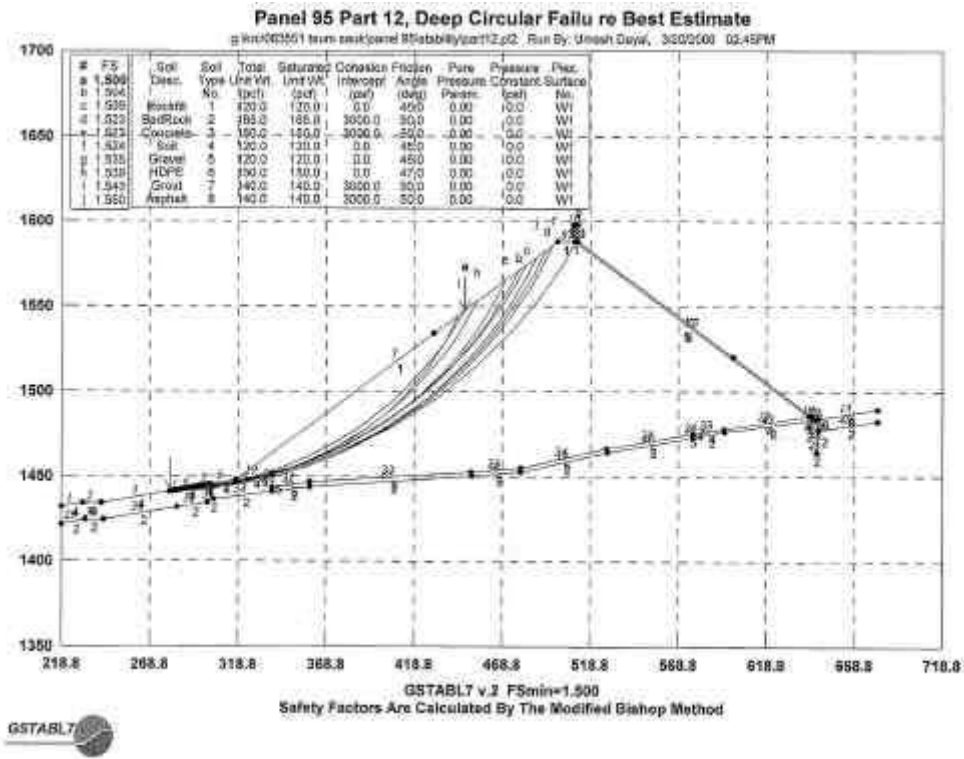
**FIGURE 8-34**

**Independent Check:** As a check, RIZZO has independently performed the slope stability analyses using the same geometry and strength properties as used in the original stability calculations—not the properties that RIZZO interprets to be appropriate. The results are presented on *Figure 8-34*. These results show a factor of safety of 1.5 as reported in the original calculations prepared by the original designer.
