## 9.0 OPERATION AND CONTROL AT TAUM SAUK

### 9.1 INSTRUMENTATION

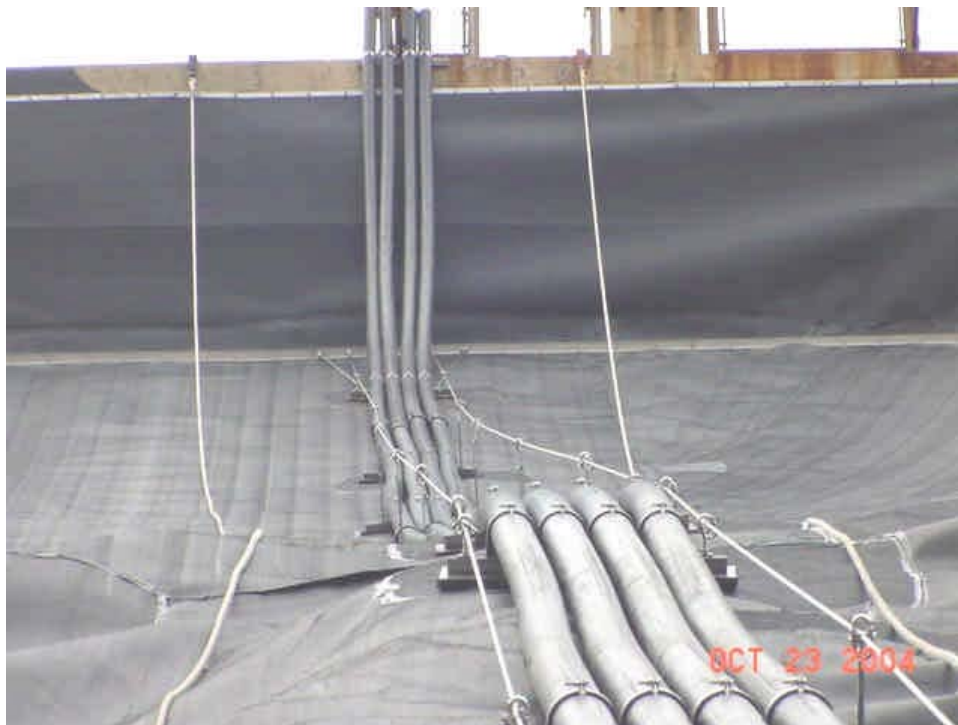
**FIGURE 9-1**

As outlined above, field changes were required because initial design was inadequate. The original design (Appendix H - Drawing # 8304-X-155099 Rev. 4) called for eye-bolts to attach the clamp baseboard/spacer to the guide cables. In the field, it was noted that once the guide cables are tensioned, the distance from the baseboard to the cable was quite variable. See *Figure 9-1* for an understanding of the turnbuckle locations.

**TURNBUCKLE-GUIDE CABLE-INSTRUMENT CONDUIT SYSTEM**

Since it would have been difficult and time-consuming to set the length of each eye-bolt to match the curvature of the embankment, the design was changed to accommodate turnbuckles in most clamp locations so that they could be field-adjusted as needed. The bottom anchor for the guide cable was changed to a turnbuckle also. We consider both changes to be a significant deviation from the original design. RIZZO's findings indicate that these field changes were poorly documented.

Overall, the substitution of a turnbuckle in a location where a bolt was originally specified was not adequate. From a generic perspective, the mechanism of bolted connections is such that the nut is held in place by the friction of the nut on the part being connected. The friction acting on the threads is not credited as there is an inherent gap between the threads of the bolt and of the nut that allows the nut to turn. This gap allows a slight vibration to release the friction in the thread-to-thread interface. In other words, to rely only on thread-to-thread friction to maintain the integrity of a bolted connection is not adequate and not consistent with function of the bolted connection.

At Taum Sauk, the turnbuckles were tightened, but no locking device, such as a locking nut or spot weld, was used to secure the fixity of the connection against vibratory effects. Thus, over time, the turnbuckle loosened and eventually was unscrewed completely. As can be seen in several photos available in the AmerenUE records, several turnbuckles were installed using less than one inch of thread.

Firstly, as the water flows around the turnbuckles, turbulence initiates a vibration in the turnbuckles. This, combined with the tension in the threads, can loosen the turnbuckles. *Figure 9-1*, taken immediately after the installation of the HDPE pipes and supports, shows that many of the turnbuckles were installed with little or no male thread protruding from the female thread. This means that as a few as a dozen revolutions of the turnbuckle could have failed the connection.

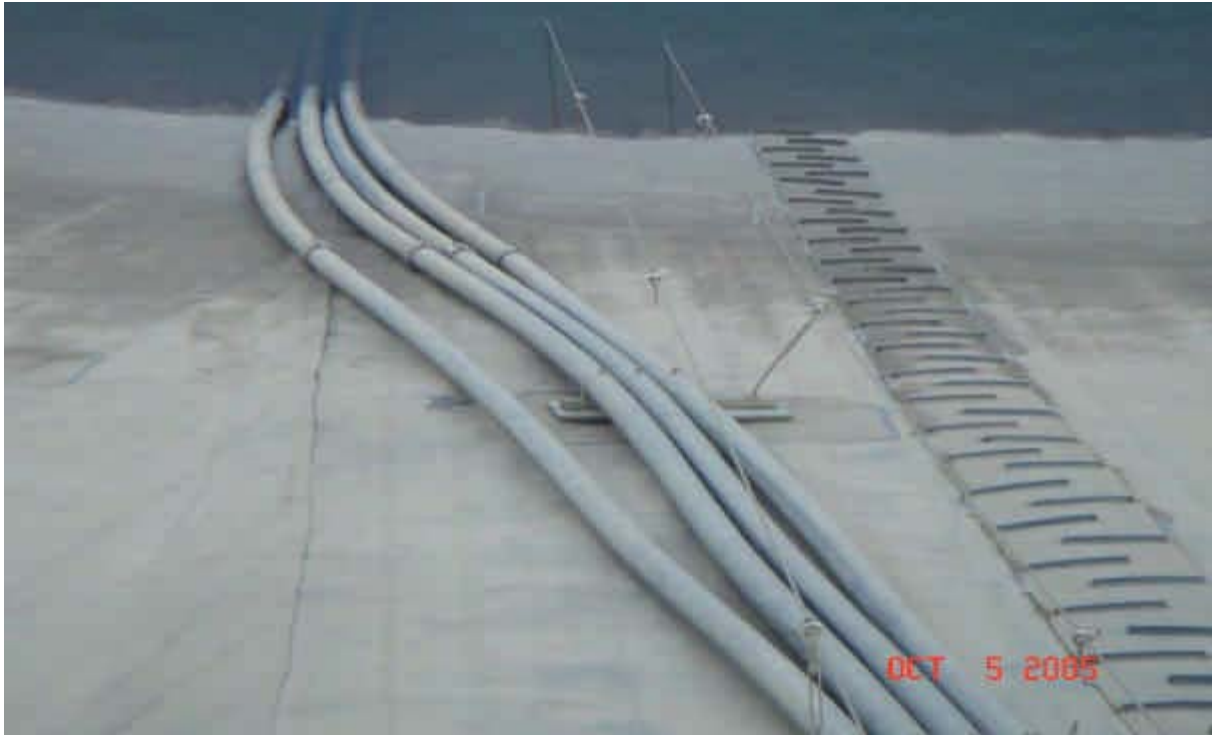
**FIGURE 9-2**

As may be seen in *Figure 9-1*, the bottom portion of the turnbuckle is connected to a horizontal steel member, called a Unistrut. A Unistrut is a U-shaped member with flanges that allow for a clamp to grasp the member. We observe on *Figure 9-2* that the Unistrut assembly failed to function as intended. The nut-Unistrut assembly became disengaged when the lateral displacement of the Unistrut became more pronounced (over one or two feet) as may be seen on *Figure 9-2*. It is RIZZO's opinion that the side to side movement of the instrumentation conduit allowed momentum to build up enough to create impact forces on the Unistrut-clamp connection. These impacts caused the clamps to slide off the Unistrut, leaving the instrumentation conduits to act as four individual elements instead of the much stiffer arrangement provided by the intended configuration.

**LAYOUT OF INSTRUMENTATION CONDUITS AND UNISTRUTS**

*Figure 9-2* shows the lateral displacement noticed in the conduits about two months before the overtopping failure of the Reservoir. Plant operators were aware that this lateral displacement would have the effect of raising the gage instruments and lowered the pump auto stop elevation by two feet after this observation. It is RIZZO's opinion that that this was not sufficiently conservative considering the level of uncertainty involved.
