FEDERAL ENERGY REGULATORY COMMISSION RESTORATION INSPECTION REPORT

**FEDERAL ENERGY REGULATORY COMMISSION
PHOTOGRAPHIC RECORD**

Docket No.: CP17-40-000 and CP17-40-001

Project: Spire STL Pipeline

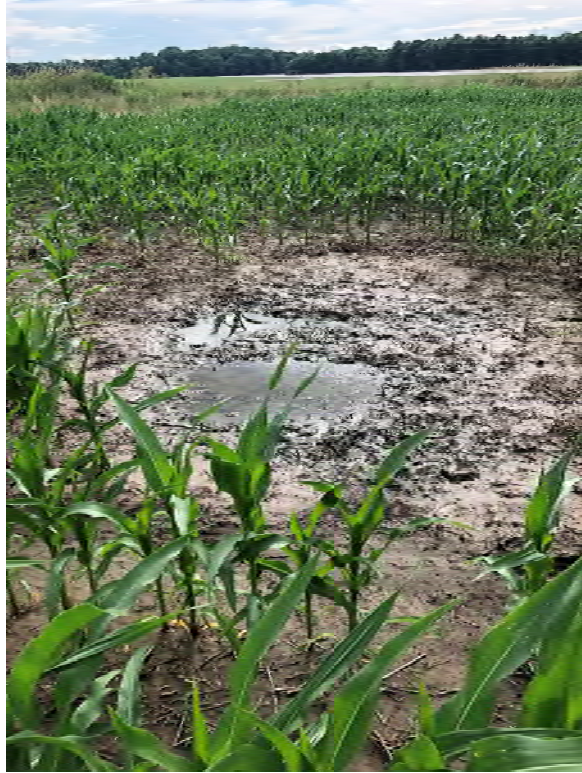
Photo No.: 1

Assessment: Problem area, previously identified.

Comments: Low-spot, grade/contour issues. Brown property contained numerous issues including low-spots, inconsistent grade/contour, rill erosion (minor – severe), rock and construction debris and modified surface flow. Mr. Brown provided pictures depicting soil mixing and also expressed concern about a nearby well.

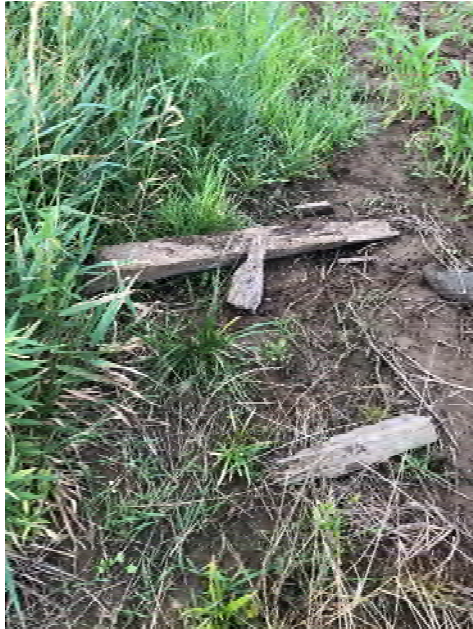
Photo No.: 2

Assessment: Problem area, previously identified.

Comments: Remaining construction debris. Representative photo - one instance of many locations where construction debris was not adequately removed from affected lands.

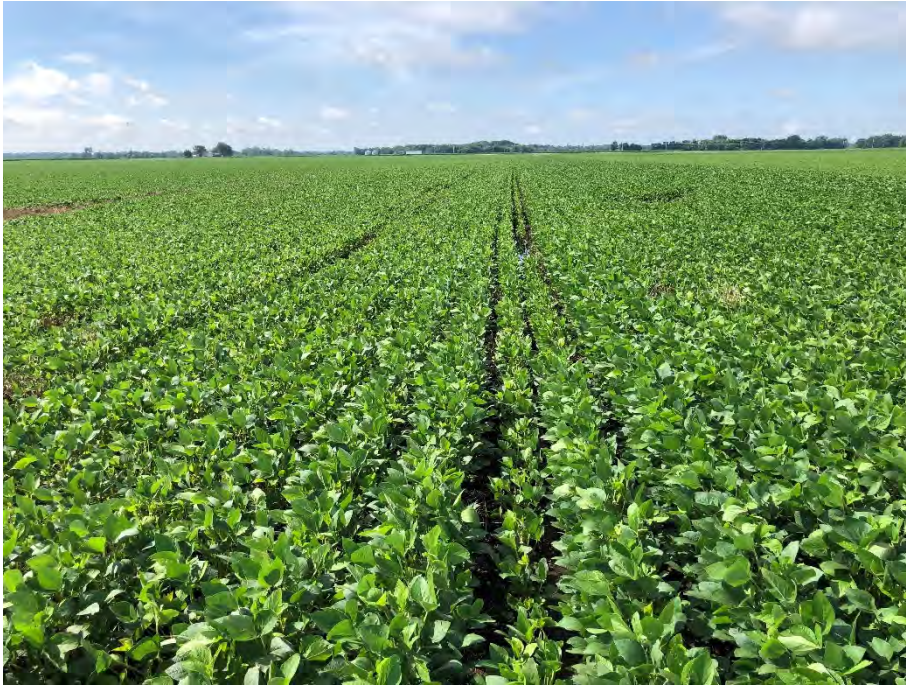
Photo No.: 3

Assessment: Acceptable.

Comments: Returned to agricultural land use. Vegetation growth is generally consistent across affected and unaffected lands. A minor low-spot was observed on the right-of-way ; Spire should discuss potential remediation actions with the landowner, whether performed by Spire or whether this low-spot will self-correct after crop harvest and reworking of the soil in between growing seasons.

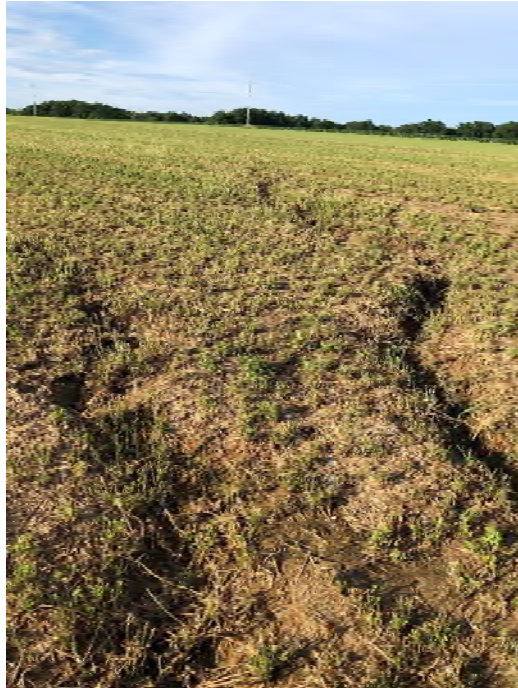
Photo No.: 4

Assessment: Problem area, previously identified.

Comments: Rill erosion. Numerous instances of rill erosion were observed throughout the multi-day inspection. This is an example of moderate rill erosion.

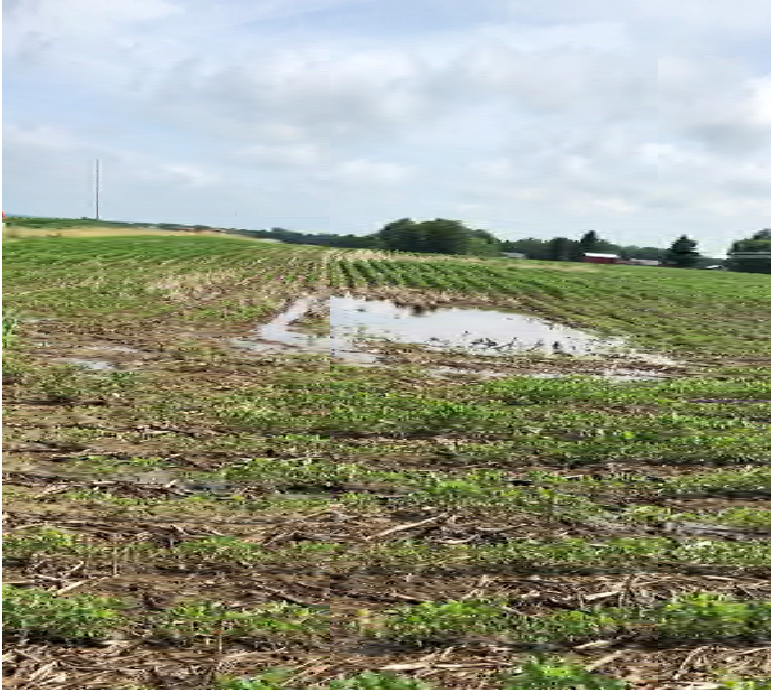
Photo No.: 5

Assessment: Problem area, previously identified.

Comments: Numerous low-spots were observed on this property and throughout the lands affected by the project. Restoration conditions of the remaining right-of-way on this property were progressing satisfactorily.

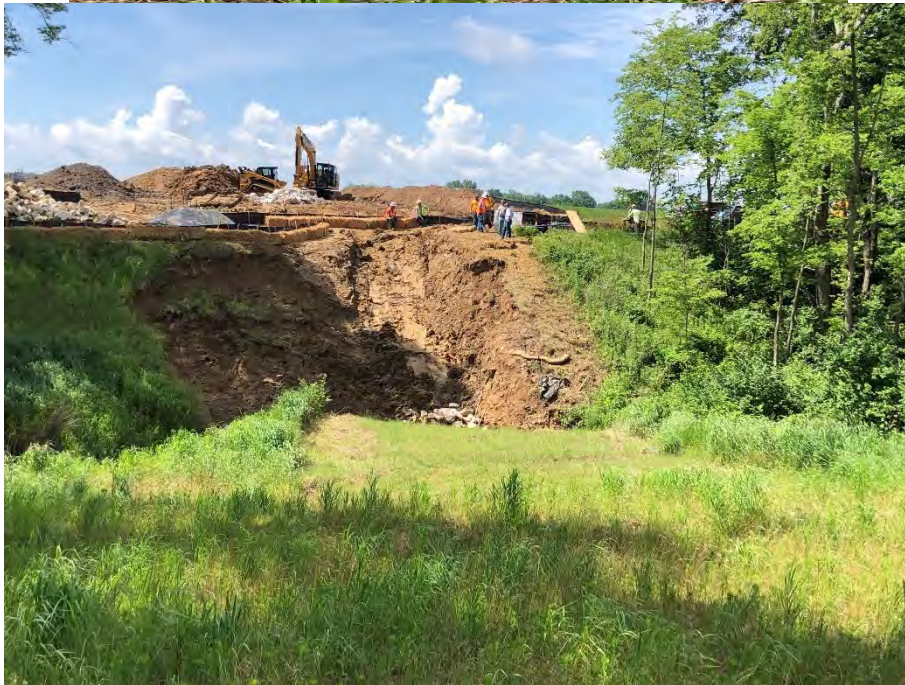
Photo No.: 6

Assessment: Acceptable.

Comments: Slope repair. The project crossed numerous slopes. The slope photographed had slipped and was being restored by Spire at the time of inspection. Restoration conditions of the remaining right-of-way on this property were progressing satisfactorily.

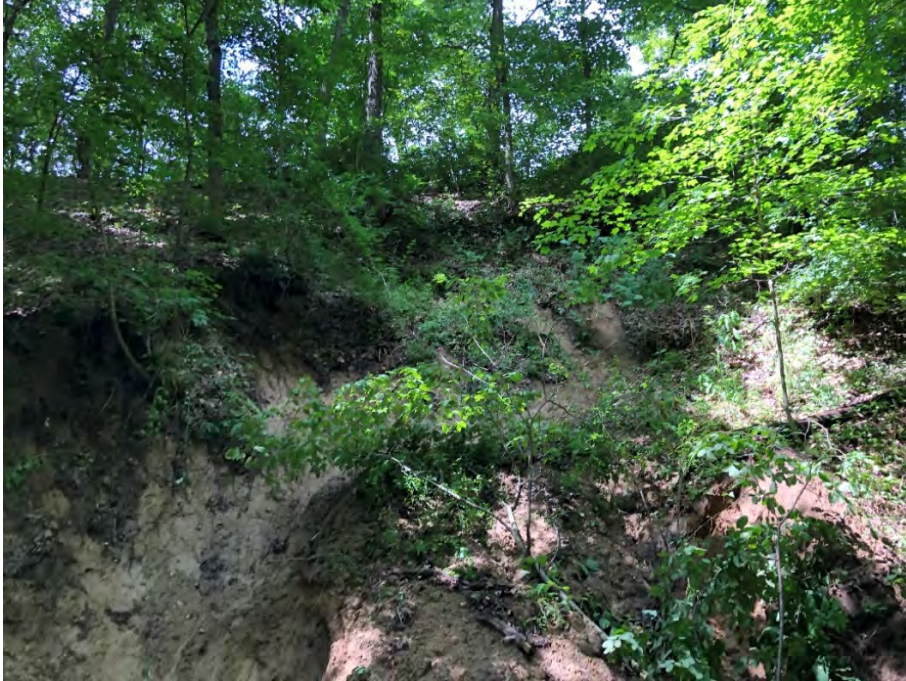
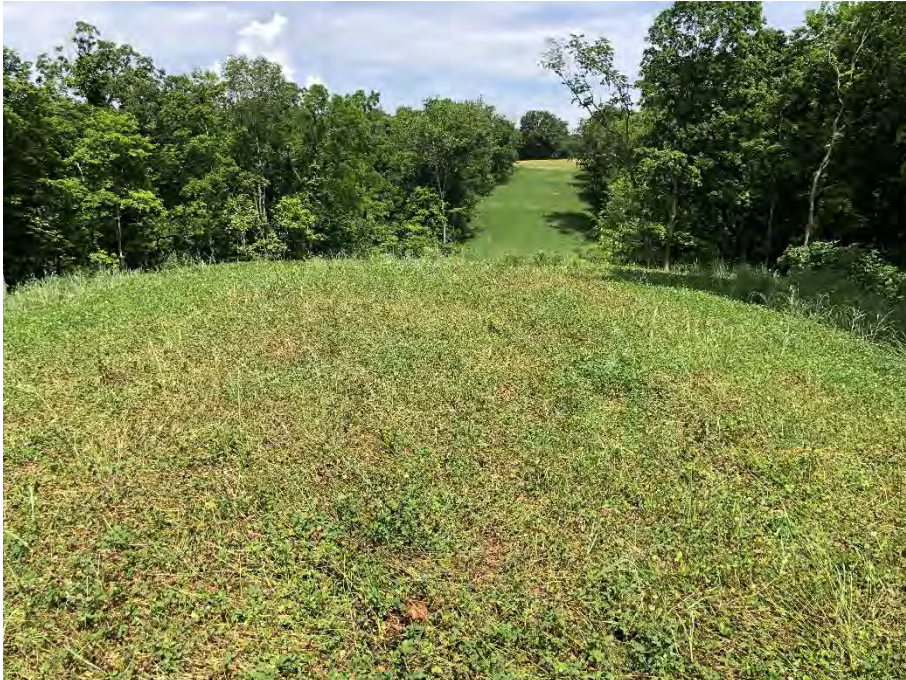
Photo No.: 7a and 7b

exhibited only mild examples of these conditions. Additionally, on two observed properties that have been stabilized, examples of modified surface flow were observed, which have resulted in new drainage patterns that may require further attention (photo nos. 7 a/b).

Assessment: Problem area, newly identified.

Comments: Slope instability/slip. The grade/contours/slope on Mr. Davis' property were stabilized and restored; however, it appears these efforts resulted in changes to drainage and waterflow which may have contributed to adjacent slope instability. Mr. Davis' property also contained low-spots, excessive rock, and rill erosion at several locations. Continued monitoring is necessary and additional remediation may be required.

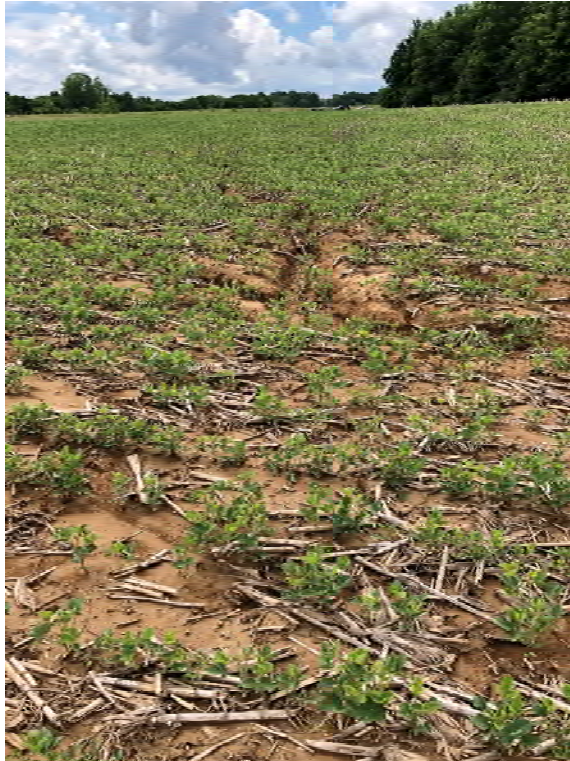
Photo No.: 8

Assessment: Problem area, newly identified.

Comments: Minor trench subsidence and sparse vegetation. The property also contained rill erosion and grade issues. Restoration conditions of the remaining right-of-way on this property were progressing satisfactorily.

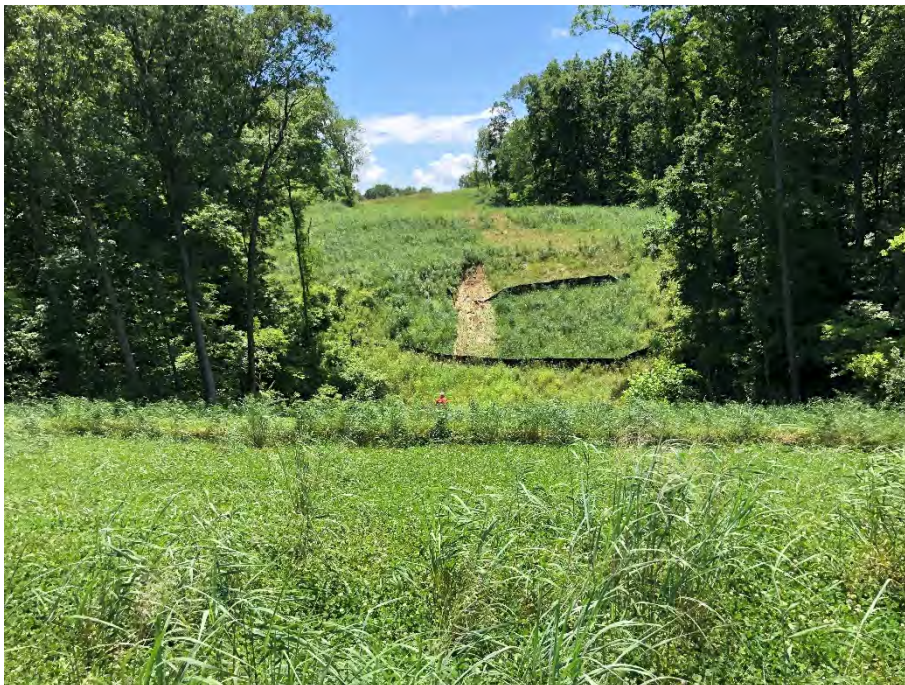
Photo No.: 9

Assessment: Problem area, newly identified.

Comments: Minor slip on stream bank requiring attention. Representative of other stream banks observed throughout inspection. Restoration conditions of the remaining right-of-way on this property were progressing satisfactorily.

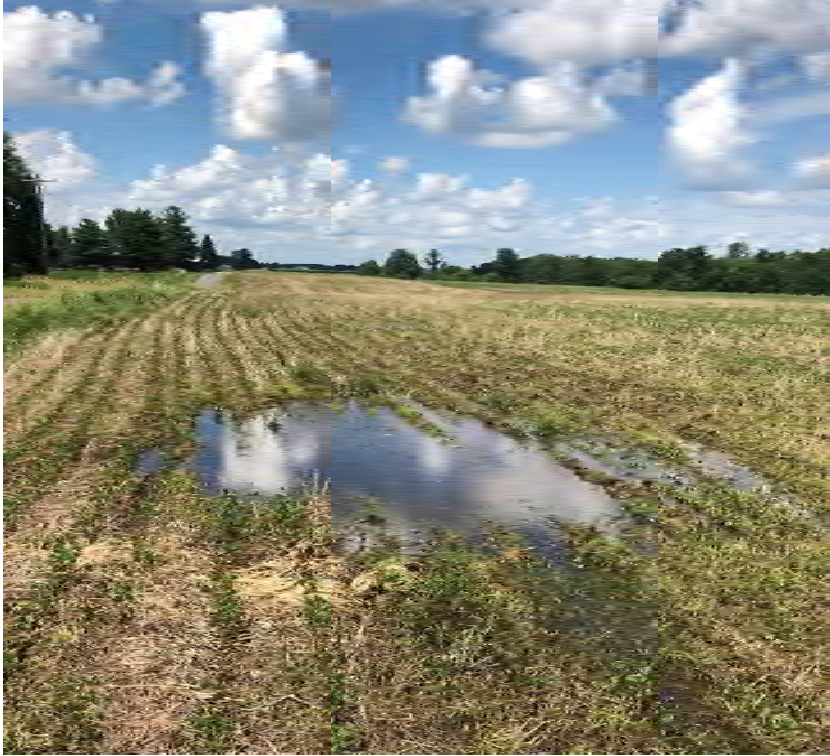
Photo No.: 10

Assessment: Problem area, previously identified.

Comments: One of numerous low-spots on this property. Restoration conditions of the remaining right-of-way on this property were progressing satisfactorily.

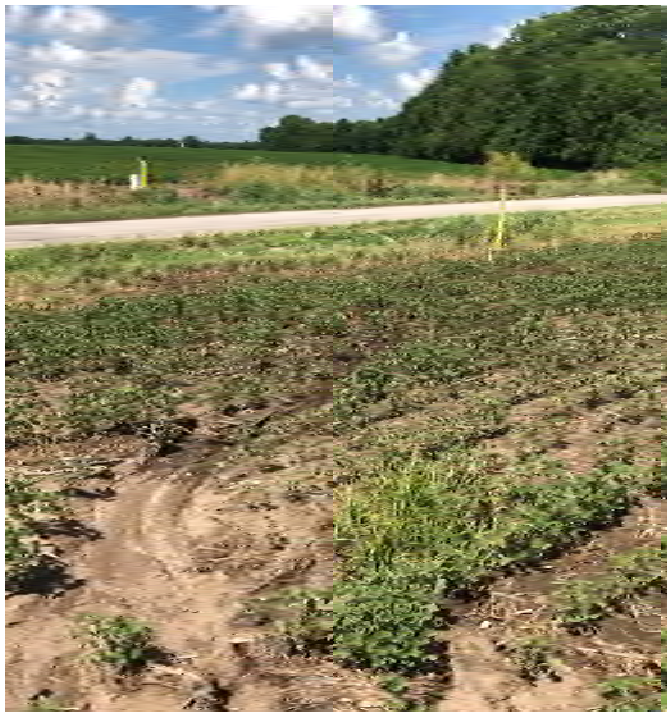
Photo No.: 11

Assessment: Problem area, previously identified.

Comments: In addition to rill erosion, low-spots throughout property. Restoration conditions of the remaining right-of-way on this property were progressing satisfactorily.

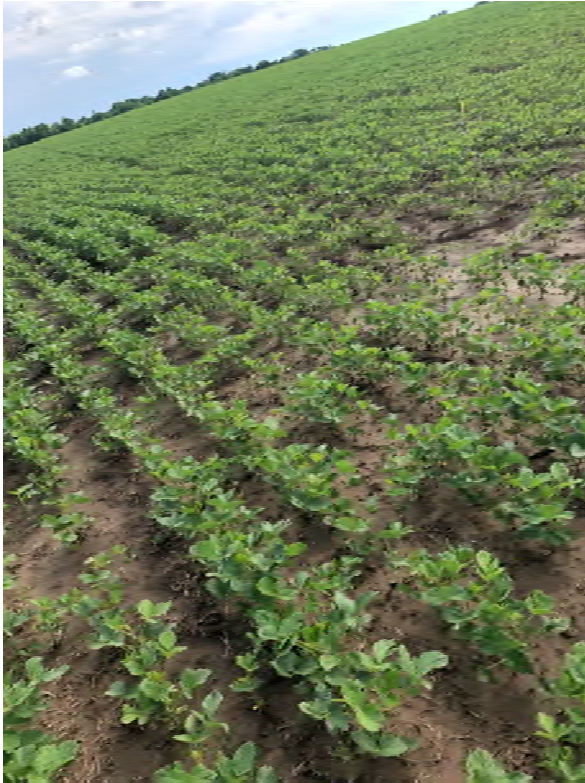
Photo No.: 12

Assessment: Problem area, previously identified.

Comments: Mr. Meyer's property included low-spots, grade issues, and spots lacking vegetation.

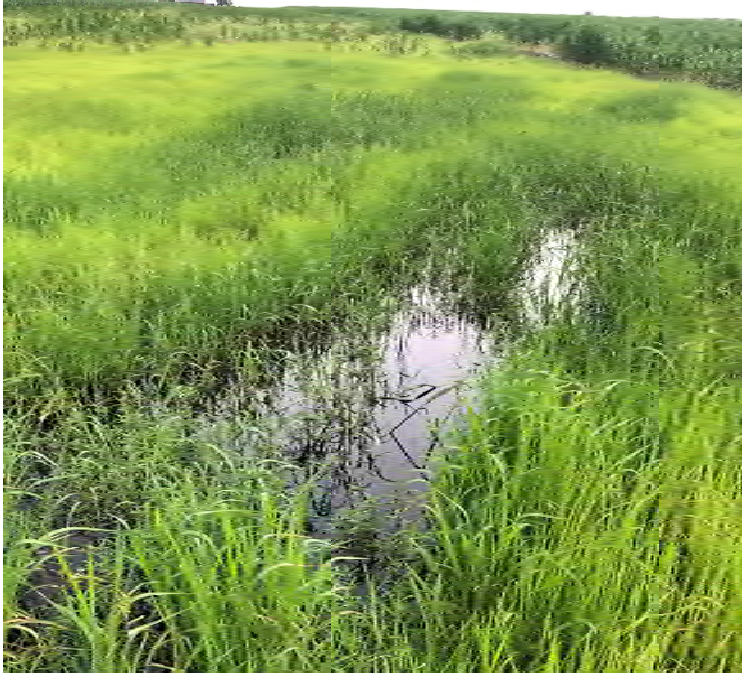
Photo No.: 13

Assessment: Problem area,
previously identified.

Comments: Mr. Gettings' property
includes low-spots and grade issues.

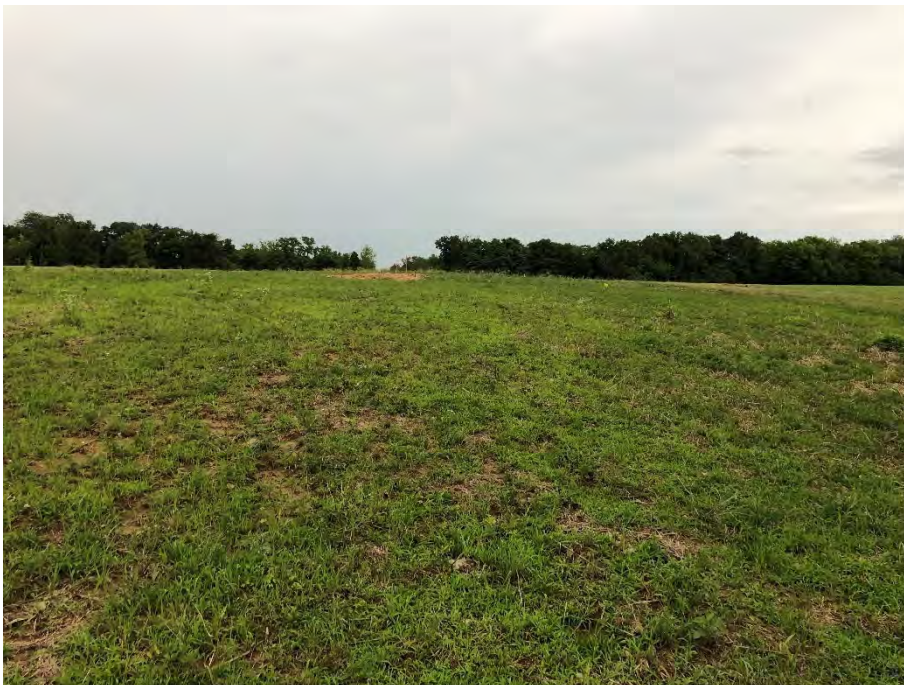
Photo No.: 14

Assessment: Problem area, newly
identified.

Comments: Cattle pasture with
vegetation that is inconsistent with
adjacent lands.

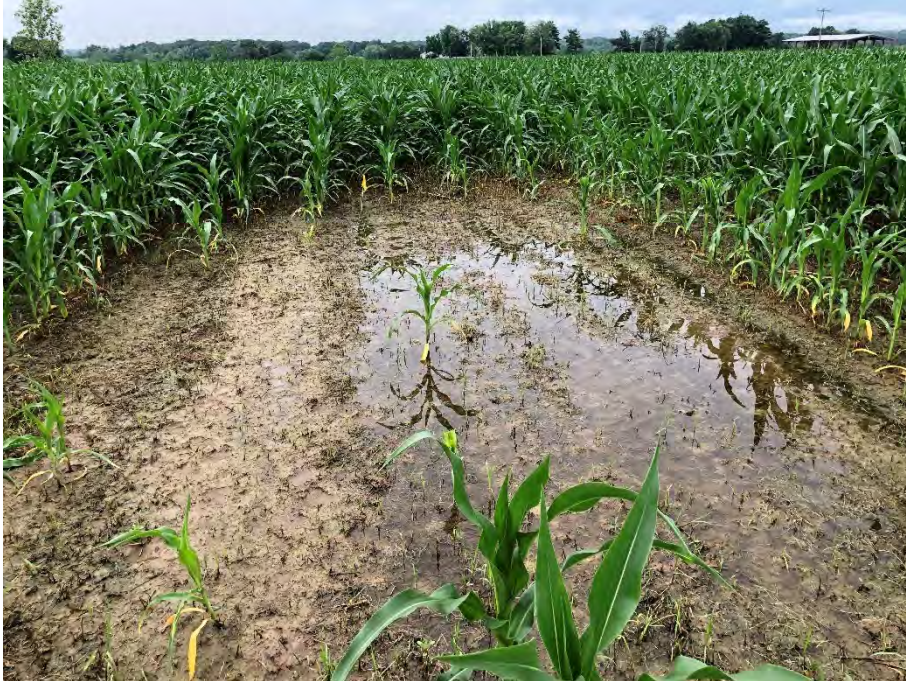
Photo No.: 15

Assessment: Problem area,
previously identified.

Comments: Low-spots, rill erosion,
construction debris all present on Mr.
Sinclair's property.

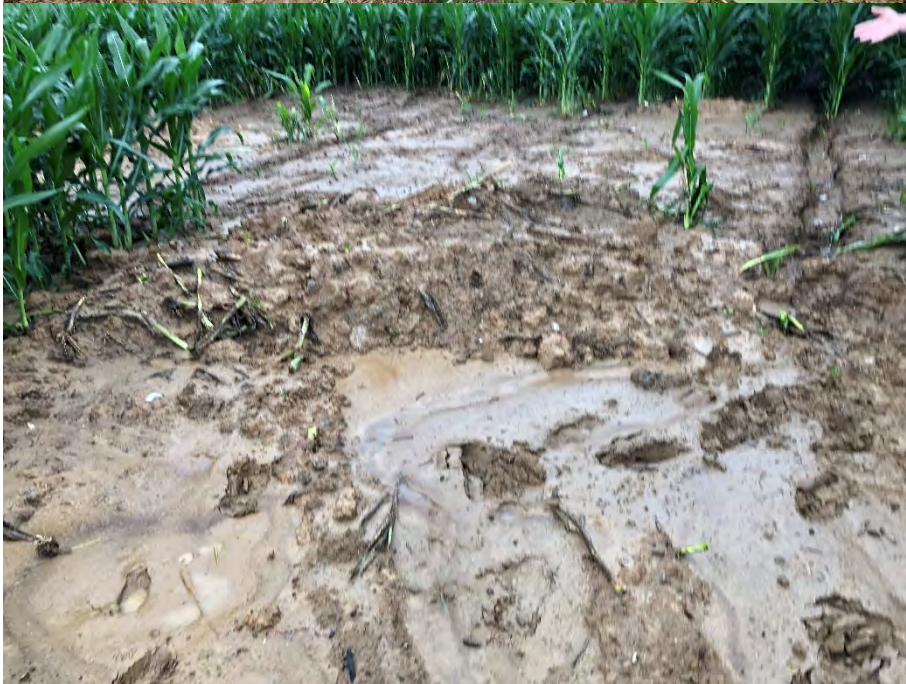
Photo No.: 16

Assessment: Problem area, newly
identified.

Comments: Erosion deposition.
Slope and rill erosion, construction
debris, creek bank slip, and lack of
vegetation observed on the Longhorn
property.

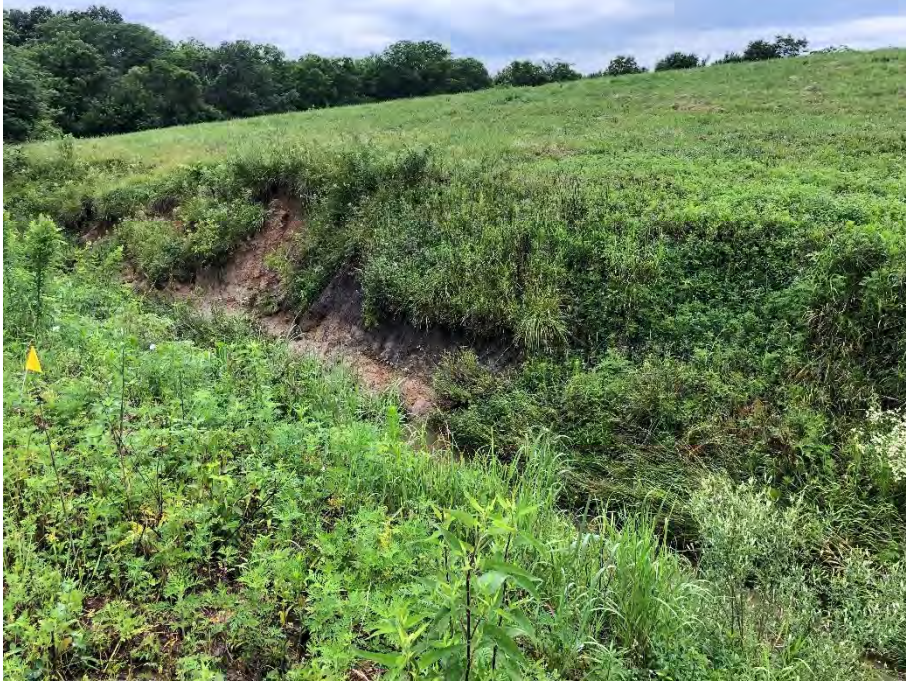
Photo No.: 17

Assessment: Problem area, newly identified.

Comments: Representative streambank slip.

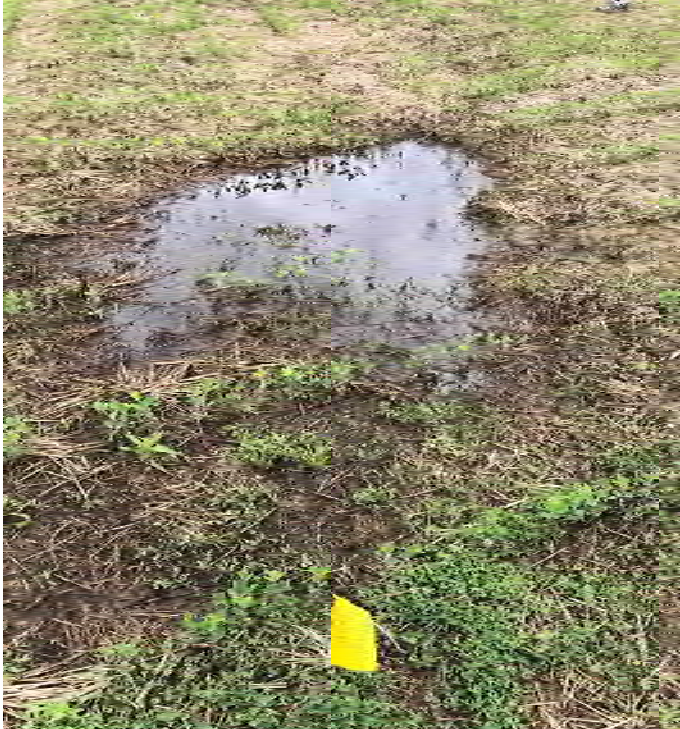
Photo No.: 18

Assessment: Problem area, previously identified.

Comments: Low-spot. Restoration conditions of the remaining right-of-way on this property were progressing satisfactorily.

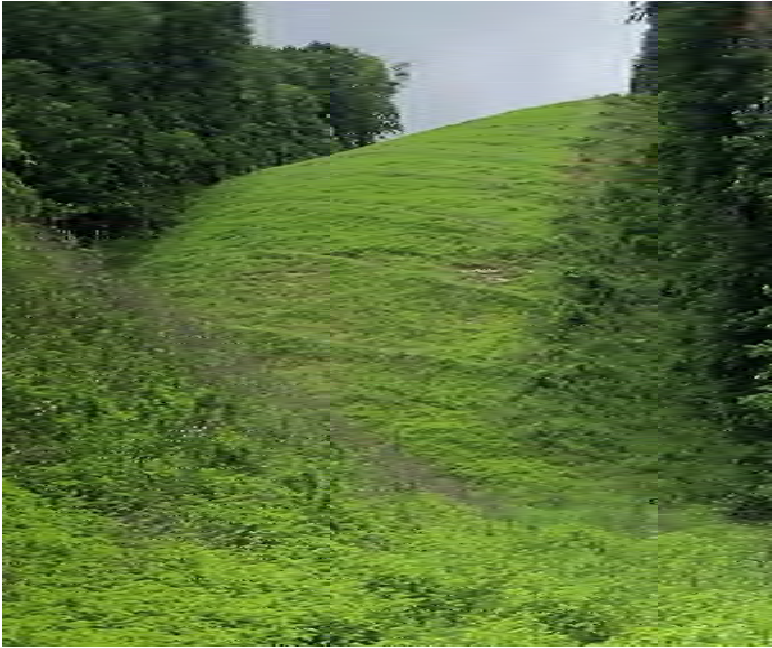
Photo No.: 19

Assessment: Successful restoration.

Comments: Slope stabilized and revegetated. No environmental concern observed.

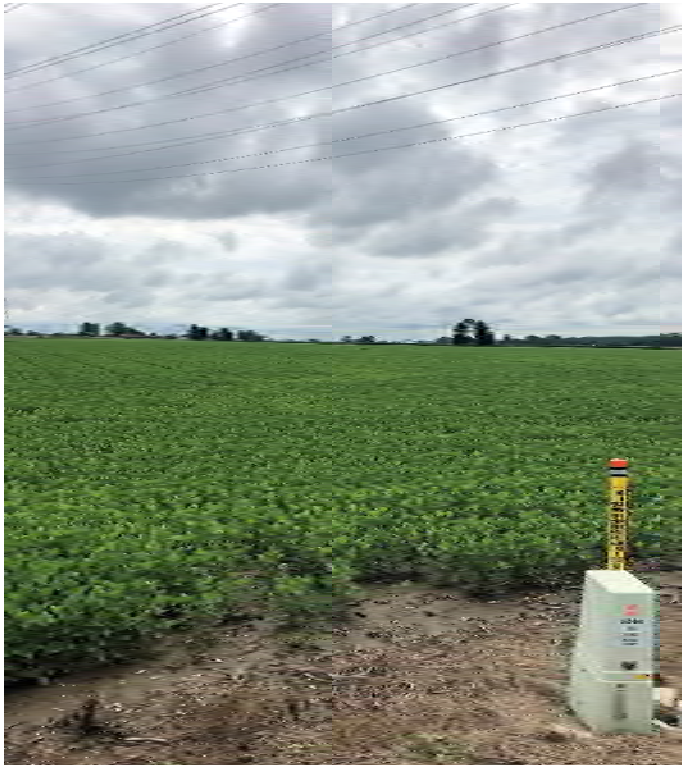
Photo No.: 20

Assessment: Successful restoration.

Comments: Road crossing. No environmental concern observed. Grade and vegetation growth appear consistent with off-right-of-way lands.
