## STAFF's GAS INCIDENT REPORT

**1106 The Paseo  
Kansas City, Missouri  
July 16, 2018 Natural Gas Incident**

**Spire Missouri Inc. d/b/a Spire Missouri West**

**Case No. GS-2019-0015**

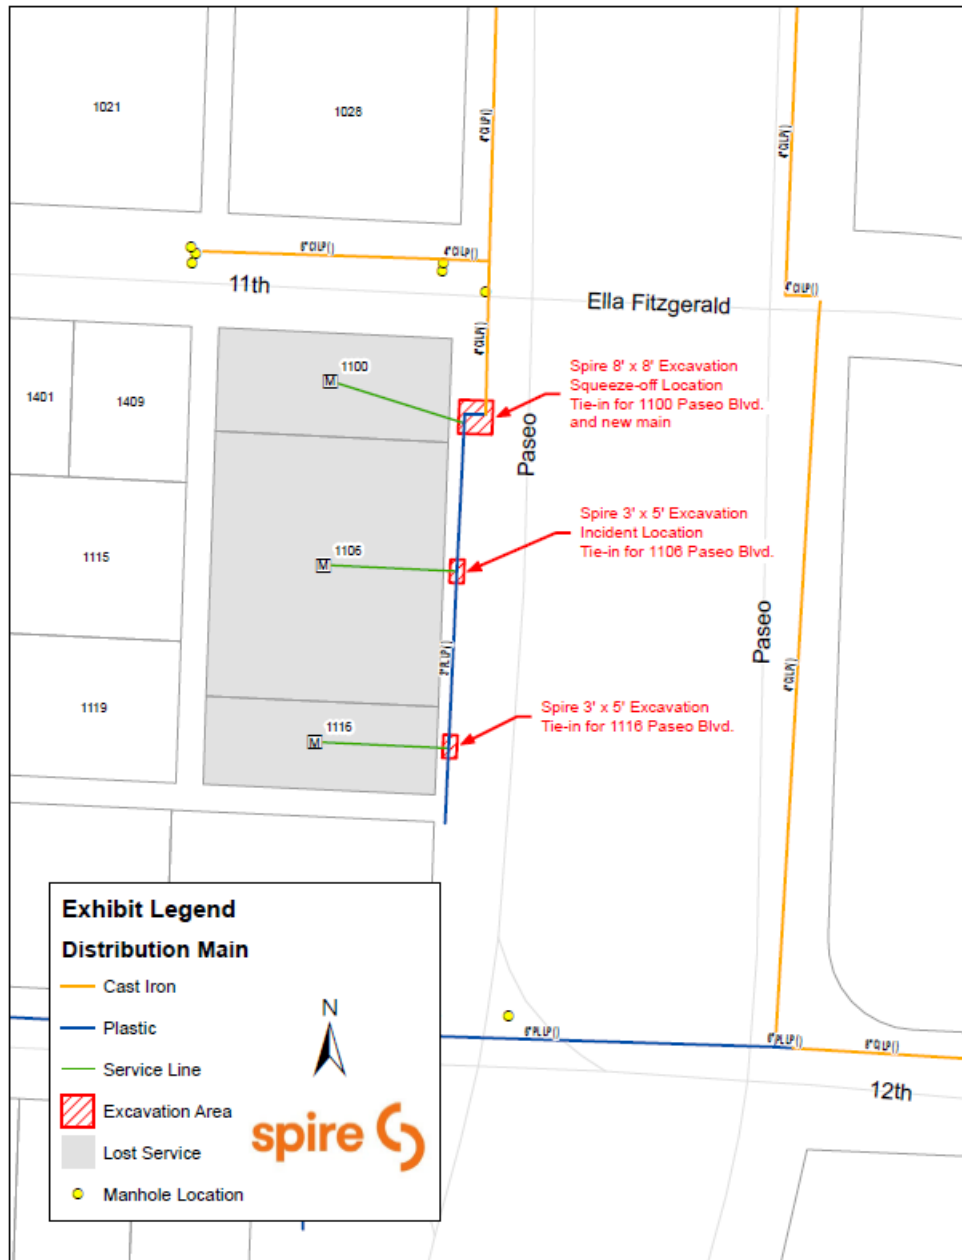
**Figure 2: Schematic Representation of Spire Mains and Service Lines in the Incident Vicinity. A Note indicates a 3-foot by 5-foot Excavation at the Tie-In Location for the Service Line to 1106 to the Main along Paseo (Source: Spire)**

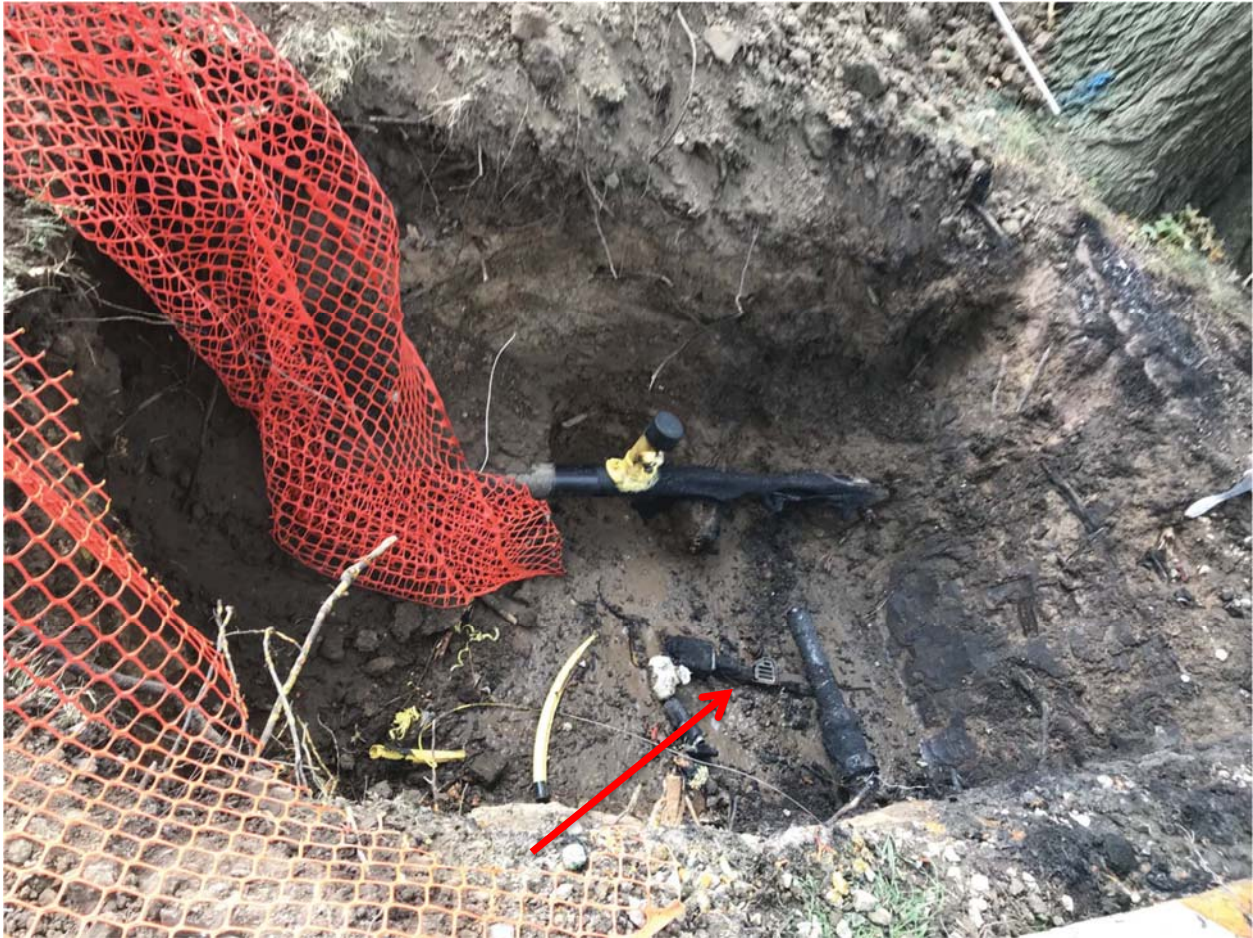
**Photograph 1: Photograph looking down into the excavation following the incident. (Source of Photograph: Spire in Response to Staff Data Request 0032). The red arrow (added by Staff) points to electric reciprocating saw shown in Photograph 2. Note: In response to Staff Data Request 0061, Spire answered that the electric reciprocating saw in Photograph 2 is the same electric reciprocating saw at the bottom center of Photograph 1.**

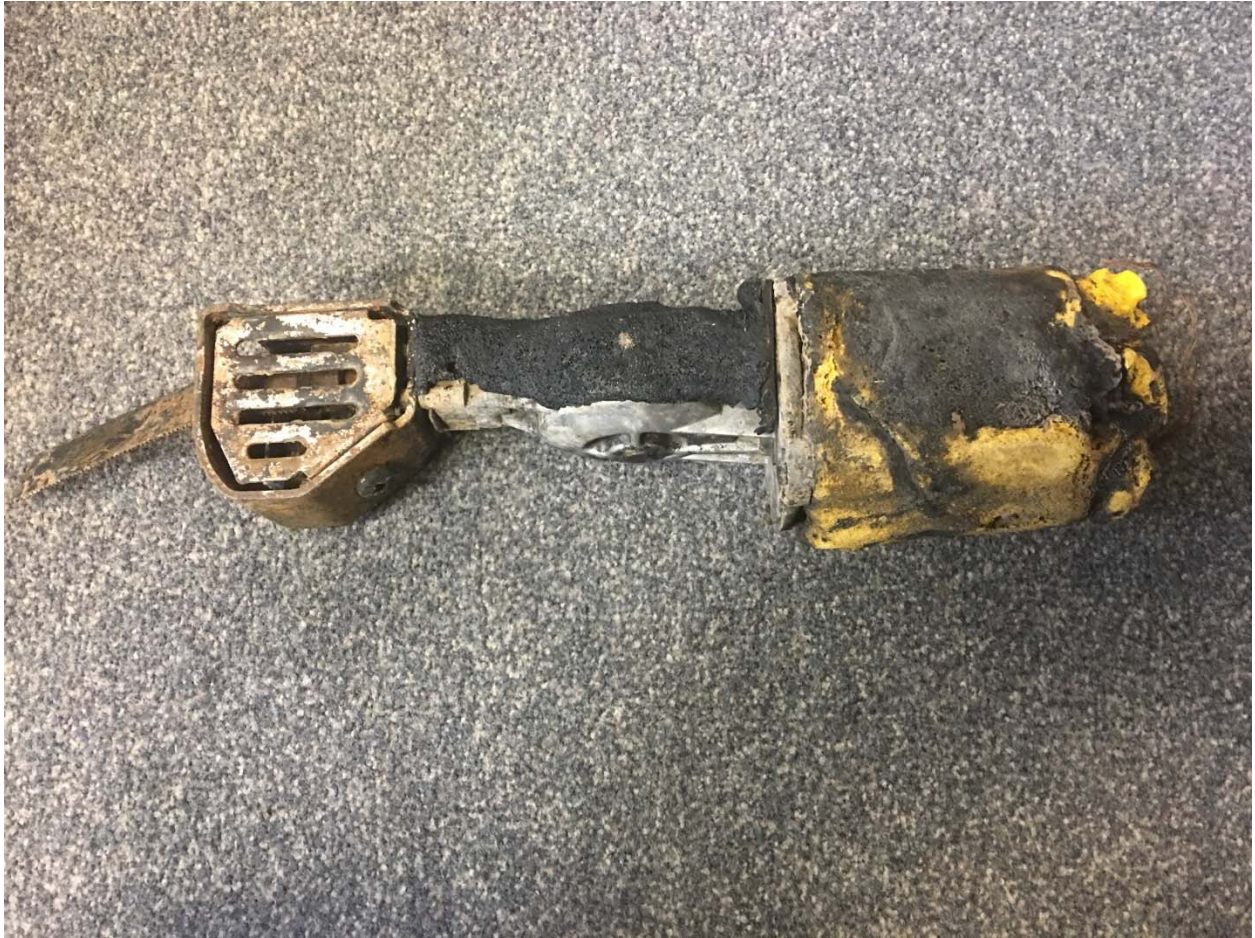
**Photograph 2:        Photograph of electric reciprocating saw following the incident  
(Source: Spire, confirmed in Spire response to Staff Data Request 0061).**

The electric Sawzall is believed to be the ignition source. The contractor's foreman failed to safely lead his crew. Required procedure for service line abandonment was not followed. There was failure to exercise stop work authority to prevent this incident. Work was being conducted in a gaseous environment without wearing a firesuit and fresh air breathing system. There was no fire watch in place.

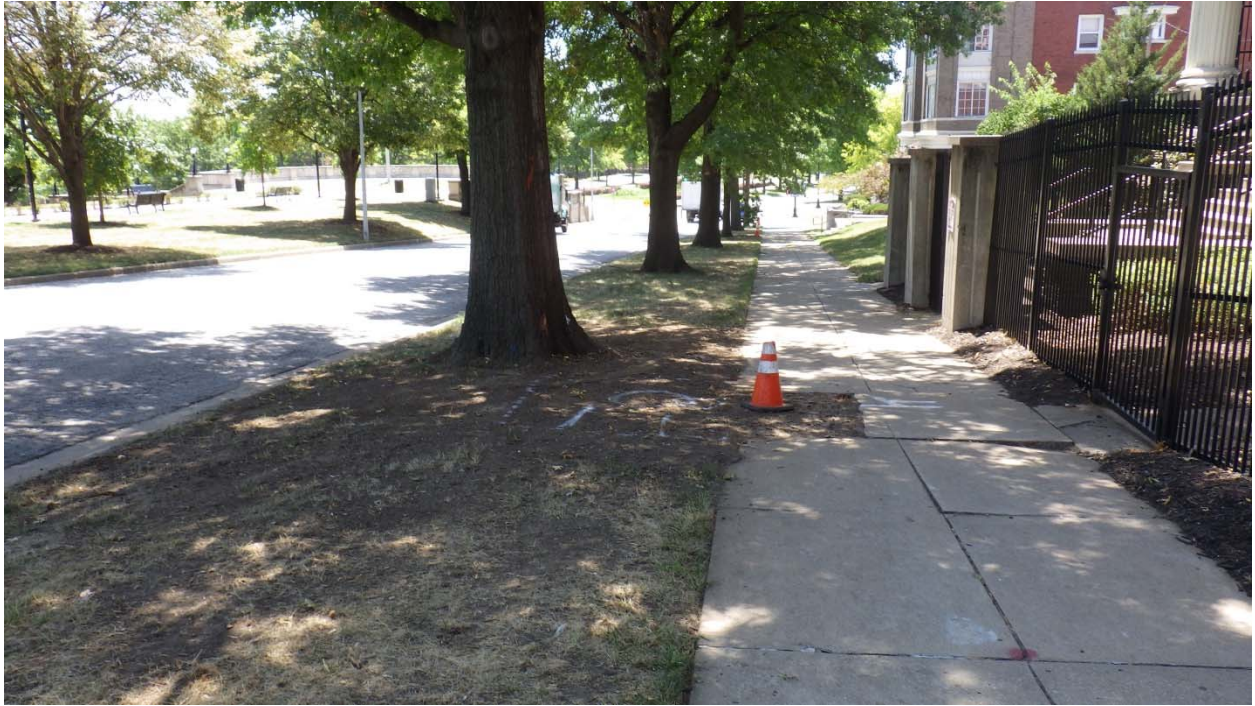
**Photograph 3: Photograph was taken on 07-24-2018 looking South along The Paseo. The excavation has been backfilled and its location is marked with a safety cone. (Source: Staff)**

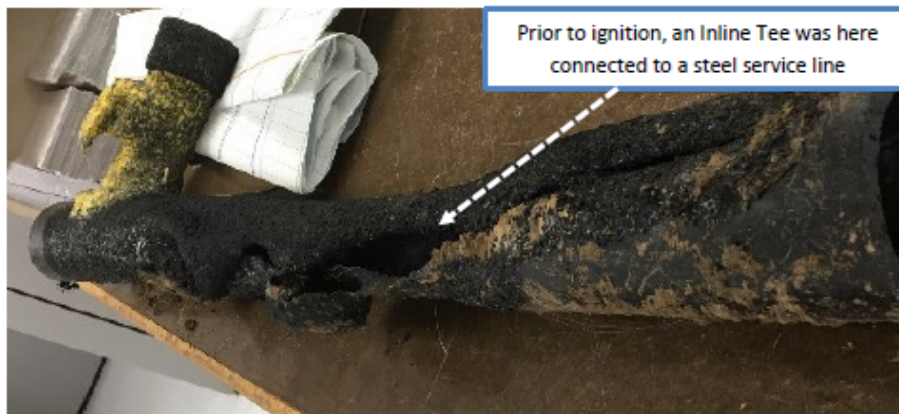
A contractor for Spire was renewing a service line. The new service line was in place and the contractor crew was abandoning the existing steel service line. The existing service line was plastic to steel. Instead of safely stopping the flow of gas to the gas main or service line, the contractor cut the plastic portion of the existing service line with a ratchet pipe cutting tool resulting in gas escaping from the cut line for several minutes. While trying to insert a Permasert coupling in the open line, the contractor crew did not have a chamfering tool available, so they used a pocket knife instead. The contractor was unable to get the Permasert coupling installed and gas continued to escape. The contractor foreman instructed his employee to use an electric sawzall to cut the steel portion of the existing service line to allow more space to install the coupling. The contractor employee in the excavation expressed concern about using the sawzall, but proceeded with using the sawzall anyway. Within a few seconds an ignition occurred, resulting in serious burns to the contractor employee in the excavation, and also to a contract laborer who had just walked up near the excavation.
