Final Staff Report

Kansas City Power & Light Company  
Case No. ES-2007-0458

Superheater Attenuator Spray Water Pipe Failure  
Iatan Plant  
Weston, Missouri  
May 9, 2007

Prepared by the Staff of the  
Missouri Public Service Commission  
March 17, 2008

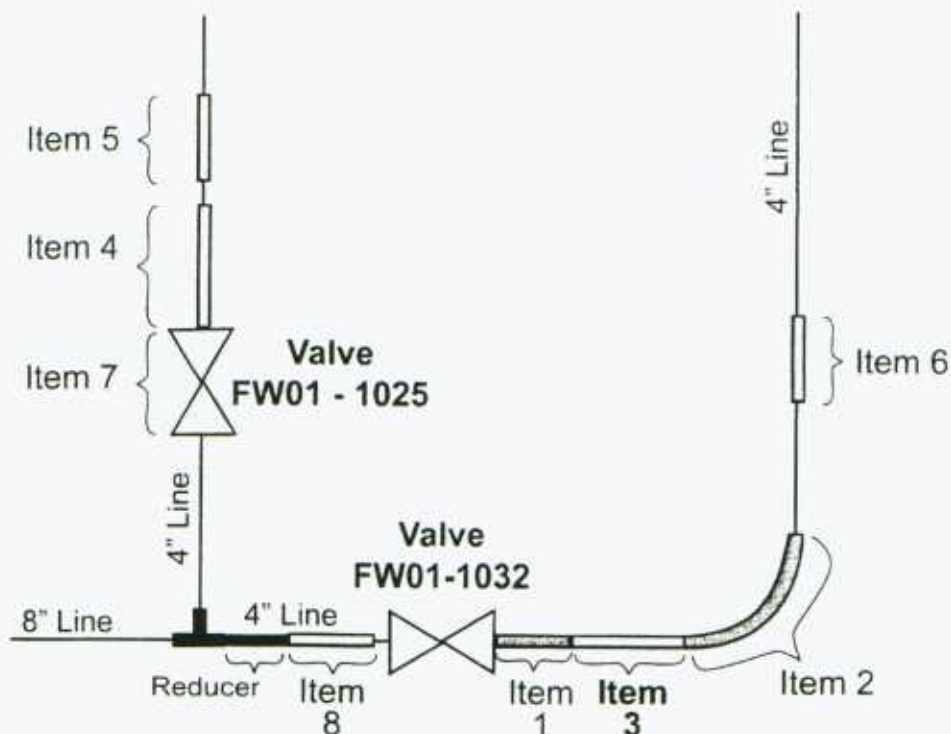
**Figure 1.1**

The failed pipe, along with seven other items, was sent to Performance Improvement International, LLC for failure mode determination. Eight items associated with the Iatan pipe rupture event were physically provided to PII to perform a detailed failure analysis. The locations of these eight items in the plant are illustrated in Figure 1.1. Due to a lack of replacement parts, SH attenuator spray 1A block valve FW01-1032 remains in service at the Iatan plant and is not included in the failure analysis. The body and the valve seats of SH attenuator spray 1B block valve FW01-1025 are included in the failure analysis.

**Designation of Items Analyzed by  
PII Investigation Team (Item 3 = Failed Pipe)**

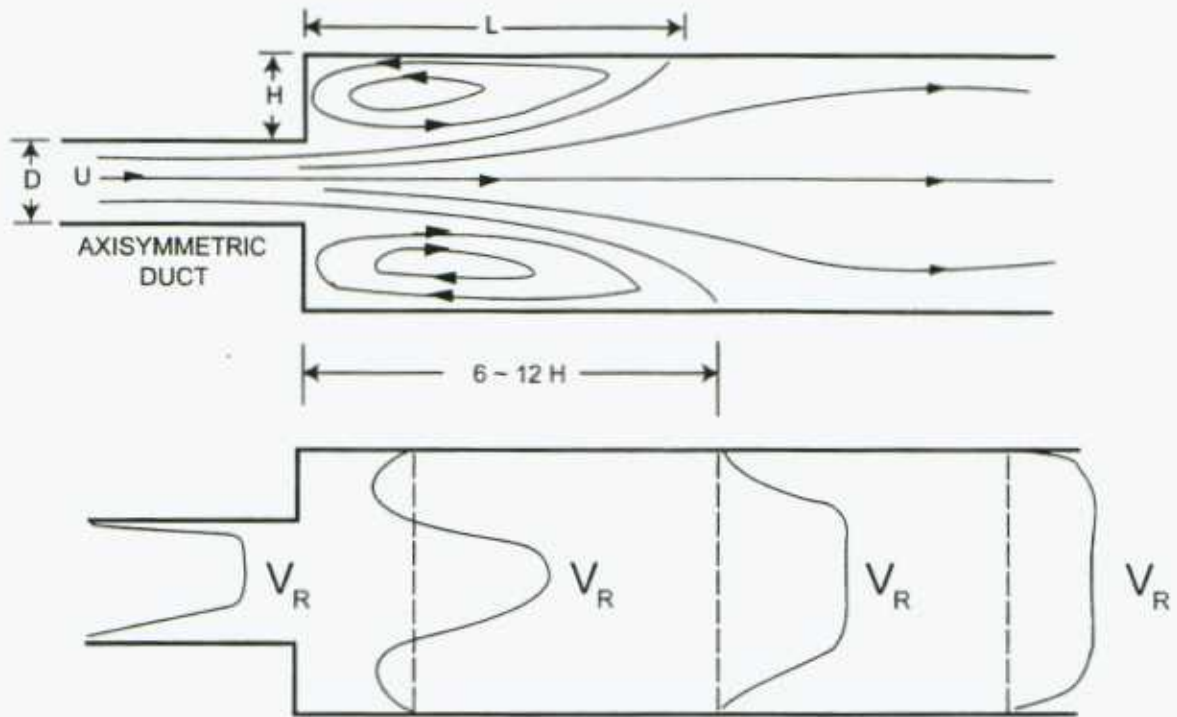
Figure 1.2

The throttled gate valve has a sudden opening, producing a flow separation and re-attachment condition in the downstream pipe (as shown in **Figure 1.2** with an exaggerated sudden expansion). The re-attachment point is approximately at a distance of 6-12H from the expansion. The re-attachment point in the failed portion of piping is located between 3.9 and 7.8 inches downstream of the weld between the failed pipe and the FW01-1032 valve.

### Typical Separation and Re-Attachment After a Sudden Expansion ( $V_R$ = Relative Velocity)

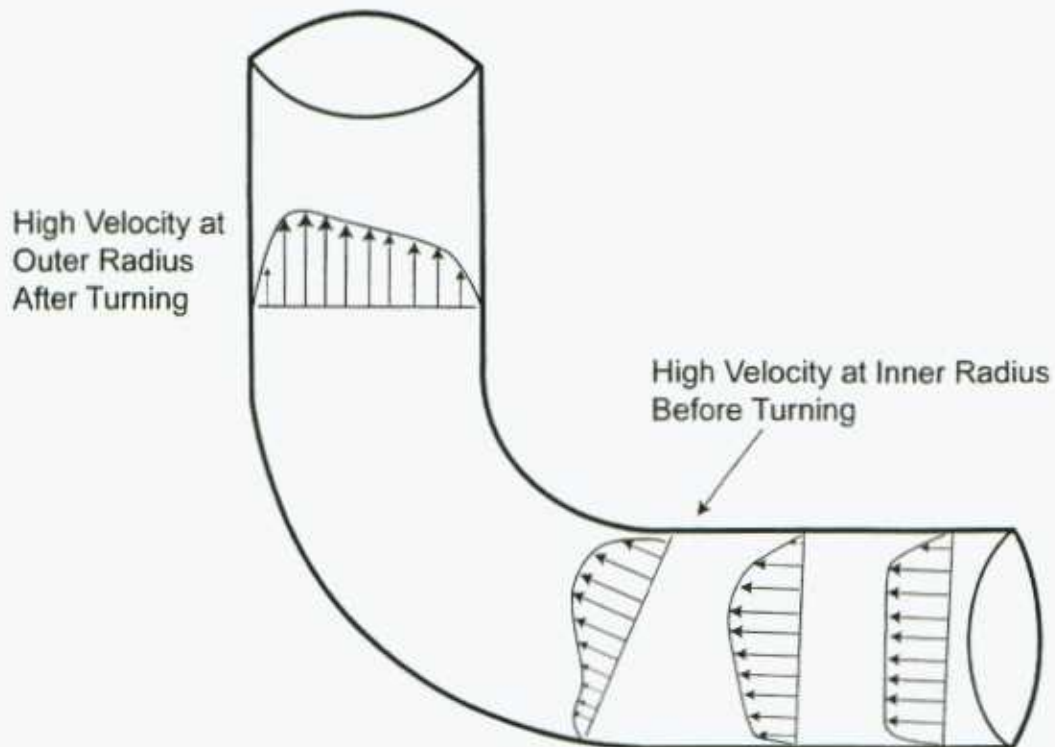
Figure 1.3

The component downstream of the failed pipe is a 90° degree standard elbow. Elbows tend to produce free-vortex flow (often called secondary flow) that result in a higher velocity at the inner radius of the elbow, starting about one pipe diameter upstream of the elbow. In the case of the failed pipe, this flow acceleration started about five inches downstream from the weld between the failed pipe and the FW01-1032 valve. The thinnest area was found to be about five inches downstream of the weld between the failed pipe and the FW01-1032 valve. **Figure 1.3** shows a typical velocity profile near and in the elbow.

### Illustration of Free-Vortex Flow Velocity Distribution

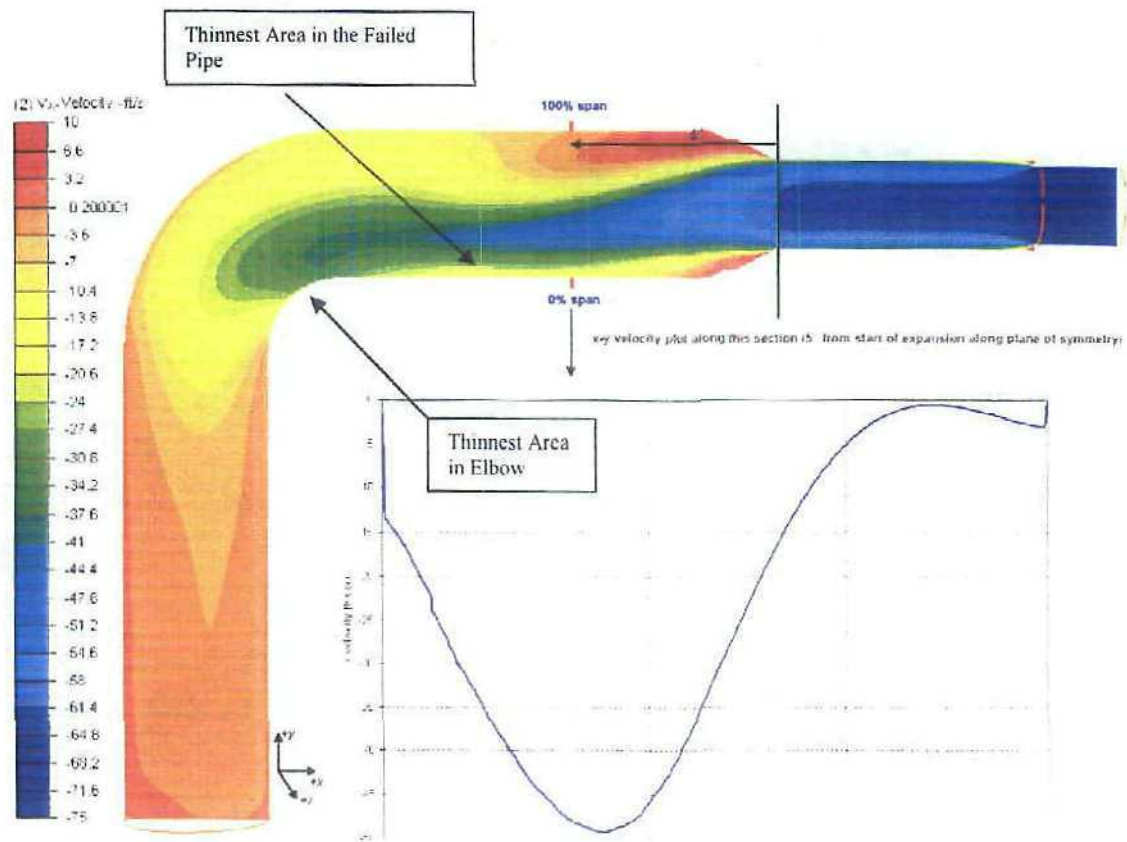
Figure 1.4

A finite element flow modeling of the failed pipe that combines both effects (free vortex flow and re-attachment) is shown in **Figure 1.4**. As can be seen in this figure, the radial velocity at the reattachment point at failed pipe near the inner radius of the elbow was very high. The investigation team believes that the radial velocity and the local high axial velocity (along the pipe line) contributed to the excessive rate of material transport, thus a high wear rate of the failed pipe.

As can be seen in the above figure, the thinnest area of the pipe was located near the reattachment point. Because of effects of impingement, the wear rate was high.

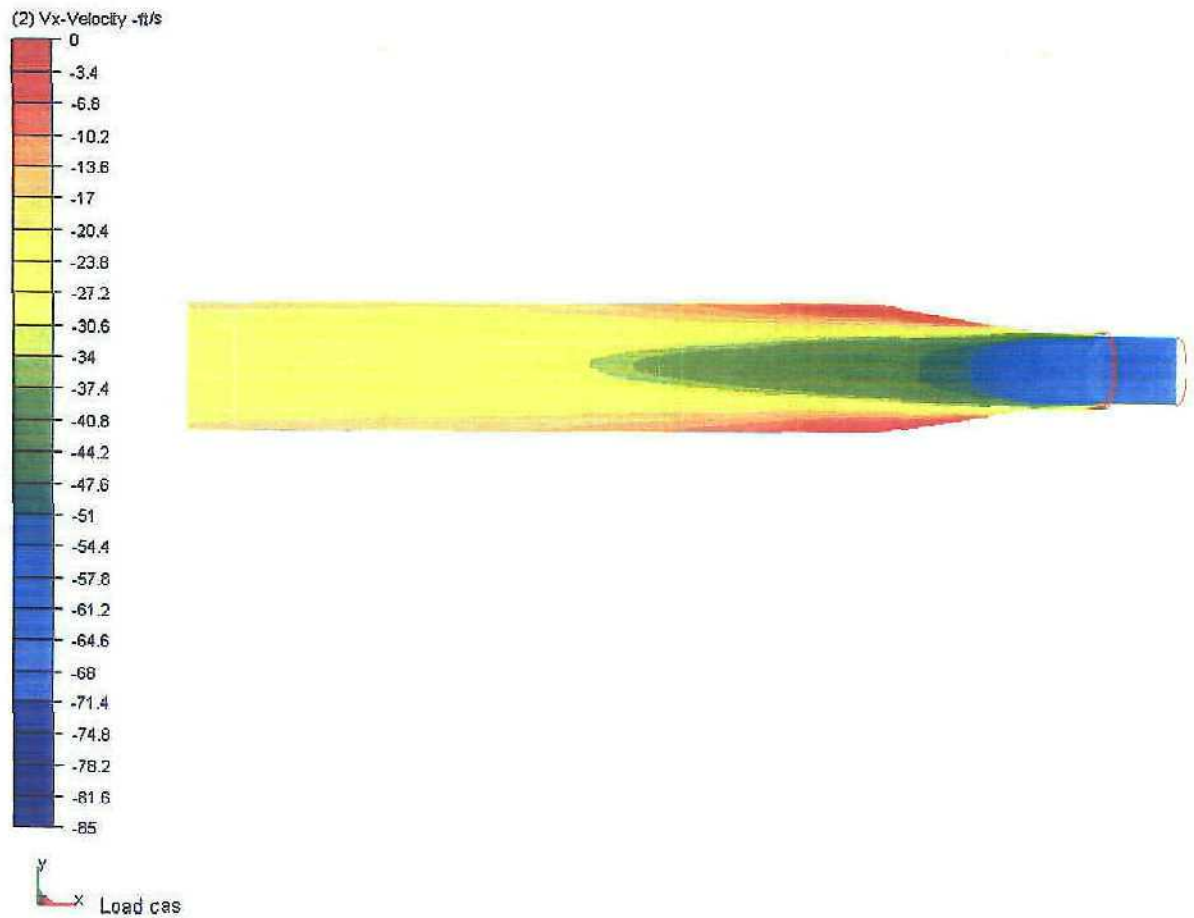
**Figure 1.5 Flow Patterns (X-Direction Velocity) Downstream of  
FW01-1025 Valve**

As can be seen in the above figure, there is little recirculation flow directly downstream of the FW01-1025. The flow was essentially attached to the pipe wall downstream of the valve without impingement. As such, the FAC rate is low.

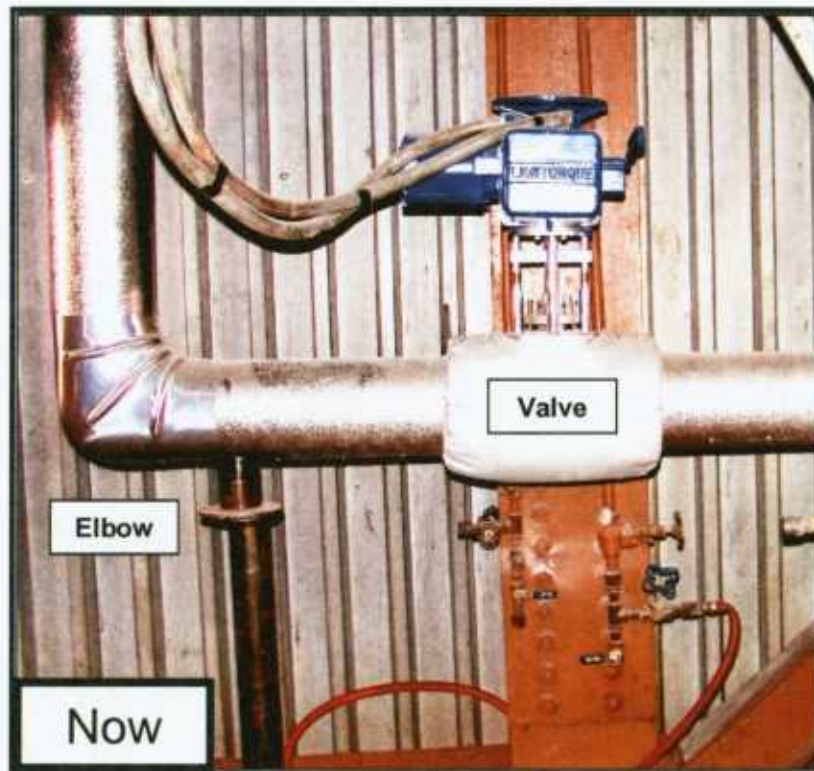
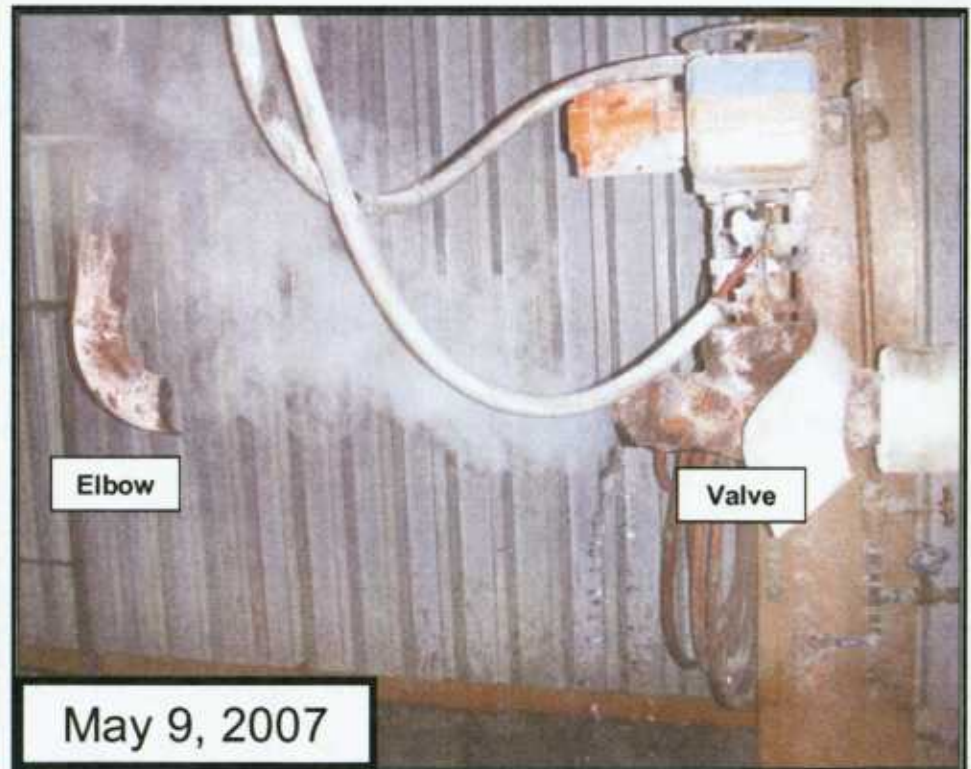
Failure occurred between gate valve & elbow

**\*\*THIS IS NOT A CONTROL VALVE, IT IS OPEN OR CLOSED\*\***

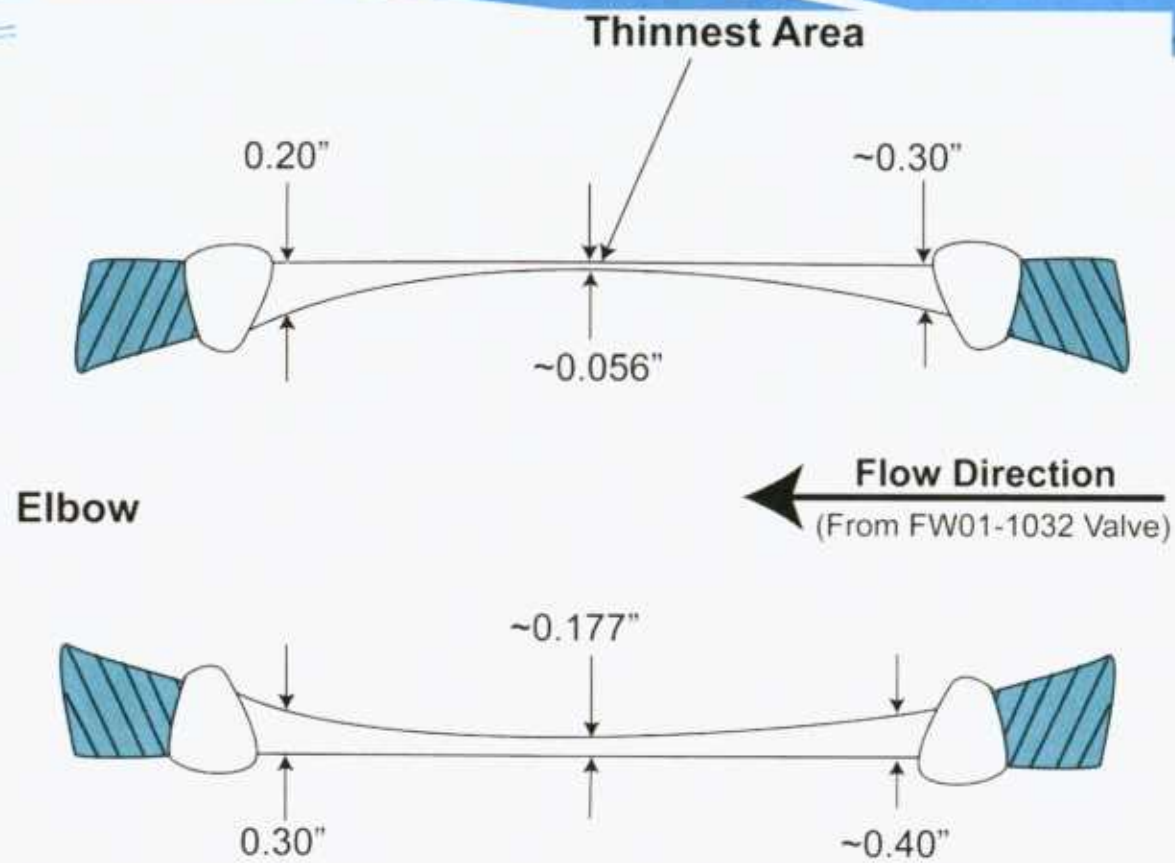
Figure 2.9

**Illustration of Wall Thickness Pattern  
at the Time of Rupture**

**Possible Origin of Fracture  
(Thinnest Wall Thickness)**

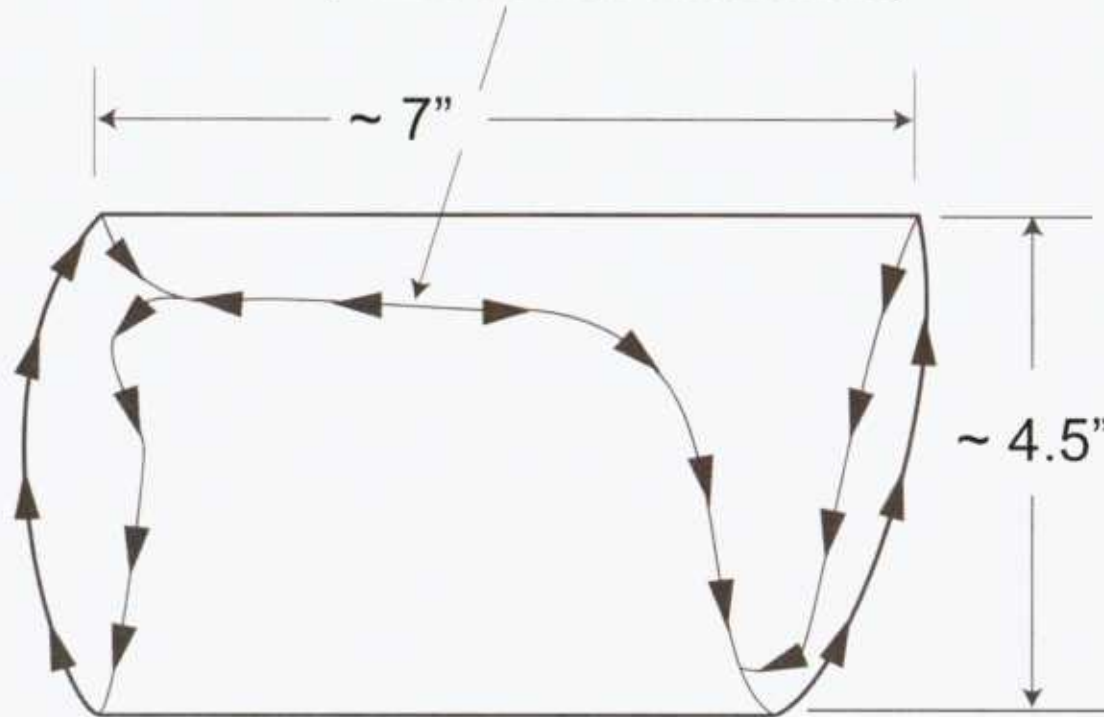
Figure 2.10

**Overload Fracture Origin & Propagation**

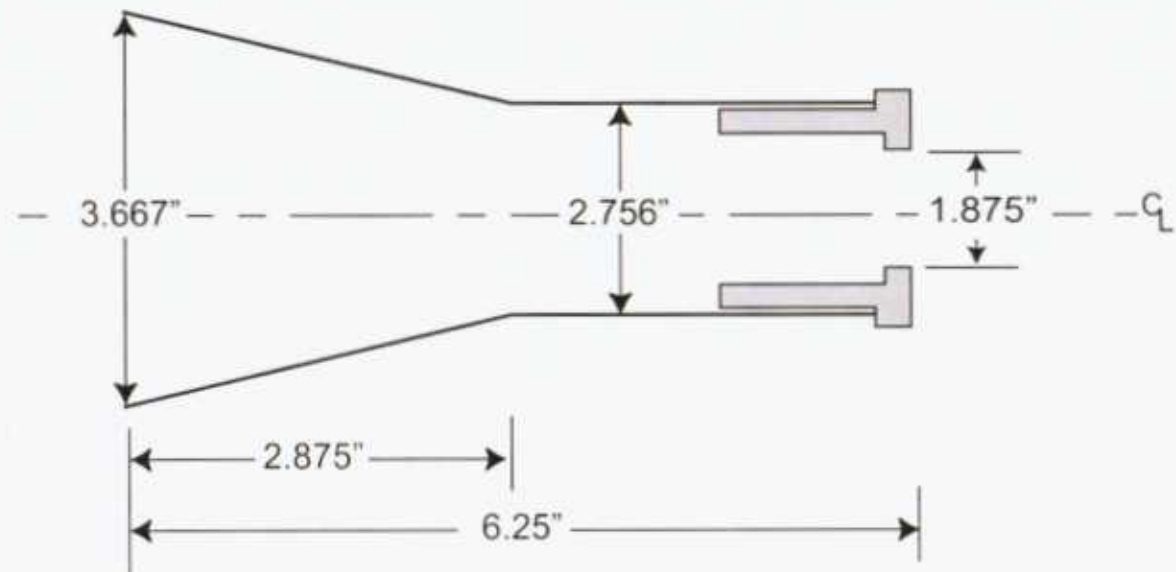
Figure 2.12

### FW-1025 Original Valve

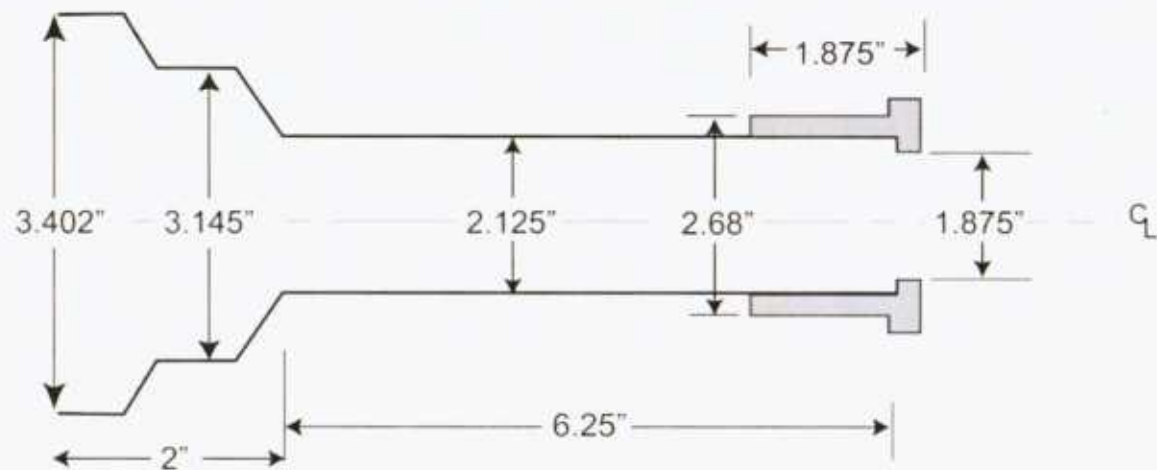
Figure 2.11

## FW01-1032 Replacement Valve

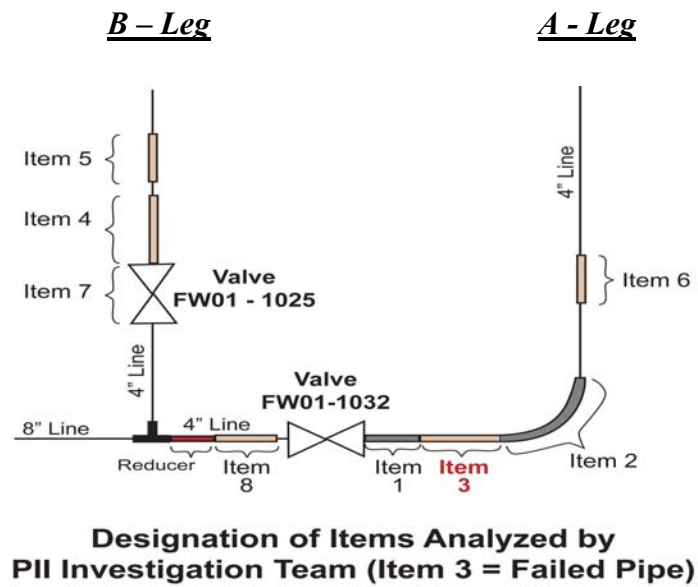
**Figure 5.1**

**Event Description:** On May 9, 2007, Iatan Unit 1 fossil power plant, owned by KCP&L, experienced a catastrophic rupture of a 4 inch Schedule 160 superheater (SH) attemperator spray line, resulting in two fatalities of personnel working in the immediate vicinity on a plugged coal feeder. The rupture occurred in a short spool piece (Item 3 in **Figure 5.1 and Figure 5.2**) immediately downstream (~5 inches from the valve to pipe weld) of the AC motor operated stop valve (FW01-1032) in the “A” leg of a dual train attemperator spray line and just upstream of a 90 degree elbow. The stop valve was a gate valve design. The valve had been installed a vertical position rather than a horizontal position, deviating from its original designed layout, prior to commission in 1980. In 1986, the original valve was replaced with a valve of a different internal design, having an abrupt opening at the valve exit and a reduced throat diameter (**See figure 5.1a**). Subsequent investigation revealed significant thinning ( $< 0.06$  inches – see **Figure 5.3**) at the rupture initiation site from an active flow-accelerated corrosion (FAC) mechanism. The wear rate in the pipe downstream of the initial stop valve in the parallel “B” leg piping (FW01-1025) was less than 25% of the wear rate found in the “A” leg. The “B” stop valve employed a gate-valve design with a similar seat opening, but with a smooth “venturi-type” transition to the entrance and exit piping.

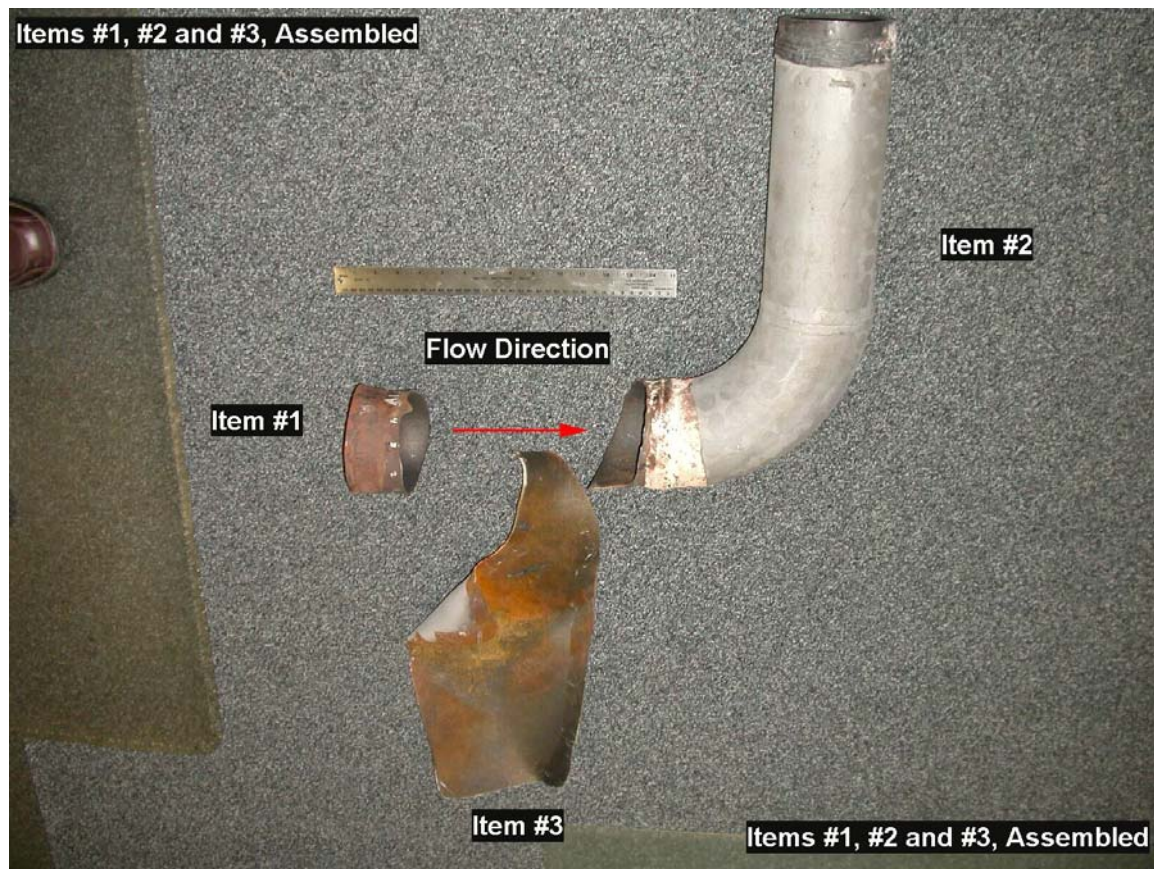
**Figure 5.2 – Failed 4 inch SH Attemperator Spray A-Line**

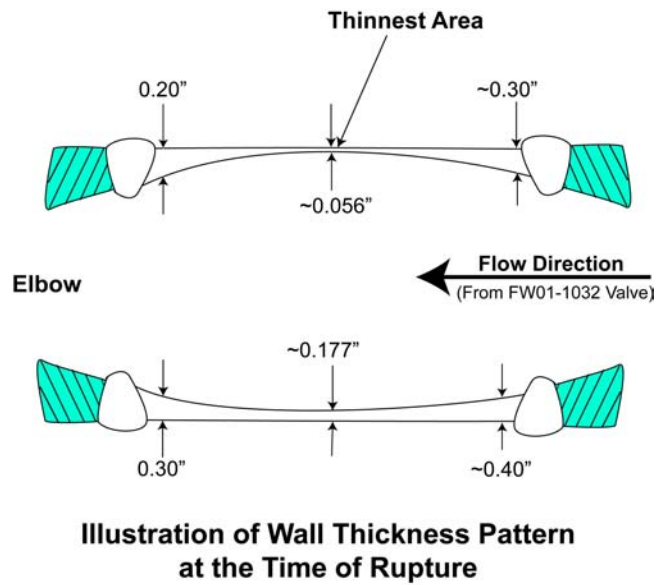
Figure 5.3

**Pipe Thinning Mechanism:** Laboratory microscopic inspection of the piping at the point of rupture identified flow-accelerated corrosion (FAC) as the mechanism causing the significant thinning shown in **Figure 5.3**. This thinning resulted in a ductile failure of the pipe wall pressure boundary due to ductile overload stresses.
