# Missouri Public Service Commission

## Gas Incident Report

**Missouri Gas Energy  
Case No. GS-2007-0381**

Blue Springs, Missouri  
January 8, 2007

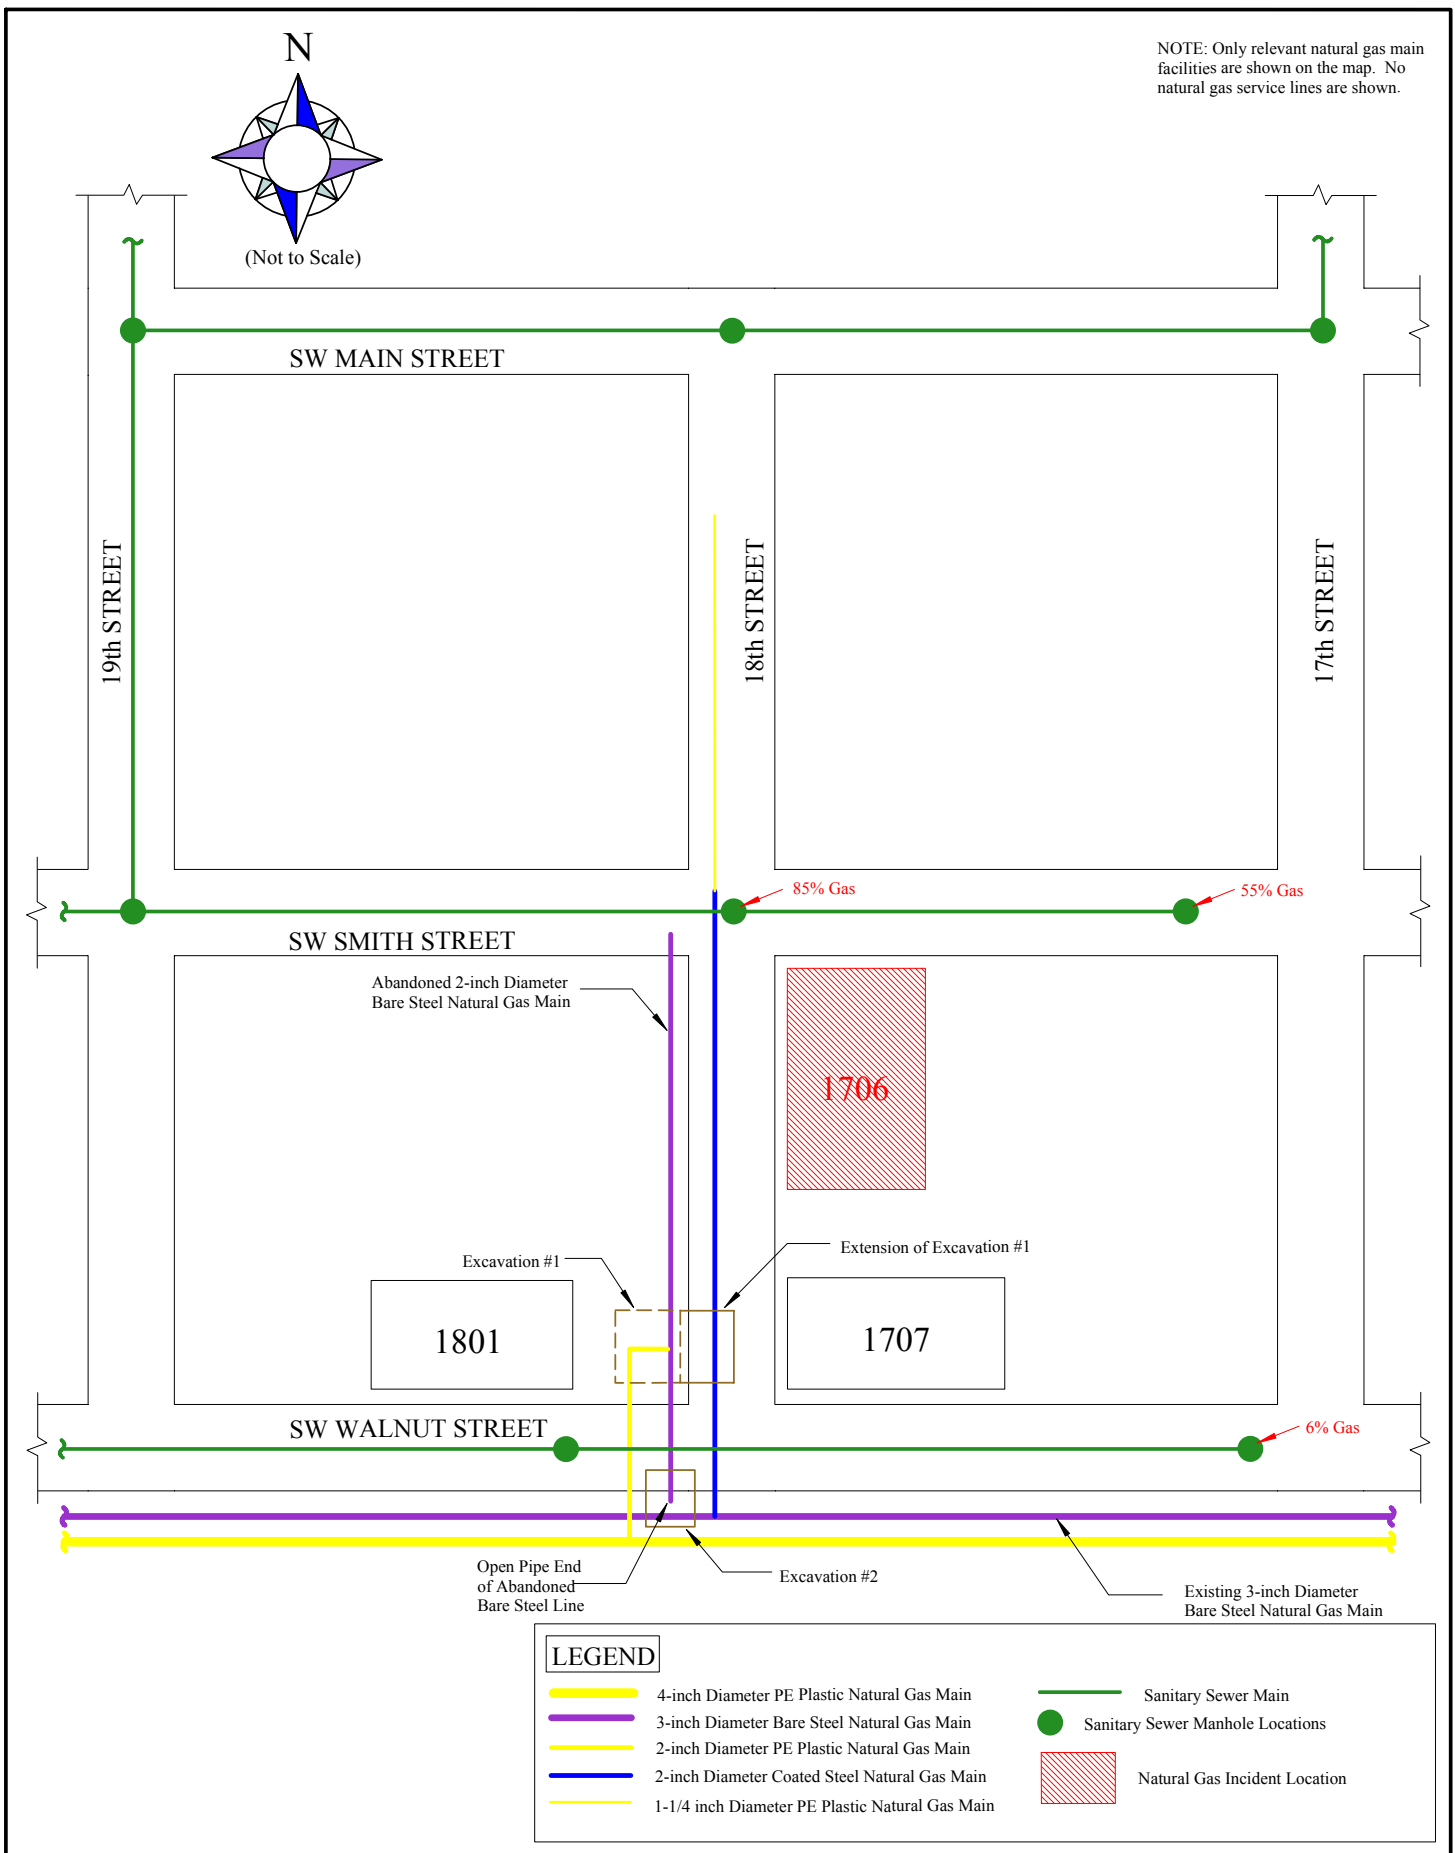
**Figure 2**  
Plan View of 1706 Smith Street-Incident Location  
Appendix A-2

At 12:49 pm MGE received a call from the public reporting an odor of natural gas in the air on Walnut St. between 15<sup>th</sup> Street and 20<sup>th</sup> Street (See Appendix A-2, Figure 2). An MGE serviceman was dispatched to the area, and arrived at 12:57 pm. He initially started to use his Flame Ionization (FI) leak detection instrument. However, it seemed to be indicating leaks at numerous locations. So, he began making a series of bar-holes<sup>5</sup> on Walnut Street. He started at 15<sup>th</sup> Street and worked his way east. However, after he was part way between 16<sup>th</sup> and 17<sup>th</sup> street he noticed the Infrsource crew working closer to 18<sup>th</sup> Street. He stopped bar testing and went to speak with the Infrsource personnel. After speaking with the Infrsource crew he came to the conclusion that the gas in the air was from a purging operation.<sup>6</sup>

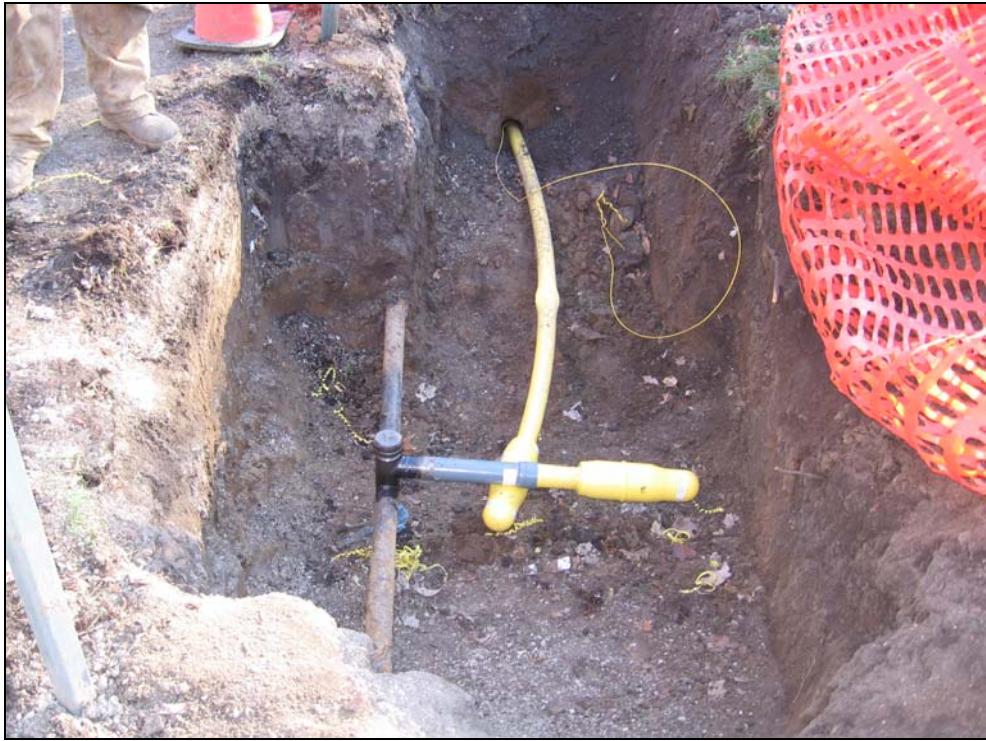
The Staff initially observed an excavation at the northwest corner of Walnut and 18<sup>th</sup> Streets. This excavation had been made by Infracore to expose a portion of an existing 2-inch diameter steel natural gas line for the purpose of connecting in new PE natural gas piping from new construction on Walnut Street (See Appendix B-1, Photograph 1). The Staff observed a 2-inch diameter bare steel pipeline traversing through the excavation and into the north and south side of the excavation. Staff noted that a 2-inch 3-way tapping tee was connected to the top of the bare steel piping. A 2-inch diameter coated steel and plastic transition fitting<sup>7</sup> was connected to the outlet of the tapping tee and a PE cap was connected to the outlet of the transition fitting. The Staff also noted that a 2-inch diameter PE pipe extended into the excavation from the south and was capped near the outlet of the capped transition fitting. Staff proceeded to take a cathodic protection reading on the bare steel piping in the excavation and obtained a reading of -0.89 volts.

Photograph 1  
Incorrectly tapped 2-inch abandoned natural gas main

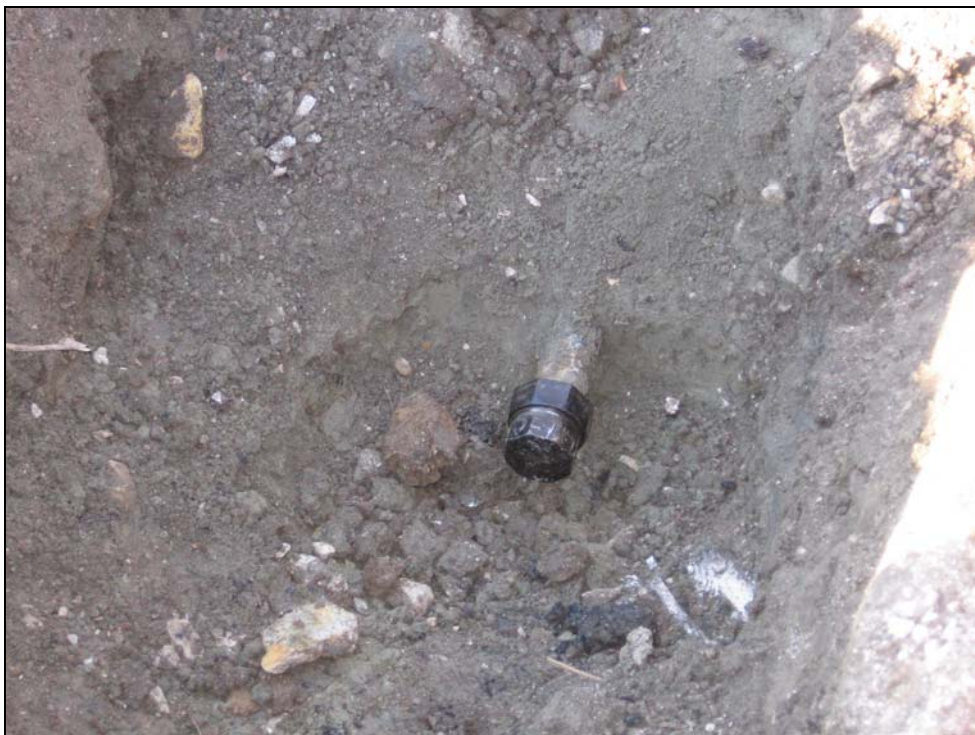
Meanwhile the Infrsource crew resumed digging, and found natural gas escaping from an open ended 2-inch bare steel pipe. They capped that line and realized they had connected to an abandoned line on 18<sup>th</sup> Street. They squeezed off the 2-inch PE natural gas main on 18<sup>th</sup> Street, which stopped the flow of natural gas into the abandoned pipeline.

The Staff then observed an excavation on the south side of Walnut Street where 18<sup>th</sup> Street intersects Walnut Street. This excavation had initially been started by the contractor to expose the connection point of the 2-inch PE natural gas main on 18<sup>th</sup> Street to the 4-inch PE natural gas main on Walnut Street, thinking this might be the source of the natural gas odor in the area. However, this connection was not found, but instead a 2-inch diameter bare steel pipeline was exposed. The Staff observed approximately 12 inches of this 2-inch bare steel piping with a cap on the end exiting from the north side of the excavation (See Appendix B-1, Photograph 2).

Photograph 2  
Capped 2-inch abandoned natural gas main

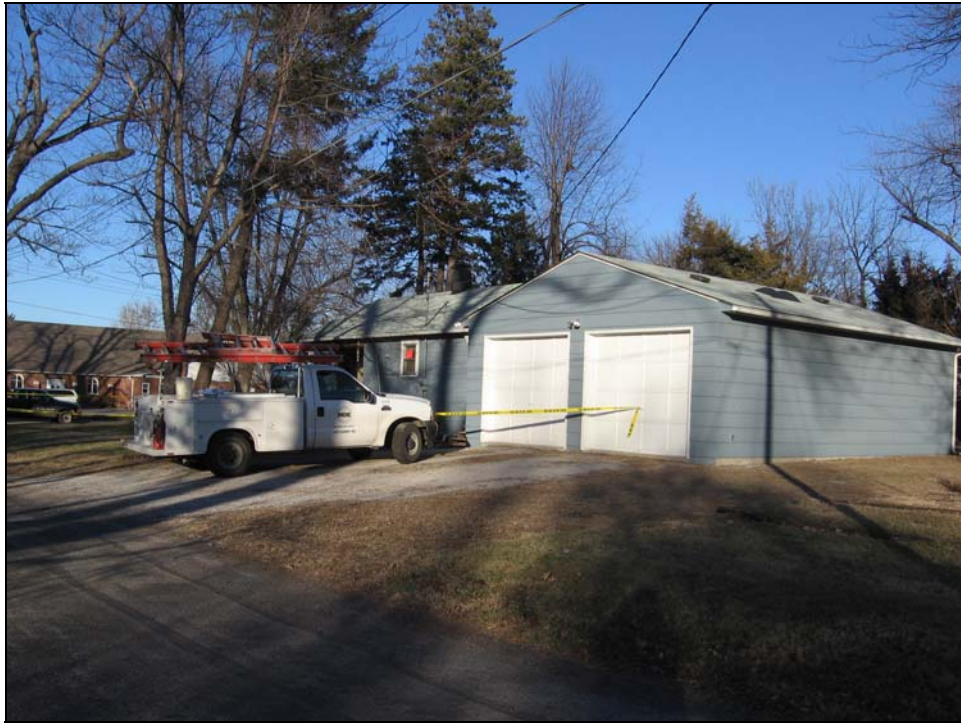
The residential structure located at 1706 SW Smith Street received minor damage as a result of the explosion and flash fire (See Appendix B-2, Photographs 1 & 2). There were no personal contents in the structure. The Central Jackson Fire Protection District estimated the damage to the building at \$5,000.

Photograph 1  
1706 SW Smith Street

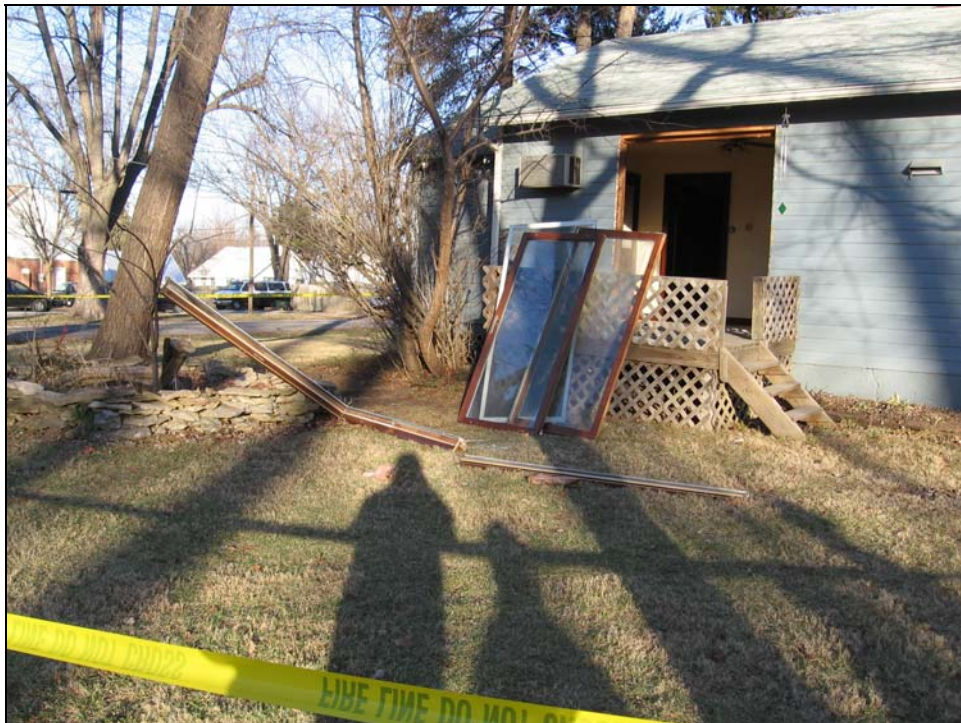
After completing an examination of the excavations and work performed by Infrasource at Walnut and 18<sup>th</sup> Streets, the Staff proceeded with an exterior and interior investigation of the structure at 1706 SW Smith Street (See Appendix B-2, Photograph 1) in order to ascertain evidence of an explosion, possible points of entry of the natural gas, and possible ignition sources. The only evidence of explosion damage was on the west side of the structure. Sliding glass doors had been separated from the structure and displaced onto the west side of the wooden deck. Guttering on the west side of the structure had been separated from the fascia and displaced onto the yard (Appendix B-2, Photograph 2).

As noted in the **Commission Staff Actions and Investigation**, the sliding glass doors on the west side of the structure were separated from the structure and displaced onto the west side of a wooden deck. This was the only evidence of structural damage to the structure by the explosion. There was some fire and heat damage located in the kitchen, top of the basement stairs and in the basement. However, the fire and heat damage was generally concentrated on wood surfaces, curtains, and concrete. The limited explosion damage coupled with the evidence of very little fire and heat damage indicate there was a small amount of natural gas in the structure before it was ignited. The ignition probably occurred when the mixture of natural gas and air was near the lower explosive limit (LEL) of the natural gas<sup>9</sup>, producing little structural damage. This is because the inefficient burning of the natural gas produces low velocity pressure waves and lower maximum pressures. This would also have allowed for a slow rise in the rate of pressure build-up during the explosion and produced a pushing or bulging type of damage. This is evident by the fact that the sliding glass doors were just dislodged and displaced a short distance and no other structural damage was evident. In addition, explosions of mixtures near the LEL do not tend to produce large quantities of post-explosion fire, as nearly all of the fuel is consumed. There was very little fire and heat damage observed in the structure as noted above.

Photograph 2  
Damage to the entrance of 1706 SW Smith Street

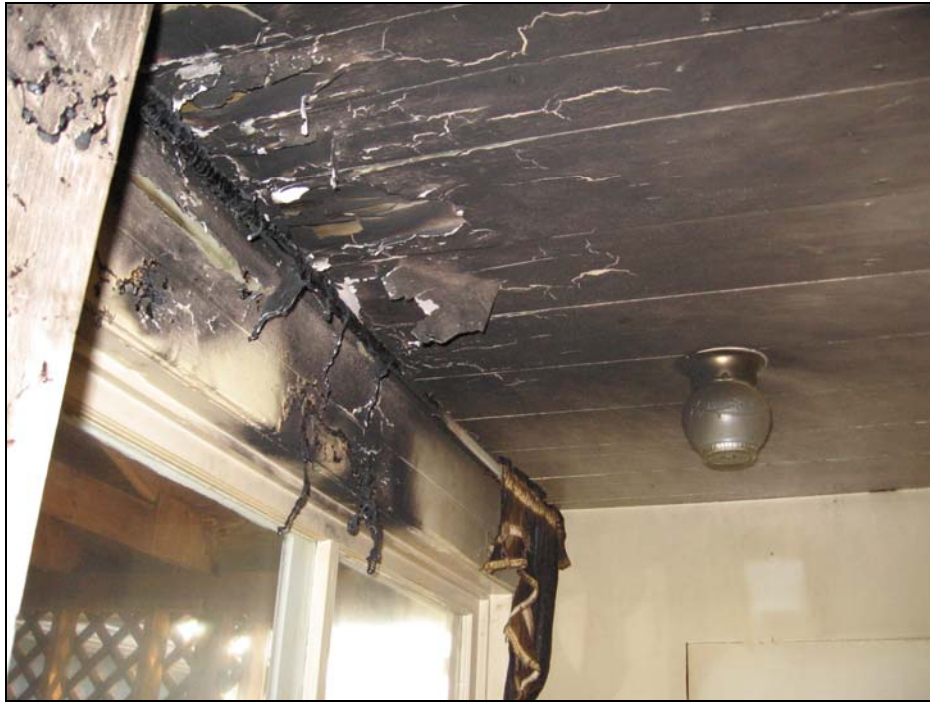
Photograph 1  
Ceiling of stairwell leading to the basement of 1706 SW Smith Street

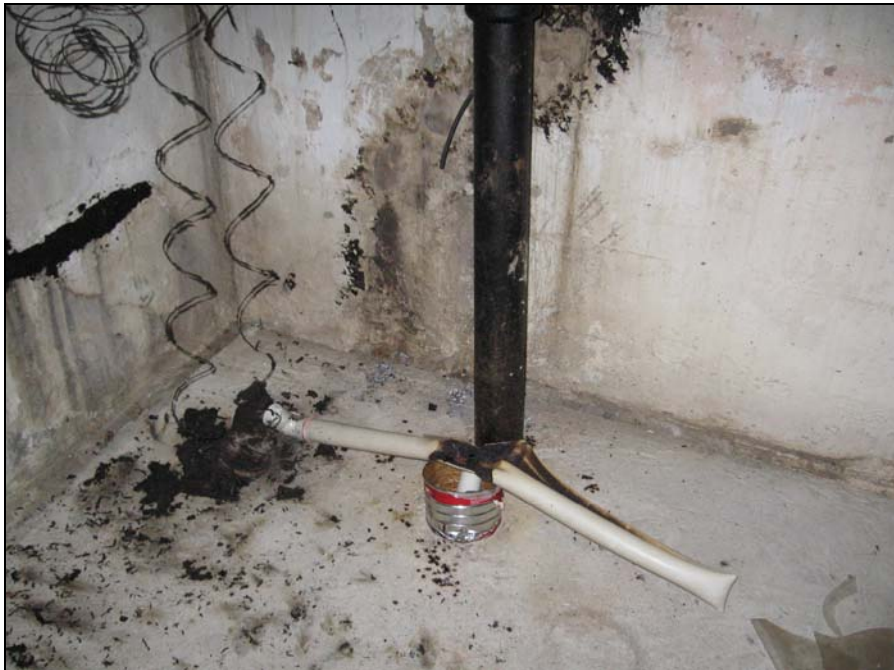
In the basement area, Staff observed a concentration of burn damage and scorching in the north and northeast area of the basement. The basement walls in this area were poured concrete, and exhibited varying degrees of scorching and soot accumulation. The scorching and soot accumulation continued upward from the basement floor, along the east wall, and up into the ceiling of the basement. This scorching and soot accumulation was concentrated in an area around and above sewer piping in the basement floor (See Appendix B-3, Photograph 2). This sewer piping consisted of a coffee can, plastic lid, and small diameter polyvinyl chloride (PVC) drain pipe located over a drain in the basement floor. The plastic lid and PVC piping were burned and melted. Also, located in the basement were a natural gas space heater, water heater, and floor furnace. All of which were found with their controls in the “ON” position.

Natural gas present in the sanitary sewer system probably entered the structure at 1706 SW Smith Street through the sewer lateral serving the dwelling. Once in the sewer lateral to the structure, the natural gas probably entered the structure through improperly installed sewer drain piping in the basement floor.

Photograph 2  
Improperly installed sewer drain pipe and fire damage in the basement of 1706  
SW Smith Street

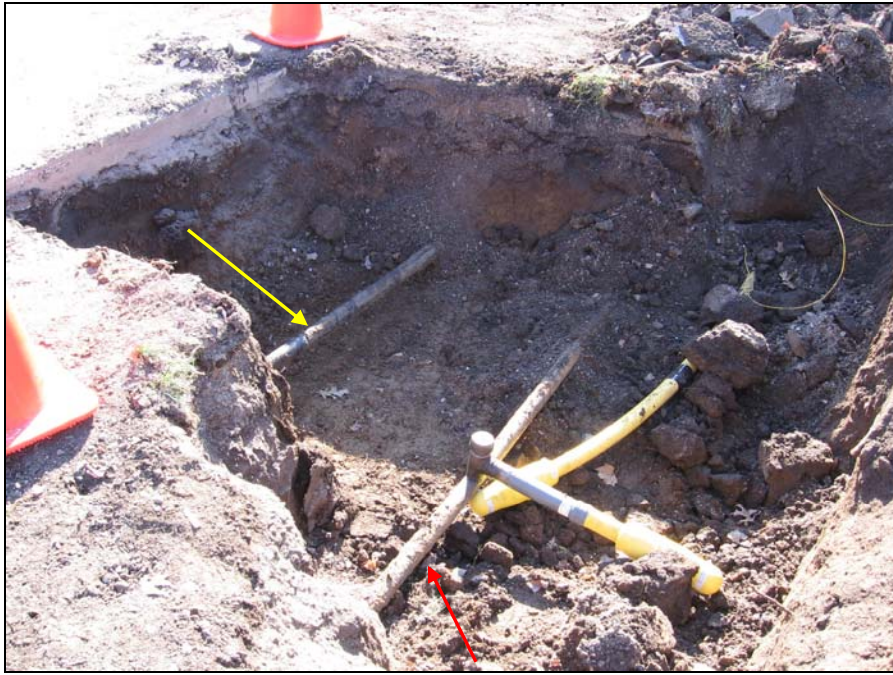
Photograph 1

Pipe to the left is the in-service natural gas main (Yellow Arrow)  
Pipe to the right is the abandoned natural gas main with the incorrect tap (Red Arrow)

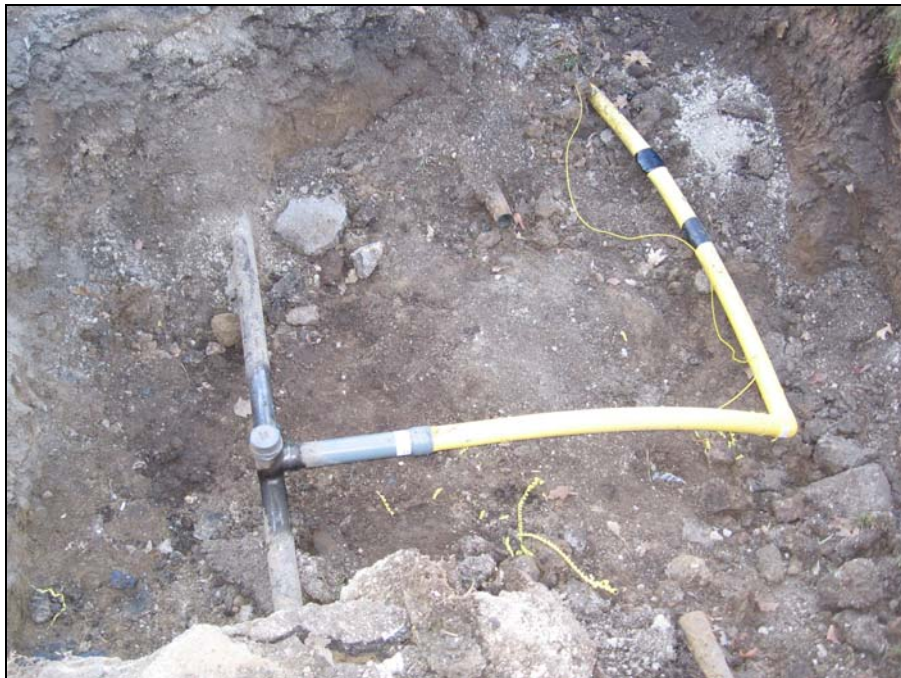
Photograph 2

Final correct tie-in connection to 2-inch in-service main on 18<sup>th</sup> Street

Upon arrival the next morning, January 10, 2007, the Staff observed the contractor connect the existing 2-inch in-service natural gas main on 18<sup>th</sup> Street and connect the new 2-inch PE natural gas main, also along 18<sup>th</sup> Street (See Appendix B-4, Photograph 2). The contractor verified the 2-inch coated steel main as the correct line to connect to by installing pressure gauges and monitoring natural gas pressure in the main
