STAFF GAS INCIDENT REPORT

Gas Incident Report

AmerenUE
Case No. GS-2006-0199

Boonville, Missouri
October 10, 2005

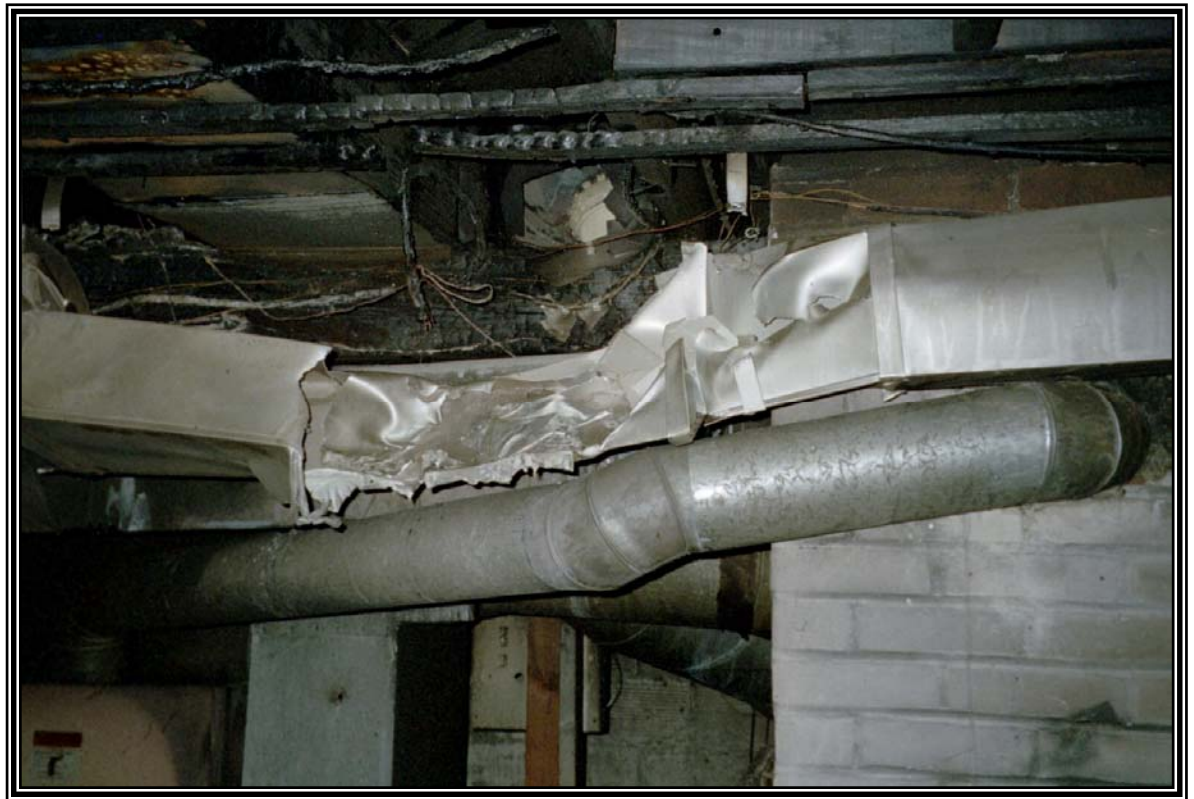
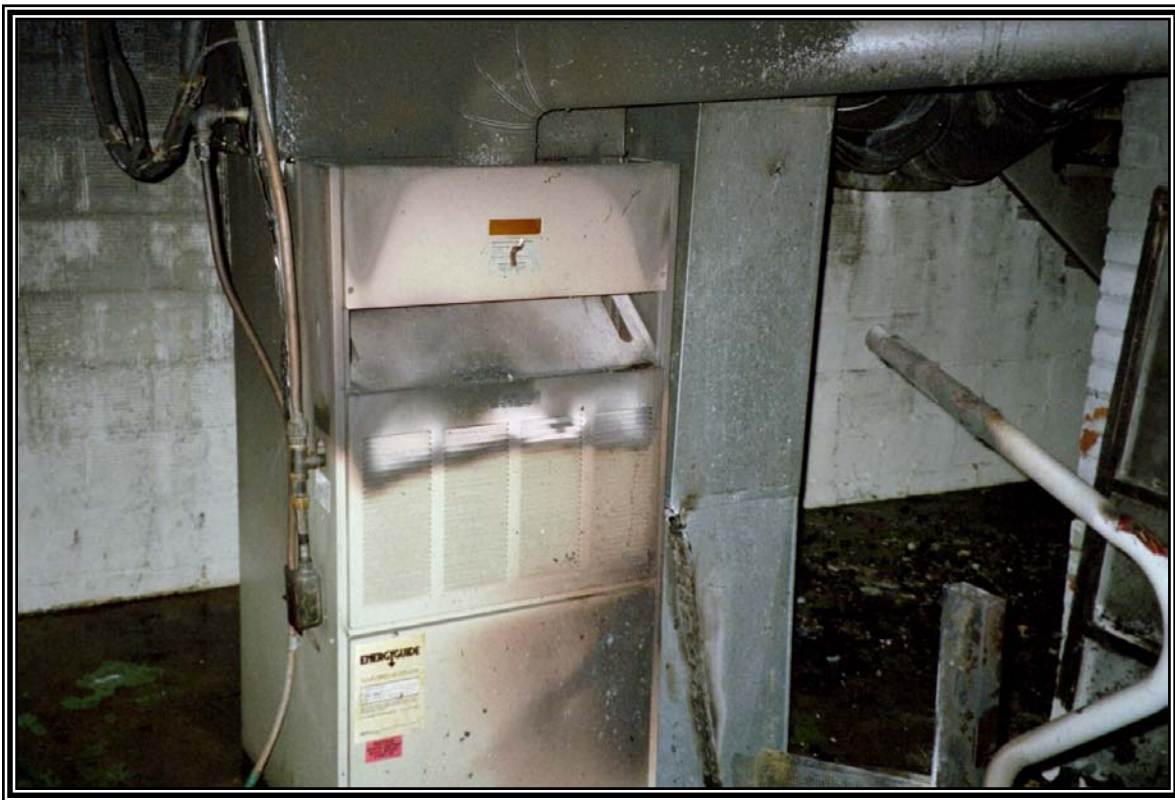
The two-story residential structure located at 1312 4th Street received extensive fire and smoke damage in the basement and both upper floors (see Appendix A-1, Photograph 1 and 2). The property damage was estimated by the Boonville Fire Department to be \$125,000.

Entry could not be gained to 1313 4th Street. At 1312 4th Street, extensive fire damage was observed in the basement, especially above the furnace and at the nearby stairway to the main floor (See Appendix A, Photographs 1 and 2). The furnace was damaged due to the over-pressurization, but the nearby water heater did not appear to have been damaged due to over-pressurization. The severe fire damage followed the stairwell and ductwork all the way to the second floor.

Photographs 1 & 2 Top view shows the duct and vent system for 1312 4th Street that was located directly above the natural gas furnace (shown in the bottom view). The furnace was located in the basement area.

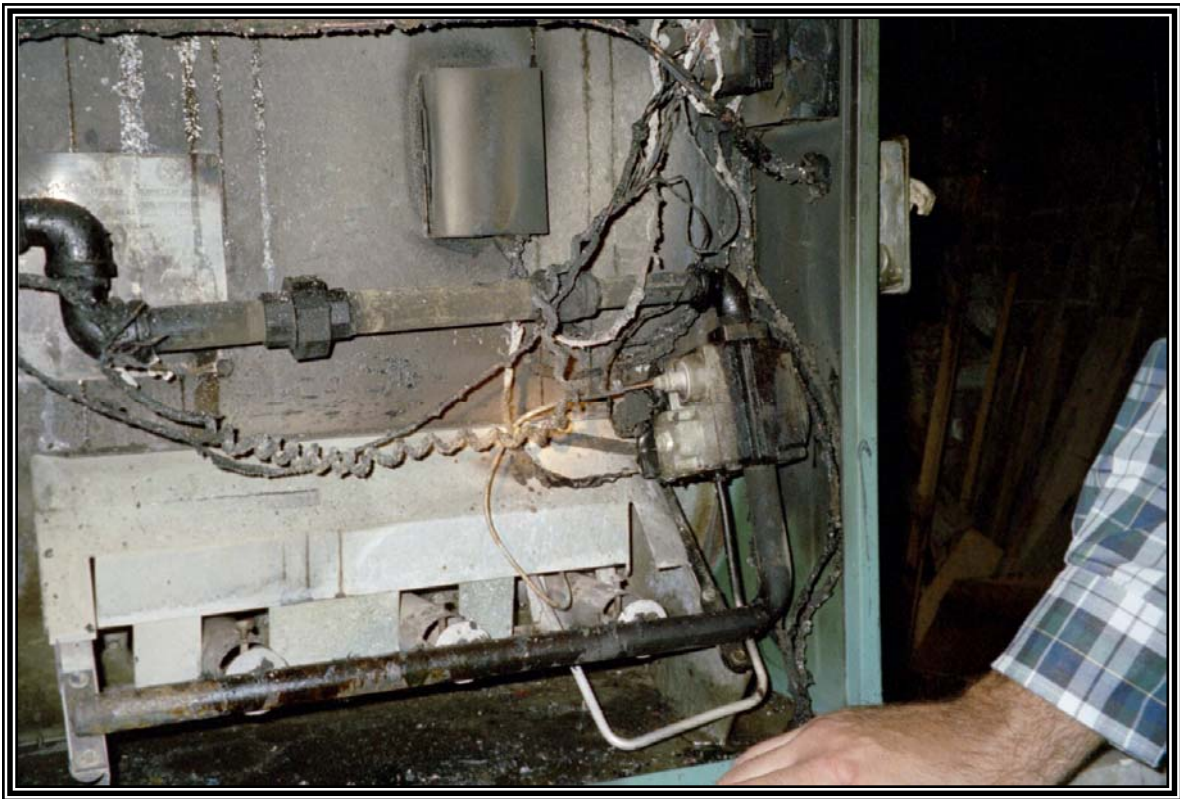
The two-story residential structure located at 519 High Street received extensive fire and smoke damage in the basement and first floor (see Appendix A-1, Photograph 3). The property damage was estimated by the Boonville Fire Department to be \$100,000.

At 519 High Street, some fire damage was observed on the main floor where fire came up through the floor heating ducts. The owner said he heard a "boom", went to the basement, and saw flames coming out of the top of the furnace. There were two forced-air furnaces and a water heater in the basement. One of the two furnace units was damaged with the control valve knobs melted and fire damage above the unit at the ceiling (See Appendix A, Photograph 3). The other furnace unit and water heater did not appear to be damaged.

Photograph 3 View of the damaged natural gas furnace in the basement of 519 High Street.

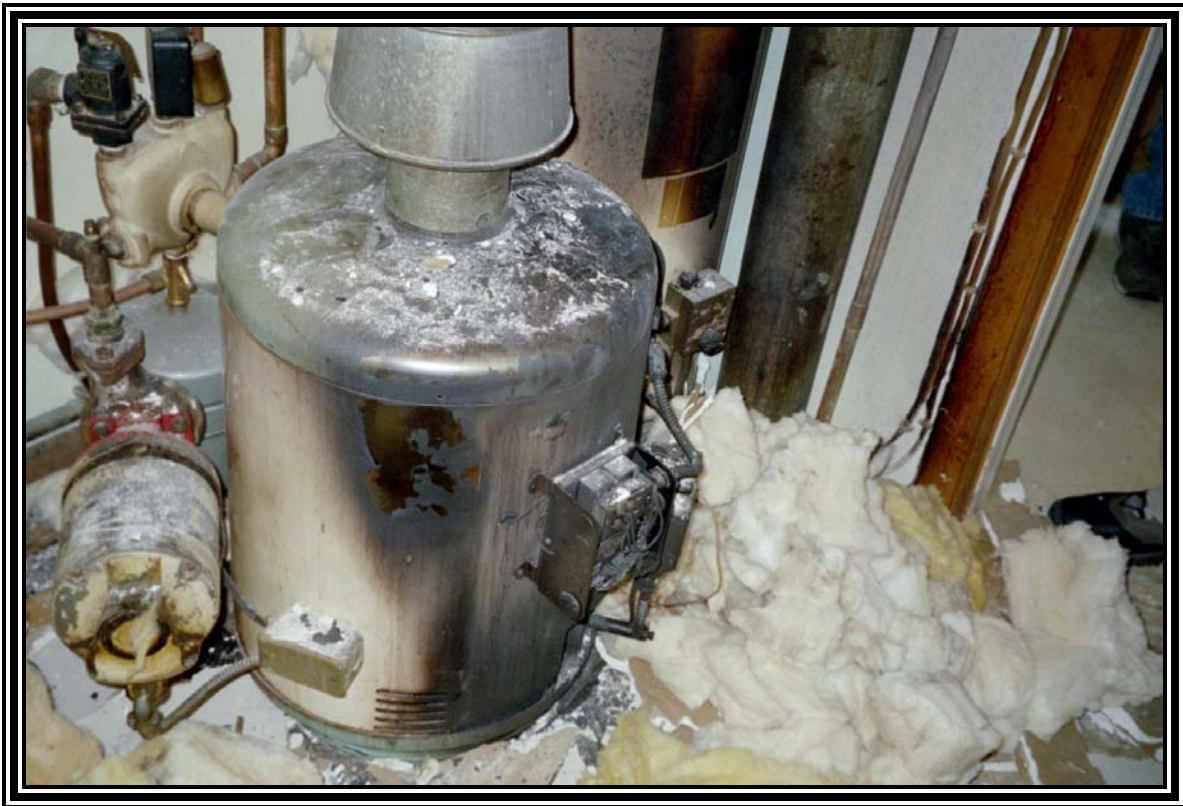
The single-story residential structure located at 1400 Nelson Street received fire and smoke damage in the utility room (see Appendix A-1, Photograph 4). The property damage was estimated by the Boonville Fire Department to be \$30,000.

Photograph 4 View of the hot water home heating system for 1400 Nelson Street which is located on the main level.

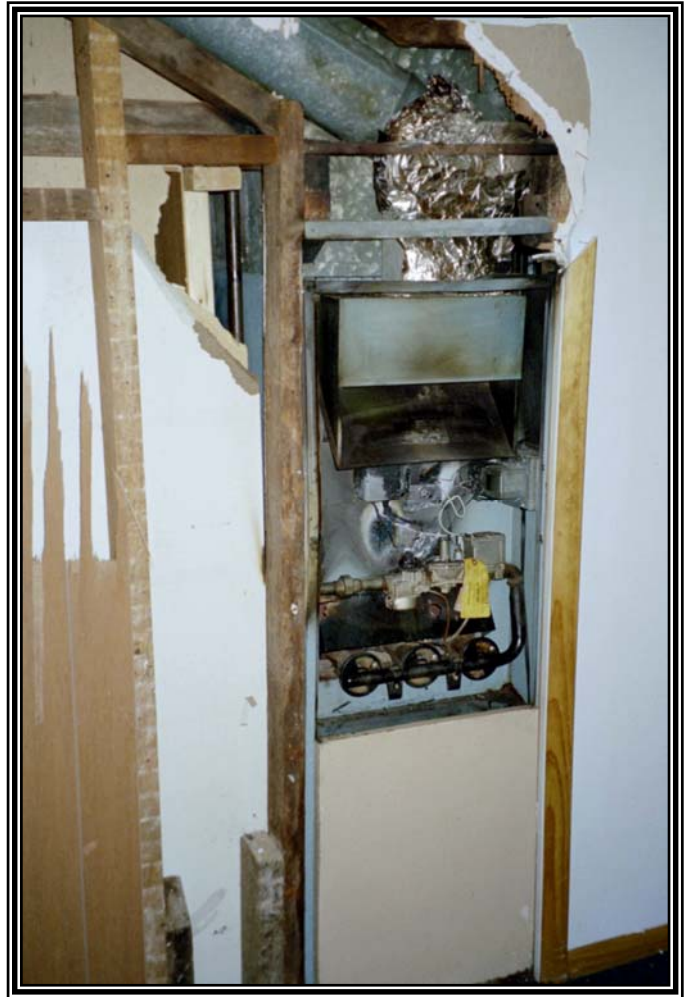
The single-story residential structure located at 1303 Nelson Street received fire and smoke damage in the basement at the furnace (see Appendix A-1, Photograph 5). The property damage was estimated by the Boonville Fire Department to be \$7,500.

Staff and AmerenUE personnel then traveled to observe residences where damage had been reported. At 1303 Nelson Street, fire damage was observed at the furnace (See Appendix A, Photograph 5). It was indicated by the resident that her husband was home when it occurred. He heard a "loud pop", observed flames, called the Fire Department, and put the fire out before the Fire Department arrived. It was noted that the control knob on the furnace control box was melted. The resident mentioned that 1400 Nelson was also damaged by fire. At 1400 Nelson, a fire at the hot water home heating system (for the main floor) had damaged the unit and surrounding utility room (See Appendix A, Photograph 4). The adjacent water heater did not appear to be damaged. The hot water home heating system (for the basement) in the basement garage did not appear to be damaged.

Photograph 5 Looking at the natural gas furnace for 1303 Nelson Street.

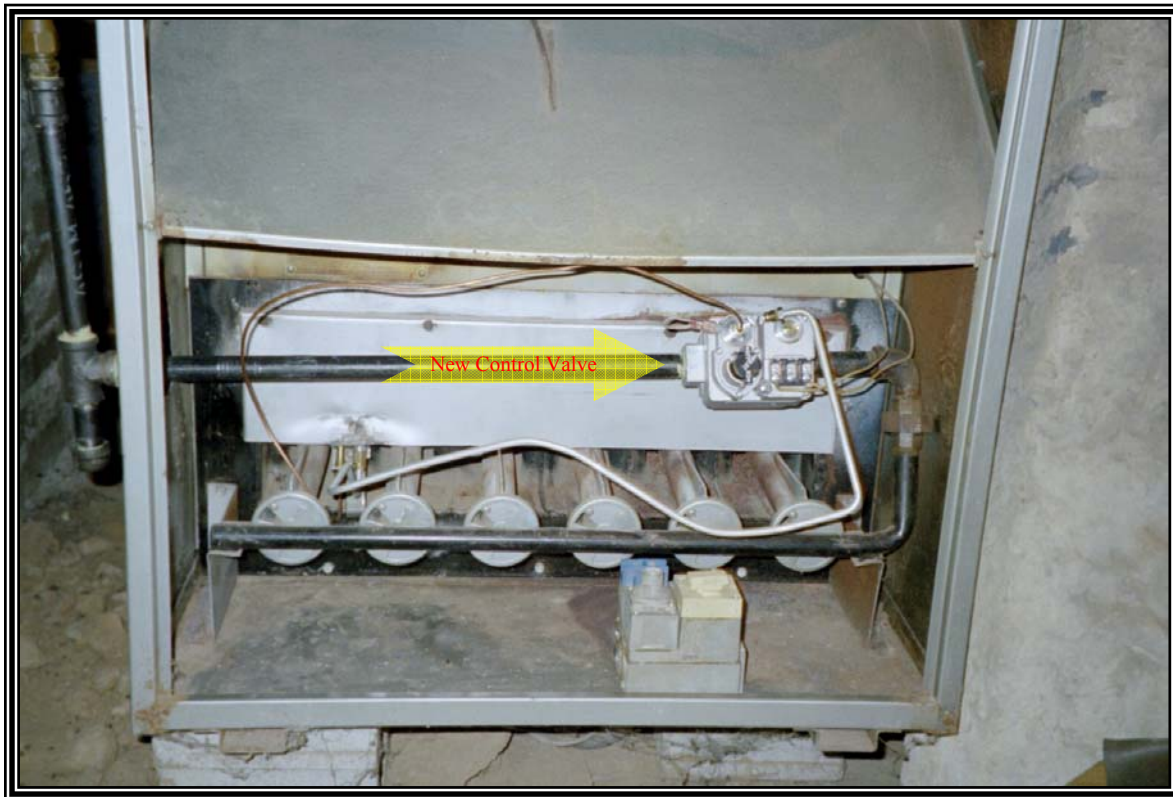
A number of other residences served by the Boonville low-pressure system received over-pressurization damage to a component of the furnace and/or other natural gas utilization equipment. An example of this was the gas control valve in the furnace at 311 High Street (see Appendix A-1, Photograph 6).

The Staff went to two other locations on October 11 where over-pressure damage was reported. At 311 High, an HVAC contractor was on-site and replacing the furnace control valve that had been over-pressured. (See Appendix A, Photograph 6) The resident said he heard a "roaring noise" down in the basement and the furnace pilot light was a "torch". He tried to turn off the

Photograph 6 View of the natural gas furnace for 311 High Street. The HVAC contractor was onsite replacing the furnace control valve. The picture shows the new control valve installed and the old one is lying beneath.

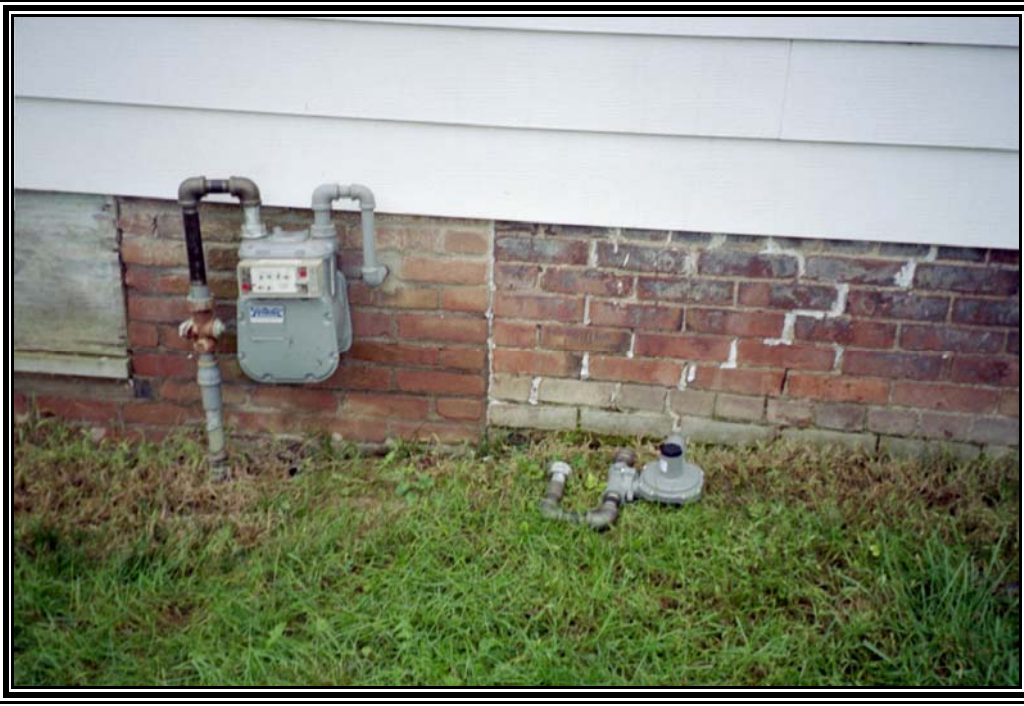
Photograph 7 Looking south at the natural gas meter that is located on the north side of 1222 6th Street. Observe that no pressure regulator is installed due to the fact that the meter is connected to the low-pressure system. Notice the new service regulator that is lying on the ground.

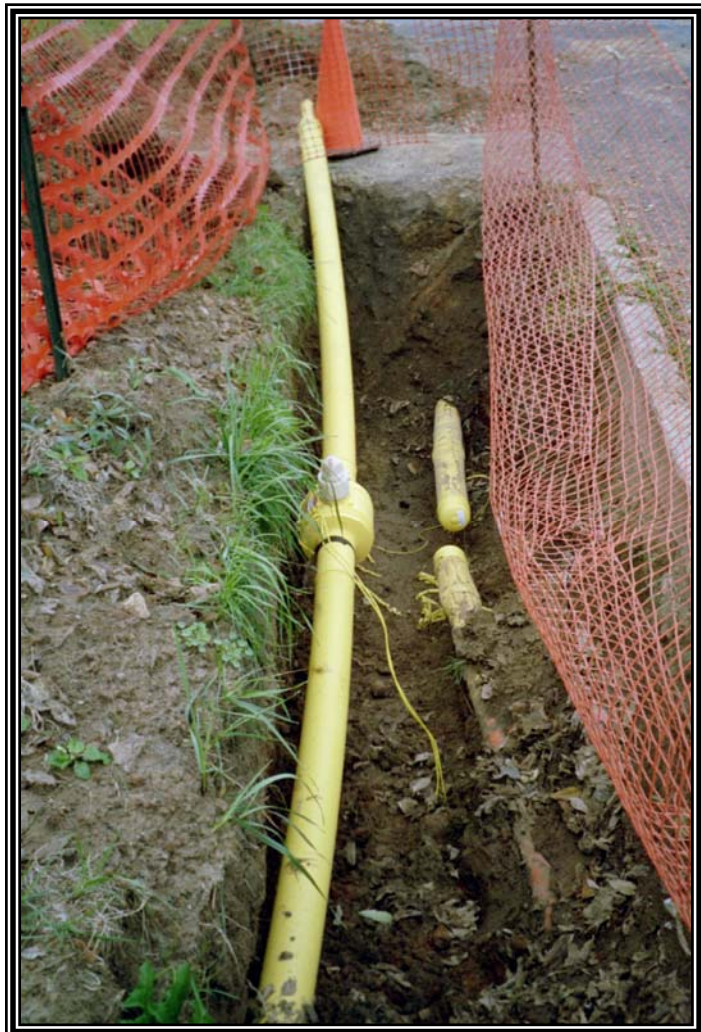
Upon returning to Boonville on October 11, Staff observed the area where the work had been performed the day before to convert a section of the low-pressure system to high-pressure. This involved the 1200 block of 6th Street between Bingham and South Streets. The Staff observed the homes in this block and noted that each had a low-pressure meter set with a service regulator lying nearby on the ground (See Appendix A, Photograph 7). The service regulators had been installed on October 10 in preparation for conversion to a high-pressure system, but had been removed after the incident so that the customers in this block could have their low pressure gas service restored. The excavations in the area were observed and involved points where system piping was separated or had been squeezed-off. The excavation at the southeast corner of 6th Street and Roberts Street included the 4-inch polyethylene main, which had not been separated prior to the incident and allowed the 10 psig gas to flow to the east on Roberts Street and into the low-pressure system. At the time of observation on October 11, this 4-inch main had been cut and capped in each direction (See Appendix A, Photograph 8). AmerenUE personnel indicated that this separation was made during the afternoon of October 10, after the incident.

Photograph 8 View looking west at an excavation that was located at the southwest corner of 6th Street and Roberts Street.
