5.200 BCRSD, Rollingwood Plat #1
Boone County
#MO-0038792

LETTER OF WARNING RESPONSE REQUIRED

Missouri Department of Natural Resources
Northeast Regional Office
Report of Inspection
BCRSD, Rollingwood Plat #1
Boone County
#MO-0038792
May 13, 2016

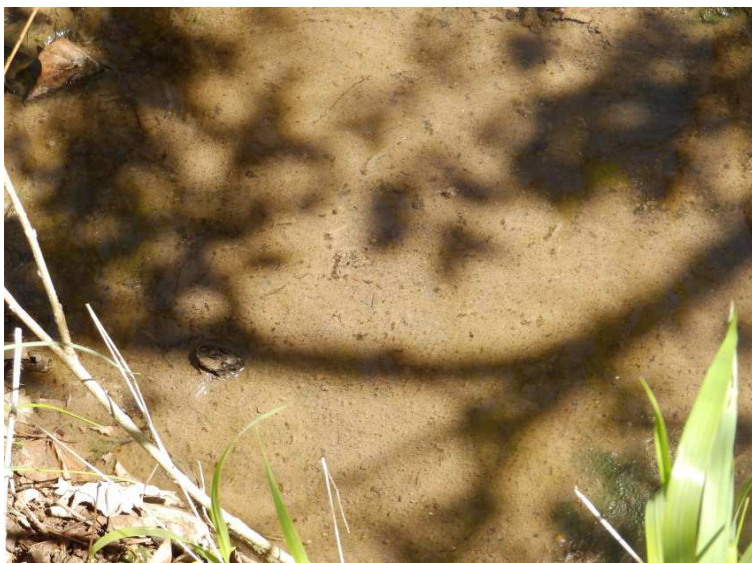
Photo #: 03
By: Michael Heaton
Facility: BCRSD, Rollingwood Plat #1
Permit: #MO-0038792
Location: Boone County

Description: Sludge deposits were observed in the tributary immediately below the outfall structure.

I told Mr. Horton about the sludge deposits in the receiving stream and that the sludge needs to be removed. Mr. Horton explained that the vac truck was being repaired and that the sludge would be removed when the truck is repaired. I asked Mr. Horton if the plant experiences any inflow/infiltration after precipitation events. Mr. Horton stated that the flows will increase about fifty percent after a rainfall event. Mr. Horton stated that he would notify me when the sludge from the receiving stream was removed. On April 14, 2016, I received an email from Mr. Horton, along with photographs, showing that the sludge in the receiving stream had been removed.

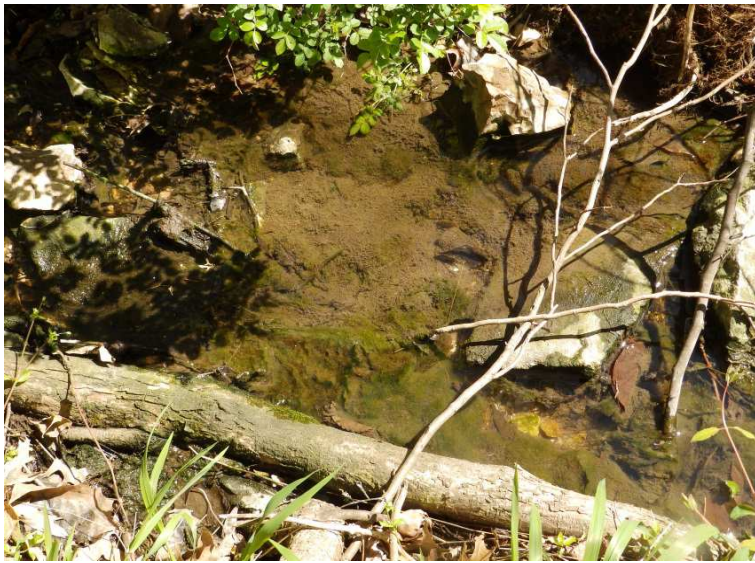
Photo #: 04
By: Michael Heaton
Facility: BCRSD, Rollingwood Plat #1
Permit: #MO-0038792
Location: Boone County

Water quality field monitoring was conducted at the following location for the listed parameters. The water being discharged from Outfall #001 at the time of the inspection was clear. Sludge deposits were observed in the receiving stream below the outfall location for approximately 10 feet below the outfall (Photos #: 02-04). The outfall location was the start of the tributary to Midway Branch and the sludge accumulation was observed only on the facility property.

Description: Sludge deposits were observed in the tributary immediately below the outfall structure. Sludge deposits were observed approximately 10 feet below the outfall.

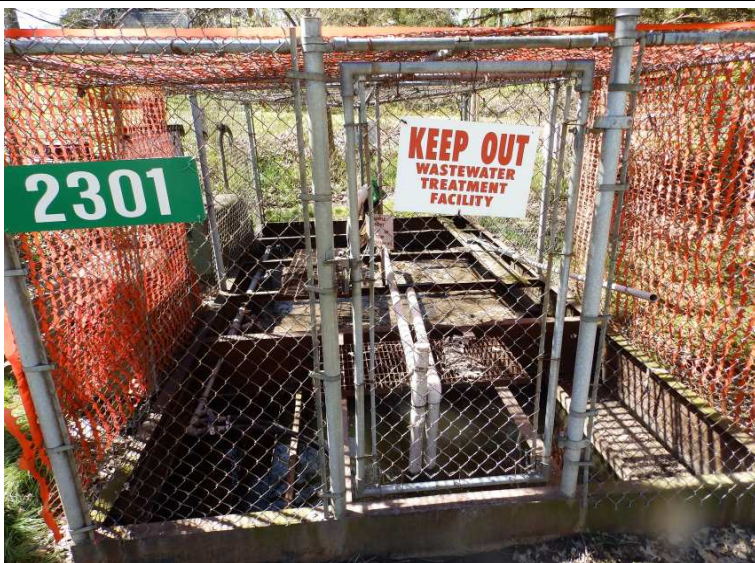
Photo #: 05
By: Michael Heaton
Facility: BCRSD, Rollingwood Plat #1
Permit: #MO-0038792
Location: Boone County

Description: Facility was securely fenced with a locked gate. Signs restricting access were observed.

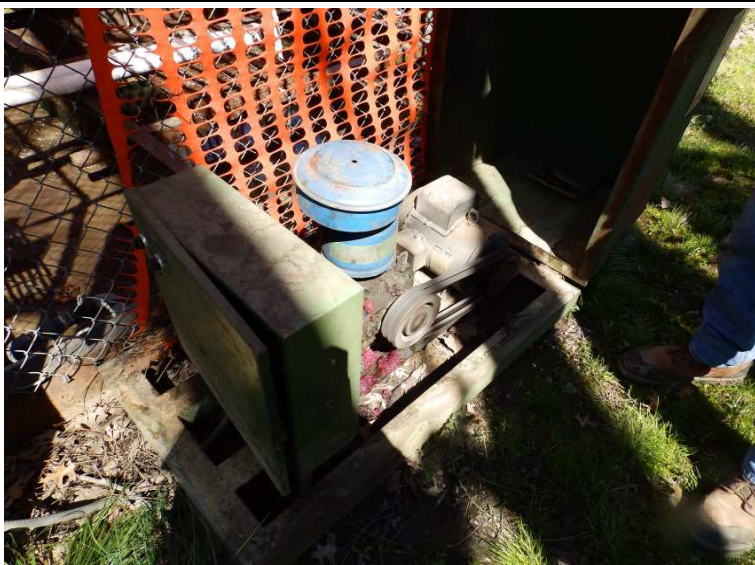
Photo #: 06
By: Michael Heaton
Facility: BCRSD, Rollingwood Plat #1
Permit: #MO-0038792
Location: Boone County

After the composite sampler was set, I observed the extended aeration plant. I observed that a chain link fence surrounded the plant. Signs restricting access to the plant were present and the gate to the facility was locked. Grates were not placed on top of the plant, however, the top of the fence was also covered by chain link (Photo #: 05). I observed the aerators at the facility. One of the aerators was operational (Photo #:06) and the other aerator was not operational (Photo #: 07).

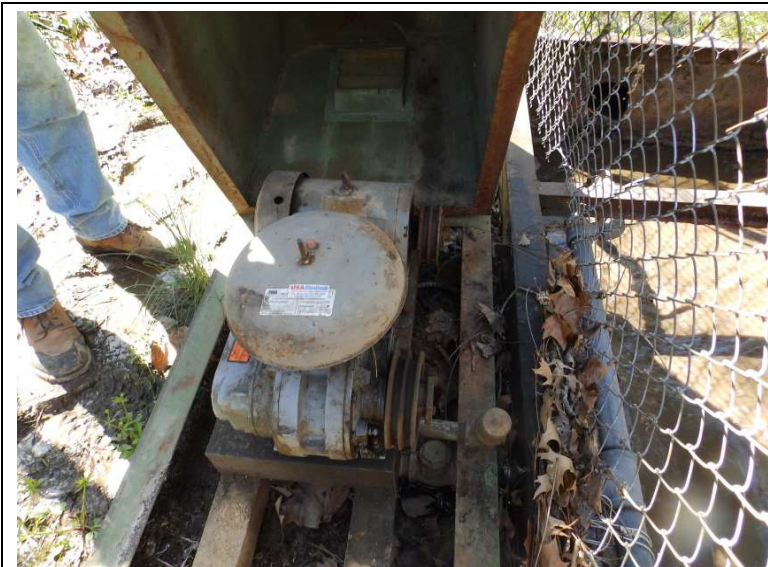
Photo #: 07

3. Failed to provide at least two operational blowers [10 CSR 20-8.180(4)(C)3.B.(V)].

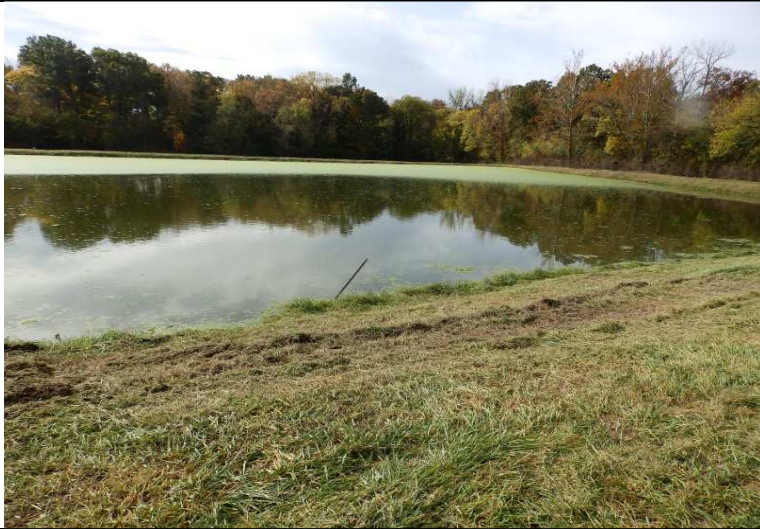
Photograph #: 1
Taken by: Leland Maize
Entity: BCRSD South Route K Wastewater Treatment Facility
Permit: #MO-0087173
Location: Boone County
Description: Primary cell of the lagoon system.
Date Taken: October 20, 2016
Program: WPC Unit

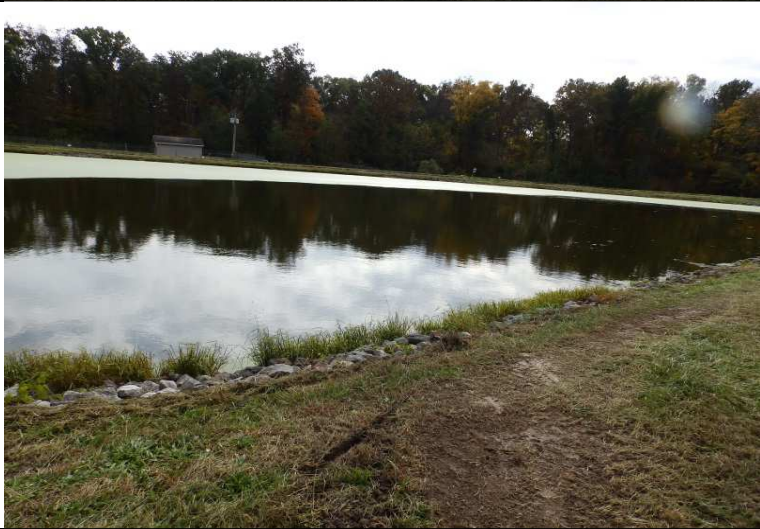
Photograph #: 2
Taken by: Leland Maize
Entity: BCRSD South Route K Wastewater Treatment Facility
Permit: #MO-0087173
Location: Boone County
Description: Secondary cell of the lagoon system.
Date Taken: October 20, 2016
Program: WPC Unit

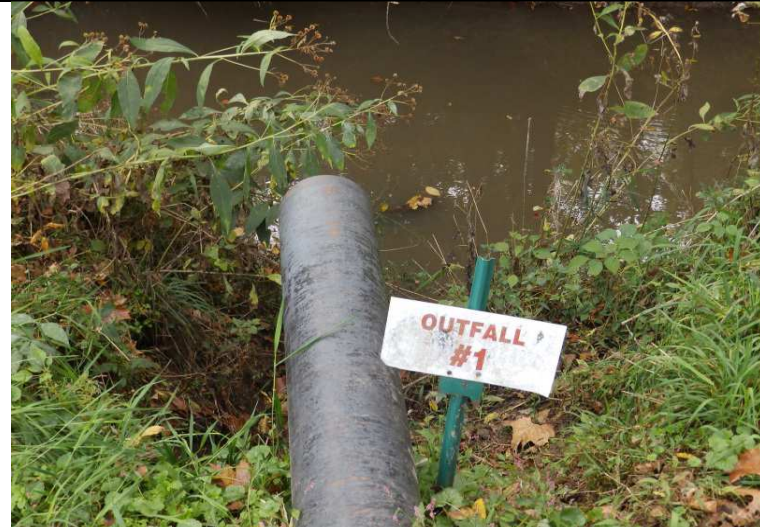
Photograph #: 4
Taken by: Leland Maize
Entity: BCRSD South Route K Wastewater Treatment Facility
Permit: #MO-0087173
Location: Boone County
Description: Outfall #001 with a sign marking the location.
Date Taken: October 20, 2016
Program: WPC Unit

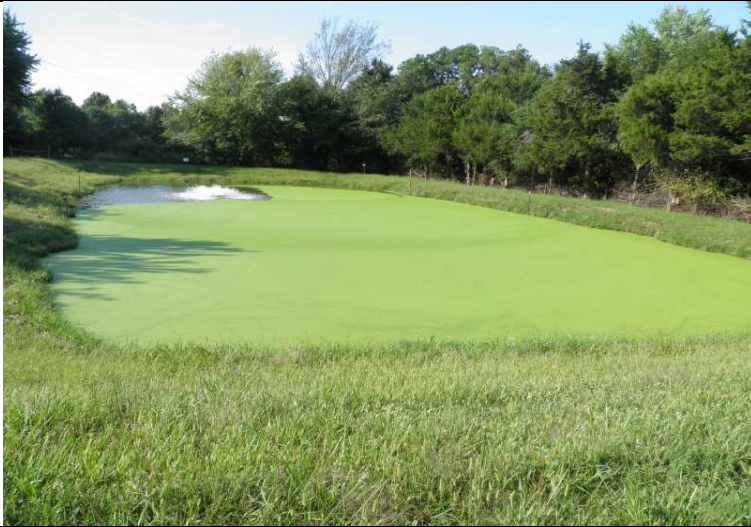
Photograph #: 1
Taken by: Stephen Moss
Entity: BCSD, Sunnyslope WWTF
Permit: #MO-0095354
Location: BOONE
Description: View of the single cell lagoon. The aerator can be observed to be operational in photo.
Date Taken: September 1, 2016
Program: WPC Unit

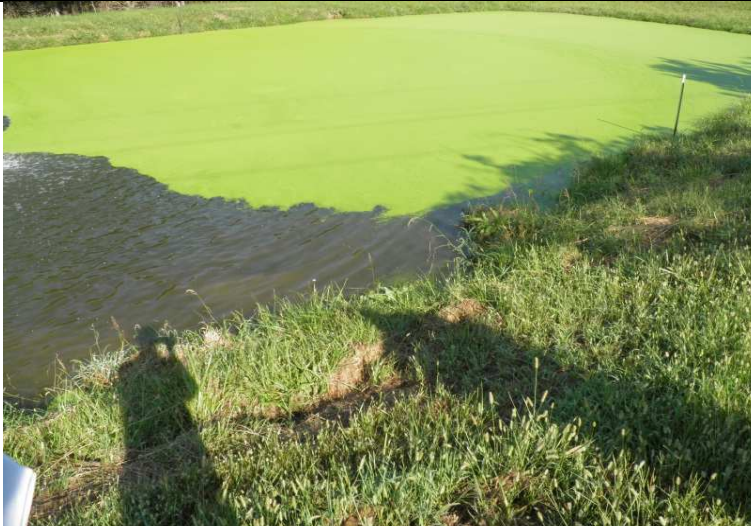
Photograph #: 2
Taken by: Stephen Moss
Entity: BCSD, Sunnyslope WWTF
Permit: #MO-0095354
Location: BOONE
Description: View of erosion damage on the inner berm slope on the east side of the lagoon cell.
Date Taken: September 1, 2016
Program: WPC Unit

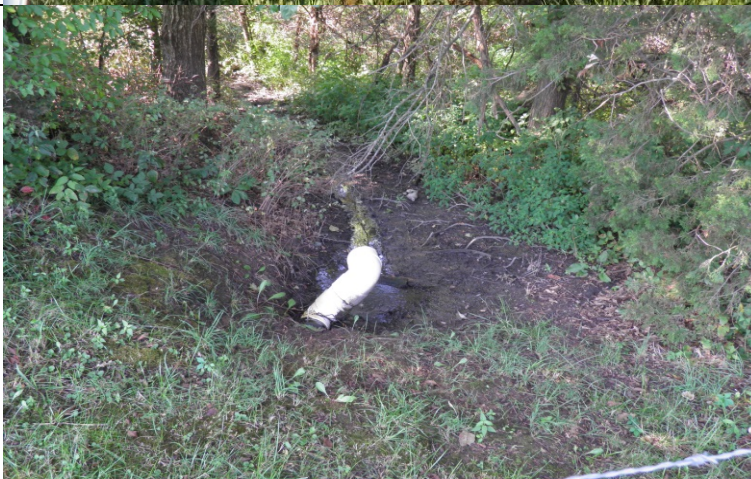
Photograph #: 3
Taken by: Stephen Moss
Entity: BCSD, Sunnyslope WWTF
Permit: #MO-0095354
Location: BOONE
Description: View of Outfall #001.
Date Taken: September 1, 2016
Program: WPC Unit

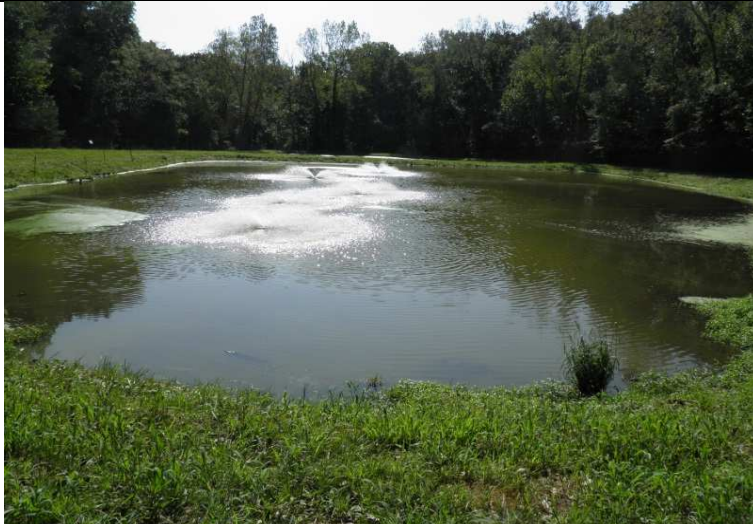
Photograph #: 1
Taken by: Stephen Moss
Entity: BCSD, Trails West Subdivision
Permit: #MO-0092002
Location: BOONE
Description: View of the primary cell. The facility's aerators can all be observed in the picture and appear to be functioning properly.
Date Taken: September 1, 2016
Program: WPC Unit

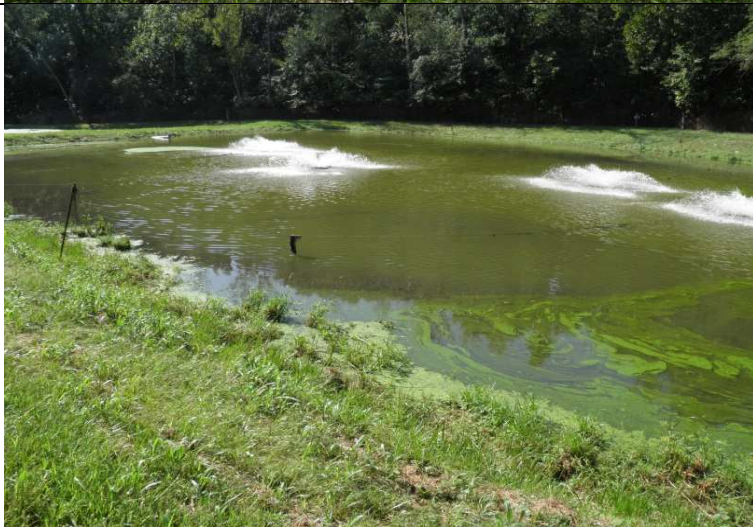
Photograph #: 2
Taken by: Stephen Moss
Entity: BCSD, Trails West Subdivision
Permit: #MO-0092002
Location: BOONE
Description: View of the primary cell. Erosion damage can be observed on the inner berm slope of the lagoon. The aerators can also be observed in the picture and they appear to be functioning properly.
Date Taken: September 1, 2016
Program: WPC Unit

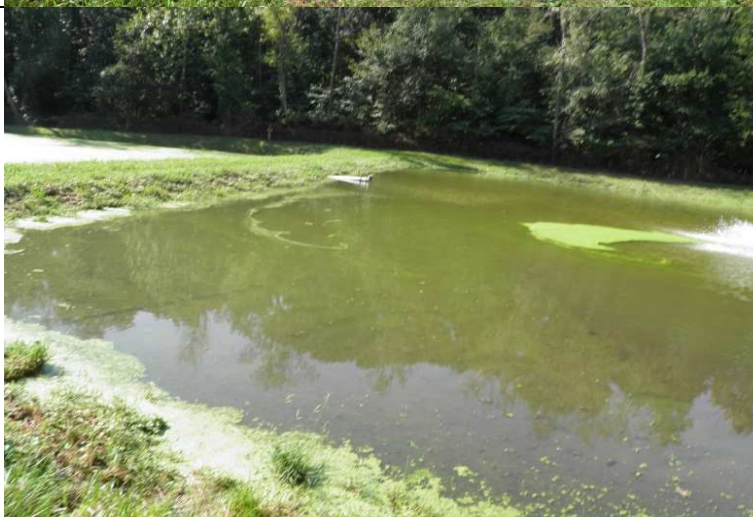
Photograph #: 3
Taken by: Stephen Moss
Entity: BCSD, Trails West Subdivision
Permit: #MO-0092002
Location: BOONE
Description: View of the south side of the primary cell. The transfer pipe between the primary and secondary cell can be observed in the picture.
Date Taken: September 1, 2016
Program: WPC Unit

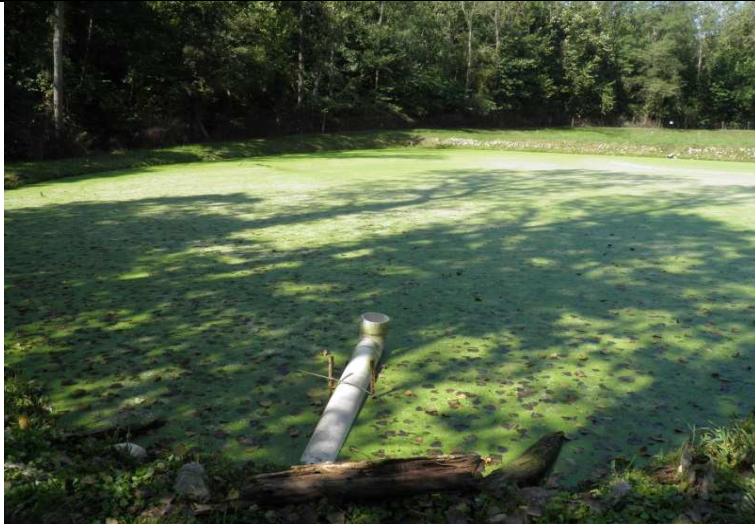
Photograph #: 4
Taken by: Stephen Moss
Entity: BCSD, Trails West Subdivision
Permit: #MO-0092002
Location: BOONE
Description: View of the secondary cell. The outfall pipe can be observed at the bottom of the picture and a T-fitting can be observed on the influent end of the outfall pipe.
Date Taken: September 1, 2016
Program: WPC Unit

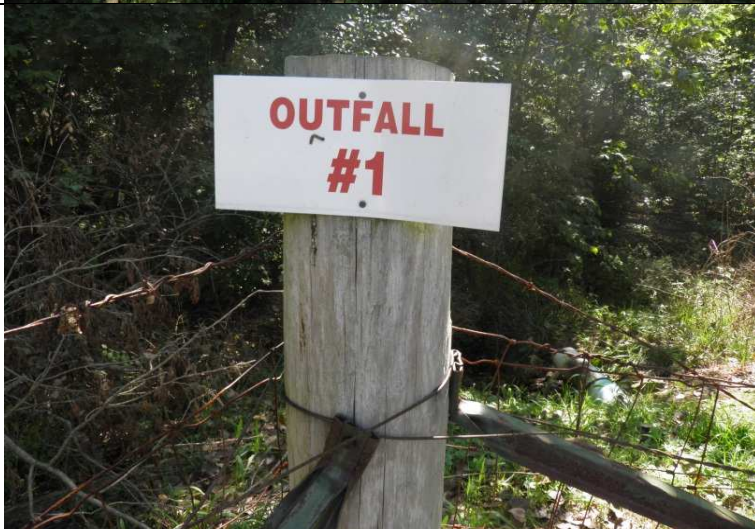
Photograph #: 5
Taken by: Stephen Moss
Entity: BCSD, Trails West Subdivision
Permit: #MO-0092002
Location: BOONE
Description: View of the facility's outfall sign.
Date Taken: September 1, 2016
Program: WPC Unit

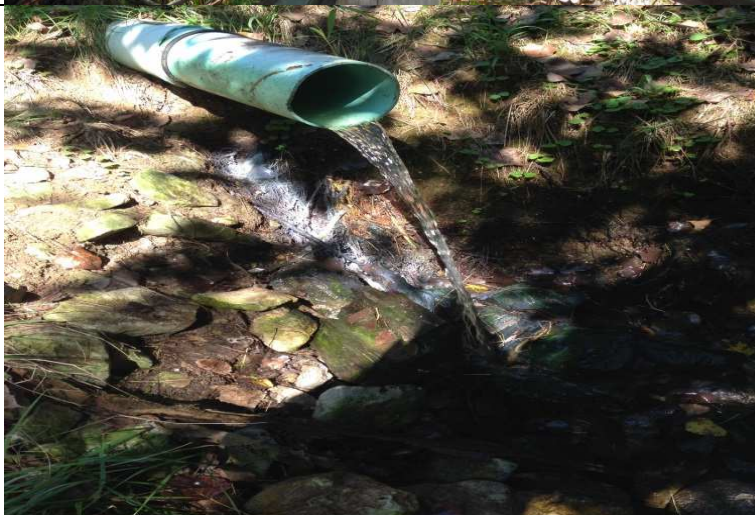
Photograph #: 6
Taken by: Stephen Moss
Entity: BCSD, Trails West Subdivision
Permit: #MO-0092002
Location: BOONE
Description: View of Outfall #001. Hydrogen sulfide bacteria can be observed below the outfall pipe.
Date Taken: September 1, 2016
Program: WPC Unit
