**BEFORE THE PUBLIC SERVICE COMMISSION
OF THE STATE OF MISSOURI**

Case No. GS-2011-0248

STAFF'S FINAL REPORT

Gas Incident Report

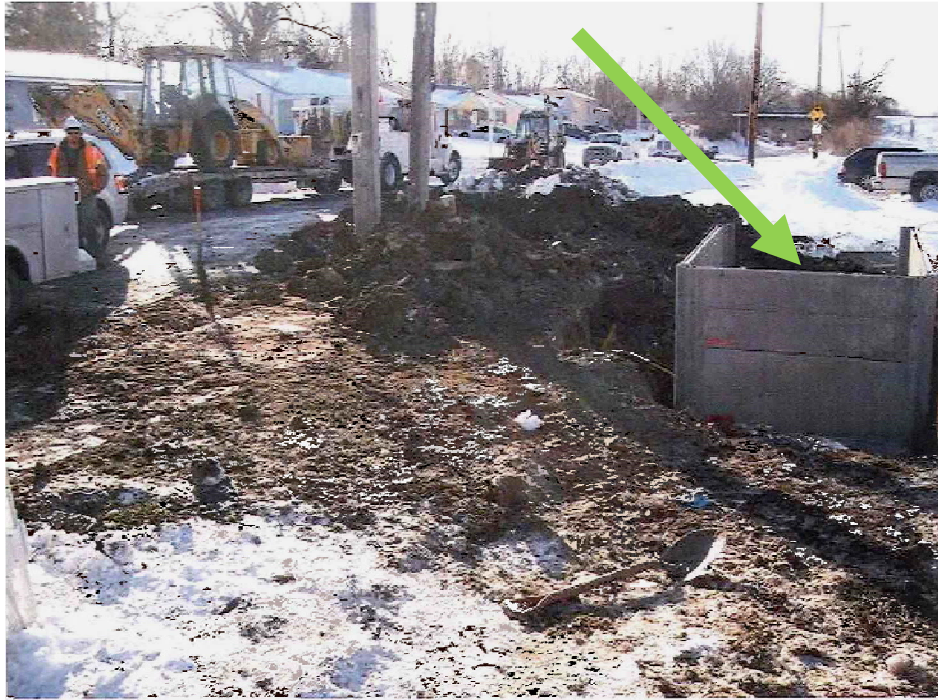
PHOTOGRAPH 1: Incident Location, Excavation Opened (Arrow), View Looking Southwest across Pipeline towards 107th Street (Photo Courtesy of MGE).

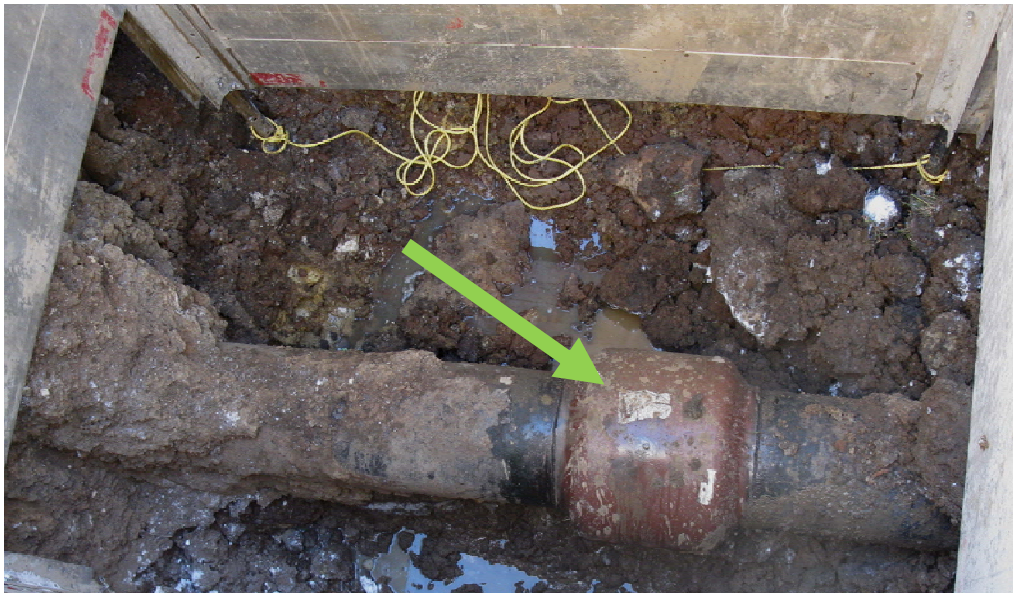
At 10:00 p.m. on February 2, 2011, the Company determined that the break was approximately 7 inches east of a girth weld, with a maximum separation of about 0.5 inches at the top, and approximately 8 inches of intact material at the bottom of the pipe. At 11:30 p.m., the Company began installation of a full circle band clamp. By 12:45 a.m. on February 3, 2011, the full circle band clamp was installed, and pressure was holding in the line between 35 and 40 psig (in the vicinity of the fracture). At 2:25 a.m., welders began installing a 16-inch reinforcing sleeve around the band clamp. Water running into the excavation from a damaged sewer slowed the installation, which was completed at 6:00 a.m.

PHOTOGRAPH 2: View Looking Down Upon Welded Repair Sleeve (Arrow) (Staff Photo).

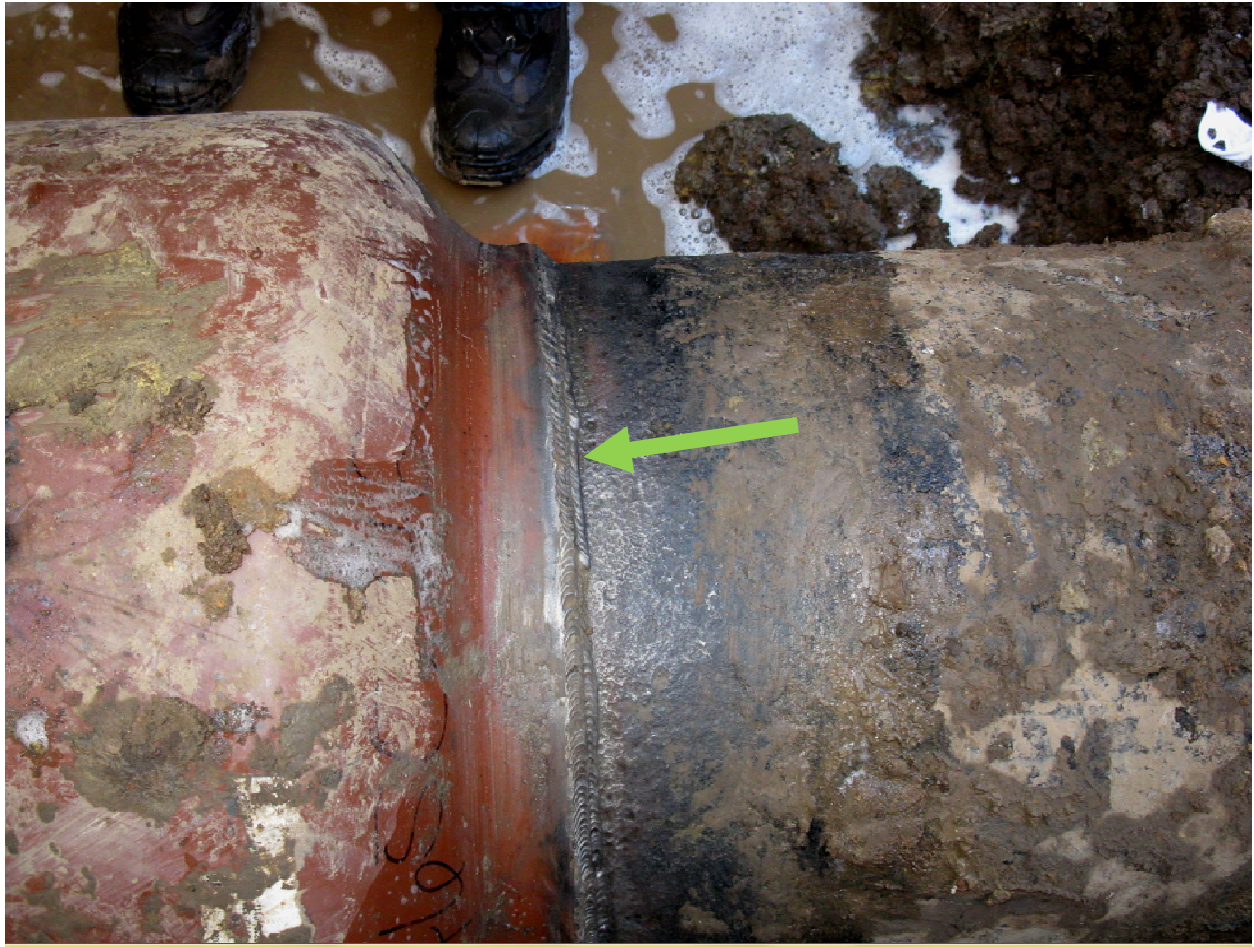
At 6:20 a.m. on February 3, 2011, the Company began to increase the pressure on the Mayfair 16-inch pipeline. By 6:40 a.m., the pressure was up to 143 psig, and a very small leak was discovered in a fillet weld on the bottom of the repair sleeve. The Company decided to keep the pressure up to accommodate the morning load due to extremely cold ambient air temperatures. For the safety of the public and for worker safety, the Company closed a section of 107th Street between Blue Ridge Boulevard and the Kansas City Southern Railroad tracks approximately 700 feet to the west. At 8:40 a.m., the leaking sewer drain was repaired. By 1:30 p.m. on February 3, 2011, the repair sleeve leak was repaired. Valves were opened and pressure was increased in the line. By 2:20 p.m. on February 3, 2011, all repairs had been made and the pressure had been restored to approximately 180 psig in the Mayfair 16-inch pipeline.

PHOTOGRAPH 3: Weld Bead (Arrow) joining Welded Repair Sleeve to Mayfair 16-inch pipeline (Staff Photo)

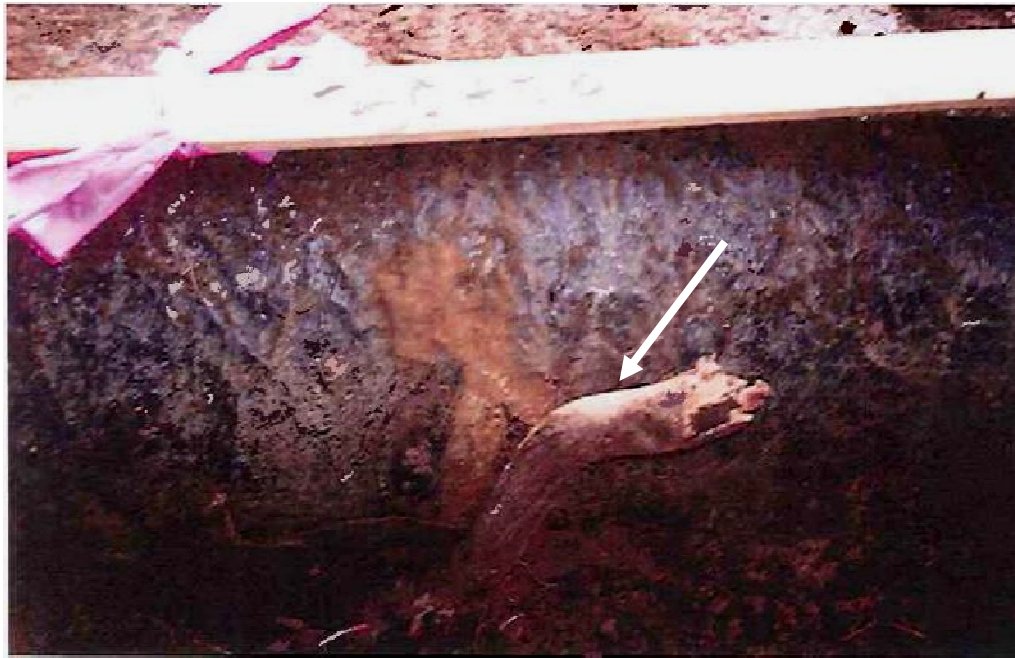
Example 1: Coating Damaged by Tree Root Intrusion (Arrow), Found in Excavation for Coating Defect No. 59, Active corrosion was observed under the coating. [45 dB μ V (Minor, ACVG Score = 4); CIS “Off” = -0.867 (CIS Score = 5), Total ECDA Score = 11].

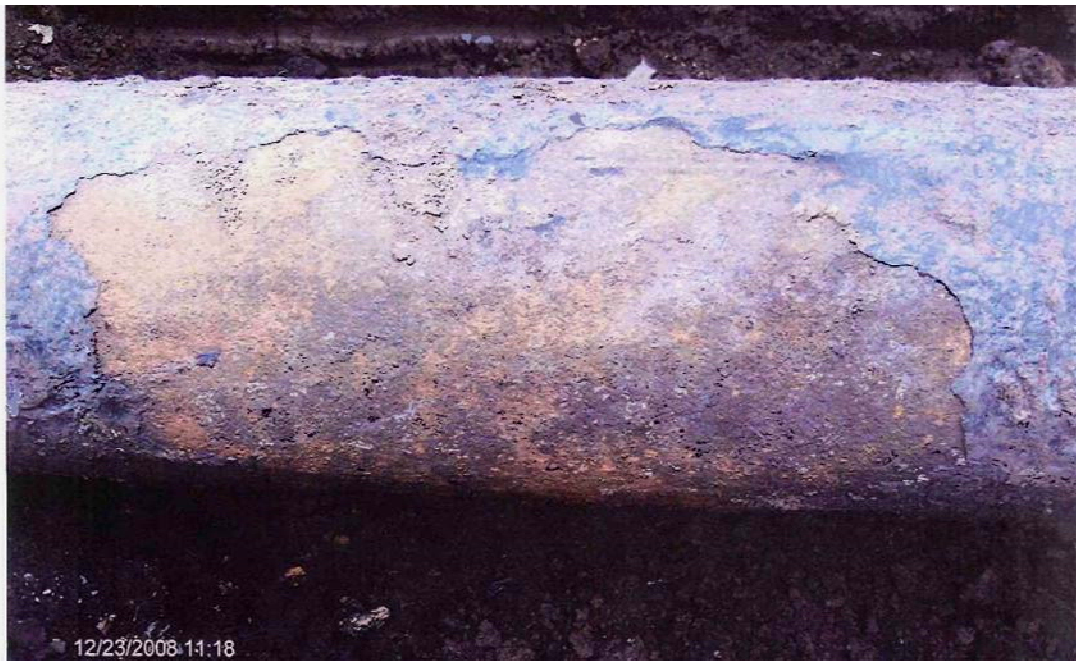
Example 2: Coating Disbonded, Found in Excavation for Coating Defect No. 137, [64 dB μ V (Moderate, ACVG Score = 6); CIS “Off” = -0.821, “On” = -0.842 (CIS Score = 10), Total ECDA Score = 18].

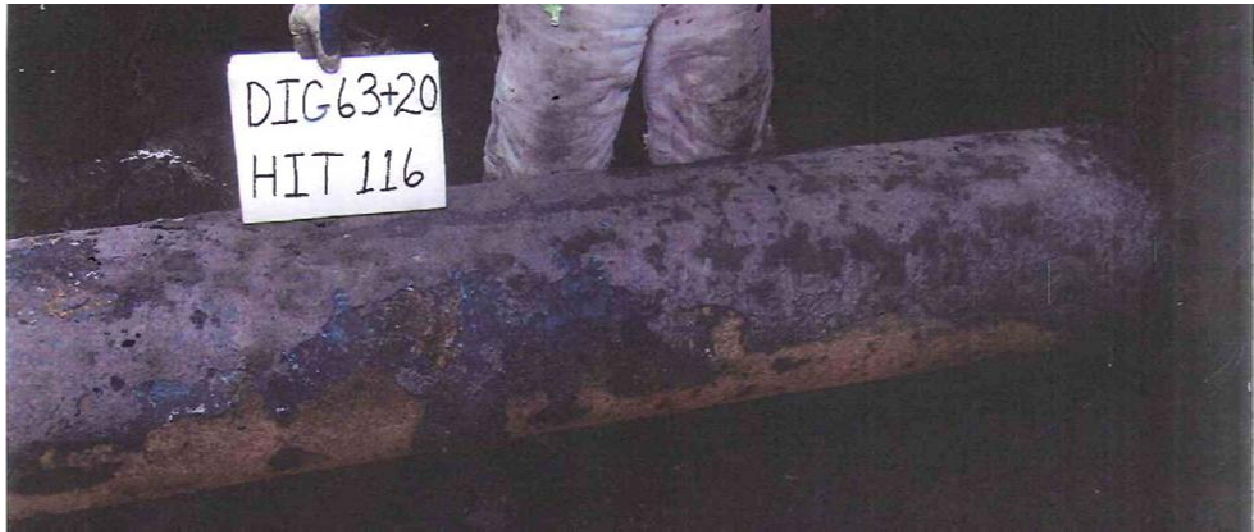
Example 3: Coating Not Properly Applied, Found in Excavation for Coating Defect No. 116, No Coating Applied to Sides, [47 dB μ V (Minor, ACVG Score = 4); CIS “Off” = -0.855, “On” = -0.907 (CIS Score = 5), Total ECDA Score = 11].

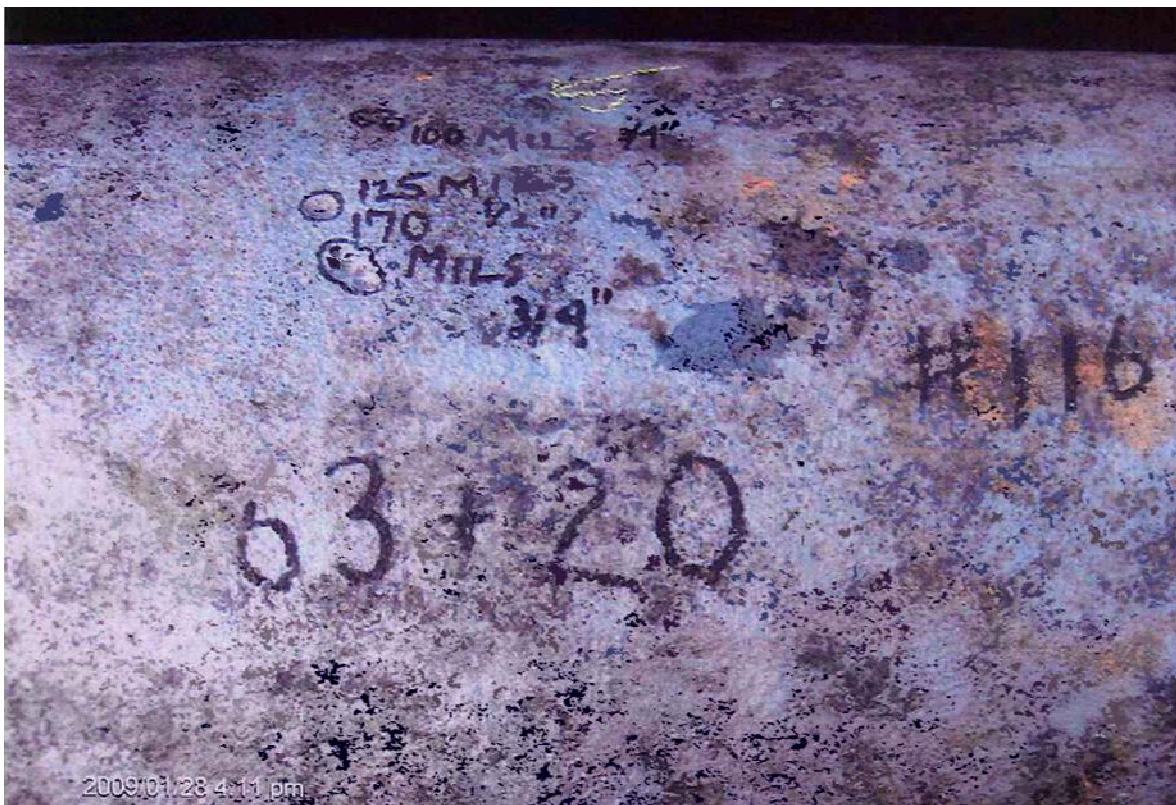
Example 4: Pitting Corrosion, Found in Excavation for Coating Defect No. 116, [47 dB μ V (Minor, ACVG Score = 4); CIS “Off” = -0.855, “On” = -0.907 (CIS Score = 5), Total ECDA Score = 11].

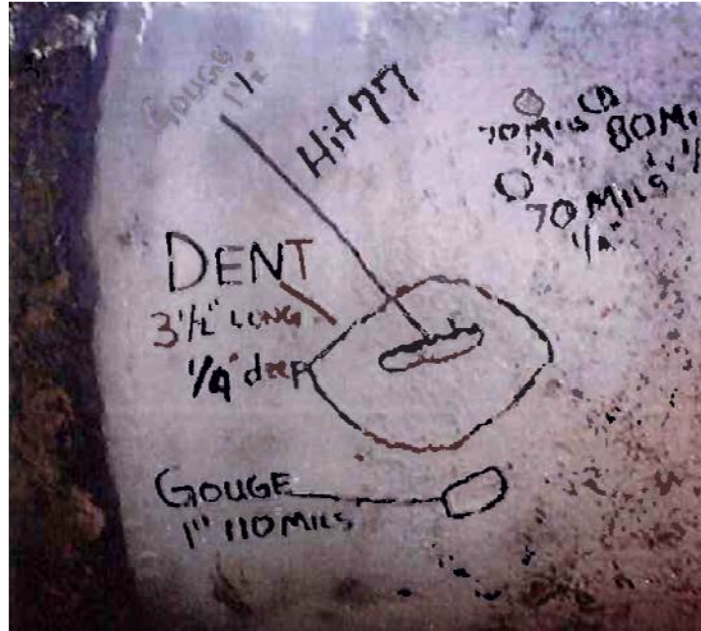
Example 5: Dents and Gouges, Found in Excavation for Coating Defect No. 77, No Coating was Observed in the Vicinity of a Water Service Crossing, Active Corrosion was also Observed at this Location, [51 dB μ V (Moderate, ACVG Score = 6); CIS “Off” = -0.853, “On” = -0.893 (CIS Score = 5), Total ECDA Score = 13].

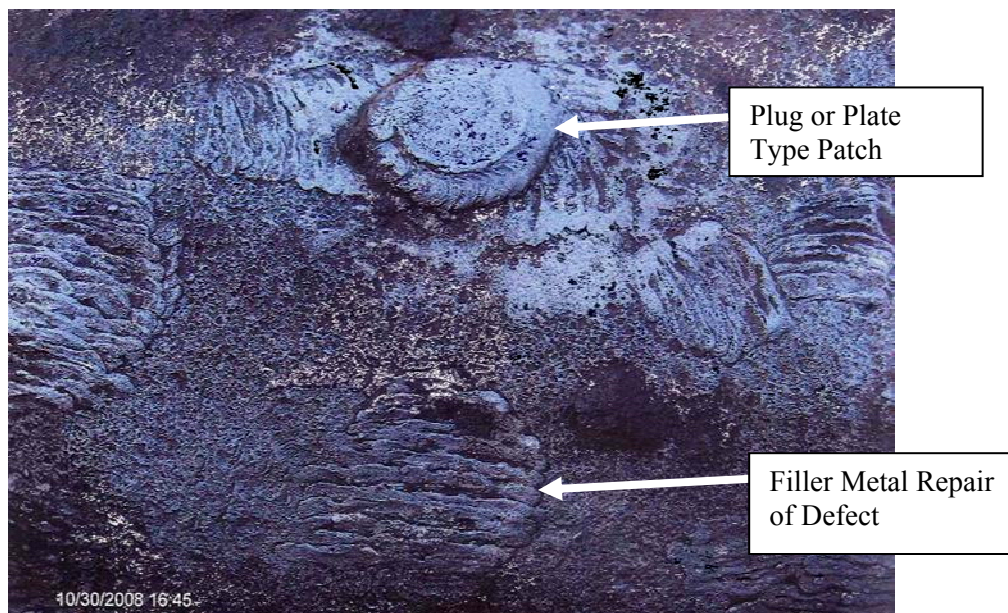
Example 6: Previous Repairs, Found in Excavation during Recoating Project, no associated Total ECDA Score. Repair Appears to Include a Plug or Plate Type Patch as well as Application of Filler Metal to Repair Defects.
