# Missouri Public Service Commission

## Gas Incident Report

**Missouri Gas Energy  
Case No. GS-2008-0002**

In the Matter of Missouri Gas Energy                     )  
Company concerning a Natural Gas                     )  
Incident near the intersection of East 72<sup>nd</sup>                     )                     GS-2008-0002  
Street and Brooklyn Avenue in Kansas  
City, Missouri.

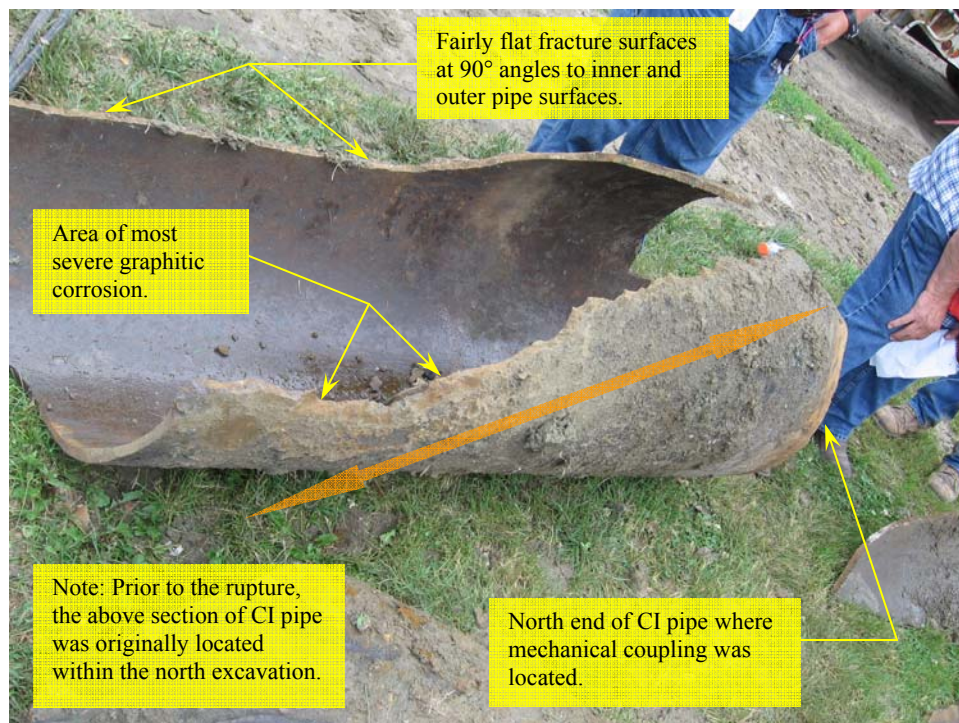
Throughout the day on May 26, the Staff and Company personnel attempted to locate and re-assemble the scattered fragments or pieces of 24-inch diameter CI piping that were heaved out of the ground when the cast iron main ruptured (**see Appendix B-2, Photograph 4**). The Staff then made an overall length measurement of the re-assembled sections of 24-inch diameter cast iron piping. The overall length was measured as 13 feet and 3 inches (compared to 14 feet and 11 inches found remaining in the north excavation). During the process of re-assembling the pipe fragments, Staff observed

what appeared to be severe graphitic corrosion along portions of the fracture surfaces (see photograph below). The CI pipe fragment shown in this photograph has been turned approximately 180° (top to bottom) from its actual undisturbed pipe orientation prior to the rupture. The severe corrosion area appeared to penetrate the entire pipe wall at numerous locations. One area of corrosion appeared to start approximately 6 inches from the north end (at approximately the 6 o'clock position) of the section of CI pipe that ruptured and extended southward somewhat longitudinally at a slight spiral rotation for a length of approximately 4 feet to approximately the 3 o'clock position. The orange arrow in the photograph below represents the approximate span of this graphitic corrosion on this CI pipe fragment. One of the many fracture surfaces developed and propagated along this area of graphitic corrosion. Most fracture surfaces of the CI pipe resulted in a fairly flat fracture surface and the fracture surfaces were at a 90° angle relative to the inner and outer pipe surfaces. The pipe surface along most of this 4-foot long fracture surface was highly irregular and cratered in appearance and the fracture surface was at a slight angle to the inner and outer pipe surfaces. In the photograph below, the north end of the CI pipe is to the right.

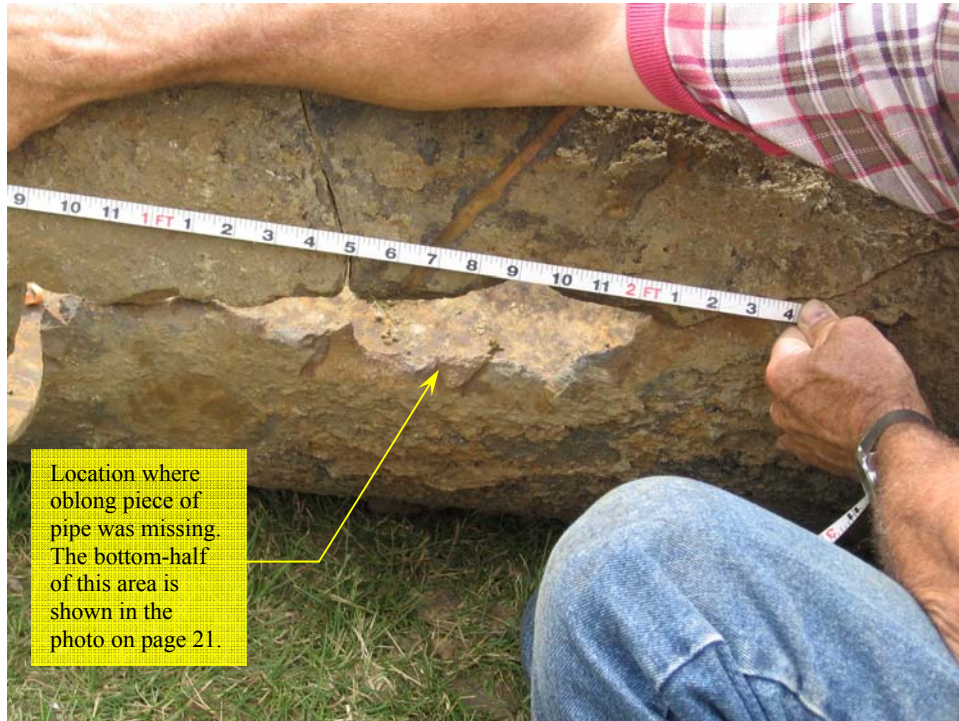
At one location along the previously mentioned fracture area, a small oblong piece of pipe (see photograph below), measuring approximately 3 inches by 10 inches could not be located. Upon reassembling the pipe segments severe graphitic corrosion was observed all along the fracture surface where this small piece of pipe would have been located. The pipe fracture surfaces were highly irregular and cratered in appearance and the fracture surface was at approximately a 45° angle to the inner and outer pipe surfaces.

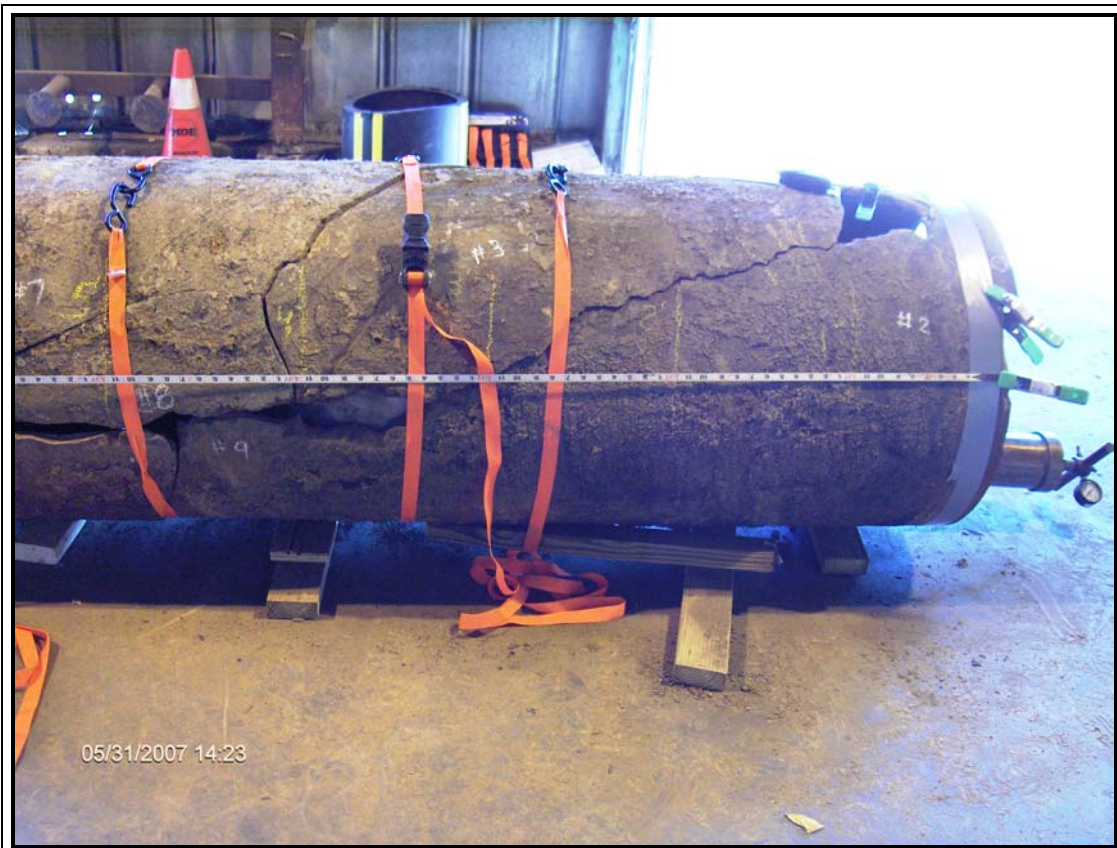
On May 31, 2007, the Company assembled the various ruptured sections of the 24-inch diameter CI main that were extracted from the north excavation, as well as, the displaced sections of cast iron piping found scattered along the ground after the pipe rupture. MGE was unable to locate all of the cast iron fragments/pieces (**see Appendix B-1, Photographs 1 and 2**).

**Photograph 1** View of a portion of the 24-inch diameter CI pipe fragments that were pieced together by MGE at their training facility. The duct tape wrapping near the right side is approximately where the mechanical coupling would have been located at the north end of the north excavation (Photograph provided by MGE).

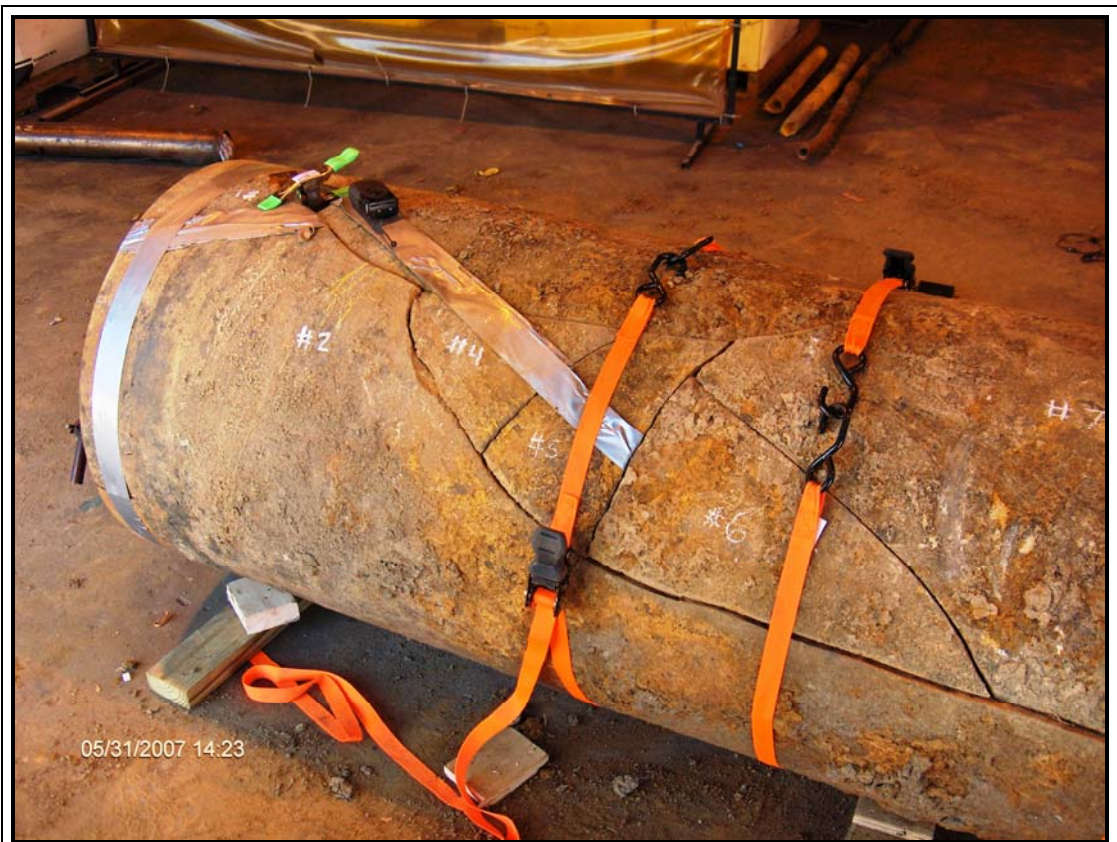
**Photograph 2** Opposite side view of the assembled CI pipe fragments. The north end of the cast iron main is to the left in this photograph (Photograph provided by MGE).

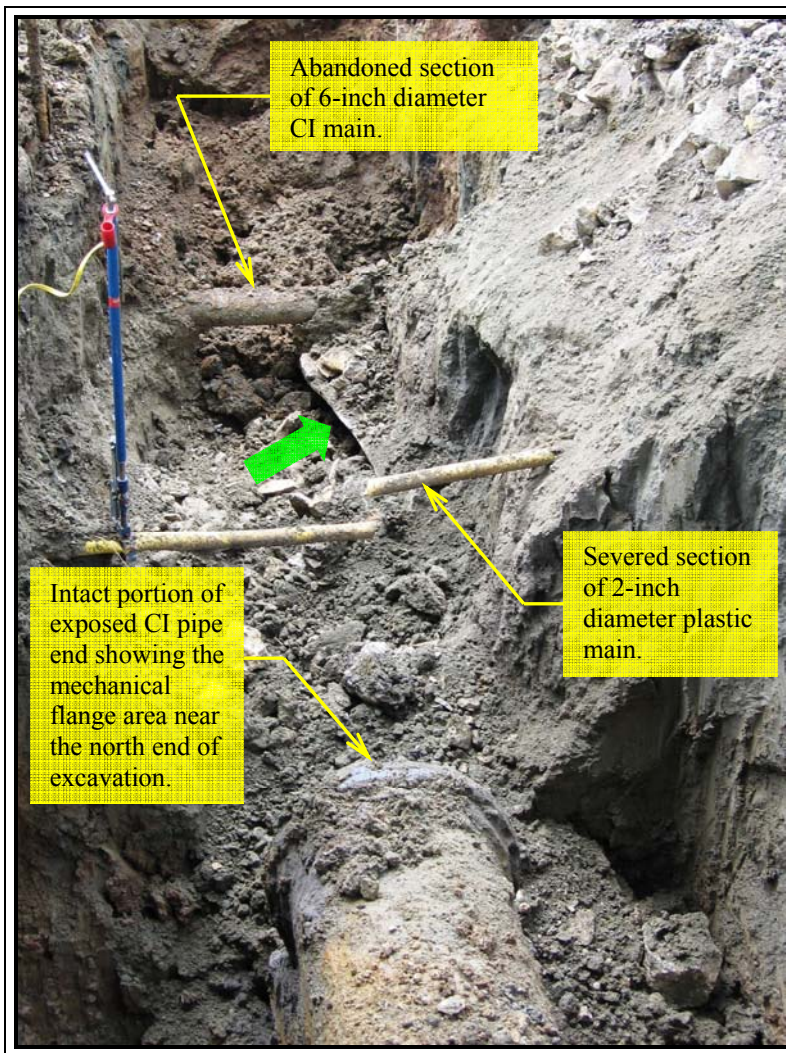
A large excavation was located near the northeast corner of the intersection of East 72<sup>nd</sup> Street and Brooklyn Avenue (**referred to as the north excavation, see Appendix B-2, Photograph 3**). Within this excavation the Staff observed approximately 11 feet of an exposed section of 24-inch diameter cast iron natural gas main that was visible near the north end of this excavation. This exposed section of cast iron pipe had an open pipe end with a mechanical flange for fastening a mechanical coupling. The burial depth to the top of cast iron was measured as approximately 5 feet. Toward the south end of the same excavation a 2-inch diameter section of plastic natural gas main was visible as it crossed the excavation, approximately 1 foot above the CI pipe in approximately an east-to-west direction. This section of plastic main appeared to have been completely severed at approximately the midpoint above the cast iron main and a temporary squeeze-off tool<sup>17</sup> had been utilized by the Company to stop the flow of natural gas. At the far south end of this excavation, an abandoned section of 6-inch diameter cast iron natural gas main also crossed above the 24-inch diameter cast iron main in an east-to-west direction. A backhoe was later used by the Company to remove additional soil from around the remaining buried segments of 24-inch diameter cast iron piping and to also discover if any past directional bore projects may have damaged the cast iron piping. During this work, the Staff observed a long section of CI piping inside of the north excavation that appeared to have been fractured in numerous locations. The overall length of this fractured section of cast iron piping that had remained in the trench was measured as 14 feet and 11 inches. The Staff then observed the sides of the excavation in an attempt to locate any past directional bore hole locations. No bore hole locations were observed.

**Photograph 3** View looking approximately to the south inside of the north excavation after a Company backhoe was used to deepen and extend the excavation to expose the sections of 24-inch diameter cast iron main that had remained in the trench. The green arrow indicates a fractured section of cast iron piping that was not heaved out of the ground. The blue rod on the left side of the photo is a squeeze-off tool that has a grounding wire attached to prevent a potential build-up of static electricity along the plastic pipe surface.

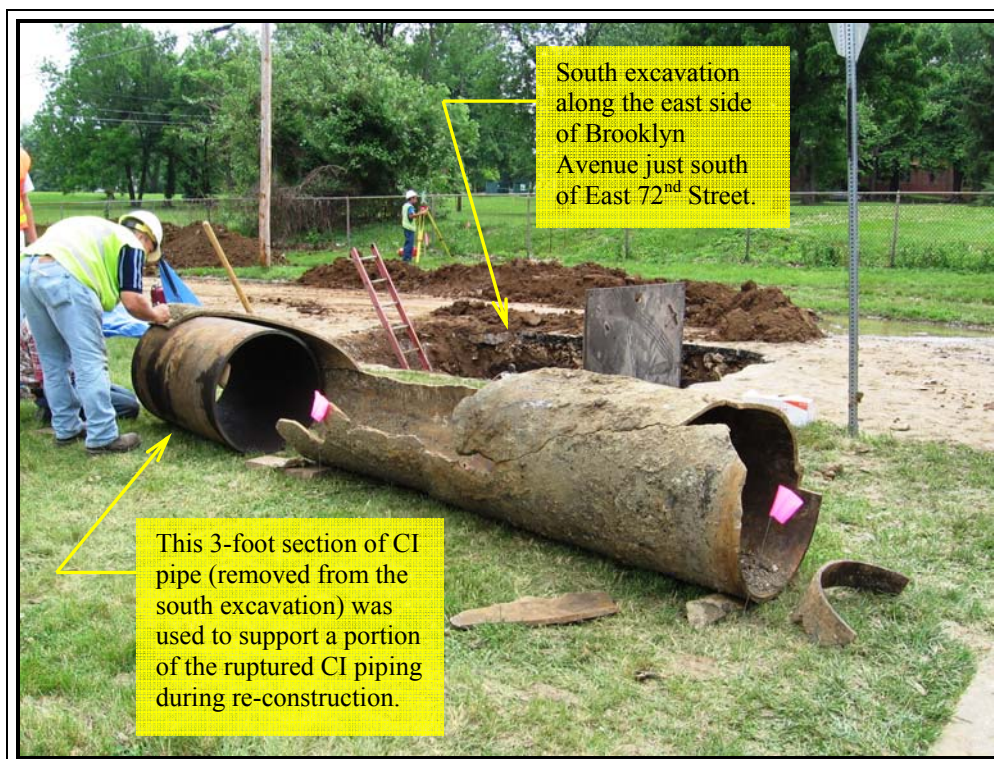
**Photograph 4** Looking southwest at the various pieces of 24-inch diameter CI main that the Staff and MGE personnel were assembling. After assembling the ruptured sections of CI pipe, the measured length along the pipe's longitudinal axis from the north end to the south end was approximately 13 feet and 3 inches.
