**File No. GS-2016-0159**

**STAFF GAS INCIDENT REPORT**

## Staff's Gas Incident Report

3404 Georgia Street  
Louisiana, Missouri  
November 27, 2015

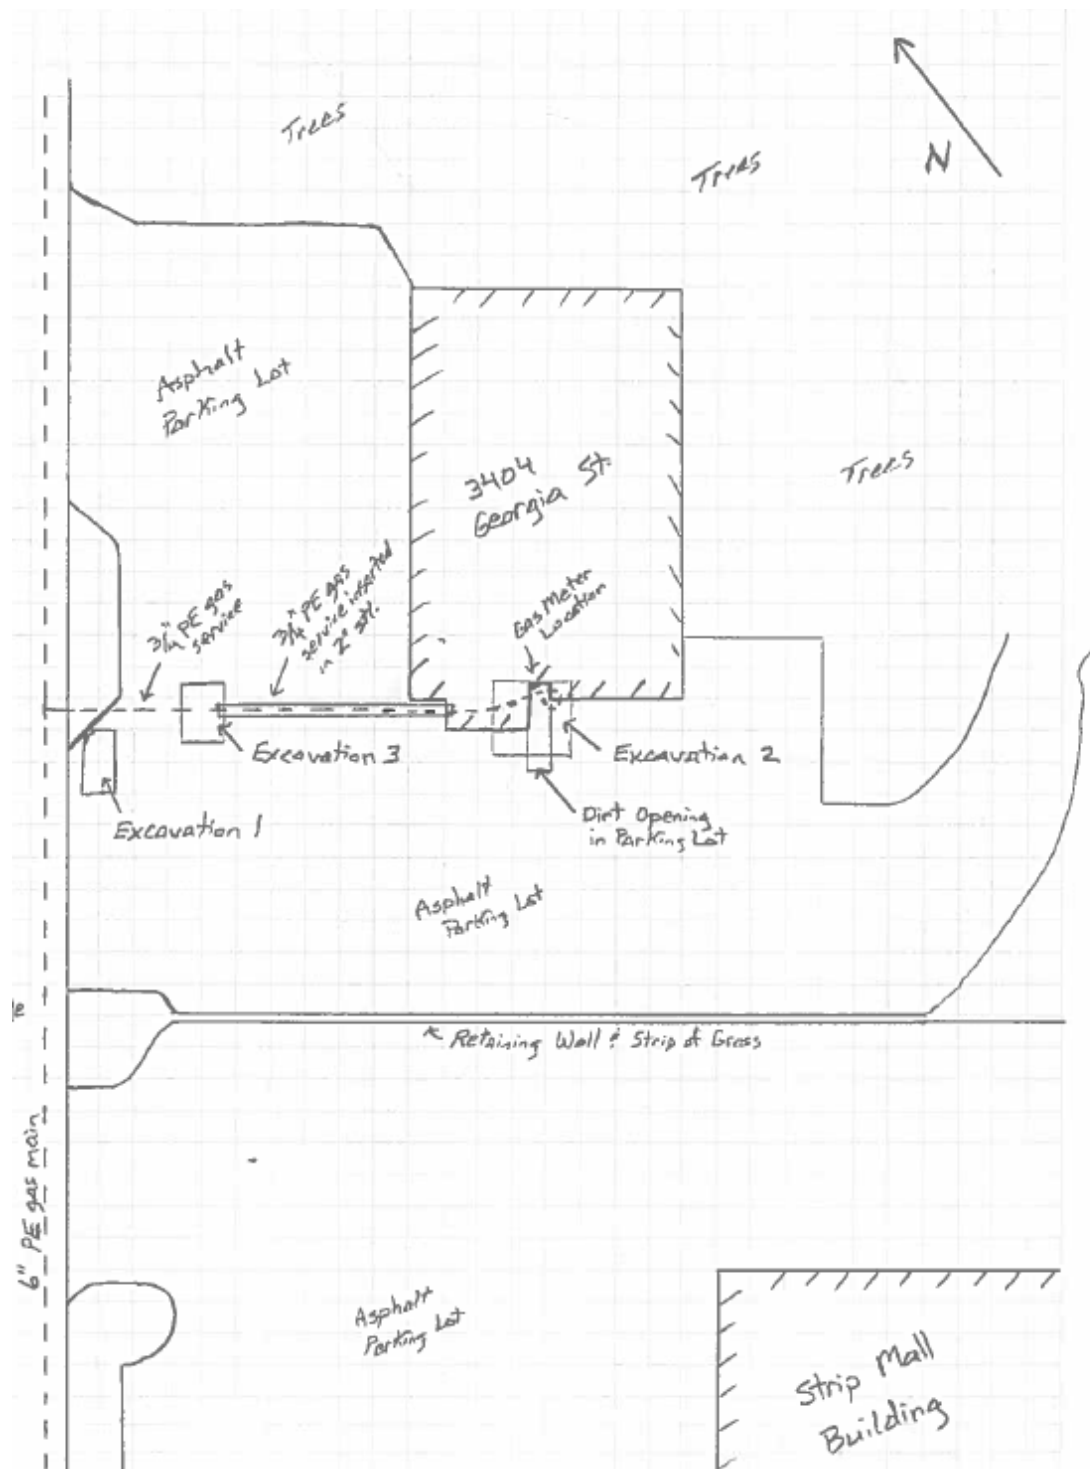
Figure 2: Ameren's sketch of 3404 Georgia Street Plan View. The areas labeled "Excavation 1", "Excavation 2" and "Excavation 3" refer to excavations Ameren made subsequent to the incident. (Source: GS-2016-0159, Ameren's response to Staff data request 0001). Note this sketch does not show the 6-inch to 8-inch transition on the main. At the location where the 3/4-inch PE gas service line connects to the main, the main is 8-inch.

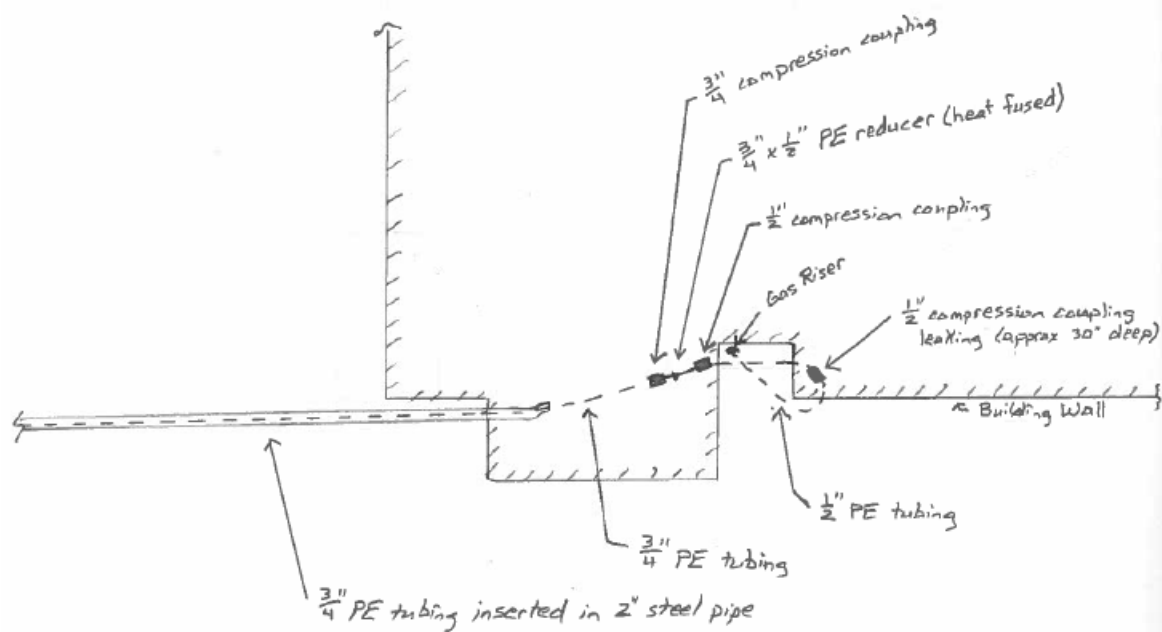
Figure 3: Ameren's sketch of the portion of service line to 3404 Georgia Street nearest the building. (Source: GS-2016-0159, Ameren's response to Staff data request 0001).

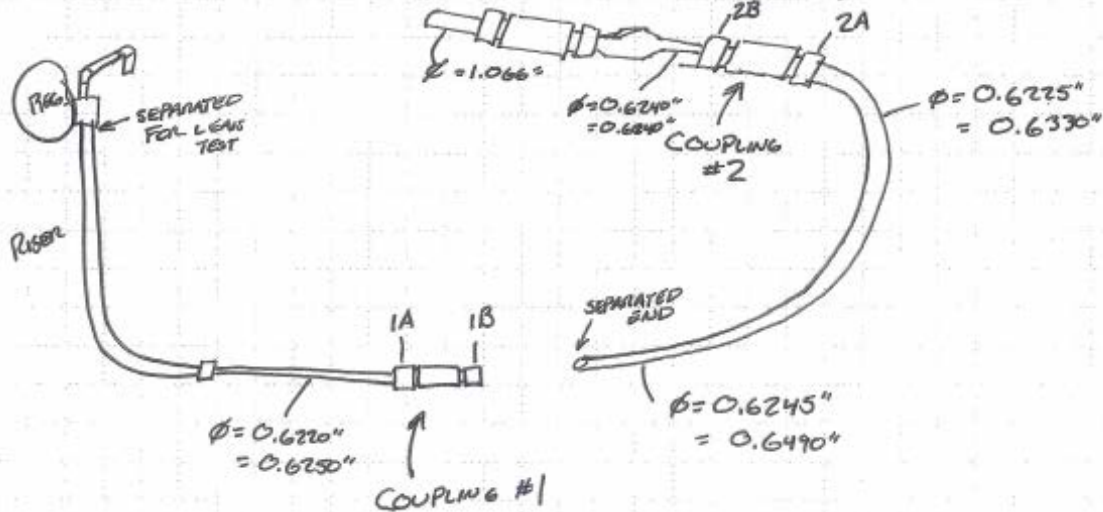
NO VISIBLE MARKINGS ON SUBJECT COMPRESSION FITTINGS (COUPLING)

AIR LEAK TEST IN WATER BATH @45 PSIG - NO LEAKS OBSERVED  
- ENDS PLUGGED

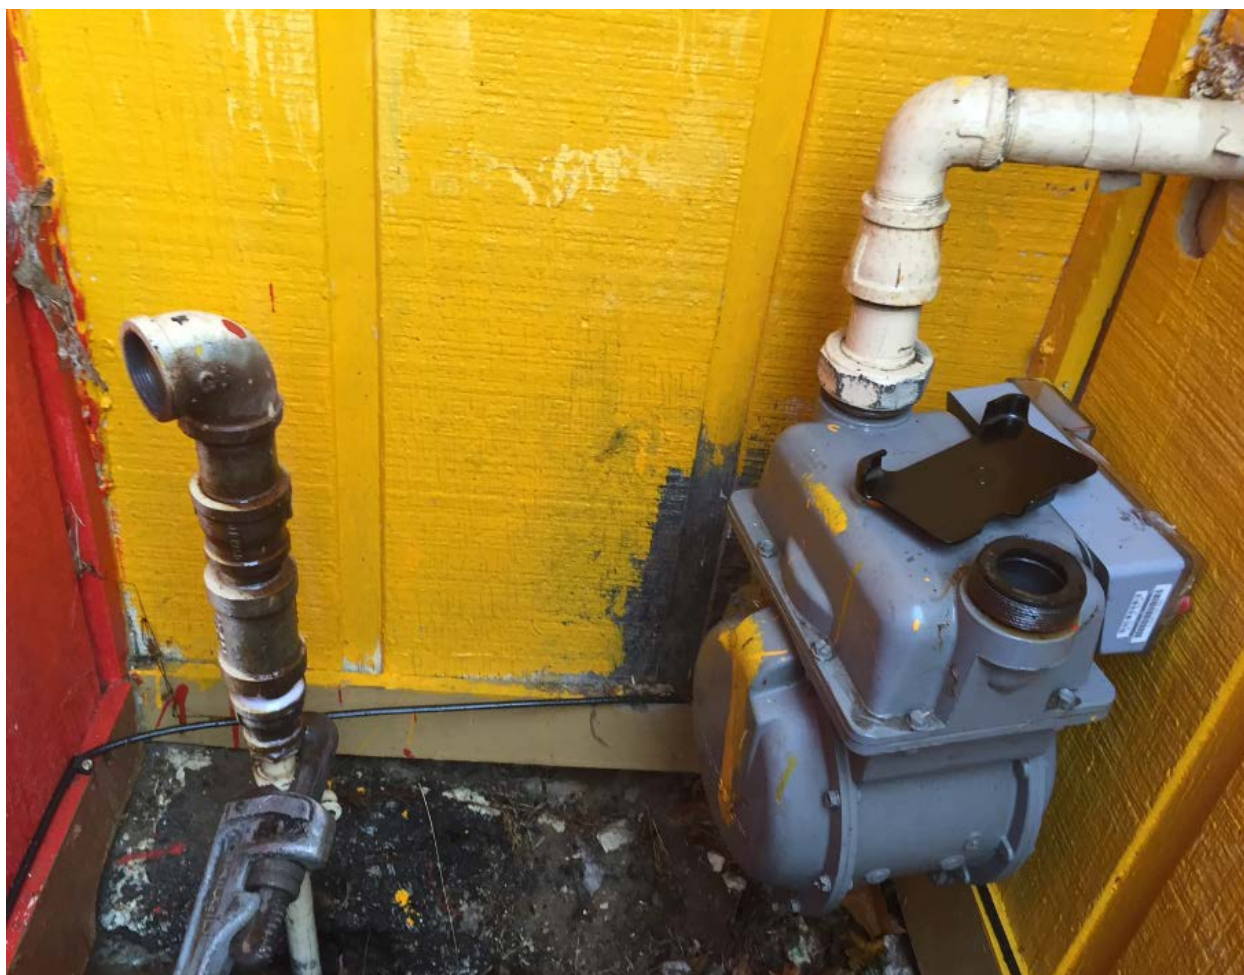
**Photograph 1: Photograph of Meter Set and Riser taken by Ameren Service Worker during repair of meter set leaks (Source: GS-2016-0159, Ameren’s response to Staff data request 0029). Note the pipe wrench on the gas riser pipe and the soap solution on the fittings above the pipe wrench. Ameren indicated this picture is of the existing fittings prior to the repairs being completed (Source: GS-2016-0159, Ameren’s response to Staff data request 0001.1).**

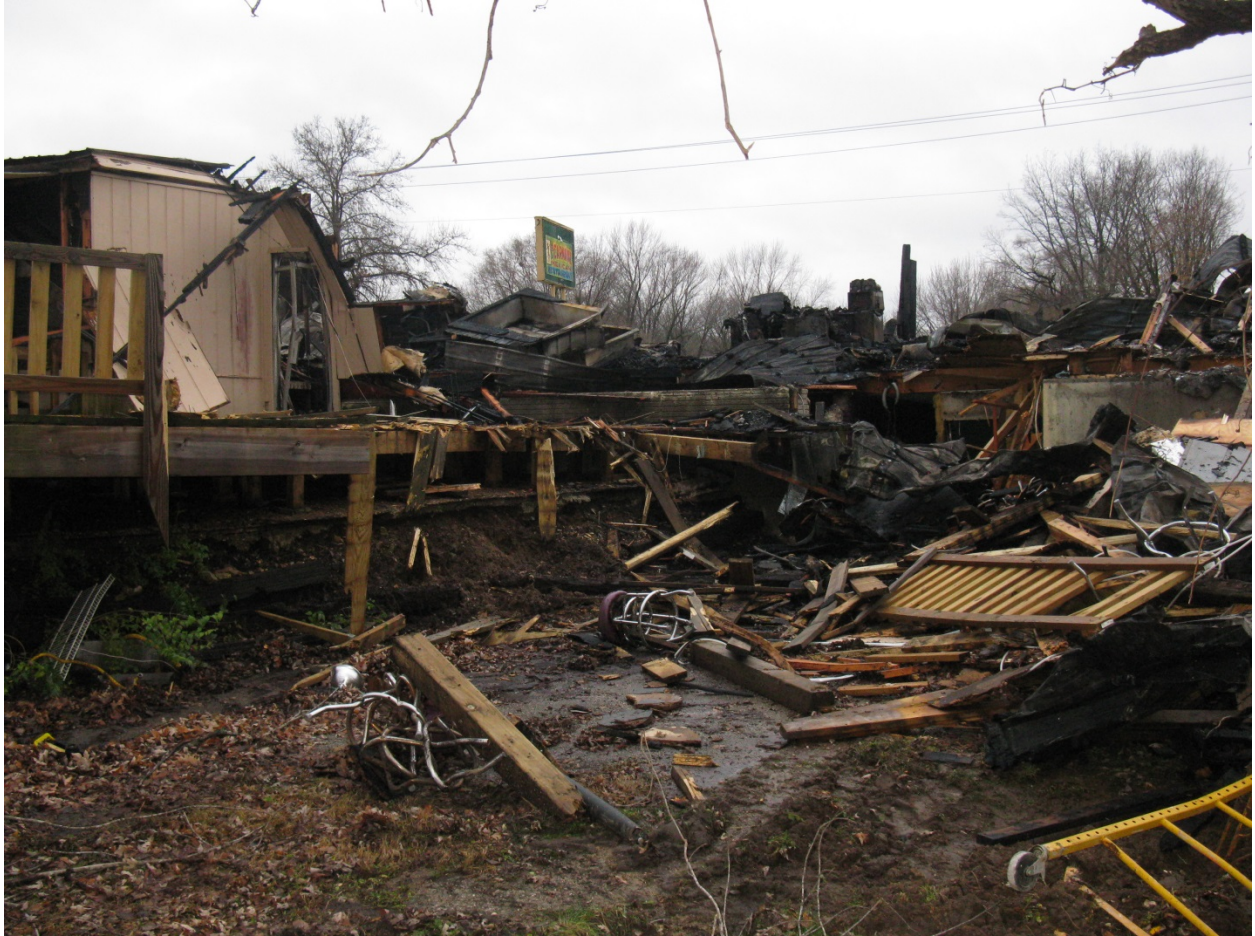
The restaurant building at 3404 Georgia St. was destroyed as a result of the natural gas fire and subsequent structure fire. The Ameren service worker's truck was parked next to the building and sustained some water damage in addition to getting covered by soot. The Ameren natural gas meter was aluminum and melted during the fire, and the other aboveground meter set piping sustained scorching and heat exposure.

Staff observed the extensive building damage (See Appendix C, Photograph 2). Staff proceeded to Ameren’s office in Louisiana and examined the service line piping and riser that had been removed from outside the restaurant the day before. An attempt was made to

**Photograph 2: 3404 Georgia Street following incident, photograph taken from behind building looking towards the entrance from Georgia Street. (Source: Staff Photograph taken November 28, 2015).**

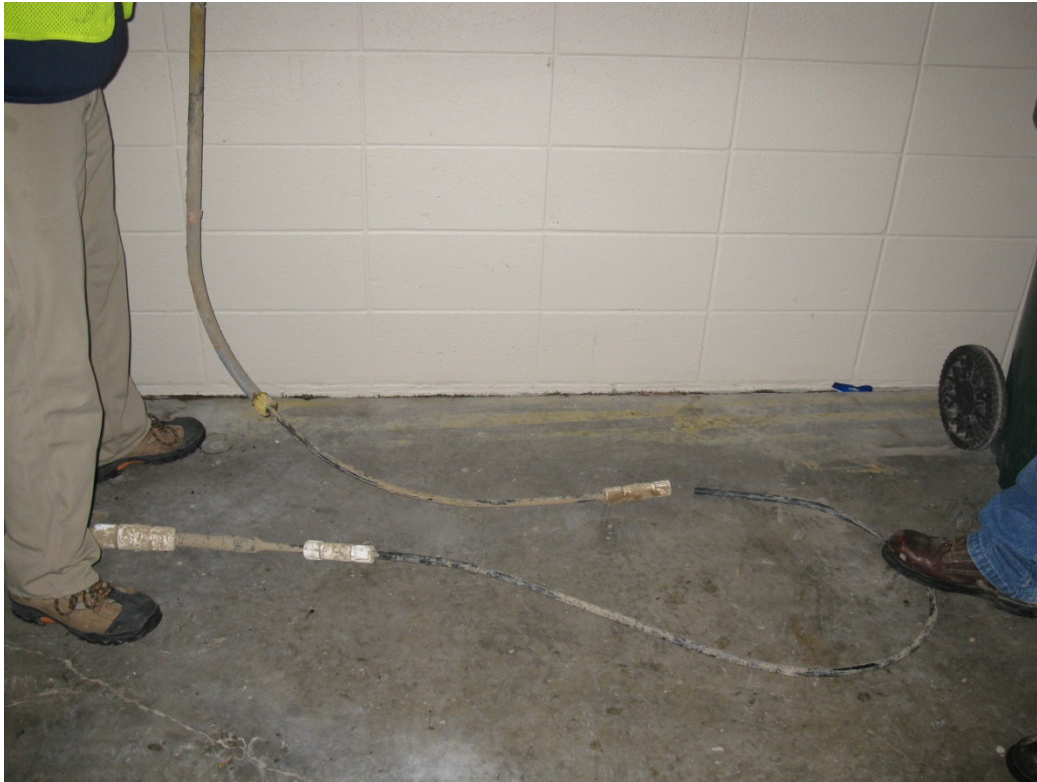
Laboratory observations indicate the service line pipe was not fully inserted into the compression coupling at the time of failure per a marking on the inside pipe wall. It could not be determined whether the compression coupling was incorrectly installed this way or had gradually pulled out over time.

1) The compression coupling separated due to pull-out forces exceeding the pull-out strength of the coupling. This may have been due to an inadequate insertion of the pipe into the coupling at the time of installation, but the pipe also could have pulled out gradually over time.

**Photograph 3: Removed section of service line from 3404 Georgia Street following incident**  
(Source: Staff Photograph taken November 28, 2015).

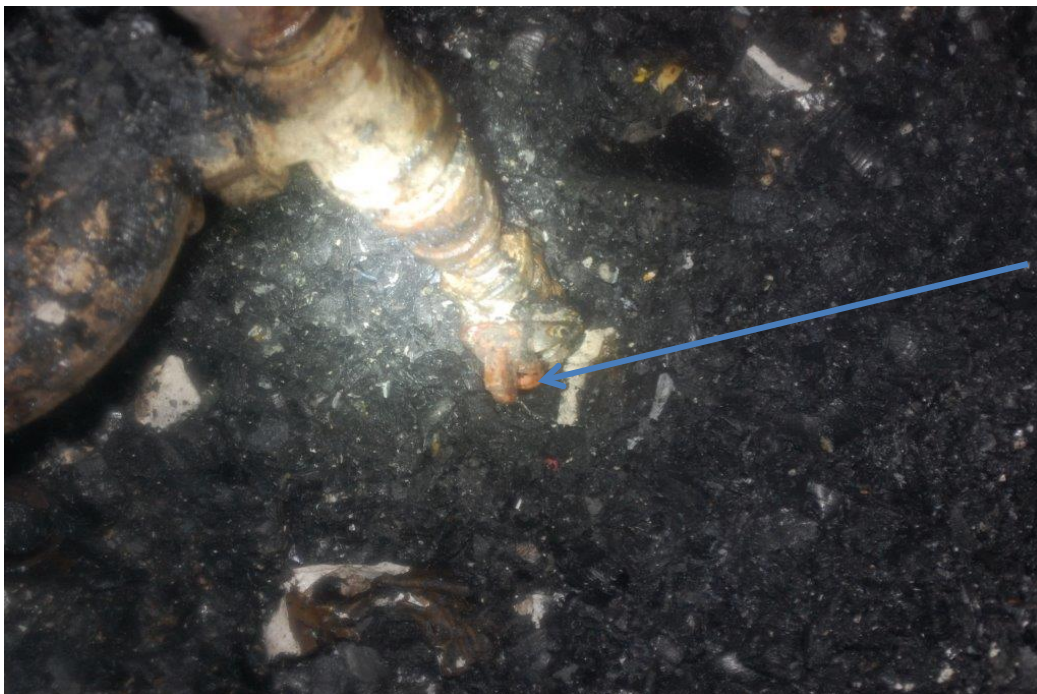
Staff Note and Arrow  
Valve is in open  
position

Based on verbal discussion with the Louisiana Fire Chief, the Louisiana Fire Chief noted that upon his arrival there was a large natural gas fire along the building wall near the meter location. The Louisiana fire department sprayed water on the roof above the gas fire for a period of time, and then observed that suddenly the gas fire went out on its own. Since the flow of gas from the main to the service line had not yet been squeezed off, and since the gas riser valve was open at this time, it was unclear why the flow of gas would have stopped escaping from the open gas pipe or why the fire would have gone out on its own. Ameren confirmed that the gas was not escaping from the open pipe up through the time when the gas riser valve was later turned off, and had no explanation for why fire would have gone out without closing this valve.

**Photograph 4: Photograph of Natural Gas Service Riser Showing Valve in Open Position**  
(Source: Missouri State Fire Marshal's Office Investigation Photographs).
