SIGHT INSPECTION REPORT

Count 2

Exhibit No. 10
Case No(s) MC-2005-0028
Date 3-02-05 Rptr XF

Subject: Structural Inspection Report and Recommendations regarding the undercarriage beams for the manufactured home at 30 Oak Leaf Drive, Foley, Missouri 63347.

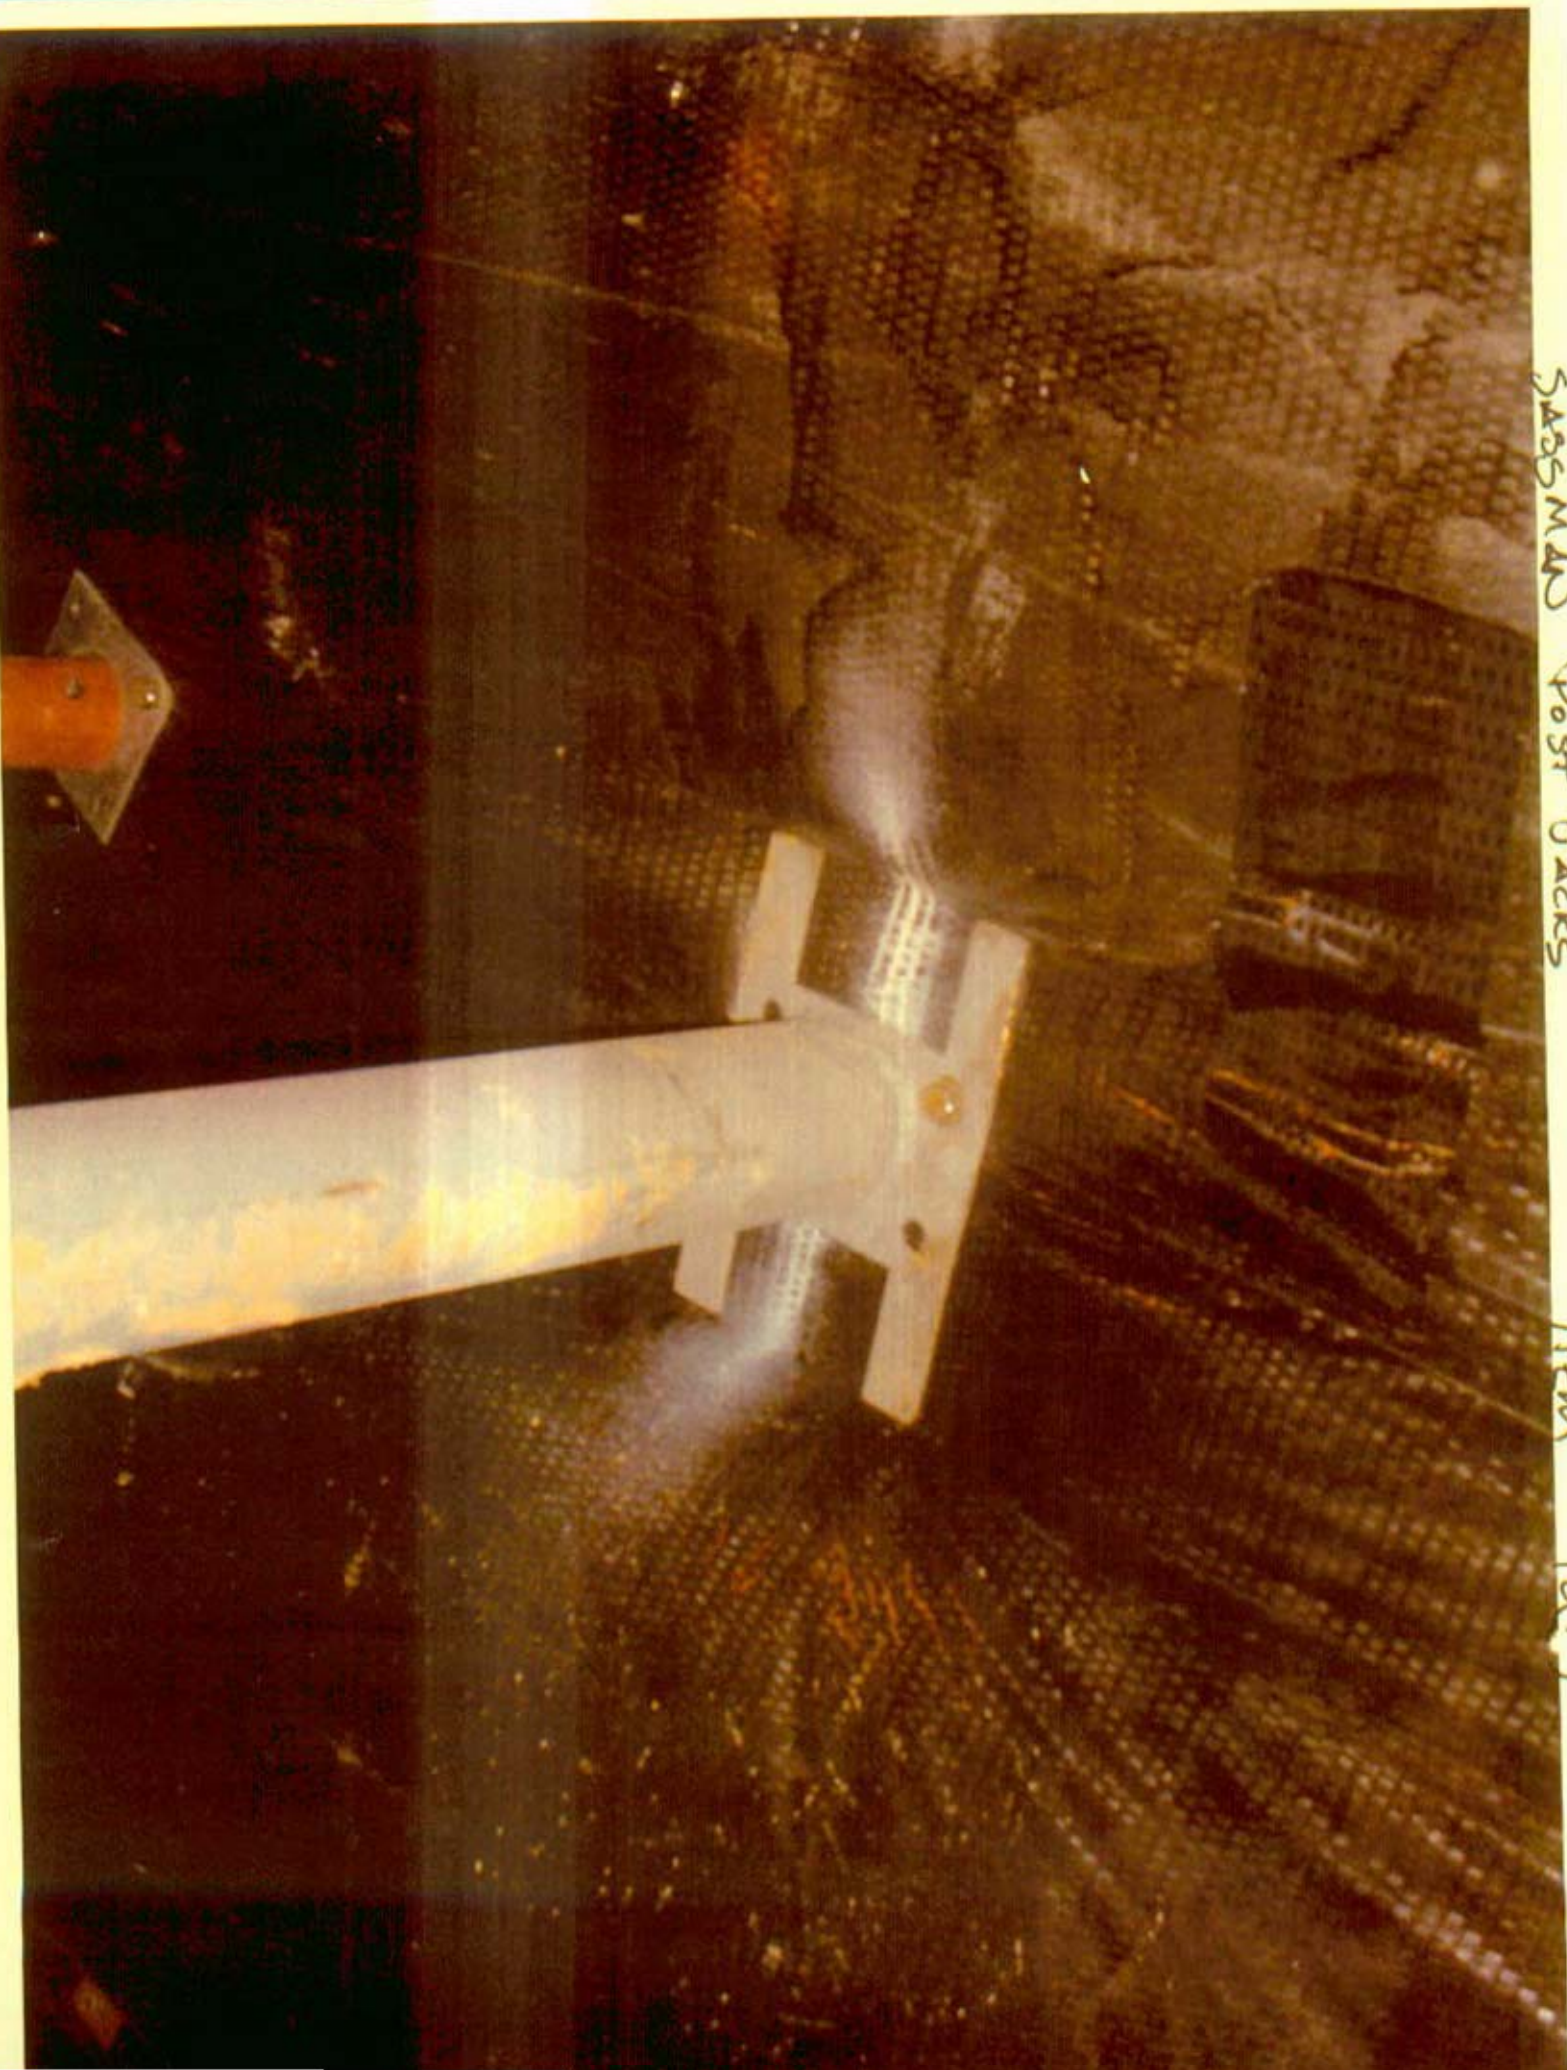
ITEM 10(F)

- f) The bottom board needs to be patched along the centerline at the lag bolt locations.
~~Incomplete 5/11/04~~ Incomplete 1/14/05, See image F
 - g) The combustion air inlet for the fireplace must be vented to the exterior of the basement foundation.
~~Incomplete 5/11/04~~ Incomplete 1/14/05, Note: The combustion inlet pipe has been extended to the exterior of the foundation but has been reduced from 6" pipe to 4" pipe and the joints are sealed with duct tape. See image G

I have been to this home over a dozen times to fix items on the public service commission list as well as other items that were not on the list. The items I corrected are as follows
Items 10 b the column support which we tried to install atleast 5 different times , but the customer kept changing her mind as to if she really wanted them or not. c) the crossover wire have been re covered and installed in the under belly of the home. d) the ground wire has been installed even though the home is welded dow to 8" steel beams. E) it is noted in the report the customer says she installed the straps I installed them. f) The bottm board has been pathced. Please turn over

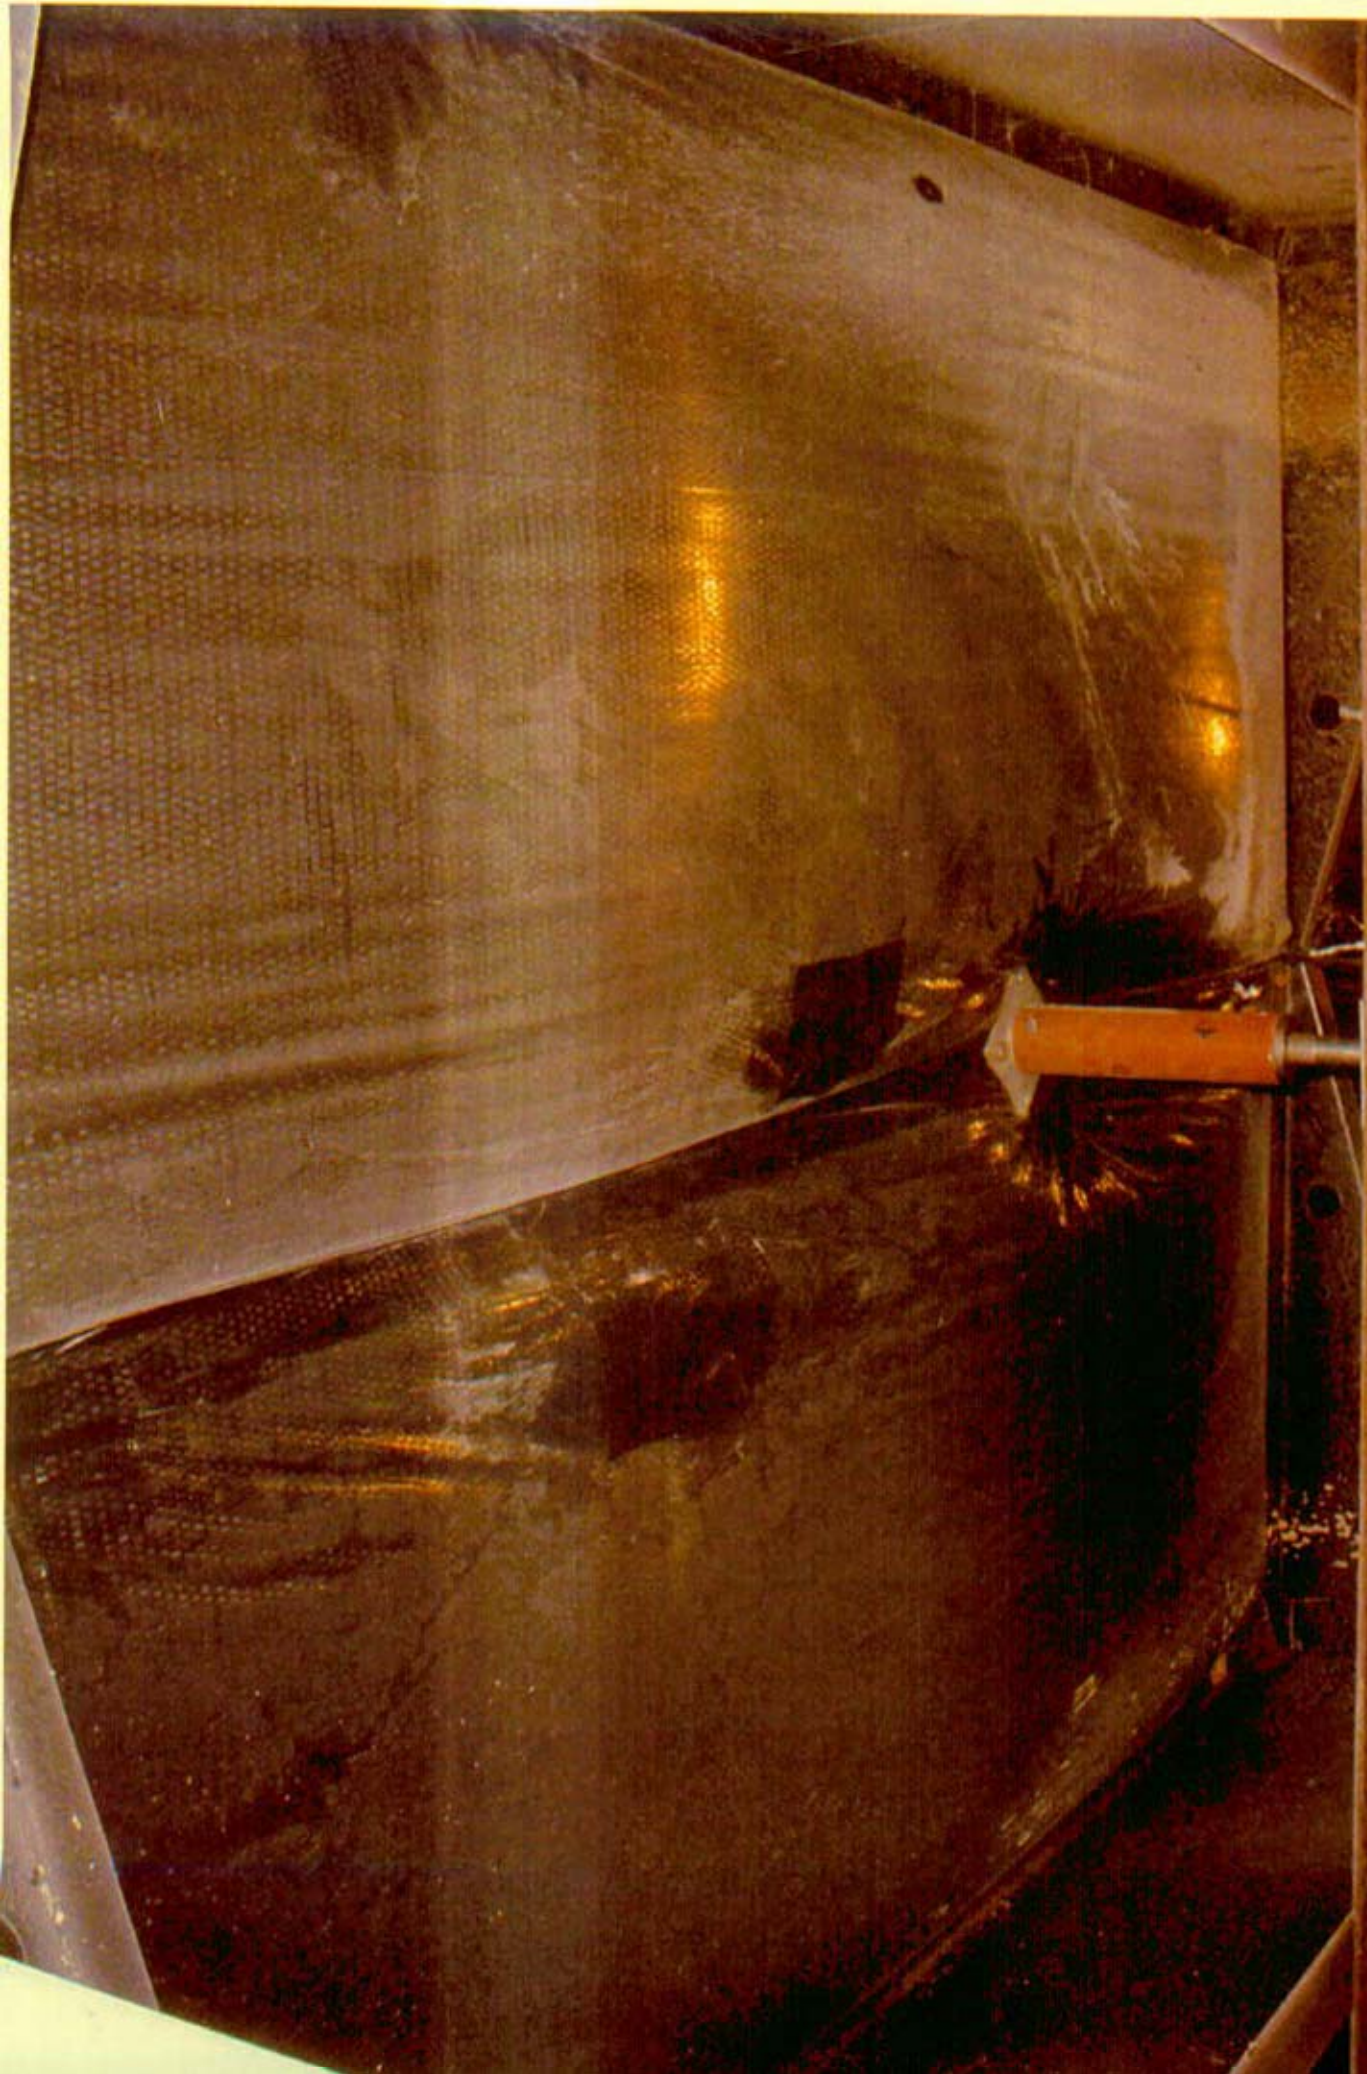
ITEM 10C + 10F

- c) The crossover electric cables have not been protected in the floor of the home as required by the manufacture.
~~Incomplete 5/11/04~~ Incomplete 1/14/05, See image D

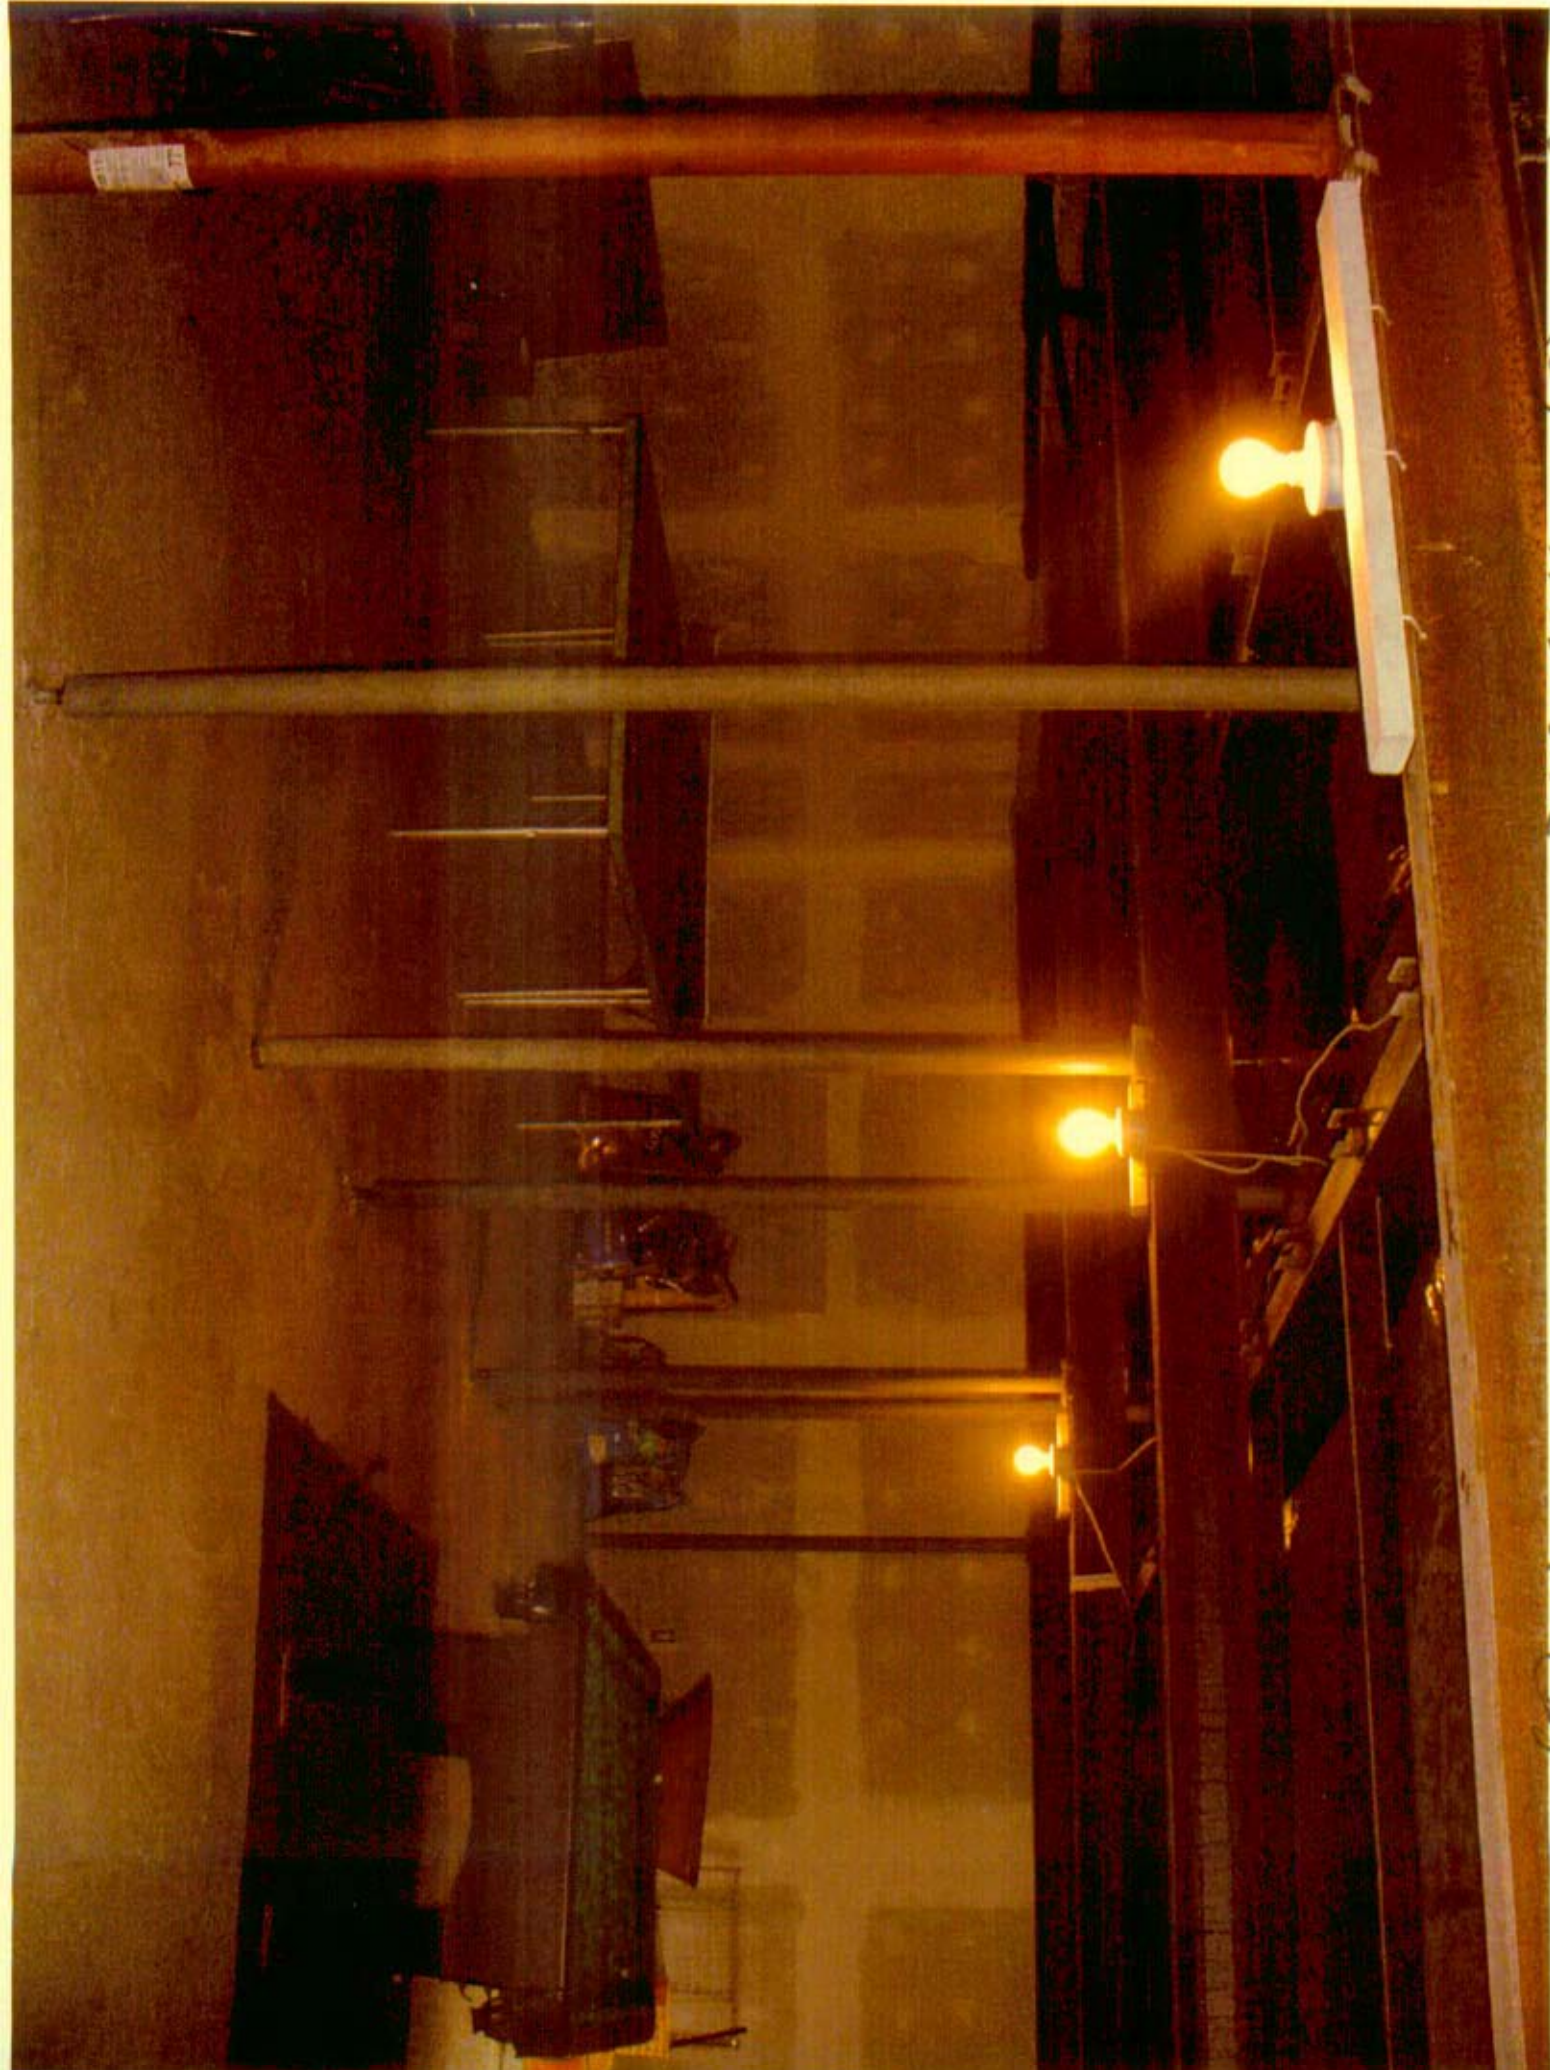
10 (B)

- b) The required centerline column supports have not been installed.
~~Incomplete 5/11/04~~ Incomplete 1/14/05, Note: Marriage line supports have been installed but are not in the correct locations for the required column supports. See images A,B,C

- a) Centerline floor line uneven- There is less than 1/8 " difference in floor
- b) Required centerline post not installed- After 5-6 conversations with customer and the customer not wanting the post installed we custom ordered the post and installed.
- C) Crossover electric wires not protected. These items were done originally and the customer has had extensive work and electrical added to the basement these wires has been recovered.
- D) Frame crossover strap not connected- Done installed
- E) Drain line not supported every 4' -- Done Installed sufficient straps
- f) Holes in Bottom Board-- Patched holes
- g) Combustion air not installed- Installed Factory Combustion air vent kit
- H) Home Not Fastened together on ends- installed fasteners on both ends
