**Director of the Manufactured Housing and
Modular Units Program of the Public Service Commission,
Complainant,**

**America's Home Brokers, Inc.
Respondent.**

Case No. MC-2005-0028

Consumer Complaint Time Line

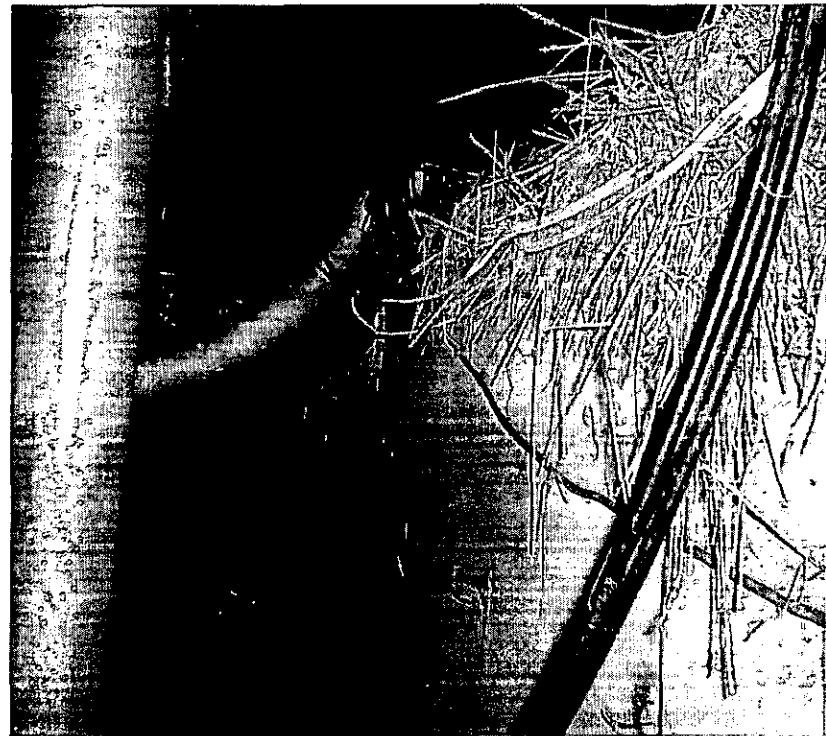
Gray Home - 1/11/05 Inspection Results

- 3. d) Master bathroom tub alteration. Electric cable is not installed properly. The cable must either run in the floor of the home and be secured every 4 ½' and within 12" of the outlet box, or installed in conduit under the home.
- HUD 3280.808(k)
- IM, page 1

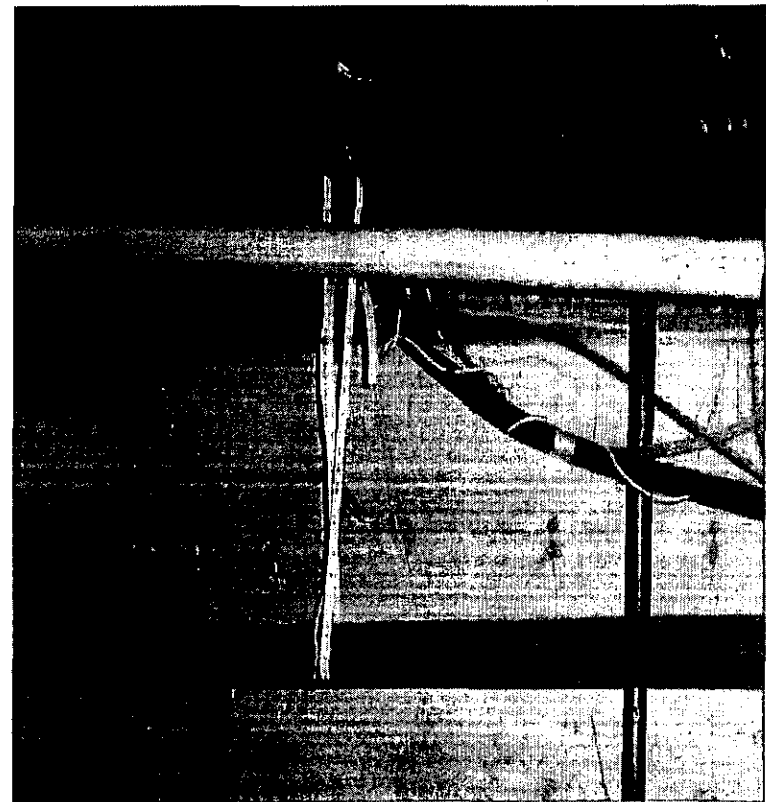
Gray Home - 1/11/05 Inspection Results

- 4. a) Electric cable installed under the home for the central air conditioner circuit is not protected in conduit from moisture and damage.
- HUD 3280.808(k)

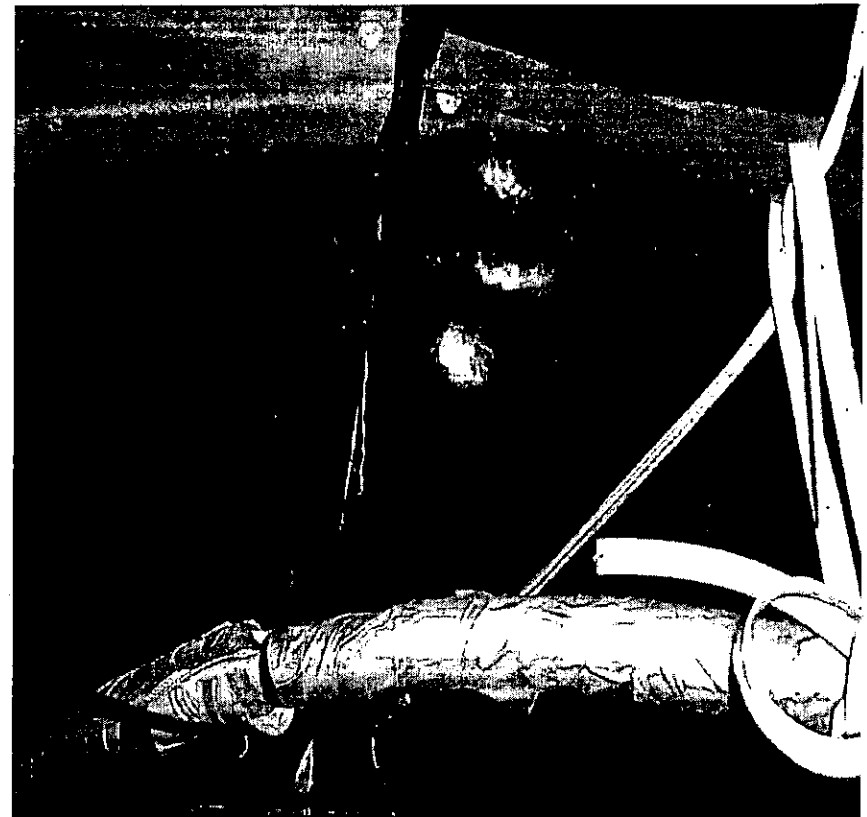
Gray Home - 1/11/05 Inspection Results

- 4. d) The bolt holes in the bottom board along the centerline of the home need to be resealed.
- HUD 3280.307 (d)
- IM, page 45

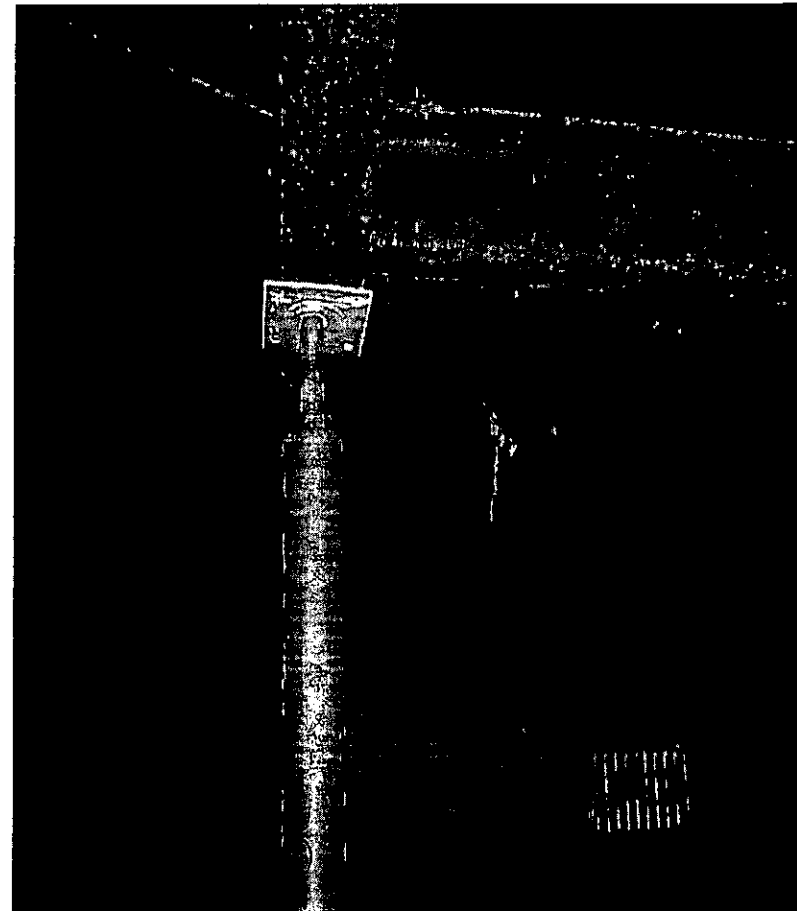
Gray Home - 1/11/05 Inspection Results

- 4. f) The jack post installed under the main frame of the home between the transverse beams must also be secured in place.
- IM, AI-2.4.1, page 4

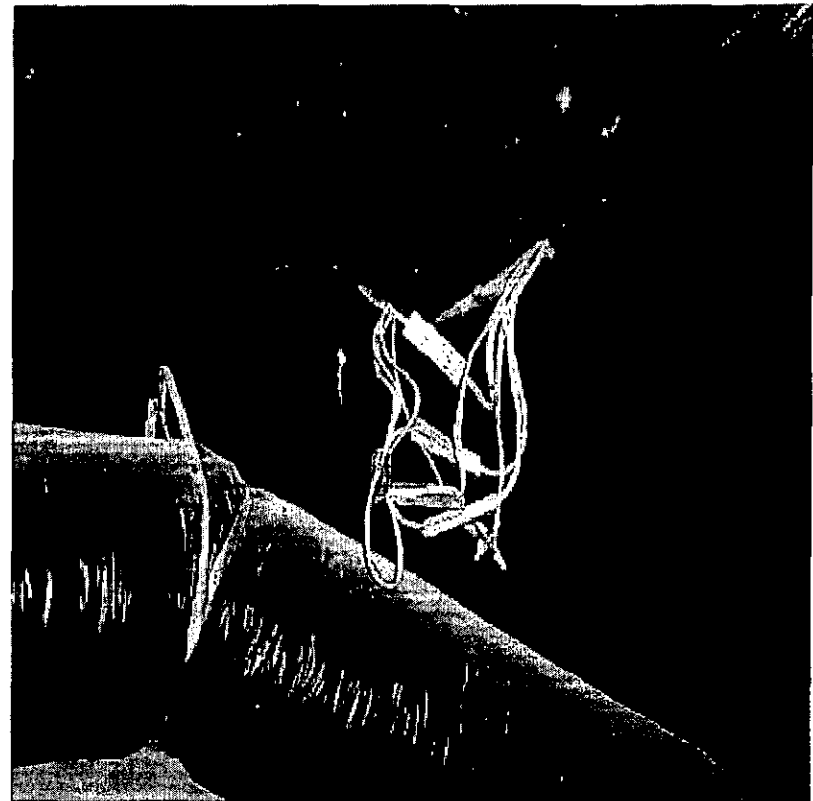
1/14/05 Inspection Results

- ❑ 10. c) The crossover electric cables have not been protected in the floor of the home.
- ❑ IM, pages 37 and 41

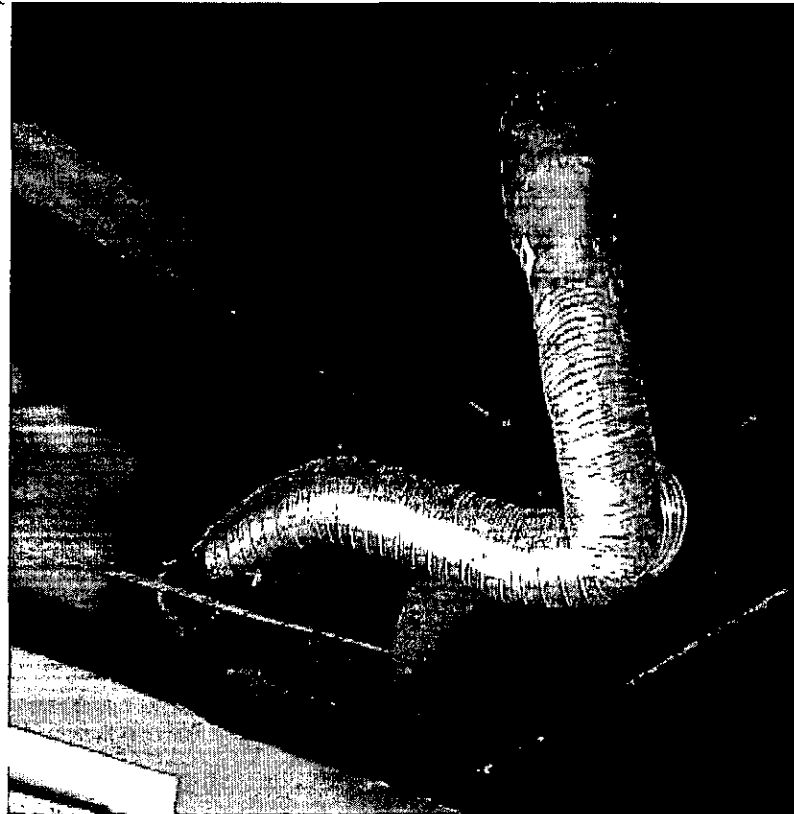
1/14/05 Inspection Results

- ❑ 10. g) The combustion air inlet for the fireplace must be properly vented to the exterior of the basement foundation.
- ❑ HUD 3280.710(b)(3)
- ❑ IM, page 29

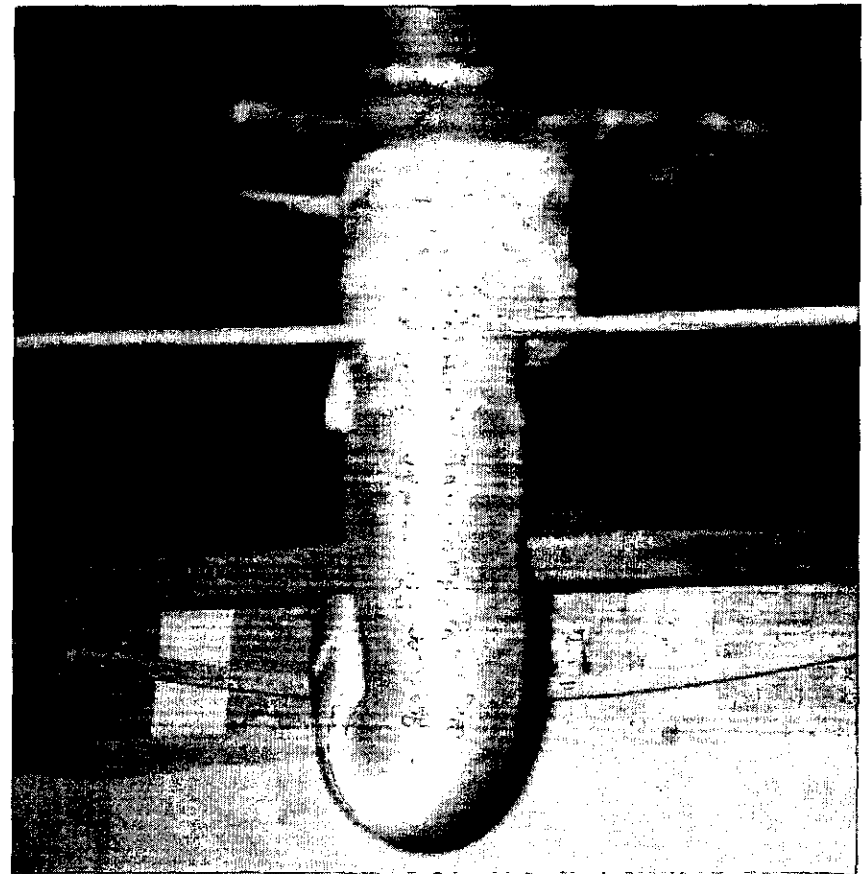
1/14/05 Inspection Results

- ❑ 7. d) The combustion air inlet for the fireplace must be properly vented to the exterior of the home.
- ❑ HUD 3280.710(b)(3)
- ❑ IM, page 29
