**MC-2006-0389**

**Manager of the Manufactured  
Housing and Modular Units  
Program of the  
Public Service Commission,  
Complainant,**

**Blakely Manufactured Homes,  
Respondent.**

**Complaint Regarding the Set Up and Installation of the  
Modular Unit Home purchased by Larry and Joyce King.**

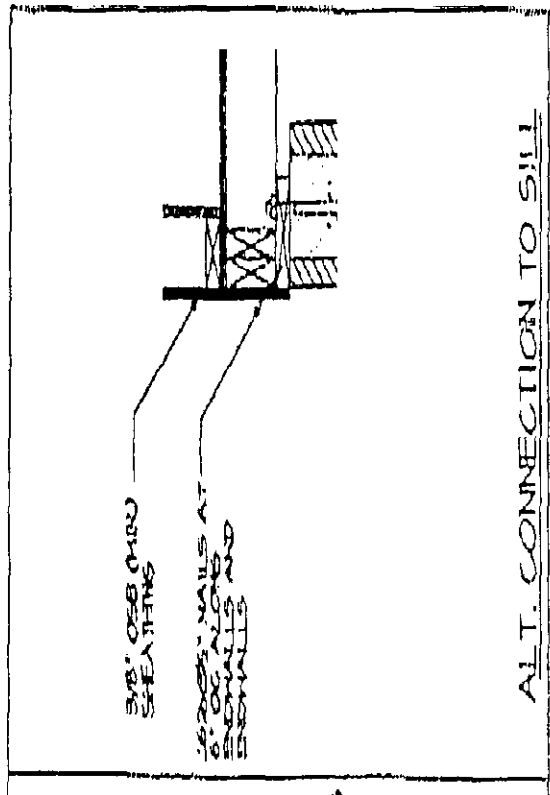
## COUNT 1

Blakely failed to properly attach the Kings' home onto the basement foundation in accordance with manufacturer instructions. This is a violation of: 4 CSR 240-123.065(1) which provides "A dealer who sells a modular unit shall arrange for the proper initial setup of the modular unit . . ."; and 4 CSR 240-123.065(2) "As used in this rule, 'proper initial setup' means installation and setup of the modular unit in accordance with the installation manual provided by the manufacturer of the modular unit and in complete compliance with the code and with all of the provisions regarding setup in sections 700.010 to 700.115, RSMo."; and, 4 CSR 240-123.080(7) which provides that "all modular units . . . shall be set up or installed according to the manufacturer's installation manual."

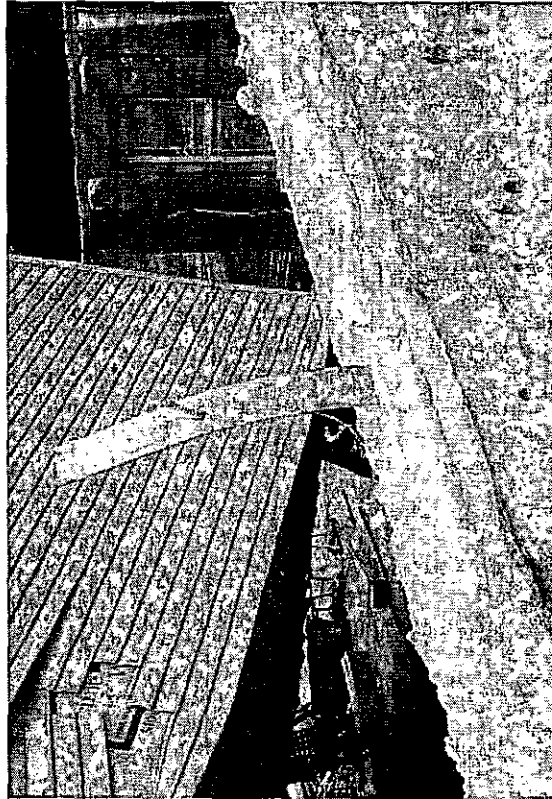
Blakely failed to properly support the centerline of the Kings' home with necessary jack posts according to manufacturer instructions. This is a violation of: 4 CSR 240-123.065(1) and (2) and 4 CSR 240-123.080(7).

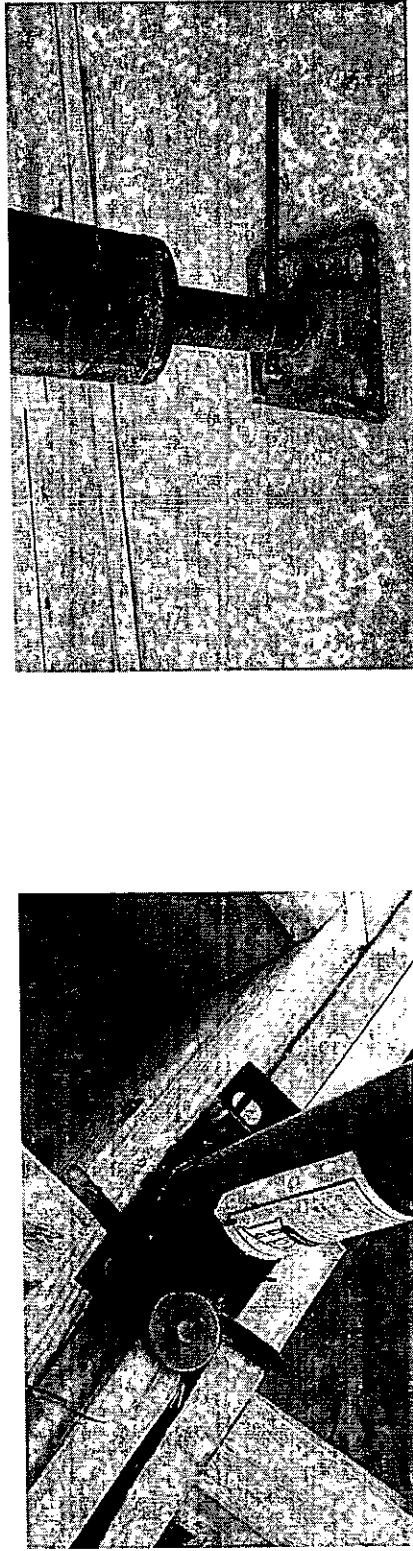
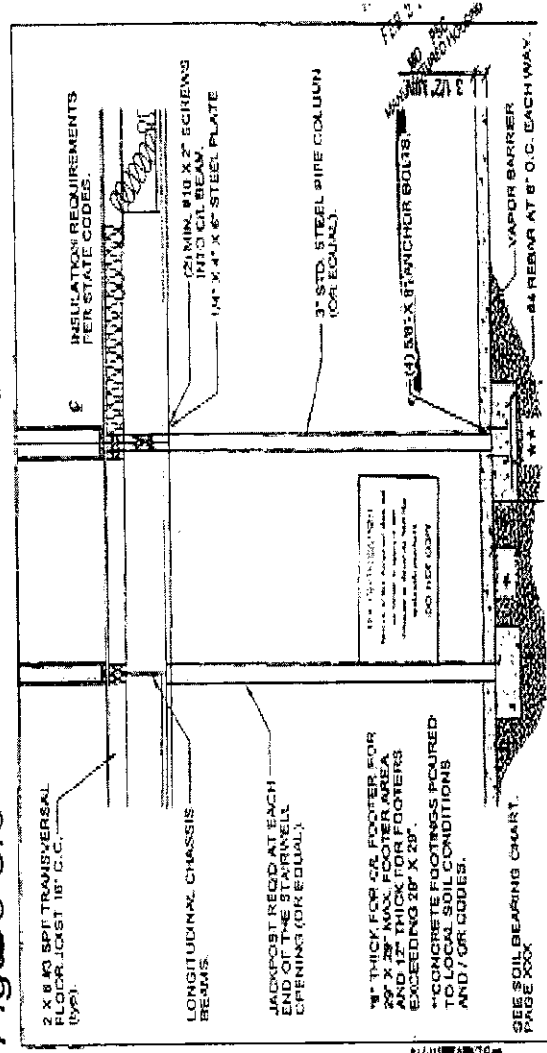
Fig 5.0

Blakely failed to properly attach the supporting jack posts to the home's center beam and to the concrete footing according to the manufacturer's foundation drawings. This is a violation of: 4 CSR 240-123.065(1) and (2) and 4 CSR 240-123.080(7).

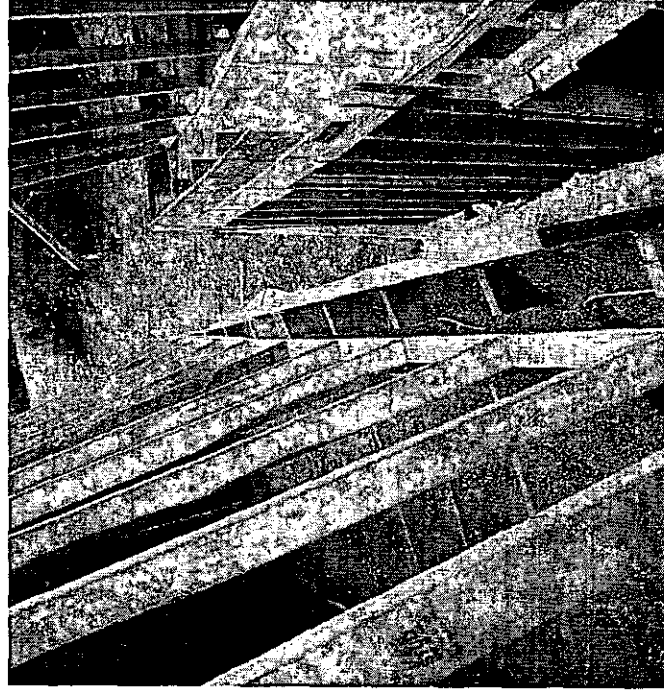
## COUNT 4

Blakely failed to properly fasten the home's hinged roof according to manufacturer installation instructions. This is a violation of: 4 CSR 240-123.065(1) and (2) and 4 CSR 240-123.080(7).

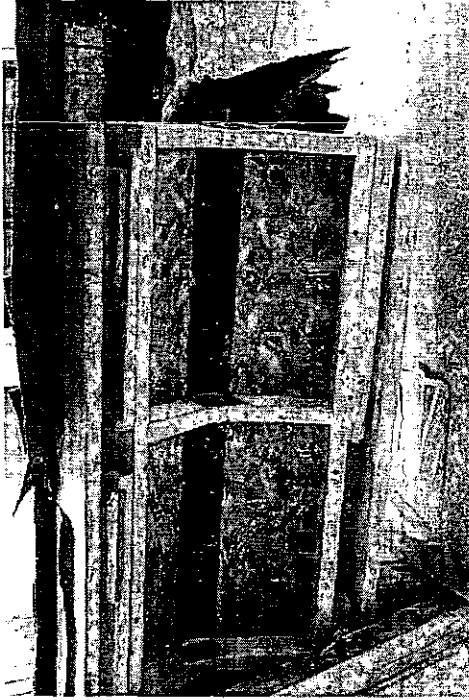
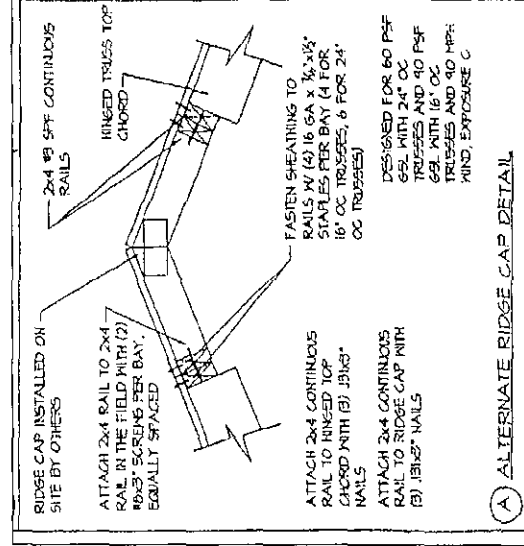
# COUNT 5

Blakely failed to properly fasten in place the drop-in roof ridge sections of the home in accordance with manufacturer installation instructions. This is a violation of: 4 CSR 240-123.065(1) and (2) and 4 CSR 240-123.080(7).

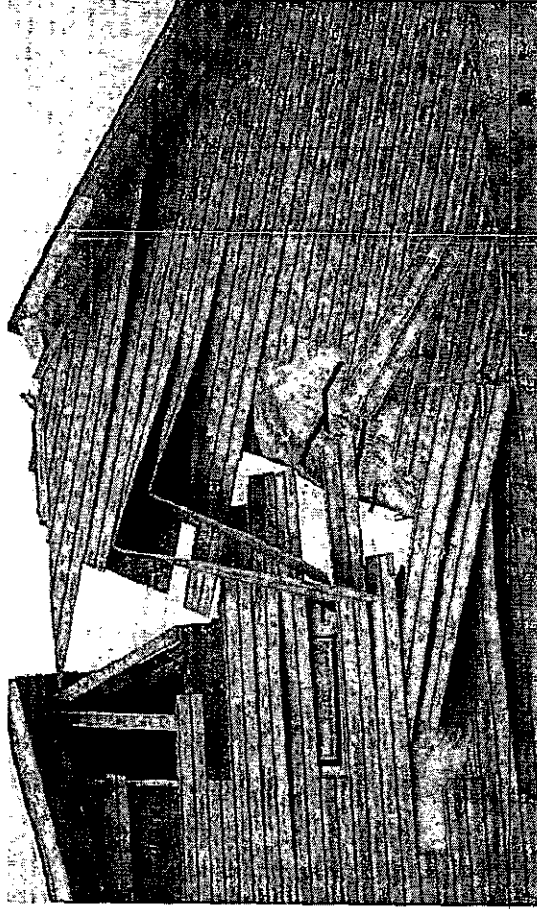
## COUNT 6

Blakely failed to properly fasten together the end walls of both home sections in accordance with manufacturer installation instructions. This is a violation of: 4 CSR 240-123.065(1) and (2) and 4 CSR 240-123.080(7).

3.7.5.1.3 END WALLS. Fasten the end walls using #8 x 3" screws at 12" O.C.

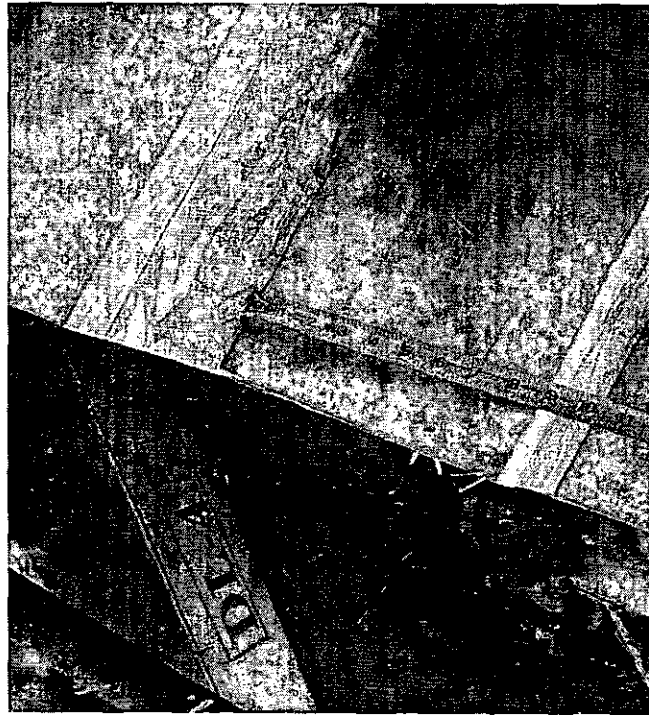
## COUNT 7

Blakely failed to properly construct the home stairway to the basement in accordance with the International Residential Code-2000. This is a violation of: 4 CSR 240-123.080(3) and (4) 4 CSR 240-123.065(1) and (2) and 4 CSR 240-123.080(7).

**R314.2 Treads and risers.** The maximum riser height shall be 7 ¾ inches (196mm) and the minimum tread depth shall be 10 inches (254 mm). The riser height shall be measured vertically between the leading edges of the adjacent treads. The tread depth shall be measured horizontally between the vertical planes of the foremost projection of adjacent treads and at a right angle to the tread's leading edge. The walking surface of treads and landings of a stairway shall be sloped no steeper than one unit vertical in 48 units horizontal (2-percent slope). The greatest rise height within any flight of stairs shall not exceed the smallest by more than 3/8 inch ( 9.5 mm). The greatest tread depth within any flight of stairs shall not exceed the smallest by more than 3/8 inch (9.5 mm).

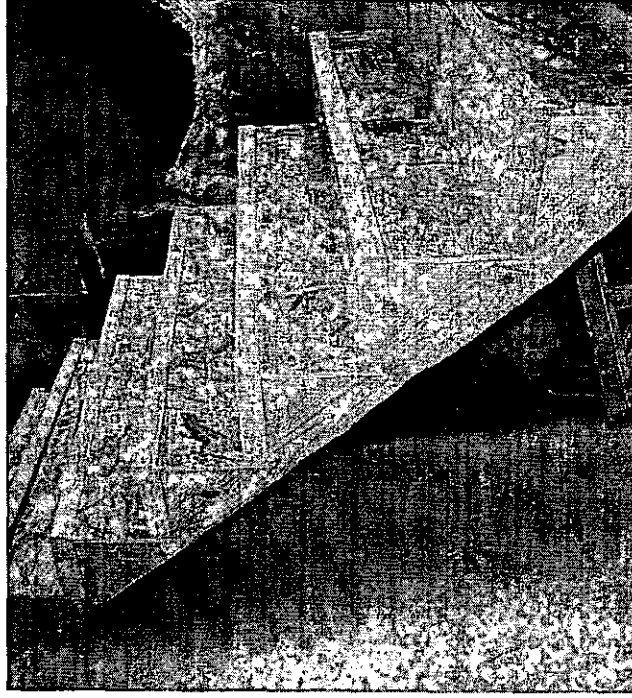
## COUNT 8

Blakely failed to install guards on the sides of the home's basement stairway in accordance with the International Residential Code-2000. This is a violation of: 4 CSR 240-123.080(3) and (4) and 4 CSR 240-123.065(1) and (2) and 4 CSR 240-123.080(7).

**R316.1 Guards required.** Porches, balconies or raised floor surfaces located more than 30 inches (762 mm) above the floor or grade below shall have guards not less than 36 inches (914 mm) in height. Open sides of stairs with a total rise of more than 30 inches (762 mm) above the floor or grade below shall have guards not less than 34 inches (864 mm) in height measured vertically from the nosing of the treads.

**R316.2 Guards opening limitations.** Required guards on open sides of stairways, raised floor areas, balconies and porches shall have intermediate rails or ornamental closures that do not allow the passage of a sphere 4 inches (102 mm) in diameter. Required guards shall not be constructed with horizontal rails or other ornamental pattern that results in a ladder effect.

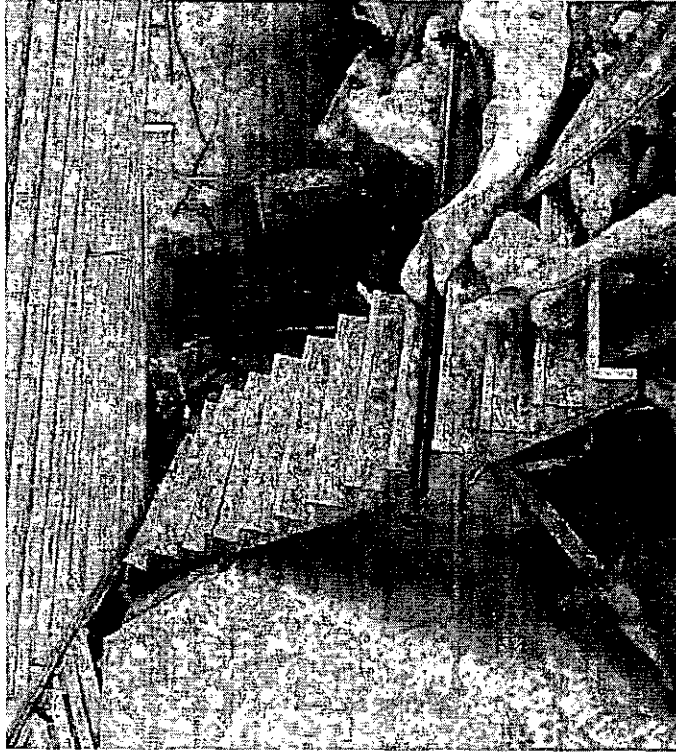
## COUNT 9

Blakely failed to install a handrail on the home's basement stairway in accordance with the International Residential Code-2000. This is a violation of: 4 CSR 240-123.080(3) and (4) and 4 CSR 240-123.065(1) and (2) and 4 CSR 240-123.080(7).

**R315.1 Handrails.** Handrails having minimum and maximum heights of 34 inches and 38 inches (864 mm and 965 mm), respectively, measured vertically from the nosing of the treads, shall be provided on at least one side of stairways. All required handrails shall be continuous the full length of the stairs with two or more from a point directly above the top riser of a flight to a point directly above the lowest riser of the flight. Ends shall be returned or shall terminate in newel posts or safety terminals. Handrails adjacent to a wall shall have a space of not less than 1.5 inches (38 mm) between the wall and the handrail.
