Missouri Public Service Commission

RE: Case No. GS-2000-62

In the Matter of Missouri Gas Energy, a)
Division of Southern Union Company,)
Regarding an Incident Near 1204 Walnut)
in Kansas City, Missouri.)

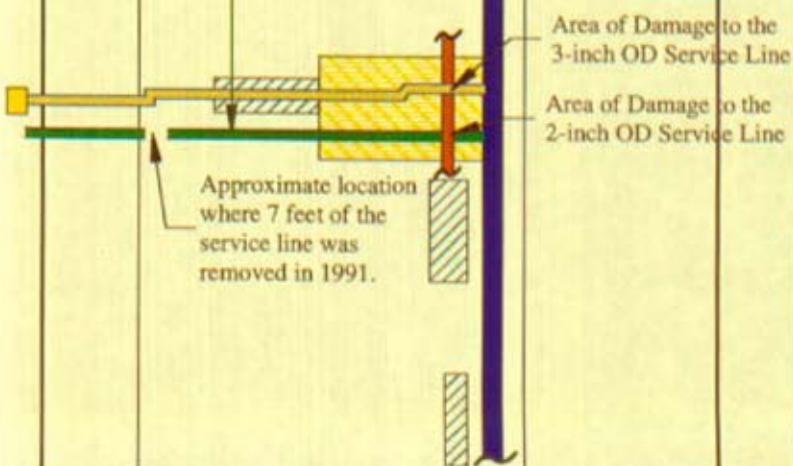
Figure 2
Plan View of the Incident Area

The Staff observed several street patches in the incident area. A street patch surrounded the 2 manhole covers and extended northwest into the intersection of 12th Street and Walnut. Several other patches were observed along Walnut, between 12th and 13th Streets, parallel to the east curb line of Walnut and the same distance from the curb as the Williams communications vault (see Appendix A-2, Figure 2 for locations of street patches).
