# Missouri Public Service Commission

## Gas Incident Report

**Laclede Gas Company**  
**Case No. GS-2004-0264**

#6 Hagers Mill Court  
Manchester, Missouri  
December 11, 2003

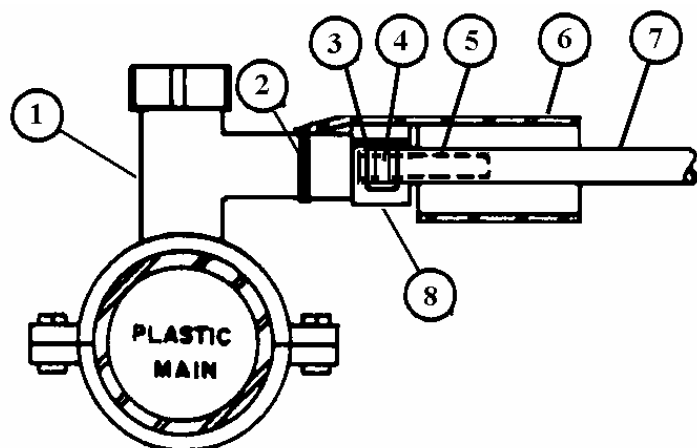
**Figure 6**

Installation as believed to be installed

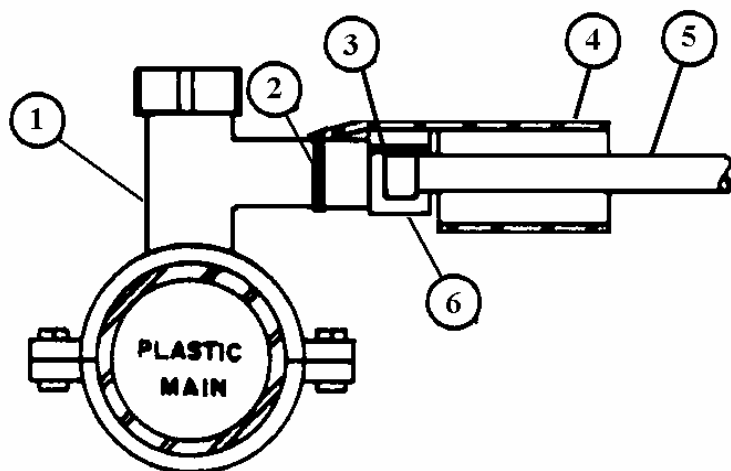
Based on the radiographic examination on December 15, 2003, and subsequent disassembly on March 10, 2004, no tubular stiffener or grip ring had been utilized when the service tee from the incident site was assembled. Figures 6 and 7 (Appendix A-5) show the assembly of the service tee as believed to be installed and the as-found assembly of the service tee at #6 Hagers Mill Court. The absence of the tubular stiffener and grip ring allowed the service line to pull out of the compression coupling with significantly less force than would be required to cause a failure of this connection with tubular stiffener and grip ring (145 pounds for pullout versus 310 pounds for tubing failure) based on tests of similar couplings by Laclede. The same testing indicated that a pullout force of 190 pounds was required for a fitting with the tubular stiffener, but without a grip ring. The table in the **Additional Information** portion of the **FACTS** section of this report provides data for representative test results. While the forces imparted by the tree and roots may have been sufficient to result in a failure of a properly installed fitting at some point in time, the absence of a tubular stiffener significantly increased the likelihood of occurrence. 49 CFR 192.281(e), as adopted by the Commission, required that each compression type mechanical joint on plastic pipe must comply with the following: a rigid internal tubular stiffener, other than a split

Installation as found at 6 Hagers Mill Ct.

1. Based on Laclede's review of factors related to this incident, the following actions have been initiated.
  - A. Laclede will modify its current procedures to inspect for the presence of a tubular stiffener in each plastic service tee manufactured for use with a non-integral tubular stiffener when exposed for routine work by Laclede crews. Any tee inspected and found not to contain a tubular stiffener will be upgraded to meet current regulatory requirements if the tee is to remain in service. The performance of these inspections will be documented on Laclede's Service Order F-610 for a period of one year beginning on June 1, 2004, with an anticipated sample size of approximately 100. The results of this sampling will be reviewed with Staff to determine if any further actions are required.

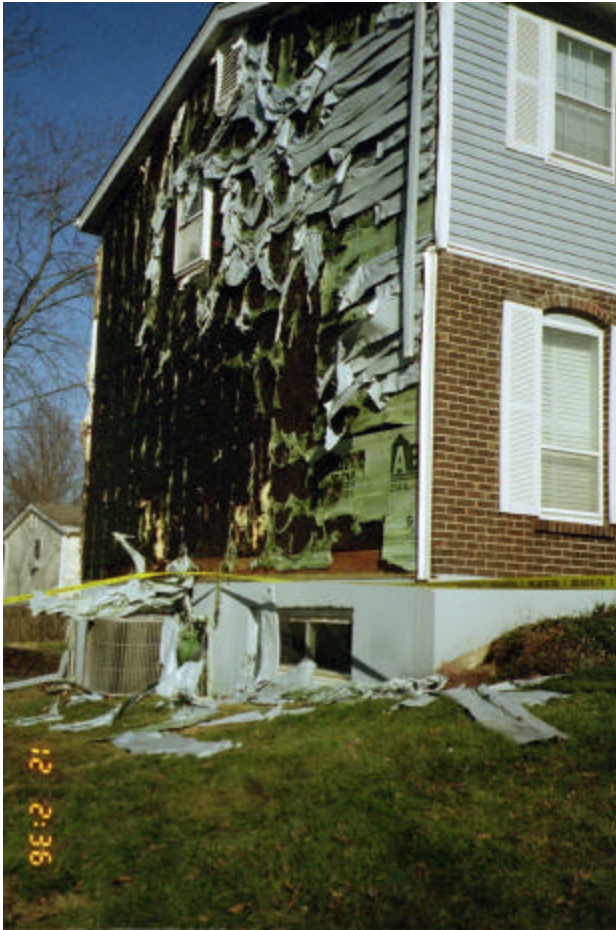
The residence at #6 Hagers Mill Court and its contents were destroyed as a result of the explosion and fire. Fire department loss estimates were \$128,000 for the structure and \$65,000 for the contents. Two adjacent residences (#5 and #7 Hagers Mill Court) received significant exterior damage. The damage included broken windows and melted/burned vinyl siding. (See Appendix B-1, Photograph 1)

**Photograph 1**  
West end of #5  
Hagers Mill Court,  
showing heat  
damage to exterior  
of building.

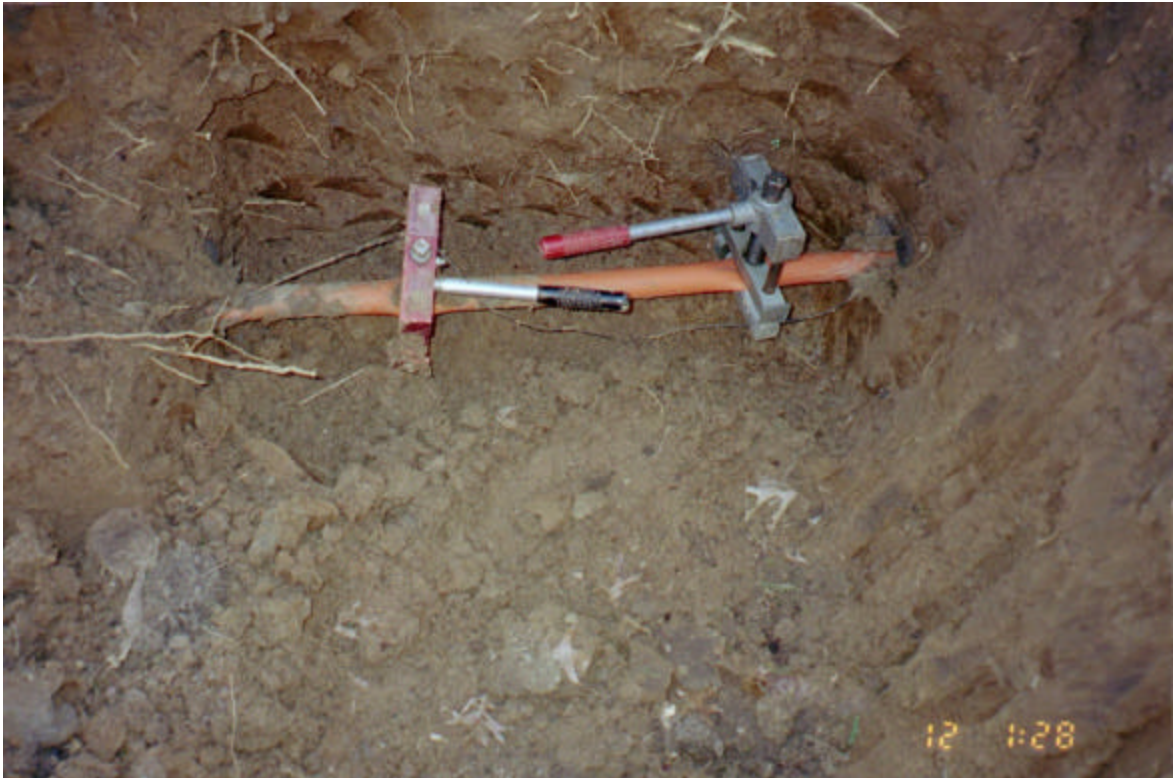
squeeze-off devices. (See Appendix A-2, Figure 3 and Appendix B-2, Photograph 3) Squeeze-off is a process where a vise-like device is installed on a gas main and the device is used to squeeze the plastic pipe together so that the flow of natural gas can be restricted or stopped.

**Photograph 3** Squeeze-off of distribution main near #14 Hagers Mill Court.

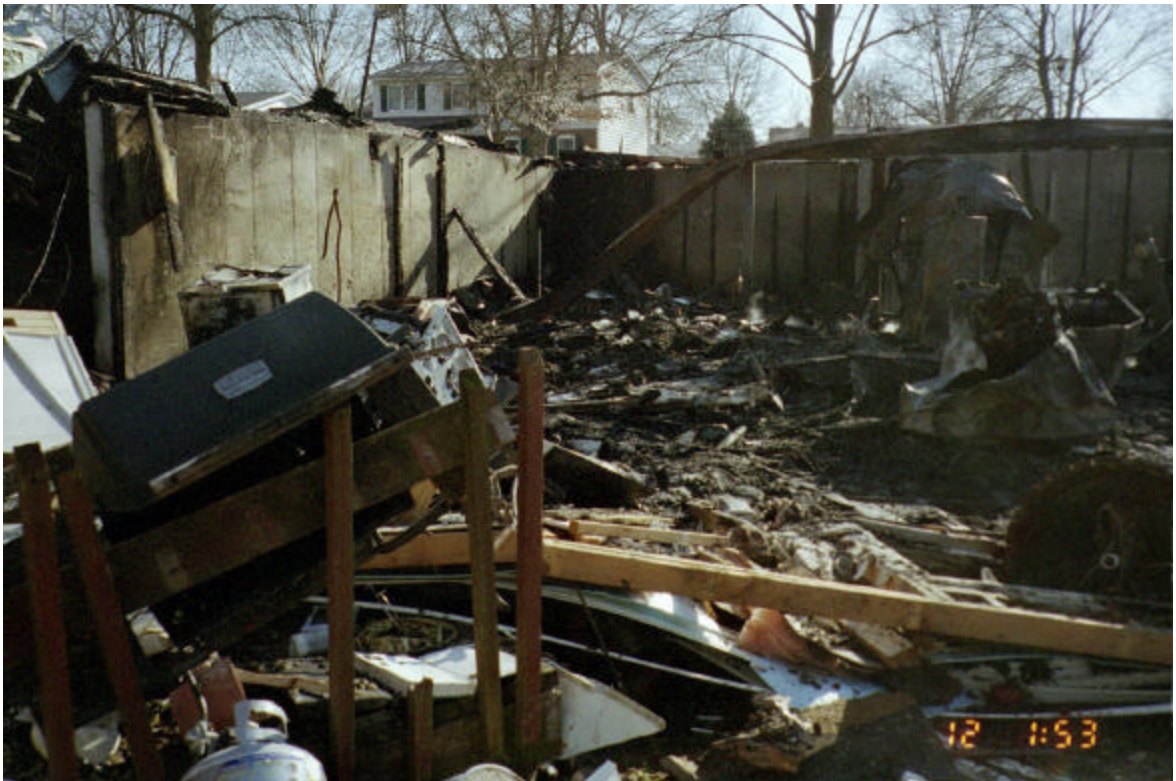
Staff's initial observations at the incident site revealed the following information. Most of the house structure and contents had burned and/or fallen into the basement area. (See Appendix B-2, Photograph 4) A small amount of unburned debris was in the front and side areas of the yard. A significant amount of unburned debris was located in the backyard and the adjoining backyard of the neighboring house to the rear. (See Appendix B-3, Photograph 5) A portion of this debris was comprised of a wooden deck that had been attached to the rear of the house. A section of a wooden panel fence at the rear of the lot was knocked down by the explosion and/or debris. (See Appendix B-3, Photograph 6) The aluminum gas meter case and pressure regulator had melted. (See Appendix B-4, Photograph 7) Various underground entrance points for natural gas to migrate into #6 Hagers Mill Court existed. A potable water line penetrated the front basement wall. There were floor drains in the basement of the structure. The front (south) foundation walls contained a horizontal crack, approximately halfway up the wall, which extended the entire

**Photograph 4** Basement of #6 Hagers Mill Court, looking towards the front and east walls from the rear of the foundation.

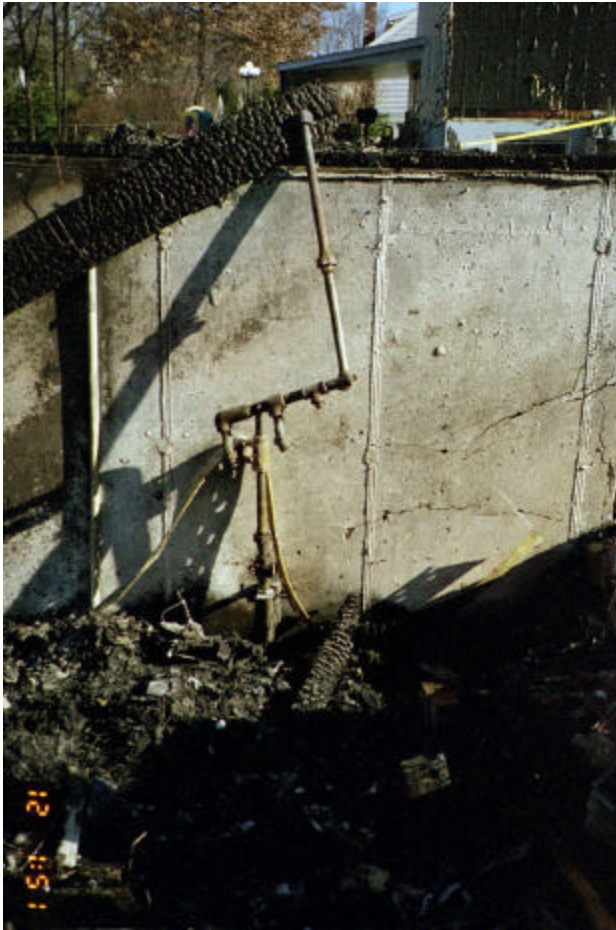
**Photograph 7** Location of the natural gas meter and service entrance on the west side of foundation. Steel service line riser, manifold and fuel piping remain intact, while meter and service regulator have melted.

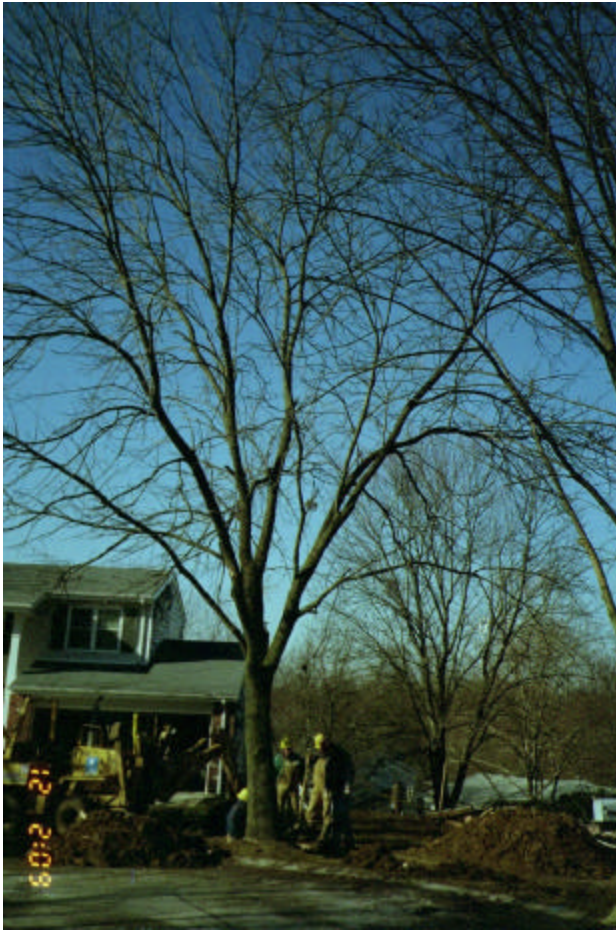
**Photograph 9** Tree growing over service tee for #6 Hagers Mill Court. View from cul-de-sac looking northwest.

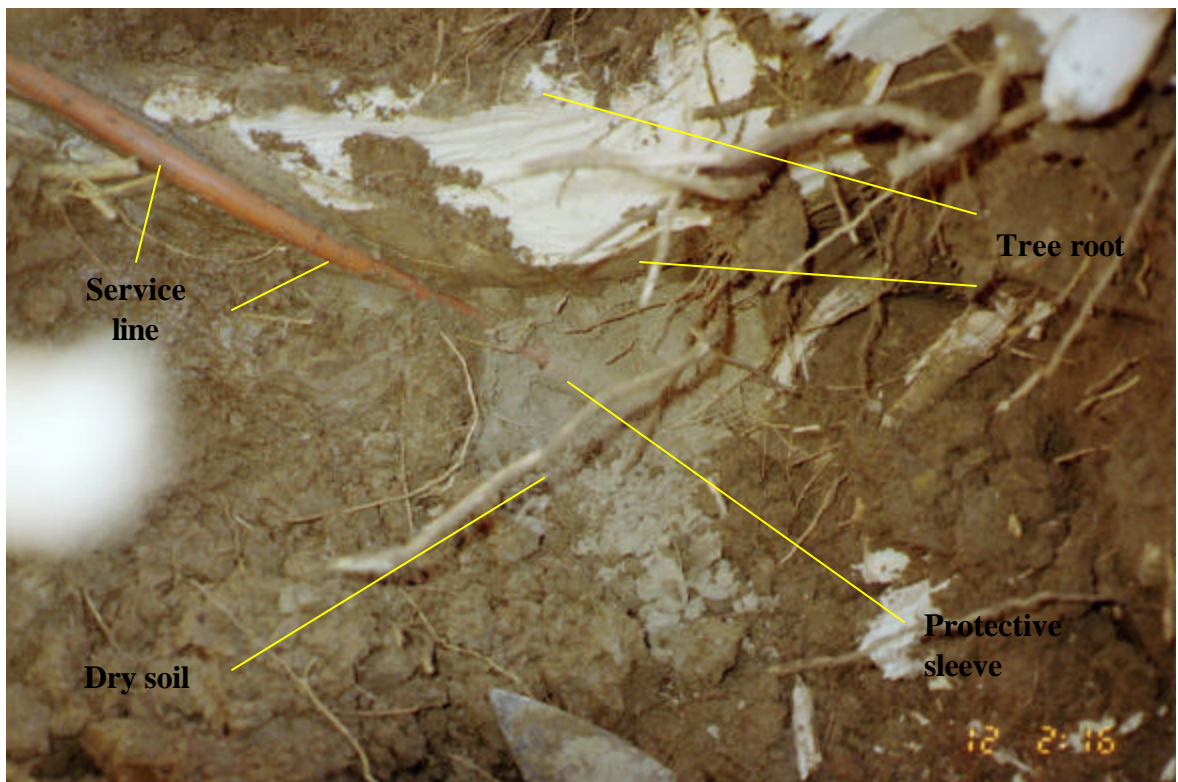
The natural gas escaping from the service tee at a pressure of approximately 37 psig would have migrated rapidly through the soil. There was a volume of soil in the vicinity of the service tee that was dried out. Passage of natural gas through soil has a drying effect and can remove most of the moisture from the soil. Natural gas is lighter than air. It would normally tend to migrate upward or follow the path of least resistance. However, the recent precipitation and freezing temperatures would tend to restrict the upward migration and seal the soil surface, preventing escape to the atmosphere. Additionally, the areas immediately north and south of the service tee connection were concrete sidewalk and street, further restricting the upward migration of natural gas. The presence of natural gas in the sanitary sewer system and two additional residences (#7 and #8 Hagers Mill Court) indicated that the natural gas had migrated to various locations in the vicinity of the leak.

**Photograph 10** Dry soil located under the tree root ball. The natural gas service line and protective sleeve can be seen in the soil.

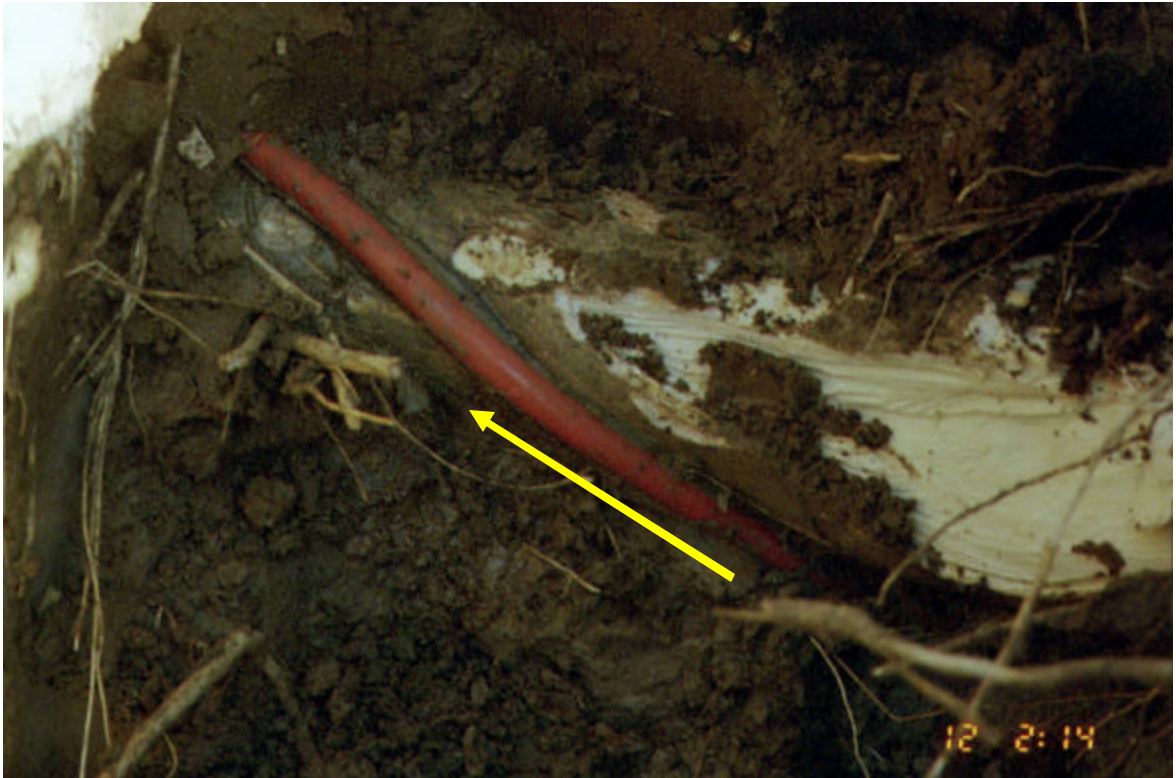
The service line was observed originating under the root ball of the tree and then proceeding upwards and northerly alongside and above a major tree root. (See Appendix B-6, Photograph 11) The service line was observed to initially contact the root on the west side and then transitioned to the top of the root proceeding toward the house. It appeared that the root had grown under and east of the service line. The tree root growth had displaced the service line and placed it in tension. This tree root was approximately 5 to 6 inches in diameter adjacent to the tree root ball.

4. The pullout of the service line from the compression coupling was caused by longitudinal forces on the connection imposed by a tree and associated tree roots growing in the location of the distribution main, service tee and service line. These longitudinal forces eventually exceeded the pullout strength of the compression coupling. This condition was exacerbated by the absence of an internal tubular stiffener in the service line and grip ring inside the compression nut. The service tee was an original installation from November 4, 1974.

**Photograph 11** Service line to #6 Hagers Mill Court--originating under tree root ball and tree root, proceeding along west side of tree root, and then along the top of the tree root. Normal flow of natural gas indicated by arrow.

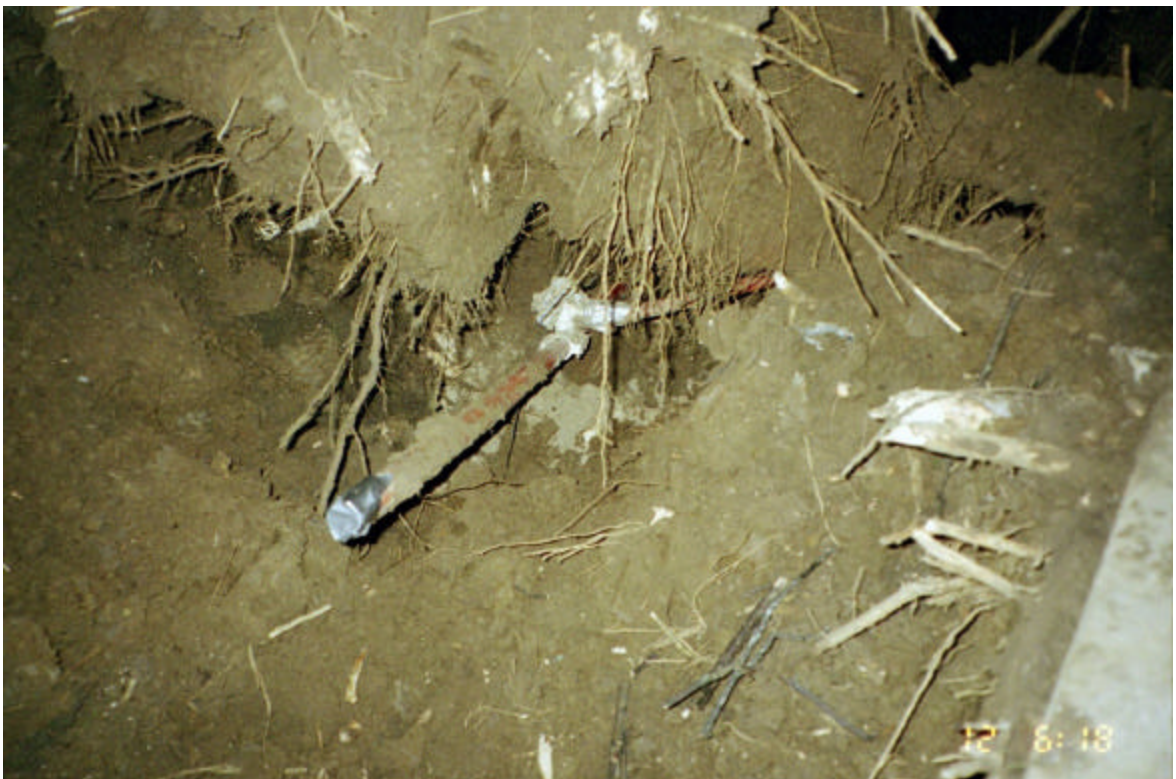
**Photograph 12** Tree root ball being lifted from ground. Section of distribution main, service tee and service line are suspended by the tracer wire. Dry soil can be seen beneath the service tee.

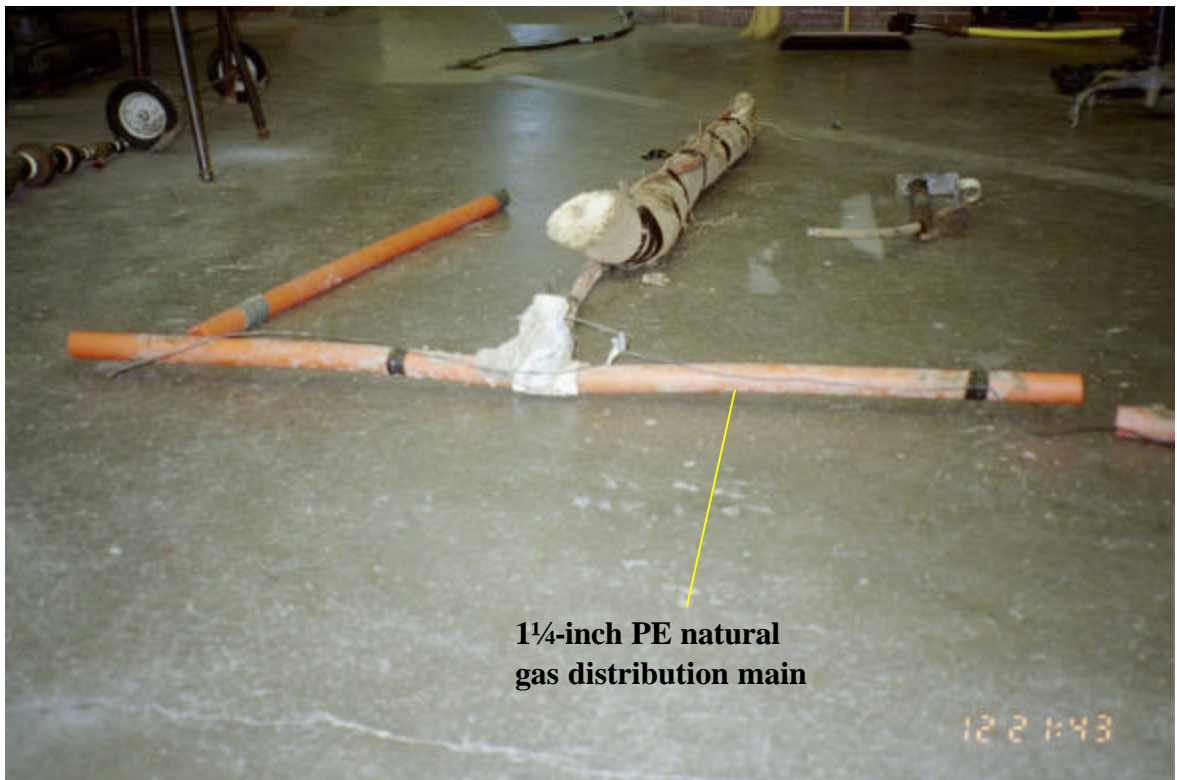
It was noted that the section of distribution main had a noticeable downward bow in the section of pipe. When placed on the laboratory floor, the center of the main (at the location of the service tee) was approximately ½ inch off the floor. This was due to the thickness of the service tee lower clamp. The ends of the section of main (approximately 62 inches in length with the service tee centered on the section) were approximately 1¼ inch off the floor. (See Appendix B-8, Photograph 15) Based on this observation, it appeared that the root ball of the tree had been deflecting the service tee/distribution main downward. This deflection was opposite to the upward deflection of the service line by the tree root.

**Photograph 15** Downward bow in the center of the distribution main can be seen by noting the elevated ends, relative to the center resting on the floor.

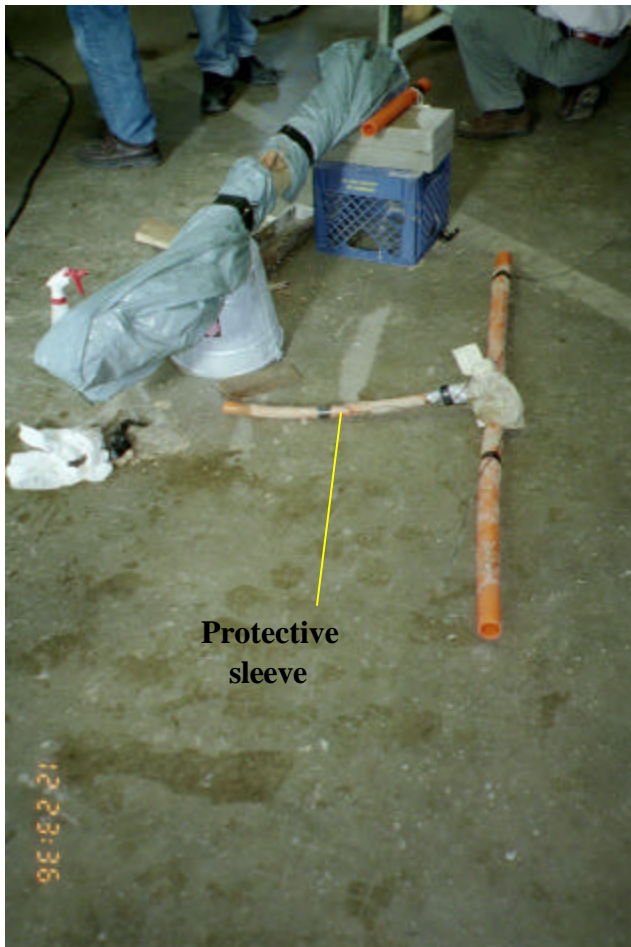
**Photograph 16** Distribution main and service tee assembly--the service line is no longer attached, however the protective sleeve is still in place.

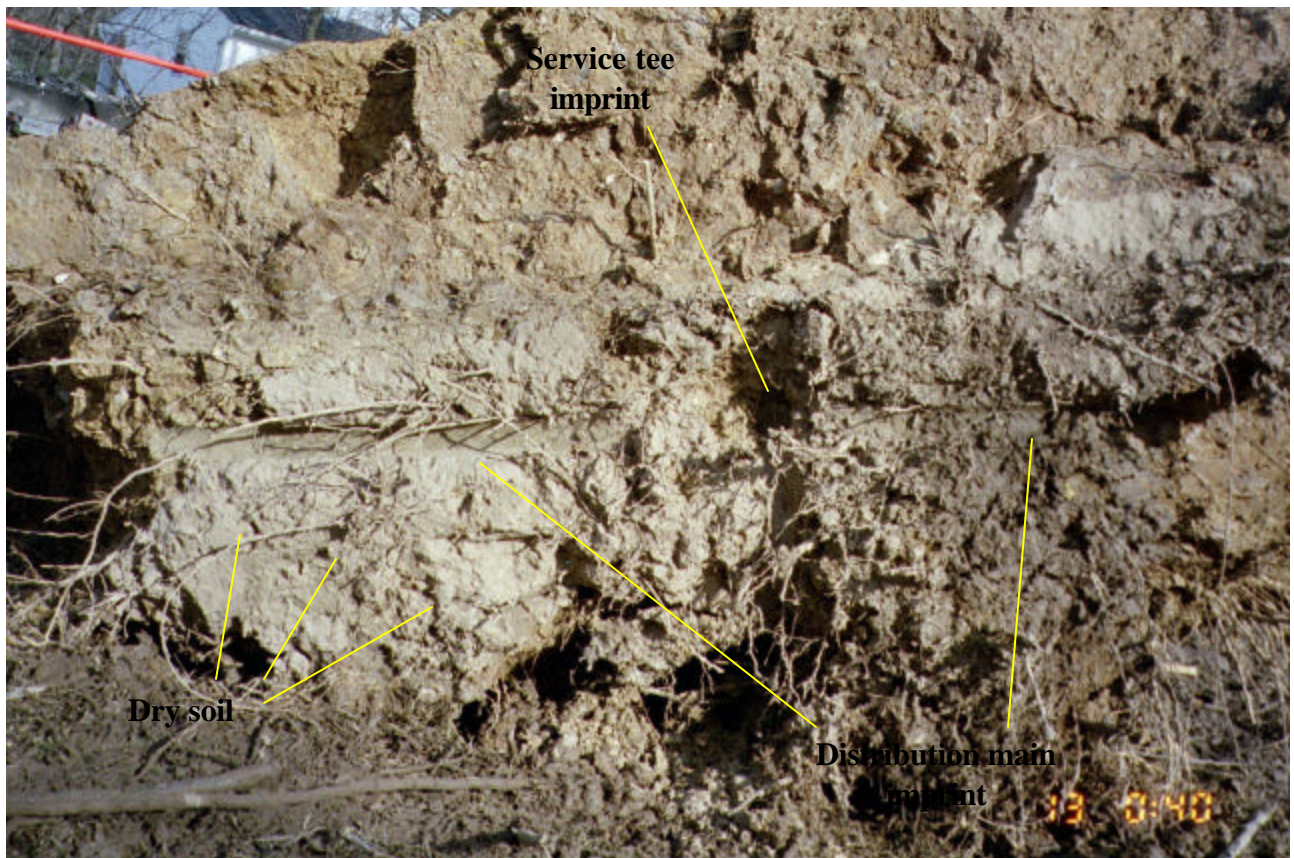
**Photograph 18** Bottom of tree root ball showing imprint of distribution main, service tee and dried soil.
