Gas Incident Report

Laclede Gas Company
Case No. GS-2004-0264

#6 Hagers Mill Court
Manchester, Missouri
December 11, 2003

Gas Safety/Engineering Section ... Energy Department ... Utility Operations Division
April 2004... Jefferson City, Missouri

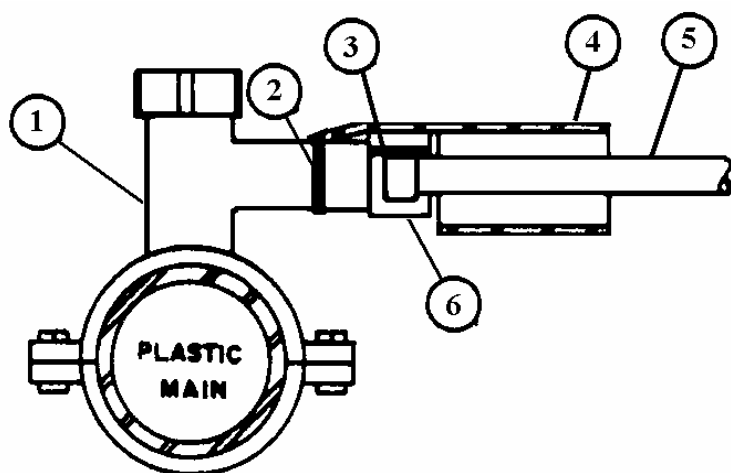
Based on the radiographic examination on December 15, 2003, and subsequent disassembly on March 10, 2004, no tubular stiffener or grip ring had been utilized when the service tee from the incident site was assembled. Figures 6 and 7 (Appendix A-5) show the assembly of the service tee as believed to be installed and the as-found assembly of the service tee at #6 Hagers Mill Court. The absence of the tubular stiffener and grip ring allowed the service line to pull out of the compression coupling with significantly less force than would be required to cause a failure of this connection with tubular stiffener and grip ring (145 pounds for pullout versus 310 pounds for tubing failure) based on tests of similar couplings by Laclede. The same testing indicated that a pullout force of 190 pounds was required for a fitting with the tubular stiffener, but without a grip ring. The table in the **Additional Information** portion of the **FACTS** section of this report provides data for representative test results. While the forces imparted by the tree and roots may have been sufficient to result in a failure of a properly installed fitting at some point in time, the absence of a tubular stiffener significantly increased the likelihood of occurrence. 49 CFR 192.281(e), as adopted by the Commission, required that each compression type mechanical joint on plastic pipe must comply with the following: a rigid internal tubular stiffener, other than a split

4. The pullout of the service line from the compression coupling was caused by longitudinal forces on the connection imposed by a tree and associated tree roots growing in the location of the distribution main, service tee and service line. These longitudinal forces eventually exceeded the pullout strength of the compression coupling. This condition was exacerbated by the absence of an internal tubular stiffener in the service line and grip ring inside the compression nut. The service tee was an original installation from November 4, 1974.

Installation as found at 6 Hagers Mill Ct.

1. Based on Laclede's review of factors related to this incident, the following actions have been initiated.
 - A. Laclede will modify its current procedures to inspect for the presence of a tubular stiffener in each plastic service tee manufactured for use with a non-integral tubular stiffener when exposed for routine work by Laclede crews. Any tee inspected and found not to contain a tubular stiffener will be upgraded to meet current regulatory requirements if the tee is to remain in service. The performance of these inspections will be documented on Laclede's Service Order F-610 for a period of one year beginning on June 1, 2004, with an anticipated sample size of approximately 100. The results of this sampling will be reviewed with Staff to determine if any further actions are required.

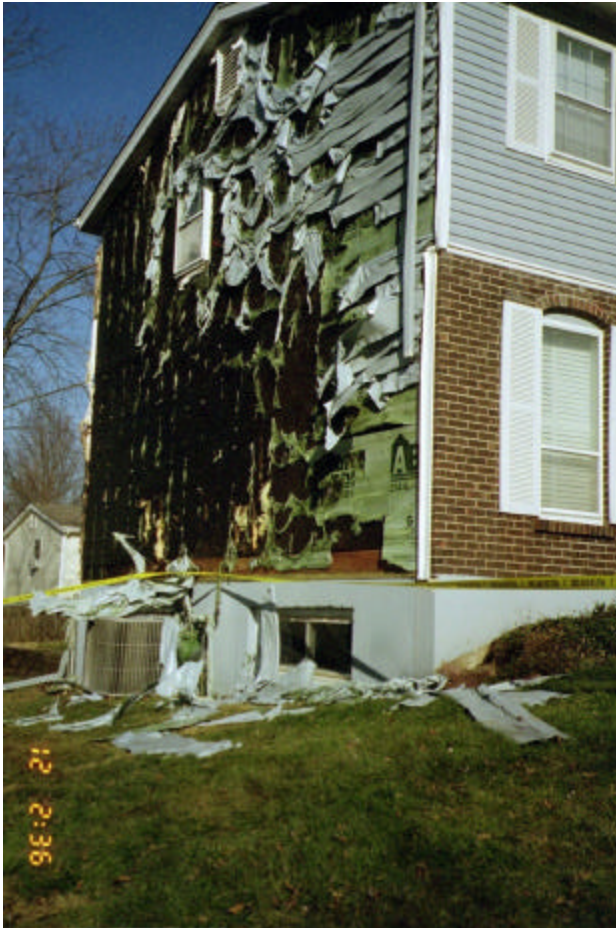
The residence at #6 Hagers Mill Court and its contents were destroyed as a result of the explosion and fire. Fire department loss estimates were \$128,000 for the structure and \$65,000 for the contents. Two adjacent residences (#5 and #7 Hagers Mill Court) received significant exterior damage. The damage included broken windows and melted/burned vinyl siding. (See Appendix B-1, Photograph 1)

Photograph 1
West end of #5
Hagers Mill Court,
showing heat
damage to exterior
of building.

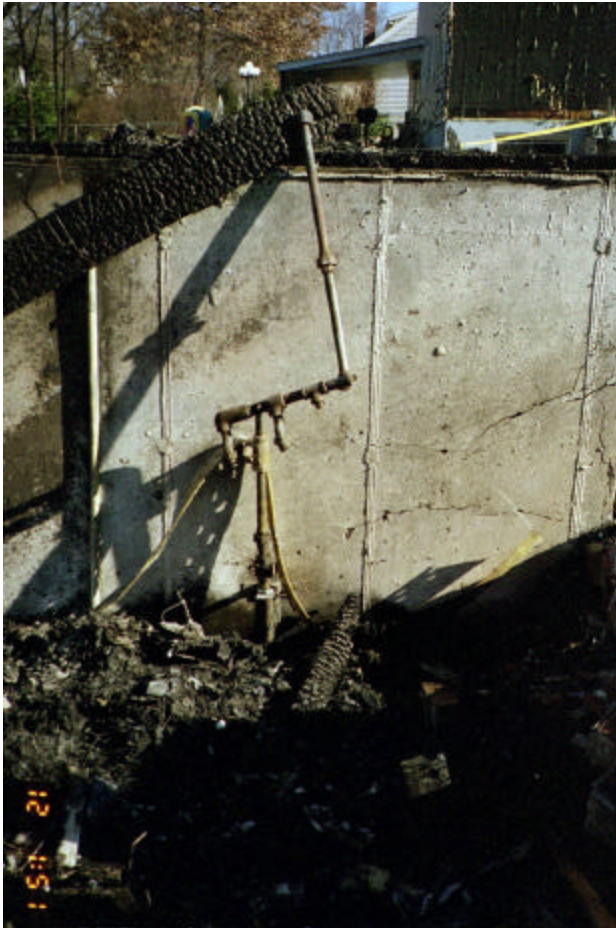
Photograph 7 Location of the natural gas meter and service entrance on the west side of foundation. Steel service line riser, manifold and fuel piping remain intact, while meter and service regulator have melted.

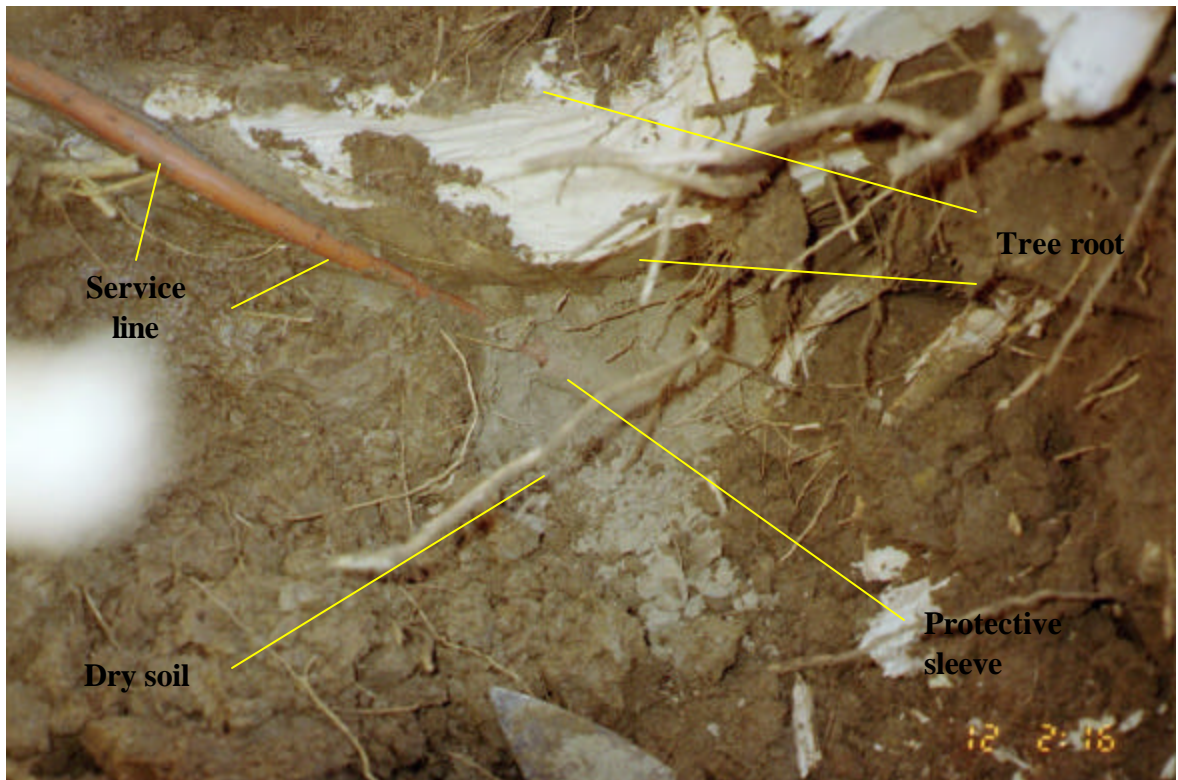
The natural gas escaping from the service tee at a pressure of approximately 37 psig would have migrated rapidly through the soil. There was a volume of soil in the vicinity of the service tee that was dried out. Passage of natural gas through soil has a drying effect and can remove most of the moisture from the soil. Natural gas is lighter than air. It would normally tend to migrate upward or follow the path of least resistance. However, the recent precipitation and freezing temperatures would tend to restrict the upward migration and seal the soil surface, preventing escape to the atmosphere. Additionally, the areas immediately north and south of the service tee connection were concrete sidewalk and street, further restricting the upward migration of natural gas. The presence of natural gas in the sanitary sewer system and two additional residences (#7 and #8 Hagers Mill Court) indicated that the natural gas had migrated to various locations in the vicinity of the leak.

Photograph 10 Dry soil located under the tree root ball. The natural gas service line and protective sleeve can be seen in the soil.

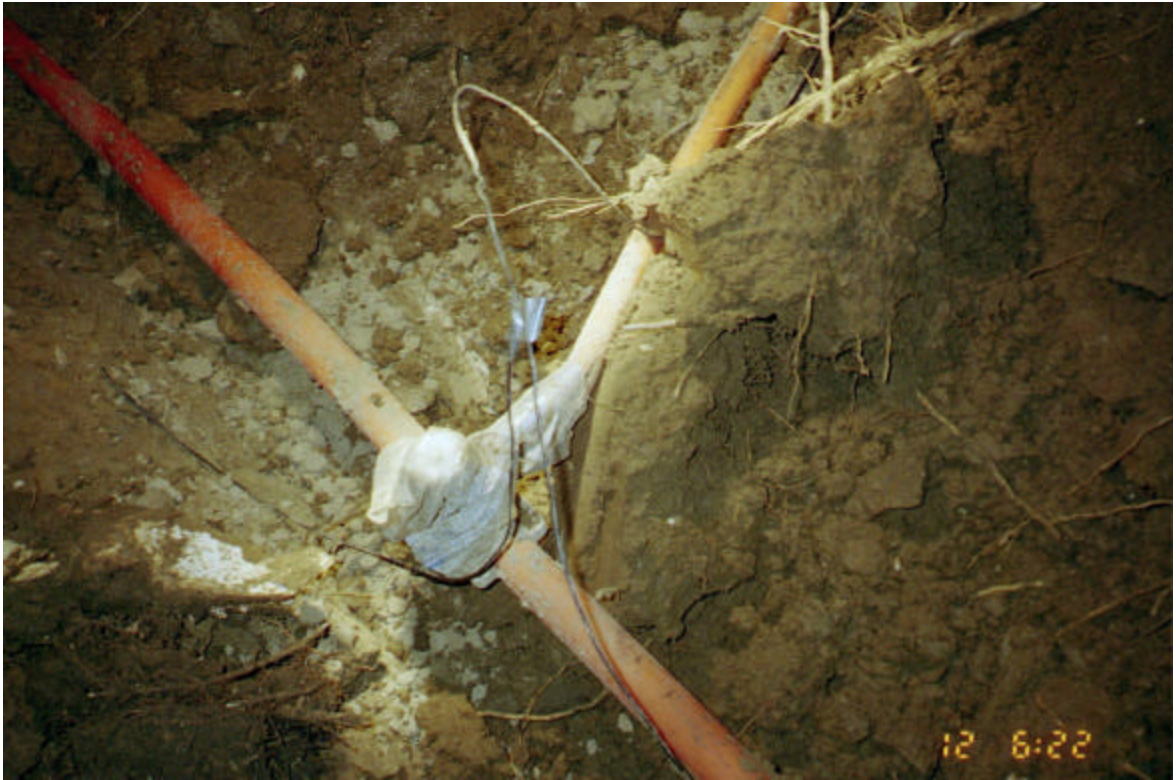
Photograph 13 Distribution main, service tee, service line and tracer wire serving #6 Hagers Mill Court.

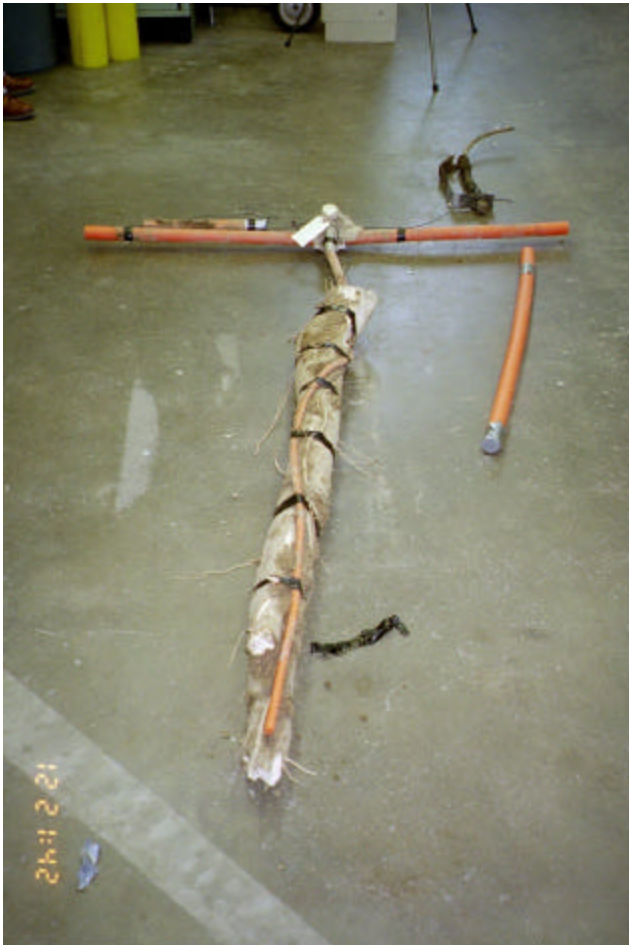
Photograph 14 Distribution main/service line assembly in laboratory--portions of the distribution main were cut off to enable transport to laboratory. Tree root/service line configuration was maintained by taping them together. Service line riser from the incident site is also visible in the photograph.

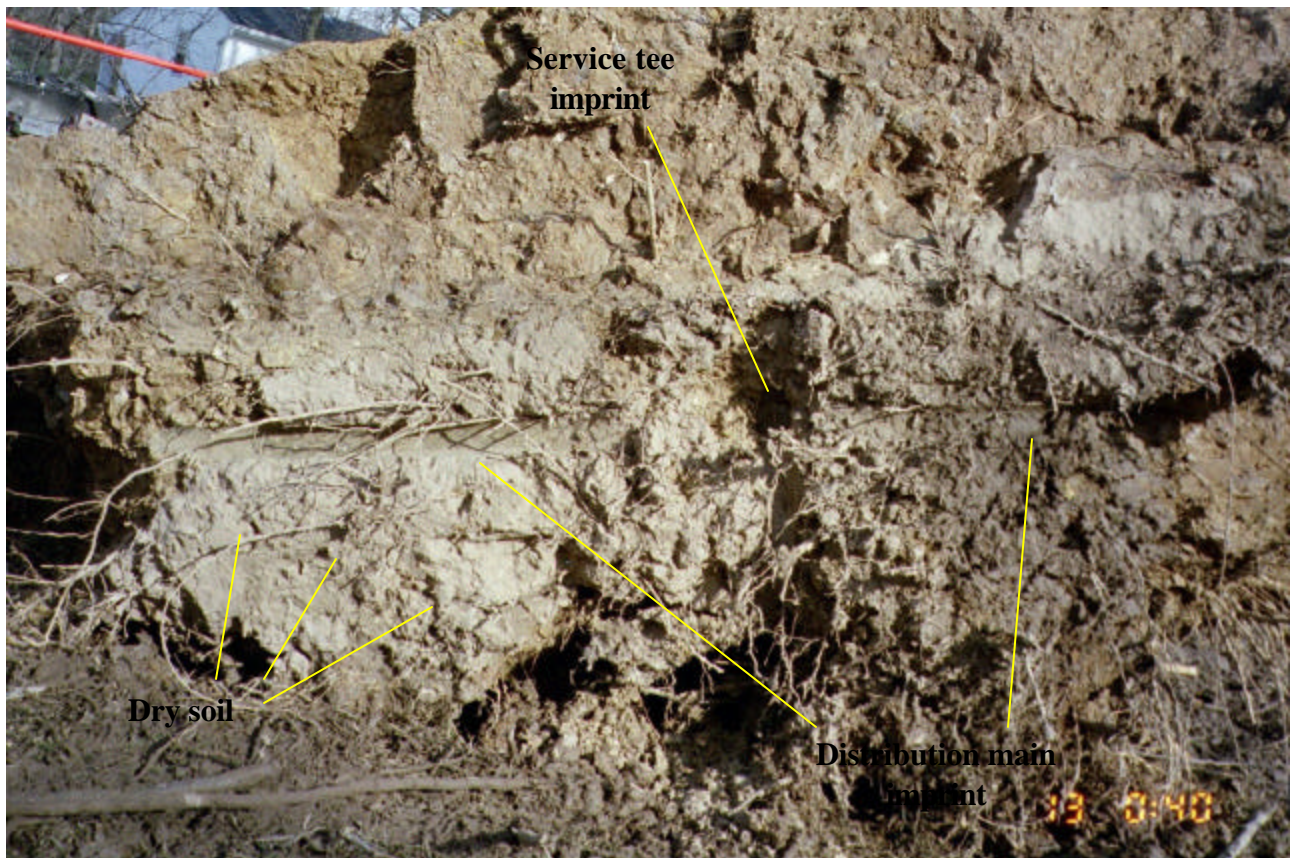
Photograph 18 Bottom of tree root ball showing imprint of distribution main, service tee and dried soil.

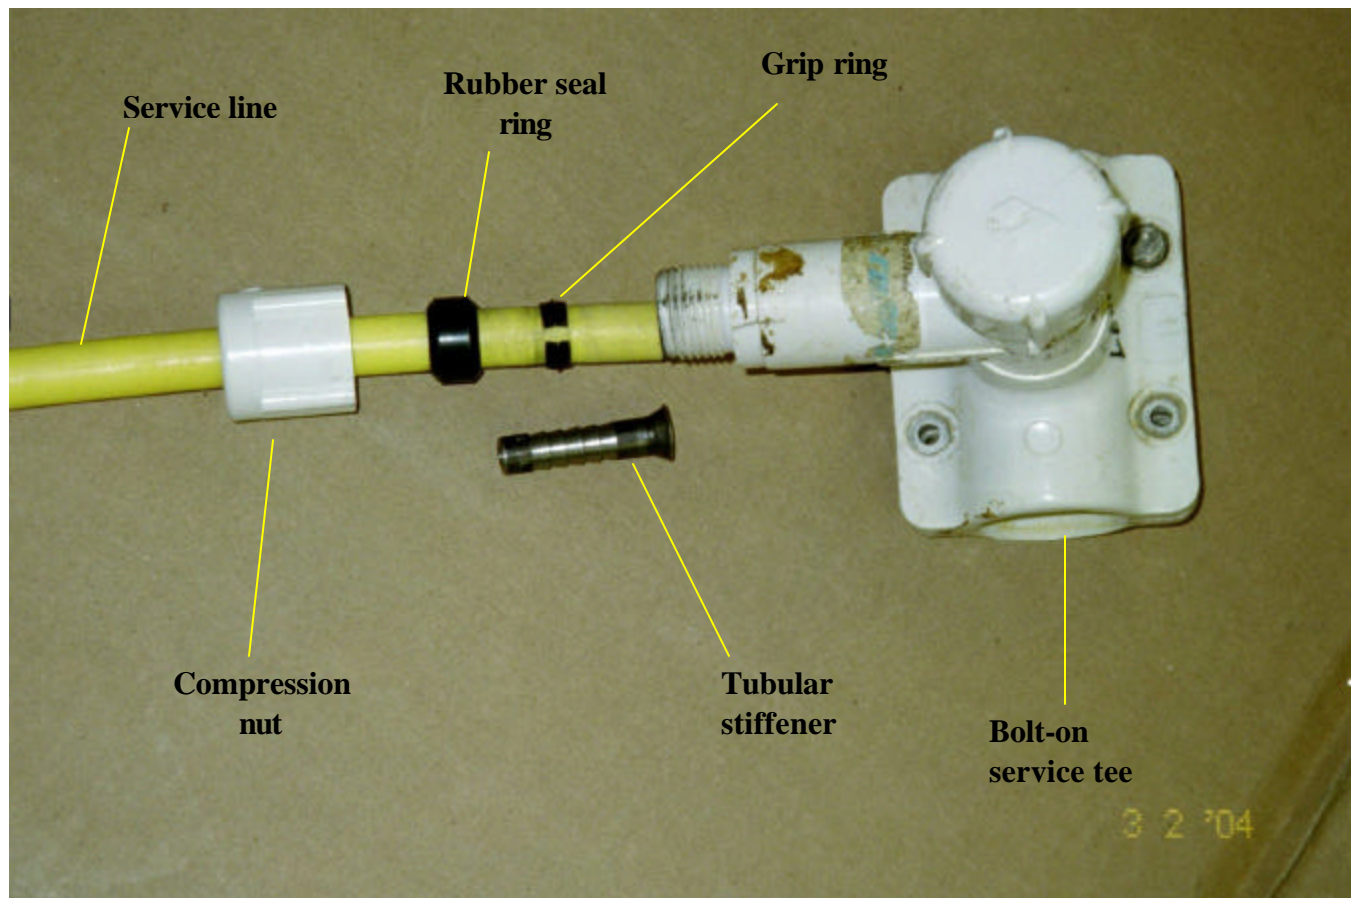
Photograph 19 Service tee similar to tee utilized at incident site. Tee is shown in disassembled configuration to illustrate component parts. Normally, the installation crew inserts the tubular stiffener into the end of service line (prior to service line insertion into the compression nut/service tee assembly). The compression nut is received from the manufacturer with the grip ring/rubber seal ring assembly installed in the compression nut. The as-received location of the grip ring is inside the rubber seal ring.
