Case No. ES-2007-0458

STAFF'S INTERIM INCIDENT REPORT

Superheater Attenuator Spray Water Pipe Failure
Iatan Plant
Weston, Missouri
May 9, 2007

Prepared by the Staff of the
Missouri Public Service Commission
September 6, 2007

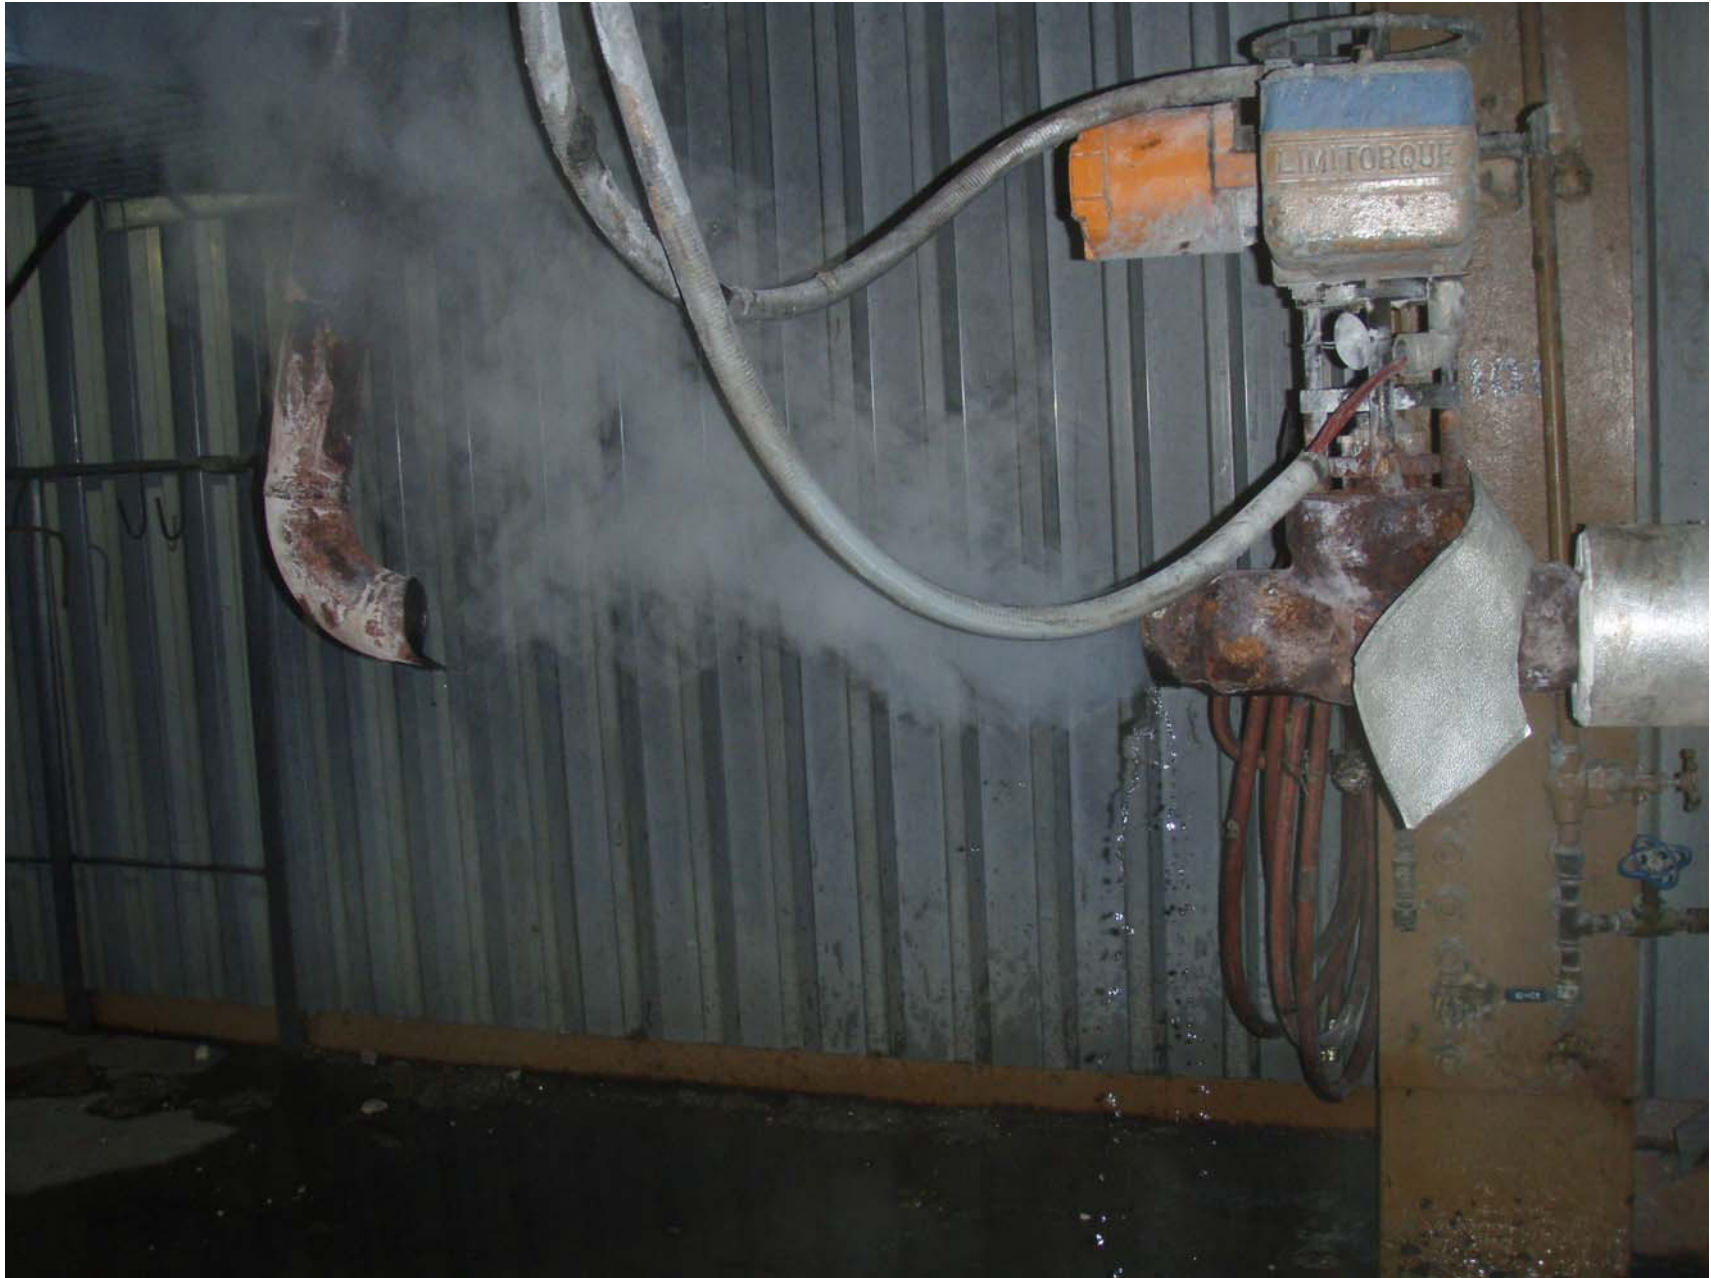
At approximately 11:45 am on May 9, 2007, a 4" diameter high pressure superheater attemperator spray water pipe ruptured near the area of the Iatan 1 coal feeders. A section of the 4" diameter pipe approximately 9 inches in length blew out. See Photographs 1, 2 and 3. The water in the pipe was at 345 degrees Fahrenheit and under 2,900 psig of pressure. When the pipe ruptured the water was exposed to atmospheric pressure causing it to flash to steam.

PHOTOGRAPH # 1
LOCATION OF PIPE RUPTURE

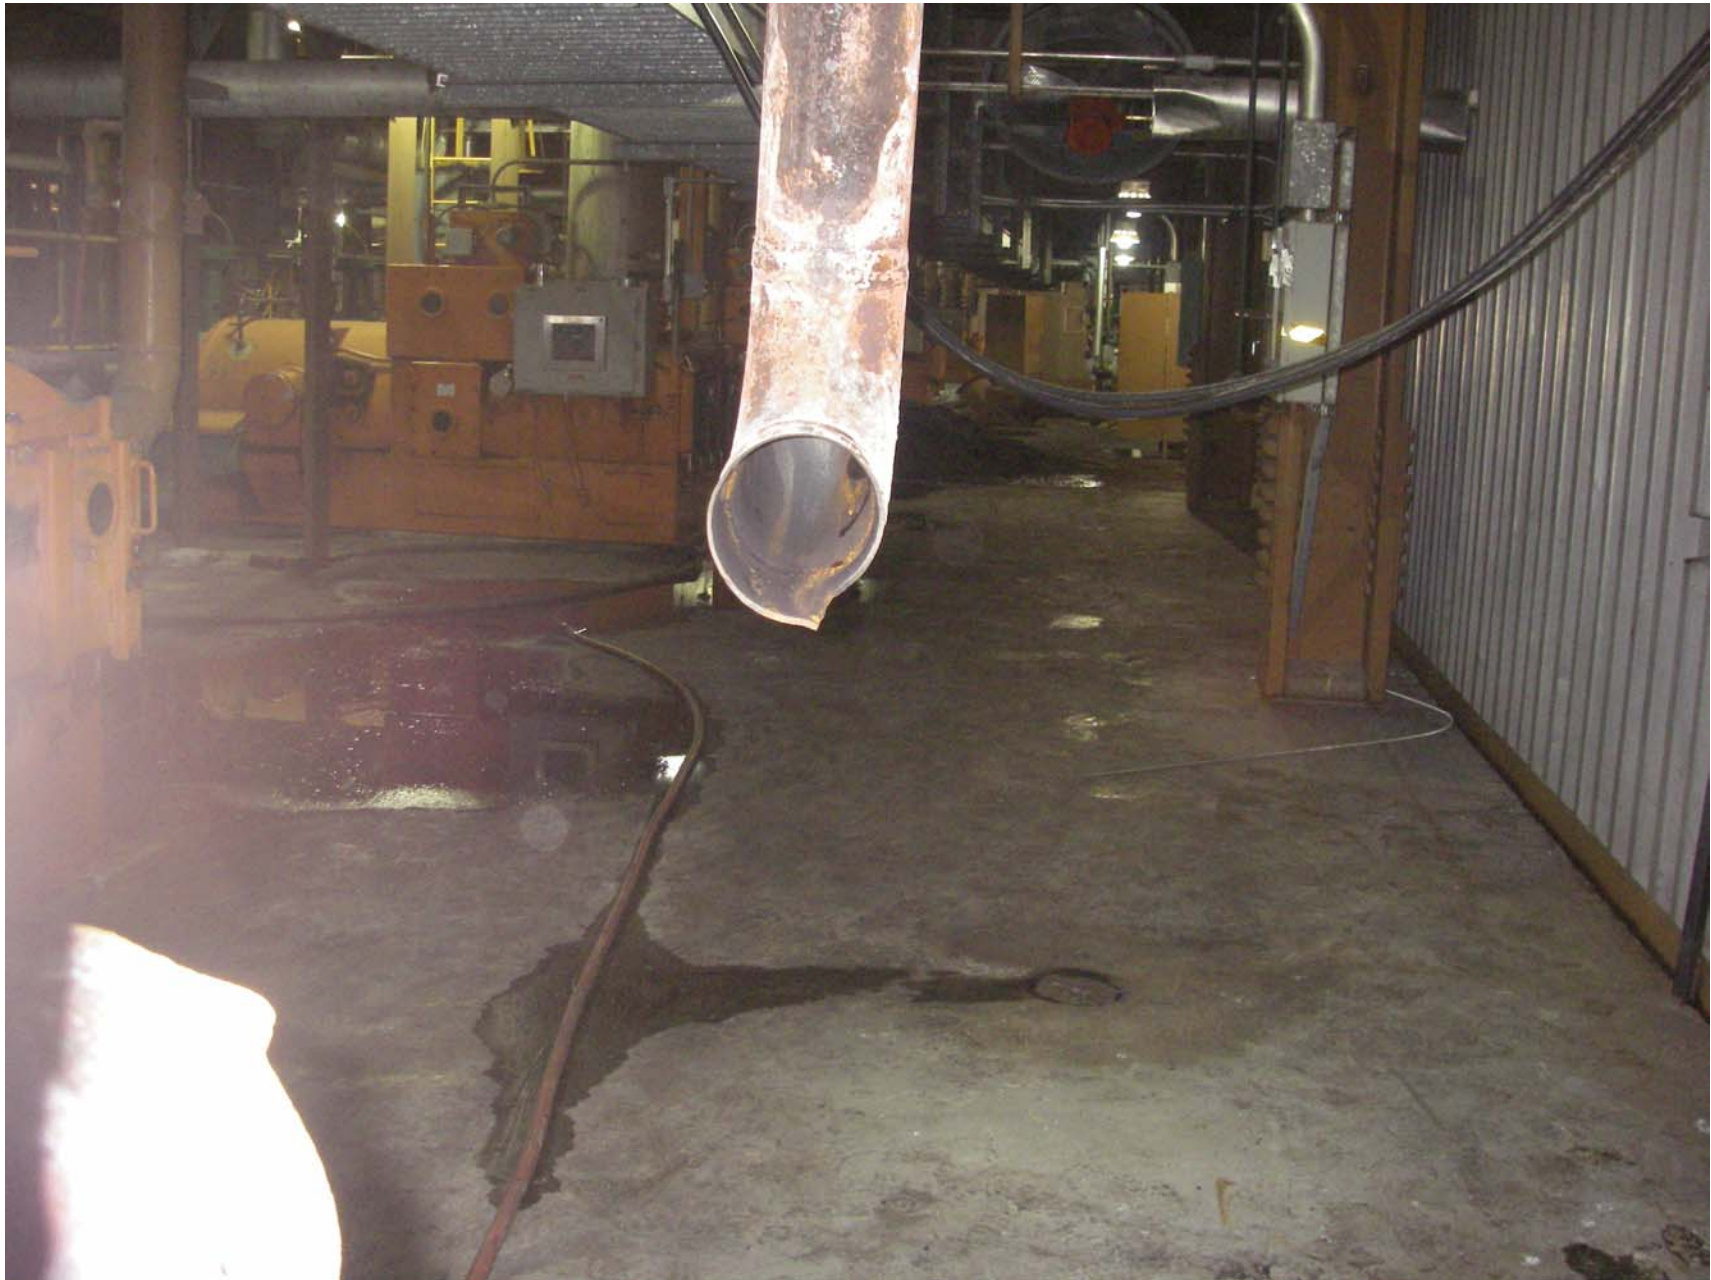
KCPL's preliminary investigation revealed that the wall thickness of the pipe section that failed was 1/8" rather than the 1/2" it should have been and that flow accelerated corrosion (FAC) in the pipe may have contributed to the failure of the pipe.

PHOTOGRAPH # 2
VIEW OF DAMAGED PIPE WITH COAL FEEDERS IN BACKGROUND

The failed superheater attemperator piping, as well as piping in five other locations, has been repaired or replaced. KCPL replaced the superheater attemperator piping with steel pipe having a higher chrome content. KCPL returned Iatan Unit 1 to service on May 27, 2007.
