Exhibit No.:  
Issues: Capital Investment Program,  
Description of Plant Additions, Water  
Storage Tank Rehabilitation, Risk  
Associated with Providing Public  
Water and Wastewater Services  
Witness: Rebecca B. Losli  
Exhibit Type: Direct  
Sponsoring Party: Missouri-American Water Company  
Case No.: WR-2022-0303  
SR-2022-0304  
Date: July 1, 2022

**CASE NO. WR-2022-0303**

**DIRECT TESTIMONY**

**REBECCA B. LOSLI**

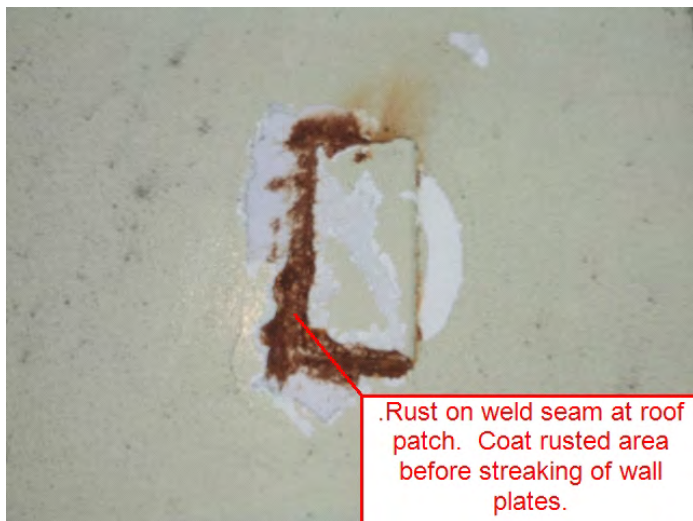
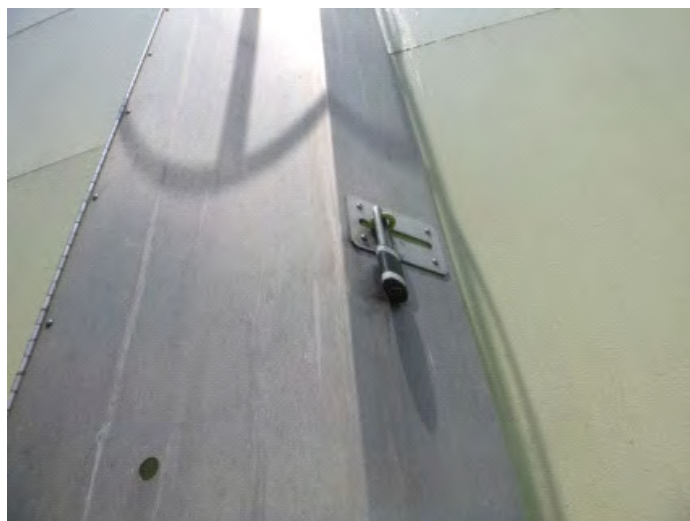
Rust on weld seam at roof patch. Coat rusted area before streaking of wall plates.

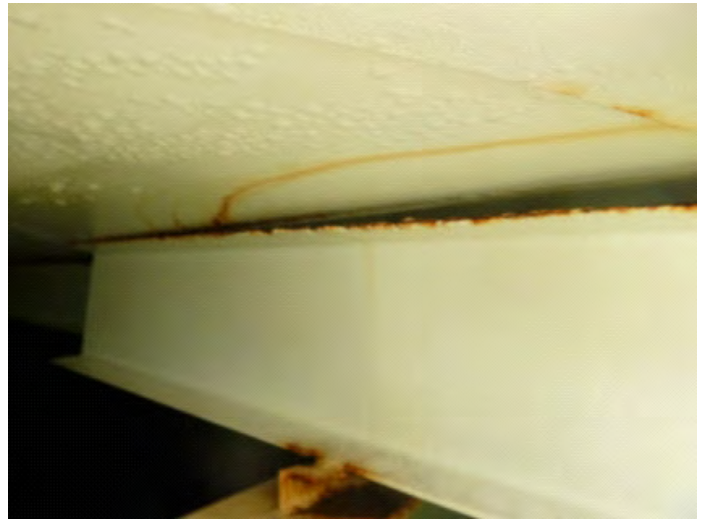
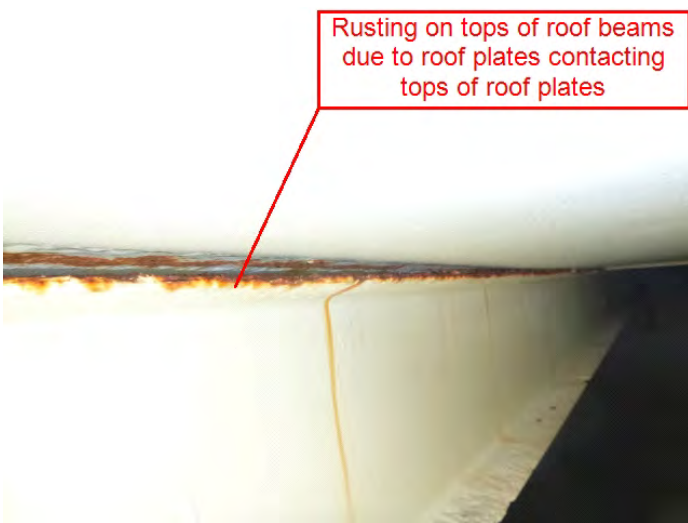
Rusting on tops of roof beams  
due to roof plates contacting  
tops of roof plates

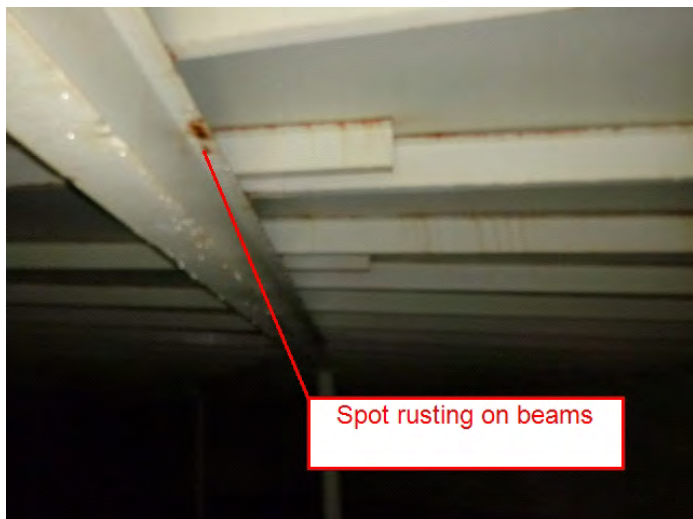
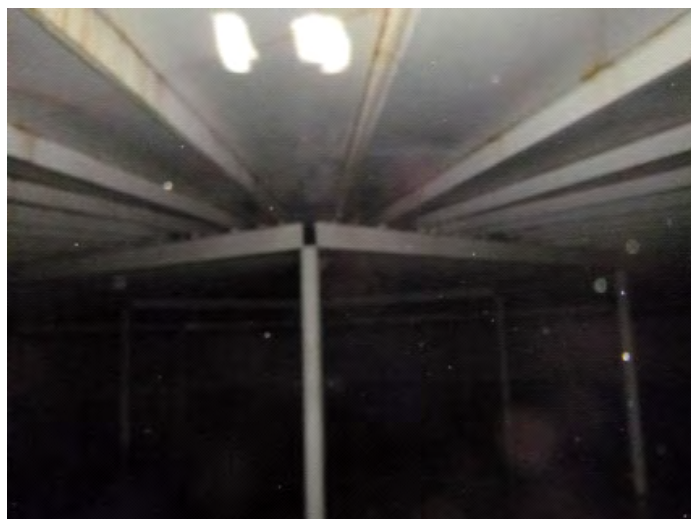
Spot rusting on beams

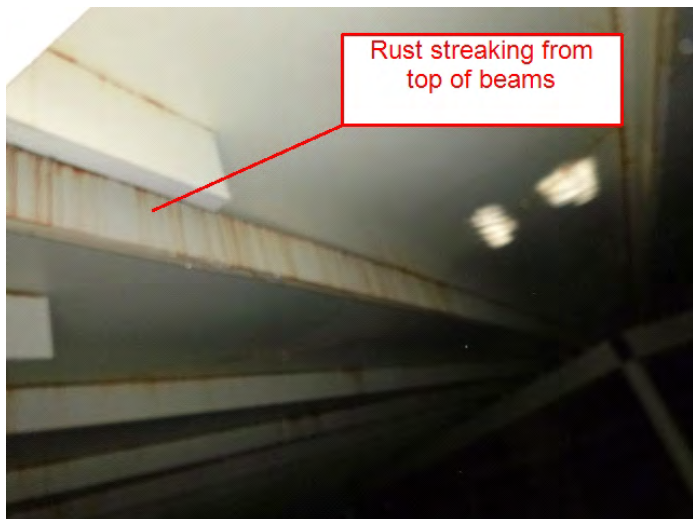
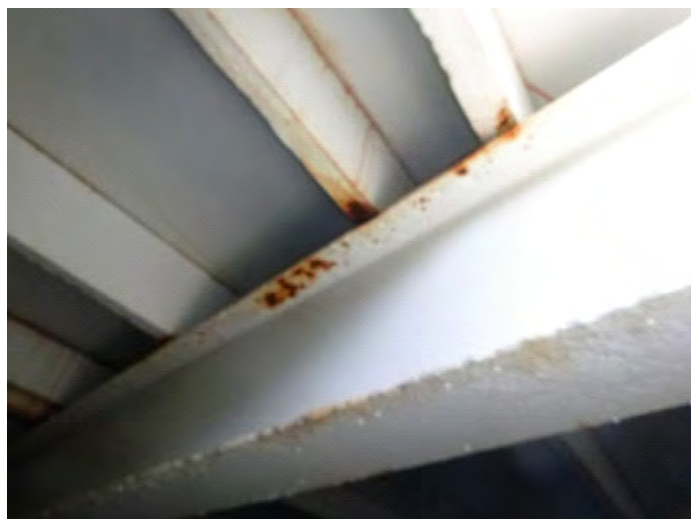
Rust streaking from top of beams

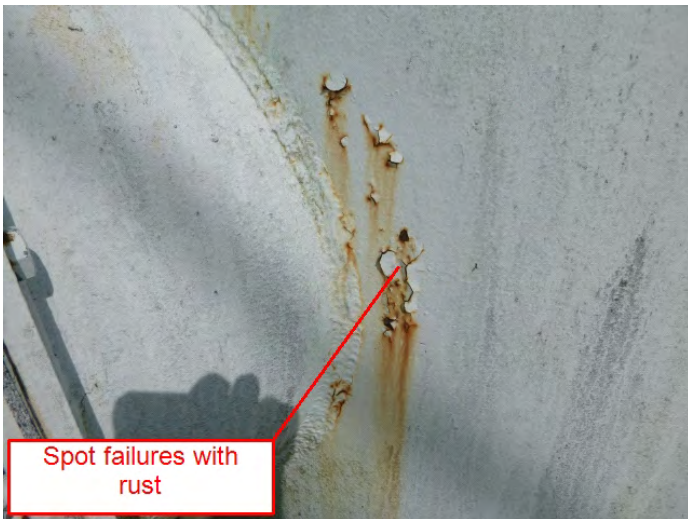
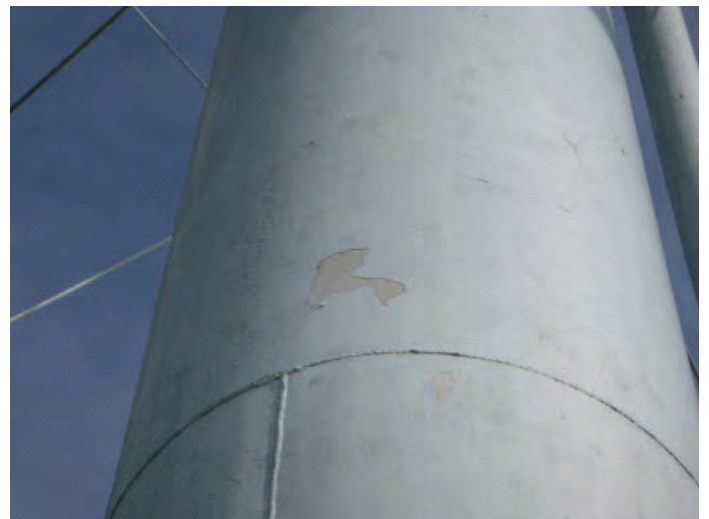
Spot failures with rust

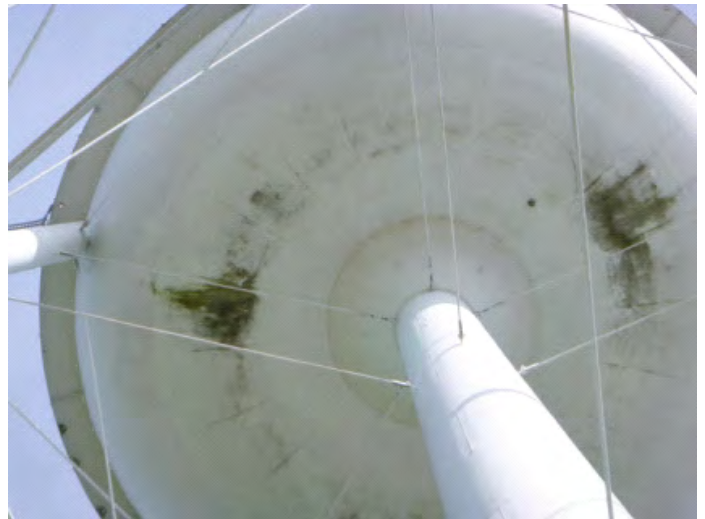
Mold growth on belly of bowl

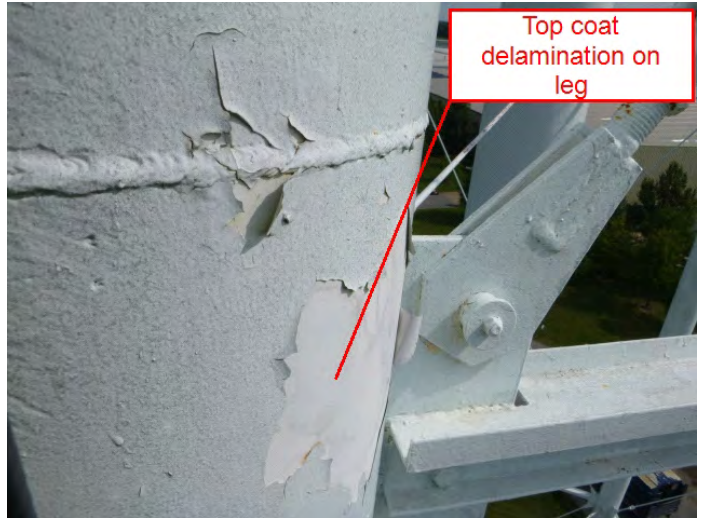
Top coat delamination on leg

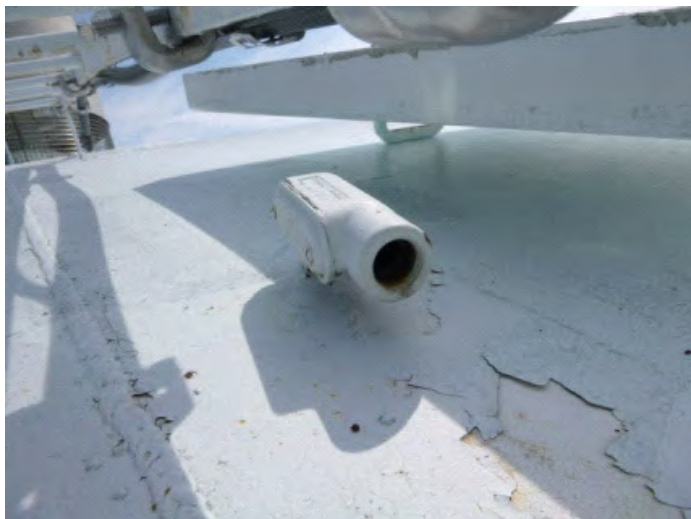
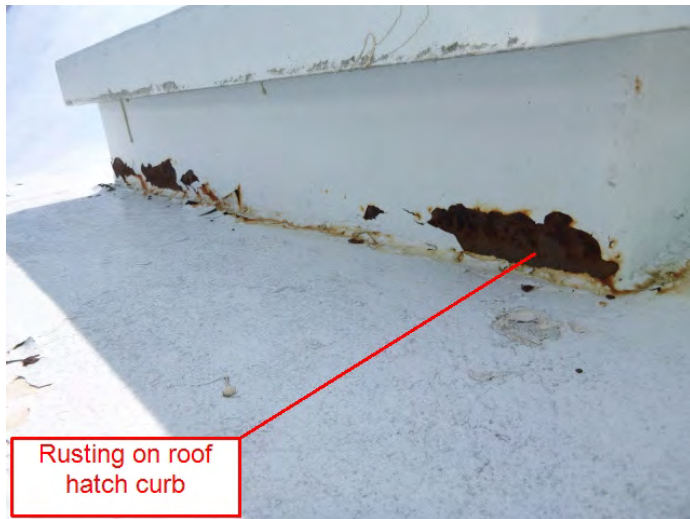
Rusting on roof hatch curb

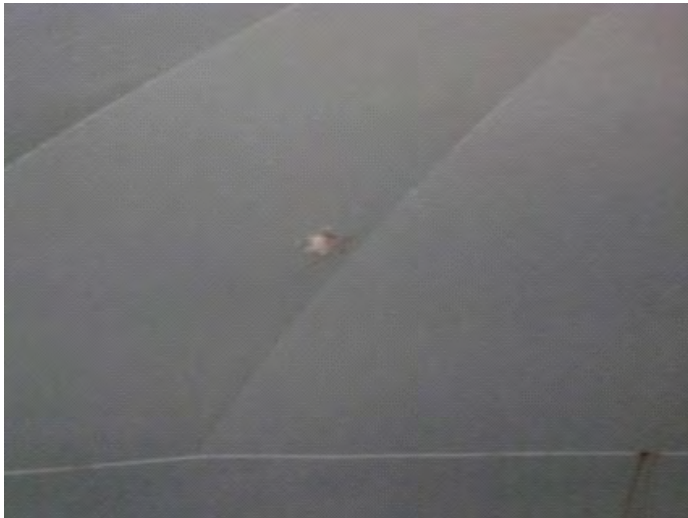
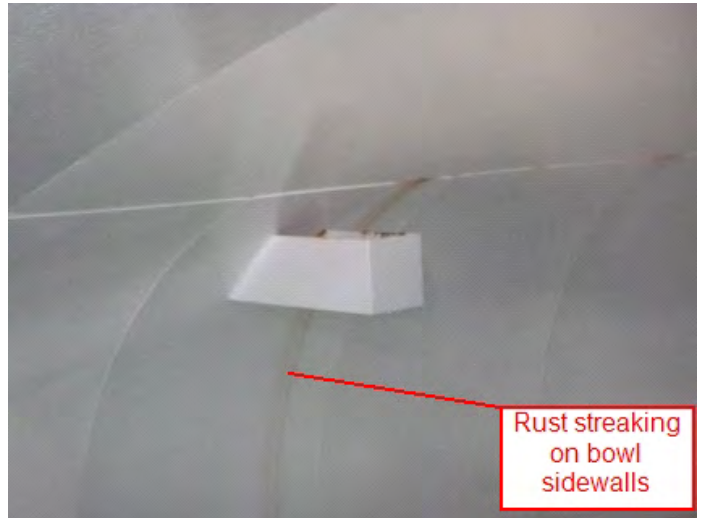
Rust streaking  
on bowl  
sidewalls
