Flinn Engineering, LLC
11216 Neumann Lane
Highland, Illinois 62249
618-550-8427
ksimpson@flinnengineering.com

March 14, 2022

Re: Engineering Report
Water and Wastewater Systems
Ironton, Missouri

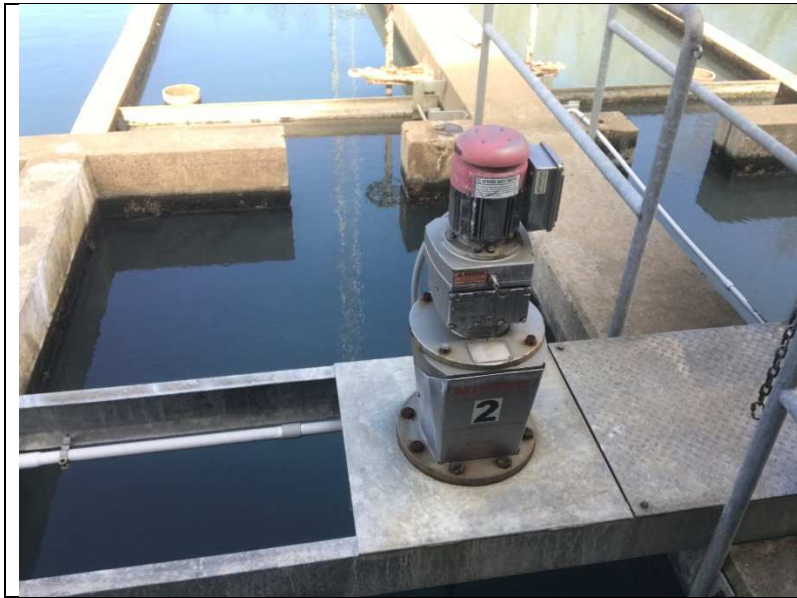
The treatment includes 2 stages of rapid mix, flocculation, and sedimentation. Rapid mix allows the treatment chemicals to be evenly distributed in the raw water before flocculation. Coagulants and flocculants are most effective when mixed with the whole volume of influent water quickly enough that the mixing is complete before significant coagulation or flocculation occurs. Ironton's process relies on the turbulence at the flocculation inlet for mixing. It appears that some mixing is occurring in flocculation, which reduces the effective flocculation time. Inadequate mixing can impair process performance.

Photograph #: 004
Taken By: Zachary Miller
Entity: Ironton PWS
PWS ID: MO4010402
Location: Water Treatment Plant
Description: Rapid Mix #2, redundant
Rapid Mix #1 not pictured but looked to
be in the condition.
Date Taken: 3/1/2021
Program: PDWB

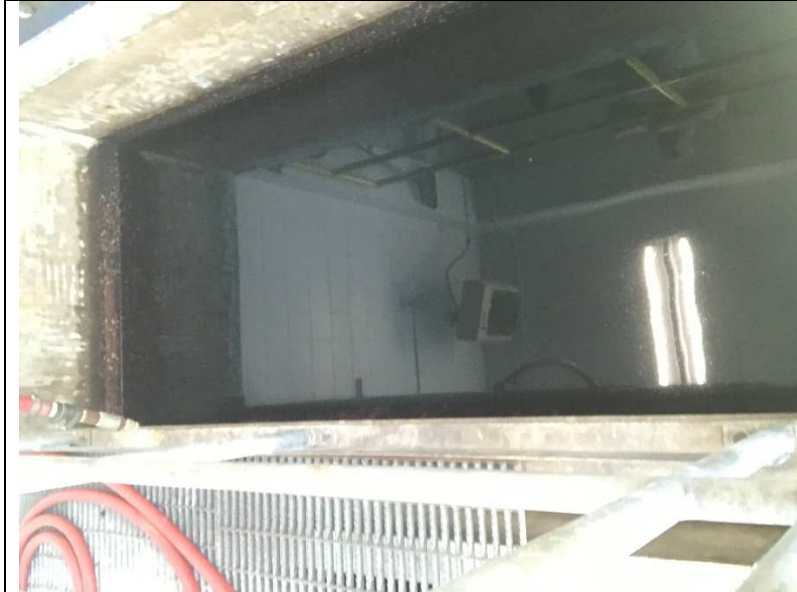
We discussed filter backwash and the lifetime of the greensand filters. Backwash is initiated based on factors including turbidity breakthrough and time in service. The backwash procedure did not include filter to waste, but the filters are sometimes allowed to settle before returning to service. The individual filter turbidimeters were indicating less than 0.1 NTU. The piping and other equipment around the filters appeared to be in reasonably good condition. The greensand has been used without being replaced since 2009, with some new sand added to the system a few years ago.

Photograph #: 005
Taken By: Zachary Miller
Entity: Ironton PWS
PWS ID: MO4010402
Location: Water Treatment Plant
Description: Greensand Plus Media
basin, not in picture but includes a
12.5% chlorine drip
Date Taken: 3/1/2021
Program: PDWB

The Department recommends that the system operate the sand filters to minimize turbidity spikes at startup and investigate the possibility of adding some filter to waste capability.

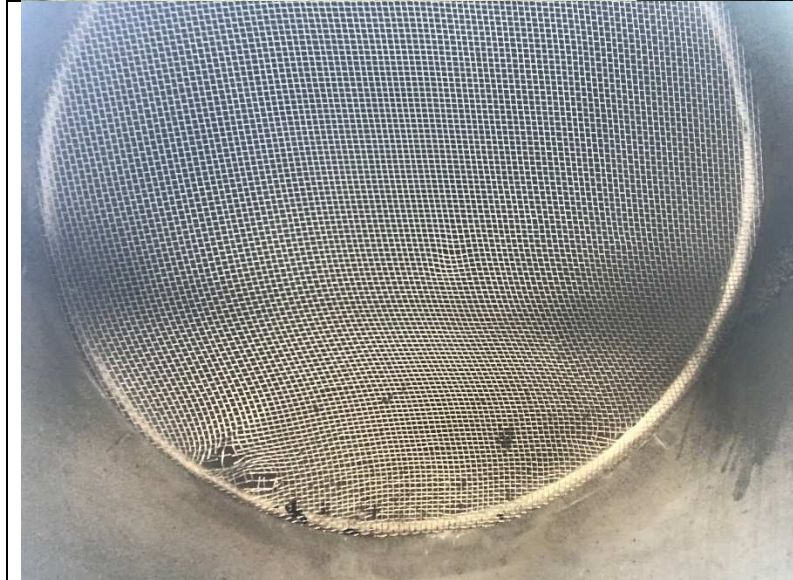
extended a foot above grade. I pointed out debris on top of the footing along the grout line, which can contribute to paint failure and corrosion. The overflows are equipped with tight fitting flaps but all three tanks had ripped screens

Photograph #: 008
Taken By: Zachary Miller
Entity: Ironton PWS
PWS ID: MO4010402
Location: South tank
Description: Overflow screen with tears
Date Taken: 3/1/2021
Program: PDWB

The Department recommends that the system have their water storage tanks professionally inspected every 3-5 years and give due consideration to the inspector's recommendations.

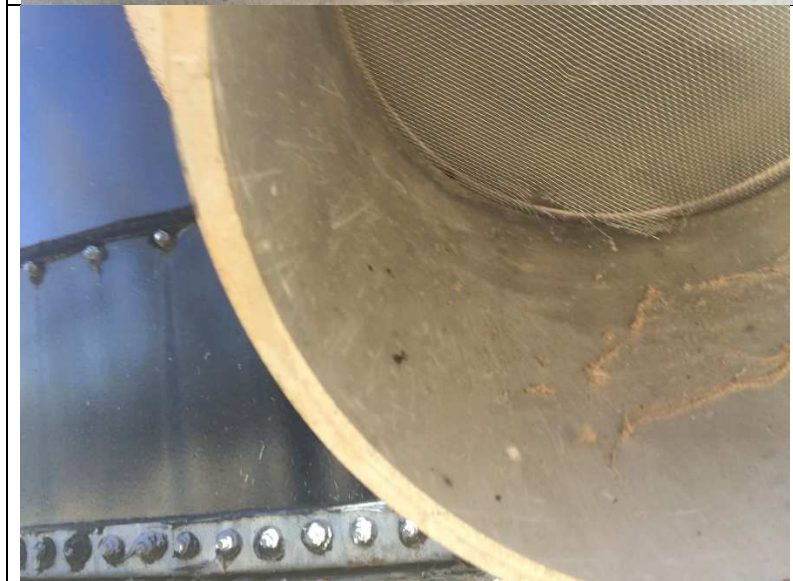
Photograph #: 009
Taken By: Zachary Miller
Entity: Ironton PWS
PWS ID: MO4010402
Location: North tank
Description: Overflow screen with tears
Date Taken: 3/1/2021
Program: PDWB
