Staff from the Missouri Department of Natural Resources (Department) conducted an inspection on December 1, 2017, of the Makalu Estates public water system (system). The system operates under the public water system identification number MO3031208.

Missouri Department of Natural Resources
Southwest Regional Office/Public Drinking Water Branch
Report of Inspection
Makalu Estates
Camden County, Missouri
Public Water System ID Number MO3031208
January 4, 2018

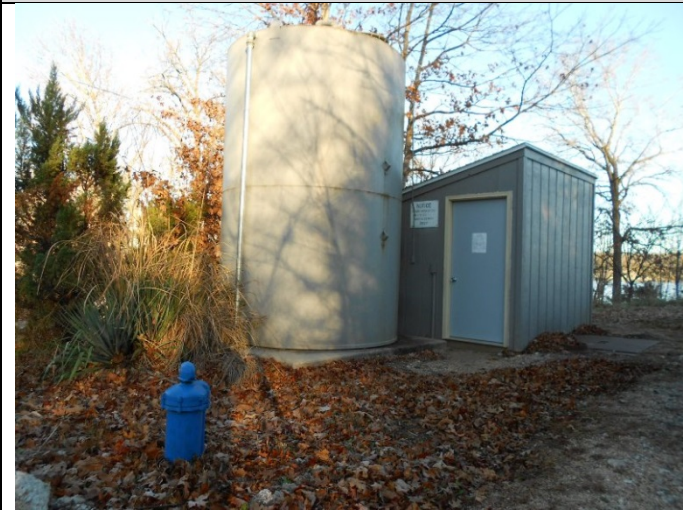
PHOTOGRAPH# 1
TAKEN BY: Darrell Barber
ENTITY: Makalu Estates
PERMIT: MO3031208
LOCATION: Next to well #2 facing Northwest
DESCRIPTION: Well #2, 3,500-gallon ground storage tank and well house.
DATE TAKEN: December 1, 2017
PROGRAM: Public Drinking Water Branch

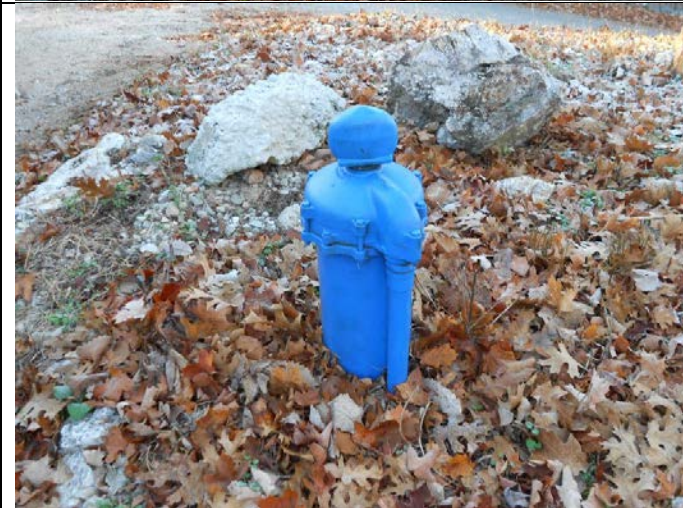
PHOTOGRAPH# 2
TAKEN BY: Darrell Barber
ENTITY: Makalu Estates
PERMIT: MO3031208
LOCATION: Next to Well #2 facing South
DESCRIPTION: Well #2
DATE TAKEN: December 1, 2017
PROGRAM: Public Drinking Water Branch

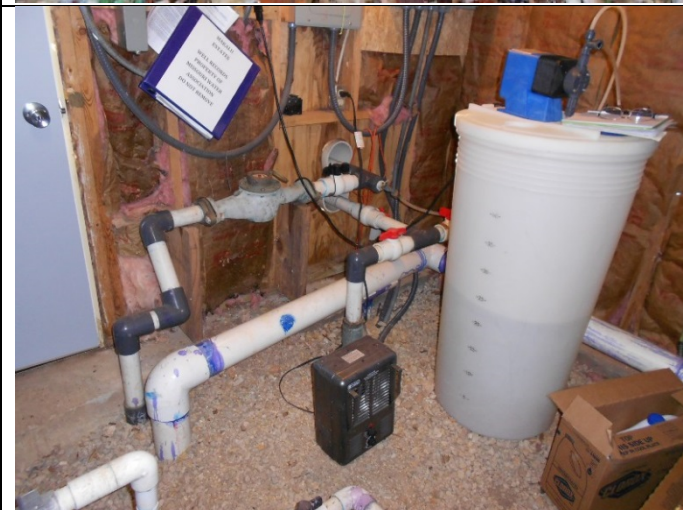
1. The public water system failed to obtain written authorization from the Department prior to construction, alteration, or extension of the water system in violation of Safe Drinking Water Regulation 10 CSR 60-3.010(1). A chlorination system was installed since the last inspection.

PHOTOGRAPH# 3
TAKEN BY: Darrell Barber
ENTITY: Makalu Estates
PERMIT: MO3031208
LOCATION: Inside well house
DESCRIPTION: Chlorination system and related piping.
DATE TAKEN: December 1, 2017
PROGRAM: Public Drinking Water Branch

REQUIRED ACTION: Within 180 calendar days of the date of this report, the public water system shall submit two copies each of an as-built engineering report, plans, and specifications prepared by a professional engineer registered in Missouri along with an application for a construction permit and a letter from the public water system authorizing the construction (unless the system is applying for the permit) to the Public Drinking Water Branch, P.O. Box 176, Jefferson City, MO 65102, 573-751-5331.

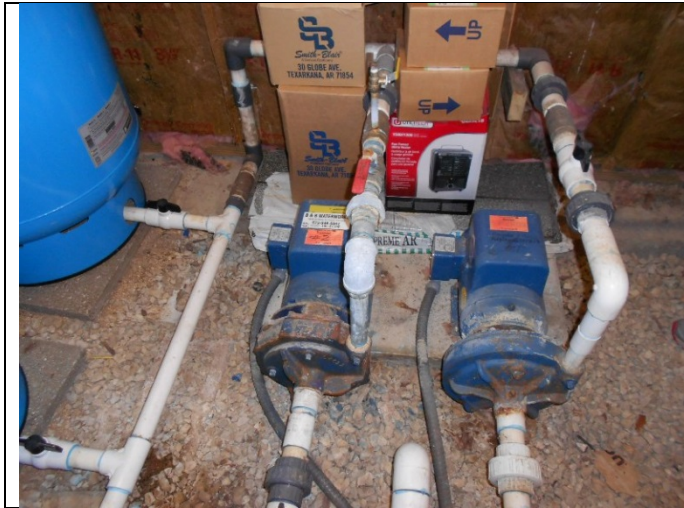
PHOTOGRAPH# 4
TAKEN BY: Darrell Barber
ENTITY: Makalu Estates
PERMIT: MO3031208
LOCATION: Inside well house
DESCRIPTION: Two 5-hp booster pumps and related piping.
DATE TAKEN: December 1, 2017
PROGRAM: Public Drinking Water Branch

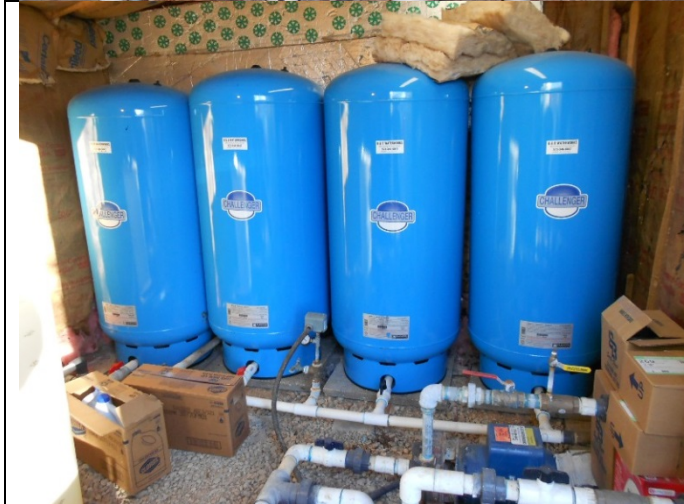
As noted in the last Report of Inspection dated June 18, 2015, the pre-charge air pressure in some of the bladder tanks needs to be adjusted. The pressure appears to be set too high and isn't allowing much water to enter some of the tanks. The water system needs to adjust the pre-charge pressure in the tanks so that all of the tanks are operating at similar levels.

PHOTOGRAPH# 5
TAKEN BY: Darrell Barber
ENTITY: Makalu Estates
PERMIT: MO3031208
LOCATION: Inside well house
DESCRIPTION: Four 119-gallon bladder tanks and related piping.
DATE TAKEN: December 1, 2017
PROGRAM: Public Drinking Water Branch
