**LETTER OF WARNING  
RESPONSE REQUIRED**

**Missouri Department of Natural Resources**  
**Central Field Operations**  
**Report of Inspection**  
**Osage Water Co KK Wastewater Treatment Plant**  
**Highway KK / Camden County**  
**MOGD00340**  
**May 28, 2020**

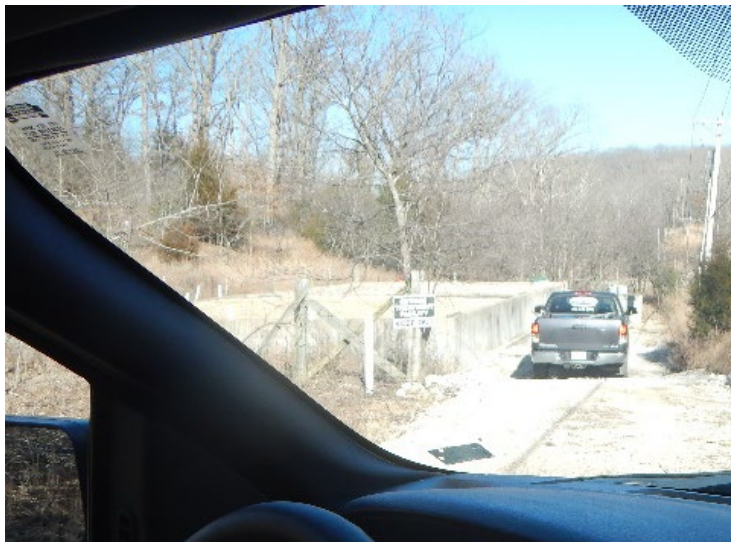
Photograph: #1  
Taken By: Keith Forck  
Entity: Central Field Operations  
Permit: MOGD00340  
Location: OWC KK WWTP

Upon arrival at the wastewater treatment facility (Figure #2), we met with Mr. Heppler and outlined the purpose and scope of the inspection. Mr. Heppler granted permission to access the site and accompanied us throughout the inspection. The gate appears unused and the fence does not surround the facility (Photo #1) (**Letter of Warning #1**).

1. The facility must be enclosed with a fence designed to discourage the entrance of unauthorized persons and animals in accordance with 10 CSR 20-8.140(8)(A) and Requirement #9 of the Missouri State Operating Permit MOGD00340.

Description: Entrance to treatment plant. Gate does not appear to have been closed recently.

**REQUIRED ACTION:** Construct a fence around the perimeter of the facility. Include access gates (Requirement #10 of MSOP) and warning signs as necessary.

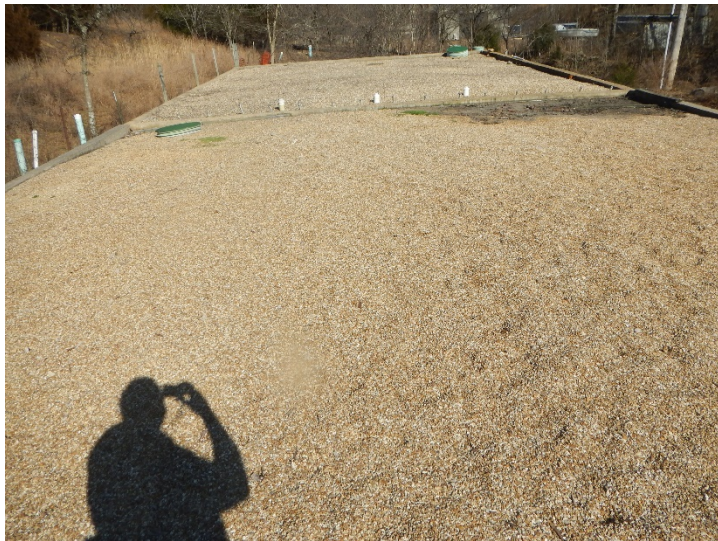
Photograph: #2  
Taken By: Keith Forck  
Entity: Central Field Operations  
Permit: MOGD00340  
Location: OWC KK WWTP

The filter beds were mostly free of vegetation (Photo #2). There was a large patch of obvious ponding in the southeast corner of Sand Filter Bed A (Photo #3) (**Letter of Warning #2**). Also in the southeast corner of Sand Filter Bed A at the seam between the sand filter beds, the wall has cracked (Photo #4). With the sand filter plugged, Mr. Heppler believes the water was overflowing the liner and leaking out of this crack and causing a bypass before the filter bed was shut down. Therefore the system is operating with Sand Filter Bed B in service (Photo #5) (**Recommendation #2**). This sand filter bed is also showing signs of plugging as water is surfacing and beginning to pond (Photo #6). A large crack was observed in the southeast corner of this filter bed (Photo #7). This crack is significant and is potentially a structural issue (Photo #8 & #9) (**Recommendation #3**). It appears that the crack may be leaking a small amount of water (**Recommendation #4**). Water from the recirculating sand filter beds flows to the recirculation flow splitter where flow is split between discharge and recirculation (Photo #11 & #12). Part of the water going to the flow splitter is being bypassed as the water is splashing onto the ground (**Letter of Warning #3**).

Description: Looking east across Sand Filter Bed A. Notice the ponding on the southeast corner of the filter bed. Sand Filter Bed B in the background.

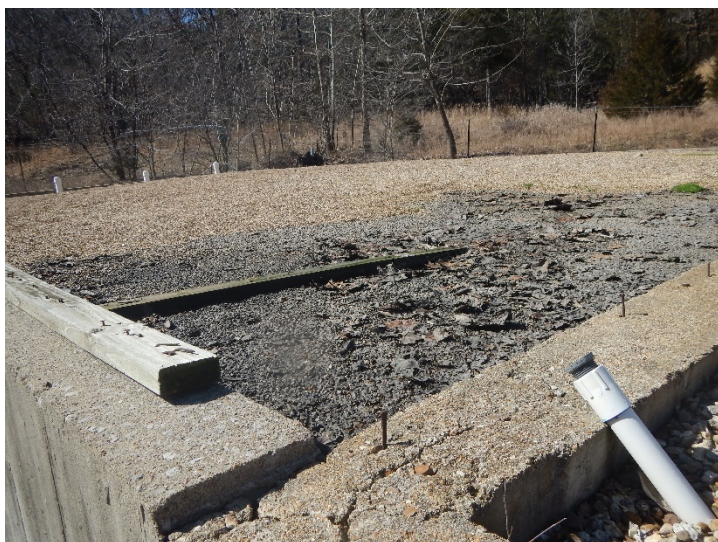
Photograph: #3  
Taken By: Keith Forck  
Entity: Central Field Operations  
Permit: MOGD00340  
Location: OWC KK WWTP

2. The surface of the recirculating sand filter had free liquid standing (ponding) indicating the filter is beginning to plug. The most common causes of premature plugging are failure to routinely pump sludge from the septic tank(s) upstream of the filter and failure to keep vegetation pulled from the surface of the filter bed. Even when properly operated and maintained, most fixed film treatment systems with relatively small media size tend to plug with biological growth over time. Once the filter is plugged, the media normally has to be replaced. It is essential that wastewater treatment facilities be properly operated and maintained in good working order so that permit limits can be met under all conditions. Failure to operate and maintain the facility is a violation of Missouri Clean Water Law Sections 644.051.1(3) and 644.076.1, RSMo.

Description: Looking northwest at ponding area of Sand Filter Bed A.

REQUIRED ACTION: Develop and submit a plan to correct this violation and implement the plan before overtopping of the filter bed(s) occur. You may contact your consulting engineer to determine if your filter media requires replacement and for recommended specifications for the new media.

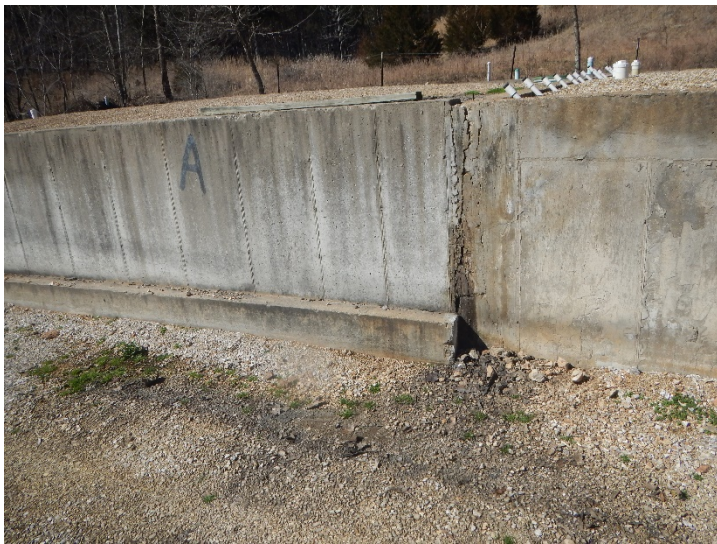
Photograph: #4  
Taken By: Keith Forck  
Entity: Central Field Operations  
Permit: MOGD00340  
Location: OWC KK WWTP

Description: Looking northwest at the seam between the sand filter beds. Sand Filter Bed A has recently been shut down due to the leak bypassing treatment.

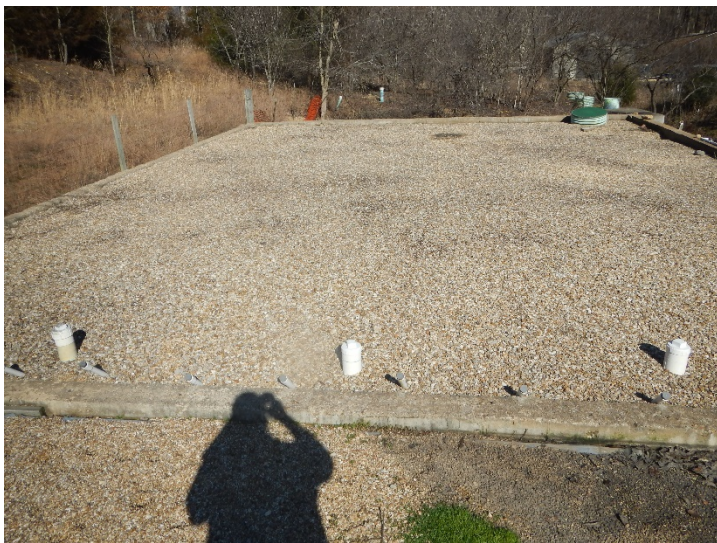
Photograph: #5  
Taken By: Keith Forck  
Entity: Central Field Operations  
Permit: MOGD00340  
Location: OWC KK WWTP

Description: Looking east across Sand Filter Bed B. See the ponding stain in the far center part of the filter bed.

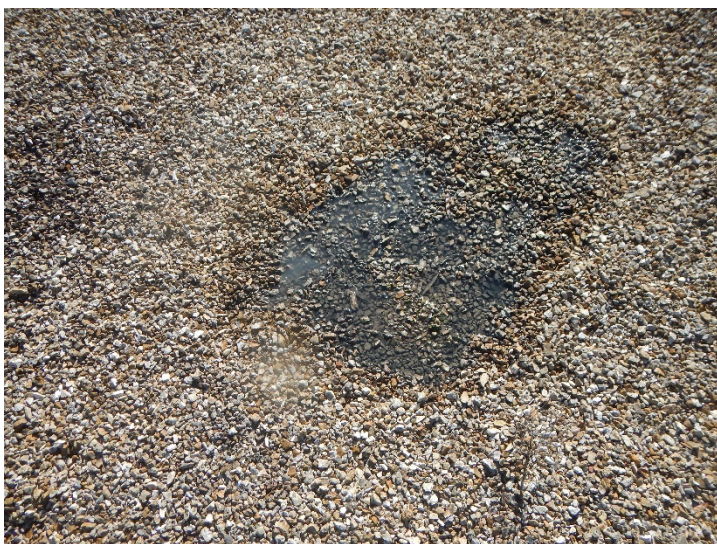
Photograph: #6  
Taken By: Keith Forck  
Entity: Central Field Operations  
Permit: MOGD00340  
Location: OWC KK WWTP

Description: Close-up of the ponding area in Sand Filter Bed B.

2. The wastewater treatment facility is designed for both recirculating sand filter beds to be in service. With the facility near the design flow and the second filter showing signs of plugging, operation of both filter beds should be restored as quickly as reasonably possible.

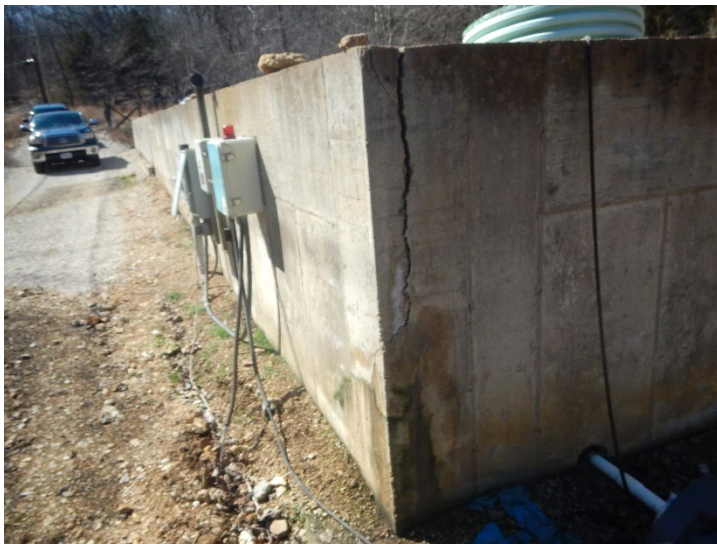
Photograph: #7  
Taken By: Keith Forck  
Entity: Central Field Operations  
Permit: MOGD00340  
Location: OWC KK WWTP

Description: Looking northwest at the southeast corner of Sand Filter Bed B. Note the large crack for the entire height of the wall.

3. Consideration should be given for having an evaluation conducted on the structural stability of the filter bed walls as the concrete has a major crack in the southeast corner of Sand Filter Bed B. Any suggested stabilization repairs should then be completed.

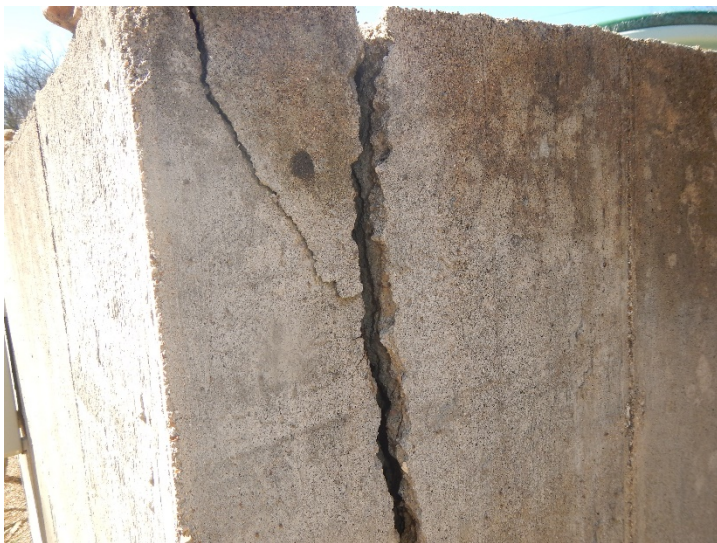
Photograph: #8  
Taken By: Keith Forck  
Entity: Central Field Operations  
Permit: MOGD00340  
Location: OWC KK WWTP

Description: Close-up of the crack at the top of the wall in the southeast corner of Sand Filter Bed B.

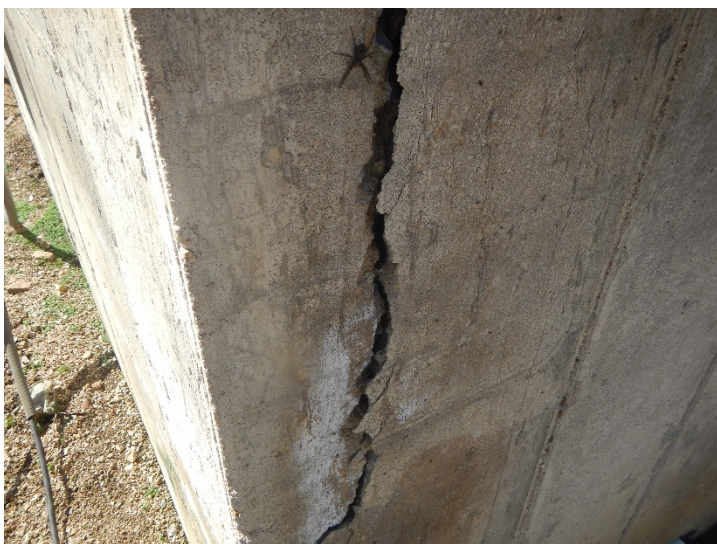
Photograph: #9  
Taken By: Keith Forck  
Entity: Central Field Operations  
Permit: MOGD00340  
Location: OWC KK WWTP

Description: Description: Close-up of the crack at the middle of the wall in the southeast corner of Sand Filter Bed B.

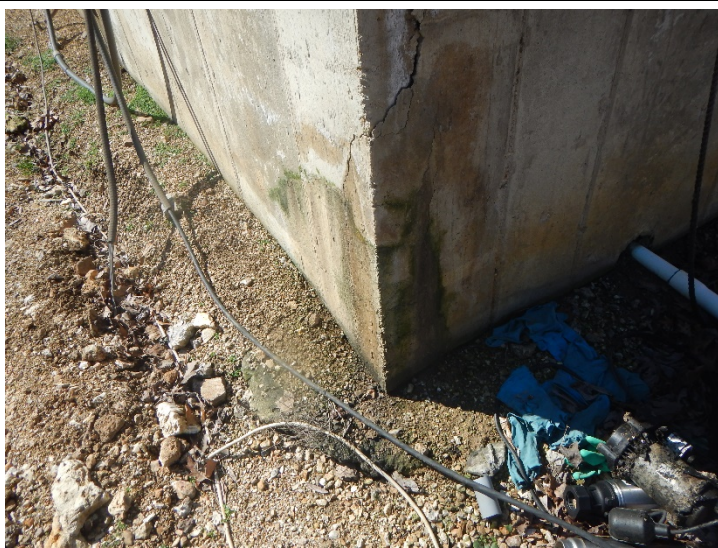
Photograph: #10  
 Taken By: Keith Forck  
 Entity: Central Field Operations  
 Permit: MOGD00340  
 Location: OWC KK WWTP

Description: Close-up of the crack at the bottom of the wall in the southeast corner of Sand Filter Bed B.

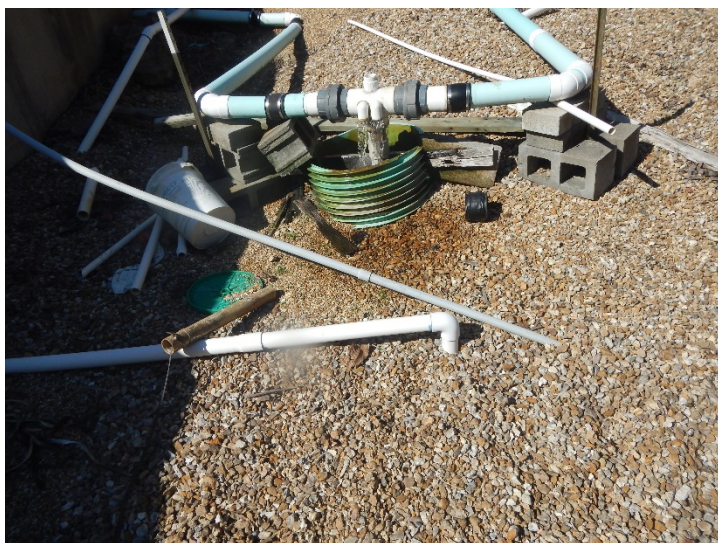
Photograph: #11  
 Taken By: Keith Forck  
 Entity: Central Field Operations  
 Permit: MOGD00340  
 Location: OWC KK WWTP

Description: Looking north at the recirculating piping and recirculation tank riser. Note the wet area around the riser from recirculating splitter falling outside the tank riser.

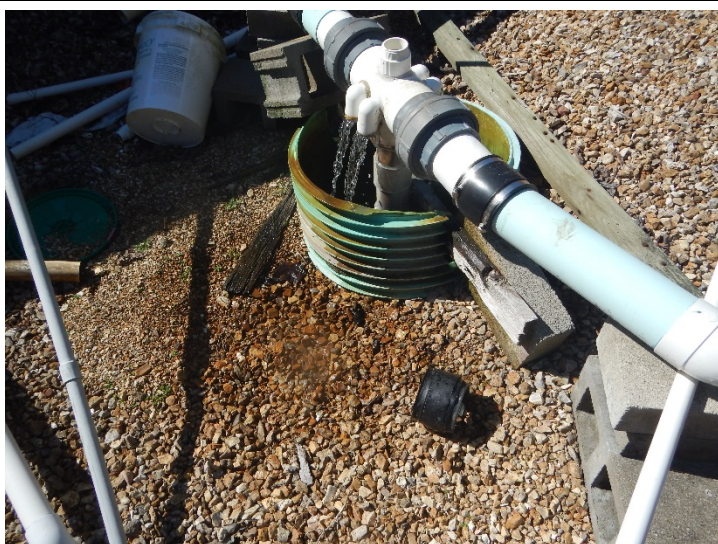
Photograph: #12  
 Taken By: Keith Forck  
 Entity: Central Field Operations  
 Permit: MOGD00340  
 Location: OWC KK WWTP

Description: Close-up of the recirculating flow splitter valve and wet area outside of the riser. Note the piping supports of concrete blocks.

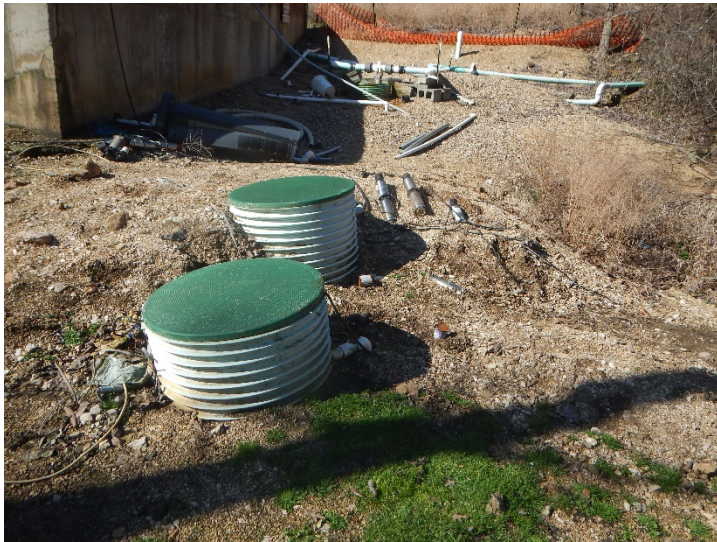
Photograph: #13  
 Taken By: Keith Forck  
 Entity: Central Field Operations  
 Permit: MOGD00340  
 Location: OWC KK WWTP

In the recirculation tank (Photo #13), the recirculated water mixes with the influent flow from the septic tanks located in the collection system at individual houses or larger ones for a cluster of houses. The mixed water in the recirculation tank is pumped to the sand filter beds. The system

There were some housecleaning issues of old pumps (Photo #13), piping, buckets (Photo #20), etc. observed around the treatment facility with a significant pile of materials located at the west end of the wastewater treatment facility (Photo #24) that could easily be cleaned up (**Recommendation #9**).

Description: Looking north at the recirculation tank. The pumps are in the two closest risers and the recirculation piping and riser in the background.

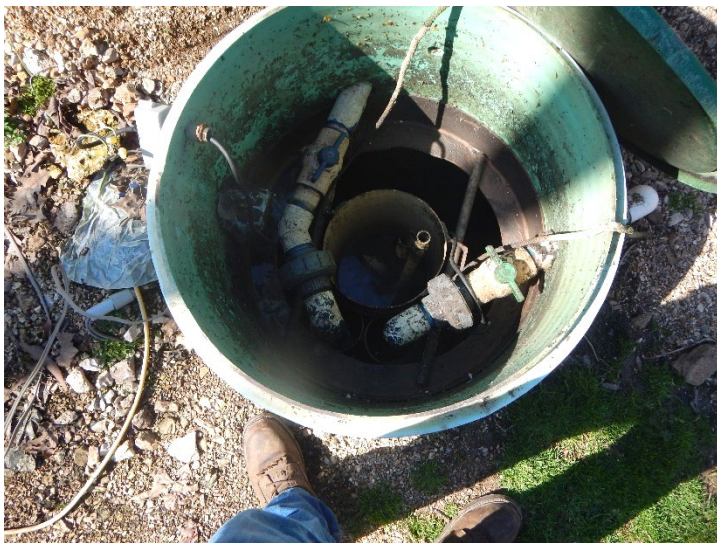
Photograph: #14  
 Taken By: Keith Forck  
 Entity: Central Field Operations  
 Permit: MOGD00340  
 Location: OWC KK WWTP

operates with two pairs of pumps with each pair plumbed for a filter bed. One pair is turned off as Sand Filter A is offline (Photo #14). One of the pumps for Filter Bed B appears to have a loose fitting as water is being sprayed back into the tank (Photo #15) (**Recommendation #4**). Mr. Heppler fixed this fitting during the inspection. The alarm was functional.

Description: Looking down at into the southern riser. These pumps are for Filter Bed A and are turned off.

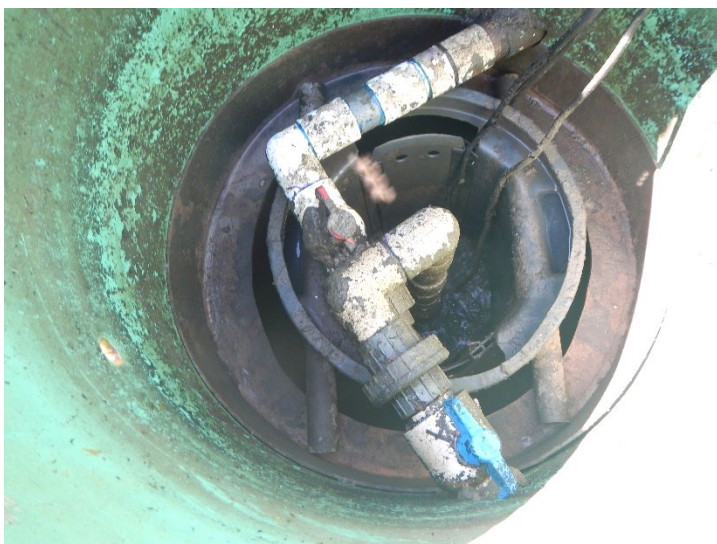
Photograph: #15  
 Taken By: Keith Forck  
 Entity: Central Field Operations  
 Permit: MOGD00340  
 Location: OWC KK WWTP

Description: Looking down at into the northern pump riser. These pumps are for Filter Bed B and one of the pumps is failing as it is just stirring the water in the screen vault.

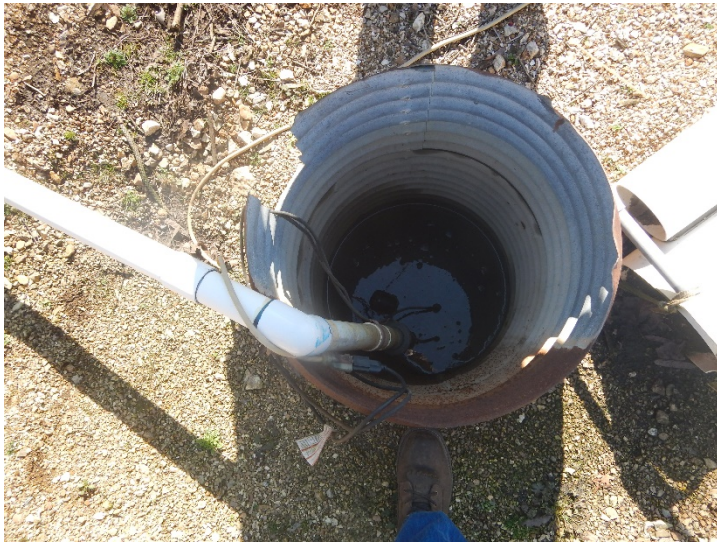
Photograph: #16  
Taken By: Keith Forck  
Entity: Central Field Operations  
Permit: MOGD00340  
Location: OWC KK WWTP

Just south of the end of the recirculation tank is a sump pump pit (Photo #16). According to Mr. Heppler, this pump is to keep groundwater from floating the recirculation tank. The recirculation tank has floated a few times since construction and has rotated the cylindrical tank a few degrees (**Recommendation #6**). This water is pumped to the nearby stream (Photo #17), where green algae is noted below the pipe. Looking upstream of the pipe, no green algae is observed (Photo #18). Looking downstream of the pipe, green algae is observed (Photo #19) (**Letter of Warning #4**). A sample was collected of this sump pump discharge and is to be analyzed for ammonia (**Sample #194690**). The analysis of this sample was 13.7 mg/L for Ammonia as N. The full report is available as Attachment #3.

Description: Sump pump at the south end of the recirculation tank. Used to pump water to keep the tank from floating.

5. The wastewater treatment facility should be thoroughly checked on a routine basis to verify the entire system is operating properly.
6. The recirculation tank and associated piping need to be watertight. When the tank was moved by flotation, stress is placed on the tank and fittings, potentially causing a stress crack, which may be leaking. The sump pump may be pumping partially treated wastewater in addition to stormwater. The recirculation tank and connecting pipes should be evaluated and verified to be watertight.

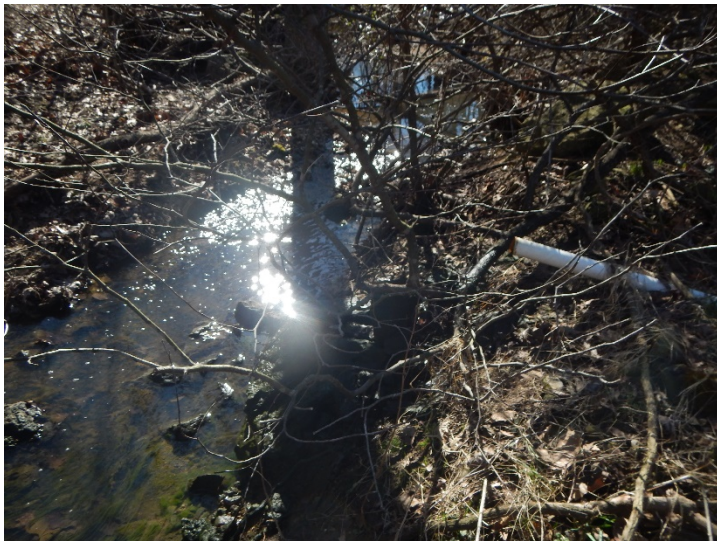
Photograph: #17  
Taken By: Keith Forck  
Entity: Central Field Operations  
Permit: MOGD00340  
Location: OWC KK WWTP

Description: Looking west at the discharge line from the sump pump. Note the green algae at the bottom of the picture, which is downstream of the pipe.

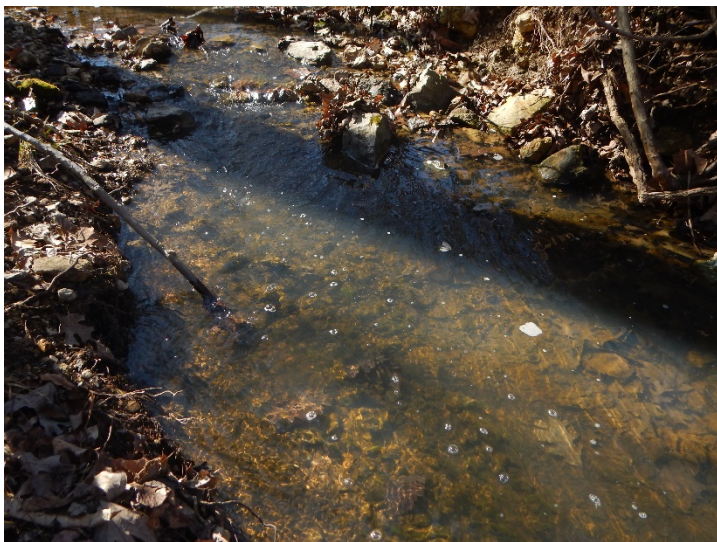
Photograph: #18  
Taken By: Keith Forck  
Entity: Central Field Operations  
Permit: MOGD00340  
Location: OWC KK WWTP

Description: Looking northwest at the stream immediately upstream of the sump discharge.

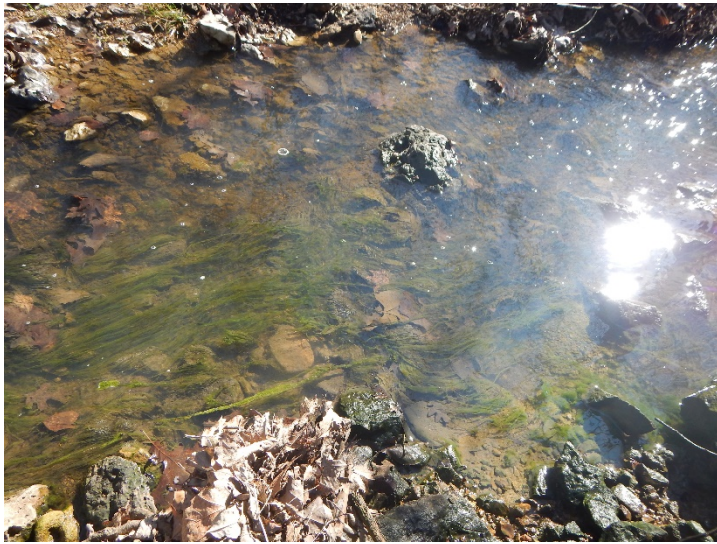
Photograph: #19  
 Taken By: Keith Forck  
 Entity: Central Field Operations  
 Permit: MOGD00340  
 Location: OWC KK WWTP

Description: Looking down at the green algae in the stream immediately below the sump pump discharge.

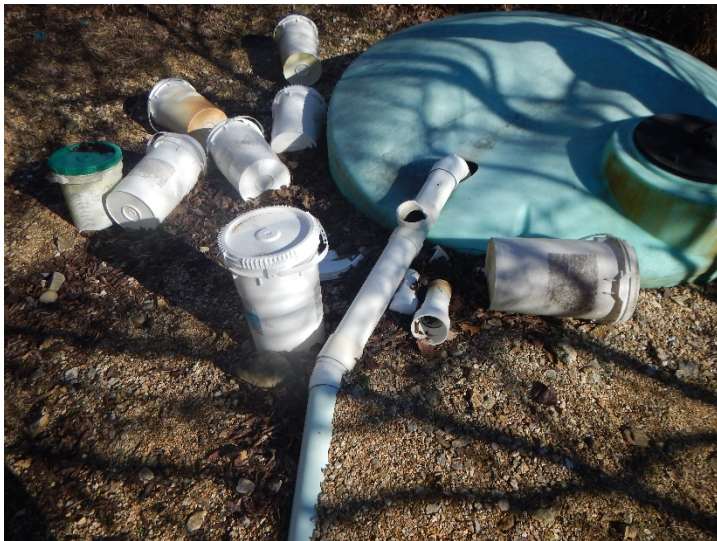
Photograph: #20  
 Taken By: Keith Forck  
 Entity: Central Field Operations  
 Permit: MOGD00340  
 Location: OWC KK WWTP

The homemade chlorine feeder was not in use and is next to the chlorine contact tank (Photo #20). Mr. Heppler stated that during the recreational season that they drop a couple tablets in the pipe when filling the feeder (**Recommendation #7**). The homemade chlorine contact had some grayish colored water and floating solids (**Recommendation #8**). Mr. Heppler stated that this tank was to be pumped out soon. The dechlorination dispenser was empty (Photo #22). The facility had no flow measurement device (**Letter of Warning #5**). The discharge appeared to discolor the ditch (Photo #23) (**Letter of Warning #6**). The outfall was marked with a sign.

Description: Looking west at the custom chlorinator and contact tank. Only one tablet feeder for chlorine.

7. Consider increasing the capacity of the tablet feeder to provide a more controlled dosage of chlorine than dropping tablets into the pipe.

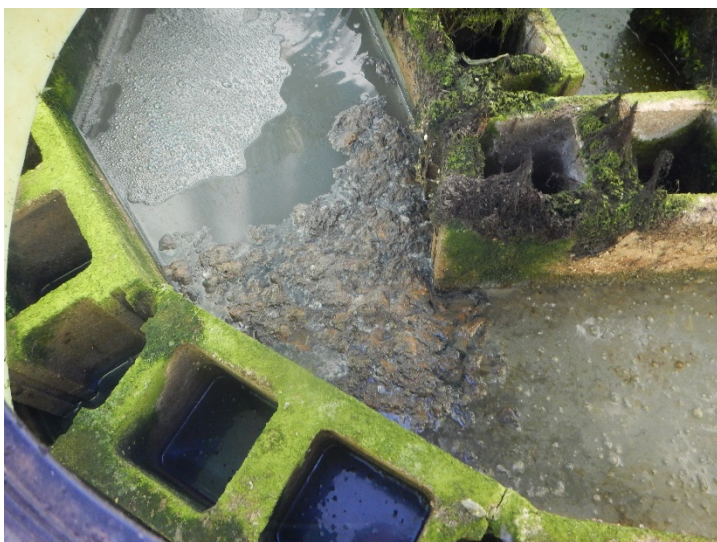
Photograph: #21  
 Taken By: Keith Forck  
 Entity: Central Field Operations  
 Permit: MOGD00340  
 Location: OWC KK WWTP

Description: Looking down into the chlorine contact tank. See the algae and floating scum in the tank.

8. The water in the chlorine contact tank should look clear and be free of floating solids. Excessive solids should be removed from the recirculation tank and chlorine contact tank. Consider checking the chlorine contact tank and cleaning as necessary.
9. For the safety of all employees, ensure that all equipment and parts are stored properly away to reduce trip hazards. All obsolete equipment should be disposed of in a proper way; chlorine/dechlor buckets should be disposed of along with old pumps.
10. If the facility is exceeding its design capacity, the facility should be expanded to serve the additional load or possibly connect to a regional facility. If the excessive loading is only organic, the facility may consider putting in a solids trap before the recirculation tank to keep the solids out of the recirculation tank and recirculating sand filter.

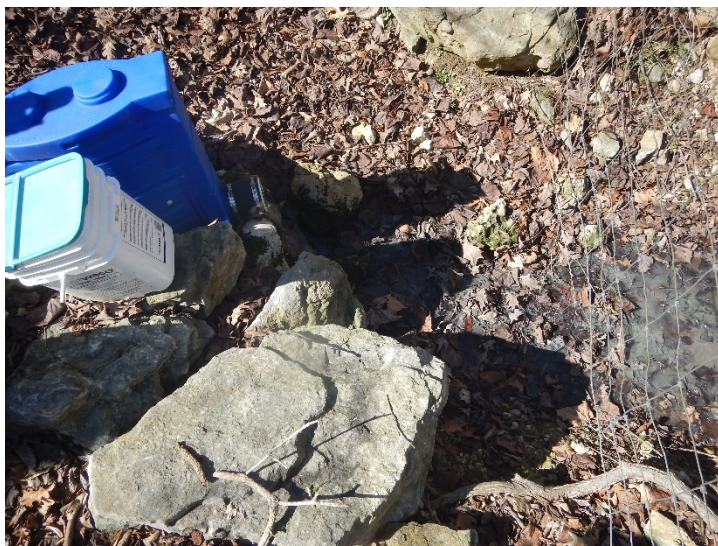
Photograph: #22  
 Taken By: Keith Forck  
 Entity: Central Field Operations  
 Permit: MOGD00340  
 Location: OWC KK WWTP

Description: Looking down at the dechlorinator and discharge ditch. Note the discoloration of the ditch.

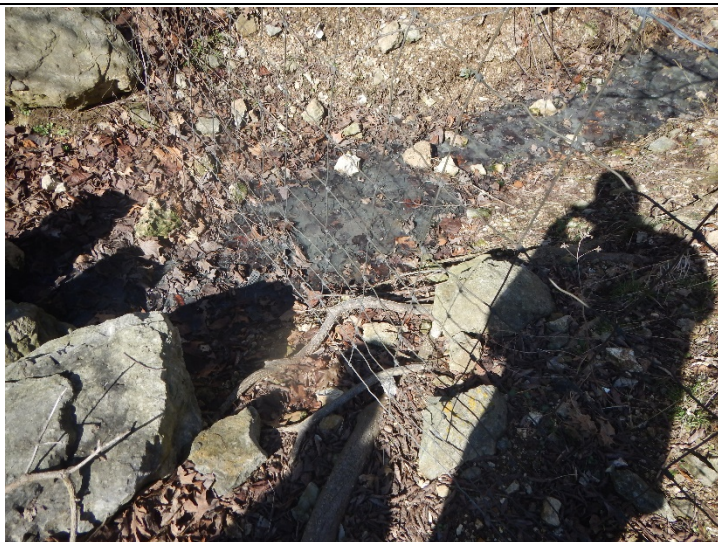
Photograph: #23  
 Taken By: Keith Forck  
 Entity: Central Field Operations  
 Permit: MOGD00340  
 Location: OWC KK WWTP

6. The outfall water shall be free from substances in sufficient amounts to cause the formation of putrescent, unsightly, or harmful bottom deposits in the receiving stream in accordance with 10 CSR 20-7.031(4).

Description: Picture of the discharge ditch below the outfall.

**REQUIRED ACTION:** Complete the operational and maintenance necessary to improve the water quality of the outfall and therefore the receiving stream. Work may include pumping sludge from the chlorine contact tank and recirculation tank and unplugging the filter beds.

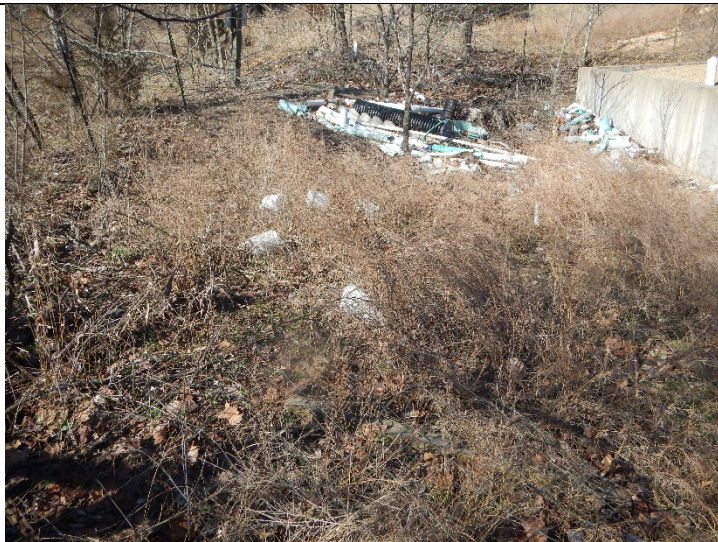
Photograph: #24  
 Taken By: Keith Forck  
 Entity: Central Field Operations  
 Permit: MOGD00340  
 Location: OWC KK WWTP

Description: Looking north at the scrap pile at the west end of the wastewater treatment facility.
