**LETTER OF WARNING  
RESPONSE REQUIRED**

Staff from the Department of Natural Resources conducted an inspection on the March 11, 2020, of Cimarron Bay/Harbor Bay Condominiums Wastewater Treatment Facility located at on MM-40PT (Cimmaron Bay Circle), Sunrise Beach, and in Camden County. The entity operates under the authority of Missouri State Operating Permit MOGD00297.

**Missouri Department of Natural Resources**  
**Central Field Operations**  
**Report of Inspection**  
**Cimarron Bay/Harbor Bay Condominiums Wastewater Treatment Facility**  
**MM-40PT (Cimarron Bay Circle), Sunrise Beach / Camden County**  
**MOGD00297**  
**May 28, 2020**

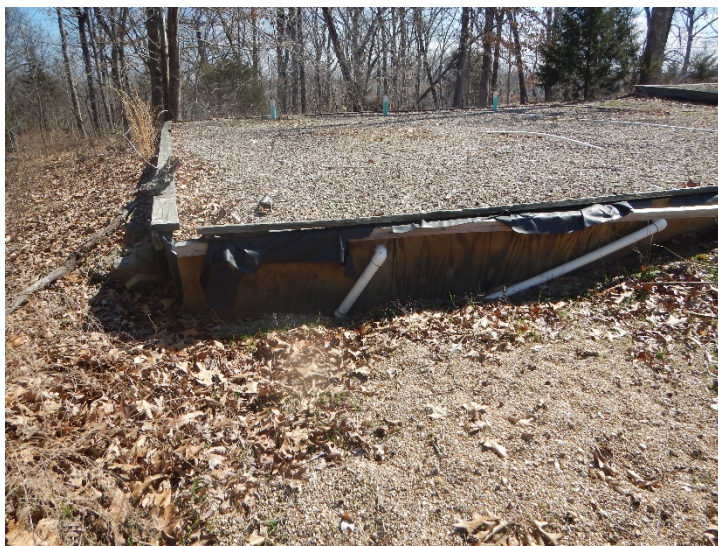
Photograph: #1  
 Taken By: Keith Forck  
 Entity: Central Field Operations  
 Permit: MOGD00297  
 Location: Cimarron Bay/Harbor Bay  
 Condominiums WWTF

Upon arrival at the wastewater treatment facility, we met with Mr. Tim Ripley and outlined the purpose and scope of the inspection. Mr. Ripley granted permission to access the site and accompanied us throughout the inspection. The wastewater treatment facility does not have a fence (Photo #1) (**Letter of Warning #1**).

The filter beds were mostly free of vegetation (Photo #2). There filter beds support walls have deteriorated. A backfill around the walls has not been maintained and is not providing much support (Photo #1- #3) (**Recommendation #2**). The facility is operating with only filter bed #2 functioning as the other two filter beds are missing piping, valves, and other appurtenances. (**Recommendation #3**). Mr. Ripley also has concerns that recirculating sand filter beds may be leaking due to the frequency of the facility being no-discharge (**Recommendation #4**). With the condition, age, and concerns about the facility, it may be time to consider a major repair or replacement of the wastewater treatment facility (**Recommendation #5**).

1. The facility should be enclosed with a fence designed to discourage the entrance of unauthorized persons and animals in accordance with 10 CSR 20-8.140(8)(A) and Requirement #9 of the Missouri State Operating Permit MOGD00297.

Description: Looking west at Recirculating Filter Bed 3. Note the failing walls and poor backfill support. Note no fence around the system.

REQUIRED ACTION: Construct a fence around the perimeter of the facility. Include access gates (Requirement #10 of MSOP) and warning signs as necessary.

2. The walls of the recirculating sand filter beds should be carefully backfilled to provide support to maintain the filter beds as they near the end of their design life. The backfill could also help with worker safety by reducing the potential tripping and slipping opportunities.

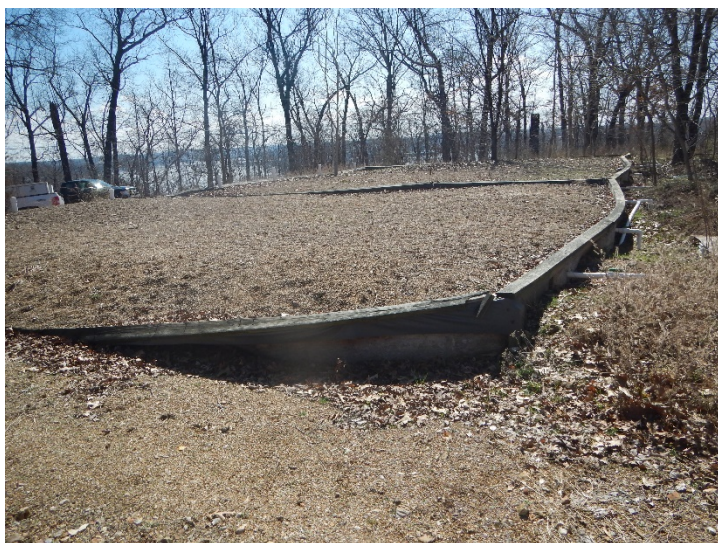
Photograph: #2  
 Taken By: Keith Forck  
 Entity: Central Field Operations  
 Permit: MOGD00297  
 Location: Cimarron Bay/Harbor Bay  
 Condominiums WWTF

Description: Looking south at the Recirculating Sand Filter Bed 2 with Recirculating Sand Filter Bed 3 in the background.

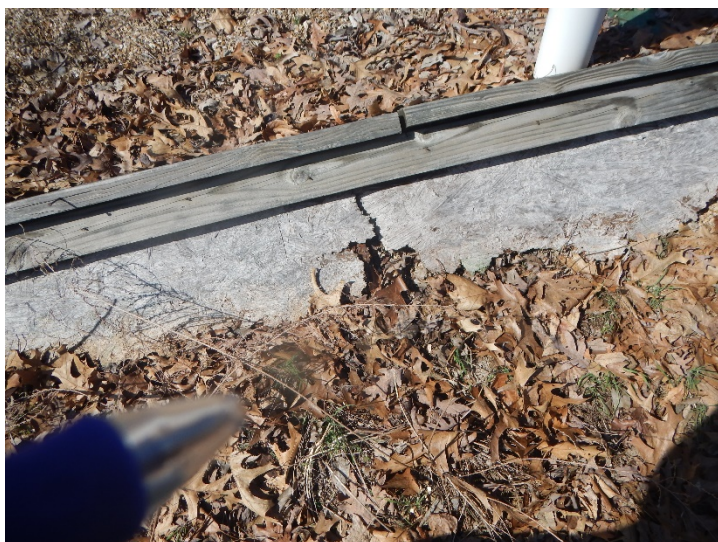
Photograph: #3  
 Taken By: Keith Forck  
 Entity: Central Field Operations  
 Permit: MOGD00297  
 Location: Cimarron Bay/Harbor Bay  
 Condominiums WWTF

Description: Close-up of the support wall that is nearing the end of the design life. The poly liner is supported by this wood and plywood wall.

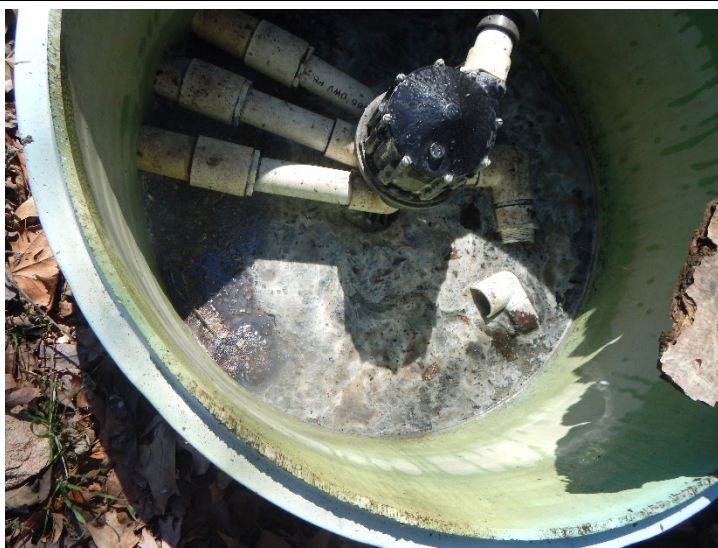
Photograph: #4  
 Taken By: Keith Forck  
 Entity: Central Field Operations  
 Permit: MOGD00297  
 Location: Cimarron Bay/Harbor Bay  
 Condominiums WWTF

Description: Looking down at the ratchetting distribution valve. Note the poor drainage in the bottom of the valve pit.

3. The valving, piping, and any other appurtenances for all the recirculating sand filter beds should be repaired or replaced to provide the maximize the capabilities of the wastewater treatment facility. In addition, electricity must be provided to the second control panel.

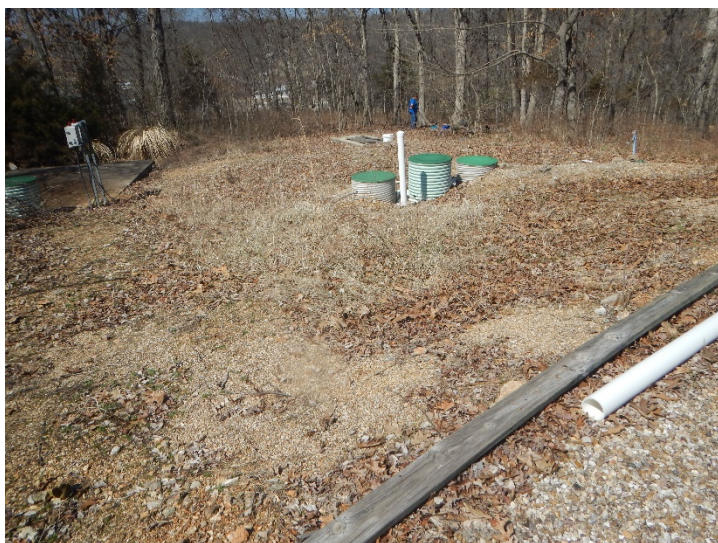
Photograph: #5  
 Taken By: Keith Forck  
 Entity: Central Field Operations  
 Permit: MOGD00297  
 Location: Cimarron Bay/Harbor Bay  
 Condominiums WWTF

In the recirculation tank (Photo #5 & #6); pumps force water to the recirculating sand filter bed for treatment through the media. Only one set of pumps functioned as the other control panel was off, but also did not have power to operate the second set of pumps. The alarm functioned properly.

Description: Looking north at the recirculation tank with the chlorine contact tank in the background. Additional tankage on the far left of the picture by the control panel is additional recirculation tank storage that the influent enters.

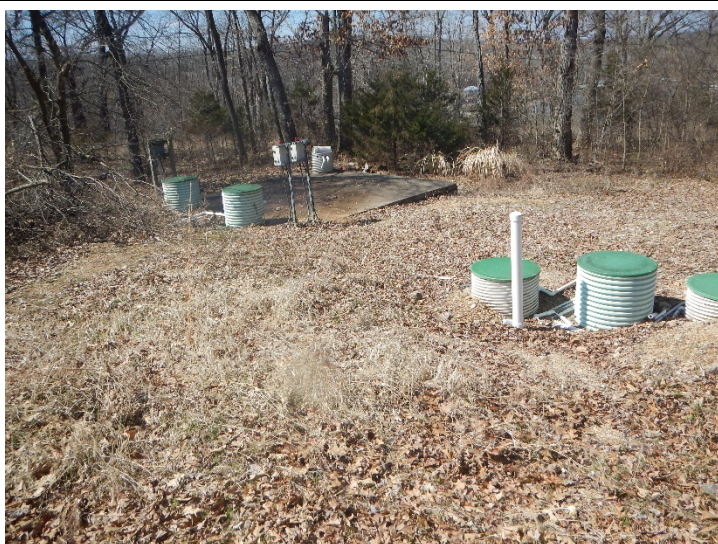
Photograph: #6  
 Taken By: Keith Forck  
 Entity: Central Field Operations  
 Permit: MOGD00297  
 Location: Cimarron Bay/Harbor Bay  
 Condominiums WWTF

Description: Looking west at both recirculation tanks. As operated, the functioning pumps and recirculation valve are in the tank in the near right.

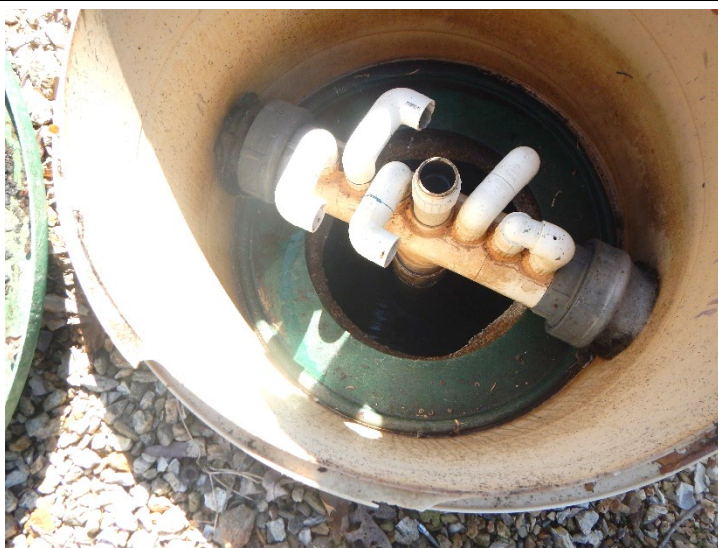
Photograph: #7  
Taken By: Keith Forck  
Entity: Central Field Operations  
Permit: MOGD00297  
Location: Cimarron Bay/Harbor Bay  
Condominiums WWTF

Water from the recirculating sand filter beds flows to the recirculation flow splitter where flow is split between discharge and recirculation (Photo #7). Then the recirculation water is returned to the recirculation tank for mixing with the influent flow from the septic tanks, which are located in the collection system.

The recirculating flow splitter needs maintenance as the ball has broken off with a cap placed on the pipe, which has allowed solids to plug the piping and only one recirculation orifice is allowing recirculation (**Recommendation #6**). Mr. Ripley was working on fixing the recirculating flow splitter as we departed the facility.

Description: Looking down at the recirculation valve. Water is only recirculating through the upper left pipe.

6. The recirculating flow splitter should be maintained to function as designed.
7. The facility should be operated and maintained as designed. This includes verifying the custom chlorine tablet feeder are operating as designed.

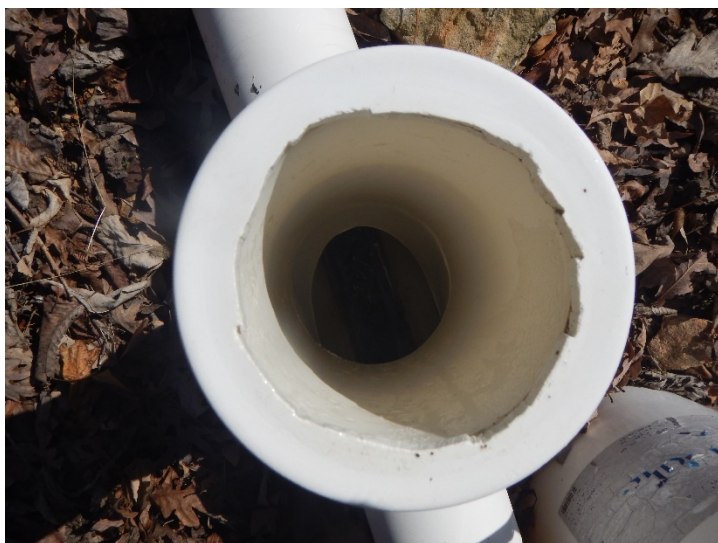
Photograph: #8  
Taken By: Keith Forck  
Entity: Central Field Operations  
Permit: MOGD00297  
Location: Cimarron Bay/Harbor Bay  
Condominiums WWTF

The custom chlorine feeder was not in use (Photo #8). Mr. Ripley stated that during the recreational season that the tablets in the feeder may get washed into the contact tank during peak flows (**Recommendation #7**). The chlorine contact basin was still covered for protection

Description: Looking down at the custom chlorinator.

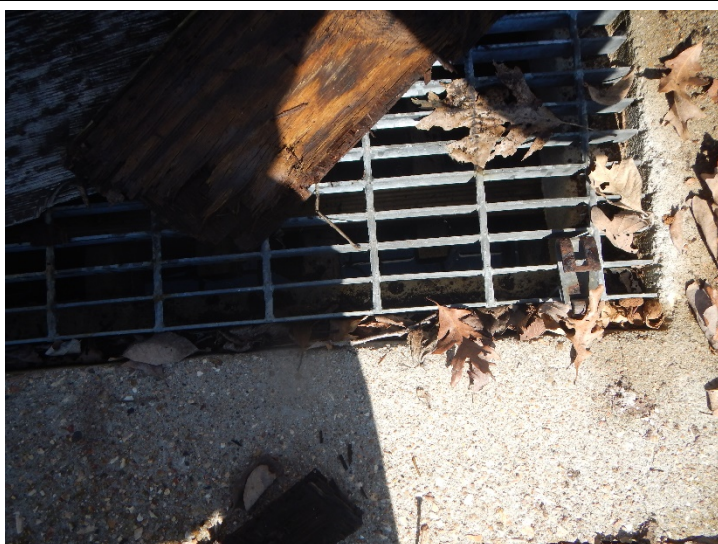
Photograph: #9  
Taken By: Keith Forck  
Entity: Central Field Operations  
Permit: MOGD00297  
Location: Cimarron Bay/Harbor Bay  
Condominiums WWTF

Description: Looking down at the chlorine contact tank.

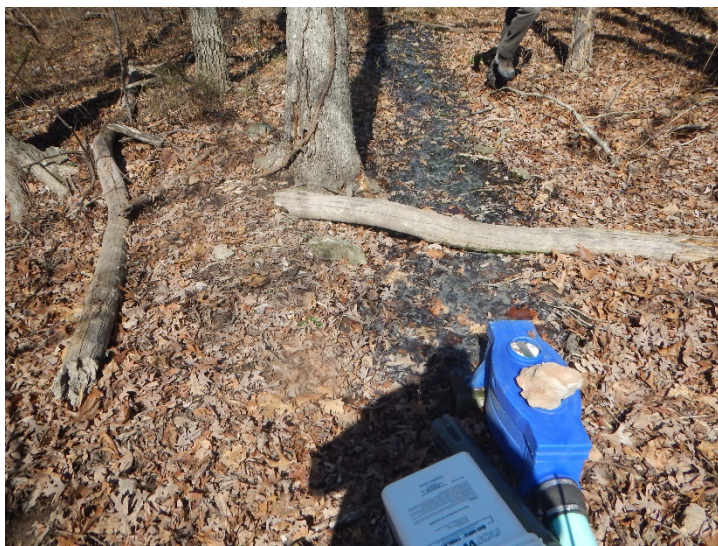
Photograph: #10  
Taken By: Keith Forck  
Entity: Central Field Operations  
Permit: MOGD00297  
Location: Cimarron Bay/Harbor Bay  
Condominiums WWTF

from freezing (Photo #9). The dechlorination dispenser was empty. The discharge appeared to discolor the ditch (Photo #10) (**Letter of Warning #2**).

2. The outfall water shall be free from substances in sufficient amounts to cause the formation of putrescent, unsightly, or harmful bottom deposits in the receiving stream in accordance with 10 CSR 20-7.031(4).

Description: Looking north at the dechlorinator and discharge flow path.

REQUIRED ACTION: Complete the operational and maintenance issues as necessary to improve the water quality of the outfall and therefore the receiving stream. Maintenance work may include pumping sludge, repairing electrical and plumbing issues, and potentially unplugging the filter beds and distribution lines.

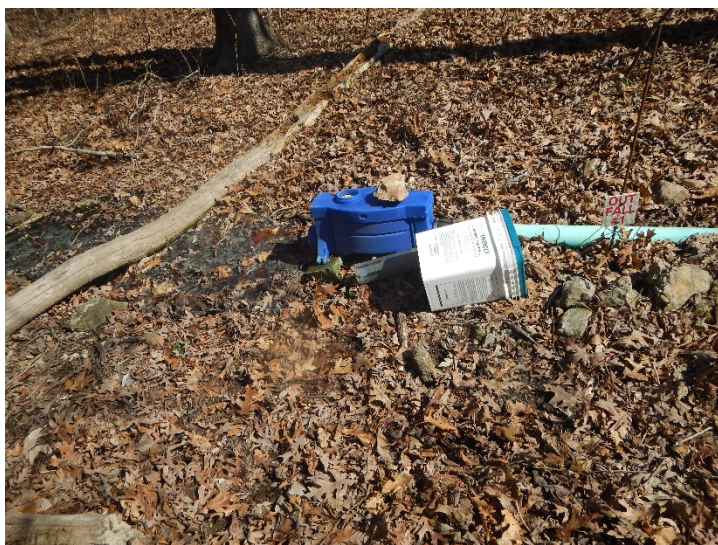
Photograph: #11  
Taken By: Keith Forck  
Entity: Central Field Operations  
Permit: MOGD00297  
Location: Cimarron Bay/Harbor Bay  
Condominiums WWTF

The outfall was marked with a small sign in the field (Photo #11). The facility had no flow measurement device (**Letter of Warning #3**).

3. In accordance with 10 CSR 20-8.140(7)(E), a means of flow measurement shall be provided at all wastewater treatment facilities.

Description: Looking east at the outfall sign.

REQUIRED ACTION: Provide the department with the proposed method of flow measurement. Some examples include a weir, parshall flume, or bucket and stop watch.
