APPENDIX B
(Photographs)

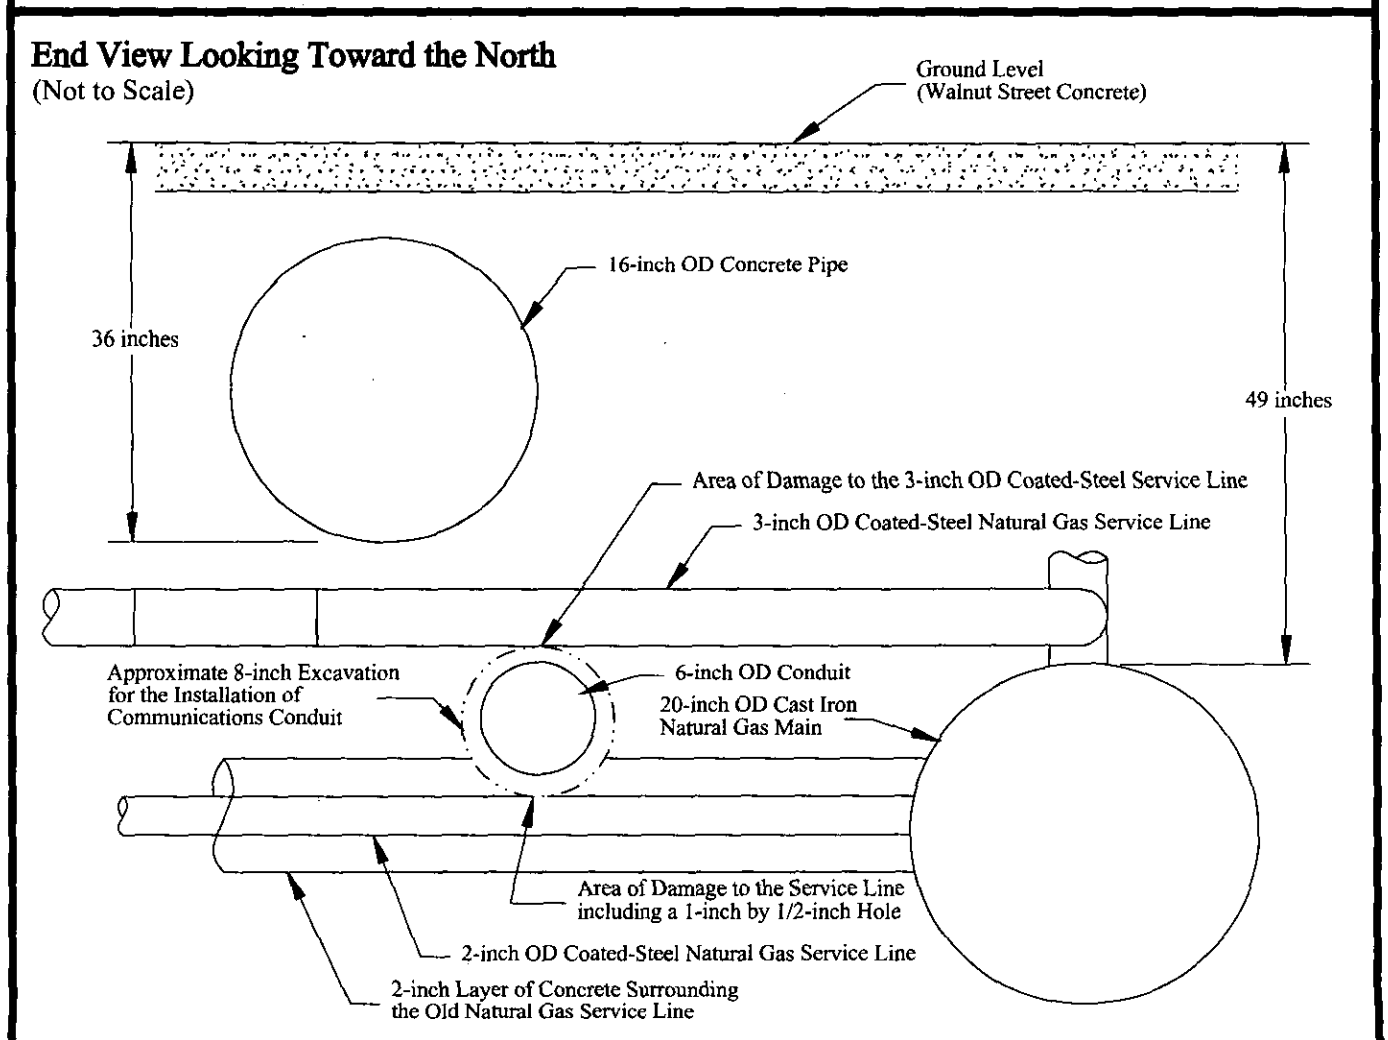
Figure 3
 Intersection of the Pipe at 1204 Walnut

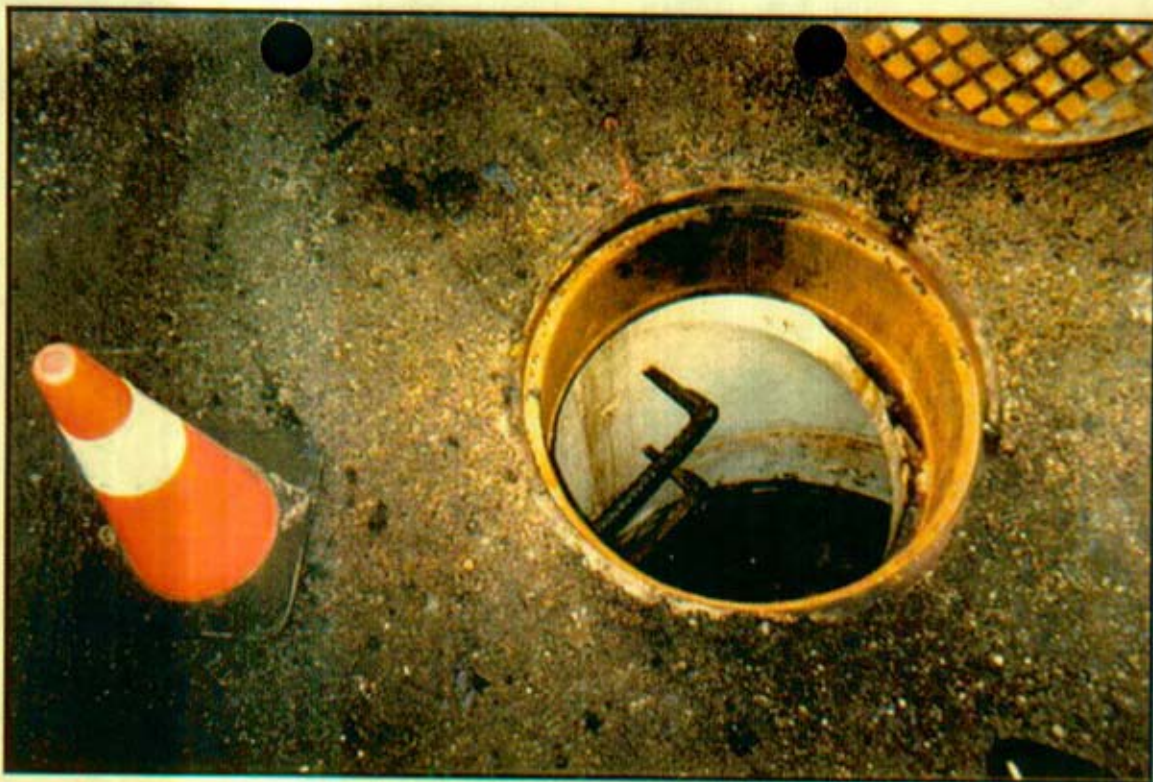
Photograph 1: View of the communications vault where the natural gas ignition and flash fire occurred. Note the dark discoloration around the upper portion of the vault. (Photograph provided by MGE.)

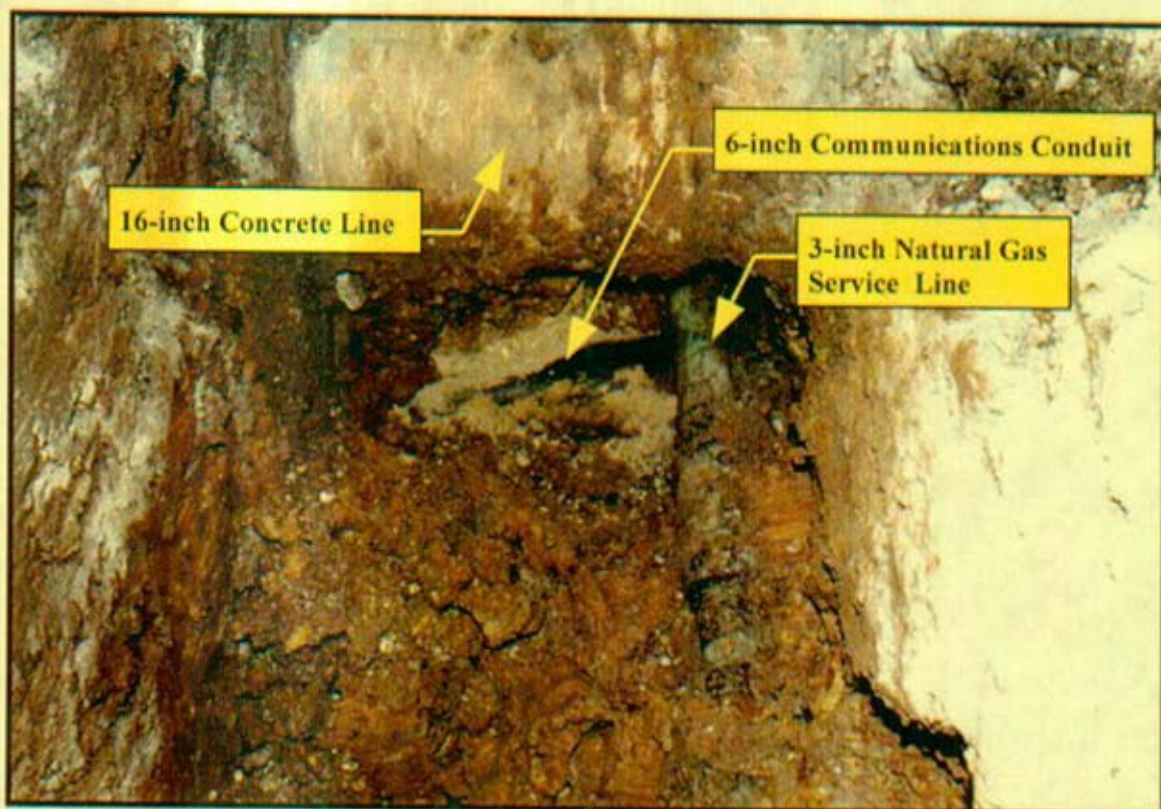
Photograph 2: Looking toward the west into the excavation. View of the 3-inch OD coated-steel natural gas service line and the communications conduit. The communications conduit lies directly below the natural gas service line. This service line was damaged when the communications conduit was installed.

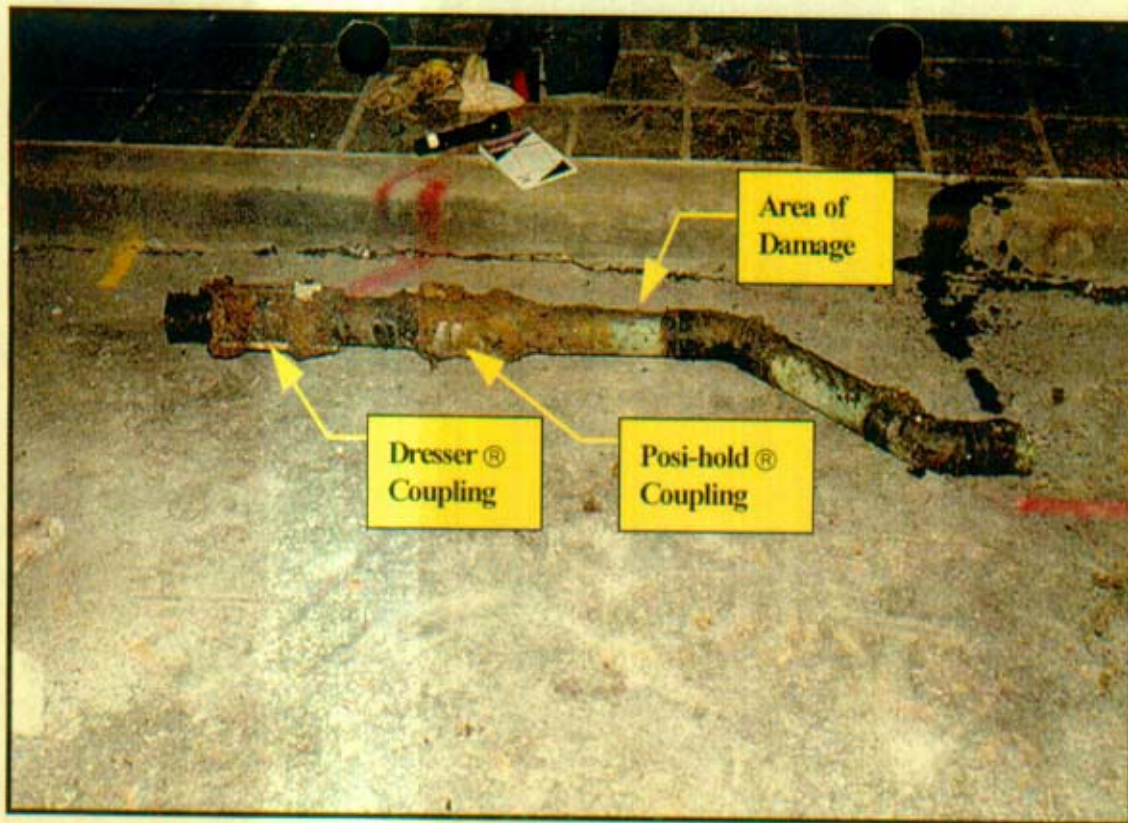
Photograph 3: View of the section of 3-inch OD coated-steel service line pipe that was removed from the excavation. The section of pipe laid east to west in the excavation, with the east end of the pipe shown on the left side of this photograph. The damage was on the bottom side of the pipe as it was situated in the ground.

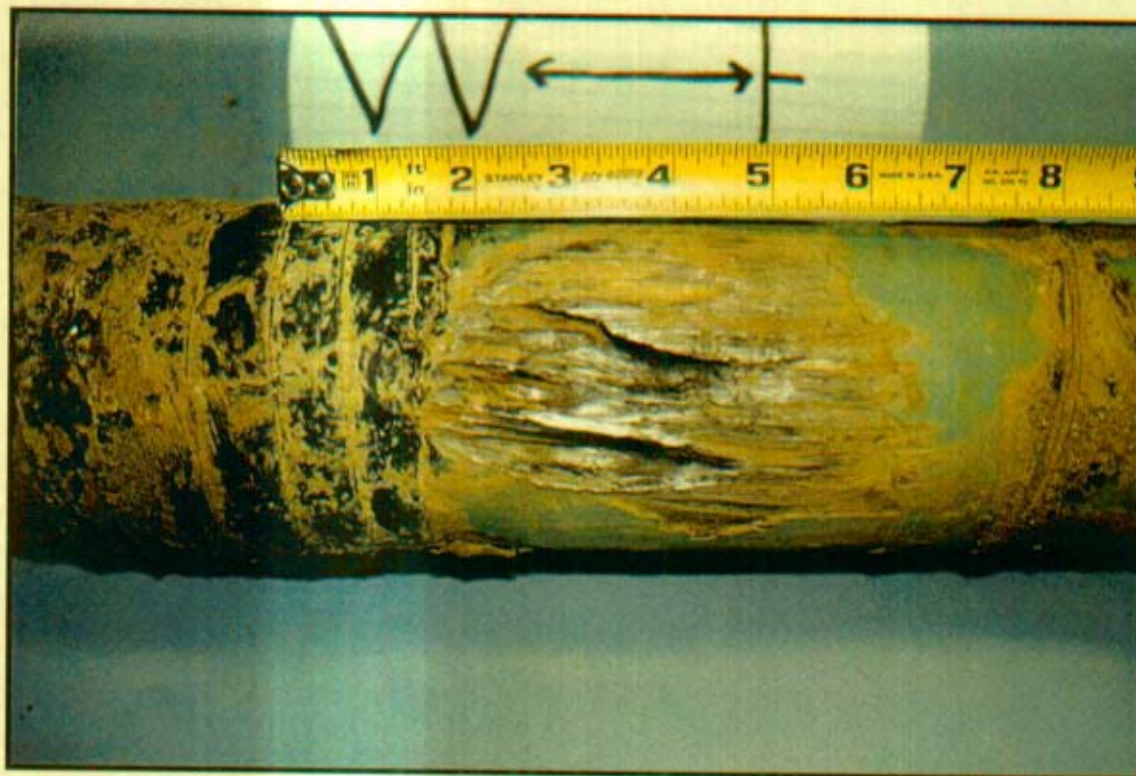
Photograph 4: Close-up view of the damage to the 3-inch OD coated-steel natural gas service line for 1204 Walnut.

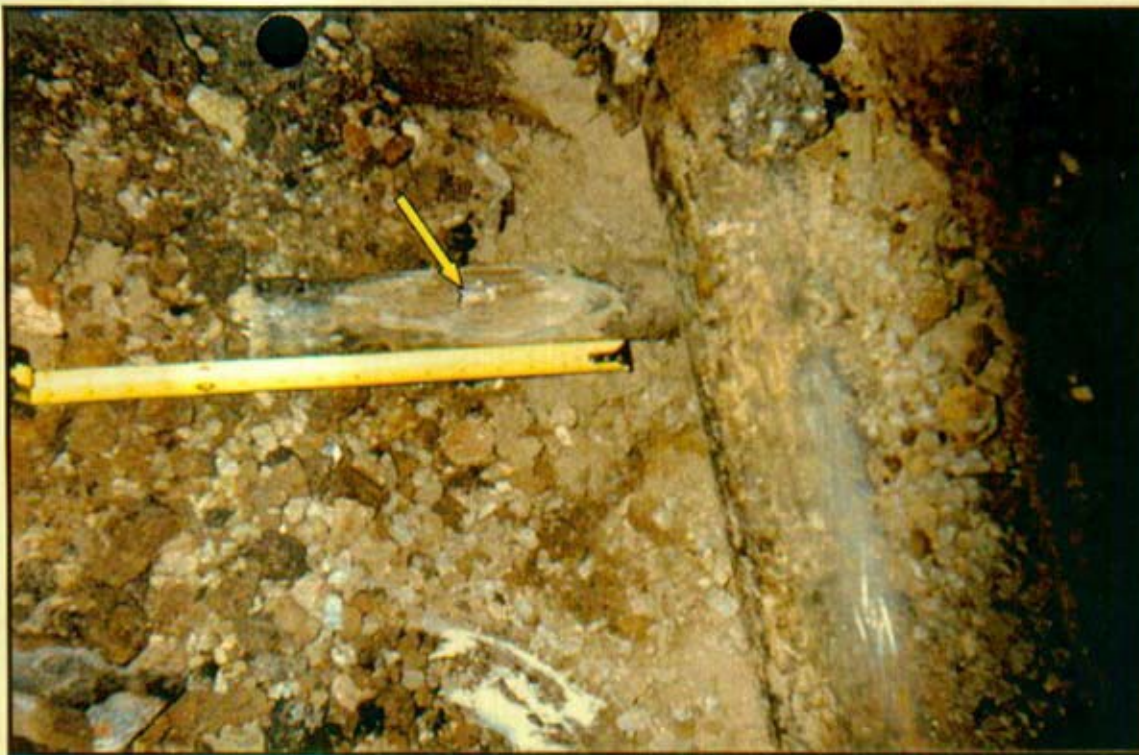
Photograph 5: View of the 2-inch OD coated-steel natural gas line after it was removed from under the communications conduit. This service line was cut and moved to the left to expose the damage. The arrow points to the hole in the top of the service line. The communications conduit is shown on the right side of the photograph. (Photograph provided by MGE.)

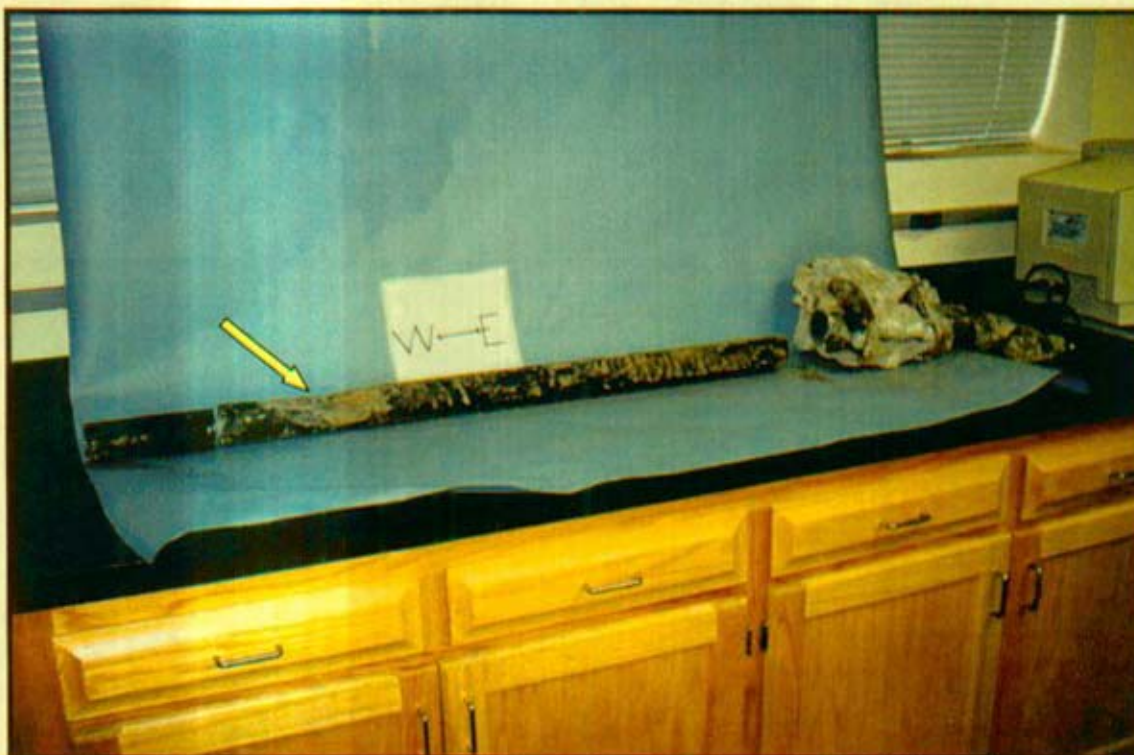
Photograph 6: View of the section of 2-inch OD coated-steel natural gas service line that was removed from the incident site. The arrow points to the area of damage. The east section of pipe, shown on the right of the photograph, still has some of the concrete encasement attached. This layer of concrete encased the service tee at the main to past the area where the service line was damaged.

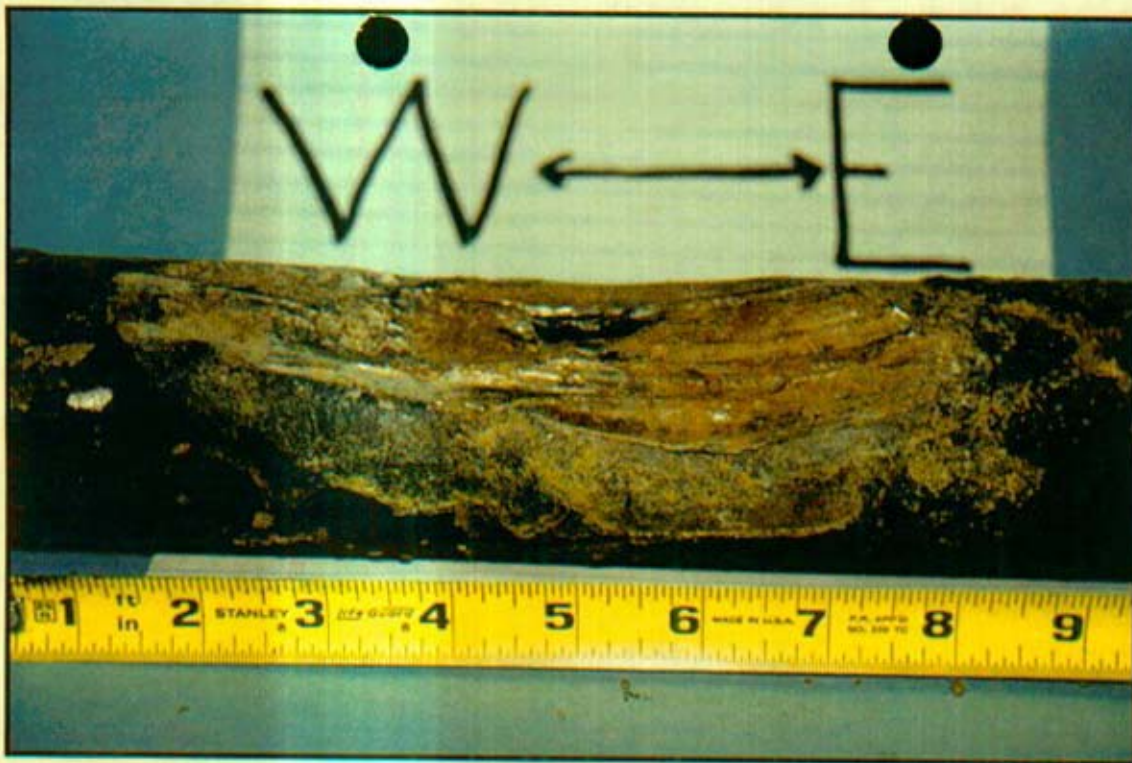
Photograph 7: Close-up view of the 2-inch OD coated-steel natural gas service line showing the damage and the approximate 1-inch by 1/2-inch hole. Natural gas escaped from this service line at a pressure of 30 inches water column.
