Finding of Compliance

Missouri Department of Natural Resources
Southeast Regional Office/Public Drinking Water Program
Report of Inspection
Indian Hills Utilities Operating Co. Inc.
500 Northwest Plaza Drive, Suite 500, St. Louis, MO 63074
Crawford County Missouri
MO6036052
November 4, 2016

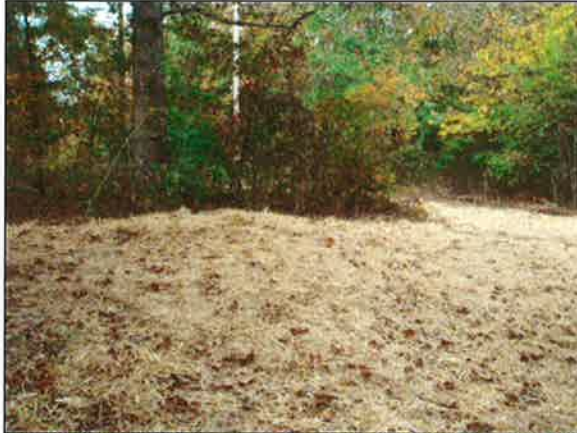
Since Well #2 could not be salvaged, it has been removed from the water system and plugged appropriately. Documentation of all water system ordinances, site plans, maps, sampling, etc. is being kept in one central location and operator is able to access if asked for.

Photo #:009
Date Taken: 10/26/2016
By: Michelle Oglesby
Program: PDWB
File: Crawford County
Location: Indian Hills Utilities Operating Co. Inc.
Description: Location where Well #2 used to be.

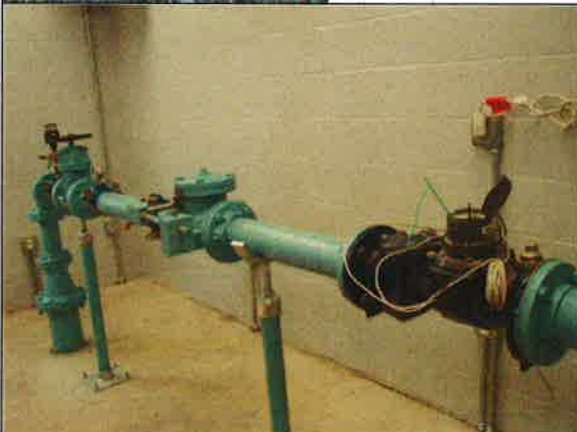
Photo #:012
Date Taken: 10/26/2016
By: Michelle Oglesby
Program: PDWB
File: Crawford County
Location: Indian Hills Utilities Operating Co. Inc.
Description: Well #3 - Piping

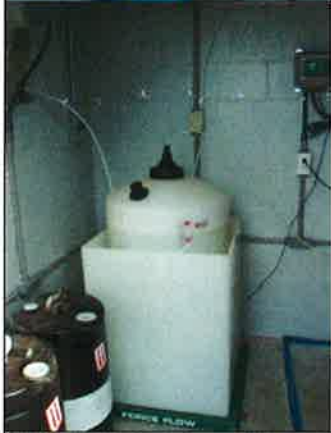
Photo #:014
Date Taken: 10/26/2016
By: Michelle Oglesby
Program: PDWB
File: Crawford County
Location: Indian Hills Utilities Operating Co. Inc.
Description: Well #3 – Chlorine Room with chemical storage.

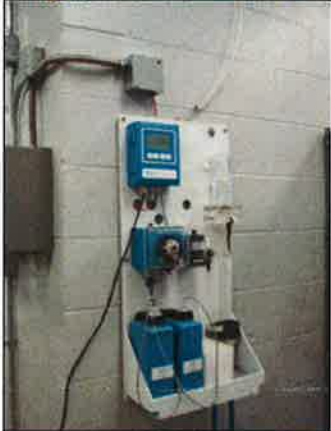
Photo #:015
Date Taken: 10/26/2016
By: Michelle Oglesby
Program: PDWB
File: Crawford County
Location: Indian Hills Utilities Operating Co. Inc.
Description: Well #3 – Continuous chlorine reader.

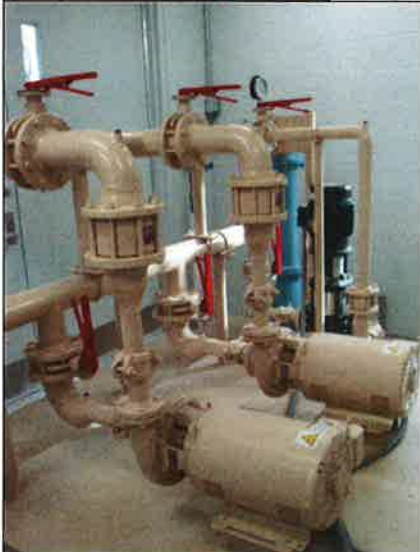
Photo #:016
Date Taken: 10/26/2016
By: Michelle Oglesby
Program: PDWB
File: Crawford County
Location: Indian Hills Utilities Operating Co. Inc.
Description: Well #3 – Booster Pump Station.
