5.200 BCSD, Brown Station Wastewater Treatment Facility
Boone County
#MO-0135305

**REPORT OF COMPLIANCE INSPECTION
BROWN STATION WASTEWATER TREATMENT FACILITY
BOONE COUNTY
#MO-0135305
June 12, 2015**

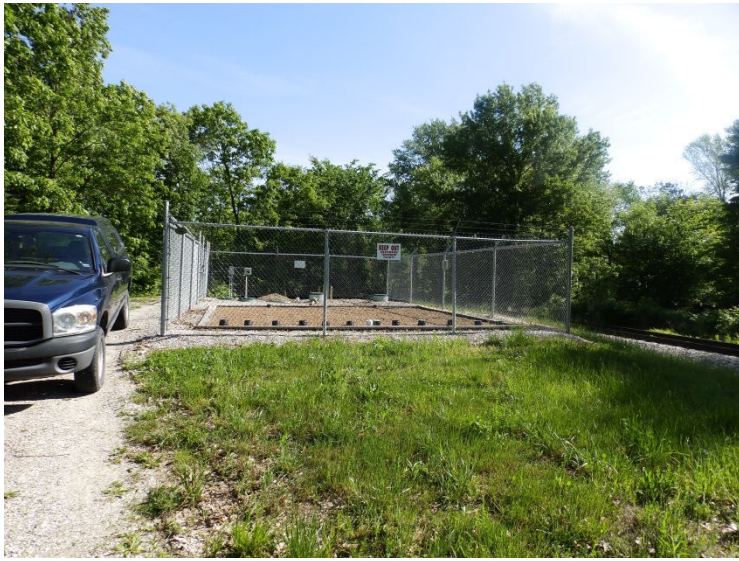
Photo #: 1
By: Leland Maize
Facility: Brown Station Wastewater Treatment Facility
Permit: #MO-0135305
Location: Boone County

Description: Wastewater treatment facility with fence surrounding the facility.

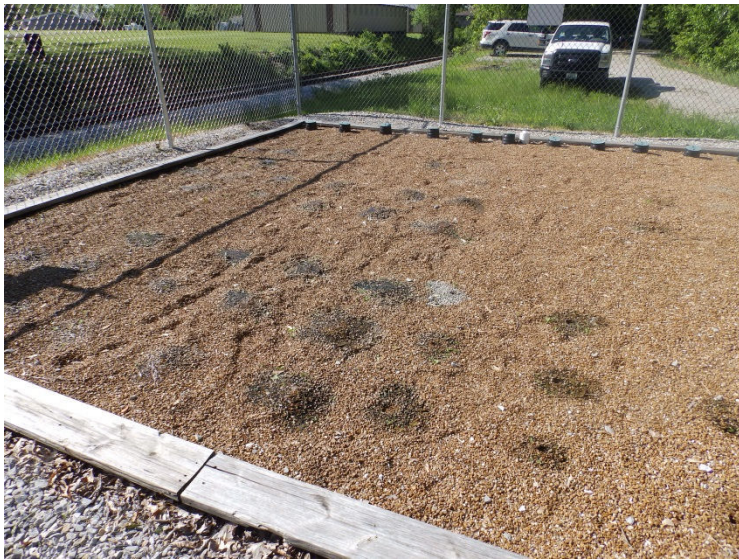
Photo #:
By: Leland Maize
Facility: Brown Station Wastewater Treatment Facility
Permit: #MO-0135305
Location: Boone County

Description: Sand filter. Wet spots can be observed where the water is surfacing. Mr. Maize did not observe any pooling.

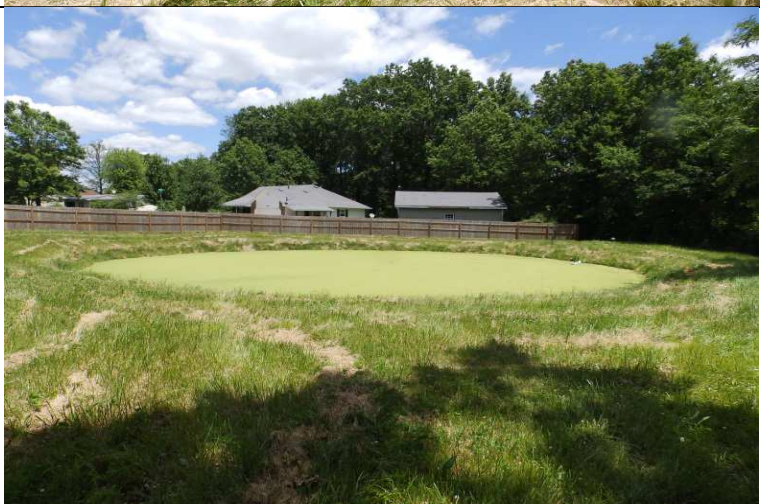
Photograph #: 3
Taken by: Leland Maize
Entity: BCSD, Cedar Gate Subdivision
Permit: #MO-0096415
Location: Boone County
Description: Secondary cell of the lagoon. Duckweed was observed covering the entire cell.
Date Taken: June 7, 2016
Program: WPC Unit

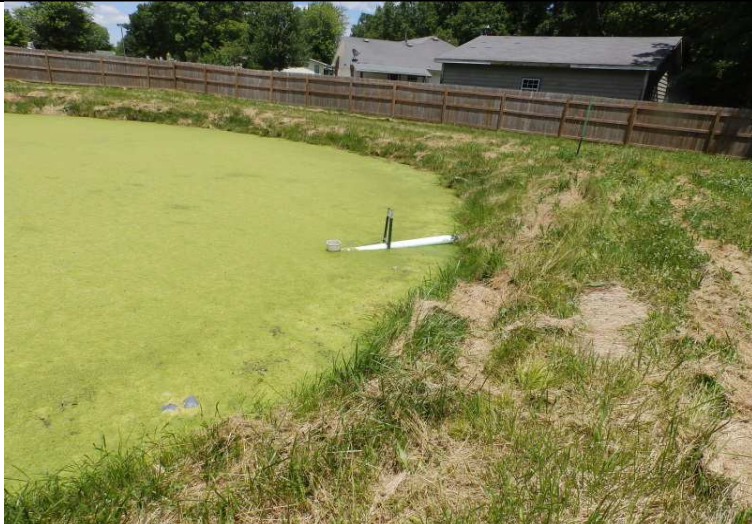
Photograph #: 4
Taken by: Leland Maize
Entity: BCSD, Cedar Gate Subdivision
Permit: #MO-0096415
Location: Boone County
Description: Inlet side of the discharge pipe. A T fitting was in place on the inlet side.
Date Taken: June 7, 2016
Program: WPC Unit

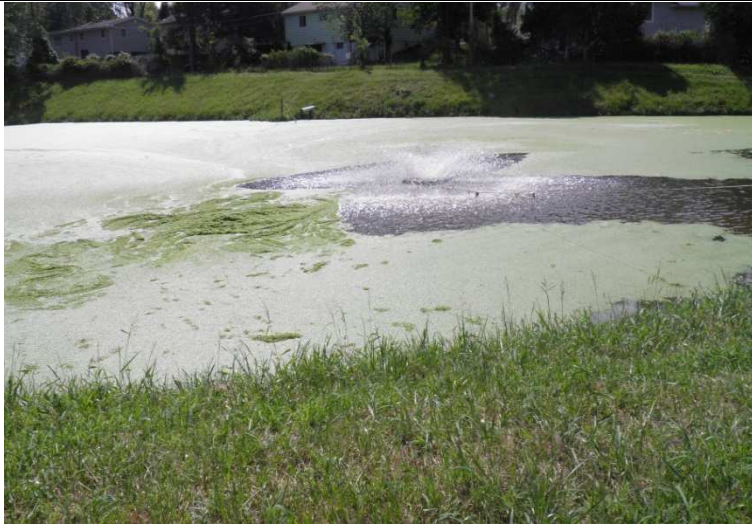
Photograph #: 1
Taken by: Michael Womack
Entity: BCRSD - Highfield Acres Wastewater Treatment Facility
Permit: #MO-0053376
Location: BOONE
Description: Observation of Outfall #001 lagoon cell. Duckweed is observed to be present and it appears the aerator is operating properly.
Date Taken: September 1, 2016
Program: WPC Unit

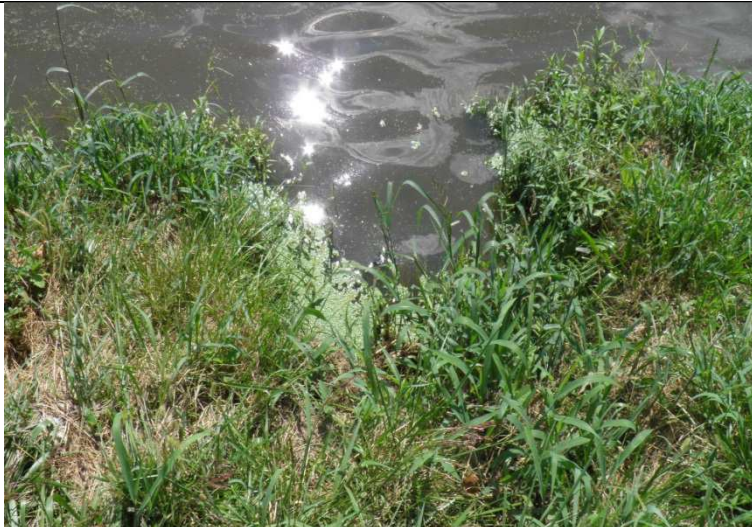
Photograph #: 2
Taken by: Michael Womack
Entity: BCRSD - Highfield Acres Wastewater Treatment Facility
Permit: #MO-0053376
Location: BOONE
Description: Observation of erosion damage on the northwest inner lagoon berm of the Outfall #001 lagoon cell.
Date Taken: September 1, 2016
Program: WPC Unit

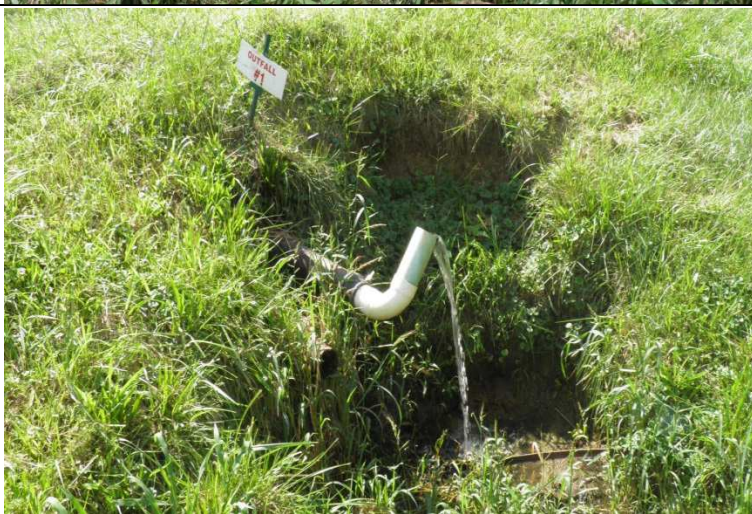
Photograph #: 3
Taken by: Michael Womack
Entity: BCRSD - Highfield Acres Wastewater Treatment Facility
Permit: #MO-0053376
Location: BOONE
Description: Observation of Outfall #001.
Date Taken: September 1, 2016
Program: WPC Unit

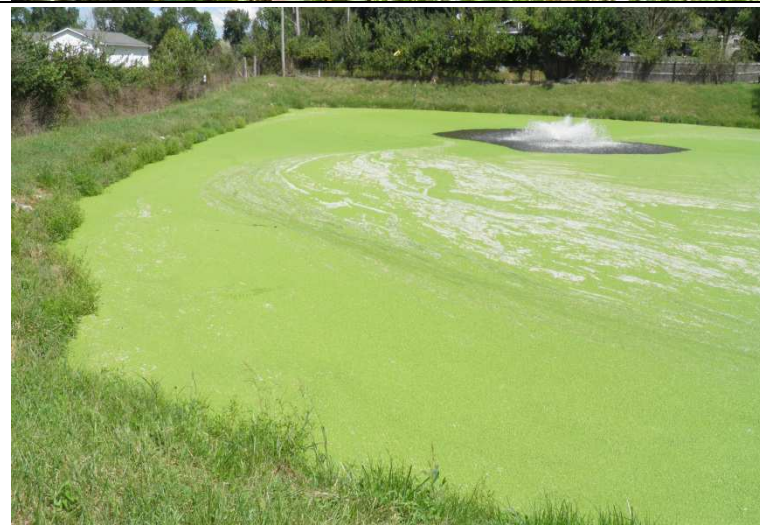
Photograph #: 5
Taken by: Michael Womack
Entity: BCRSD - Highfield Acres Wastewater Treatment Facility
Permit: #MO-0053376
Location: Boone
Description: Observation of Outfall #002 lagoon cell. Duckweed is observed within the lagoon and erosion damage is observed at the southwest inner lagoon berm of the lagoon (bottom left corner). The aerator appears to be operating properly.
Date Taken: September 1, 2016
Program: WPC Unit

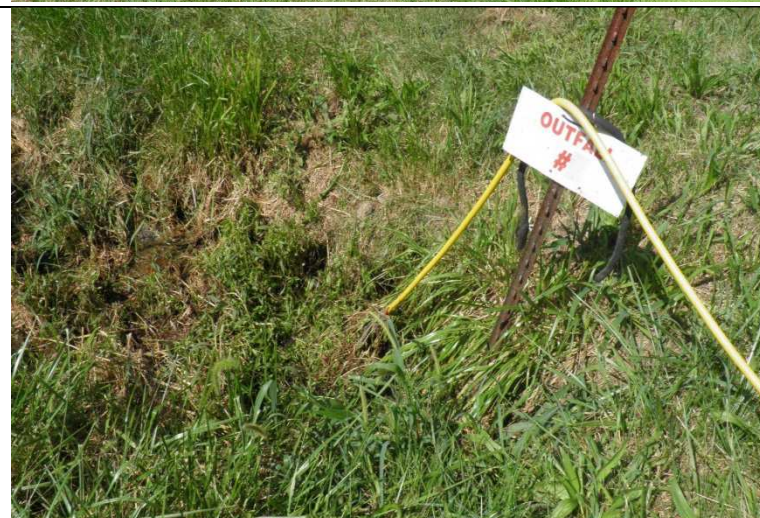
Photograph #: 6
Taken by: Michael Womack
Entity: BCRSD - Highfield Acres Wastewater Treatment Facility
Permit: #MO-0053376
Location: Boone
Description: Observation of Outfall #002 with the missing number 2. The hose was observed to be draped over the sign but was not observed to be entering the lagoon.
Date Taken: September 1, 2016
Program: WPC Unit

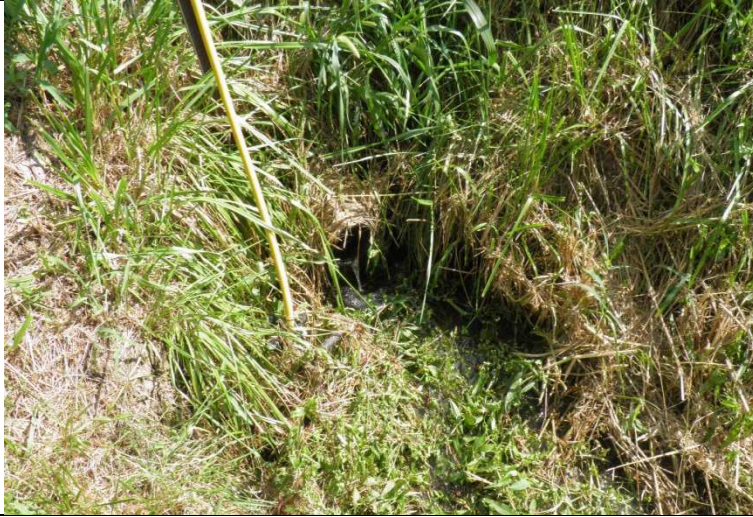
Photograph #: 7
Taken by: Michael Womack
Entity: BCRSD - Highfield Acres Wastewater Treatment Facility
Permit: #MO-0053376
Location: Boone
Description: Observation of Outfall #002 with duckweed present below the outfall location.
Date Taken: September 1, 2016
Program: WPC Unit
