5.200 BCRSD, Oberlin Valley Wastewater Treatment Facility
Boone County
#MO-0117323

**LETTER OF WARNING
NO RESPONSE REQUIRED**

Missouri Department of Natural Resources
Northeast Regional Office
Report of Inspection
BCRSD, Oberlin Valley Wastewater Treatment Facility
North Oberlin Valley Road, Columbia,
Missouri, 65201, Boone County
#MO-0117323
May 23, 2018

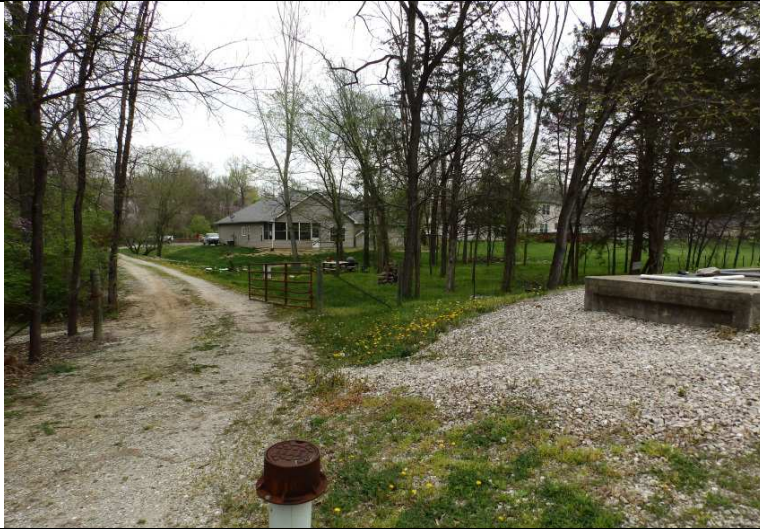
As I arrived at the facility, I observed that an all-weather access road to the facility was available. The facility gate was equipped with a lock to prevent unauthorized access. A perimeter fence around the facility was observed and appeared to be in good condition. Warning signs were observed posted on all four sides of the perimeter fence (Photograph #1).

Photograph #: 1
Taken by: Michael Heaton
Entity: BCRSD, Oberlin Valley Wastewater Treatment Facility
Permit: #MO-0117323
Location: Boone County
Description: Front entrance to the facility. Gate to facility with an all-weather access road.
Date Taken: May 2, 2018
Program: WPC Unit

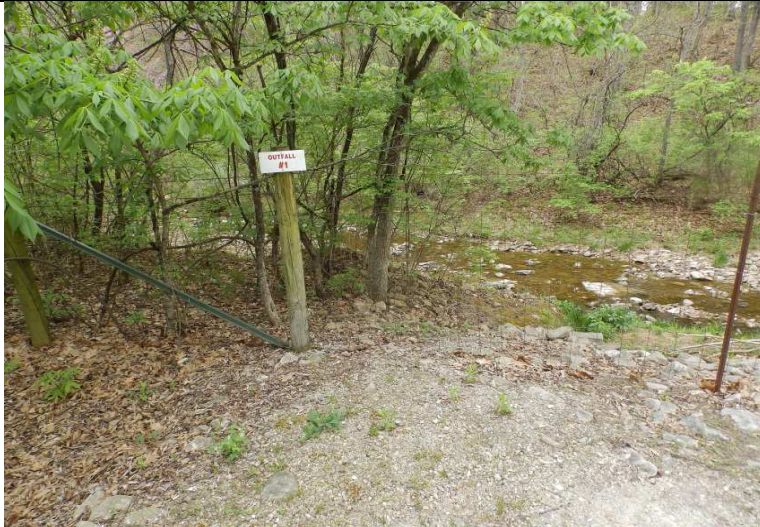
Photograph #: 2
Taken by: Michael Heaton
Entity: BCRSD, Oberlin Valley Wastewater Treatment Facility
Permit: #MO-0117323
Location: Boone County
Description: Sign marking the outfall location.
Date Taken: May 2, 2018
Program: WPC Unit

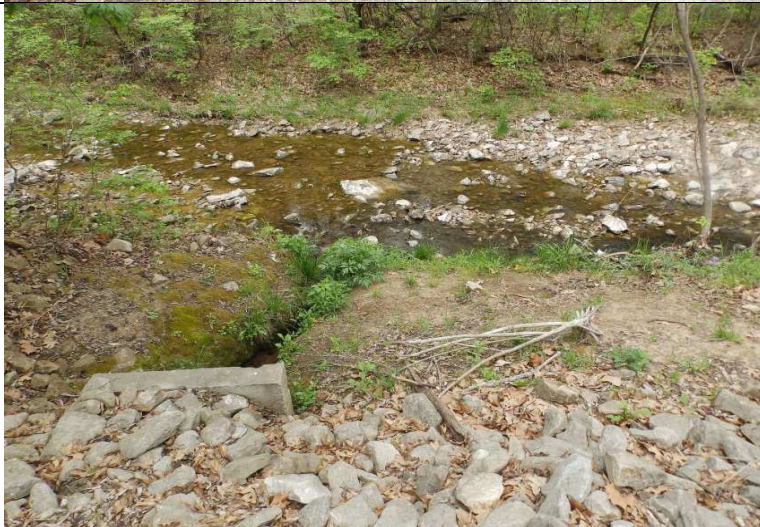
I then observed the outfall location. A sign marking the outfall was observed (Photograph #2). Effluent was observed discharging at the time of the inspection. The effluent appeared relatively clear with no odors detected in the area (Photographs: #3 and 4). Below the outfall, in the

tributary to Cow Branch, I observed sludge deposits and algae growth in the receiving stream for approximately 20 feet below the outfall. The sludge deposits were relatively light and appeared to be approximately ¼ to ½ inch in depth (Photographs #3 and 5).

Photograph #: 3
Taken by: Michael Heaton
Entity: BCRSD, Oberlin Valley Wastewater Treatment Facility
Permit: #MO-0117323
Location: Boone County
Description: View of the outfall location. Sludge and algae was observed in the stream below the outfall.
Date Taken: May 2, 2018
Program: WPC Unit

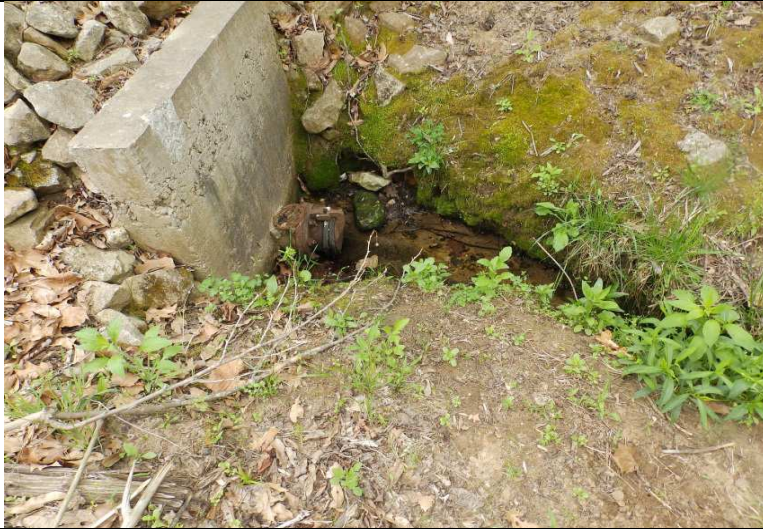
Photograph #: 4
Taken by: Michael Heaton
Entity: BCRSD, Oberlin Valley Wastewater Treatment Facility
Permit: #MO-0117323
Location: Boone County
Description: Outfall #001
Date Taken: May 2, 2018
Program: WPC Unit

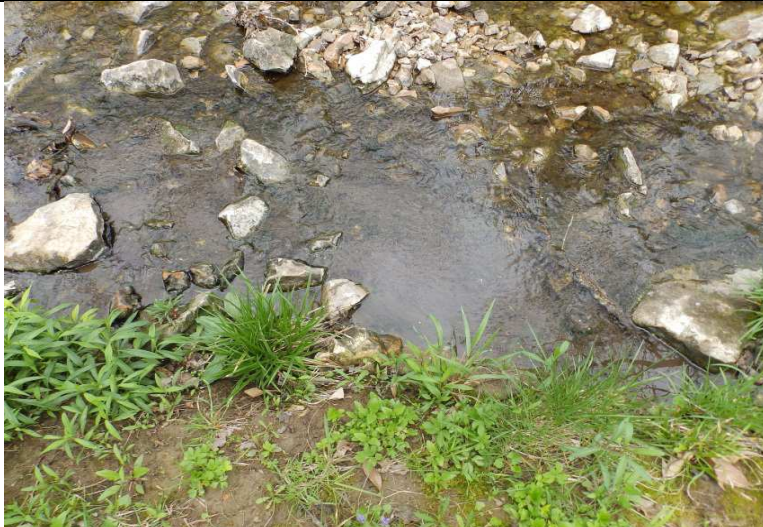
Photograph #: 5
Taken by: Michael Heaton
Entity: BCRSD, Oberlin Valley Wastewater Treatment Facility
Permit: #MO-0117323
Location: Boone County
Description: View of the algae and sludge in the receiving stream below the outfall.
Date Taken: May 2, 2018
Program: WPC Unit

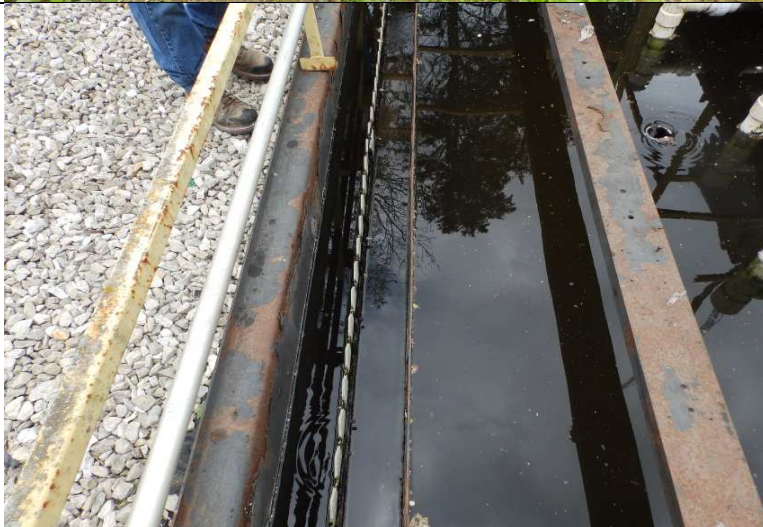
Photograph #: 6
Taken by: Michael Heaton
Entity: BCRSD, Oberlin Valley Wastewater Treatment Facility
Permit: #MO-0117323
Location: Boone County
Description: Clarifier weir.
Date Taken: May 2, 2018
Program: WPC Unit

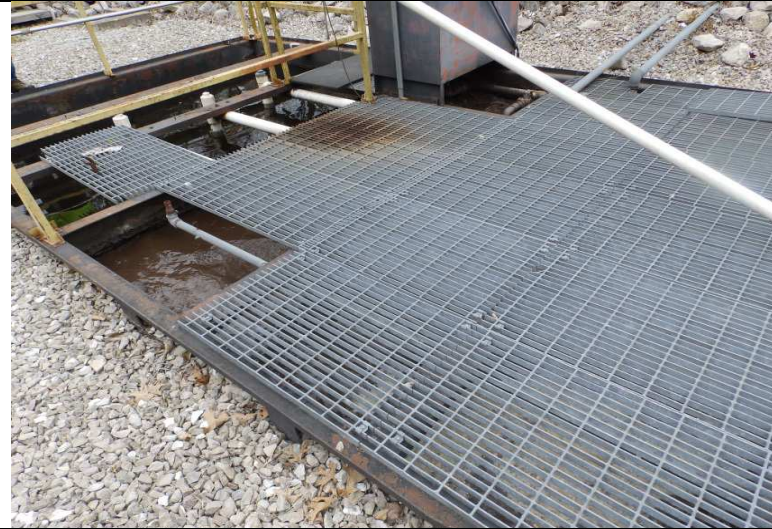
I then observed the WWTF. The facility's extended aeration basin appeared to have proper aeration, as there were no non-aerated sections in the basin (Photograph #7). The clarifier was then observed. The water in the clarifier appeared clear and some solids were observed going over the weir. The weir appeared level as all the flow through the weir appeared consistent (Photograph #6). Mr. Horton explained that they need to remove some sludge from the plant and plan on removing the sludge soon. I asked about disinfection for the facility. Mr. Farnen explained that disinfection was not installed since the facility will be closed and a pump station will be installed to pump the wastewater to the City of Columbia WWTF.

Photograph #: 7
Taken by: Michael Heaton
Entity: BCRSD, Oberlin Valley Wastewater Treatment Facility
Permit: #MO-0117323
Location: Boone County
Description: Extended aeration facility.
Date Taken: May 2, 2018
Program: WPC Unit

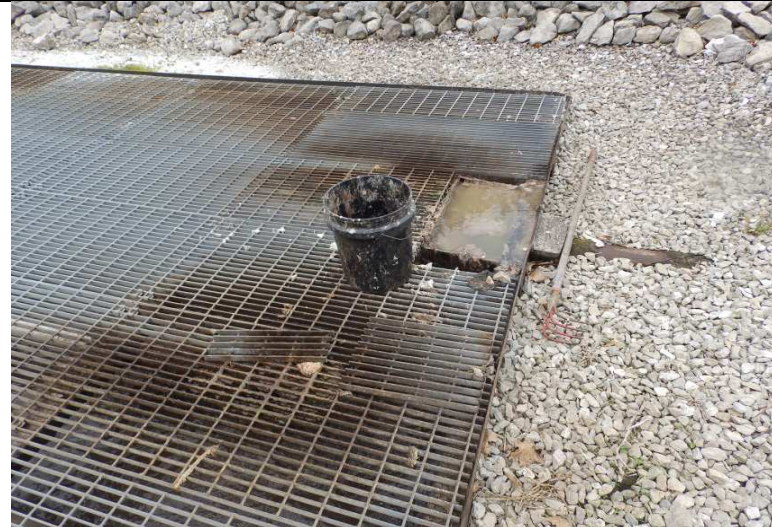
I then observed the bar screen where the influent enters the plant. Mr. Horton stated that the bar screen is cleaned regularly. A five gallon bucket was observed near the bar screen. The five gallon bucket is used to store the material removed off the bar screen for proper disposal (Photograph #8). Mr. Horton stated that the bar screen was too level with the influent, which caused some issues with toiletries building up on the bar screen.

Photograph #: 8
Taken by: Michael Heaton
Entity: BCRSD, Oberlin Valley Wastewater Treatment Facility
Permit: #MO-0117323
Location: Boone County
Description: View of bar screen at the facility.
Program: WPC Unit

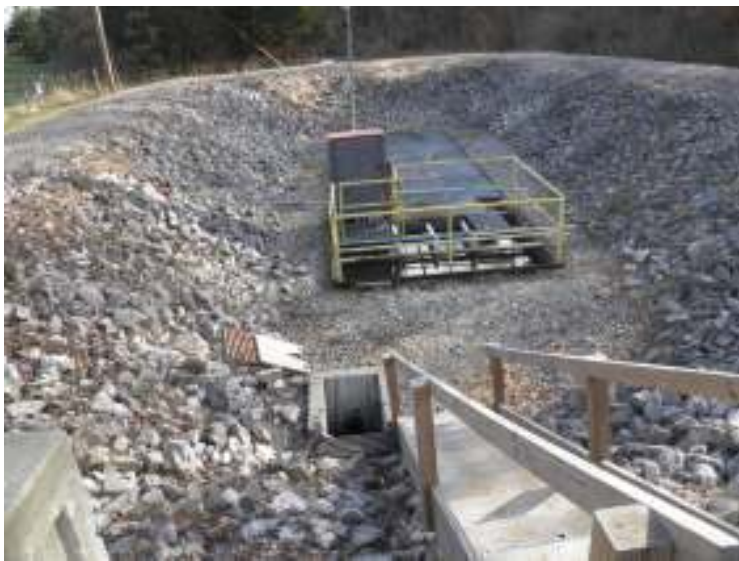
Photo #: 1
By: Stephen Moss
Facility: BCSD, Oberlin Valley WWTF
Permit: #MO-0117323
Location: Boone County

Description: View of the mechanical plant. The concrete weir structure can be observed with the weir plate lying on the ground near the concrete structure.

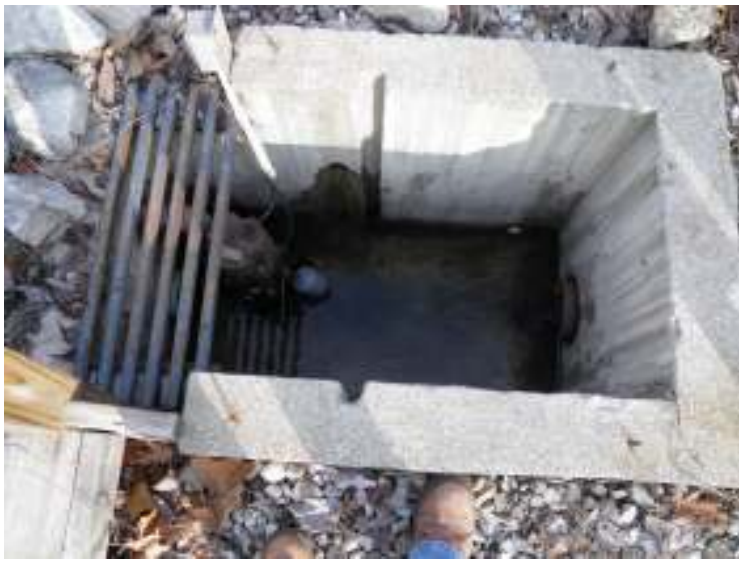
Photo #: 2
By: Stephen Moss
Facility: BCSD, Oberlin Valley WWTF
Permit: #MO-0117323
Location: Boone County

Mr. Moss continued the inspection with observations of the outfall location. Mr. Moss observed that the facility has a V-notch weir that is contained within a concrete weir box just west of the clarifier basin. At the time of the inspection, the V-notch weir plate was not in place in the concrete weir structure. Mr. Cooksey put the V-notch weir plate back in the concrete structure. The effluent passes through the V-notch weir and is then discharged through Outfall #001. Mr. Moss observed that the outfall location is marked with a sign. Mr. Moss observed that the outfall pipe was submerged in the mud. Mr. Cooksey stated that sampling is conducted in the concrete weir structure. At the time of the inspection, Outfall #001 was observed to be discharging and a 24-hour composite sampler was set at the facility's concrete weir structure to collect a 24-hour composite sample, as specified in MSOP #MO-0117323. Mr. Moss did not observe any water quality impacts caused by previous discharges in the receiving stream. No odors were noted at the outfall location. On December 18, 2014, Mr. Moss returned to the facility to collect the 24-hour composite sample. The sample collected by the composite sampler was light brown in color with no odors noted.

Description: View of the concrete weir structure. The V-notch weir plate was not in place.

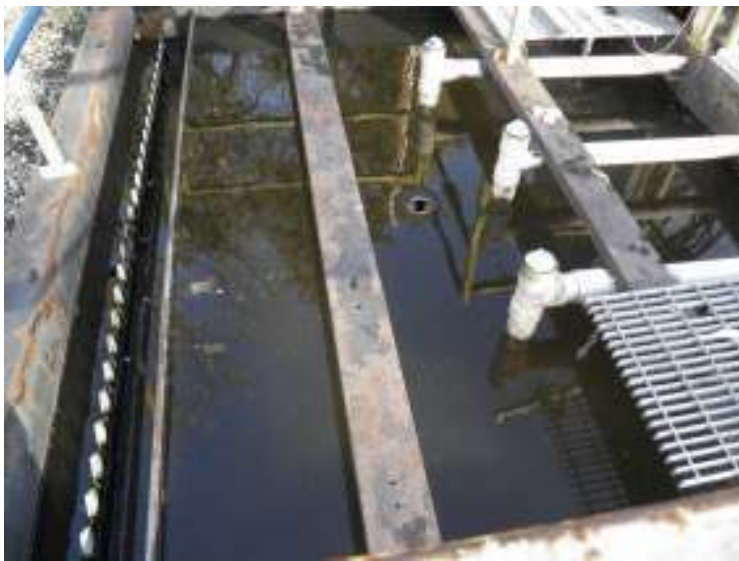
Photo #: 3
By: Stephen Moss
Facility: BCSD, Oberlin Valley WWTF
Permit: #MO-0117323
Location: Boone County

Description: View of the clarifier basin.

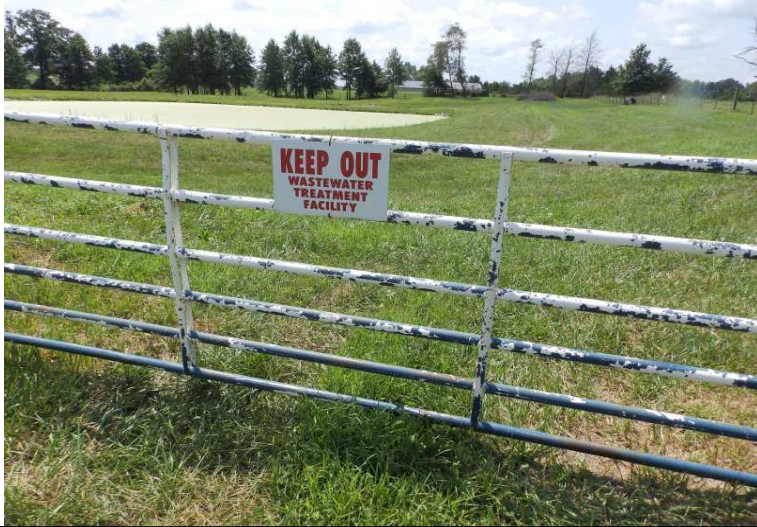
Photograph #: 1
Taken by: Leland Maize
Entity: BCRSD, Quarter Mile Hills Subdivision
Permit: #MO-0126446
Location: Boone County
Description: Gate at the entrance to the facility with a warning sign.
Date Taken: July 27, 2016
Program: WPC Unit

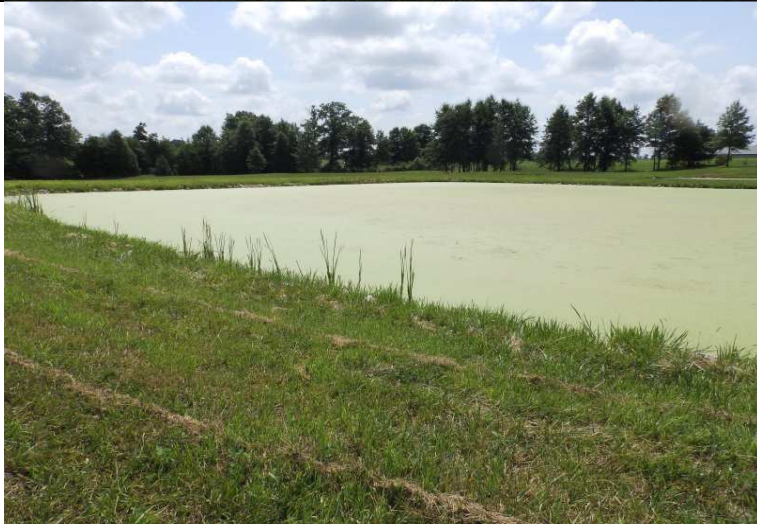
Photograph #: 2
Taken by: Leland Maize
Entity: BCRSD, Quarter Mile Hills Subdivision
Permit: #MO-0126446
Location: Boone County
Description: Primary lagoon cell with cattails observed along the inner berm. Primary cell was covered with duckweed.
Date Taken: July 27, 2016
Program: WPC Unit

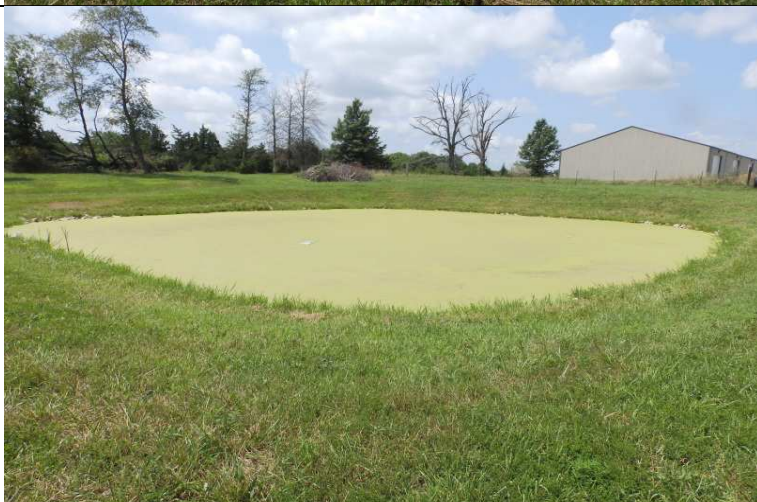
Photograph #: 3
Taken by: Leland Maize
Entity: BCRSD, Quarter Mile Hills Subdivision
Permit: #MO-0126446
Location: Boone County
Description: Secondary lagoon cell covered with duckweed.
Date Taken: July 27, 2016
Program: WPC Unit

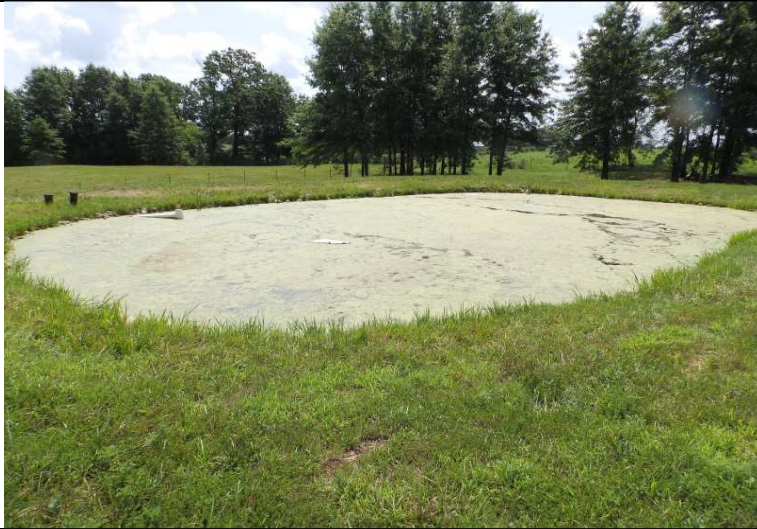
Photograph #: 4
Taken by: Leland Maize
Entity: BCRSD, Quarter Mile Hills Subdivision
Permit: #MO-0126446
Location: Boone County
Description: Tertiary lagoon cell covered with duckweed.
Date Taken: July 27, 2016
Program: WPC Unit

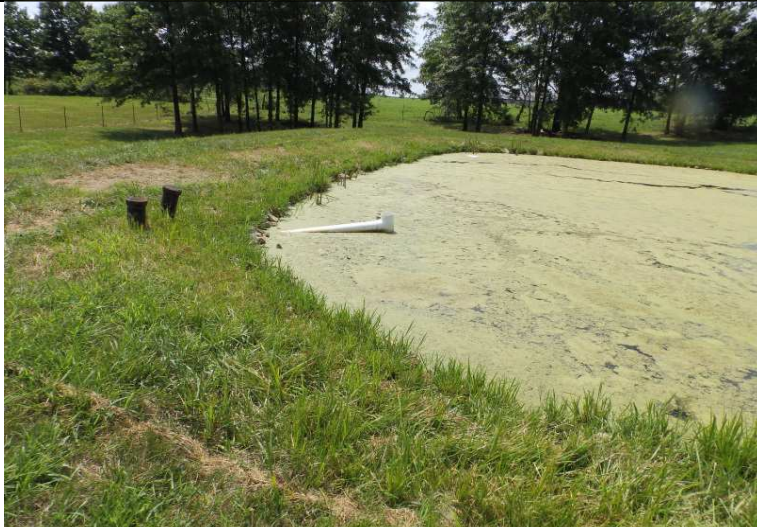
Photograph #: 5
Taken by: Leland Maize
Entity: BCRSD, Quarter Mile Hills Subdivision
Permit: #MO-0126446
Location: Boone County
Description: Inlet side of the discharge pipe with a T-fitting on the end.
Date Taken: July 27, 2016
Program: WPC Unit

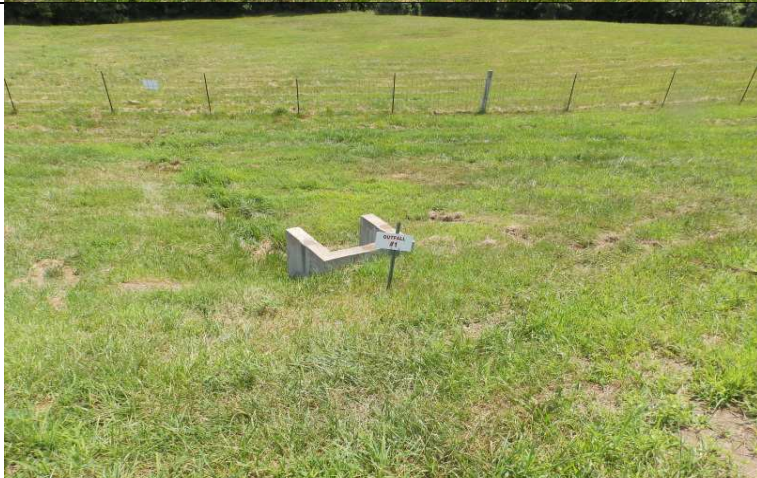
Photograph #: 6
Taken by: Leland Maize
Entity: BCRSD, Quarter Mile Hills Subdivision
Permit: #MO-0126446
Location: Boone County
Description: Location of the outfall with a sign marking the location.
Date Taken: July 27, 2016
Program: WPC Unit

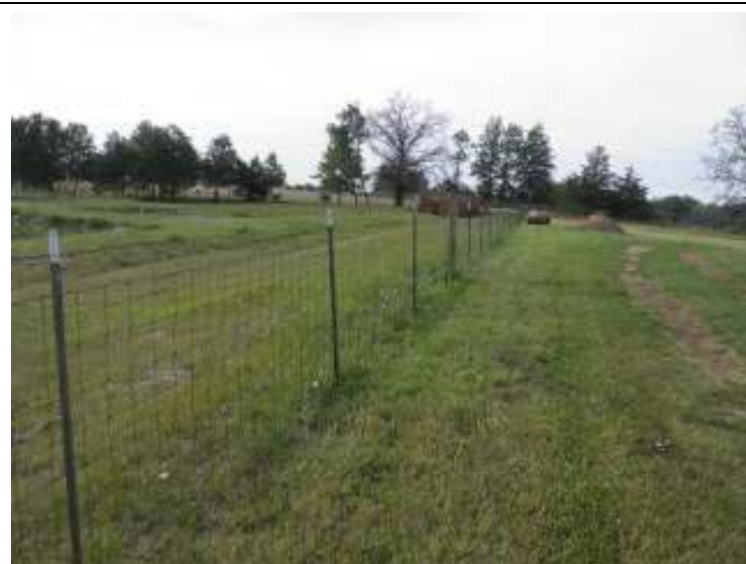
Photo #: 1
By: Mike Smith
Facility: BCSD - Quarter Mile Hills Subdivision
Permit: #MO-0126446
Location: Boone County

Description: View of perimeter fence around the facility. Fence appeared to be in good condition.

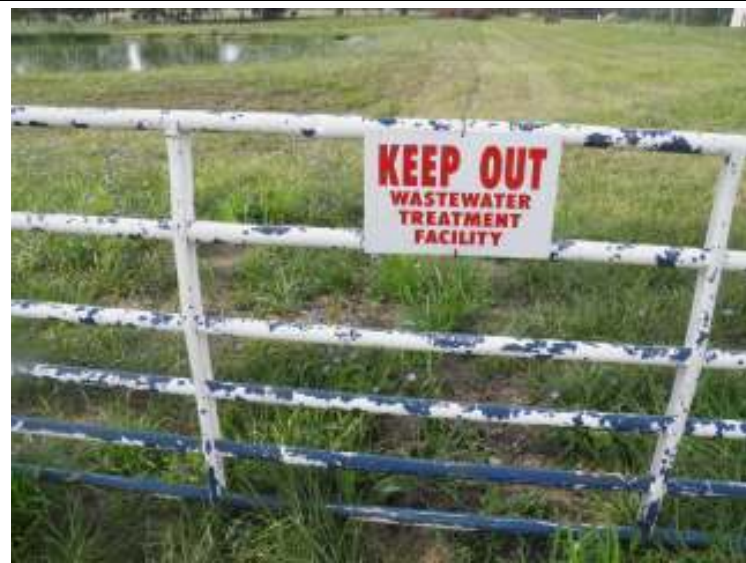
Photo #: 2
By: Mike Smith
Facility: BCSD - Quarter Mile Hills Subdivision
Permit: #MO-0126446
Location: Boone County

Description: View of warning sign posted on facility gate. Facility gate was locked upon arrival.

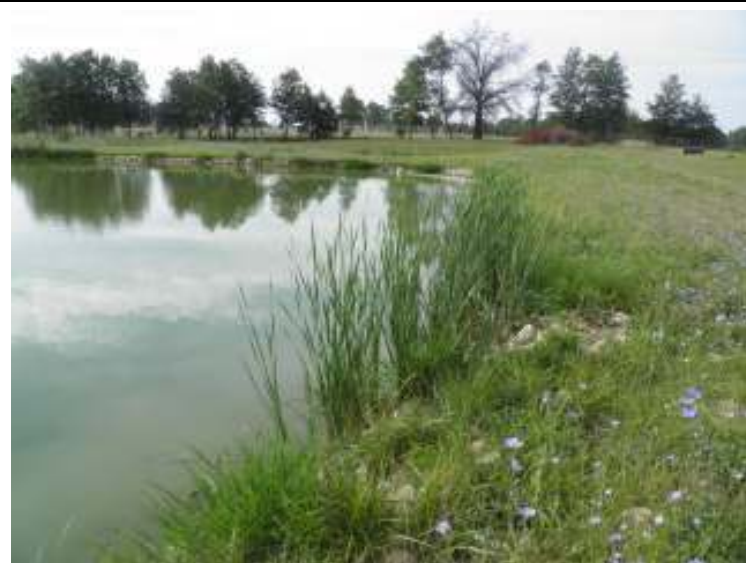
Photo #: 3
By: Mike Smith
Facility: BCSD - Quarter Mile Hills Subdivision
Permit: #MO-0126446
Location: Boone County

Description: View of cattails growing within the first lagoon cell.

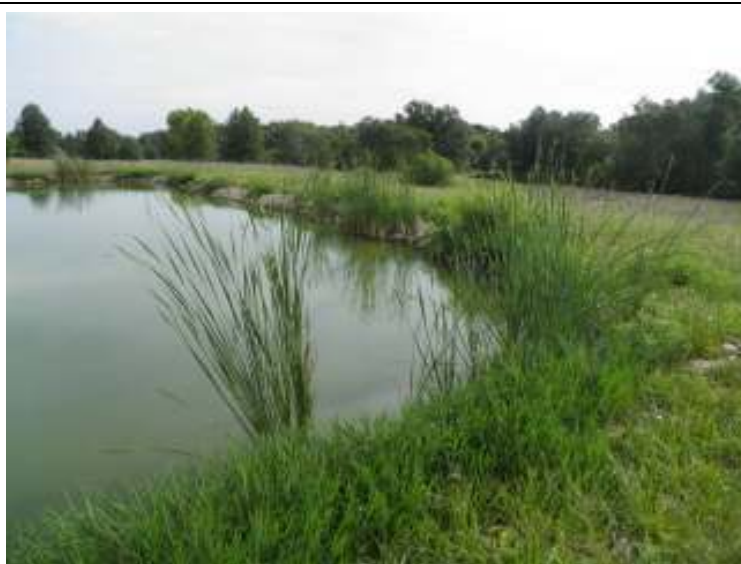
Photo #: 4
By: Mike Smith
Facility: BCSD - Quarter Mile Hills Subdivision
Permit: #MO-0126446
Location: Boone County

Description: View of additional cattails growing within the first lagoon cell.

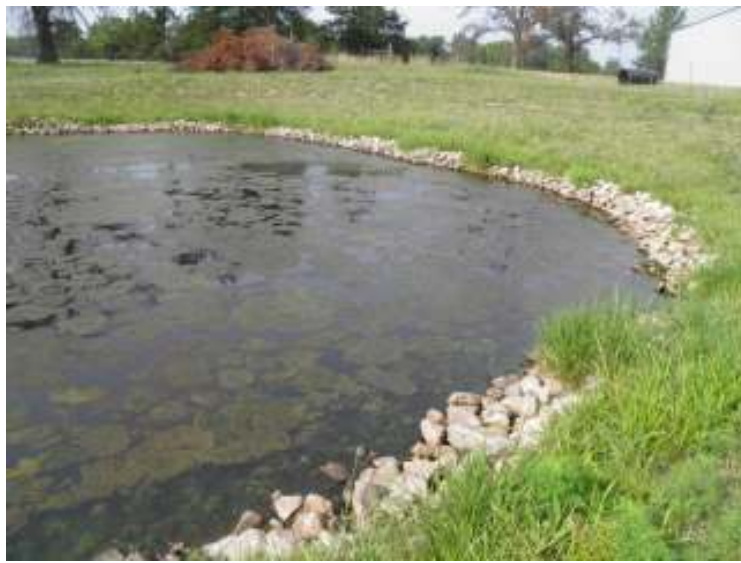
Photo #: 5
By: Mike Smith
Facility: BCSD - Quarter Mile Hills Subdivision
Permit: #MO-0126446
Location: Boone County

Description: View of second lagoon cell. Rip-rap on inner lagoon berms. Algae observed on lagoon surface.

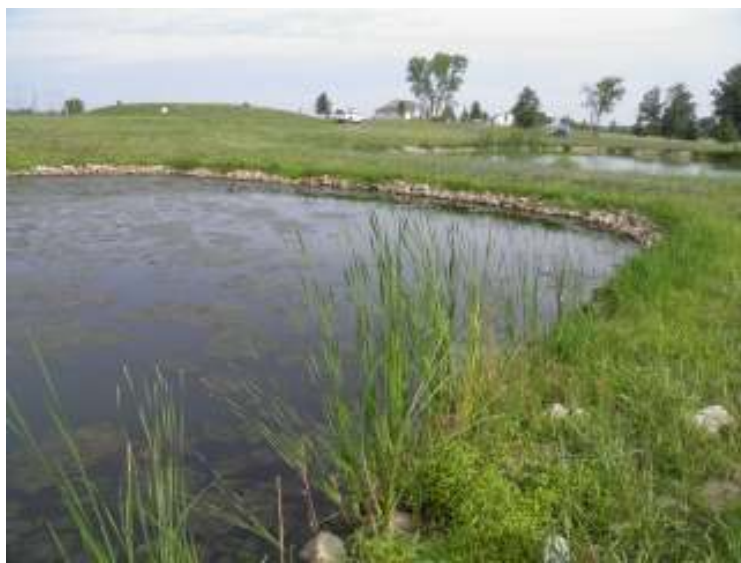
Photo #: 6
By: Mike Smith
Facility: BCSD - Quarter Mile Hills Subdivision
Permit: #MO-0126446
Location: Boone County

Description: View of cattails growing within the second lagoon cell.

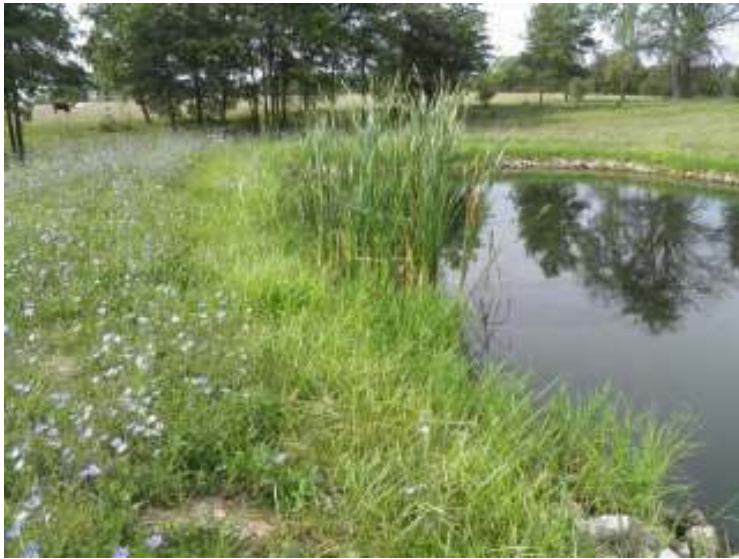
Photo #: 7
By: Mike Smith
Facility: BCSD - Quarter Mile Hills Subdivision
Permit: #MO-0126446
Location: Boone County

Description: Cattails observed growing in the third lagoon cell.

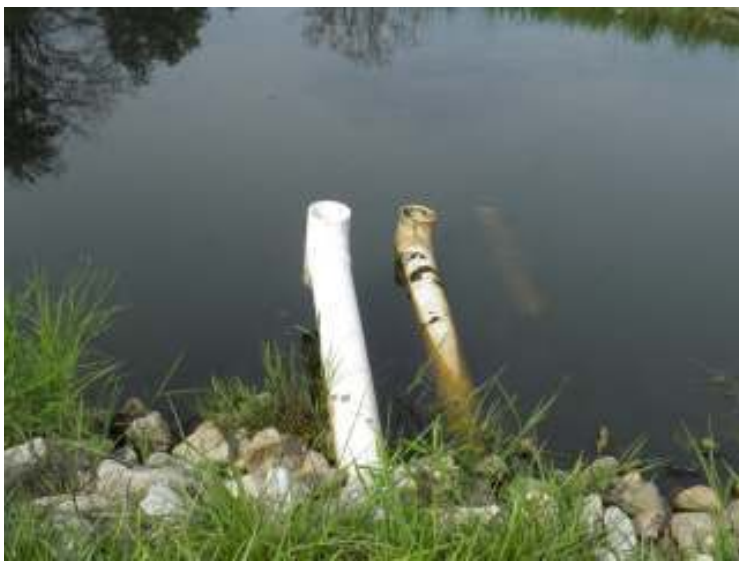
Photo #: 8
By: Mike Smith
Facility: BCSD - Quarter Mile Hills Subdivision
Permit: #MO-0126446
Location: Boone County

Description: View of inlet side of three discharge pipes at different levels in the third lagoon cell.

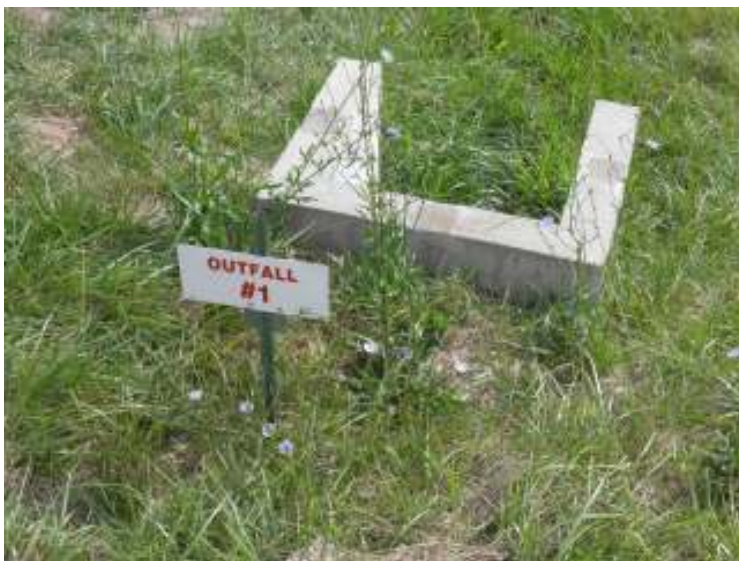
Photo #: 9
By: Mike Smith
Facility: BCSD - Quarter Mile Hills Subdivision
Permit: #MO-0126446
Location: Boone County

Description: View of sign marking the outfall location.

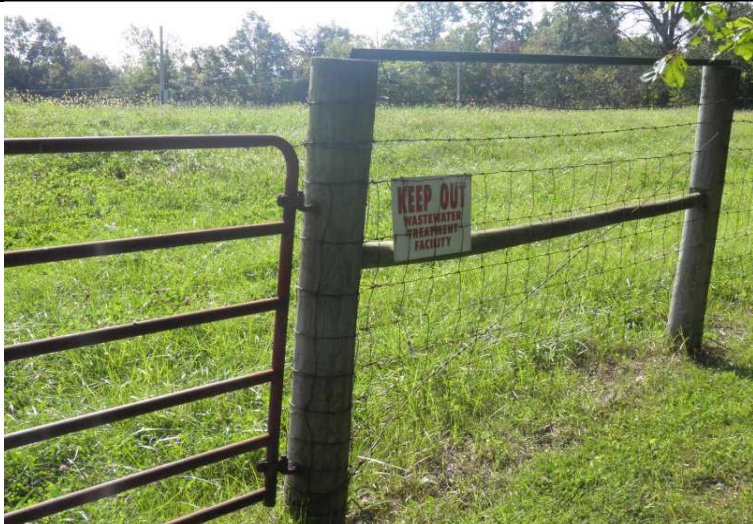
Photograph #: 1
Taken by: Mike Smith
Entity: BCRSD Richardson Acres WWTF
Permit: #MO-0115185
Location: Boone County

Description: View of perimeter fence and a warning sign posted on the fence.

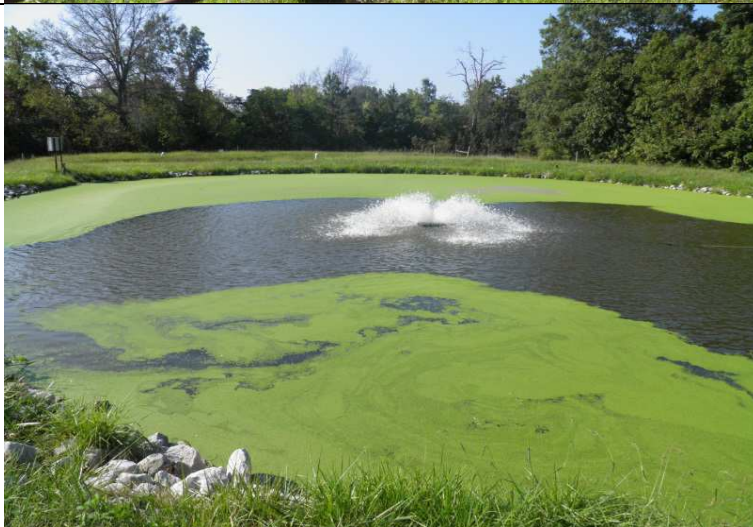
Photograph #: 2
Taken by: Mike Smith
Entity: BCRSD Richardson Acres WWTF
Permit: #MO-0115185
Location: Boone County

Description: View of primary lagoon cell. Aerator appeared to be functioning properly. Approximately half of the lagoon covered in duckweed.

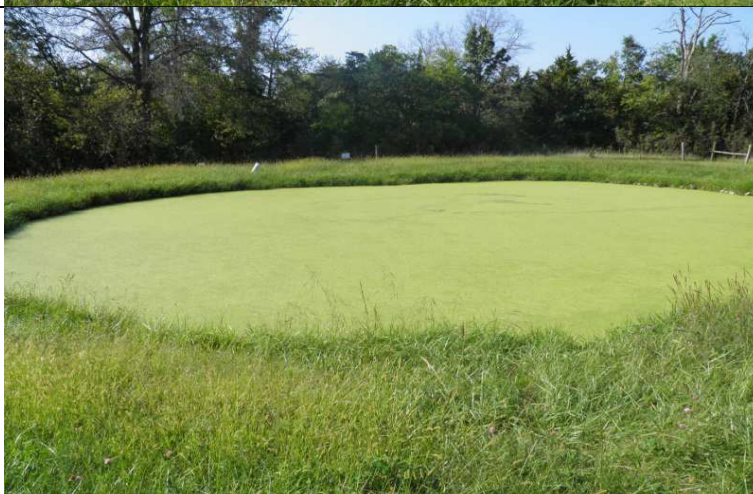
Photograph #: 3
Taken by: Mike Smith
Entity: BCRSD Richardson Acres WWTF
Permit: #MO-0115185
Location: Boone County

Description: View of secondary lagoon cell. Lagoon surface covered in duckweed.

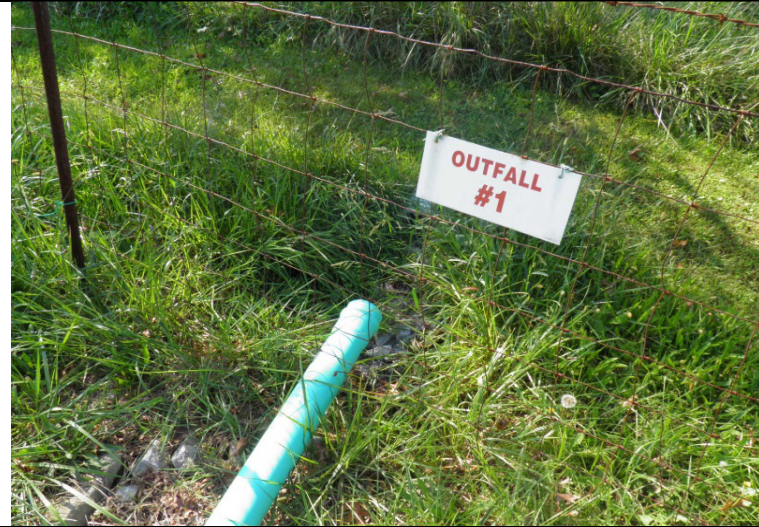
Photograph #: 4
Taken by: Mike Smith
Entity: BCRSD Richardson Acres WWTF
Permit: #MO-0115185
Location: Boone County

Description: View of outfall location with a sign posted.

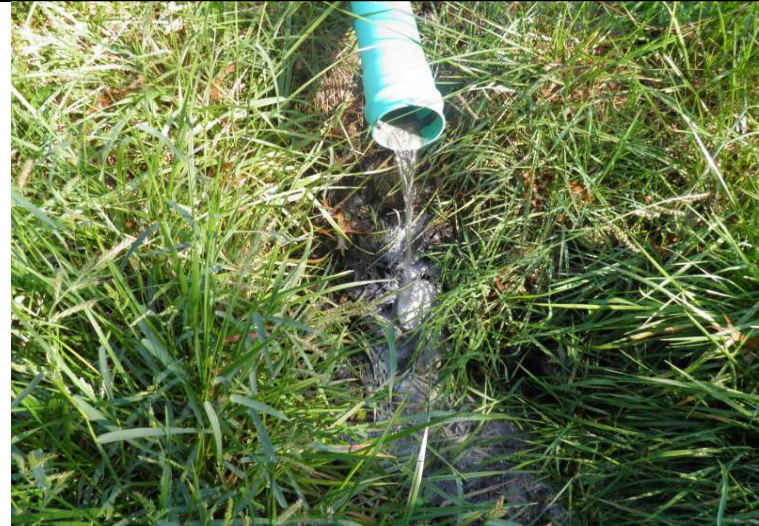
Photograph #: 5
Taken by: Mike Smith
Entity: BCRSD Richardson Acres WWTF
Permit: #MO-0115185
Location: Boone County

Description: View of effluent discharging. Strong sulfur odor detected. Sulfur bacteria observed directly below the outfall.

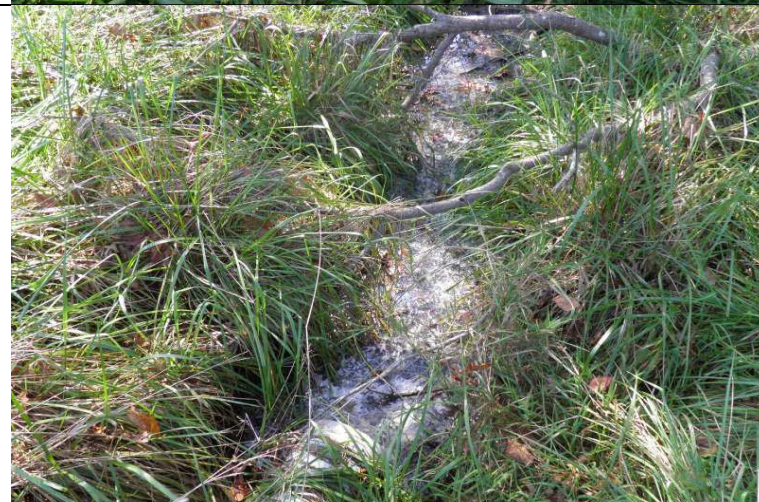
Photograph #: 6
Taken by: Mike Smith
Entity: BCRSD Richardson Acres WWTF
Permit: #MO-0115185
Location: Boone County

Description: View of sulfur bacteria observed approximately 10 feet downstream of the outfall.

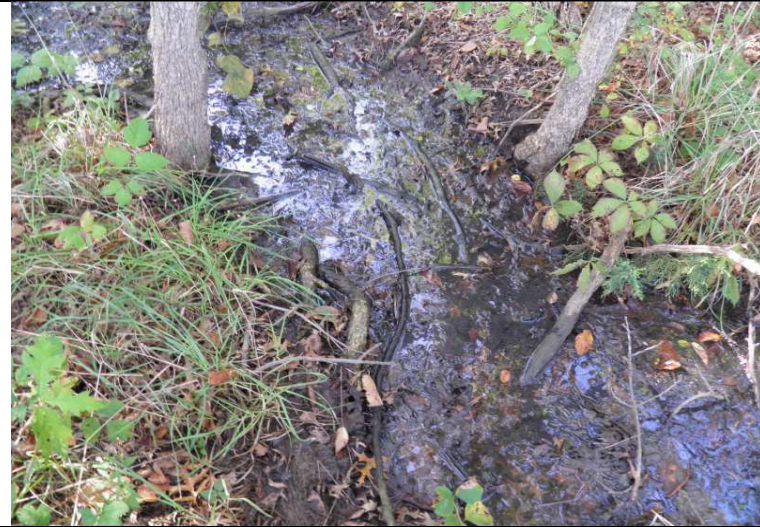
Photograph #: 7
Taken by: Mike Smith
Entity: BCRSD Richardson Acres WWTF
Permit: #MO-0115185
Location: Boone County

Description: View of receiving stream approximately 20 feet below the outfall. Water appeared clear.

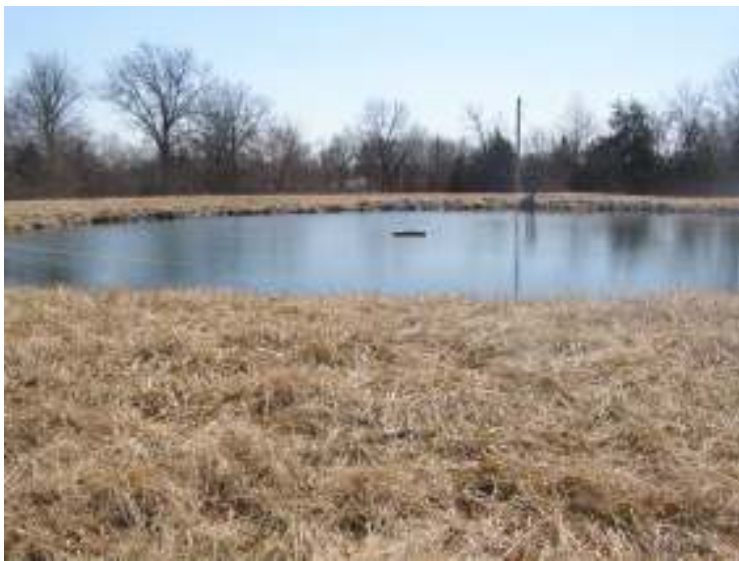
Photo #: 1
 By: Stephen Moss
 Facility: BCRSD, Richardson Acres WWTF
 Permit: #MO-0115185
 Location: Boone County

Description: View of the primary cell. The aerator can be observed in the middle of the lagoon.

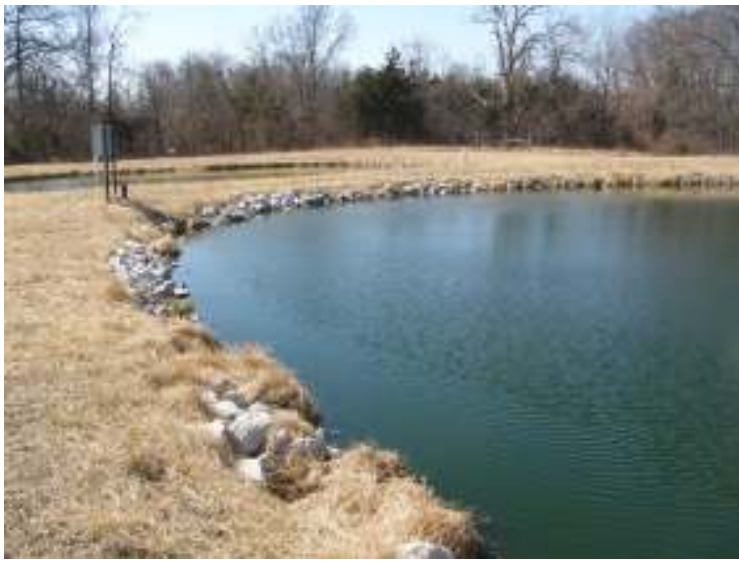
Photo #: 2
 By: Stephen Moss
 Facility: BCRSD, Richardson Acres WWTF
 Permit: #MO-0115185
 Location: Boone County

Description: View of the primary cell.

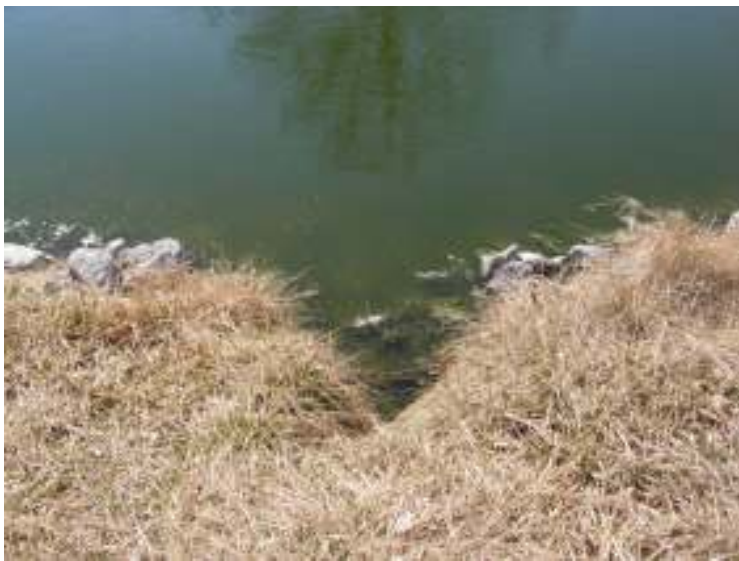
Photo #: 3
 By: Stephen Moss
 Facility: BCRSD, Richardson Acres WWTF
 Permit: #MO-0115185
 Location: Boone County

Description: View of erosion damage on the inner berm slope of the secondary cell.
