**LETTER OF WARNING  
PUBLIC DRINKING WATER  
SIGNIFICANT DEFICIENCY  
RESPONSE REQUIRED**

**Missouri Department of Natural Resources  
Kansas City Regional Office, Public Drinking Water Branch  
Report of Sanitary Survey Inspection  
City of Garden City  
30109 South Little Road, Garden City, Cass County  
MO1010301**

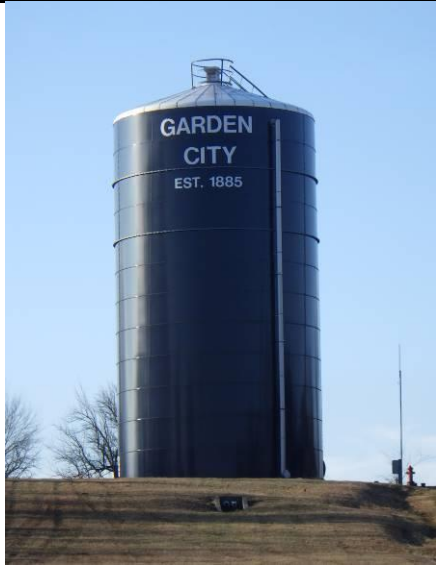
Photograph: 1  
Taken By: Denise Eagan  
Facility: Garden City PWS  
Permit: MO1010301  
Location: UTM 15N 397168/4267366

We started the tour in the distribution system at the 300,000 (300k) gallon standpipe (Photograph 1). The ladder did not have a ladder guard (**Recommendation 1**). I observed an electrical panel for a mixer on the side of the standpipe. Mr. Brown stated they had purchased a mixer for the standpipe and had the electrical installed before learning that a construction permit was needed for installation. This caused a halt in the installation of the mixer (**Unsatisfactory Finding 1**). The overflow was equipped with a tight fitting flap valve and #18-mesh screening which was adequate to prevent the entrance of contaminants. The overflow was also equipped with a splash pad to prevent erosion during overflows. There is a hydrant onsite for flushing the mains leading to the tower but a separate valve to drain the standpipe for inspections and maintenance was located down the hill from the standpipe in a concrete structure.

Description: Viewing the 300k gallon standpipe with overflow and draining piping visible.

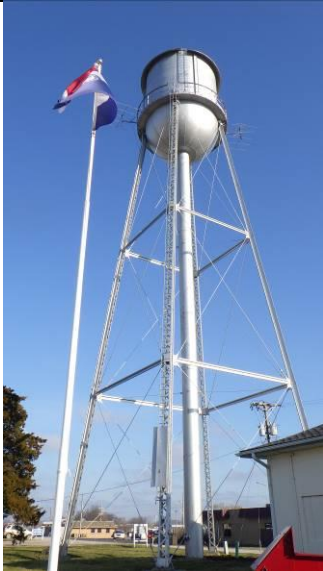
Photograph: 2  
Taken By: Denise Eagan  
Facility: Garden City PWS  
Permit: MO1010301  
Location: UTM 15N 396250/4268812

Next, we observed the 50,000 (50k) gallon elevated tower (Photograph 2). The tower did not have security fencing but it did have a ladder guard though the style of the legs would allow the legs to be climbed (**Recommendation 2**). There was ponding around the footings of the tower (Photograph 3, **Recommendation 3**). The overflow was equipped with a tight fitting flap valve and #18 mesh screen, which was adequate to prevent the entrance of contaminants. The overflow also had a splash pad to help prevent erosion. Corrosion was observed on the tower (Photograph 4, **Recommendation 4**). Mr. Brown stated they are unable to take the tower out of service, as the pressure loss would prevent supply of water to the west side of the city. Inspections are completed after cold winters to ensure any freezing that may have occurred has not damaged the tower.

Description: Viewing the 50k gallon elevated storage tower with ladder guard, overflow piping visible on the left side leg, and lack of security fencing.

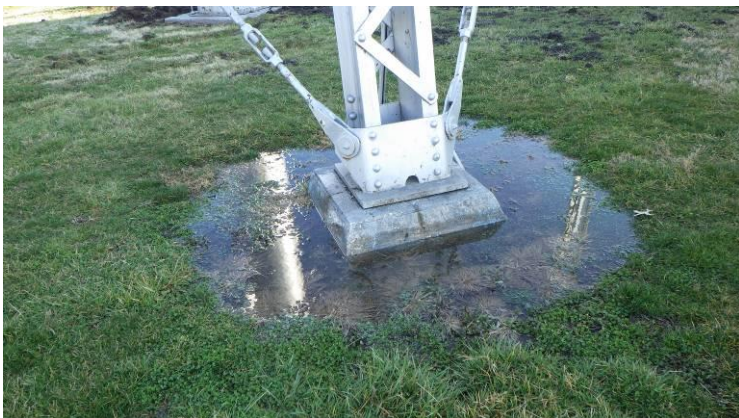
Photograph: 3  
Taken By: Denise Eagan  
Facility: Garden City PWS  
Permit: MO1010301  
Location: UTM 15N 396250/4268812

Description: Viewing the ponding around one of the footings at the 50k gallon tower.

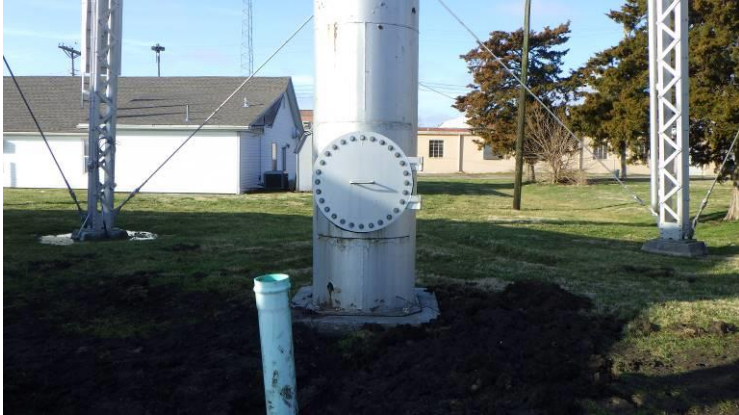
Photograph: 4  
Taken By: Denise Eagan  
Facility: Garden City PWS  
Permit: MO1010301  
Location: UTM 15N 396250/4268812

Description: Viewing some corrosion on the central piping around the manway.

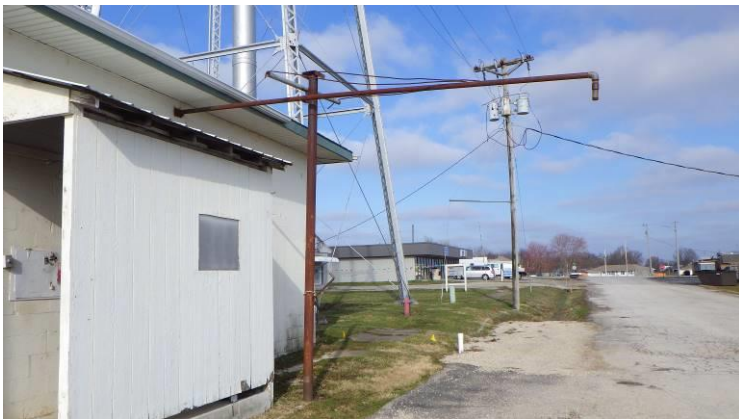
Photograph: 5  
Taken By: Denise Eagan  
Facility: Garden City PWS  
Permit: MO1010301  
Location: UTM 15N 396271/4268810

Description: Viewing the bulk water sales station where an air gap is maintained.

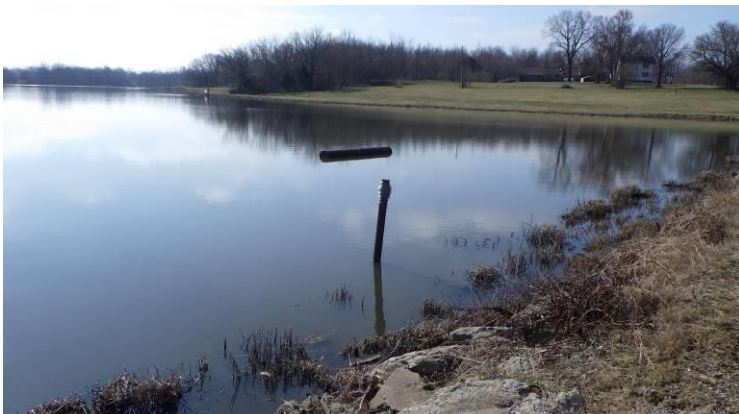
Photograph: 6  
Taken By: Denise Eagan  
Facility: Garden City PWS  
Permit: MO1010301  
Location: UTM 15N 397698/4269179

Mr. Brown and Mr. Schrock proceeded to lead us to the Old Lake intake (Photograph 6). The Old Lake intake is screened with 1-inch square grate which was last checked by divers approximately 8-10 years ago (**Recommendation 5**). The intake is fixed at two-and-a-half feet below the surface. The Old Lake is only used for emergency purposes. The Old Lake spillway was located north of the intake (Photograph 7). The concrete of the spillway was starting to deteriorate (**Recommendation 6**). It also had some excess vegetation on the spillway (**Recommendation 7**). Mr. Brown stated the piping for the spillway was replaced approximately nine (9) years ago. We observed the Old Lake Emergency Spillway (Photograph 8). The spillway had some riprap installed to help protect against erosion. Mr. Brown stated he would like to dig out the spillway more to ensure that overflow is more thoroughly redirected away from the WTP. I also observed a burn pile, which included vegetation, treated wood and plastic trash bags at the emergency spillway. The pile was burning at the time of the inspection (Photograph 9, **Recommendation 8**).

Description: Viewing the intake at the Old Lake.

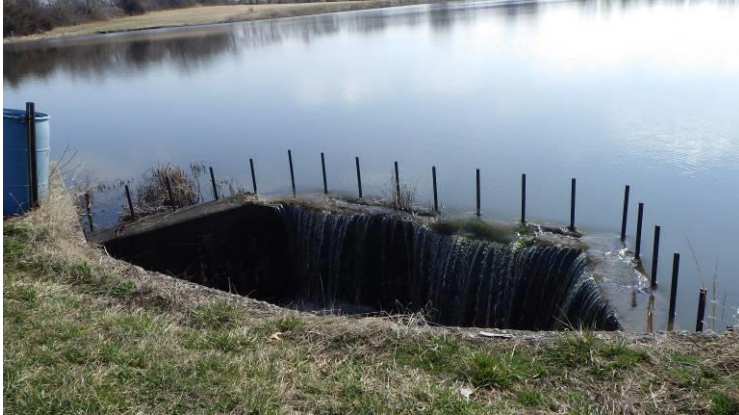
Photograph: 7  
Taken By: Denise Eagan  
Facility: Garden City PWS  
Permit: MO1010301  
Location: UTM 15N 397719/4269229

Description: Viewing the spillway for the Old Lake with the concrete starting to deteriorate causing uneven flow and some excess vegetation.

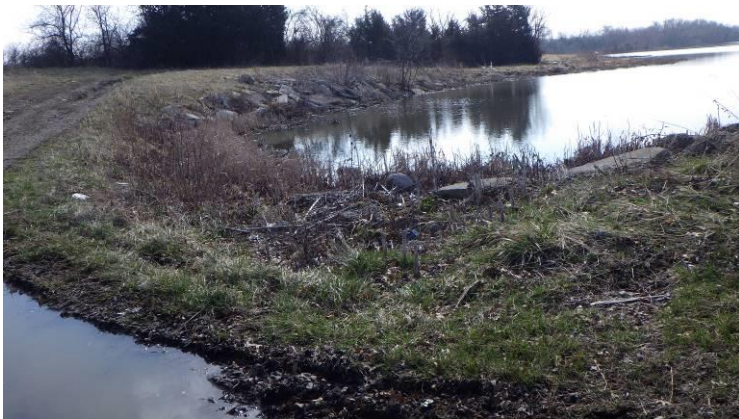
Photograph: 8  
Taken By: Denise Eagan  
Facility: Garden City PWS  
Permit: MO1010301  
Location: UTM 15N 397799/4269357

Description: Viewing the Emergency Spillway at the Old Lake with some ripraping to help prevent erosion.

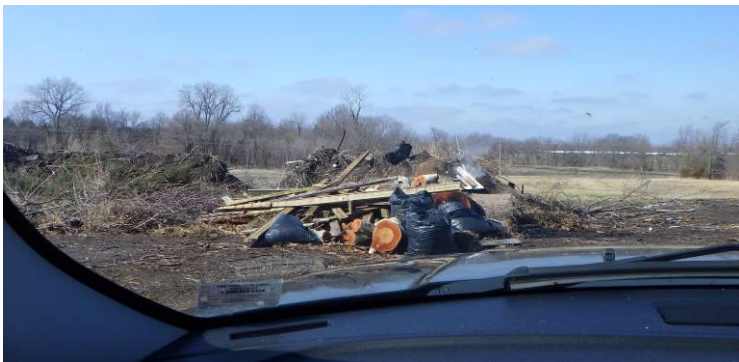
Photograph: 9  
Taken By: Denise Eagan  
Facility: Garden City PWS  
Permit: MO1010301  
Location: UTM 15N 397766/4269359

Description: Viewing the burn pile at the Old Lake Emergency Spillway, which included bags of waste and treated lumber.

If Garden City decides to burn vegetation or untreated wood, then the following requirements must be met:

1. Burning is limited to 80 cubic yards per week unless an air curtain incinerator (ACI) is used.
2. Burning is to take place only between sunrise and sunset.
3. Burning is to occur at least two hundred (200) yards from the nearest structure not owned by the City, unless an ACI is used AND one of the following two conditions is met:
  - a) Waivers are obtained from the owner or occupant of the structure, OR
  - b) The local fire department provides approval in those circumstances where the distance cannot be maintained.
4. Burning is to be supervised at all times.
5. The local fire control or other authority with jurisdiction shall be notified of the burning activities prior to initiation.

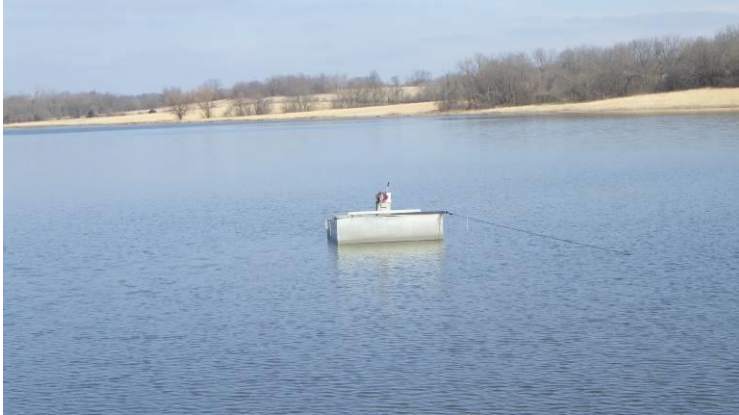
Photograph: 10  
Taken By: Denise Eagan  
Facility: Garden City PWS  
Permit: MO1010301  
Location: UTM 15N 397968/4264350

We continued to the New Lake Intake (Photograph 10). The intake is adjustable from eight (8) to ten (10) feet depth to the surface. The current setting is at two-and-a-half (2.5) feet below the surface level. The intake is anchored and locked to prevent vandalism. Mr. Brown stated that sometimes he catches members of the public fishing off the intake (**Recommendation 9**). Water system staff visually inspect the intake approximately once every two (2) weeks. Liquid copper sulfate is used on the New Lake to help control algae approximately every two (2) to three (3) weeks based on a visual inspection of the lake conditions. Mr. Brown stated they did not have enough employees to treat the lake late last year. The lake water level depth marker is located next to the spillway. The New Lake Spillway is located on the southeastern side of the lake (Photograph 11). I observed that water was starting to erode under the concrete shelf of the spillway at the base along with some trees growing in the area through the seams of the concrete spillway (**Recommendation 10**). We continued to the Raw Water Pumps at the New Lake (Photograph 12). The pump station consists of two (2) horizontal turbine pumps on variable frequency drives (VFDs) that are designed for approximately 400 gallons per minute (gpm). Their current setting was approximately 60-62% of full capacity. The pumps are alternated every two (2) months and run approximately eight (8) to nine (9) hours per day. The station has a sump pump, which was malfunctioning at the time of the inspection (**Recommendation 11**). The pump station was locked to prevent vandalism. Since the pump station is considered a confined space, Mr. Brown stated they ensure all operators undertake confined space training when it becomes available in the Garden City area. I observed another old burn pile near the pump station, which included some previously burnt mattresses (**Recommendation 8**). Mr. Brown stated if they were unsure how to dispose of an object then they burn it. I recommended against burning any future furniture while on site. The last thing observed at the New Lake was the emergency spillway (Photograph 13). The spillway was not riprapped (**Recommendation 12**).

Description: Viewing the New Lake Intake.

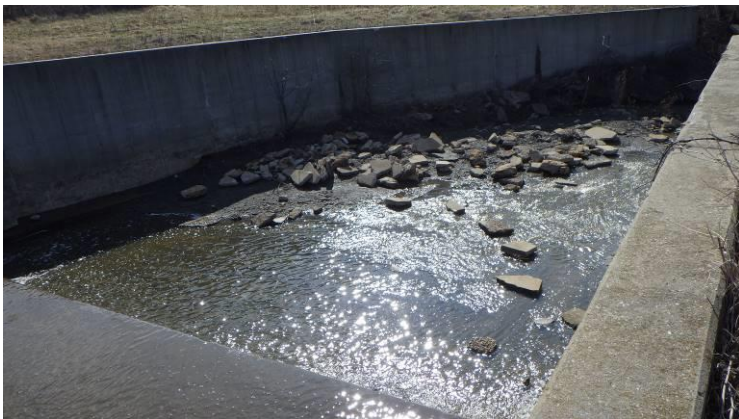
Photograph: 11  
Taken By: Denise Eagan  
Facility: Garden City PWS  
Permit: MO1010301  
Location: UTM 15N 398202/4264330

Description: Viewing the New Lake Spillway with some concrete debris washed away and some wooded vegetation growing in the seams of the spillway.

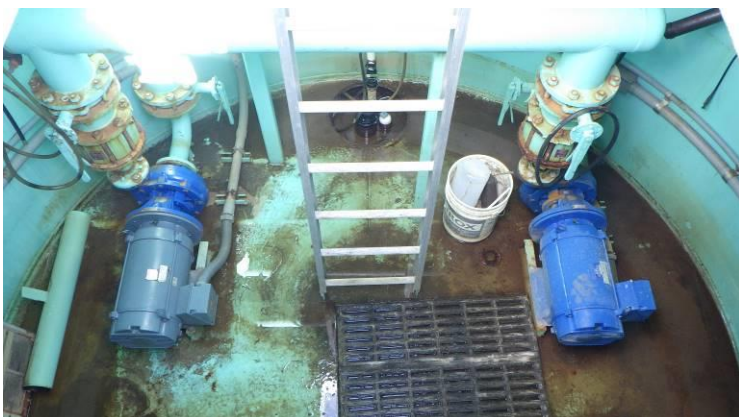
Photograph: 12  
Taken By: Denise Eagan  
Facility: Garden City PWS  
Permit: MO1010301  
Location: UTM 15N 397971/4264281

Description: Viewing the Raw Water Pumps with standing water on the floor and sump pump.

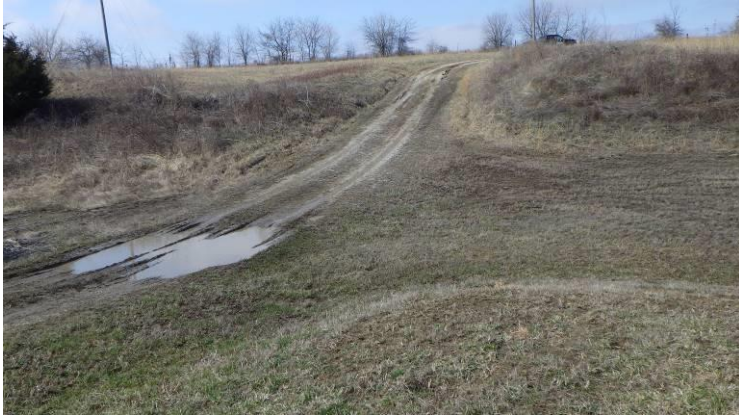
Photograph: 13  
Taken By: Denise Eagan  
Facility: Garden City PWS  
Permit: MO1010301  
Location: UTM 15N 397887/4264314

Description: Viewing the emergency spillway at the New Lake without any riprapping.

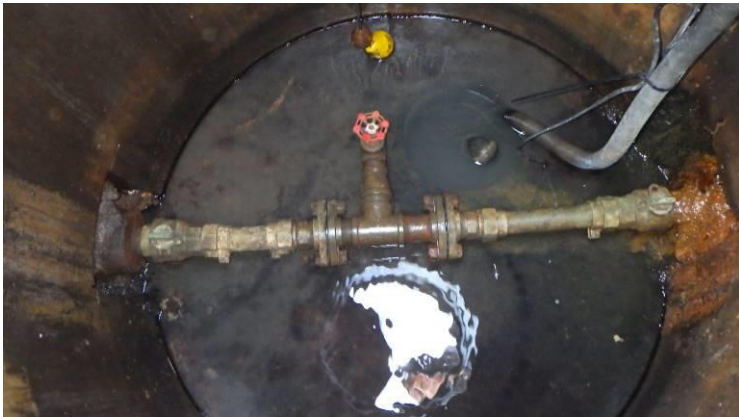
Photograph: 14  
Taken By: Denise Eagan  
Facility: Garden City PWS  
Permit: MO1010301  
Location: UTM 15N 397159/4267313

Description: Viewing inside the Cass County PWSD #1 connection pit with excess water, sump pump, and flush valve visible.

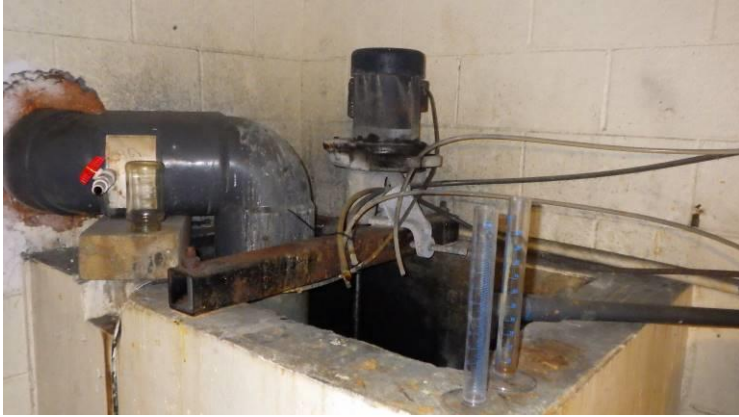
Photograph: 16  
Taken By: Denise Eagan  
Facility: Garden City PWS  
Permit: MO1010301  
Location: UTM 15N 397647/4269198

We then viewed the primary rapid mix (Photograph 16). The basin had four (4) chemical feed lines and none were labeled (**Recommendation 22**). Mr. Brown stated they use flow turbulence to mix the chemicals in the basin and do not use the mechanical mixer (**Recommendation 23**). A sample tap was available prior to the chemical additions and graduated cylinders were available to check the chemical feed outputs. Next, we observed the powdered activated carbon (PAC) feed area (Photograph 17). Empty bags of carbon were discarded in the corner of the room (**Recommendation 24**). Mr. Brown stated the equipment was spark proof. He stated that they could feed a maximum of 30-35 ppm of PAC if necessary during a HAB event before the settling basins would start to discharge black water to the creek.

Description: Viewing the primary rapid mix with unlabeled chemical feed lines, sample point, and extra mechanical rapid mixer.

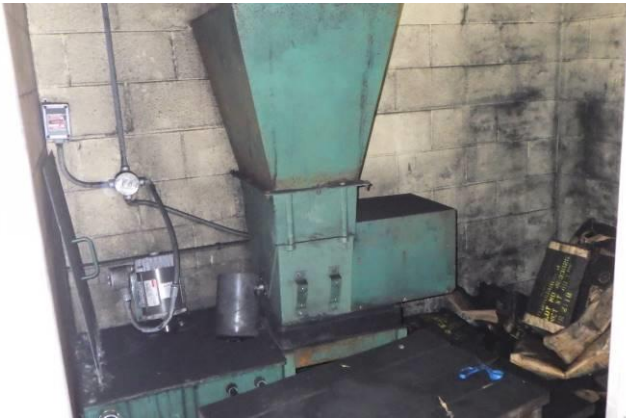
Photograph: 17  
Taken By: Denise Eagan  
Facility: Garden City PWS  
Permit: MO1010301  
Location: UTM 15N 397647/4269198

Description: Viewing the PAC feed area with mechanical mixer and discarded PAC bags.

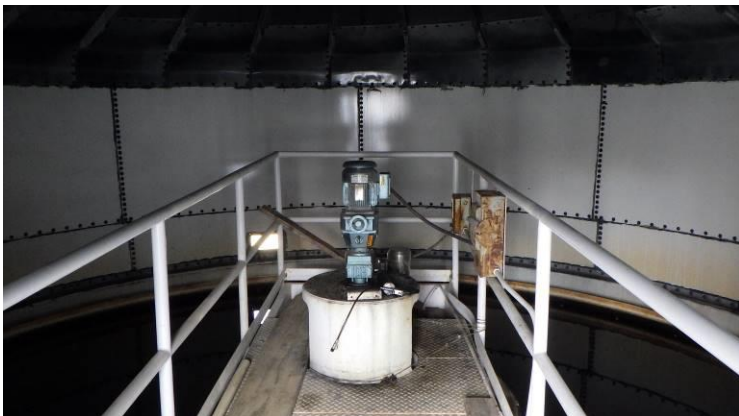
Photograph: 18  
Taken By: Denise Eagan  
Facility: Garden City PWS  
Permit: MO1010301  
Location: UTM 15N 397647/4269198

Next, we viewed the Clarifier (Photograph 18). The water in the clarifier was very dark which made it impossible to evaluate the water and clarifier (**Recommendation 25**). Mr. Brown stated the sludge motor was replaced in 2002. He has noticed some short-circuiting in the clarifier and would like to add a baffle to extend the detention time. The clarifier is approximately fifteen (15) feet deep and they try to maintain a six (6) foot sludge blanket. Sludge is continuously removed to the settling basins. The clarifier is cleaned on an as-necessary basis.

Description: Viewing inside the clarifier with continuous sludge removal motor visible along with effluent baffles.

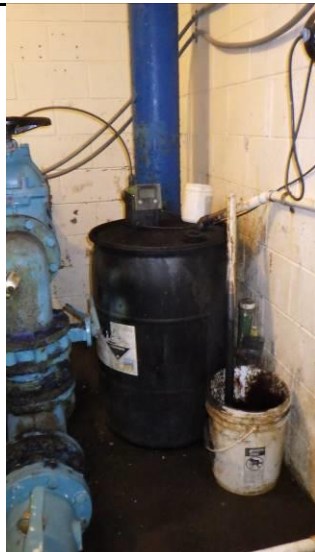
Photograph: 21  
Taken By: Denise Eagan  
Facility: Garden City PWS  
Permit: MO1010301  
Location: UTM 15N 397647/4269198

Description: Viewing the sodium permanganate without any secondary containment.

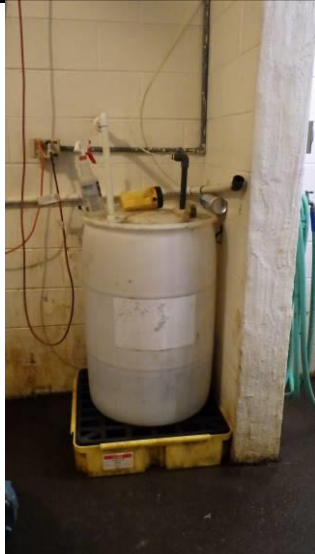
Photograph: 22  
Taken By: Denise Eagan  
Facility: Garden City PWS  
Permit: MO1010301  
Location: UTM 15N 397647/4269198

Description: Viewing the sodium chlorite on secondary containment, vented outside, and without a label. Piston style chemical feed pump on top of the barrel along with an unknown chemical spray bottle and aerosol can.

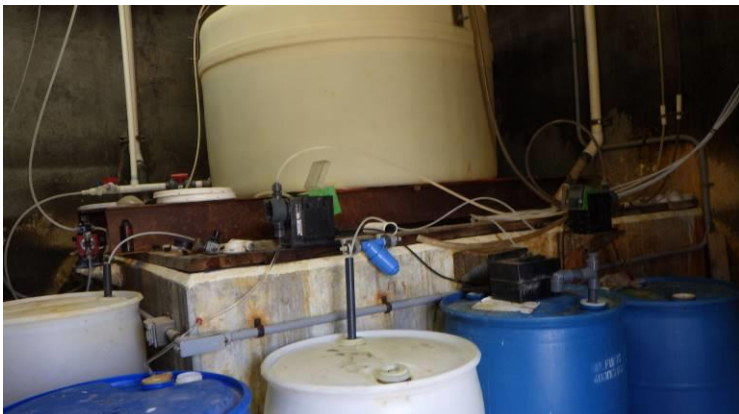
Photograph: 24  
Taken By: Denise Eagan  
Facility: Garden City PWS  
Permit: MO1010301  
Location: UTM 15N 397647/4269198

Next, we viewed the chemical storage room (Photograph 24). The bulk tank of sodium hypochlorite is stored over the secondary containment area and is used for post treatment disinfection purposes. There are chemicals stored below the bulk tank inside the secondary containment area and some are potentially no longer used (Photograph 25, **Recommendation 29**). Mr. Brown stated he does not use the sodium hydroxide from the bulk tank for chlorine dioxide generation as the particulates at the bottom of the tank clog the chlorine dioxide generation equipment (**Recommendation 30**). Therefore, a separate 55-gallon barrel of sodium hydroxide is used for chlorine dioxide generation (Photograph 26). The majority of the chemicals in the room did not have secondary containment (Photograph 27, **Recommendation 31**). The exterior door to the room was rusting at the bottom and would allow any spilled chemicals to flow outside (Photograph 28, **Recommendation 32**) into a storm drain, along with some French style drains. The drains were installed to help divert the leaking water from the Old Lake around the plant and discharge into the creek leading to a high likelihood of spilled chemicals entering waters of the state, which is a violation of the Missouri Clean Water Law (Photographs 29-30, **Letter of Warning 1**). Adjacent to the chemical storage area is the chlorine dioxide generation area (Photograph 31). Chlorine dioxide is generated by combining sodium hydroxide, muriatic acid, and sodium chlorite. The safety shower and hose for cleaning the area are also located directly across from the chlorine dioxide generation equipment (Photograph 32). The safety shower is not on any routine flushing schedule (**Recommendation 33**). Mr. Brown stated that he uses it regularly to wash off chemicals to help prevent chemical burns (**Recommendation 34**). I requested to see the backflow prevention device for all water usage in the WTP. Mr. Brown stated that there is no backflow prevention device and that he thought one would not be required for this WTP. I observed that each hose, safety shower, continuous monitoring equipment, and chemical feed equipment have individual tie-ins to the finished water (**Unsatisfactory Finding 3**).

Description: Viewing the chemical storage room with the bulk sodium hypochlorite tank, muriatic acid, sulfuric acid, and a barrel of sodium hypochlorite.

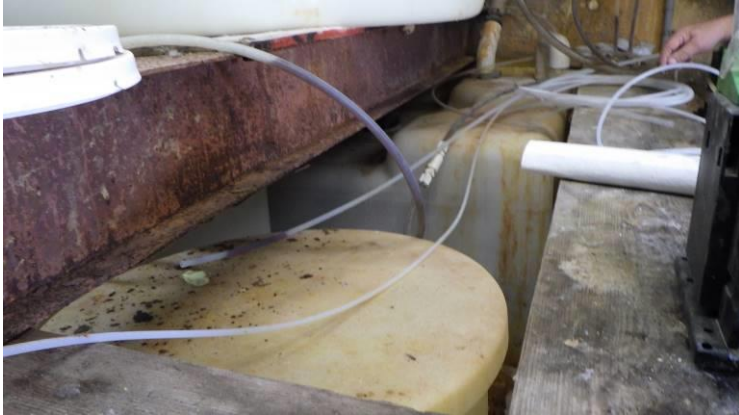
Photograph: 25  
Taken By: Denise Eagan  
Facility: Garden City PWS  
Permit: MO1010301  
Location: UTM 15N 397647/4269198

Description: Viewing the chemicals in the secondary containment area, some of which are potentially waste chemicals with the sodium hypochlorite bulk tank resting on the rails.

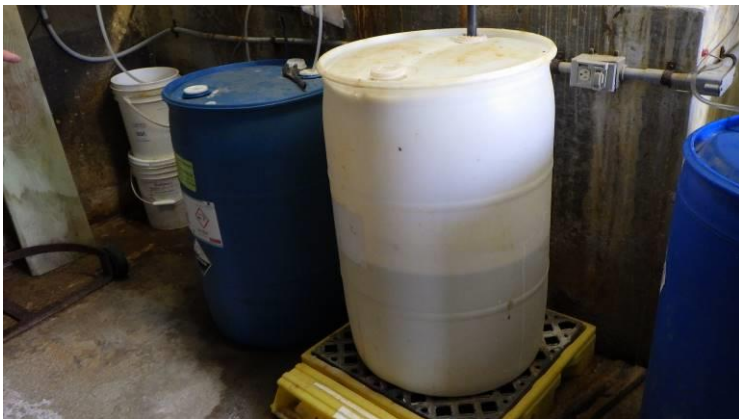
Photograph: 26  
Taken By: Denise Eagan  
Facility: Garden City PWS  
Permit: MO1010301  
Location: UTM 15N 397647/4269198

Description: Viewing the barrel of sodium hypochlorite on the secondary containment while other chemicals to the left and right are not on secondary containment.

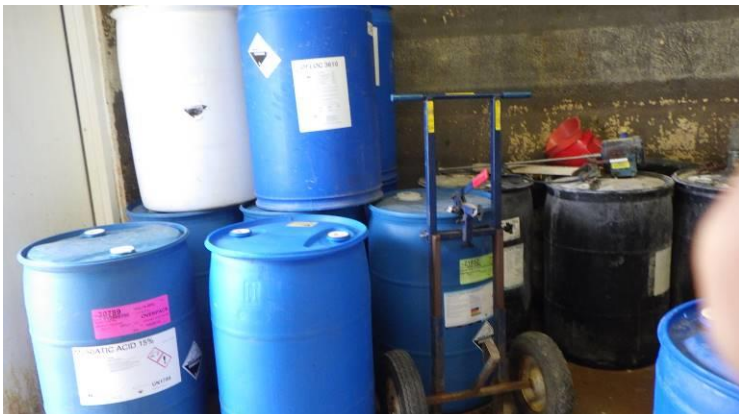
Photograph: 27  
Taken By: Denise Eagan  
Facility: Garden City PWS  
Permit: MO1010301  
Location: UTM 15N 397647/4269198

Description: Viewing the unused product chemicals stored together, stacked, and located near the exterior door without any secondary containment.

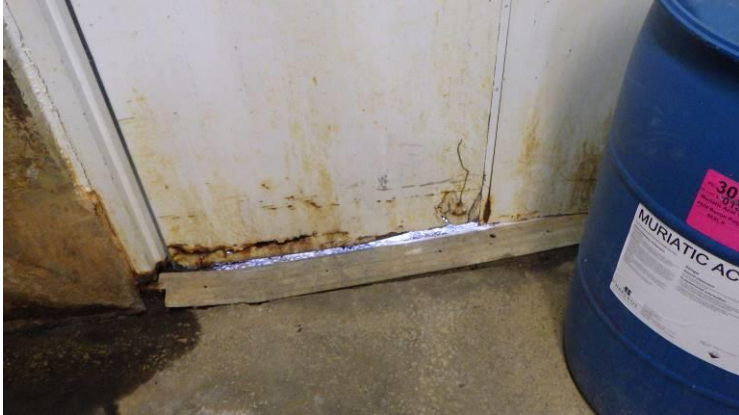
Photograph: 28  
Taken By: Denise Eagan  
Facility: Garden City PWS  
Permit: MO1010301  
Location: UTM 15N 397647/4269198

Description: Viewing the exterior door to the chemical storage room which is rusted out the bottom with the door sill starting to bend upwards and no longer connected to the floor.

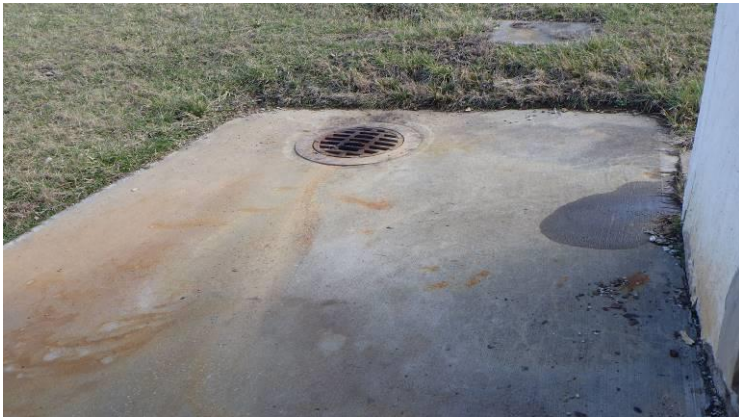
Photograph: 29  
Taken By: Denise Eagan  
Facility: Garden City PWS  
Permit: MO1010301  
Location: UTM 15N 397647/4269198

- 1. The City placed water contaminants, muriatic acid along with others, in a location where it is reasonably certain to cause pollution of waters of the state [§ 644.051.1(1) and 644.076.1, RSMo].**

Description: Viewing the storm drain outside the chemical storage room that discharges to the creek.

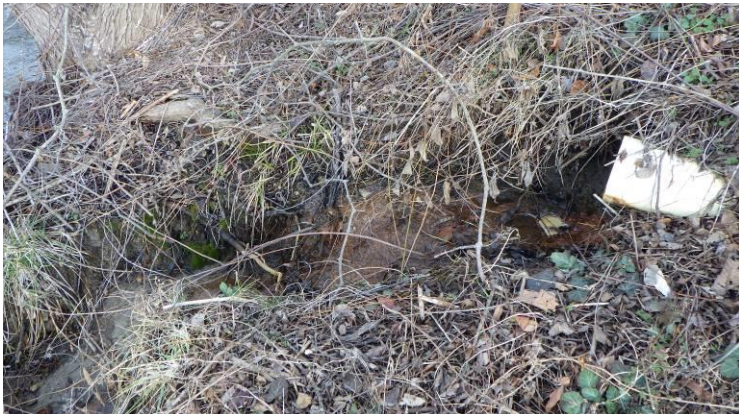
Photograph: 30  
Taken By: Denise Eagan  
Facility: Garden City PWS  
Permit: MO1010301  
Location: UTM 15N 397689/4269239

Description: Viewing the discharge pipe of the storm drain located approximately two feet upstream of the MOG64 settling basin outfall.

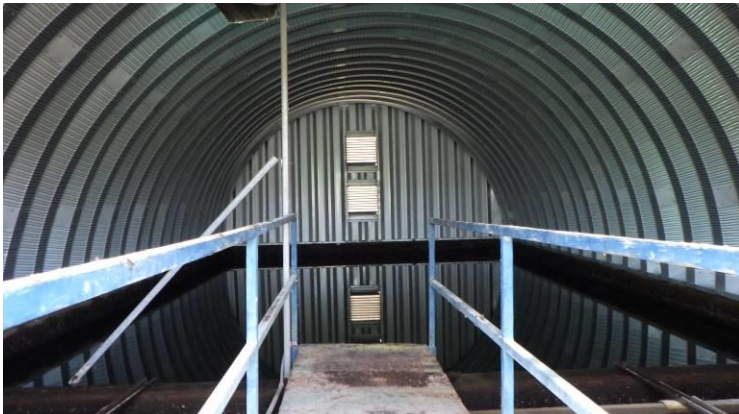
Photograph: 33  
Taken By: Denise Eagan  
Facility: Garden City PWS  
Permit: MO1010301  
Location: UTM 15N 397650/4269170

Next, we observed the Settling Basin (Photograph 33). The water enters the settling basins through baffling created from membrane fabric. The detention time is approximately four (4) hours. The basin is cleaned approximately once every seven (7) months or in response to manganese problems, they may be experiencing. The building did not have any interior lighting and I was unable to verify the quality of the floc or view the sludge level (**Recommendation 25**).

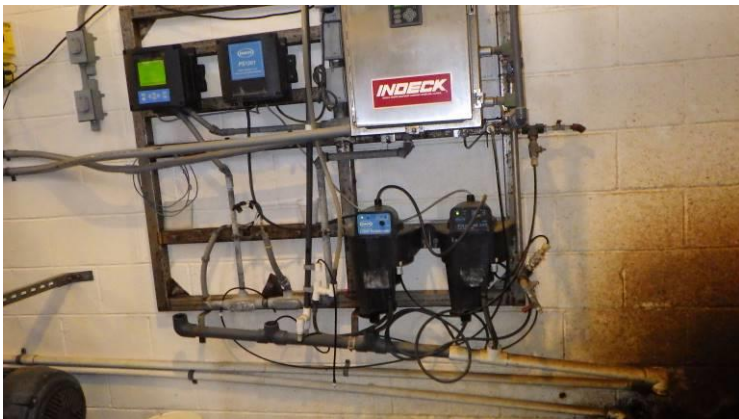
Photograph: 41  
Taken By: Denise Eagan  
Facility: Garden City PWS  
Permit: MO1010301  
Location: UTM 15N 397647/4269198

The continuous turbidity meters are calibrated quarterly by a contractor (Photograph 41). I observed the hoses entering and exiting the meters appeared to be dark, potentially from build-up (**Recommendation 36**). Mr. Brown stated he has the ability to call the contractor to work on the meters when necessary to help with any troubleshooting.

The operators were not sure of the exact settings on the continuous turbidity meters. The Department has established recommended settings to help Cities ensure optimal operation. The turbidity meters need to be calibrated quarterly to ensure accuracy with bulbs that should be changed annually. The turbidity meters should have a signal span of 0-5 NTUs to verify that all meters catch any large spikes in turbidity. The bubble-reject needs to be turned on to ensure that bubbles do not cause a false turbidity spike. The error hold mode should be set to "Transfer to 0.0" so the operators will notice when the turbidity meters are experiencing issues instead of holding the last reading which could be misleading. Turbidity meters need a specific range of water flow through the meter to ensure proper readings. This should be checked monthly and the range can be found in the meter's operations manual. The signal averaging should be set on 30 seconds to catch all potential spikes in turbidity. The controller datalog interval should be set to every 1 to 5 minutes to ensure the majority of data is saved before encountering an error.

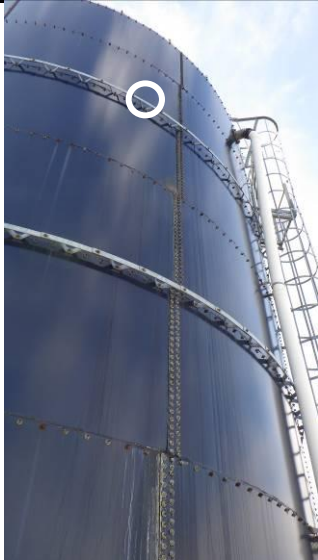
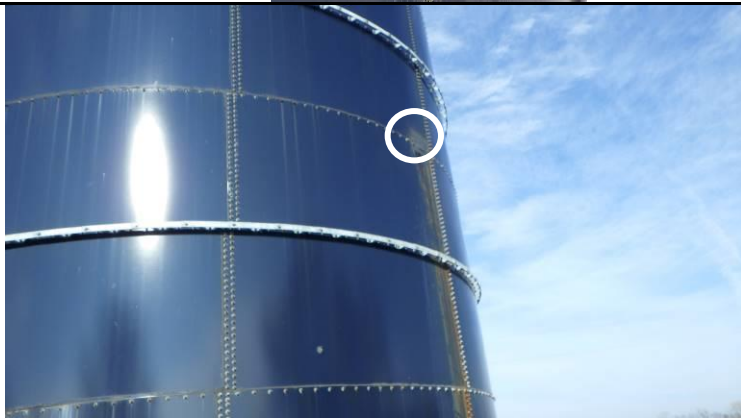
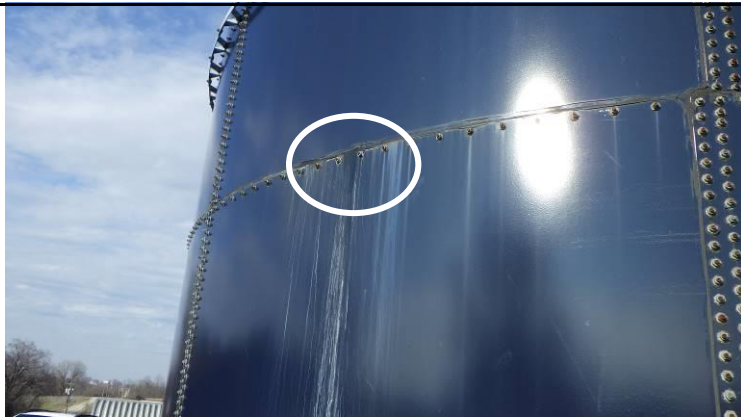
Lastly, we observed the clearwell (Photograph 42). The clearwell had a manway on ground level. The ladder was locked to prevent vandalism. The overflow was fitted with #18 mesh screen to which was adequate to prevent the entrance of contaminants. The overflow also had splash pad to prevent against erosion. During observation of the outside of the clearwell tank, three (3) active leaks were discovered (Photographs 43-45, **Significant Deficiency 1**).

- 1. The Clearwell has inadequately protected openings, which can allow the entrance of contaminants into the finished water. This is a violation of 10 CSR 60-4.080(7) and a Significant Deficiency under 10 CSR 0-4.025(4)(A)4.**

The clearwell had three (3) active leaks located at difference seams at the time of the inspection.
