DEPARTMENT OF NATURAL RESOURCES

Finding of Compliance

Missouri Department of Natural Resources
Southeast Regional Office/Public Drinking Water Program
Report of Inspection
Indian Hills Utilities Operating Co. Inc.
500 Northwest Plaza Drive, Suite 500, St. Louis, MO 63074
Crawford County Missouri
MO6036052
November 4, 2016

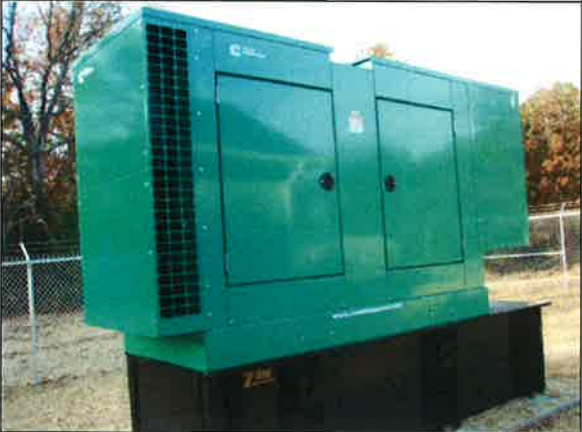
Photo #:008
Date Taken: 10/26/2016
By: Michelle Oglesby
Program: PDWB
File: Crawford County
Location: Indian Hills Utilities Operating Co. Inc.
Description: Well #1 – Generator

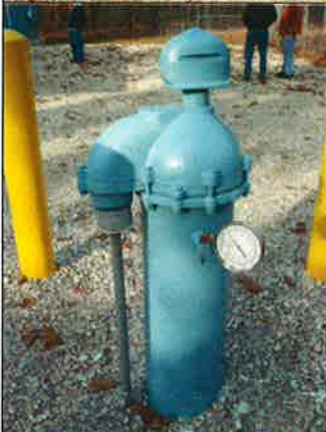
Photo #:011
Date Taken: 10/26/2016
By: Michelle Oglesby
Program: PDWB
File: Crawford County
Location: Indian Hills Utilities Operating Co. Inc.
Description: Well #3

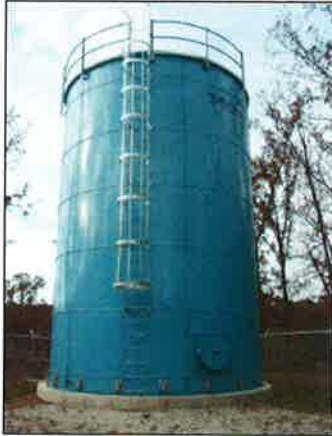
Photo #:017
Date Taken: 10/26/2016
By: Michelle Oglesby
Program: PDWB
File: Crawford County
Location: Indian Hills Utilities Operating Co. Inc.
Description: Well #3 – 53,000 gallon standpipe.
