### FINDING OF COMPLIANCE

Staff from the Missouri Department of Natural Resources conducted an inspection on February 28, 2017, of the Hillcrest Manor Wastewater Treatment Facility (WWTF), at 720 Williams Street, Cape Girardeau, Missouri, in Cape Girardeau County.

**Missouri Department of Natural Resources**  
**Southeast Regional Office/Water Protection Program**  
**Report of Inspection**  
**Hillcrest Manor WWTF**  
**720 Williams Street/Cape Girardeau/Cape Girardeau County**  
**MO-0088072**  
**March 1, 2017**

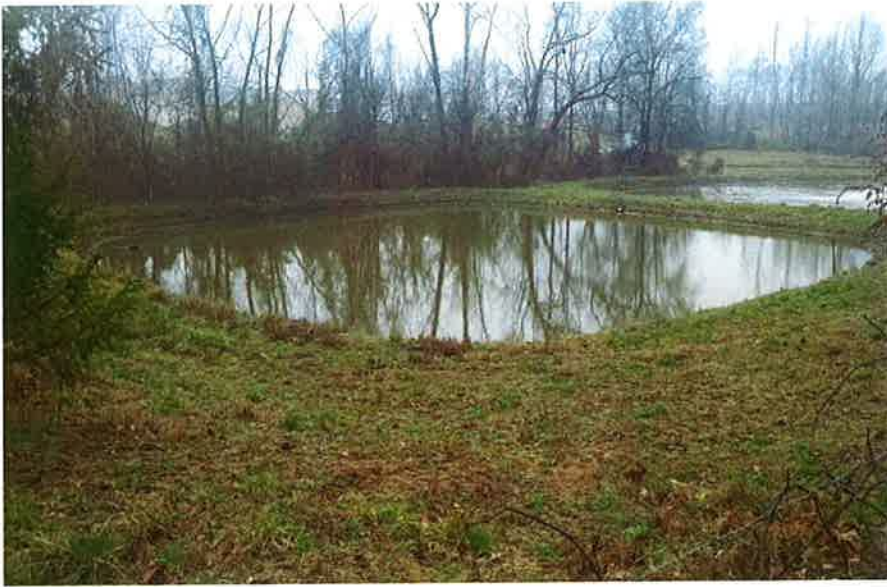
**Photo #:** 001  
**By:** Tim Mattingly  
**Facility:** Hillcrest Manor  
**Permit:** MO-0088072  
**Location:** Cape Girardeau County

**Description:** This is a photo of the primary cell of the lagoon system at Hillcrest Manor Subdivision.

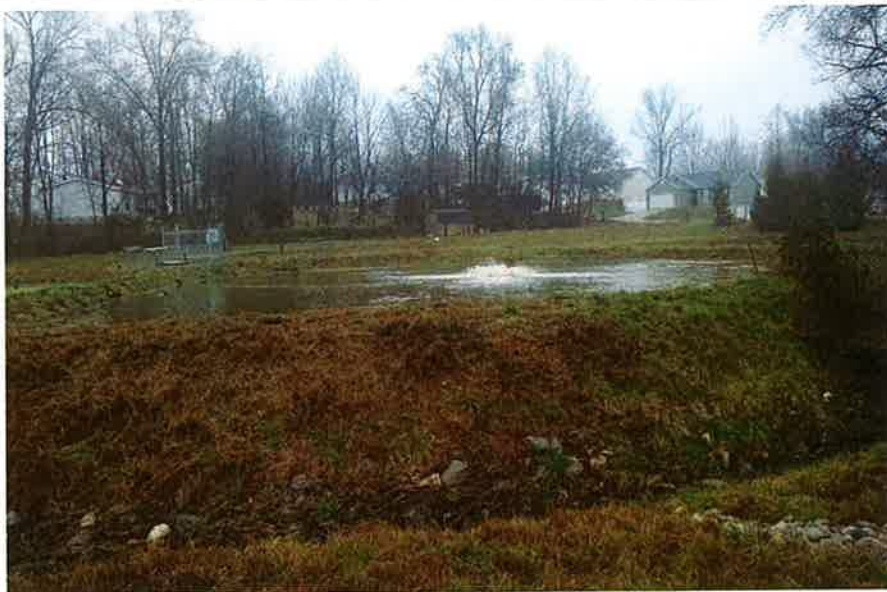
**Photo #:** 002  
**By:** Tim Mattingly  
**Facility:** Hillcrest Manor  
**Permit:** MO-0088072  
**Location:** Cape Girardeau County

We walked around the lagoons and I noted that the aerator in the second cell was functioning properly. There were some areas in the berms of the lagoons where burrowing animals had caused some minor damage. Mr. Brady informed me that Strickland Engineering does retain the services of a trapper who serves the WWTF's that they contract operate and that he was scheduled to come to Hillcrest Manor Subdivision in the very near future.

**Description:** The second cell of the lagoon serving Hillcrest Manor Subdivision. The aerator was fully functional.

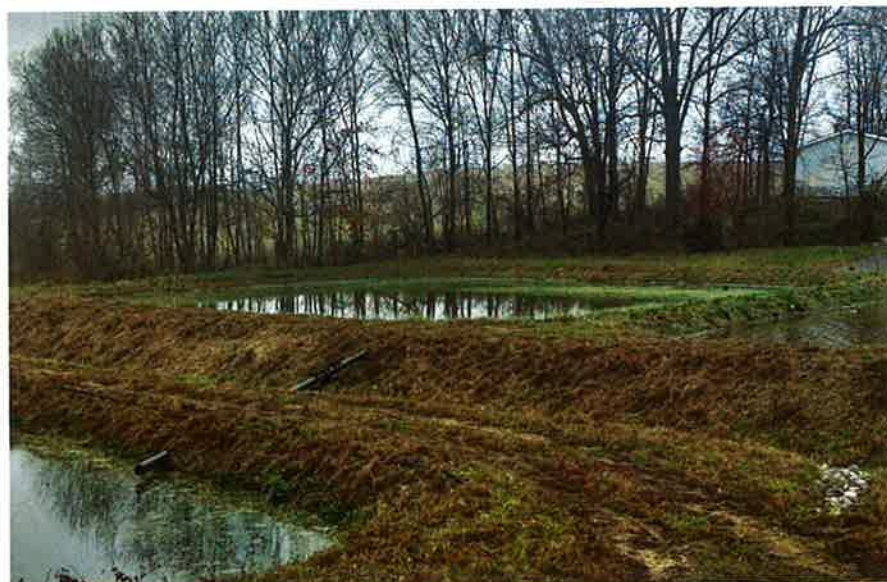
**Photo #:** 003  
**By:** Tim Mattingly  
**Facility:** Hillcrest Manor  
**Permit:** MO-0088072  
**Location:** Cape Girardeau County

**Description:** A photograph of the third cell of the Hillcrest Manor Subdivision. The pipe seen is for emergency maintenance on the second or third cells.

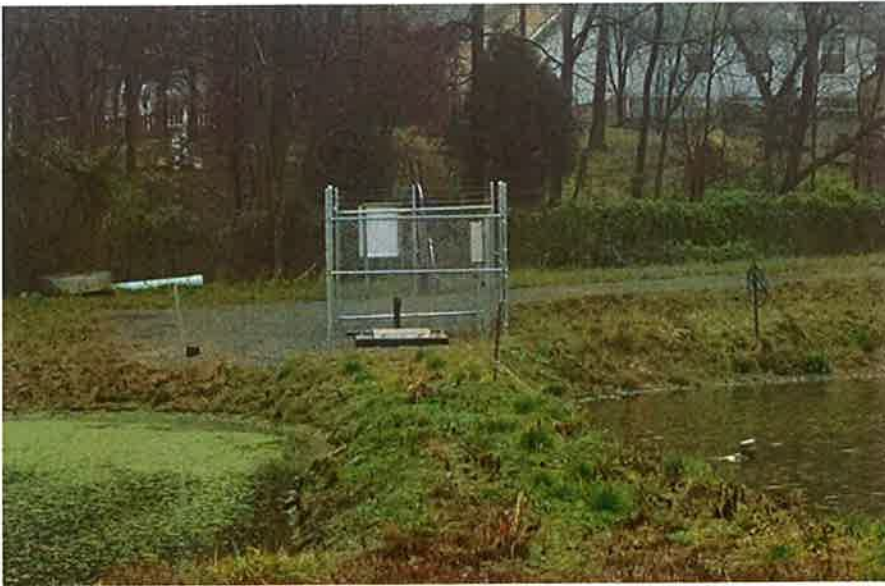
**Photo #:** 004  
**By:** Tim Mattingly  
**Facility:** Hillcrest Manor  
**Permit:** MO-0088072  
**Location:** Cape Girardeau County

**Description:** This small lift station is located between cells two and three and pumps wastewater from cell three to the moving bed biofilm reactor.

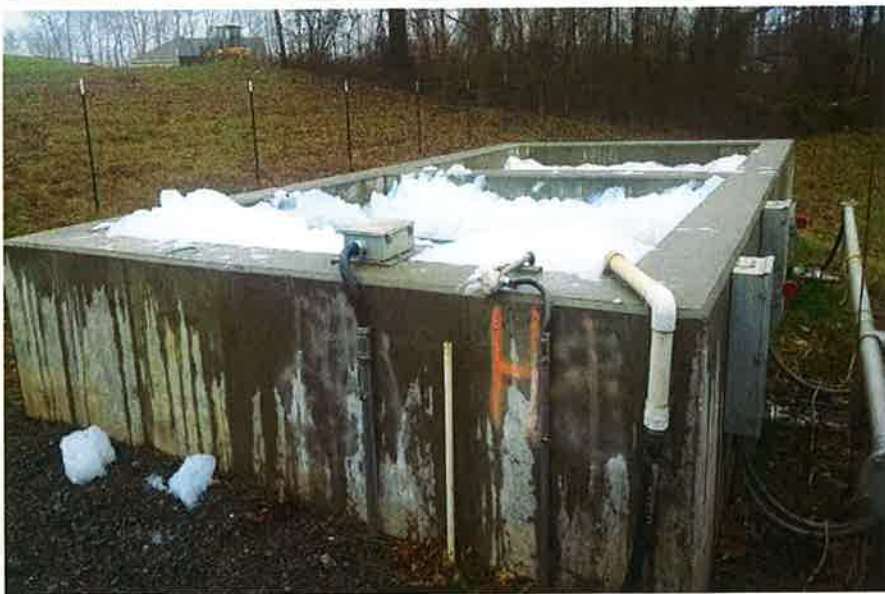
**Photo #:** 005  
**By:** Tim Mattingly  
**Facility:** Hillcrest Manor  
**Permit:** MO-0088072  
**Location:** Cape Girardeau County

There was foaming on the surface of the reactor during the inspection. I asked Mr. Brady about the foam and he informed me that any time there was a large temperature variance or if the facility experienced rainfall they had some foam on the surface. It appears that these variances slightly interfere with the microbial activity in the top layers of the biofilm.

**Description:** This is a photo of the moving bed biofilm reactor. The foam seen here is minimal, only occurring during extreme temperature fluctuations or periods of rain.

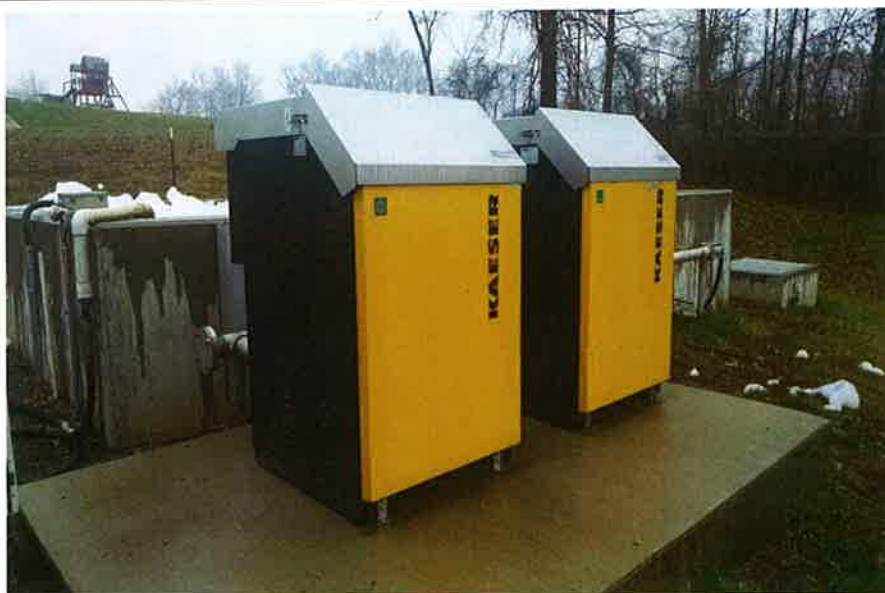
**Photo #:** 006  
**By:** Tim Mattingly  
**Facility:** Hillcrest Manor  
**Permit:** MO-0088072  
**Location:** Cape Girardeau County

**Description:** These are the two blowers that provide the air for the moving bed biofilm reactor. Their usage alternates between the two.

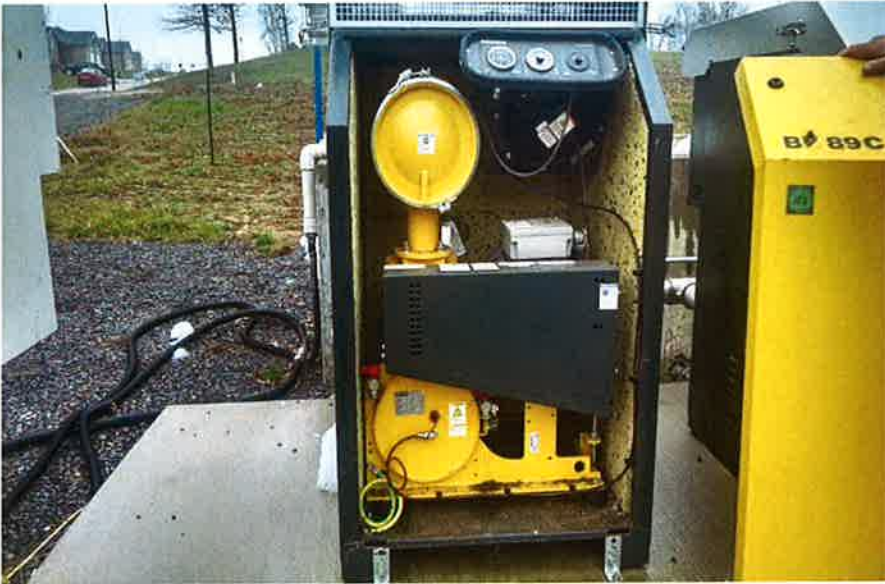
**Photo #:** 007  
**By:** Tim Mattingly  
**Facility:** Hillcrest Manor  
**Permit:** MO-0088072  
**Location:** Cape Girardeau County

**Description:** A picture of the internal components of the individual blowers.

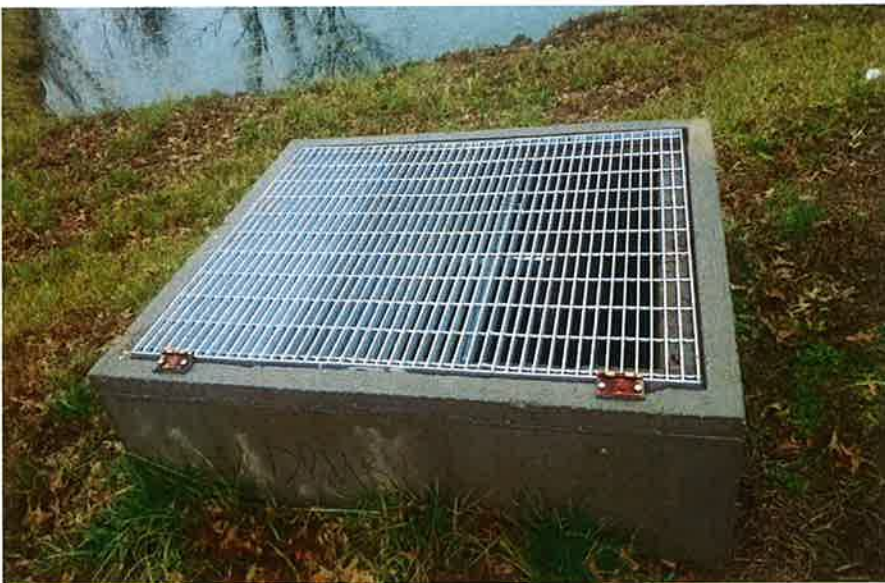
**Photo #:** 008  
**By:** Tim Mattingly  
**Facility:** Hillcrest Manor  
**Permit:** MO-0088072  
**Location:** Cape Girardeau County

**Description:** This is a photograph of the exterior of the weir box. The wastewater travels from the moving bed biofilm reactor to this structure.

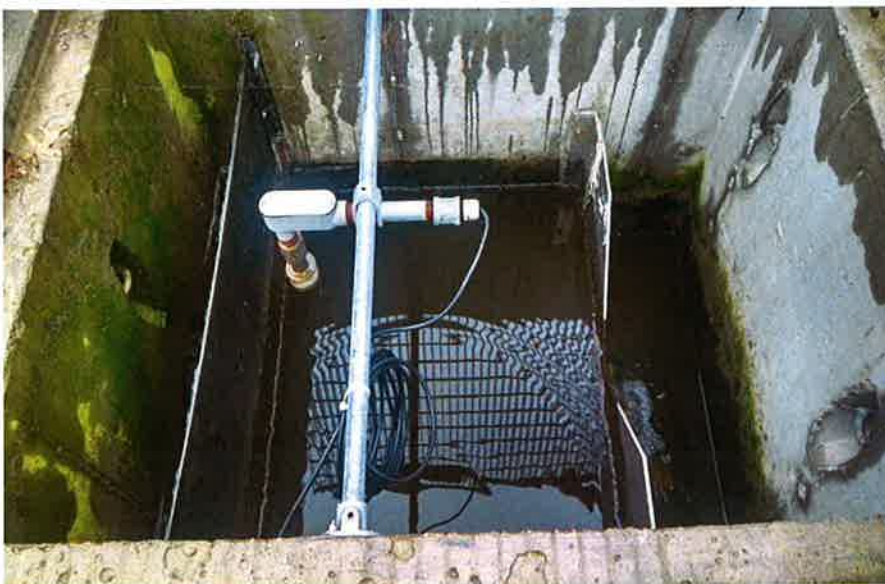
**Photo #:** 009  
**By:** Tim Mattingly  
**Facility:** Hillcrest Manor  
**Permit:** MO-0088072  
**Location:** Cape Girardeau County

**Description:** This is the interior of the weir box.

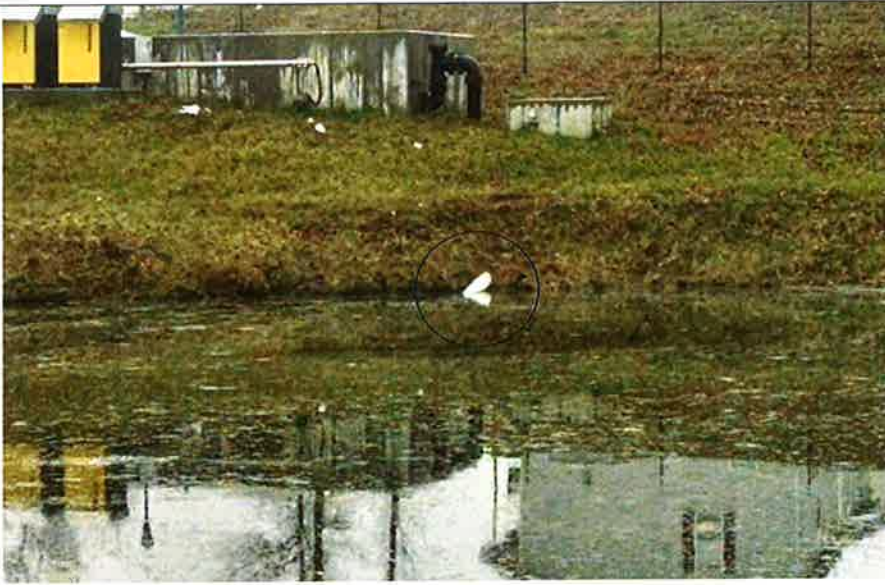
**Photo #:** 010  
**By:** Tim Mattingly  
**Facility:** Hillcrest Manor  
**Permit:** MO-0088072  
**Location:** Cape Girardeau County

**Description:** The pipe in the center of the circle is the pipe through which the wastewater travels from the weir box into the polishing cell.

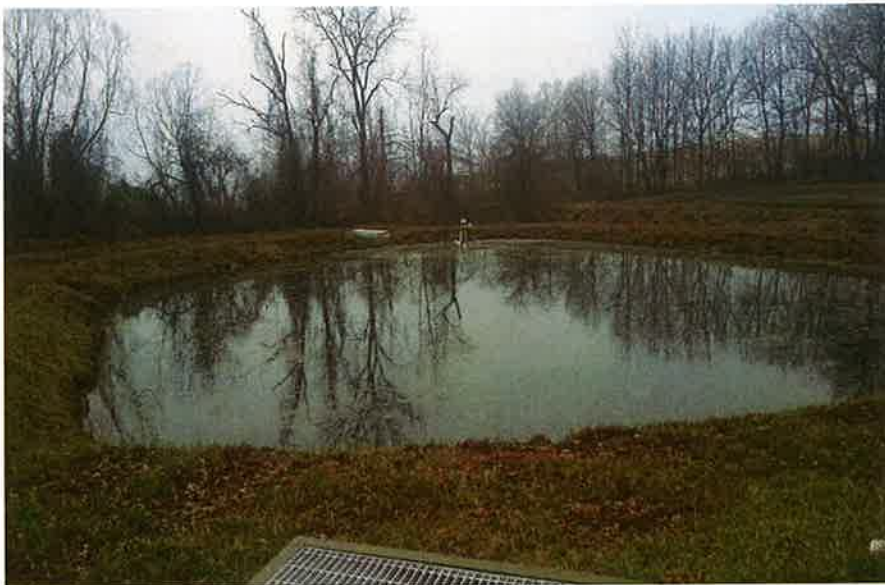
**Photo #:** 011  
**By:** Tim Mattingly  
**Facility:** Hillcrest Manor  
**Permit:** MO-0088072  
**Location:** Cape Girardeau County

**Description:** This photo is a view of the polishing cell.

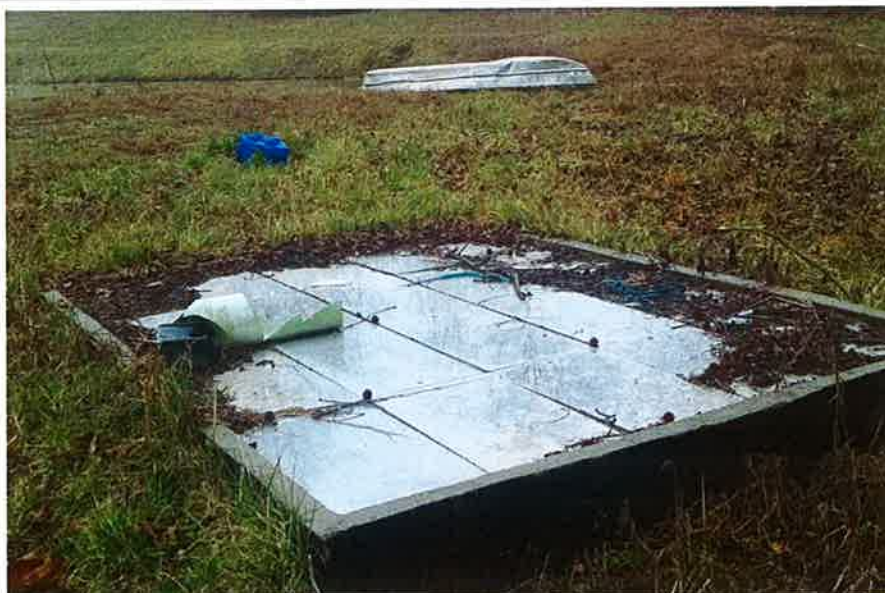
**Photo #:** 012  
**By:** Tim Mattingly  
**Facility:** Hillcrest Manor  
**Permit:** MO-0088072  
**Location:** Cape Girardeau County

**Description:** This is a photograph of the chlorine contact chamber. The blue box at the top of the picture is the tablet chlorinator.

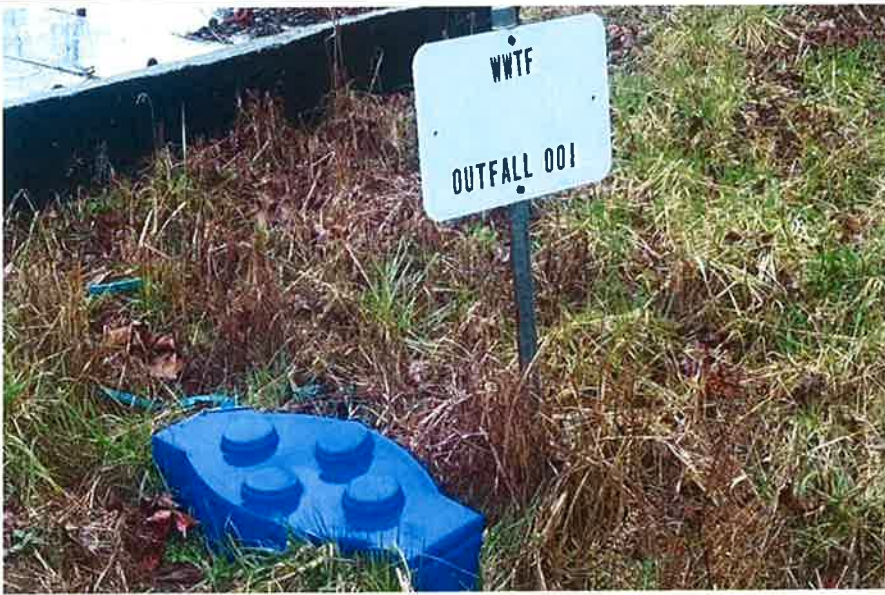
**Photo #:** 013  
**By:** Tim Mattingly  
**Facility:** Hillcrest Manor  
**Permit:** MO-0088072  
**Location:** Cape Girardeau County

**Description:** The blue box in this picture is the tablet de-chlorination unit. Obviously, the facility's outfall sign is also seen.

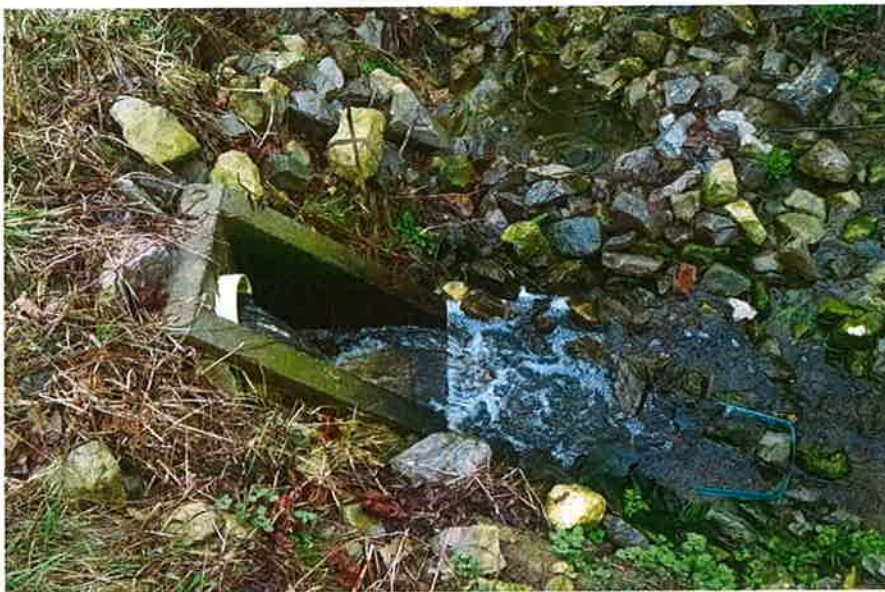
**Photo #:** 014  
**By:** Tim Mattingly  
**Facility:** Hillcrest Manor  
**Permit:** MO-0088072  
**Location:** Cape Girardeau County

**Description:** This photo show outfall #001 for the facility. The effluent was clear with no odor.

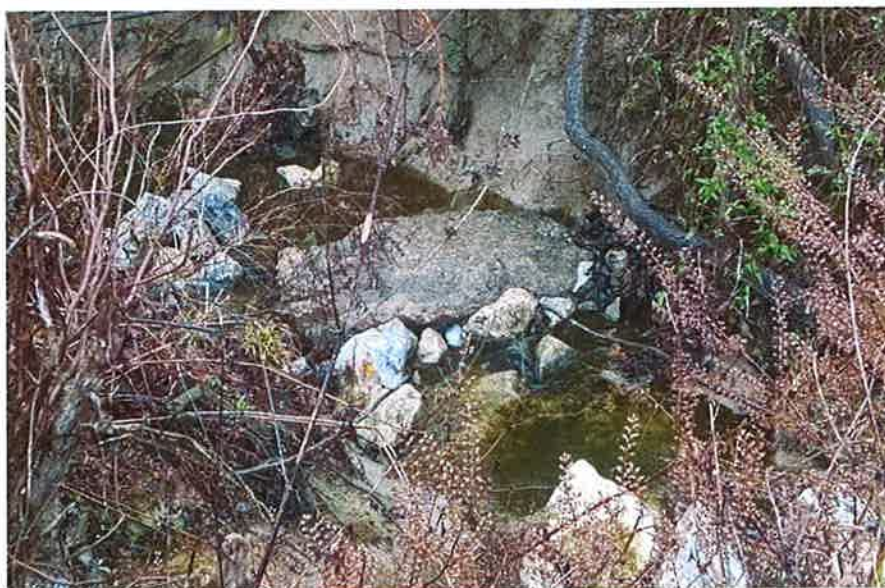
**Photo #:** 015  
**By:** Tim Mattingly  
**Facility:** Hillcrest Manor  
**Permit:** MO-0088072  
**Location:** Cape Girardeau County

We proceeded to the discharge area and I observed the tablet chlorination unit, the chlorine contact chamber, the de-chlorination unit, and the discharge pipe. Mr. Brady did tell me that he often has problems with turtles getting stuck in the inlet to the chlorination unit or the inlet to the discharge pipe at the inlet. I suggested perhaps a large grid screen of some type could be placed over the opening of the inlet of the discharge pipe. The chlorination disinfection unit was not in operation as it is only required April 1 through October 31. The discharge on the day of inspection was very clear. There was no offensive odor and no trash or bottom deposits, only a little algae growth. The receiving stream had a low flow, but the water was clear with no odor.

**Description:** This is a picture of the receiving stream downstream of the WWTF. It had a low flow with a little algae growth. This stream also receives drainage for the subdivision just prior to the area where this photo was taken.
