FINDING OF COMPLIANCE

Missouri Department of Natural Resources
Southeast Regional Office/Public Drinking Water Program
Report of Inspection
Hillcrest Utility Operating Company, Inc.
Highway K, Cape Girardeau, MO 63702
Cape Girardeau County Missouri
MO4036038
February 1, 2018

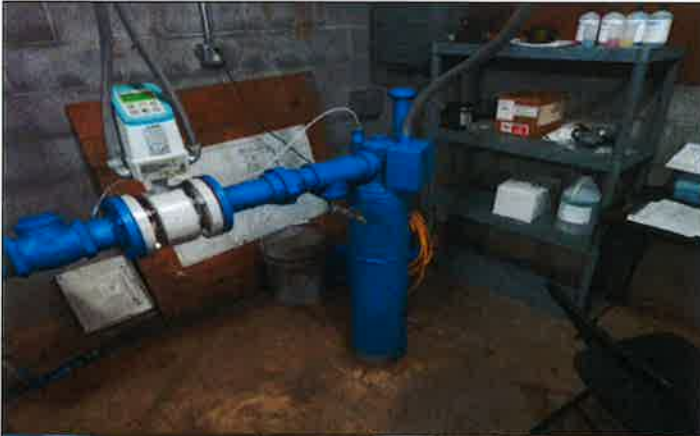
Photo #: 001
Date Taken: 01/24/2018
By: Michael Wyatt
Program: PDWB
File: Hillcrest Utility Operating Co., Inc. – General
Location: Well house
Description: Well.

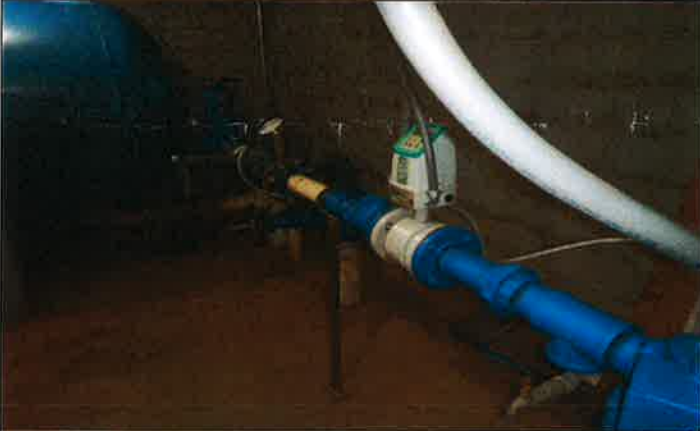
Photo #: 002
Date Taken: 01/24/2018
By: Michael Wyatt
Program: PDWB
File: Hillcrest Utility Operating Co., Inc. – General
Location: Well house
Description: Discharge piping.

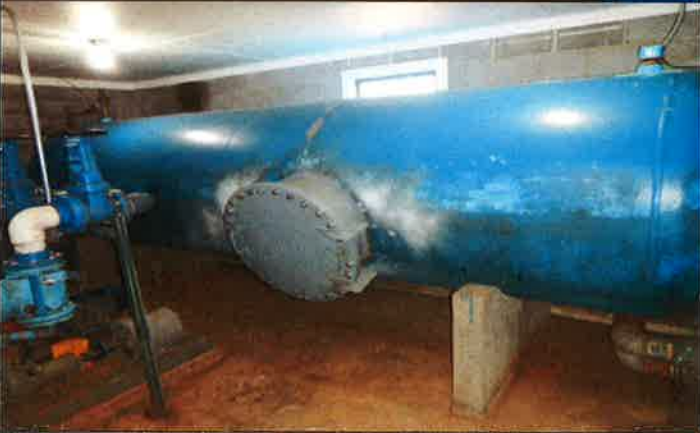
Photo #: 003
Date Taken: 01/24/2018
By: Michael Wyatt
Program: PDWB
File: Hillcrest Utility Operating Co., Inc. – General
Location: Well house
Description: ~2,100 gallon hydro-pneumatic pressure tank.

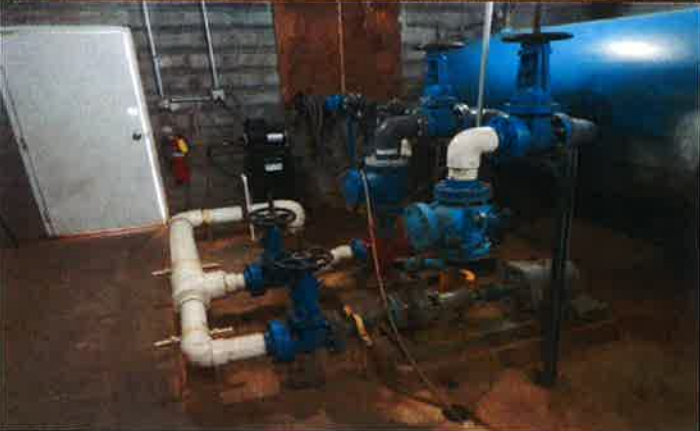
Photo #: 004
Date Taken: 01/24/2018
By: Michael Wyatt
Program: PDWB
File: Hillcrest Utility Operating Co., Inc. – General
Location: Well house
Description: High service pumps.

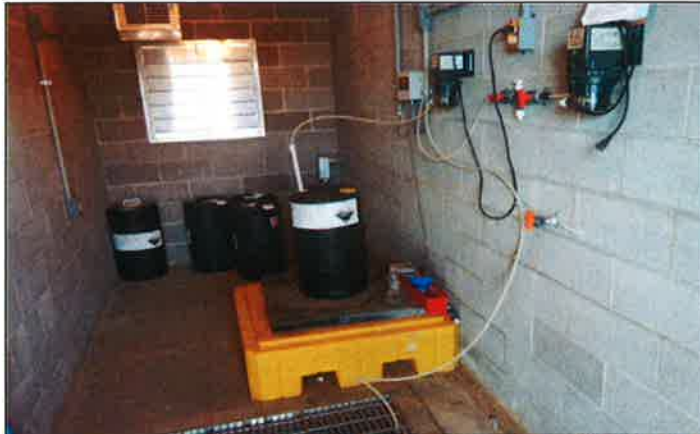
Photo #: 005
Date Taken: 01/24/2018
By: Michael Wyatt
Program: PDWB
File: Hillcrest Utility Operating Co., Inc. – General
Location: Chlorine feed room
Description: Chlorine feed system.

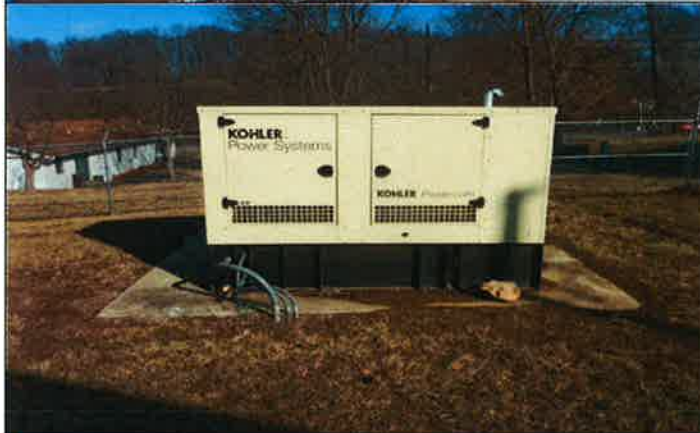
Photo #: 006
Date Taken: 01/24/2018
By: Michael Wyatt
Program: PDWB
File: Hillcrest Utility Operating Co., Inc. – General
Location: Back of well house building
Description: Stationary generator.

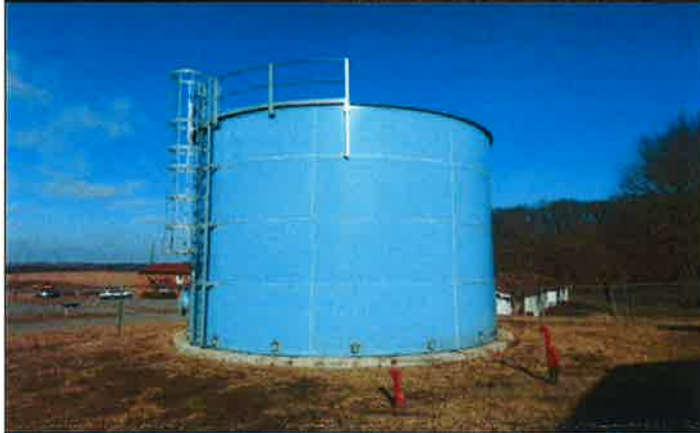
Photo #: 007
Date Taken: 01/24/2018
By: Michael Wyatt
Program: PDWB
File: Hillcrest Utility Operating Co., Inc. – General
Location: Tank site
Description: 58,000 gallon ground storage tank.

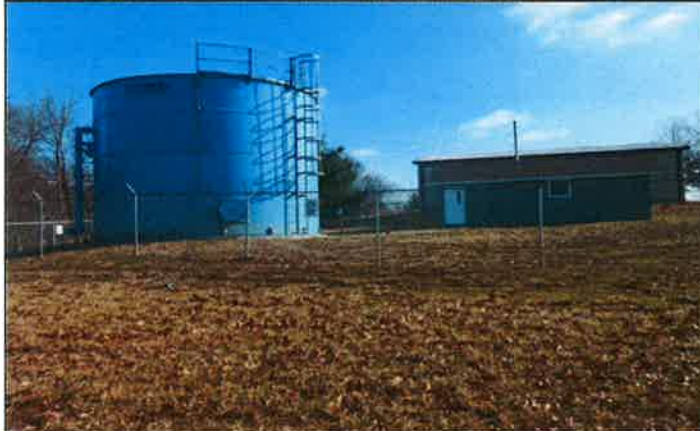
Photo #: 008
Date Taken: 01/24/2018
By: Michael Wyatt
Program: PDWB
File: Hillcrest Utility Operating Co., Inc. – General
Location: Well/tank site
Description: Fenced well house and storage tank.
