# AmerenUE's Storm Outage Planning and Restoration Effort Following the Storms on July 19 and 21, 2006

**Case No. EO-2007-0037**  
**Missouri Public Service Commission Staff**  
**November 17, 2006**

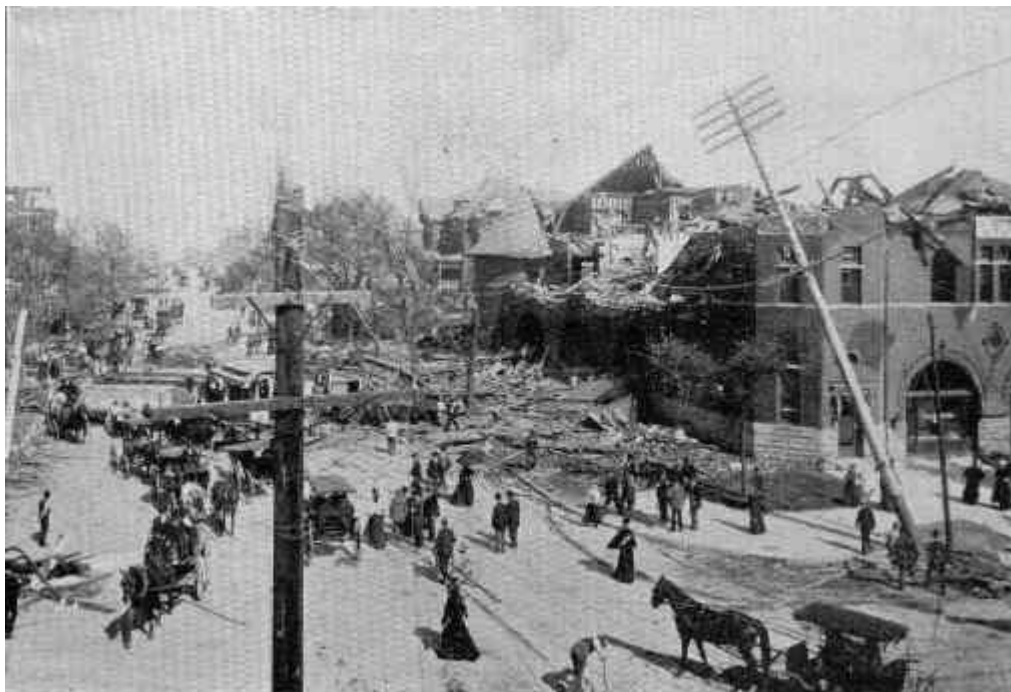
In a St. Louis Post-Dispatch article on August 13, 2006, referencing damage to Tower Grove Park, sources reported that “114 trees overturned, and 100 more may need to be cut down” and “The storm was the second worst to hit the park since it was founded in 1868. The only event more destructive was the Great Cyclone of 1896...”

Picture from this website link of damage in St. Louis:

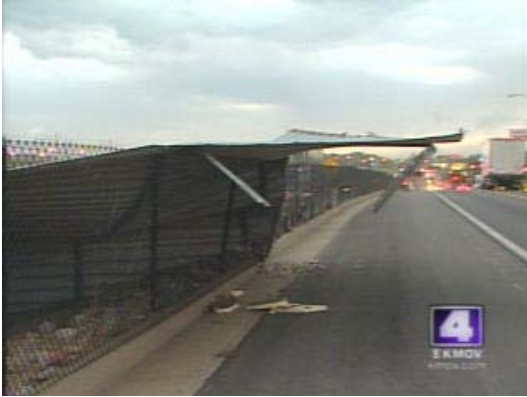
Part of Lambert Terminal Roof on I-70  
(Courtesy: Channel 4, St. Louis)

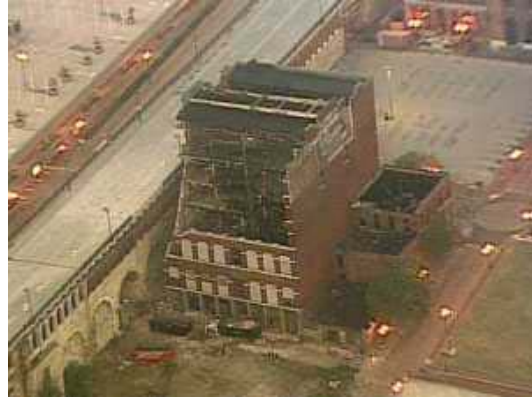
Switzer Bldg. in Laclede's Landing  
(Courtesy: Ameren)

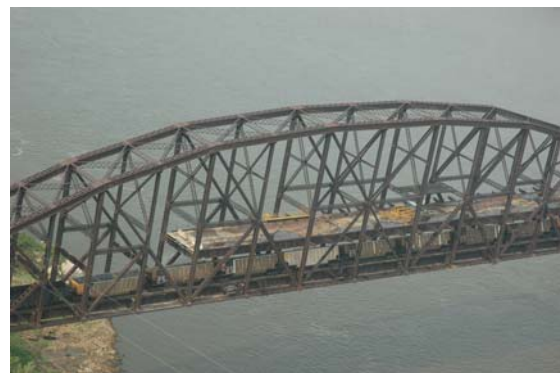
Tipped Rail Cars on Bridge  
(Courtesy: Ameren)

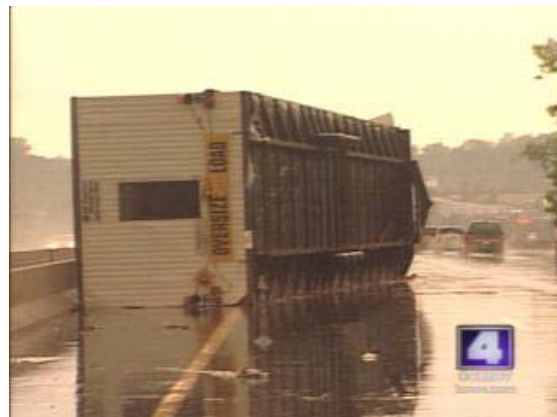
Manufactured Home on Highway  
(Courtesy: Channel 4, St. Louis)

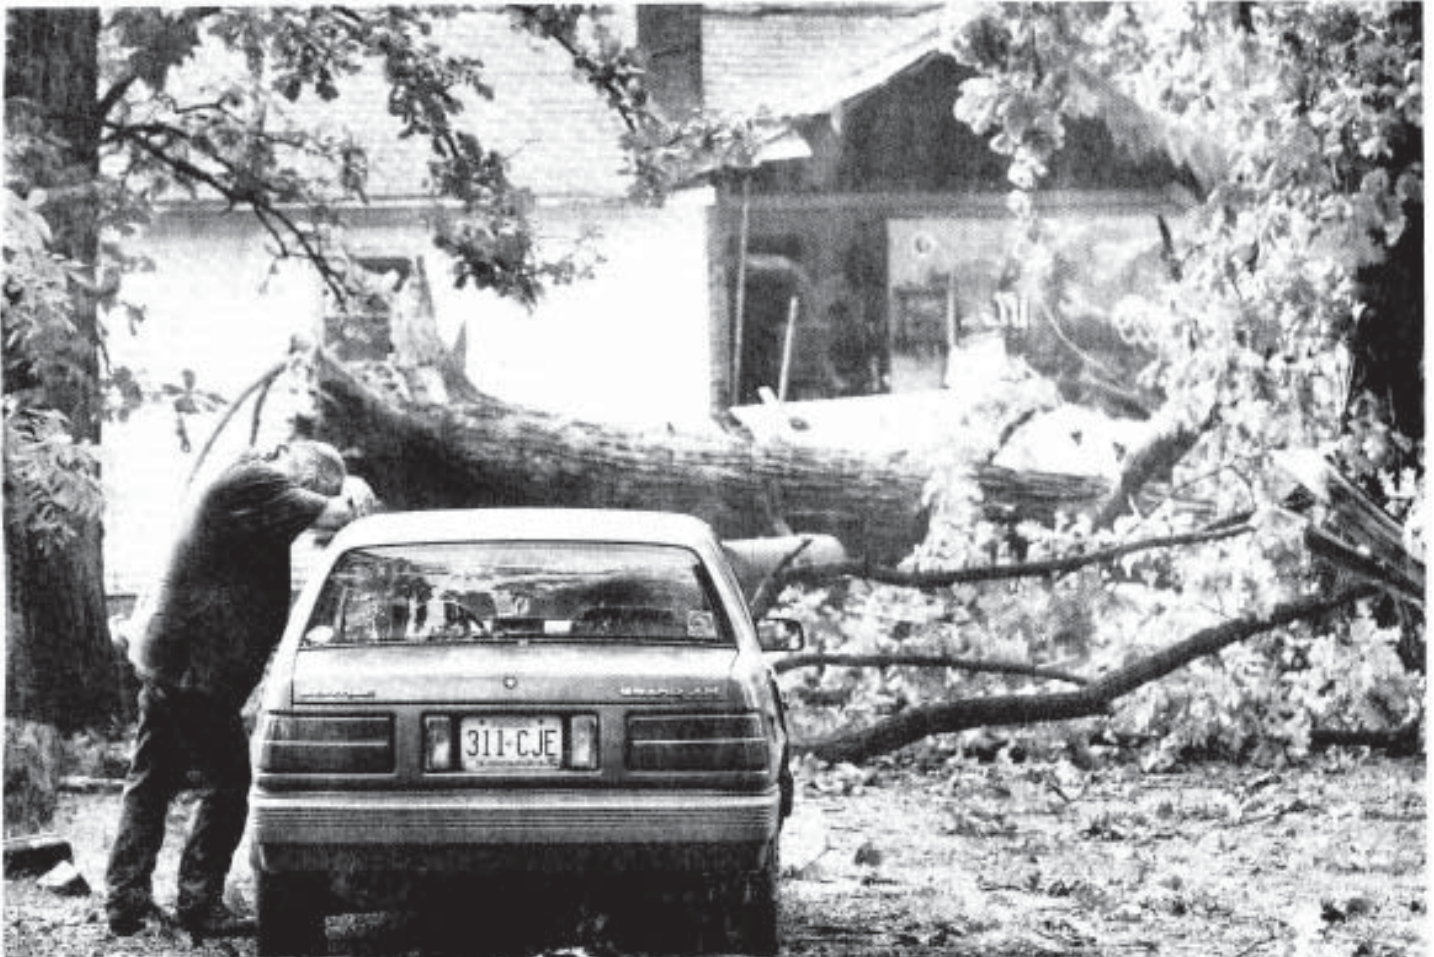
In Arnold on Thursday, Tom Harris waits for the arrival of the American Red Cross after trying to salvage belongings at his home on Fannie Drive. A large white oak tree ripped through his living room Wednesday night while he and his wife, Tana, were watching television weather reports with their family. When the roof collapsed, his son Levi, 5, was trapped and was freed when family members lifted the roof trusses. Photos (Clockwise from Top Left)

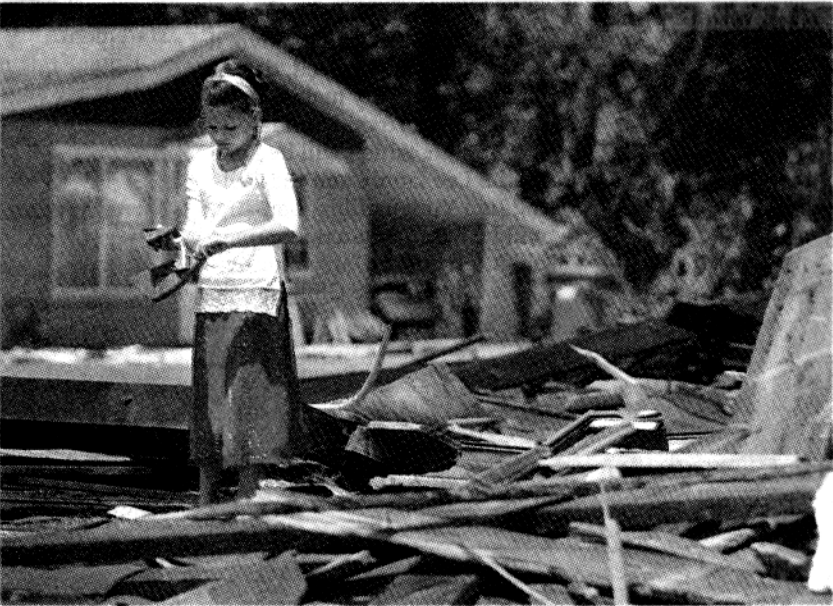
Allyson Heil, 9, of Hamel, stands Sunday amid the rubble of Landmark Pentecostal Church in Bethalto, which was shattered in Wednesday's storm. "I took a few mementos of our church," she said, with tears in her eyes. The congregation worshipped Sunday at First Baptist Church of Bethalto. Gabriel B. Tait | Post-Dispatch

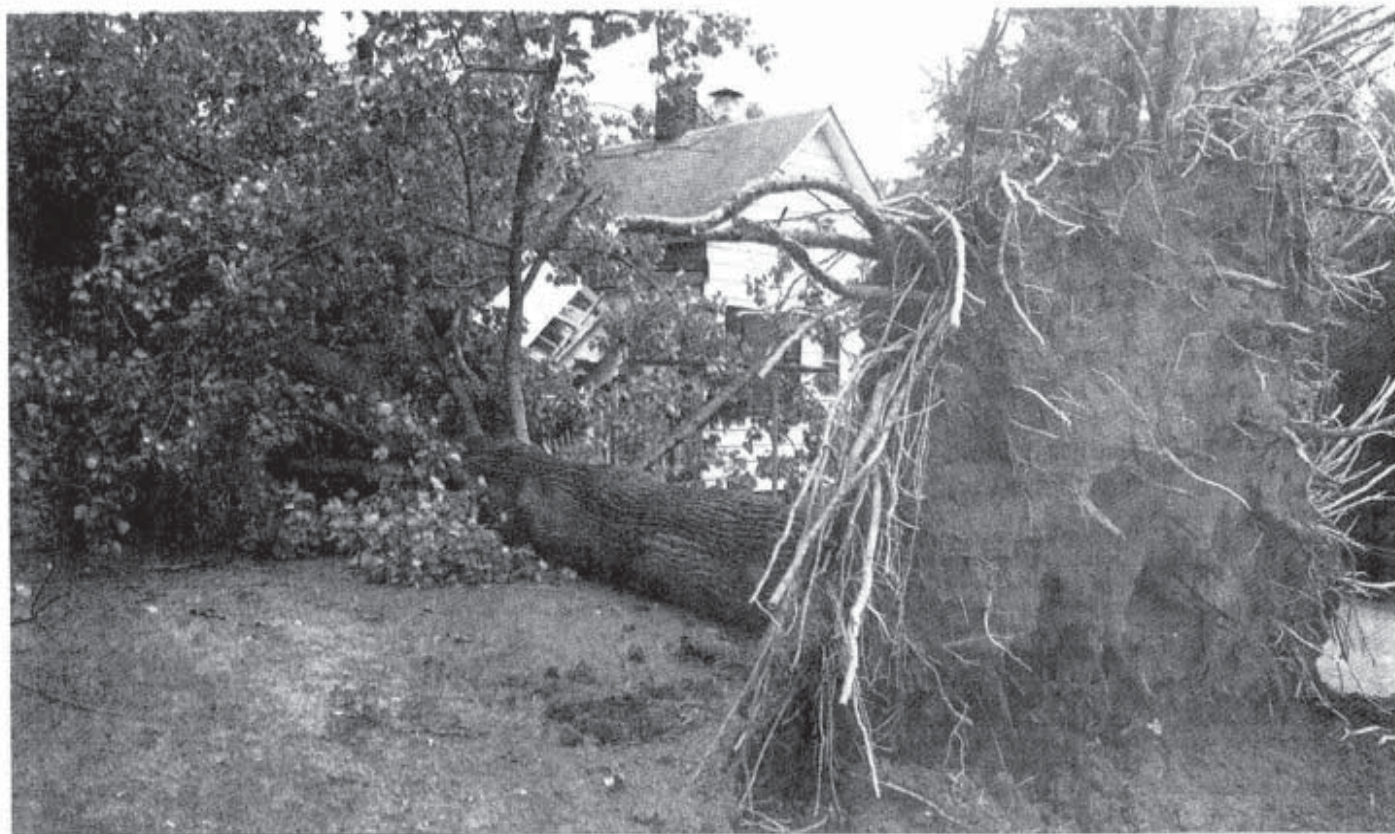
This tree fell on this home in Troy, Ill., during last week's storms. Claims for property damage from rain, wind, fallen trees and limbs, and lightning throughout the area have been filed with insurance companies. Dawn Majors | Post-Dispatch
