The Staff of the Missouri Public Service Commission,)	
)	
)	
Complainant,)	
)	<u>Case No. WC-2008-0030</u>
v.)	
)	
Suburban Water and Sewer Co. and Gordon Burnam,)	
)	
)	
Respondents.)

STAFF’S UPDATED REPORT AND MOTION FOR EVIDENTIARY HEARING

PICTURE REPORT

INSPECTION REPORT

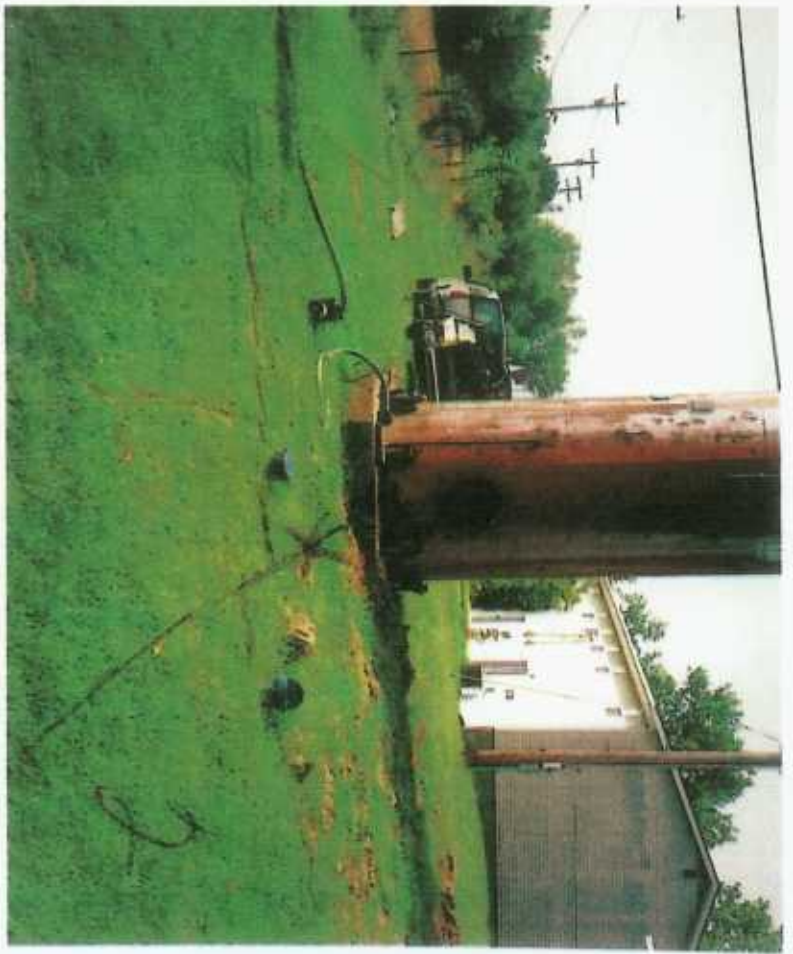
| 2. | Looking from the well house towards the tank – I drew piping lines on this picture as I believe they exist. There are two valves that can shut water off, both right and left, going to distribution BUT CAN NOT CLOSE OFF THE TANK, another valve is needed at the (X), marked on the picture. |

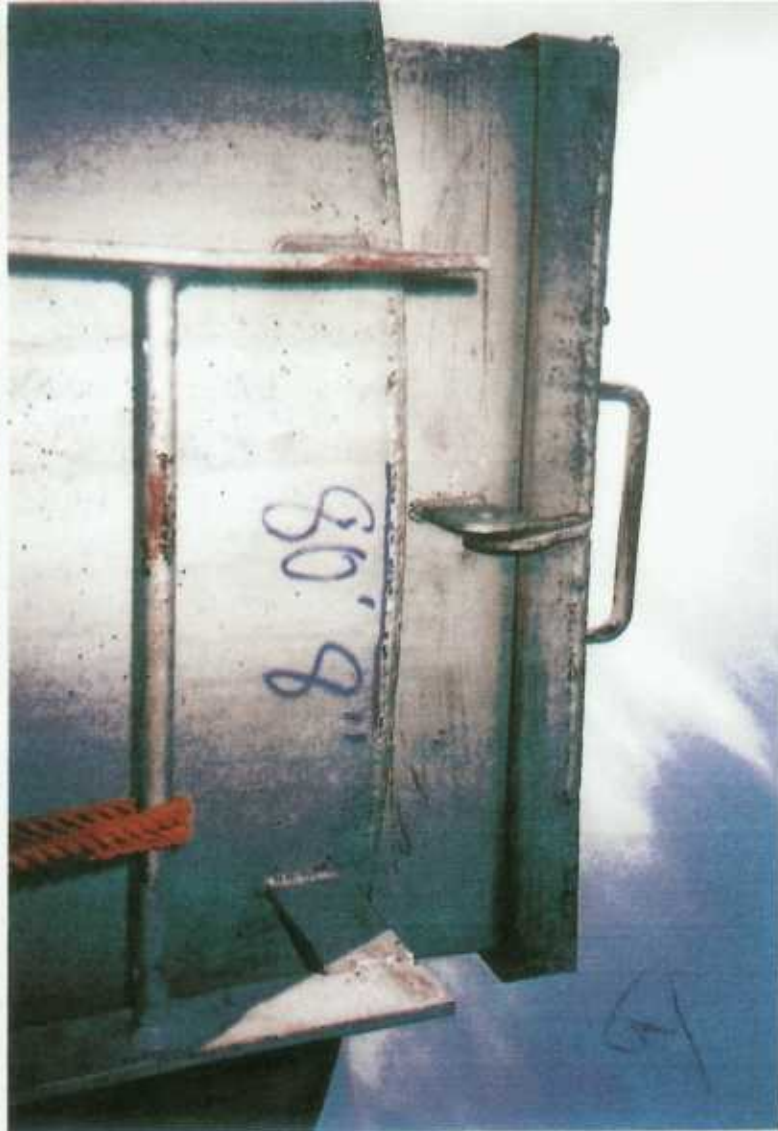
5. Tank is 80' 8" tall. The ladder is not compliant with current OSHA Design & Safety Regulations, has no safety climb and no climb prevention cover. The roof hatch is 24" square, hinged and lockable, this would be okay.

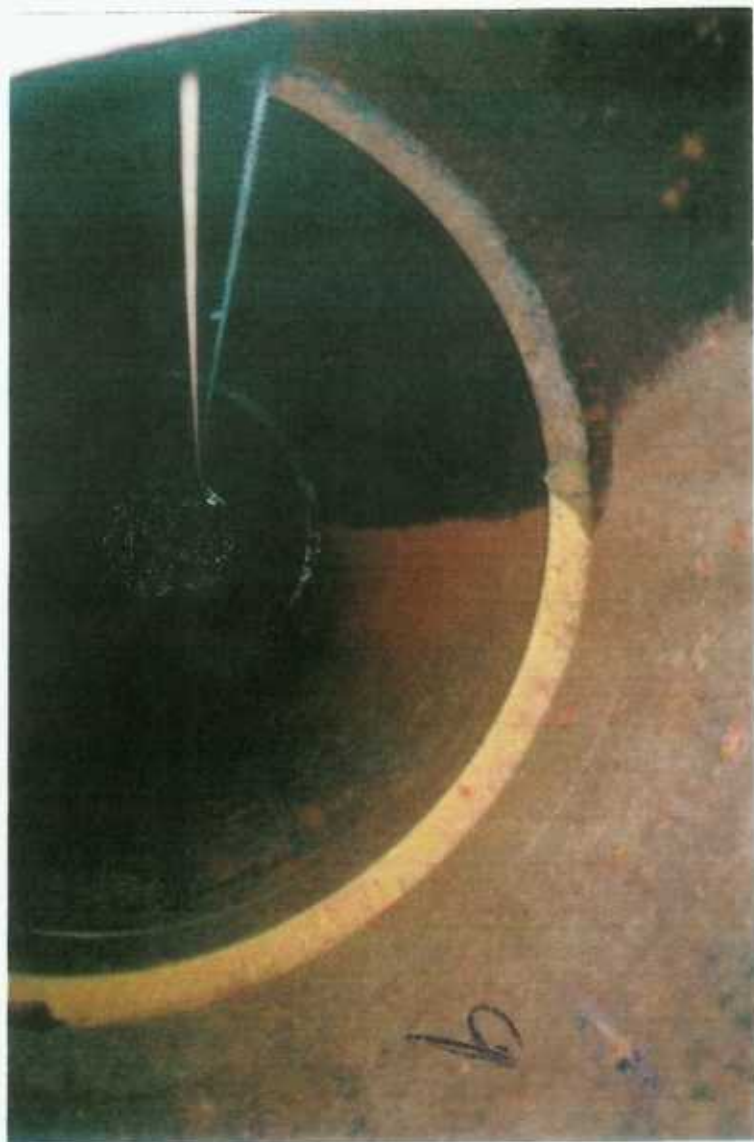
7. Inside the tank - overflow intake is an open end 4" pipe and the high water level is 79' 10". There is a very small amount of red paint on the roof and top few feet of shell wall.

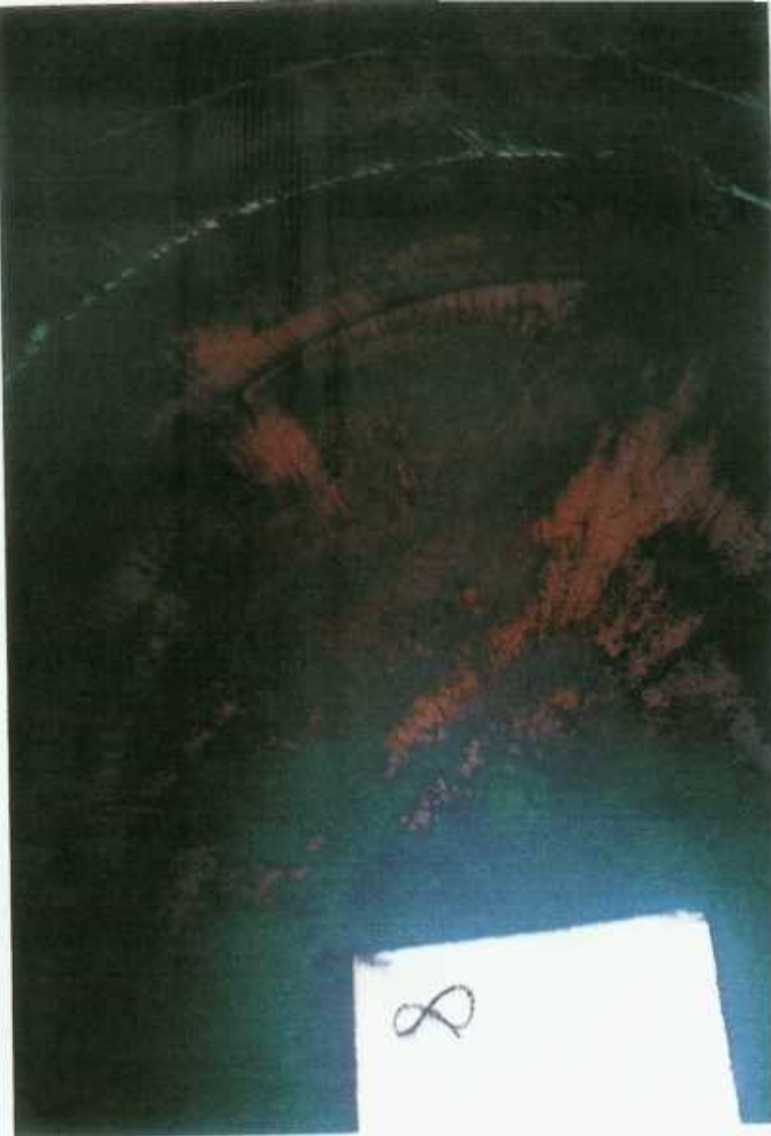
8. Very little paint at the top and nothing but RUST going down.
9. Looking down - Solid RUST. There are 4 or 5 reinforcement bands inside.
10. The top 3 shell sections are covered with rust grains, starting at the 4th section down there is scale rust and pitting.

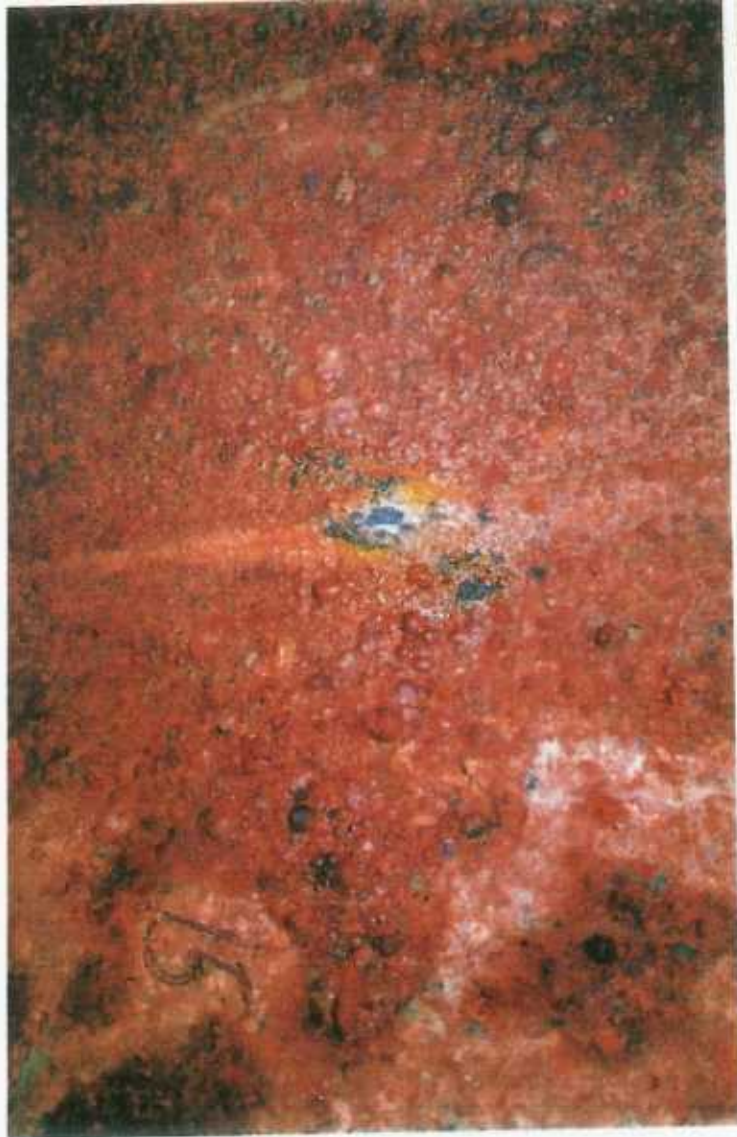
2. Zelch states that picture number 15 shows "heavy barnacles, blisters and pits. **I am confident that if I scratched very much, I would find pits that go completely through to daylight**"(emphasis in original). Describing picture number 17, Zelch claims "the lower $\frac{1}{4}$ to $\frac{1}{3}$ of the tank is ABSOLUTE JUNK AND NOT REPAIRABLE. The tank will have to be replaced, it is not worth spending money on this one." Zelch Depo. Exhibit 15. Zelch identified over 30 patched leaks on the tank. Zelch Depo., p. 41.

14. About halfway down I found NO paint, just rust.
15. About 2/3 down are heavy barnacles, blisters and pits. I am confident that if I scratched very much, I would find pits that go completely through to daylight.

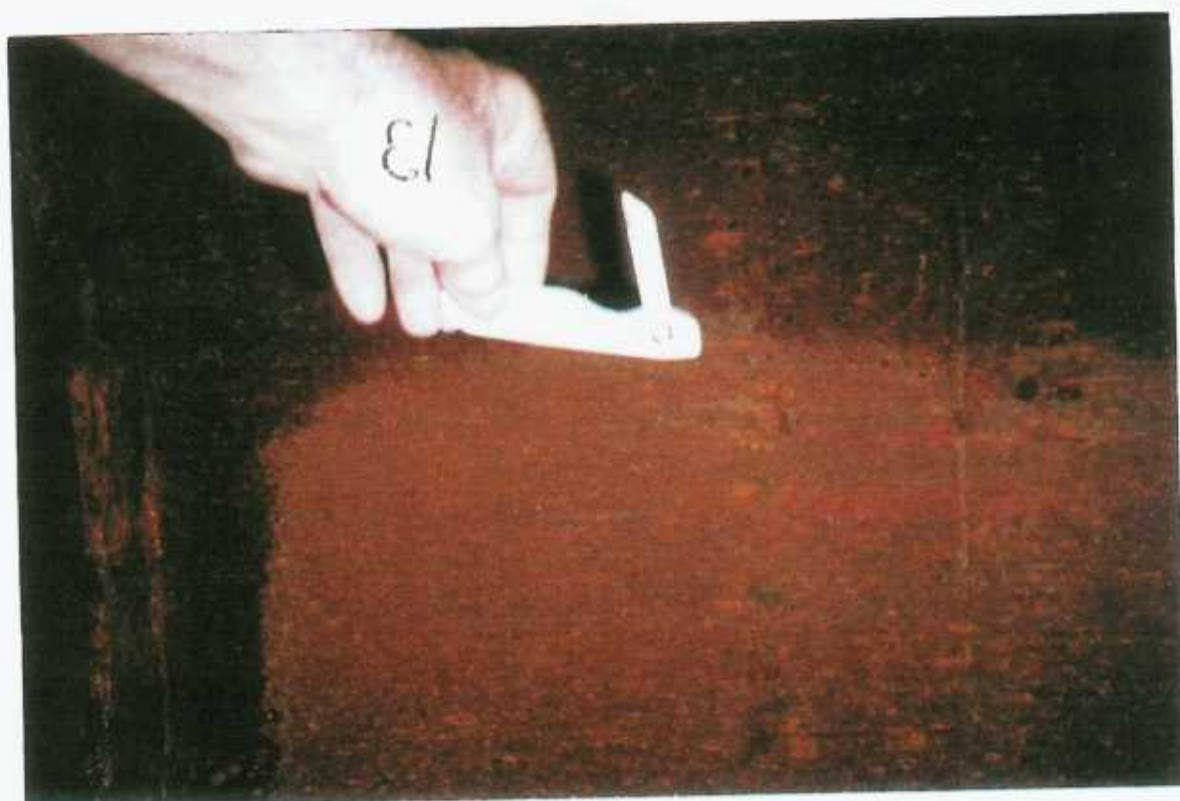
16. RUST, pits and patches welded on the outside.
17. The lower ¼ to 1/3 of the tank is ABSOLUTE JUNK AND NOT
18. REPAIRABLE. The tank will have to be replaced, it is not worth
& spending money on this one. Start over with a different tank, there

19. should be decent repairable 6' tanks out there, that could be moved here and set on this concrete pad.
20. The roof hatch is closed and held with a bolt.

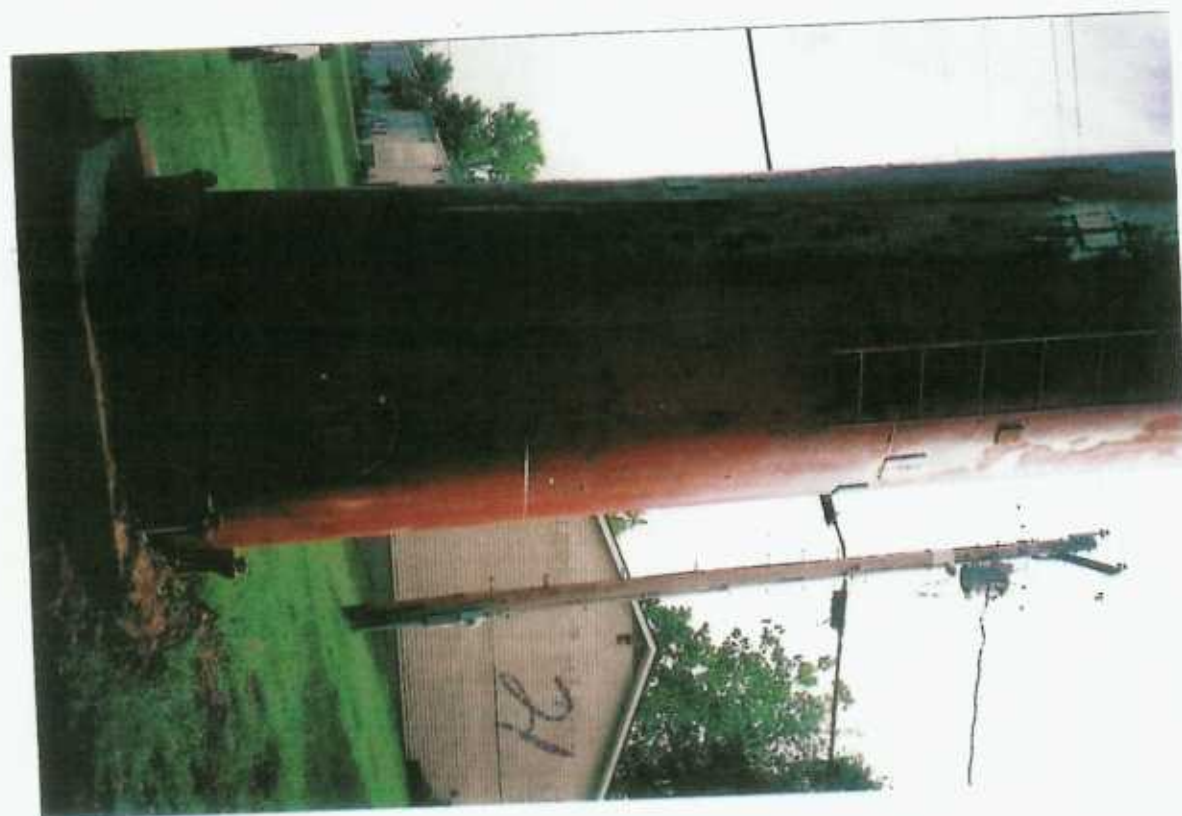
21. The hatch is closed and bolted. The tank is chlorinated and refilling.
22. There are 30 + patches on the bottom 5 or 6 shell sections. Very little aluminum finish and not much red primer. This tank is in VERY POOR condition.

There were no indications of leaks in the tank on the day of the inspection, but the bottom section had at least 32 patches.
